August 8, 2019

Project No. 9231000005.5000

LANDSBURG MINE SITE REMEDIATION CONSTRUCTION ACTIVITIES SUMMARY REPORT JULY AND AUGUST 2019

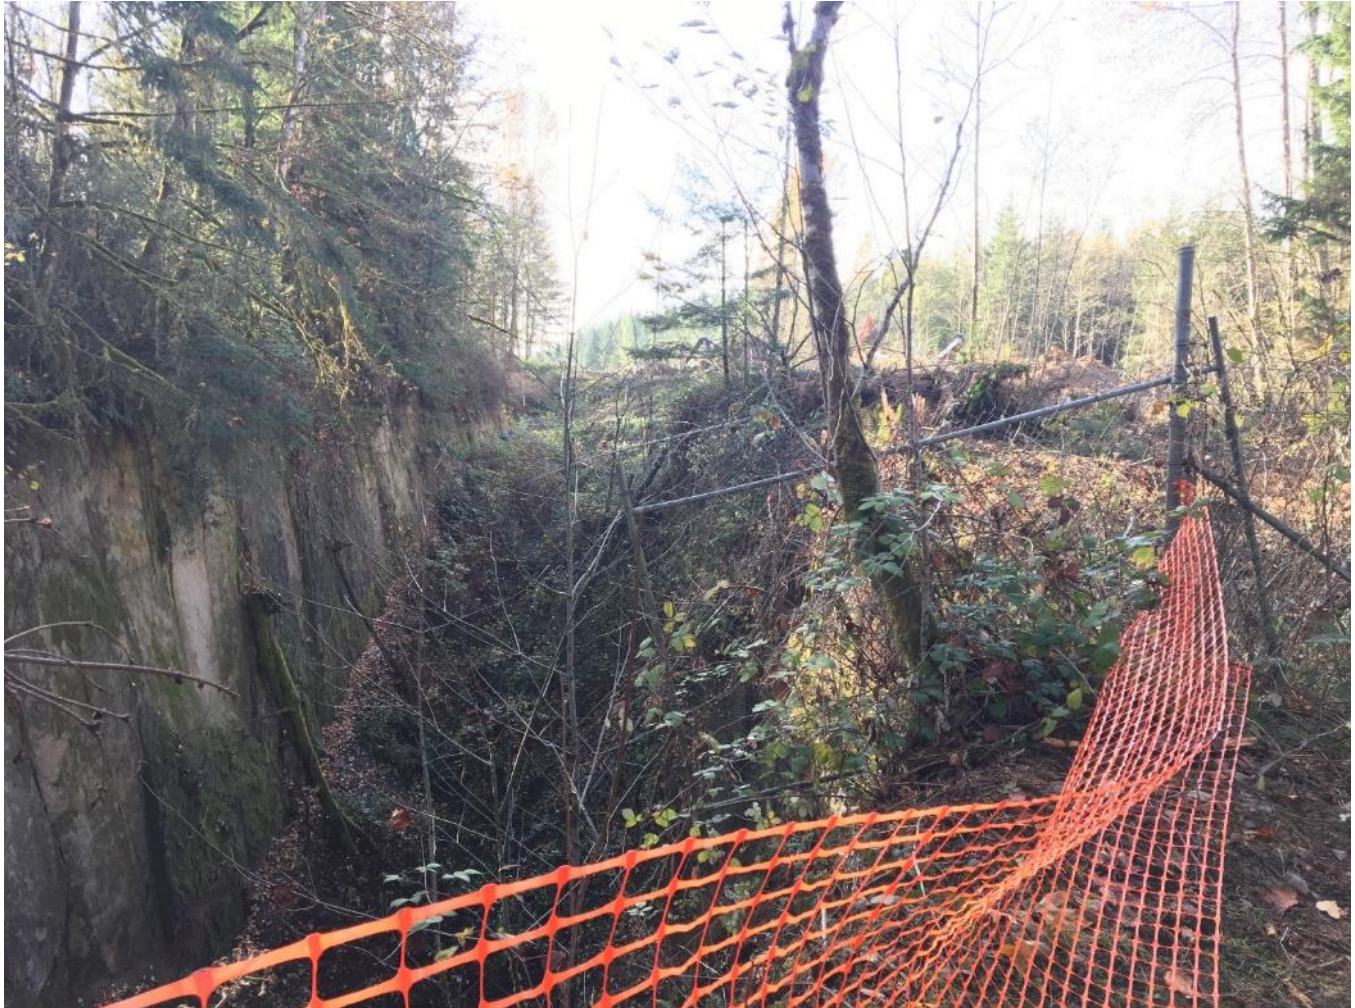
Photo 1 – Area 9, November 15, 2018 (looking south from northern tip)

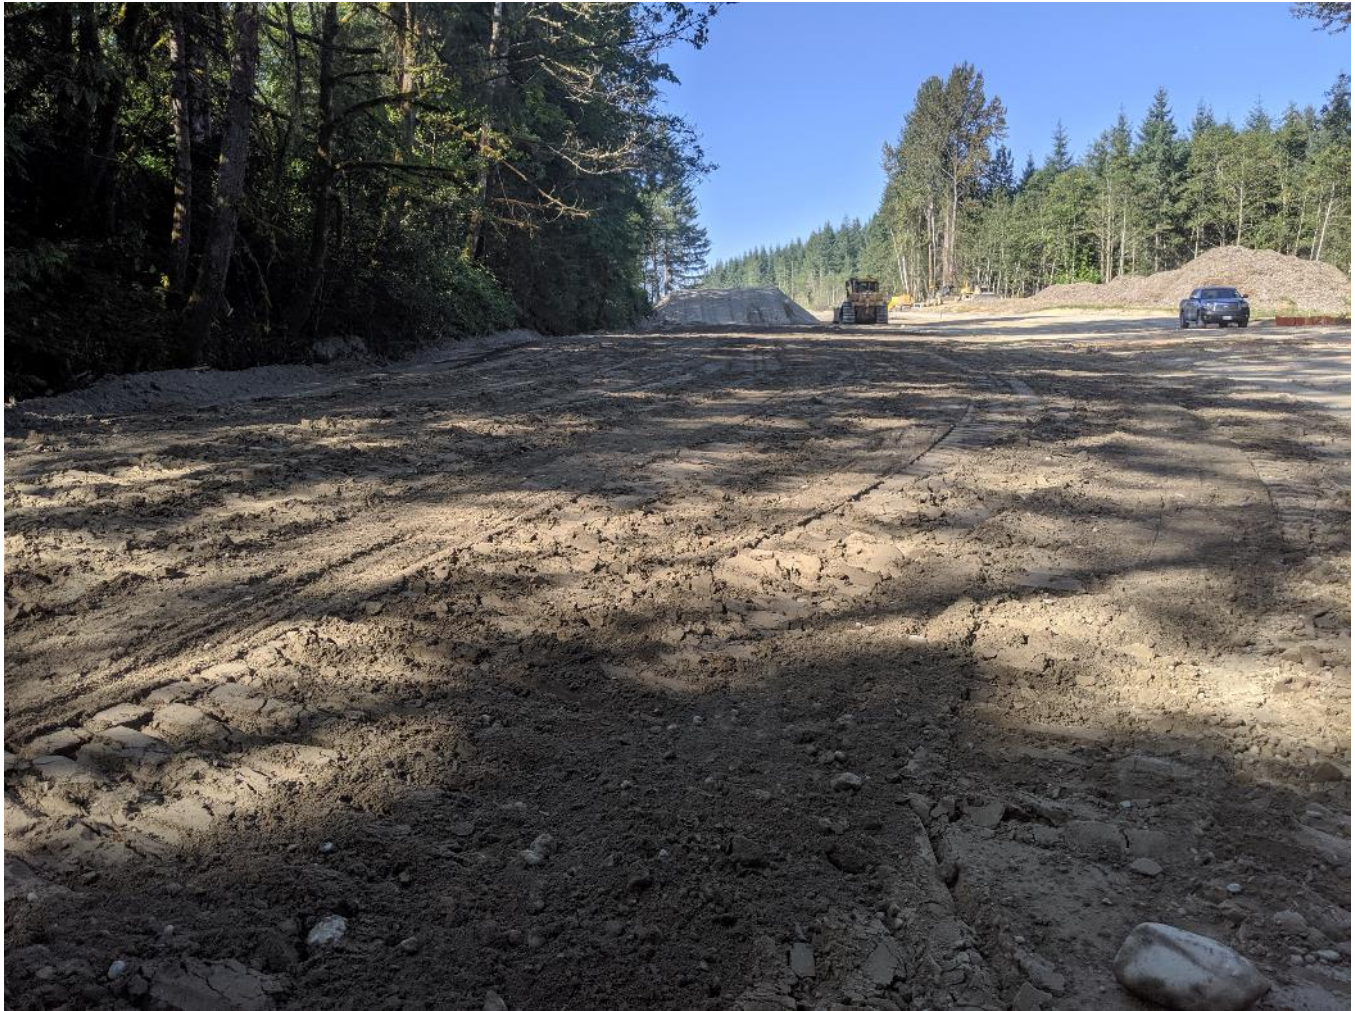
Photo 2 – Area 9, August 5, 2019 (looking south from northern tip)

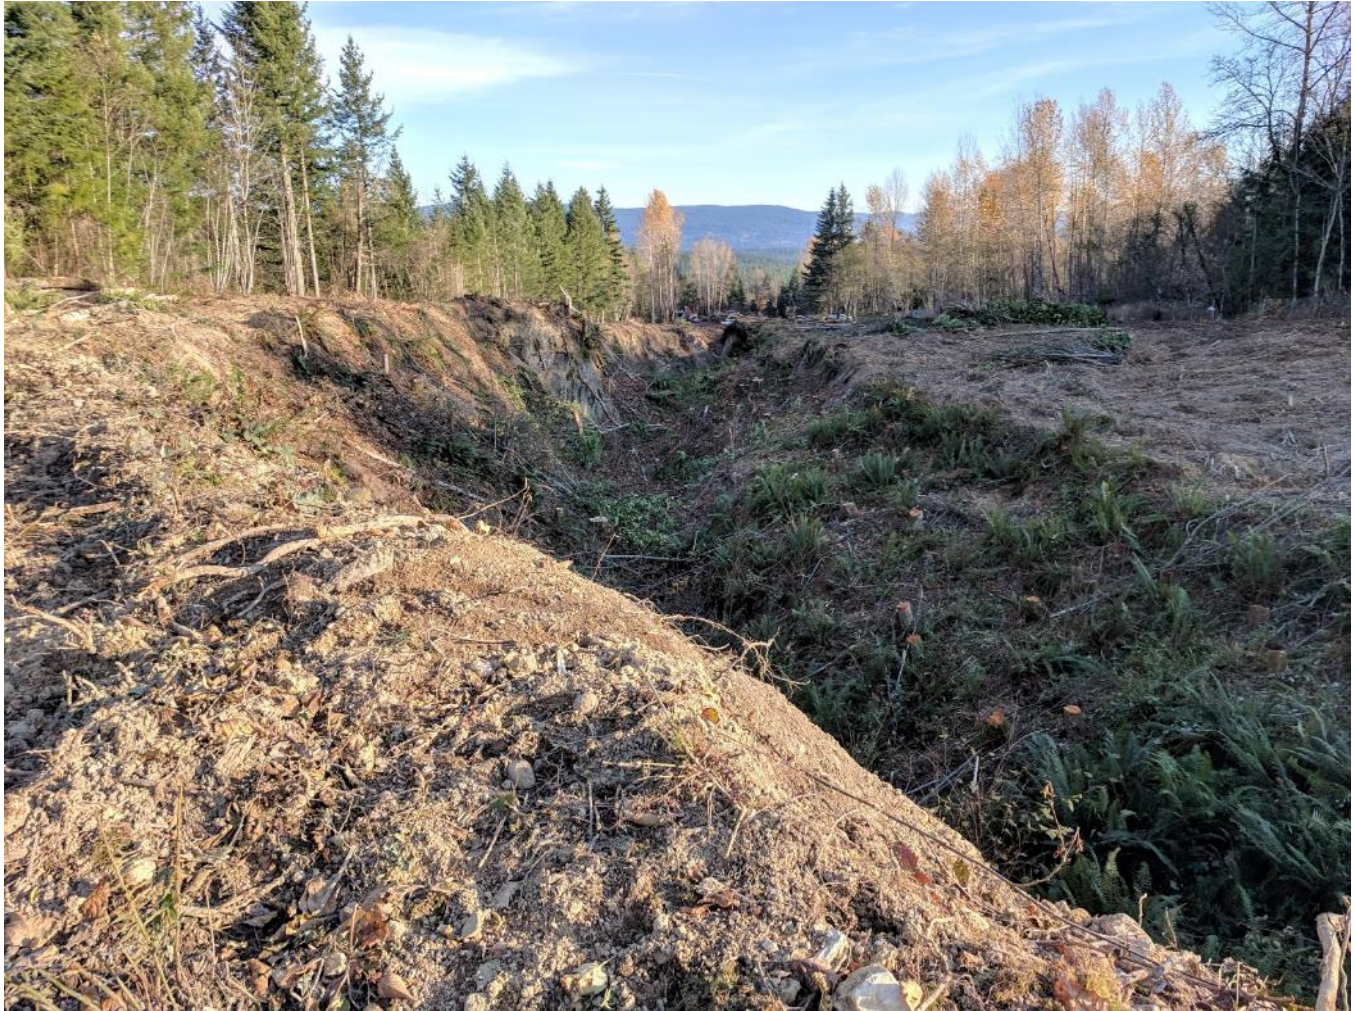
Photo 3 – Area 8, November 20, 2018 (looking northeast from southern tip)

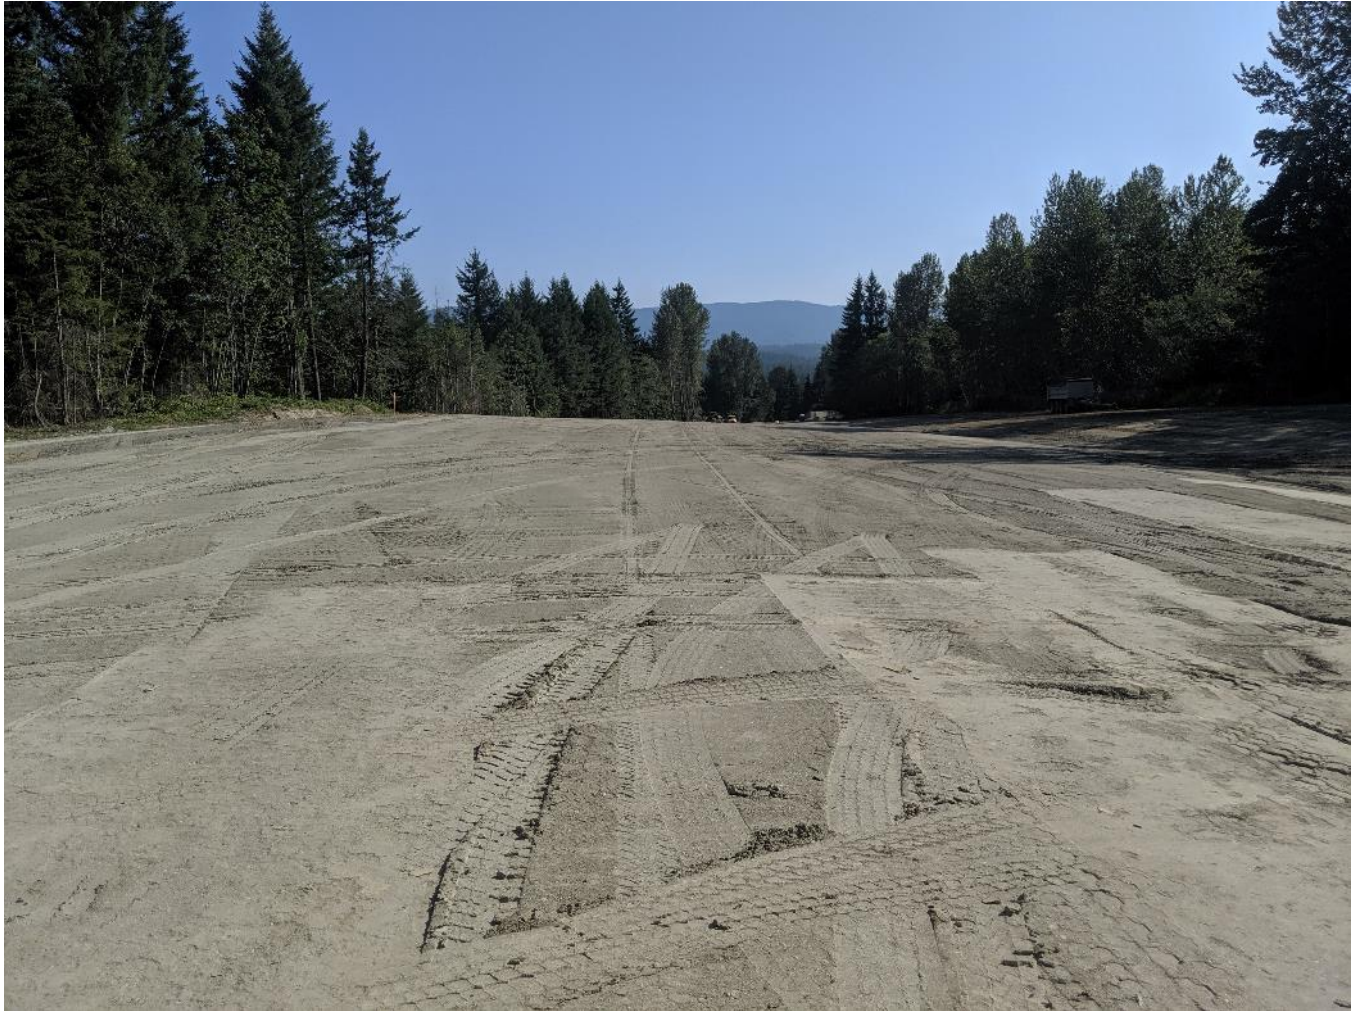
Photo 4 – Area 8, August 5, 2019 (looking north from southern tip)

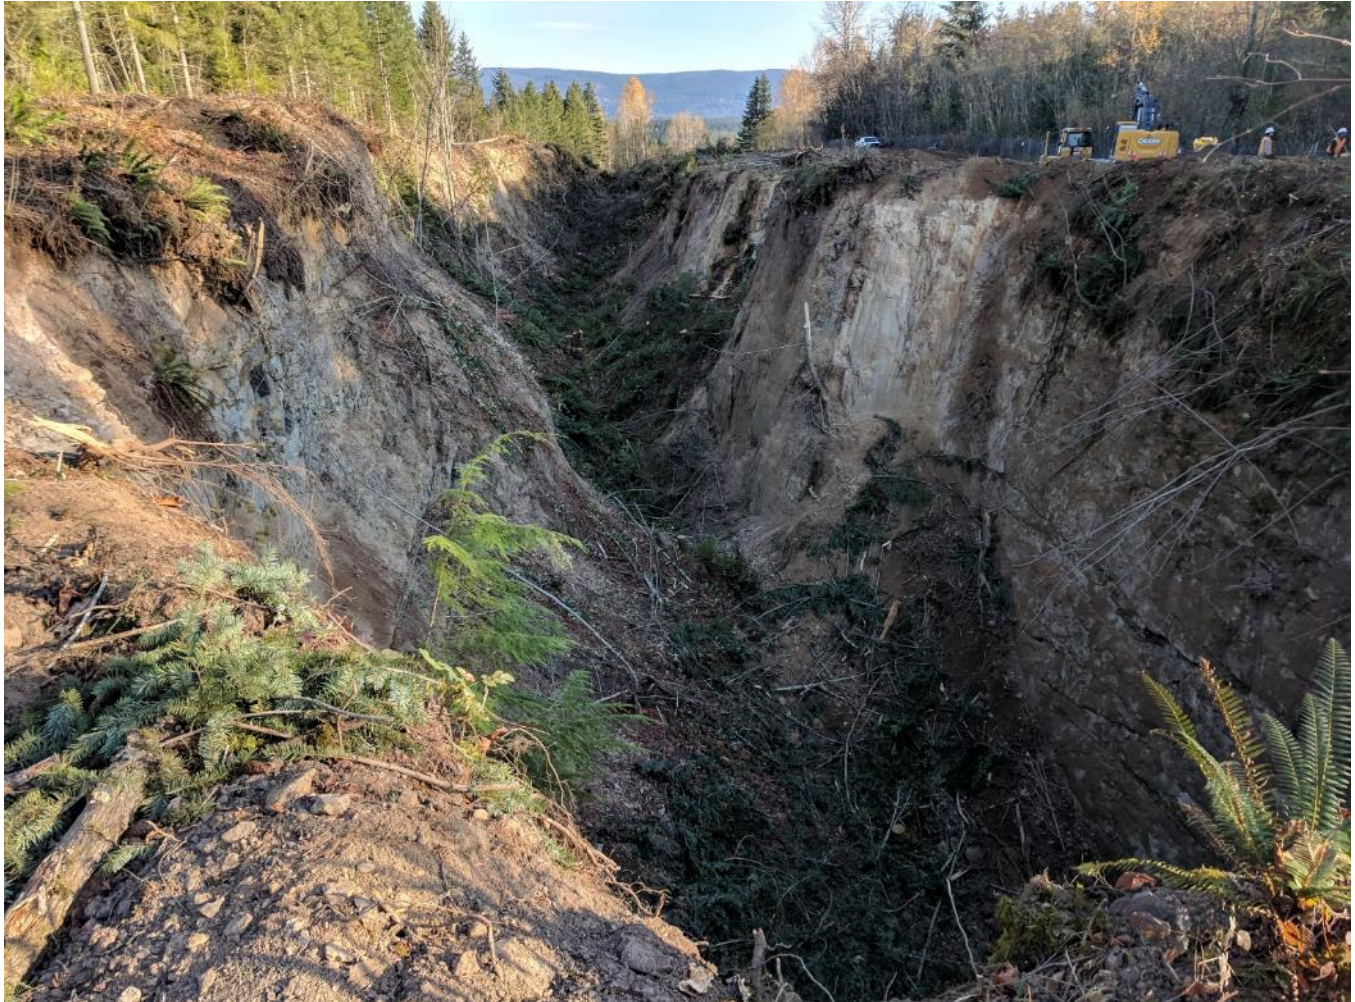
Photo 5 – Area 7, November 20, 2018 (looking northeast from southern tip)

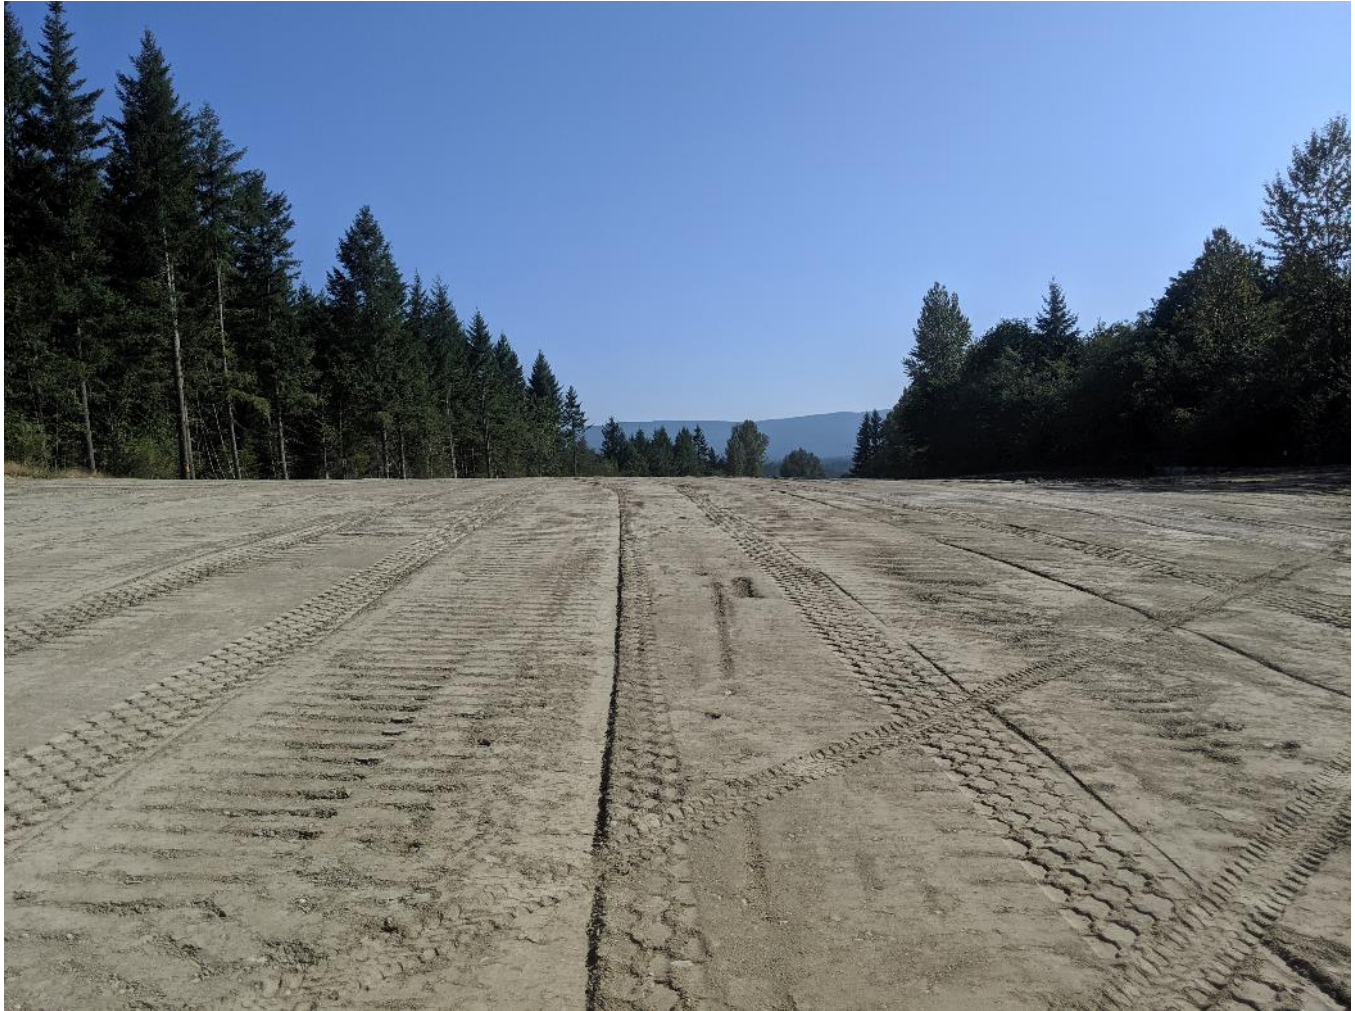
Photo 6 – Area 7, June 25, 2019 (looking north from southern tip)

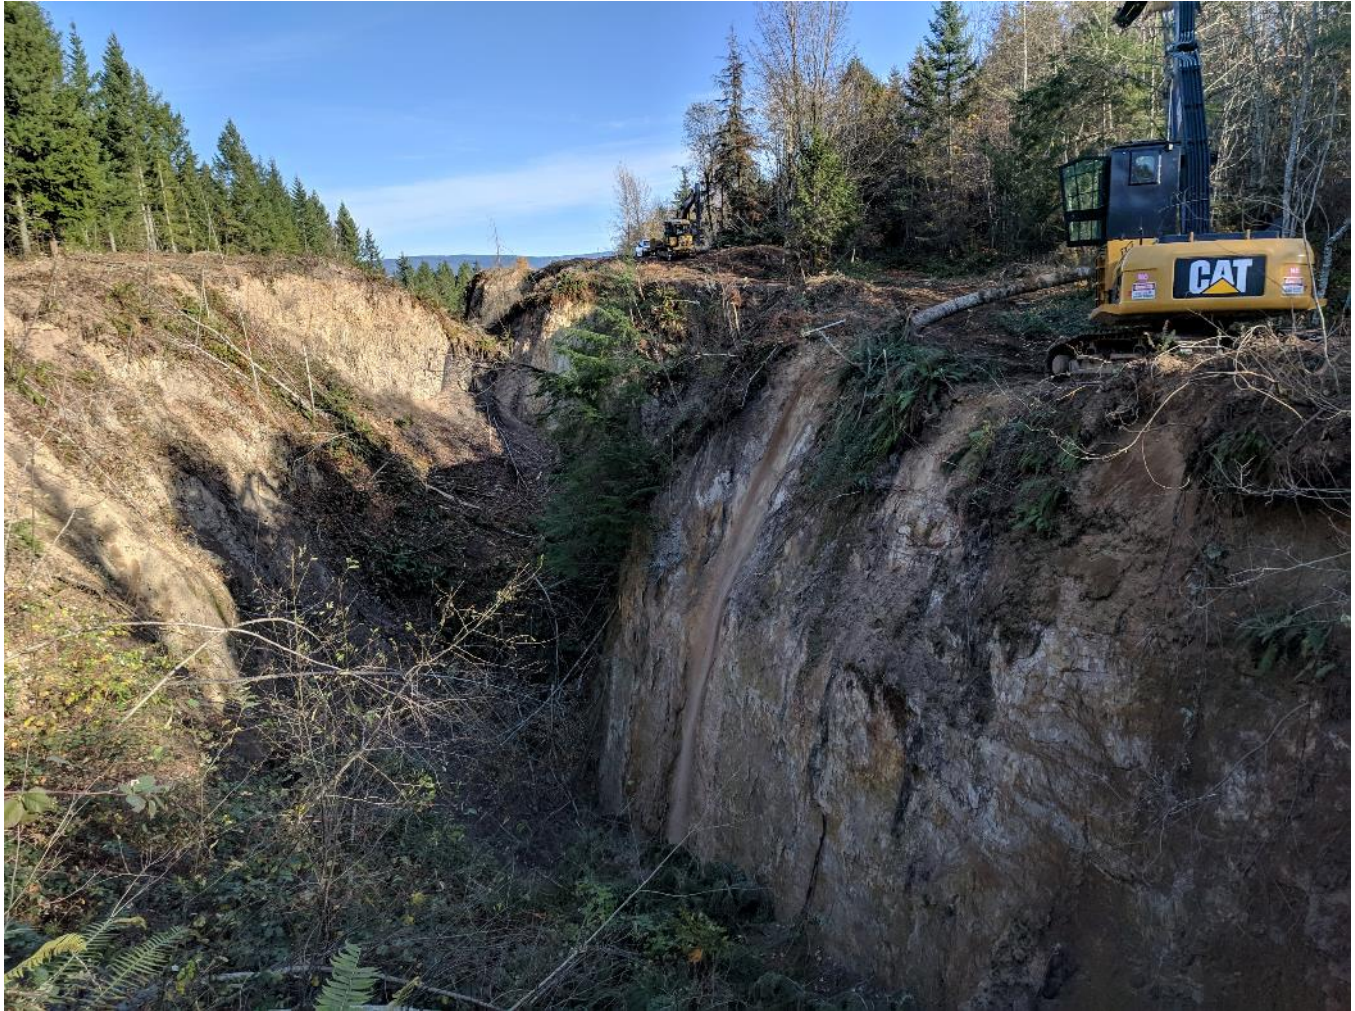
Photo 7 – Area 6, November 20, 2018 (looking north from southern tip)

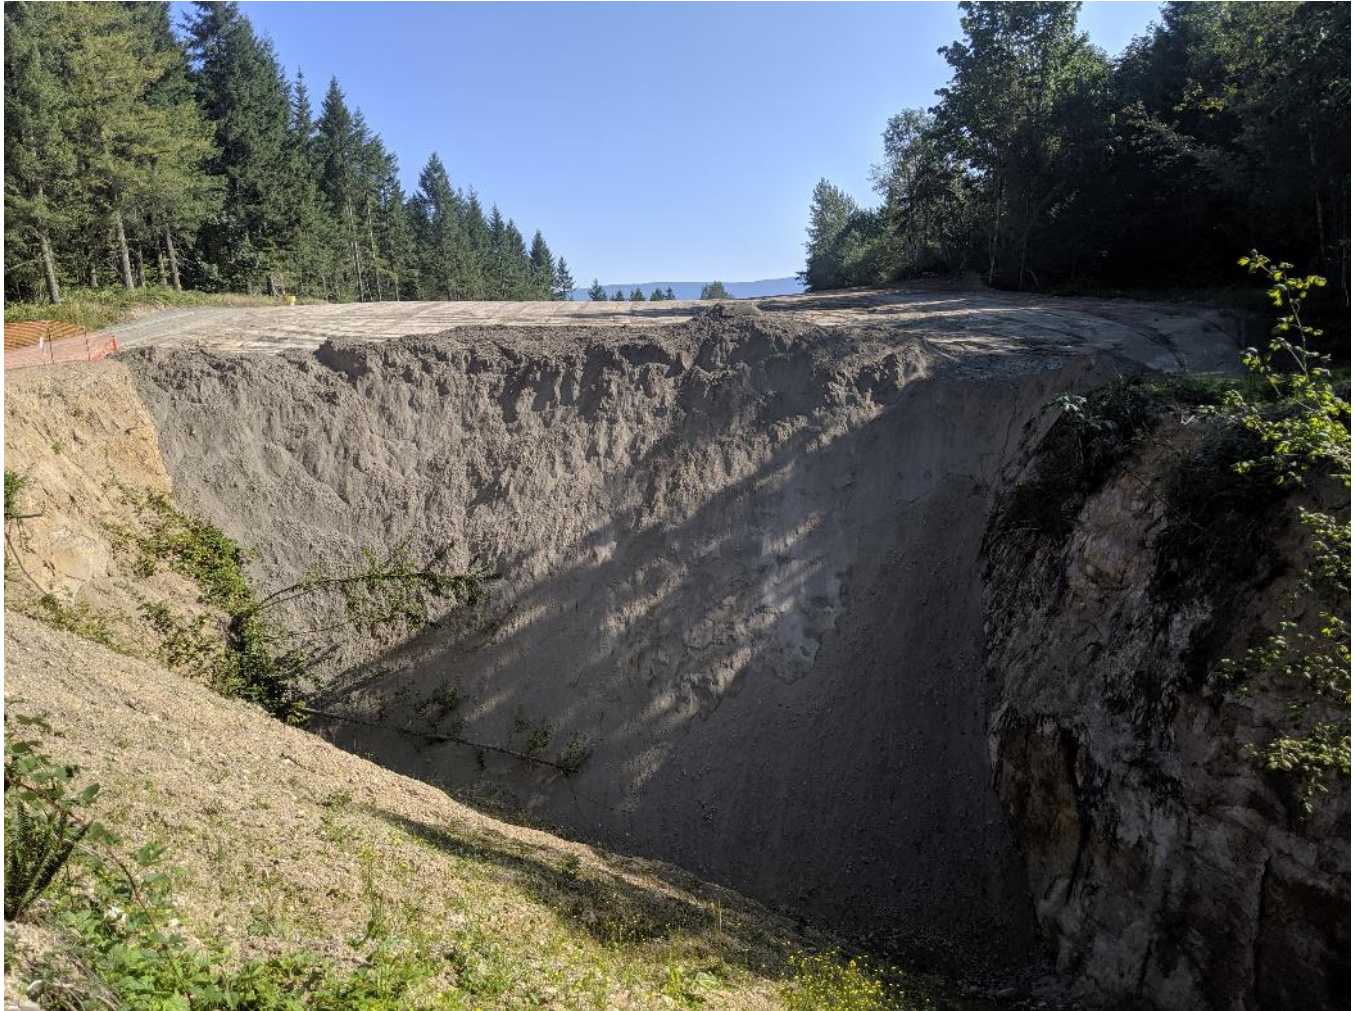
Photo 8 – Area 6 buttress, August 5, 2019 (looking north from southern tip)
