STATE OF WASHINGTON
DEPARTMENT OF ECOLOGY
4601 N Monroe Street • Spokane, WA 99205-1295 • 509-329-3400

Re: Further Action at the following Site:

Site Name: Avista Corp Spokane Service Center
Site Address: 1411 E Mission Ave, Spokane
Cleanup Site ID: 3512
Facility/Site ID: 31739484
VCP Project ID: EA0343

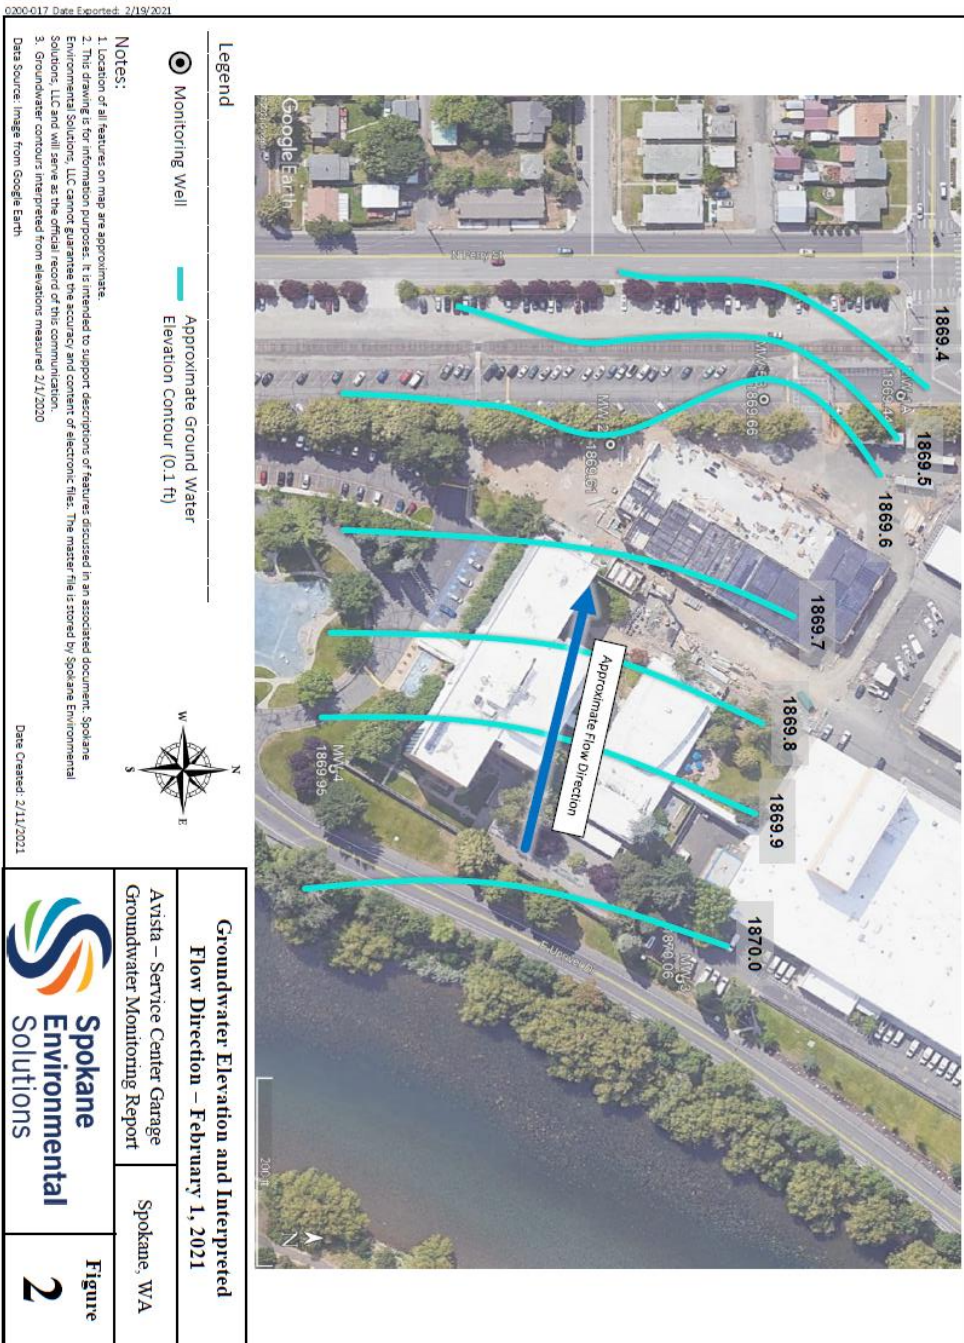
Site Diagram

Facility near Medical Lake, WA. Confirmation samples indicated that contaminated soil remains underneath Bays 1, 2, 4, 5, and 7 at depths ranging from 15 to 24 feet bgs. Further soil excavation could not be conducted due to the proximity to buildings and utility infrastructure. Residual contaminants include DRPH from 2,100 to 6,800 mg/kg, ORPH from 2,600 to 25,000 mg/kg, and PAHs with a toxic equivalency of 0.386 to 0.396 mg/kg. Following excavation, a low-density polyethylene (LDPE) liner was installed in the excavation between 6 and 8.5 feet bgs, graded to divert stormwater to an onsite management system.

- Since contaminated soil remains onsite and industrial cleanup levels were selected, an environmental covenant will be required to restrict site usage and ensure the protection of all engineered controls. Please provide a legal description of the site, an illustrated diagram that delineates the extent of remaining contaminated soil, and a maintenance and repair plan for the LDPE liner and soil cap.
