MEMORANDUM

To:	Rebecca Lawson, Washington State	Date:	February 24, 2011
	Department of Ecology		
	Olivia Romano, U.S. Army Corps of Engineers		
From:	Dan Berlin, Anchor QEA, LLC	Project:	080166-01
	Tom Wang, Anchor QEA, LLC		
Cc:	Joanne Snarski, Port of Olympia		
Re:	21-Month Final Monitoring Results - Berths 2 a	nd 3 Interi	m Cleanup Action Pilot
	Study

This memorandum summarizes the results of sediment chemistry monitoring and a bathymetric conditions survey performed in December 2010 by the Port of Olympia (Port) as part of the Berths 2 and 3 Interim Cleanup Action Pilot Study (Interim Action) in West Bay in Olympia, Washington. The 21-month monitoring effort is the last monitoring event required by the Monitoring Plan (Anchor Environmental 2009) contained in Agreed Order (AO) No. DE 6083 between the Port and the Washington State Department of Ecology (Ecology). Previous sampling was conducted 3, 9, and 15 months following completion of the Interim Action (Anchor QEA 2009a, 2010a, and 2010b, respectively). Sampling conducted as part of the Interim Action is documented in the Completion Report – Berths 2 and 3 Interim Action Cleanup (Anchor QEA 2009b). This memorandum also prov

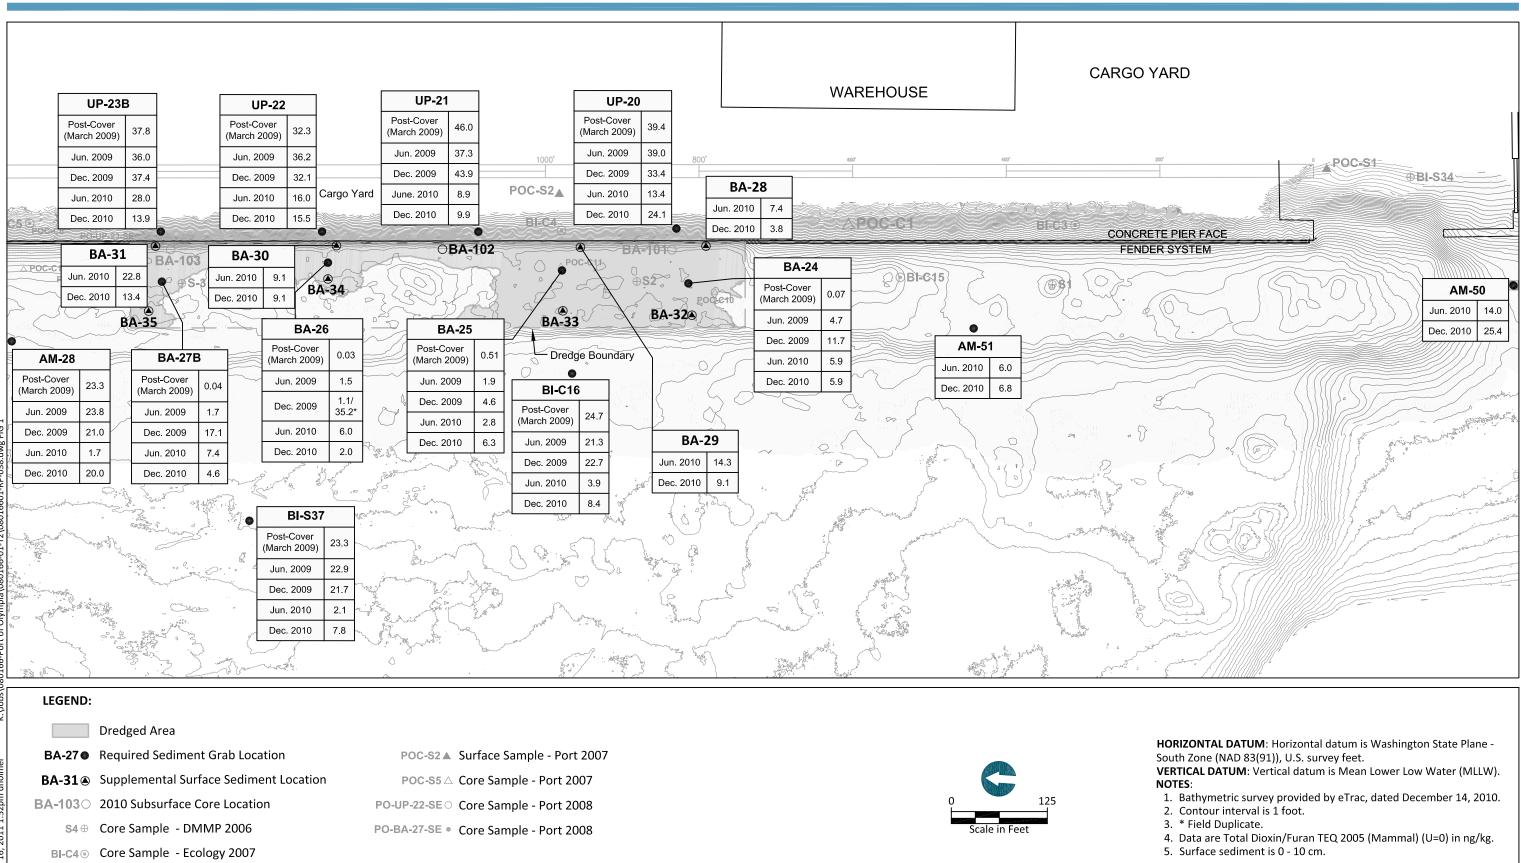
Figure 1

Five ambient samples were collected during the 15-month and 21-month monitoring events (three ambient samples were collected during the 9-month, 3-month, and post-cover monitoring events). Ambient samples in the 21-month monitoring event ranged from 6.8 TEQ to 25.4 TEQ and averaged 13.7 TEQ. Average ambient concentrations during the 15-month, 9-month, 3-month, and post-cover monitoring events were 5.6 TEQ, 21.8 TEQ, 22.7 TEQ, and 23.8 TEQ, respectively. The 21-month monitoring results were higher than the 15-month monitoring event for each ambient location. The greatest increases were observed in AM-28 (from 1.8 TEQ in June 2010 to 20.0 TEQ in December 2010) and in AM-50 (from 14.0 TEQ in June 2010 to 25.4 TEQ in December 2010).

Post-Construction Dioxin Concentrations through December 2010 Berth 2 and 3 Interim Cleanup Action Pilot Study Port of Olympia

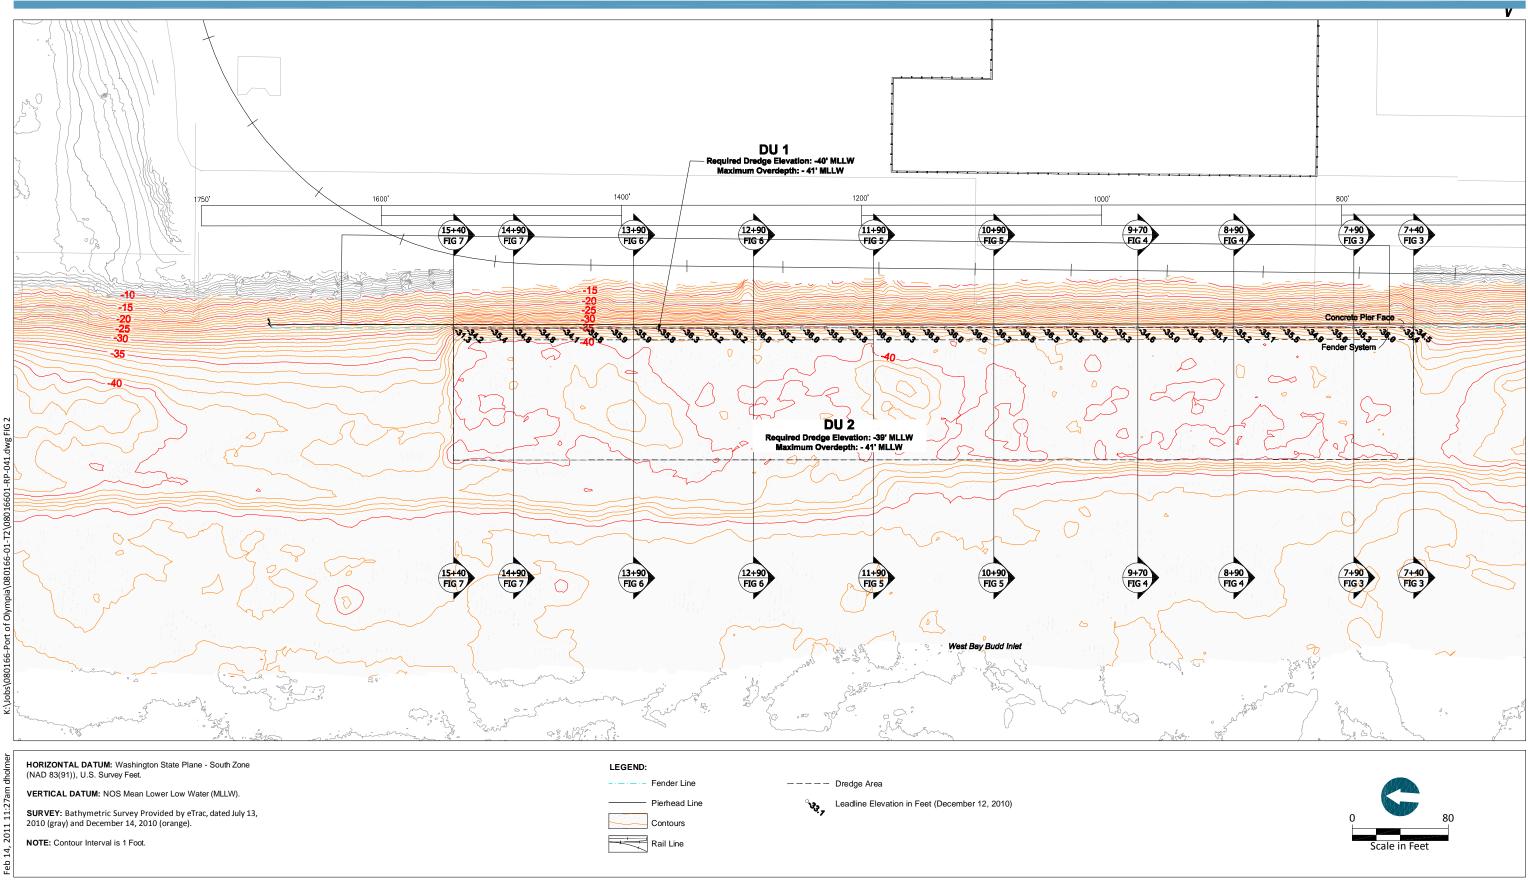
Results of the December 2010 bathymetric survey are provided in Figures 2 through 8. Figure 2 presents a plan view of the bathymetry results along with cross section locations. Ten cross sections are presented in Figures 3 through 7. Figure 8 presents a comparison of the December 2010 survey with the July 2010 survey for the berth area and October 2010 for the underpier area.

21-Month Post-Dredge Bathymetry Berths 2 and 3 Interim Cleanup Action Pilot Study Port of Olympia

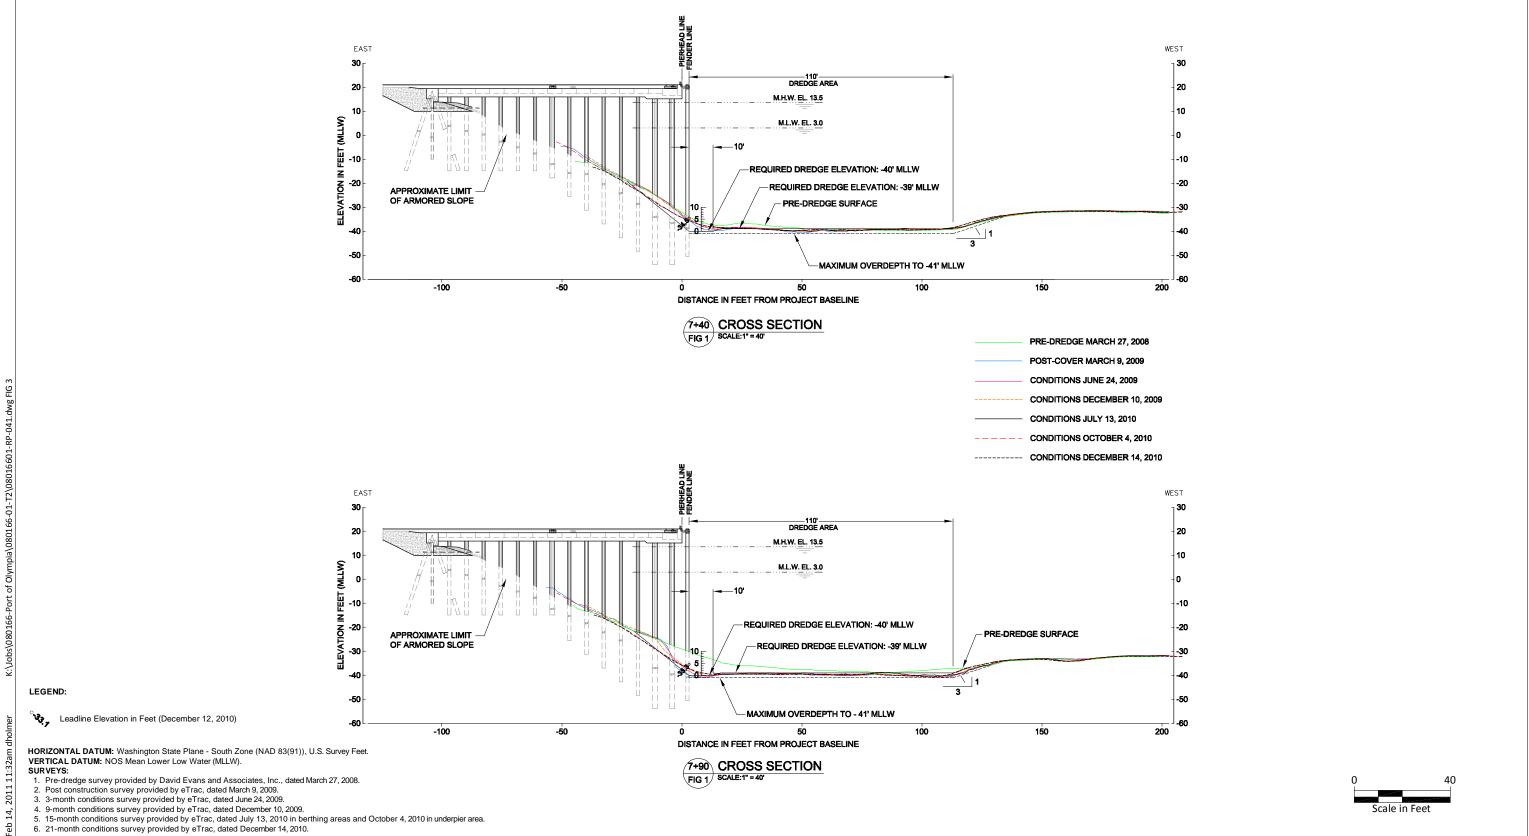
Figure 3

As part of the Interim Action, the area immediately adjacent to the pierface was dredged to between -40 and -41 feet MLLW; however, sloughing/slumping from the underpier slope resulted in an accumulation of material at the pierface shortly after the dredging was completed. The approach to dredge at the pierface to allow the slope to slough/slump in a controlled manner was discussed with Ecology during development of the Interim Action Plan. This approach was determined to be the most environmentally protective and present the least risk to the pile-supported structure. However, the slope sloughed/slumped less than expected during construction. As discussed with Ecology during plan development, this outcome meant that sloughing/slumping was likely to continue after dredging was complete until the slope reached equilibrium. Table 4 provides a summary of bathymetry measurement comparisons between June/October 2010 and December 2010. Based on the cross sections from the December 2010 survey, sediment elevations at the pierface within the dredged berth area range from -31.9 to -36.2 feet MLLW. The mean depth was -34.8 feet MLLW. The mulline elevation along the pierface increased an average of 0.5 feet between June and December 2010 (Table 4).

Cross Sections 7+40 and 7+90 Berths 2 and 3 Interim Cleanup Action Pilot Study Port of Olympia

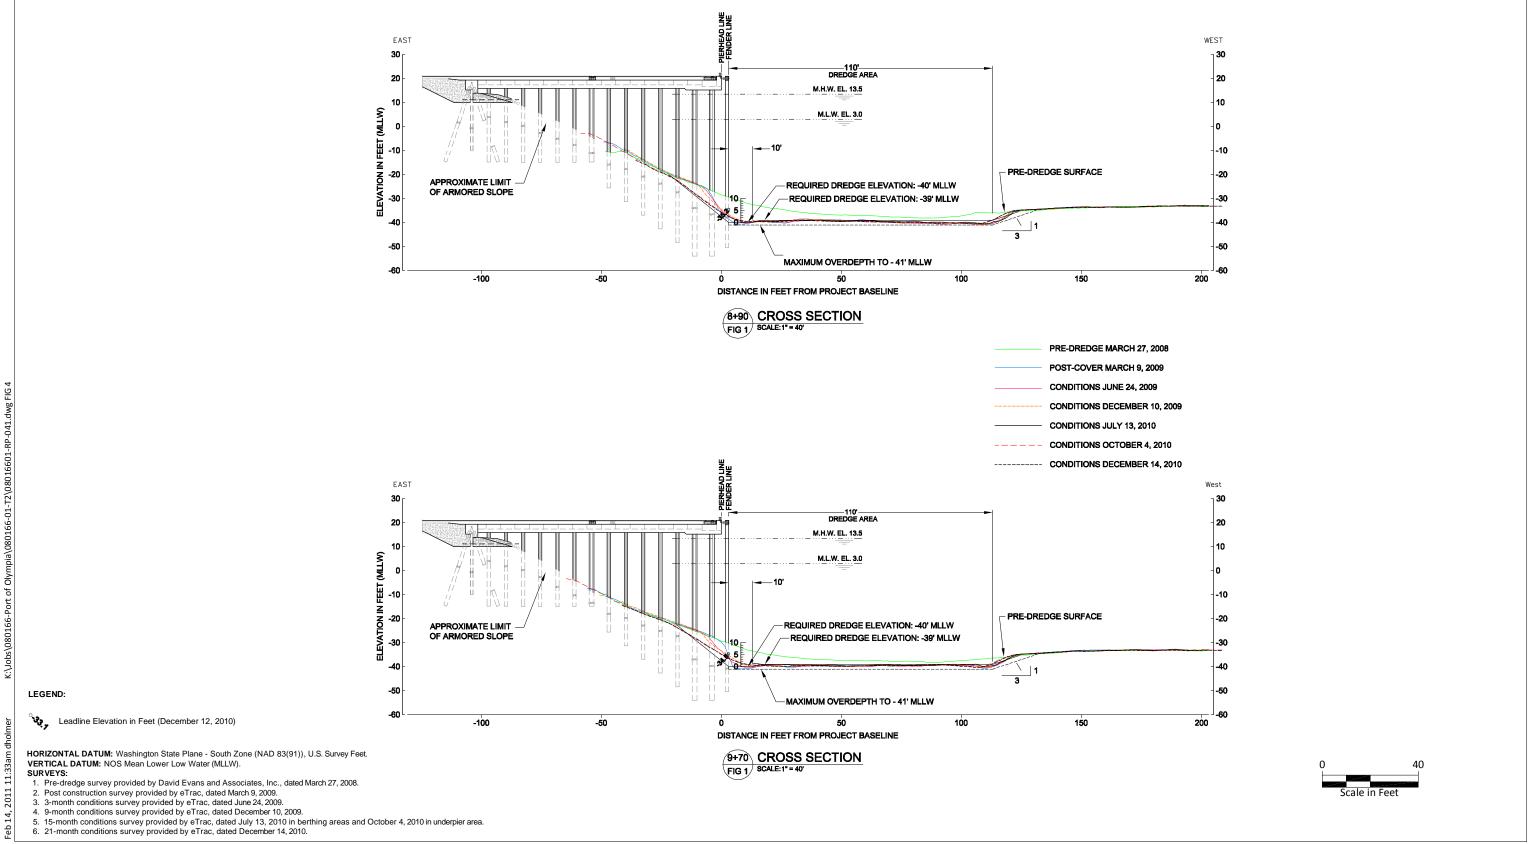
Figure 4

Cross Sections 8+90 and 9+70 Berths 2 and 3 Interim Cleanup Action Pilot Study Port of Olympia

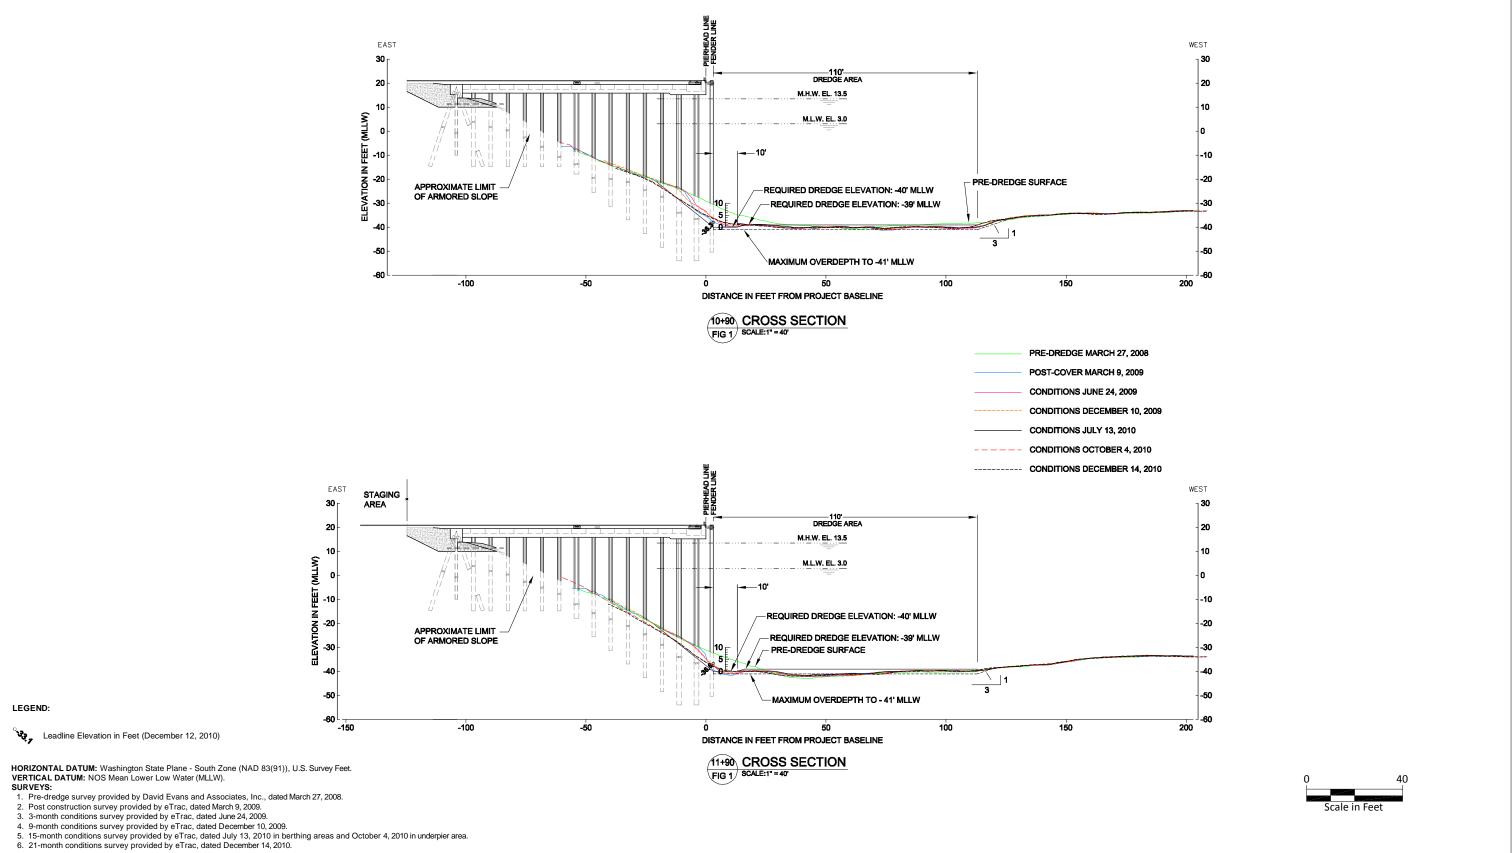
Figure 5

Cross Sections 10+90 and 11+90 Berths 2 and 3 Interim Cleanup Action Pilot Study Port of Olympia

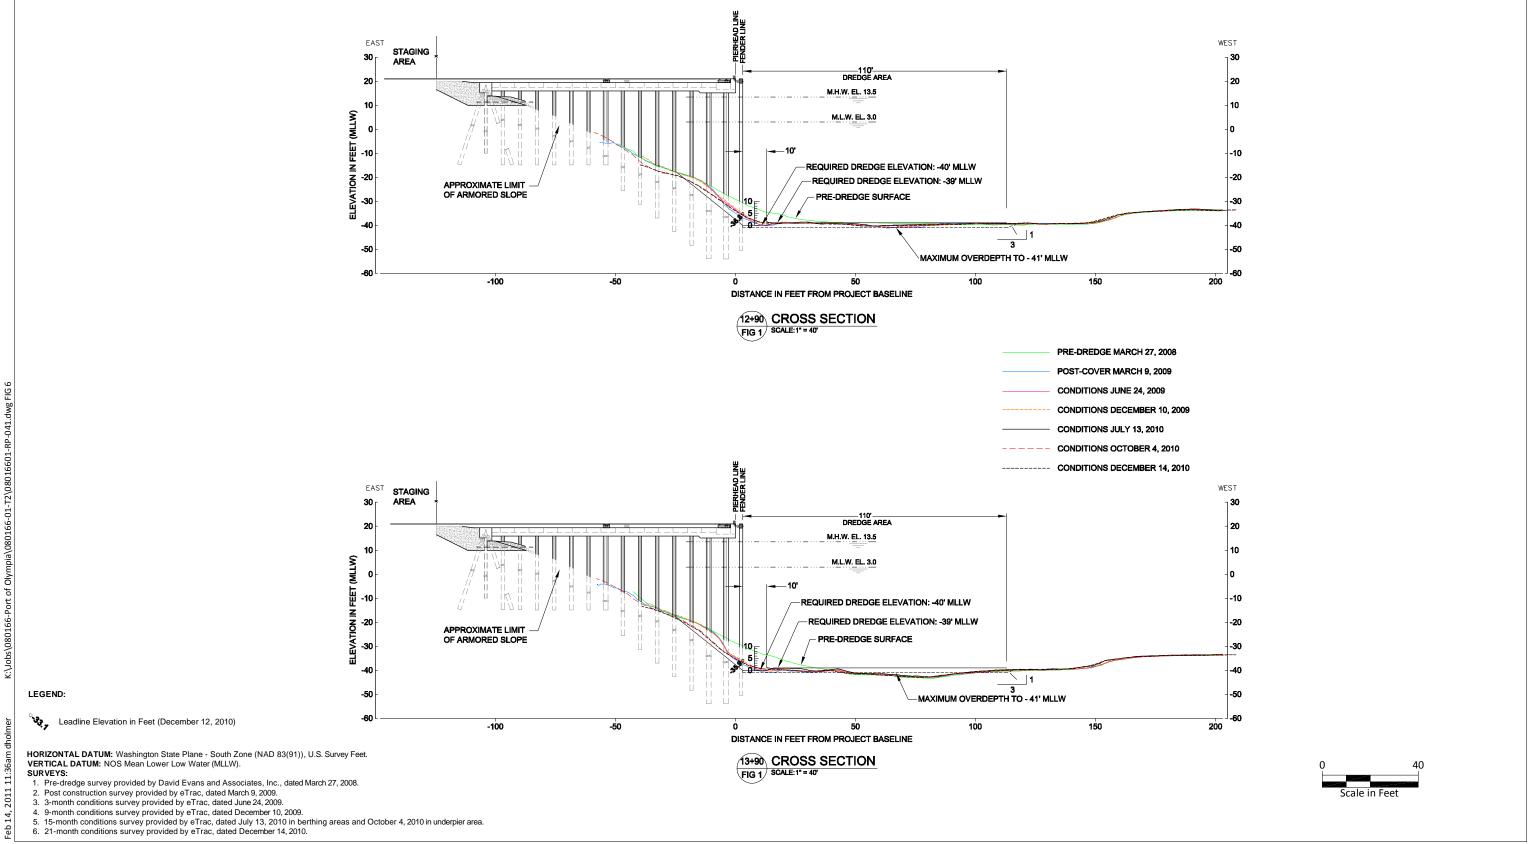
Figure 6

Cross Sections 12+90 and 13+90 Berths 2 and 3 Interim Cleanup Action Pilot Study Port of Olympia

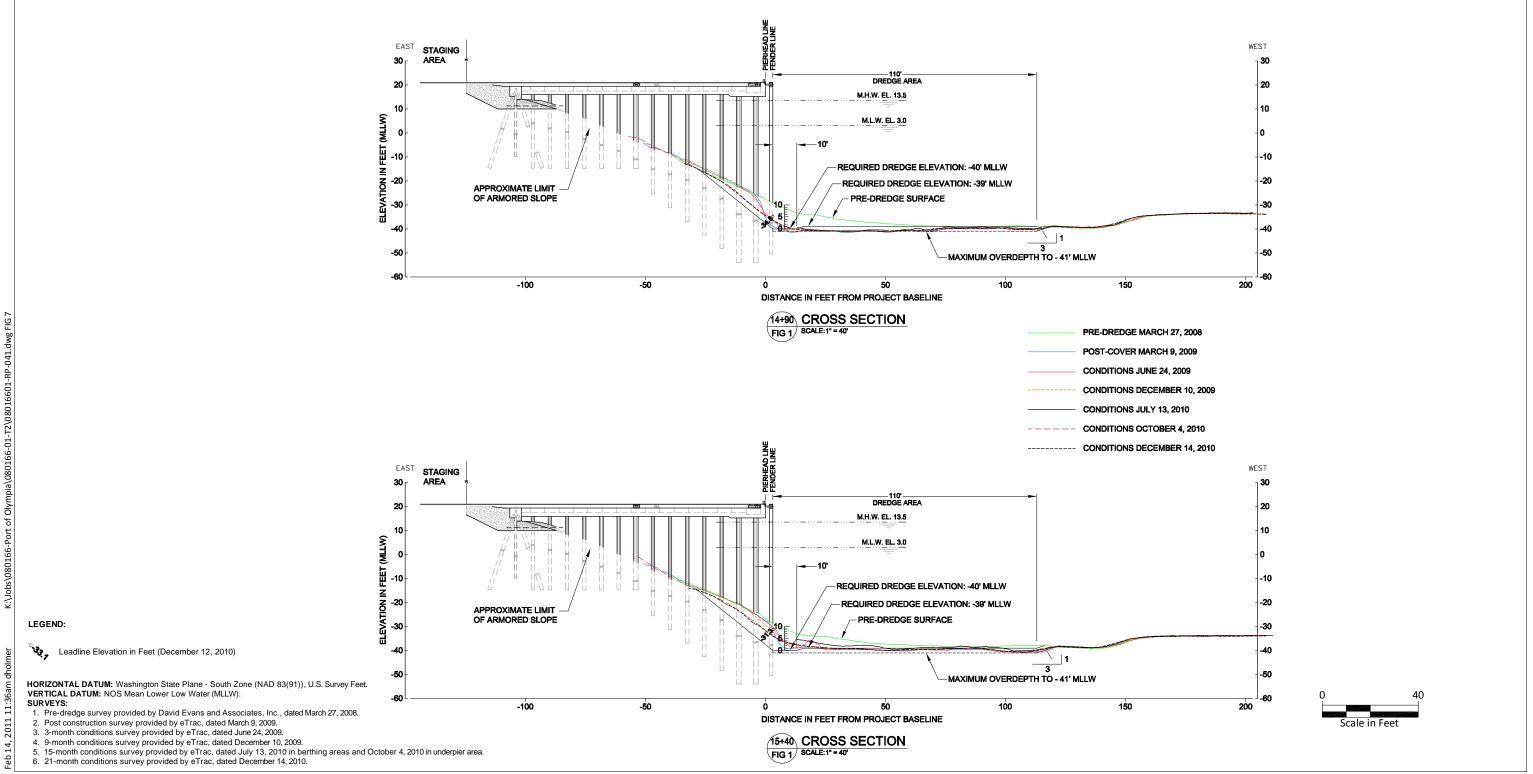
Figure 7

Cross Sections 14+90 and 15+40 Berths 2 and 3 Interim Cleanup Action Pilot Study Port of Olympia

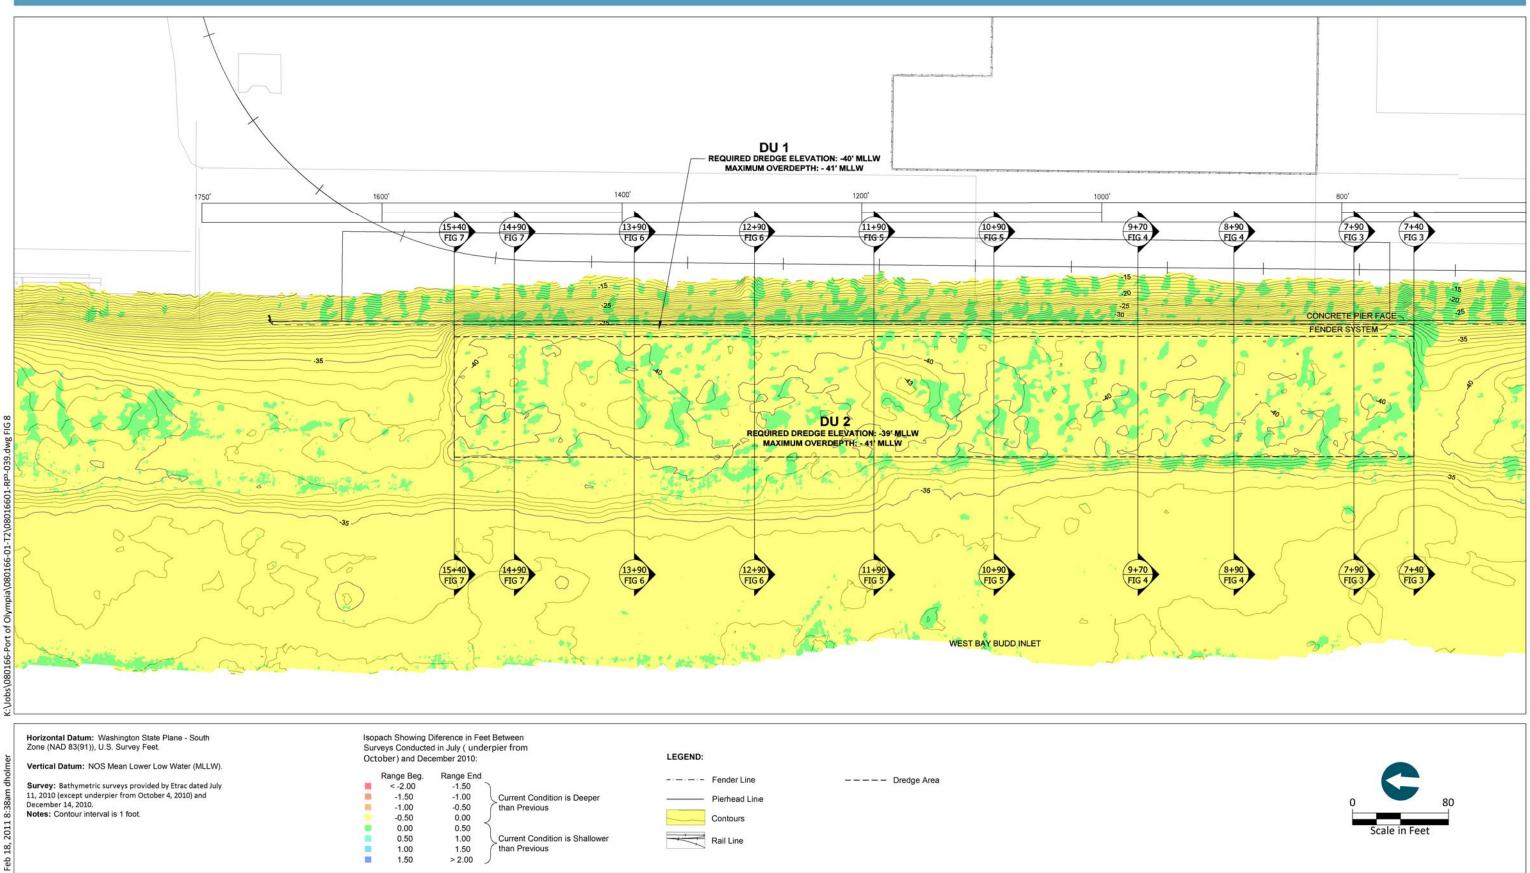
Figure 8

During the December 2010 survey, multibeam bathymetric surveying was conducted throughout the entire Berths 2 and 3 area, as well as in the underpier area. Identical methods and equipment were used for each of the previous surveys using a base station and Real Time Kinematics (RTK) Global Positioning System (GPS). The RTK GPS provides horizontal positioning accuracy of 1 cm or less. The survey presented in Figures 2 through 8 provides RTK-quality horizontal GPS for all survey areas, including open water portions of the berth area, underpier areas, and adjacent to the pierface. Previous surveys had difficulty collecting RTK-quality horizontal GPS in the underpier and pierface areas due to the presence of cranes in the Berths 2 and 3 area and the unfavorable satellite constellation pattern during the time of survey. However, no problems of this nature were experienced during the December 2010 survey.

Comparison of July and December 2010 Bathymetric Surveys Berths 2 and 3 Interim Cleanup Action Pilot Study Port of Olympia
