## **PERIODIC REVIEW**

**Continental Airlines Hydrant Fuel System  
SeaTac International Airport  
Facility Site ID#: 77676343**

**SeaTac International Airport  
Concourse C and North Satellite  
SeaTac, Washington**

**March 2019**

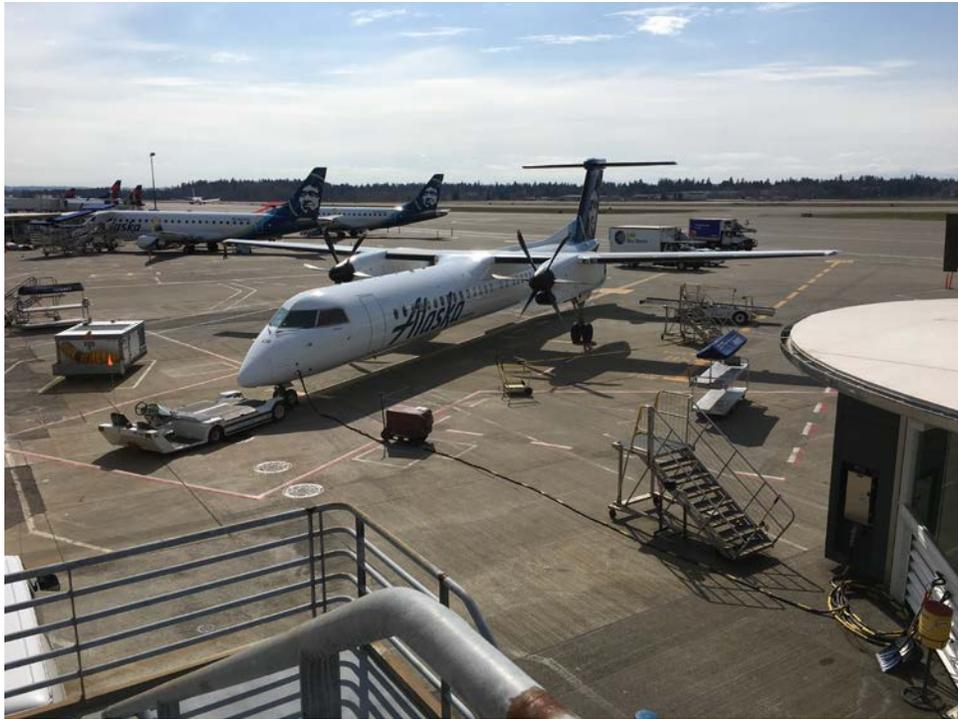
Based upon the Site visit conducted on March 21, 2019, the thick concrete surface at the Site continues to eliminate exposure to contaminated soils by ingestion and direct contact. The surface appears in satisfactory condition, and no repair, maintenance, or contingency actions appear to be required at this time. The Site is still operating as an airport. A photo log is available as Appendix 6.5.

**Photo 1: Concrete pavement cap at SeaTac Airport's Concourse C.**

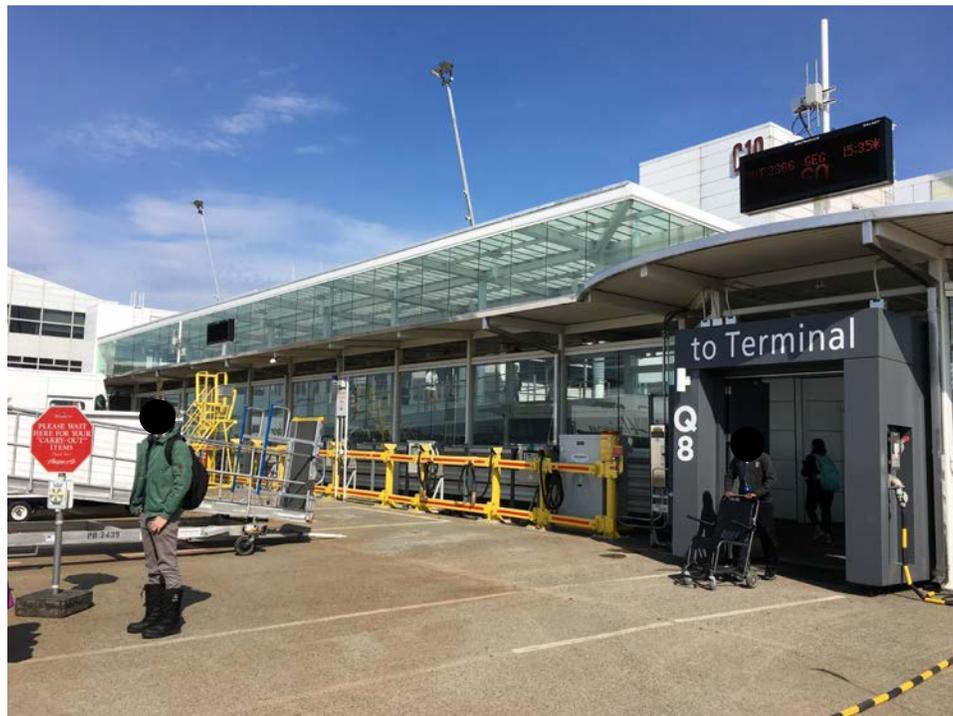
The Port provided documentation of a construction project performed in 2014 and 2015. The purpose of the project was to install new ADA-compliant walkways, ramps, elevators, and utilities to upgrade passenger conveyance routes to and from smaller airplanes at Gates C2, C10/12, and C14. Fuel pipeline removal and contaminated soil removal and disposal occurred during the course of the construction project. No groundwater was encountered.

**Photo 2: New walkway for passenger conveyance to small planes (constructed 2015).**

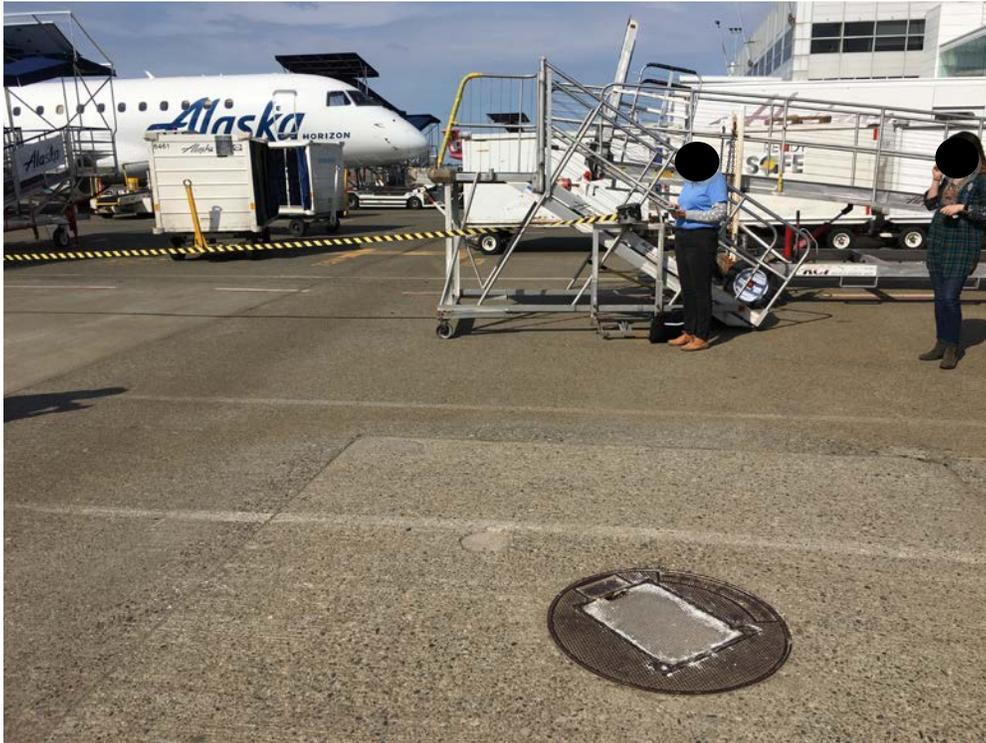
SLR International Corp performed the work to close the inactive fuel hydrant system between November 14 and 16, 2011. No remaining fuel was identified in the inactive fuel hydrant system, as it had already been removed years prior. To close the fuel hydrant system, the valve was removed and the fuel line was capped at each hydrant valve pit. Then, the valve pits and the pits that housed the remaining high point vents and low point drains were filled with concrete. Metal utility lids cover the closed pits.

**Photo 3: Closed hydrant fuel line access pit (filled with concrete with metal lid on top).**

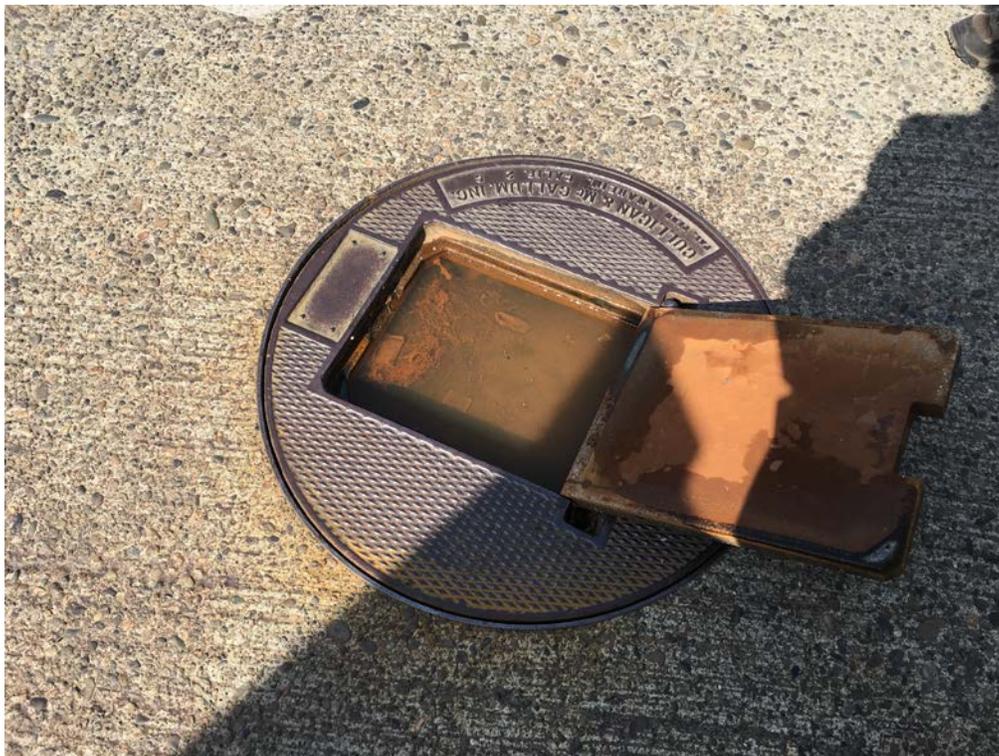
**Photo 4: Closed hydrant fuel line access pit (filled with concrete with metal lid on top).**
