Construction Completion Report

Proposed Development - Former Turnbull Landfill Southeast of SR 500 and NE Fourth Plain Boulevard Vancouver, Washington

GeoDesign Project: Orchard-1-01

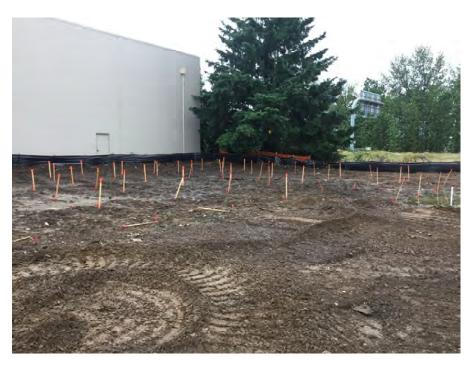
STAKING FOR ENGINEERED AGGREGATE PIERS. PHOTOGRAPH TAKEN FACING SOUTHWEST.

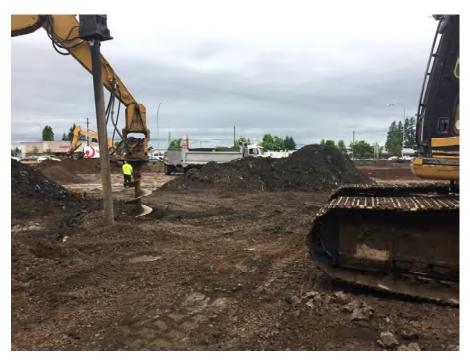
AUGER FOR ENGINEERED AGGREGATE PIERS. PHOTOGRAPH TAKEN FACING NORTH.

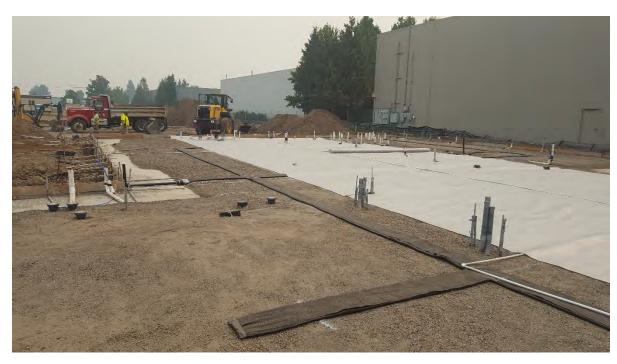
SUB-SLAB VENT PIPE LAYOUT. PHOTOGRAPH TAKEN FACING SOUTHEAST.

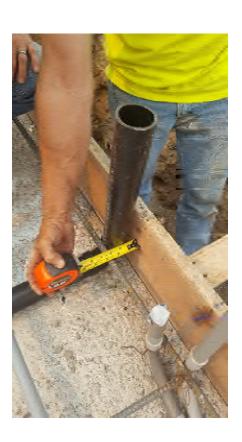
CLEARANCE FOR VENT RISER.

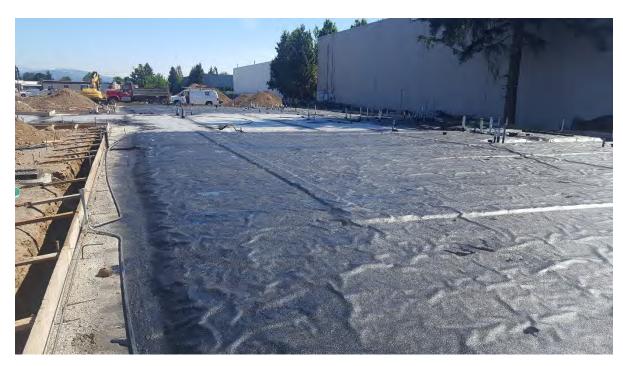
APPLICATION OF LOW-PERMEABLE MEMBRANE. PHOTOGRAPH TAKEN FACING EAST.

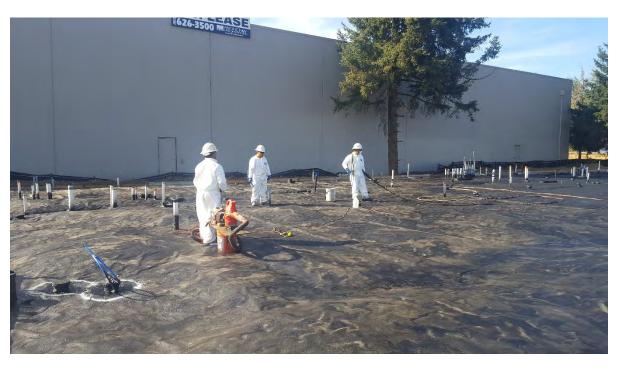
APPLICATION OF LOW-PERMEABLE MEMBRANE AND SMOKE TEST SETUP. PHOTOGRAPH TAKEN FACING SOUTHWEST.

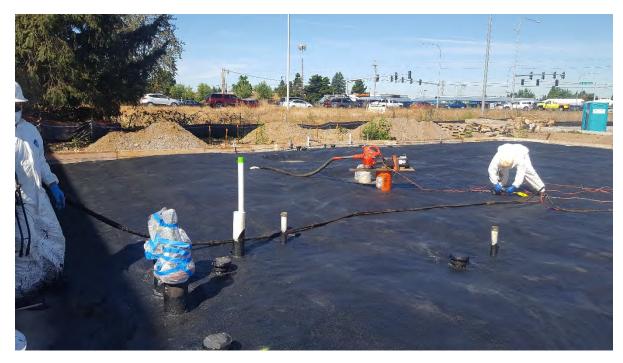
LOW-PERMEABLE MEMBRANE AND SMOKE TEST SETUP. PHOTOGRAPH TAKEN FACING NORTHEAST.

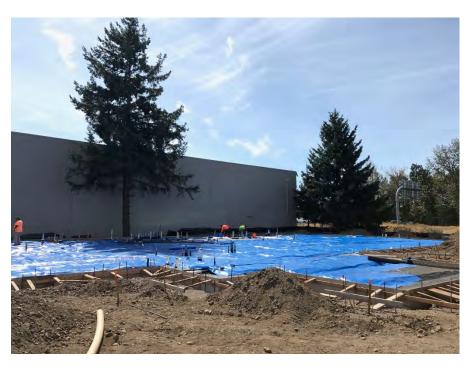
PROTECTIVE SHEETING OVER LOW-PERMEABLE MEMBRANE. PHOTOGRAPH TAKEN FACING SOUTHWEST.

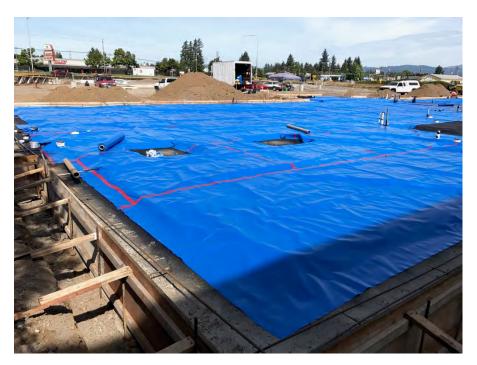
PROTECTIVE SHEETING OVER LOW-PERMEABLE MEMBRANE. PHOTOGRAPH TAKEN FACING NORTH.

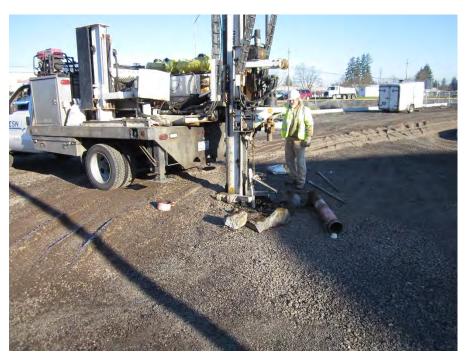
ABANDONMENT OF MONITORING WELL MW-2. PHOTOGRAPH TAKEN FACING NORTH.

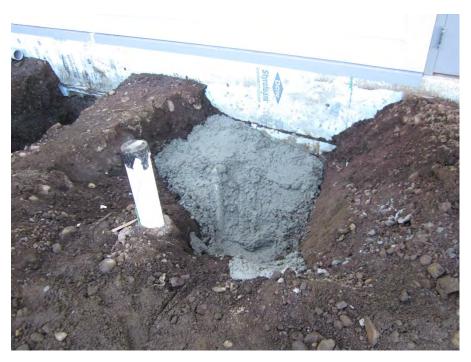
GeoDesign observed the placement of each trench dam. The trench dams were constructed by over-excavating the utility trenches to fully expose the pipe at the bottom by a minimum of 4 inches. Trench dam widths corresponded to the width of the excavator bucket and the number of utilities located in the trench and were generally 2 to 4 feet wide. The pipes were wrapped in black plastic prior to pouring the concrete mixture. Using pre-mixed concrete, Green

TYPICAL TRENCH DAM.

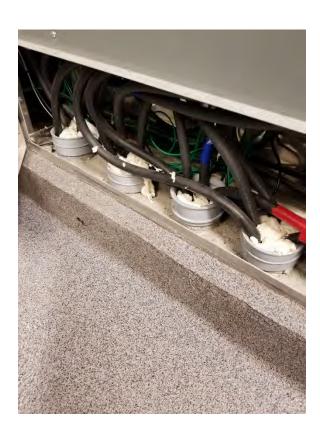
Using a closed-cell polyurethane expanding foam, the electrical contractor placed conduit seals in the annular spaces of electrical conduits as they entered electrical panels from underground. GeoDesign observed the installed conduit seals or was provided photographic documentation of the installed conduit seals. Conduit seals were installed in the electrical panels in the interior and exterior of the building. Prior to completion of the conduit seal installation, GeoDesign observed four conduits without conduit seals in the outside electrical panel on the south side of the building. At the time of installation, the electrical contractor indicated that they were not able to access the panel because it was locked by Clark Public Utilities. Based on GeoDesign's observations, the panel is naturally ventilated and potential methane accumulation will most likely not occur. This location will be monitored as part of the proposed monitoring program described in Section 7.0. Photographic documentation is presented in Appendix C.

CONDUIT SEALS IN INTERIOR ELECTRICAL PANEL.

GeoDesign recommends Orchard Crossings, LLC retain a qualified environmental professional to assist in completing the long-term monitoring activities and reporting. Furthermore, GeoDesign recommends sealing the remaining conduits in the outdoor electrical panel on the south side of the building the next time the panel is opened by an electrician or Clark Public Utilities. Lastly,

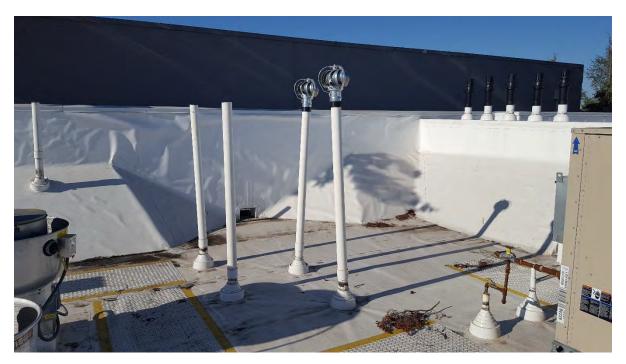
VENT RISERS WITH WIND TURBINES ON WEST SIDE OF BUILDING. PHOTOGRAPH TAKEN FACING SOUTH.

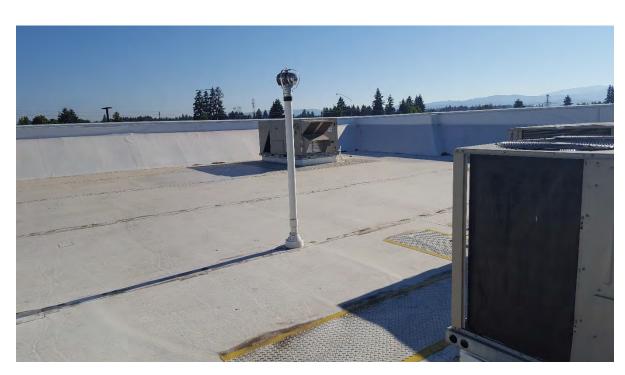
VENT RISER WITH WIND TURBINE ON EAST SIDE OF BUILDING. PHOTOGRAPH TAKEN FACING SOUTHEAST.

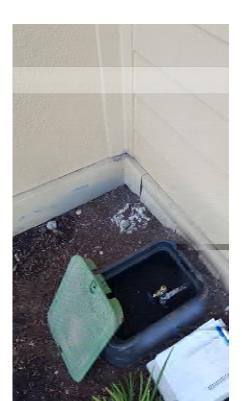
During construction, three sub-slab monitoring probes were installed to assist in evaluating sub-slab conditions after construction. The probes consisted of 10-foot sections of $\frac{1}{2}$ -inch-diameter, Schedule 40 PVC slotted pipes connected to $\frac{1}{2}$ -inch-diameter, Schedule 40 PVC blank pipes. The probes were located underneath the low-permeable membrane and extended to the exterior of the building. Each probe was fitted with a sample port and valve and protected by a flush to grade vault.

TYPICAL SUB-SLAB MONITORING PROBE.

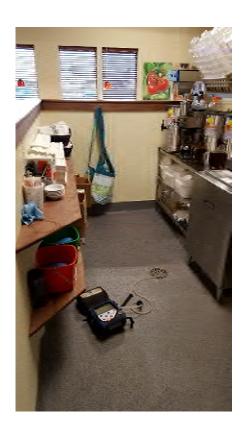
$\label{eq:methane} \mbox{METHANE VERIFICATION SCREENING IN FLOOR} \\ \mbox{DRAIN.}$

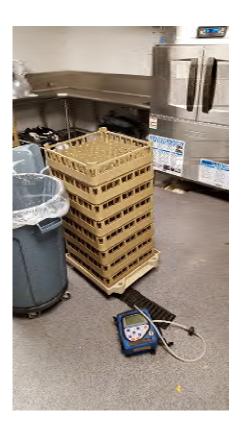
METHANE VERIFICATION SCREENING IN TRENCH DRAIN.
