STORMWATER COMPLIANCE INSPECTION REPORT

State of Washington Department of Ecology

Water Quality Name and Location of Site Inspected: Martine Servicenter Inc 2417 T Ave Anacortes, WA 98221	GPS Lat: Long:	Entry Time 10:15 Exit Time 11:30
On-Site Representative Name: Curtis Hamburg Title: Paint/Fiberglass Lead Phone: 360-239-8200 Email: curtis@marinesc.com	Additional Participants: N/A

Inspection Date: 2/25/2019

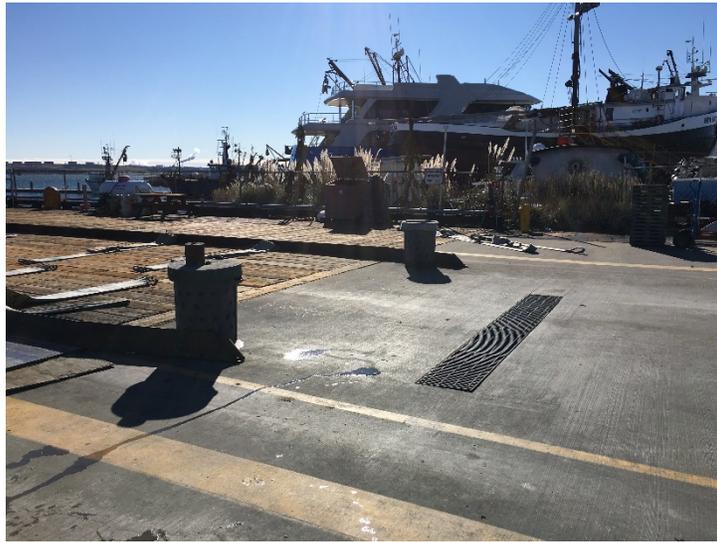
Figure 1 Description: Pressure wash pad located on concrete just beyond boat ramp.

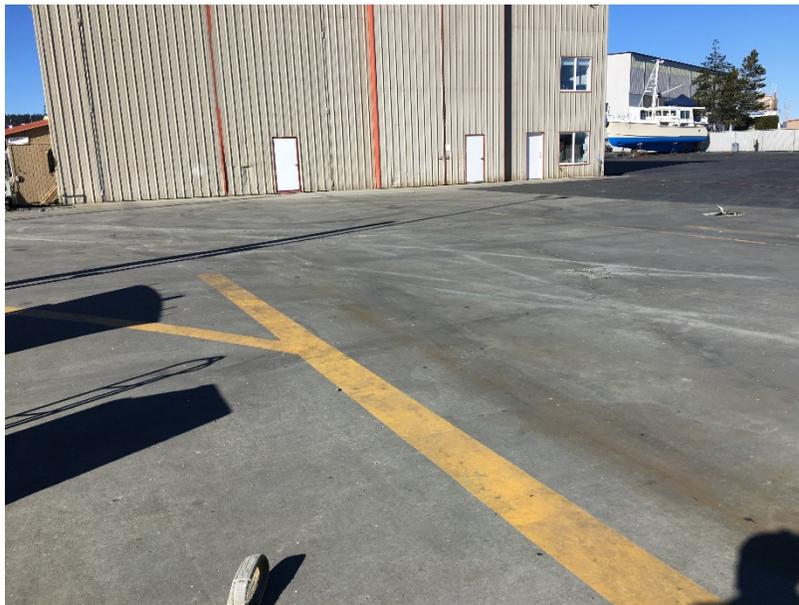
Figure 2 Description: Yellow lines depict limits of pressure wash pad. Grade from yellow lines slopes in toward the center.

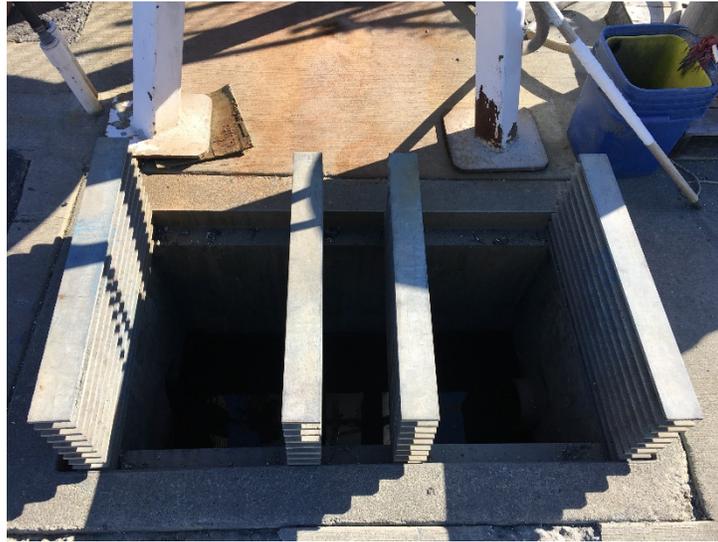
Yellow lines painted on both sides of the concrete portion of the boat ramp depict where pressure washing must occur in order to capture waste wash water in the trench drain at the lowest point on the wash pad. See Figures 1 and 2. There is no physical barrier to contain overspray from pressure washing activities. The trench drains to a six-foot-deep by three-foot-wide sump located roughly twenty-feet to the north of the pressure wash pad, and roughly five-feet west of the marine shoreline. See Figure 3.

Figure 3 Description: Sump associated with pressure wash pad and treatment system.

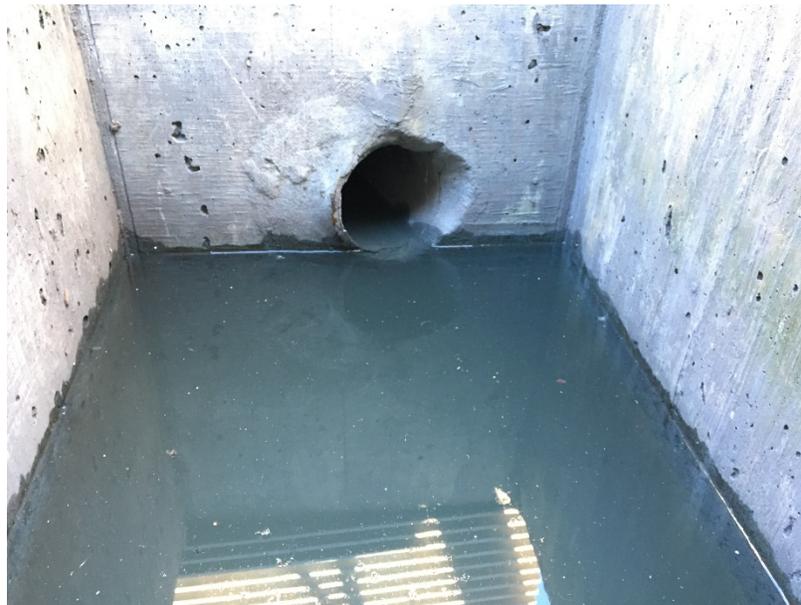
The outlet pipe from the sump connects to a sanitary sewer manhole roughly another twenty-feet north. There is no structural mechanism to prevent discharge to the sanitary sewer once water reaches the height of the sump's outlet pipe. See Figure 4. Travel lift operators manually pump untreated pressure wash water from the sump into a modified five hundred-gallon propane tank, located between the sump and the shoreline. See Figure 5. The operators add a flocculent to the tank, and then agitate the water with a bubbler to mix. Curtis Hamburg says it takes about one week to fill the tank, assuming the average length of boat pressure washed is about forty-feet. There is no mark on the tank to tell operators when it is full. Operators must physically climb up the tank and look inside to gauge capacity. Treated water empties from the bottom of the tank to the same sump and discharges to the City of Anacortes POTW when the water fills to the height of the outlet pipe.

Figure 4 Description: Sump outlet to City of Anacortes POTW.

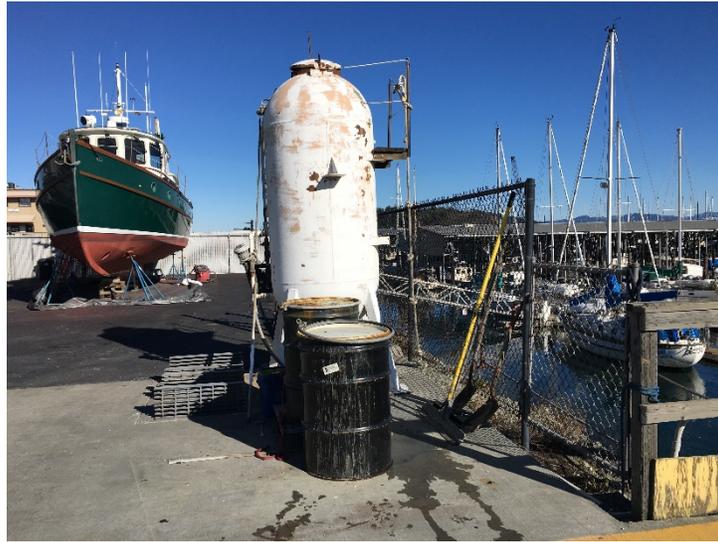
Figure 5 Description: Modified 500-gallon propane tank to treat pressure wash water prior to discharge to City of Anacortes POTW. The tank is within 5-feet of the marine shoreline. No curbing present on boundary between tank and marine waters.

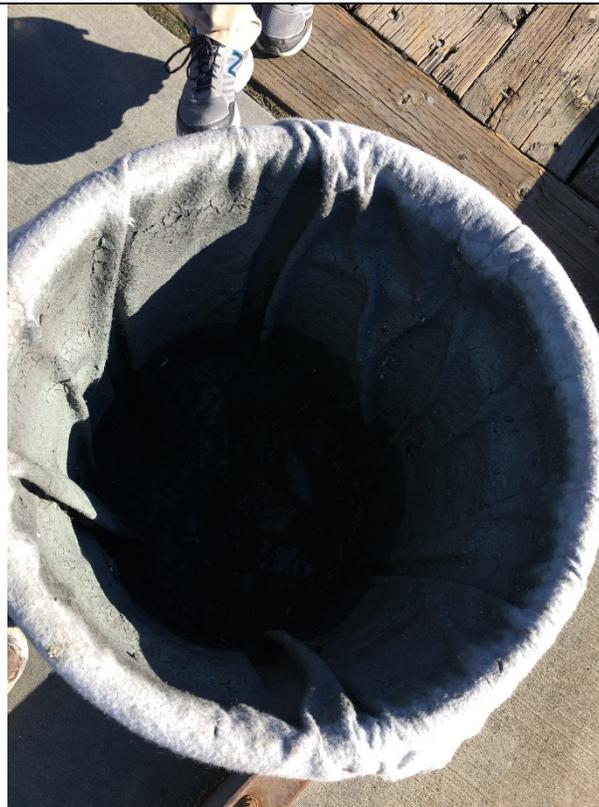
Figure 6 Description: Trash can lined with geotextile.

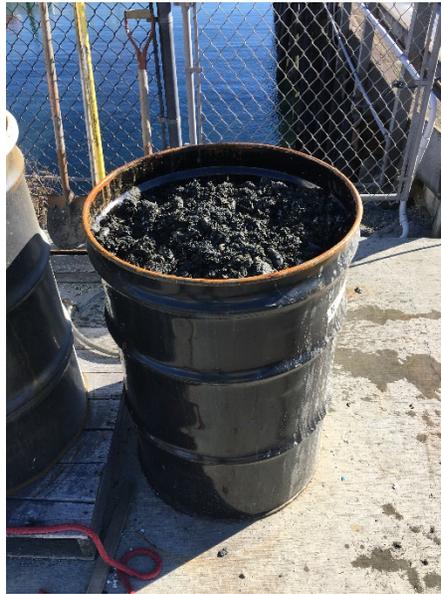
Ecology did not witness pressure washing at the time of the inspection. Curtis Hamburg said the facility uses square shaped buckets (i.e. cat litter container) to scoop solids out of the trench drain in the pressure wash pad. The facility empties the buckets filled with solids from the trench drain into two plastic trashcans, lined with geotextile and perforated to drain liquid from solids. See Figure 6. The trashcans are located on both sides of the trench. The liquid drains to the trench. Two metal drums located next to the treatment tank contain solids from the trashcans. See Figure 7.

Figure 7 Description: Solids removed from pressure wash pad trench drain. Trashcans show in Figure 1.

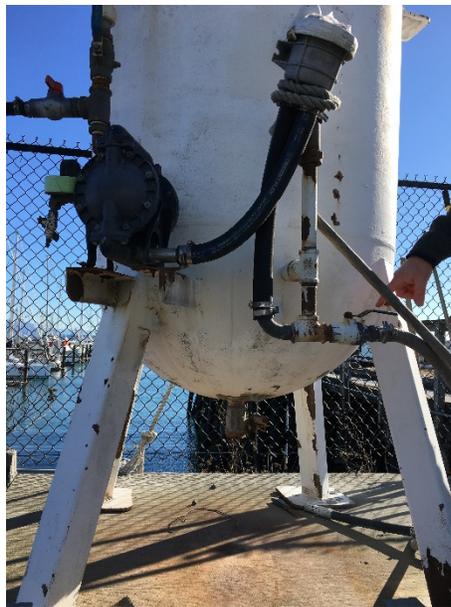
Figure 8 Description: Sampling point for pressure wash discharges to the City of Anacortes POTW.

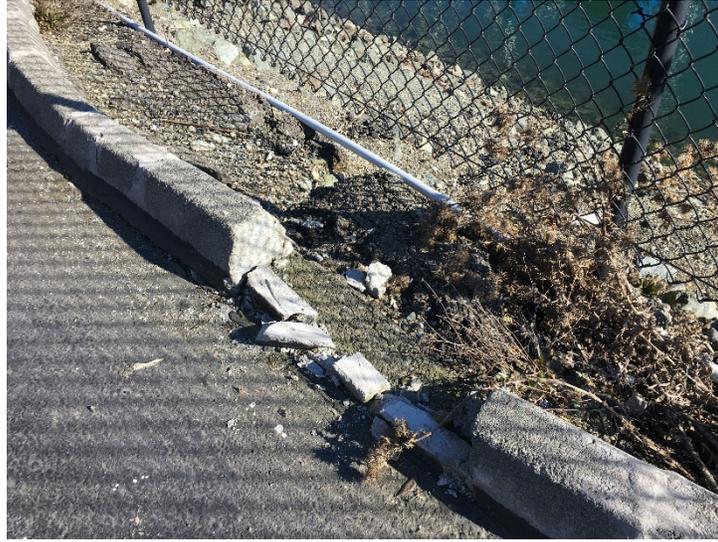
Curbing at the edge of the pavement between the facility and marine waters is present for a portion of the eastern boundary. There is no curbing between the treatment system and marine waters. A break in the curbing (damaged/missing curb) was located within fifty-feet of the treatment system. Curtis said the facility has repaired the curb break in the past. The curbing is currently missing and a rill from the top of the slope to marine waters is present. See Figure 9.

Figure 9 Description: Broken, missing curbing and associated rill on slope to marine waters.

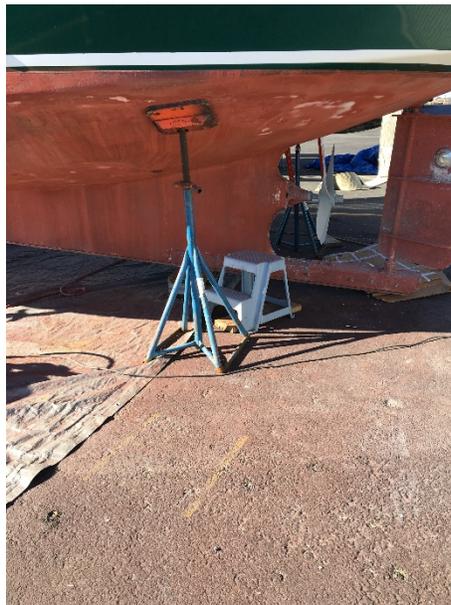
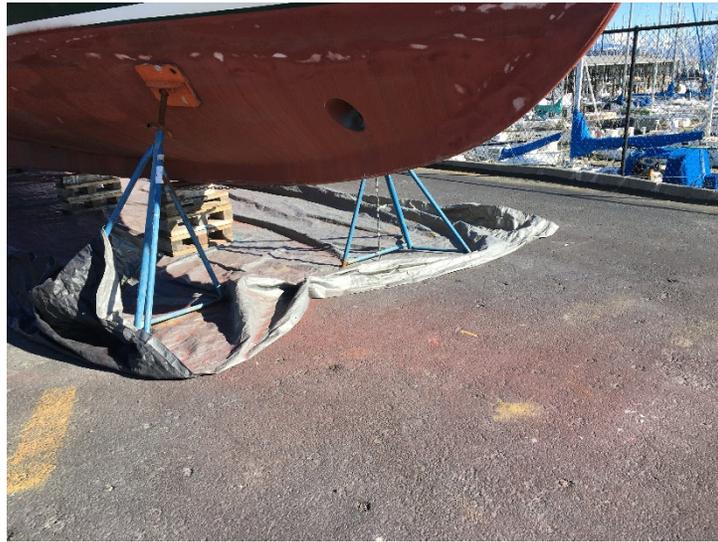
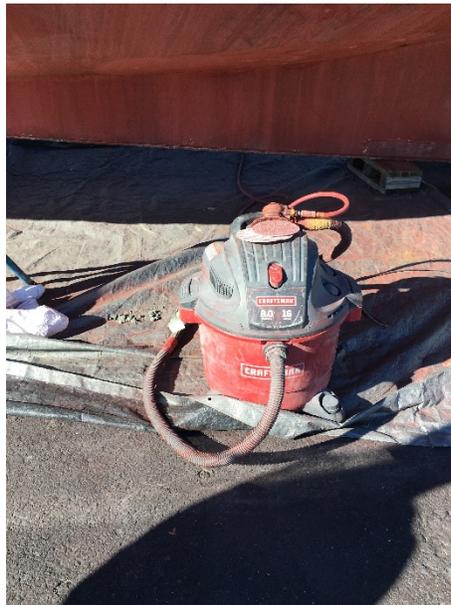
Roughly, sixty-five-feet from the marine shoreline, in a workspace adjacent to the neighboring property, a vessel sat on stands with a tarp laid out on the ground beneath. No one was actively sanding the hull during Ecology's visit. The tarp was a few feet shorter than the vessel. No physical barrier exists to contain airborne dust generated from sanding. Only a chain link fence separates the facility from the neighboring property. Where the tarp did not reach, Ecology observed red dust deposition on the ground beneath the vessel from sanding the hull. We did observe a power sander attached to a shop vacuum stationed beneath the vessel. See Figures 10, 11, and 12.

Failure to meet Condition S3.D. Upland Vessel Maintenance and Repair (Pg. 17): When stripping, sanding, scraping, sandblasting, painting, coating, and/or varnishing any portion of a vessel, Permittees must collect and manage all particles, oils, grits, dusts, flakes, chips, drips, sediments, debris, and other solids to prevent their release into the environmental and entry into waters of the State.

Permittees must secure drop cloths, tarpaulins, structures, drapes, shrouding or other protective devices around the vessel, as necessary, to collect all such materials. The Permittee must routinely clean up all collected materials to prevent their release into the environmental and entry into waters of the state.

Figure 10 Description: Red dust deposition on ground beneath vessel because the tarp is too short.

Figure 11 Description: Tarp beneath vessel unsecured and too short to provide adequate cover to collect dust generated from bottom sanding.

Figure 12 Description: Power sander attached to shop vacuum.

Condition S3.A. Vacuum Sander Required: Based on dust deposition on the ground, evaluate if employees operate the vacuum sander properly and/or if it requires maintenance. Maintain the sander as appropriate.

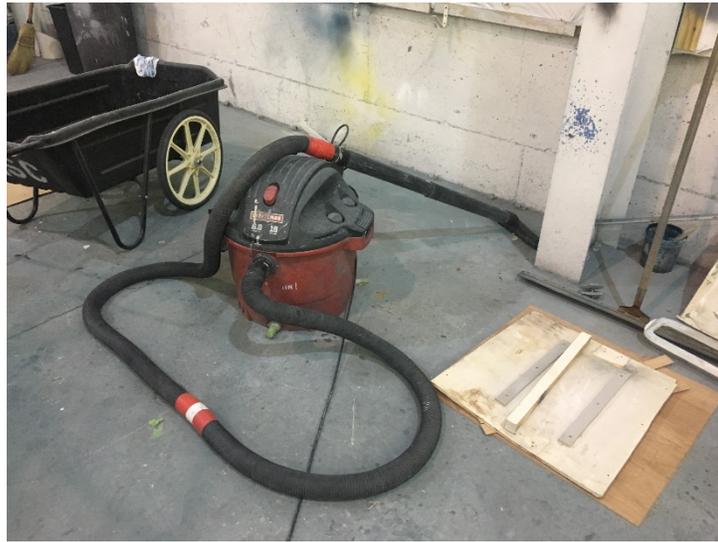
Curtis Hamburg said the facility removes dust deposited on the ground with a dedicated shop vacuum with a floor attachment secured to the hose. Later we came across the shop vacuum located within an indoor workspace. See Figure 13.

Figure 13 Description: Shop vacuum with floor attachment, used for vacuuming dust deposition on pavement.

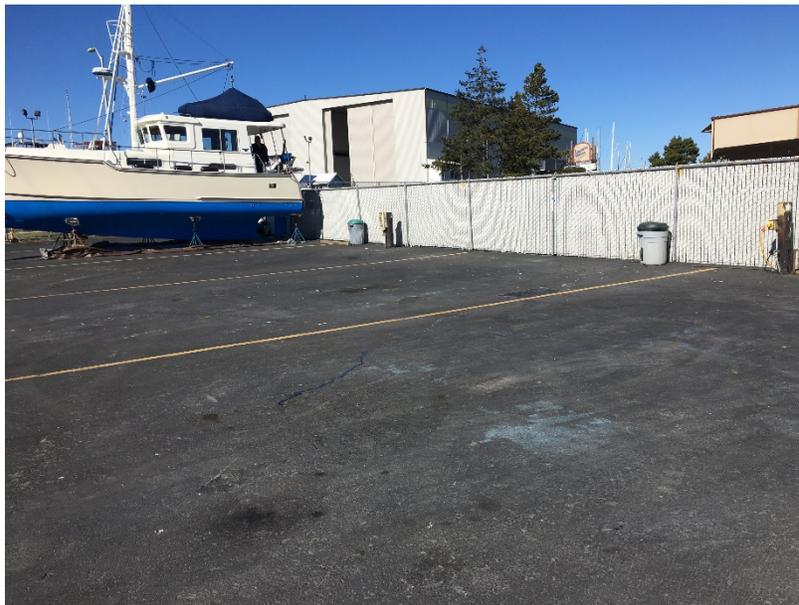
Paint residue, soil, and oil residue stains the pavement of vacant workspaces in the yard. The tarp beneath a freshly painted hull is not securely fastened and several feet shorter than the vessel. See Figure 14. Ecology staff noted a paint can without containment beneath this vessel upon arrival at the facility. Someone removed the paint can while Ecology was in the office meeting Curtis Hamburg upon arrival.

Failure to meet Condition S3.E. Solids Management (Pg. 17): The Permittee must control and collect all particles, oils, grit, dusts, flakes, chips, drips, sediments, debris, and other solids from work, service, and storage areas of the boatyard to prevent their release into the environment and entry into waters of the State. When solids-generating activity is occurring, the minimum collection frequency is once per day and prior to tidal inundation. The Permittee must avoid wetting the solids during collection and must not wash solids into any surface waters or into a stormwater collection system.

Figure 14 Description: Paint and oil residue, and sediment on pavement of workspaces in the yard.

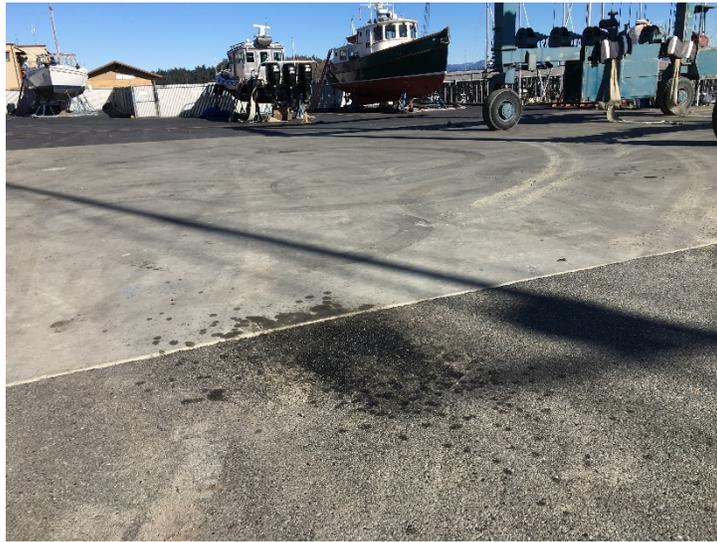
Ecology observed free liquid from a very recent oil spill on pavement just beyond the pressure wash pad. See Figure 15. Curtis Hamburg believes the spill occurred on Friday of last week. He says the boom truck has a leak. The presence of free liquid suggests the spill occurred very recently. Ecology did not see the boom truck. Curtis says the facility parks the boom truck at another property in Anacortes. He did not mention any facility procedures to clean up spills when discovered.

Failure to meet Condition S8.B.3.f. Spill Prevention and Emergency Cleanup Plan (Pg. 34): Section 4.2.5 of the facility's SWPPP requires stopping, containing, and cleaning up all spills immediately upon discovery. It calls for the placement of emergency spill containment and cleanup kit(s) at outside areas where there is a potential for fluid spills. The kits must contain appropriate materials, readily accessible, and contents maintained.

Figure 15 Description: Free liquid present at an oil spill in the yard near the pressure wash pad. A leaking boom truck is likely the source of the spill. Boom truck not present at the facility at the time of the inspection.

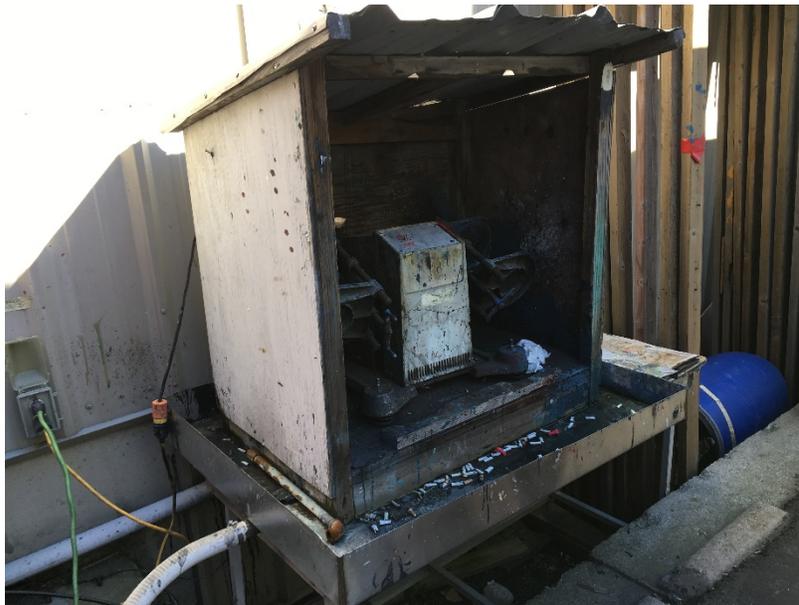
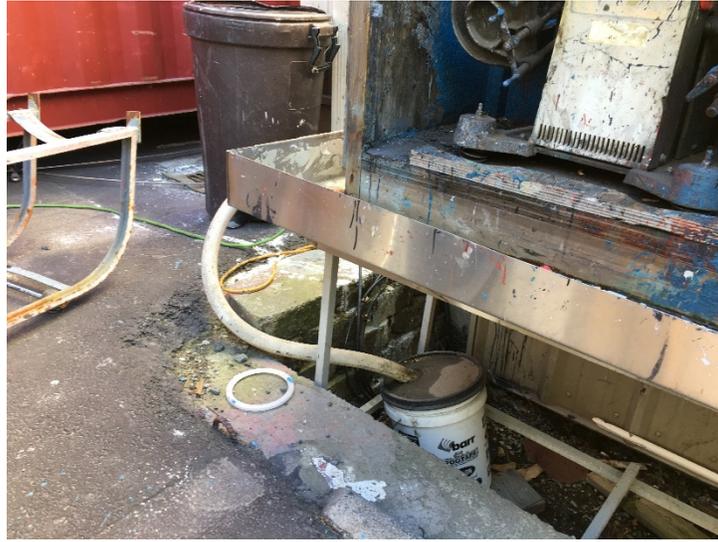
The paint mixer is located on the south wall of the building. A housing structure with three walls and a roof eliminate direct exposure of the mixer to stormwater. The housing sits within secondary containment. Presumably, the containment

is for the collection of paint spills; however, it collects stormwater. A hose connected to a five-gallon bucket drains the secondary containment. The bucket sits beneath the mixer in a gravel-filled trench that runs along the south wall of the building. Curtis Hamburg tipped the bucket with his foot and said it is full, presumably of commingled stormwater and paint. See Figures 16 and 17.

Figure 16 Description: Paint mixer, housing, and secondary containment.

Figure 17 Description: Bucket connected by hose to mixer housing secondary containment. The bucket is full, presumably with commingled stormwater and paint. The trench, which the mixer sits in, is lined with gravel.

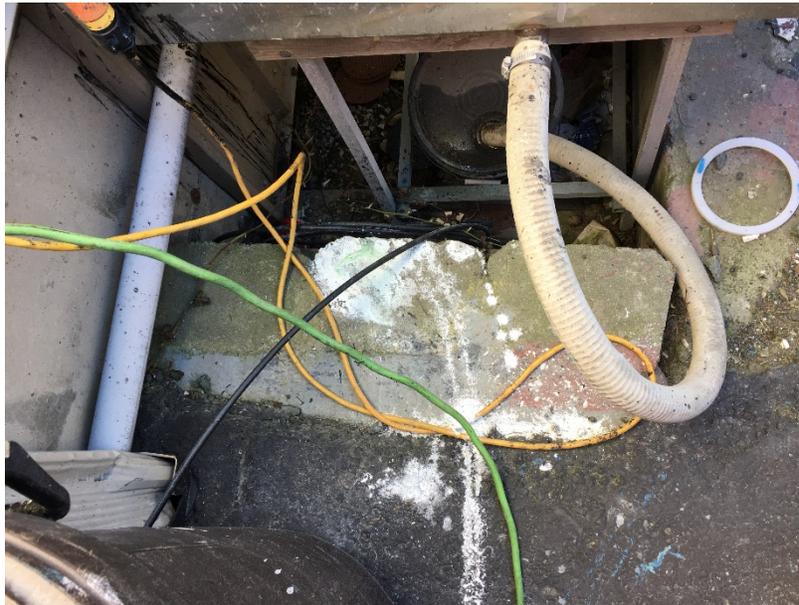
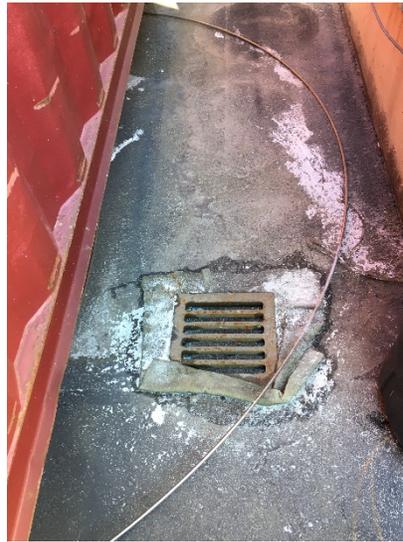
Paint residue from past spills is present on the pavement surrounding the mixer. It appears a spill of white paint occurred more recently. White paint residue is present on the top, and sides of the trench retaining wall. Dried white paint is on the geotextile fabric placed beneath a small catch basin grate at the southwest corner of the building. This catch basin is located within ten-feet of the paint mixer. There is no paint residue or dried paint chips on the catch basin grate. See Figures 18 and 19.

Figure 18 Description: White paint residue from past spill on top and side of trench wall.

Figure 19 Description: White paint staining on geotextile fabric, but not on catch basin grate, in the southwest corner of the facility. This catch basin is located within 10-feet of the paint mixer.

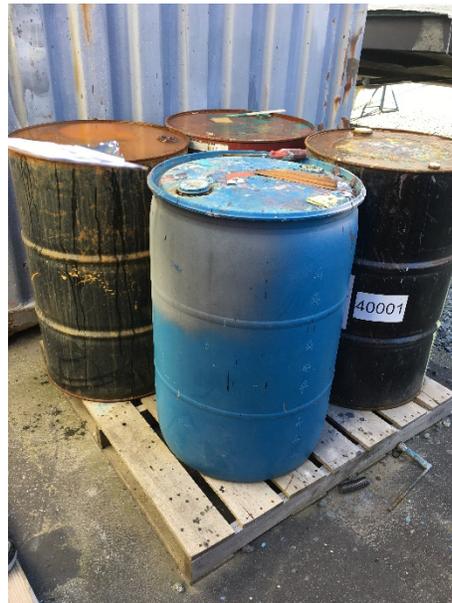
Four barrels, three metal and one plastic, sit on a wood pallet directly across from the paint mixer. The bungs are closed, but the barrels contain unknown liquids. Paint residue, and a wooden stirring stick is present on the tops of the drums, and on the pavement beneath the pallet. See Figure 20.

Figure 20 Description: Barrels sitting directly across from the paint mixer, containing unknown liquids, with presence of paint residue on the tops and pavement surrounding the barrels.

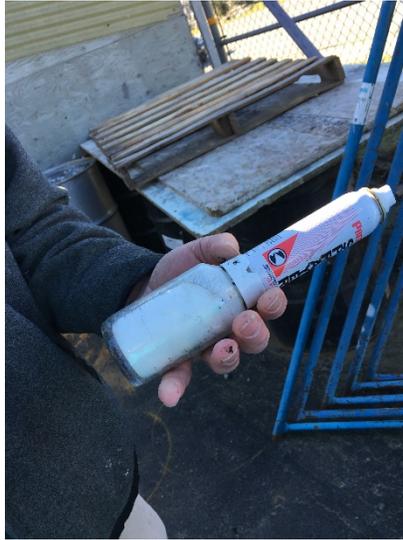
Curtis Hamburg found a discarded aerosol spray can attached to a coating product on the fence line on the west side of the property. Curtis believes this product is the source of residue located on pavement near the pressure wash water treatment tank. See Figure 21.

Figure 21 Description: Coating applicator, found discarded along the western fence line.

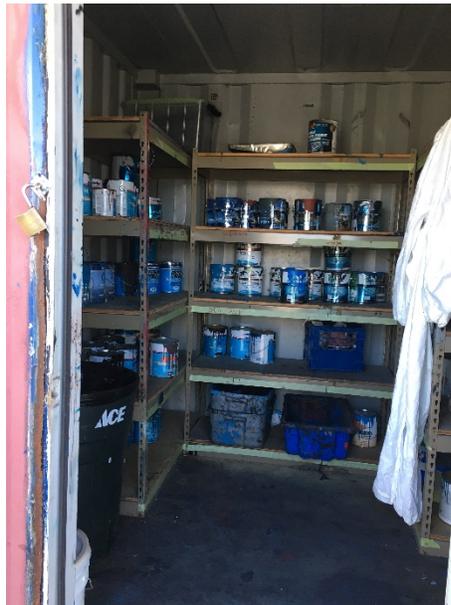
Figure 22 Description: Shipping container on west side of building where paint is stored.

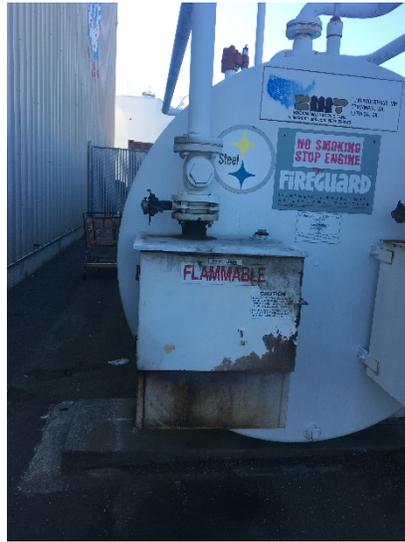
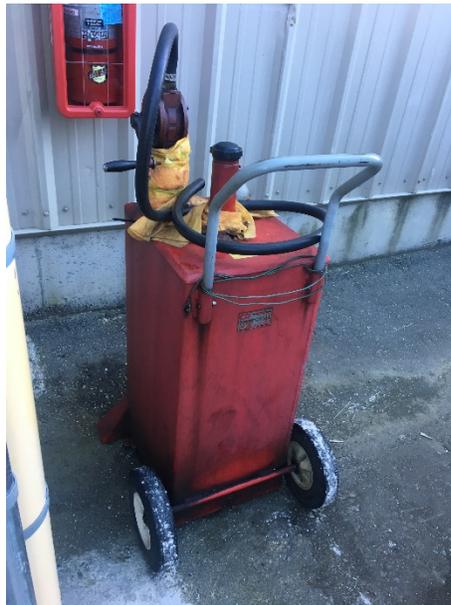
A modified shipping container provides storage for paint. The container is located on the west wall of the building. See Figure 22. Next to the shipping container, within a fenced perimeter is a large double-walled fuel tank. Also located within the fencing is a mobile fueling tank. The facility has wrapped absorbent cloths around the nozzle of the mobile fueling unit. Oil residue stains the pavement beneath where the mobile fueling unit sites. There is no spill kit within the vicinity of the large fuel tank or mobile fueling unit. White residue, presumably paint, coats the wheels of the mobile fueling unit. See Figures 23 and 24.

Figure 23 Description: Large, double-walled fuel tank.

Figure 24 Description: Mobile fueling unit. Absorbent cloth wrapped around the nozzle. Oil residue stains the pavement where the fueling unit sits. Paint residue on the tires.

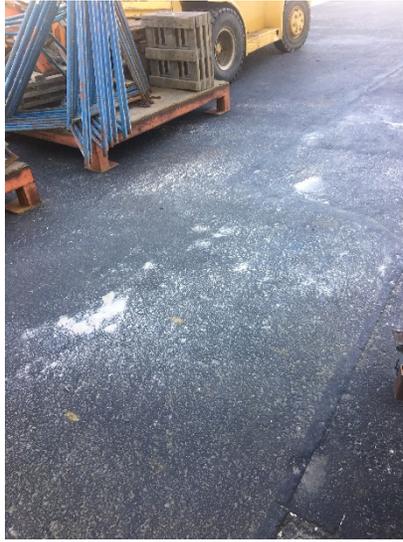
Ecology noted white residue, presumably paint, on the pavement just outside the fuel tank perimeter fencing. See Figure 25.

Figure 25 Description: White residue, presumably paint, on pavement just outside the gate to the fuel tank perimeter fence, near the northwest corner of the facility.

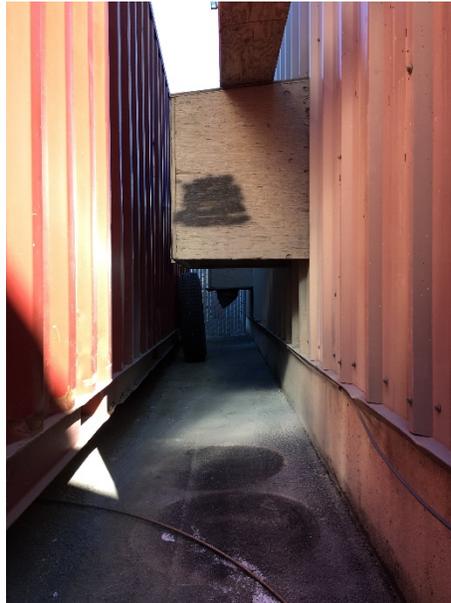
Boat building and repair activities occur within indoor workspaces, adjacent to the offices within the facility's single building. The building has concrete floors and no drains. Exhaust ports exist on the west wall of the building. Particulate fall out from the exhausts has deposited on the ground between the paint storage-shipping container and building. This area drains to the small catch basin at the southwest corner of the building. See Figure 26.

Figure 26 Description: Particulate fall out from inside exhausts depositing on the pavement between the building and paint storage-shipping container. The absence of dust suggests two barrels were previously stored here and have since moved.
