Seattle Steam Outfall Pipe Measurement FINDINGS REPORT

Pier 57, 1301 Alaskan Way
Seattle, Washington

Muir Job No. 12010035

Report Issue Date: November 2, 2012

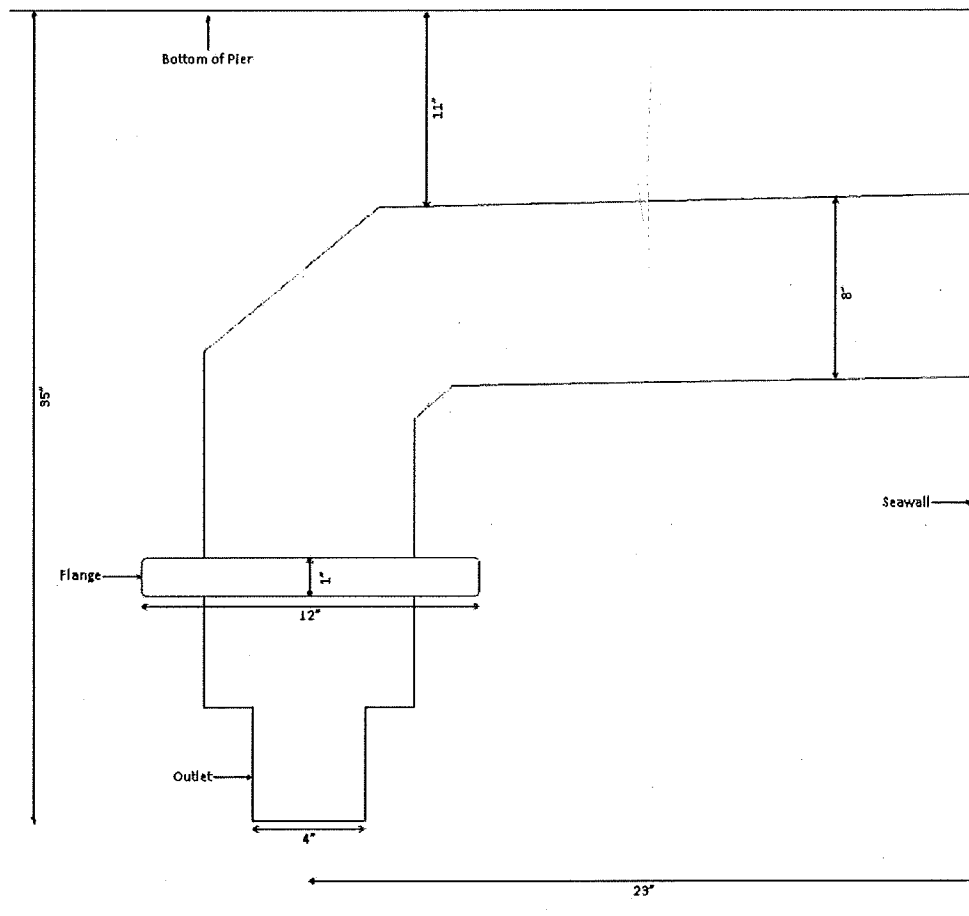
Figure 3. Pipe Diagram Facing North (Not To Scale)

- Pipe Diameter: 8"
- Flange Diameter: 12"
- Pipe Outlet Diameter: 4" (Approximate – outlet exhibits signs of deterioration/rust)
- Pipe Length Extending from Seawall: 27"
- Pipe Orientation Extending from Seawall: Slight slope down (less than 1-2 percent slope)
- Distance from Bottom of Pier to top of Pipe: 11"
- Distance from Bottom of Pier to Pipe Outlet: 35"
- Distance from Pipe Outlet to Seafloor: 188"
- Water Depth at Time of Measurement: 108" (Approximate)
- Distance from Pipe Outlet to Water at Time of Measurement: 80" (Approximate)

Overall, the pipe shows signs of deterioration (rust). There is significant build-up of rust and other organics on the pipe outlet (below the flange). The pipe did not emit any liquids during the investigation. There was a faint stream of air emitting from the pipe that was slightly warmer than the ambient temperature at the time. Photos are provided in Appendix A.
