DEPARTMENT OF ECOLOGY State of Washington	CONSTRUCTION STORMWATER GENERAL PERMIT INSPECTION REPORT State of Washington Department of Ecology		
Section A: General Data			
Ecology Inspector(s): Evan Wood	On-Site Representative Name: Title: Phone: Email:	Inspection Date and Entry/Exit Time: July 21, 2022, 1317/1345	Inspection Type: Announced
		Receiving waters: City of Lacey MS4	Permit webpage: https://fortress.wa.gov/ecy/paris/FacilitySummary.aspx?FacilityId=63651
Section B: Background			
<p>The Woodbrook Townhomes project is covered under the State of Washington's Construction Stormwater General Permit (CSWGP). The CSWGP is a National Pollutant Discharge Elimination System (NPDES) and a State Waste Discharge permit for discharge of construction-related stormwater. The purpose of this inspection is to conduct a compliance inspection and to provide technical assistance as appropriate.</p> <p>Ecology arrived on site to conduct a routine CSWGP compliance inspection. Responsible party or their representative were not present at the time of inspection. Site is active.</p> <p>Weather at time of inspection: 70s and cloudy <u>Precipitation in the past 24 hours?</u> <input type="checkbox"/> Y

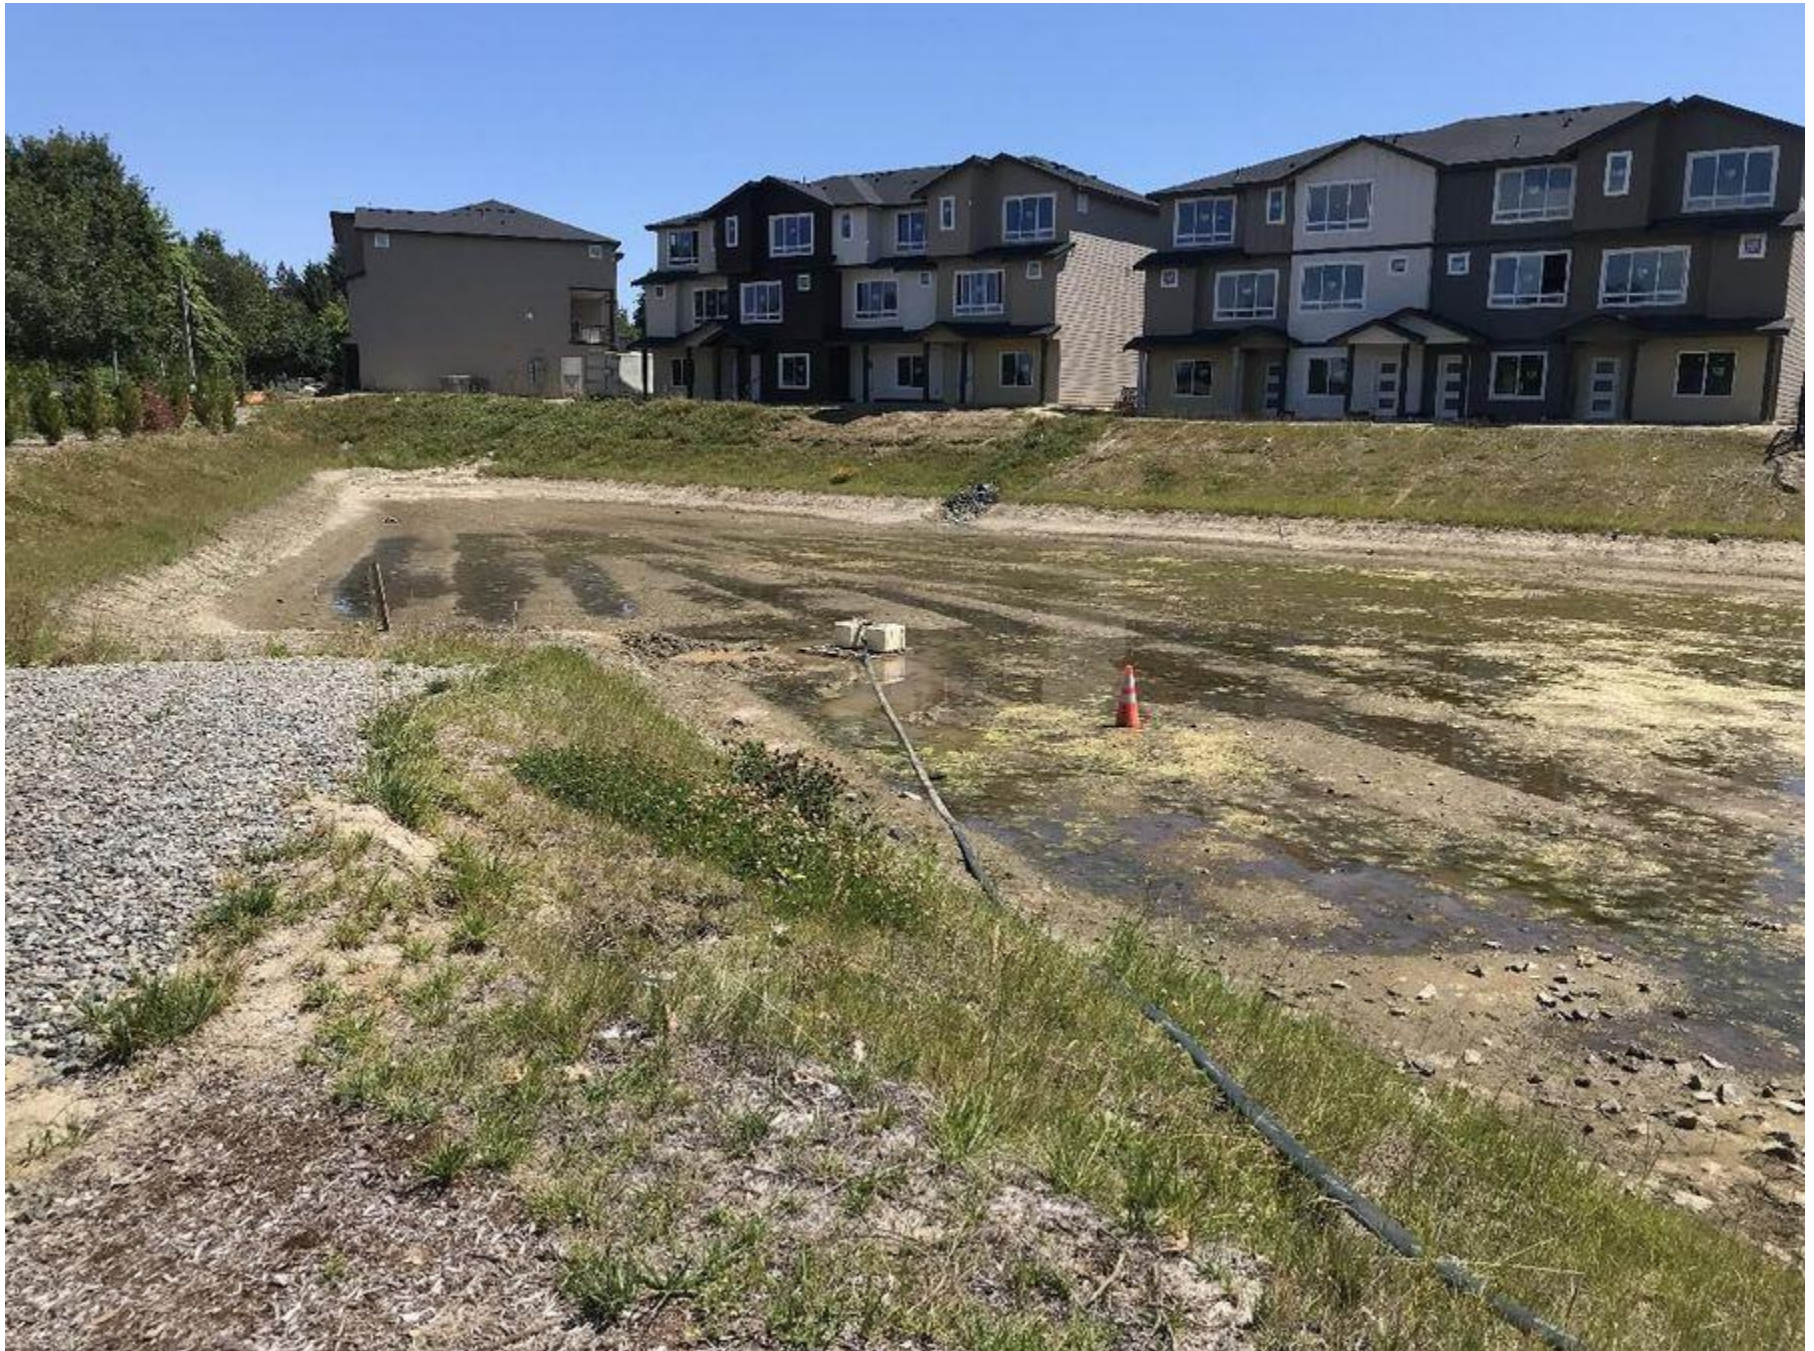
Photo 1

Photo Description: Pump noted sitting in turbid water

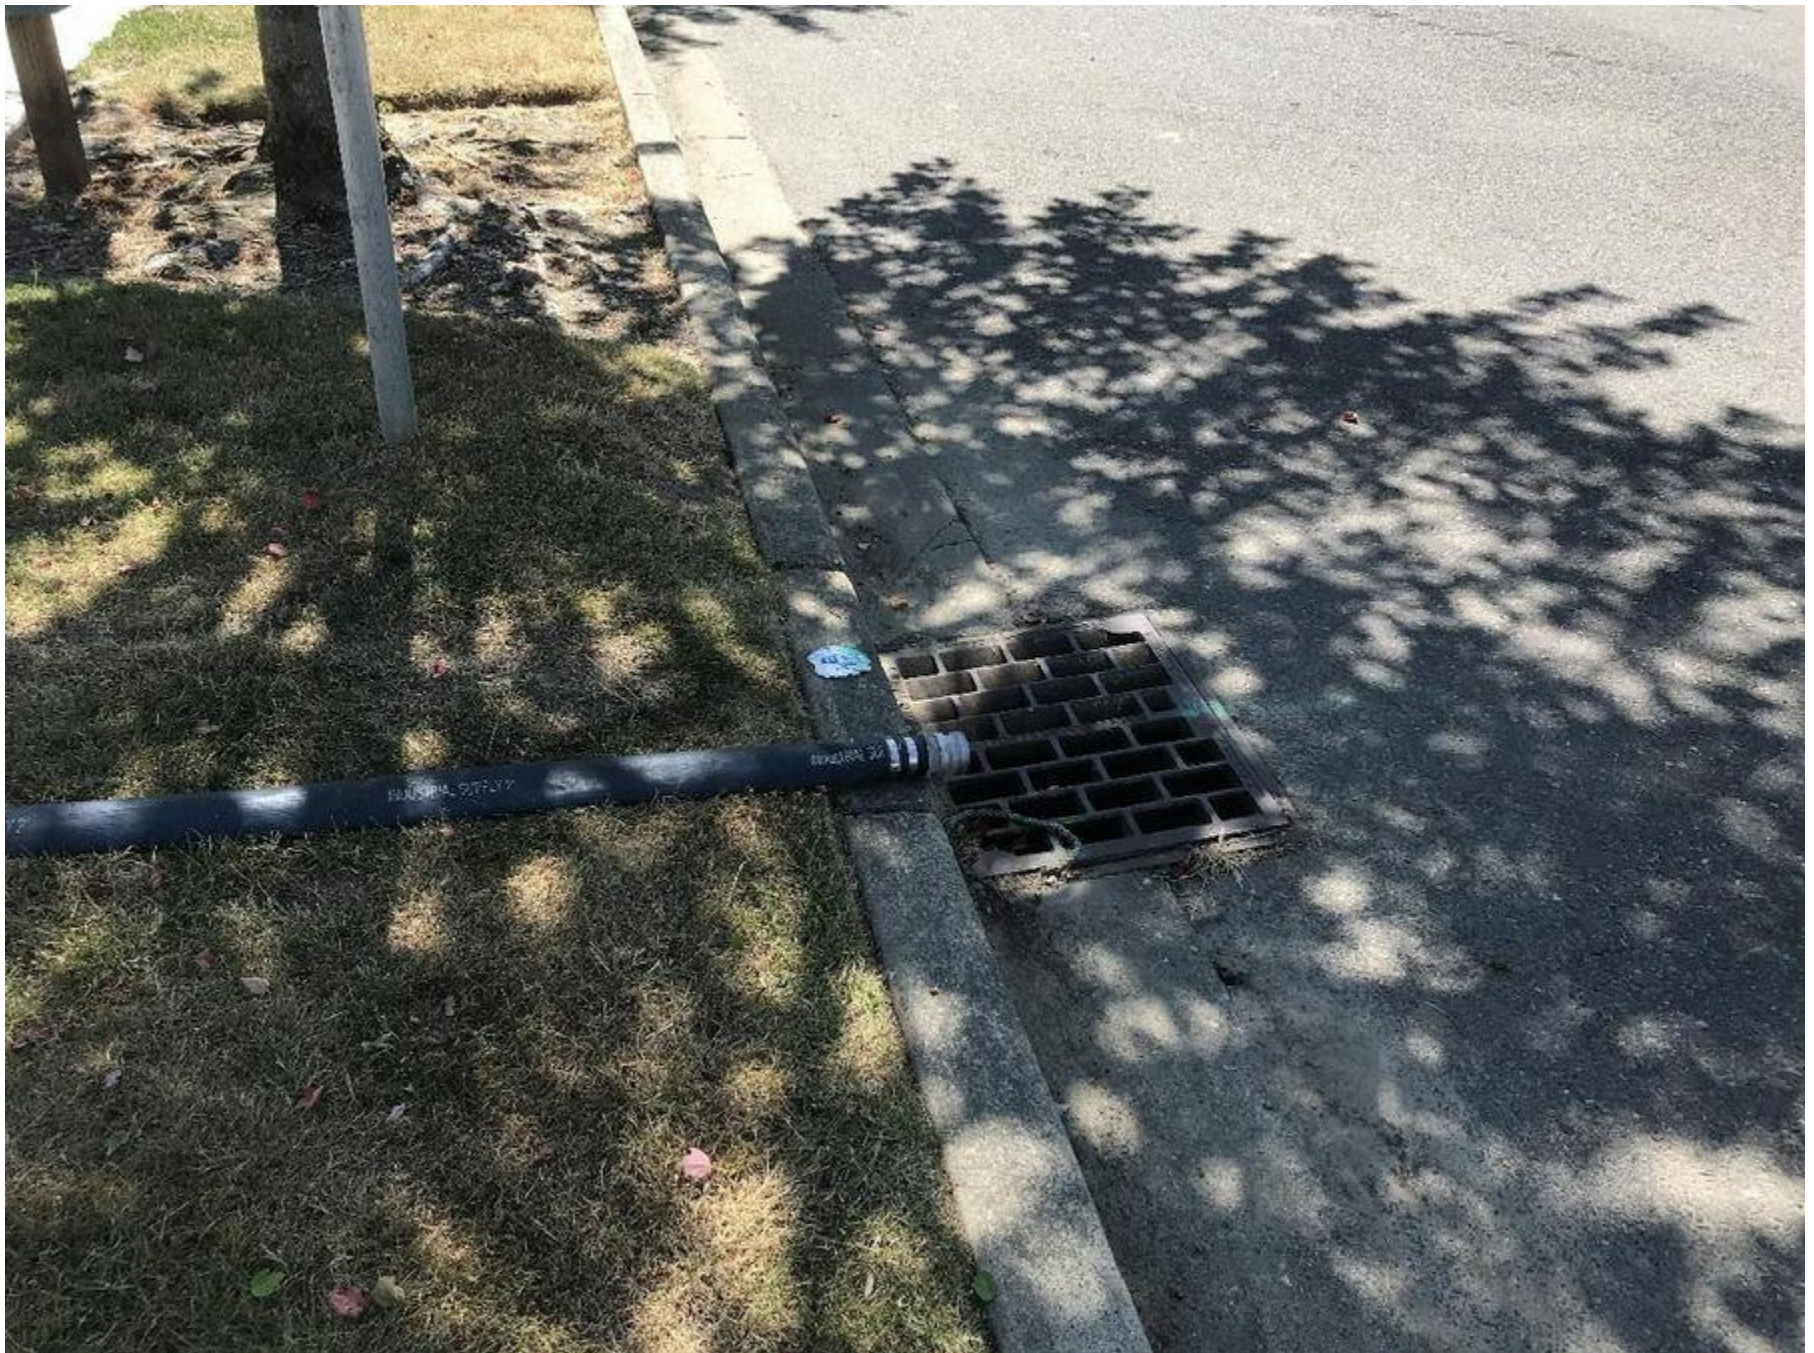
Photo 2

<p><u>S9.D.10 Control Dewatering</u></p>	<p>Immediately begin. Address the problems no later than 10 days from the date of this inspection.</p>	<p>C203, C206, C236</p>
<p>Pump noted with discharge hose directed towards City of Lacey MS4 (Pump was not discharging at time of inspection) Failure to meet S9.D.10.d: Permittee must handle highly turbid or contaminated dewatering water separately from stormwater. Control dewatering to include discharges from foundations, vaults and trenches, as set forth in permit condition S9.D.10.</p>		
<p>For assistance with any of these compliance issues or recommendations regarding BMPs, please see the 2019 Stormwater Management Manual for Western Washington (SWMMWW), Volume II, Construction Stormwater Pollution Prevention which includes BMPs for Source Control and Runoff Conveyance and Treatment BMPs. The full SWMMWW is available at: http://www.ecy.wa.gov/programs/wq/stormwater/manual.html.</p>

Photo Description: Discharge end of pipe directly over Lacey MS4 with no protection

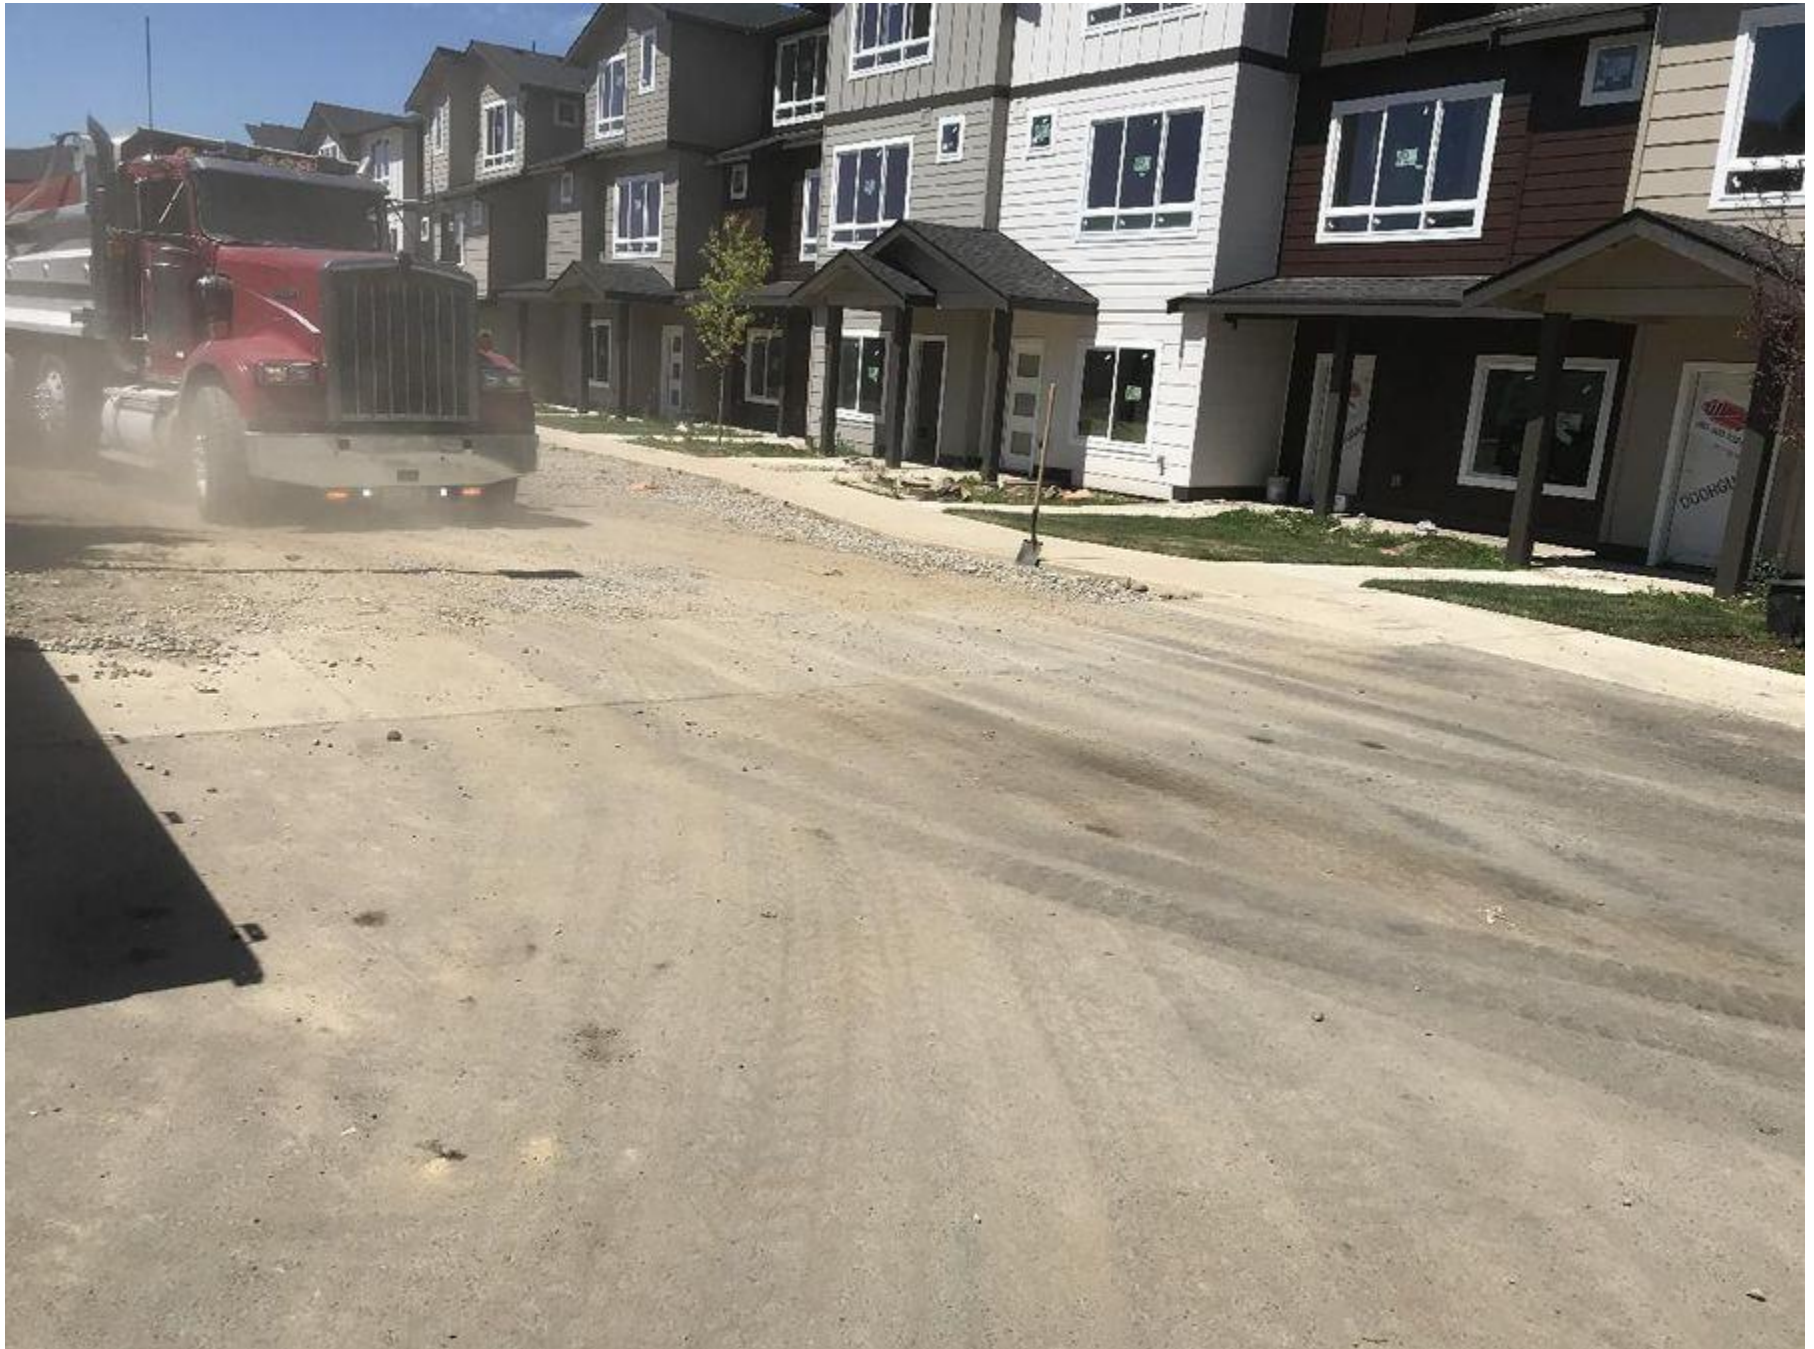
Photo 3

Section C: Compliance			
<u>Violations and action required to achieve compliance</u> <u>S9.D.2 Establish Construction Access</u> Vehicle track-out noted in areas where construction is finished Failure to meet S9.D.2.d: If sediment is tracked off site, clean the affected roadway thoroughly at the end of each day, or more frequently as necessary (for example, during wet weather). Remove sediment from roads by shoveling, sweeping, or pickup and transport of the sediment to a controlled sediment disposal area. Install and maintain adequate construction access to prevent track-out off-site.	<u>Complete or submit date</u> Clean the affected roadway thoroughly at the end of each day , or more frequently as necessary . Immediately begin. Address the problems no later than 10 days from the date of this inspection.	<u>Guidance</u> BMP C105 , BMP C106 , BMP C107

Photo Description: Vehicle track-out and insufficient construction Entrance

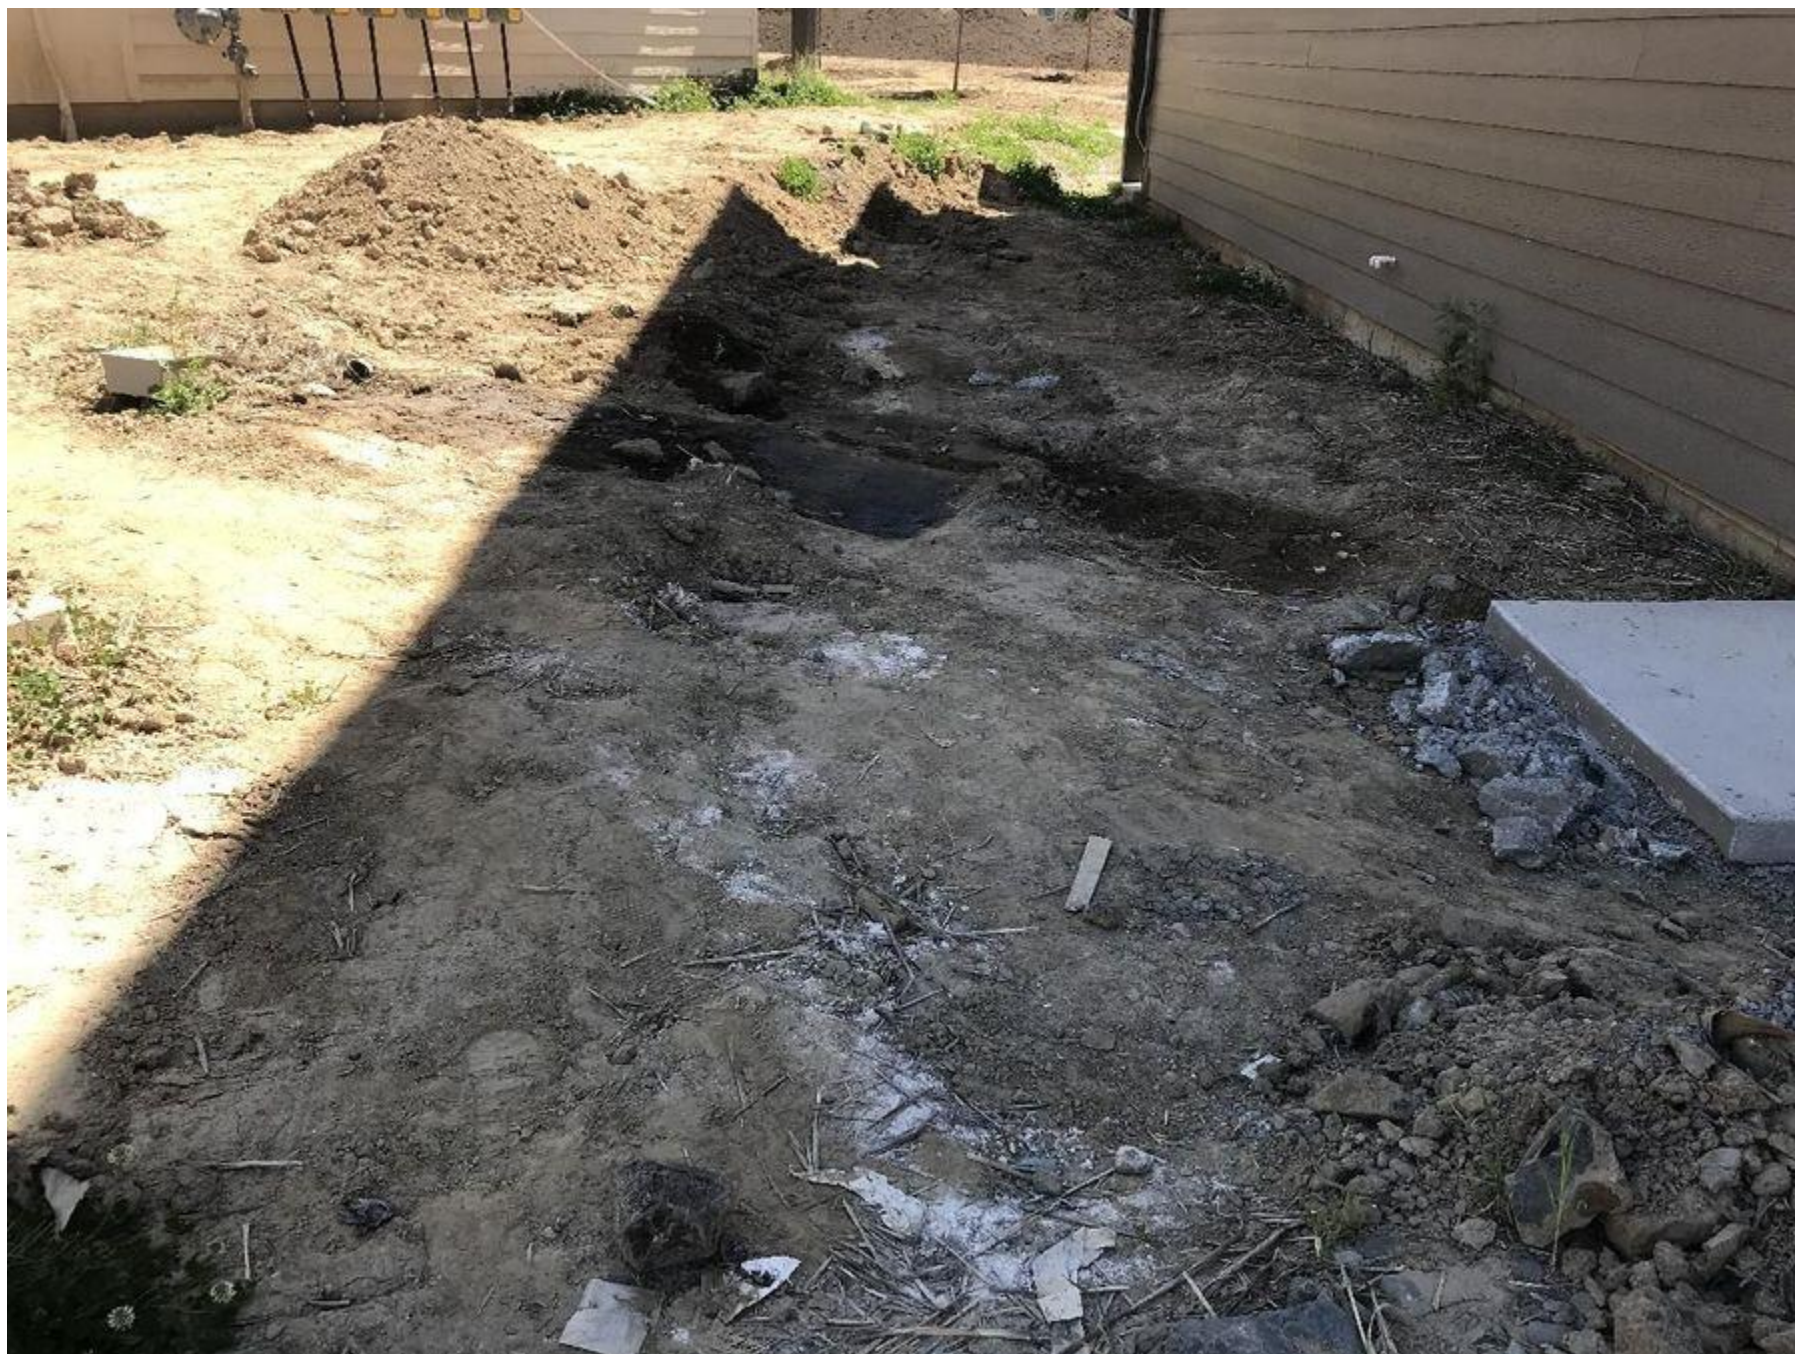
Photo 4

Photo Description: Concrete and drywall wash waste noted on bare soils

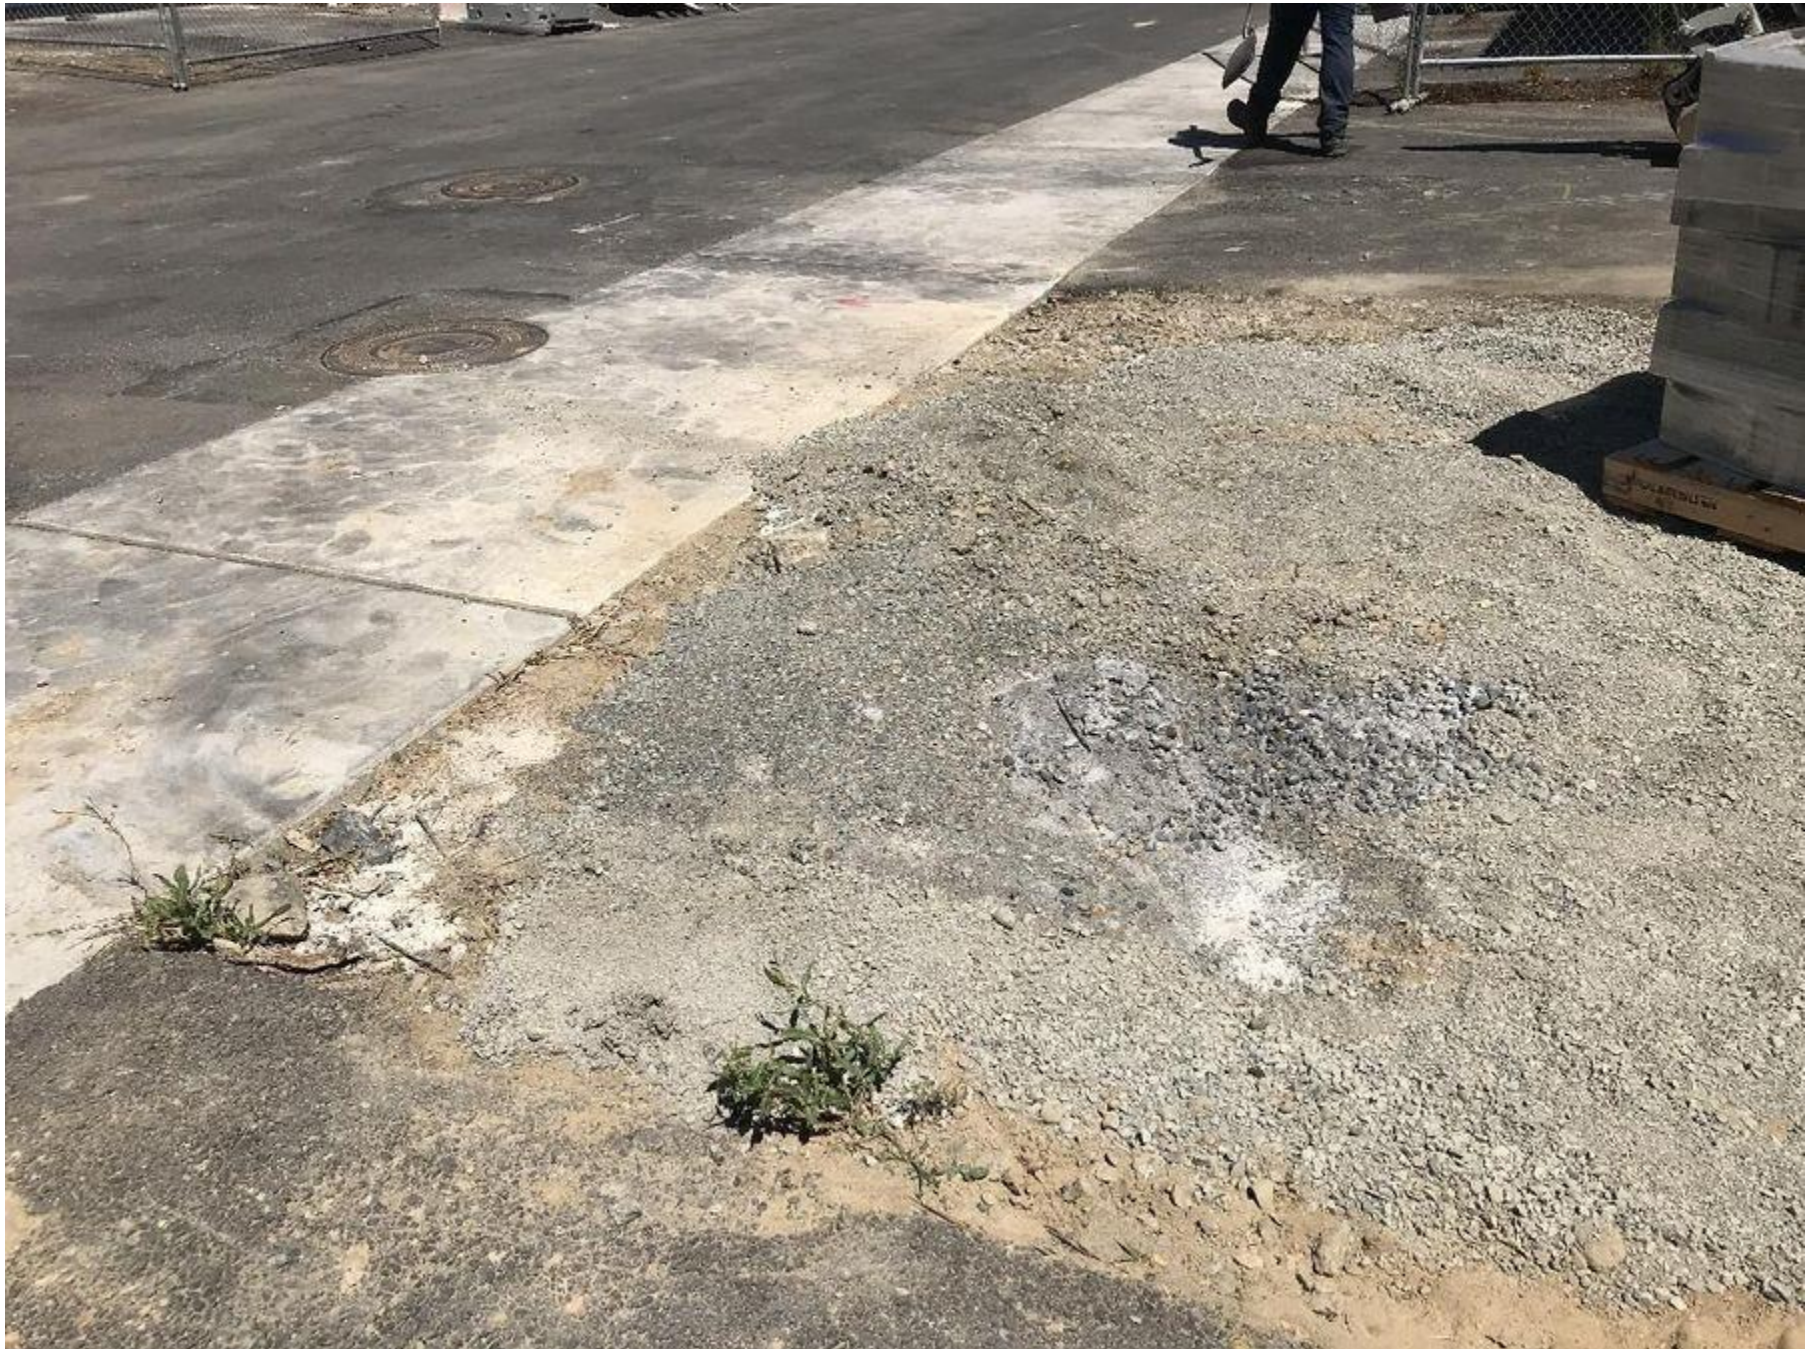
Photo 5

Photo Description: Concrete waste not in a lined concrete wash area

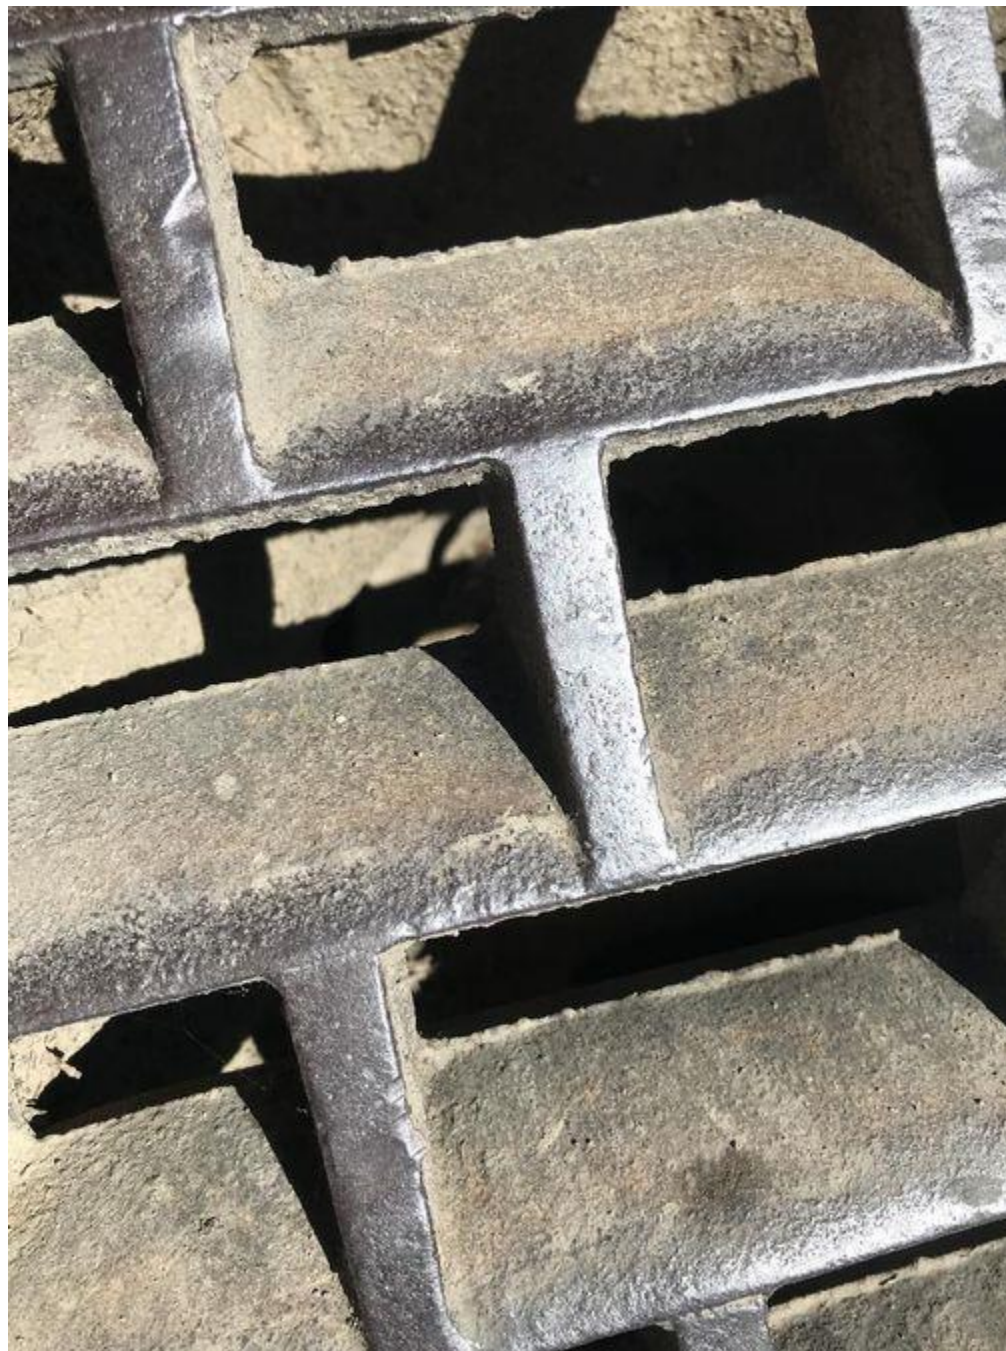
Photo 6

<p><u>S9.D.7 Protect Drain Inlets</u></p>	<p>Immediately begin. Address the problems no later than 10 days from the date of this inspection.</p>	<p>C220</p>
<p>Inlet protection not maintained near areas of high dump truck traffic Failure to meet S9.D.7.b: Clean or remove and replace inlet protection devices when sediment has filled one-third of the available storage (unless a different standard is specified by the product manufacturer). Protect and maintain drain inlets, as set forth in permit condition S9.D.7.a.</p>		
<p><u>S9.D.9 Control Pollutants</u></p>	<p>Immediately begin. Address the problems no later than 10 days from the date of this inspection.</p>	<p>C151, C152, C153, C154, C250, C251, C252</p>
<p>Drywall wash waste noted on bare soils Failure to meet S9.D.9.a: Handle and dispose of all pollutants, including waste materials and demolition debris that occur on site in a manner that does not cause contamination of stormwater.</p> <p>Concrete waste noted on bare soils Failure to meet S9.D.9.h: Assure that washout of concrete trucks is performed off-site or in designated concrete washout areas only. Do not wash out concrete truck drums onto the ground, or into storm drains, open ditches, streets, or streams. Washout of small concrete handling equipment may be disposed of in a formed area awaiting concrete where it will not contaminate surface or ground water. Do not dump excess concrete on site, except in designated concrete washout areas. Concrete spillage or concrete discharge directly to groundwater or surface waters of the State is prohibited. At no time shall concrete be washed off into the footprint of an area where an infiltration BMP will be installed. Design, install, implement and maintain effective pollution prevention measures to minimize the discharge of pollutants, as set forth in permit conditions S1.D.1, S9.D.9.</p>

Photo Description: Unmaintained inlet protection
