DEPARTMENT OF <b>ECOLOGY</b> State of Washington	<h2 style="text-align: center;">CONSTRUCTION STORMWATER GENERAL PERMIT</h2> <h3 style="text-align: center;">INSPECTION REPORT</h3> <p style="text-align: center;">State of Washington Department of Ecology</p>		
<b>Section A: General Data</b>			
Ecology Inspector(s):  Evan Wood Joe McCord Jacob Neuharth Angela Vincent	On-Site Representative Name: n/a Title: Phone: Email:	Inspection Date and Entry/Exit Time: November 18, 2022, 09:43/10:02	Inspection Type: Unannounced
		Receiving waters: Existing stormwater facility.	Permit webpage: <a href="https://www.ecy.wa.gov/programs/wq/stormwater/permit/WAR308378">WAR308378</a>
<b>Section B: Background</b>			
<p>The Woodbrook Townhomes project is covered under the State of Washington's Construction Stormwater General Permit (CSWGP). The CSWGP is a National Pollutant Discharge Elimination System (NPDES) and a State Waste Discharge permit for discharge of construction-related stormwater. The purpose of this inspection is to conduct a compliance inspection and to provide technical assistance as appropriate.</p> <p>Ecology arrived on site to conduct a routine CSWGP compliance inspection. Responsible p

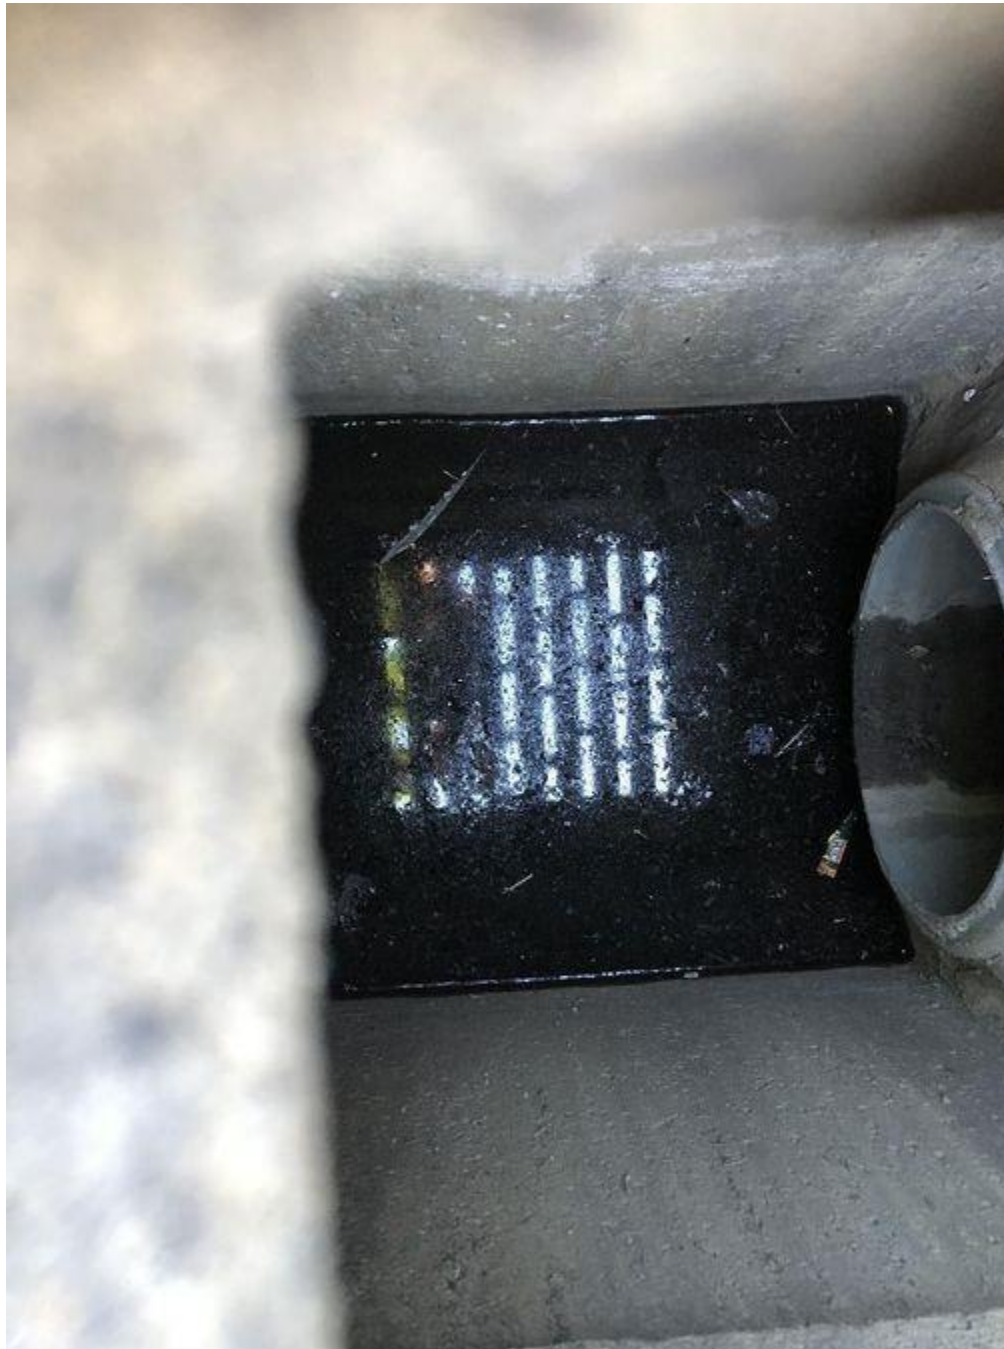
**Photo 1**

Photo Description: Catch Basins on site no longer have BMP C220: Inlet Protection installed.

<b>Section C: Compliance</b>			
<b><u>Violations and action required to achieve compliance</u></b>		<b>Complete or submit date</b>	<b>Guidance</b>
<u>S9.D.7 Protect Drain Inlets</u> <b>Inlet protection should be left in place until the site is ready to submit a Notice to Terminate the CSWGP.</b> <b>Failure to meet S9.D.7.a:</b> Protect all storm drain inlets made operable during construction so that stormwater runoff does not enter the conveyance system without first being filtered or treated to remove sediment. Protect and maintain drain inlets, as set forth in permit condition S9.D.7.a.		Immediately begin. Address the problems <b>no later than 10 days</b> from the date of this inspection.	<a href="#">C220</a>
<p>For assistance with any of these compliance issues or recommendations regarding BMPs, please see the 2019 Stormwater Management Manual for Western Washington (SWMMWW), Volume II, Construction Stormwater Pollution Prevention which includes BMPs for <a href="#">Source Control</a> and <a href="#">Runoff Conveyance and Treatment BMPs</a>. The full SWMMWW is available at:  <a href="http://www.ecy.wa.gov/programs/wq/stormwater/manual.html">http://www.ecy.wa.gov/programs/wq/stormwater/manual.html</a>.</p>

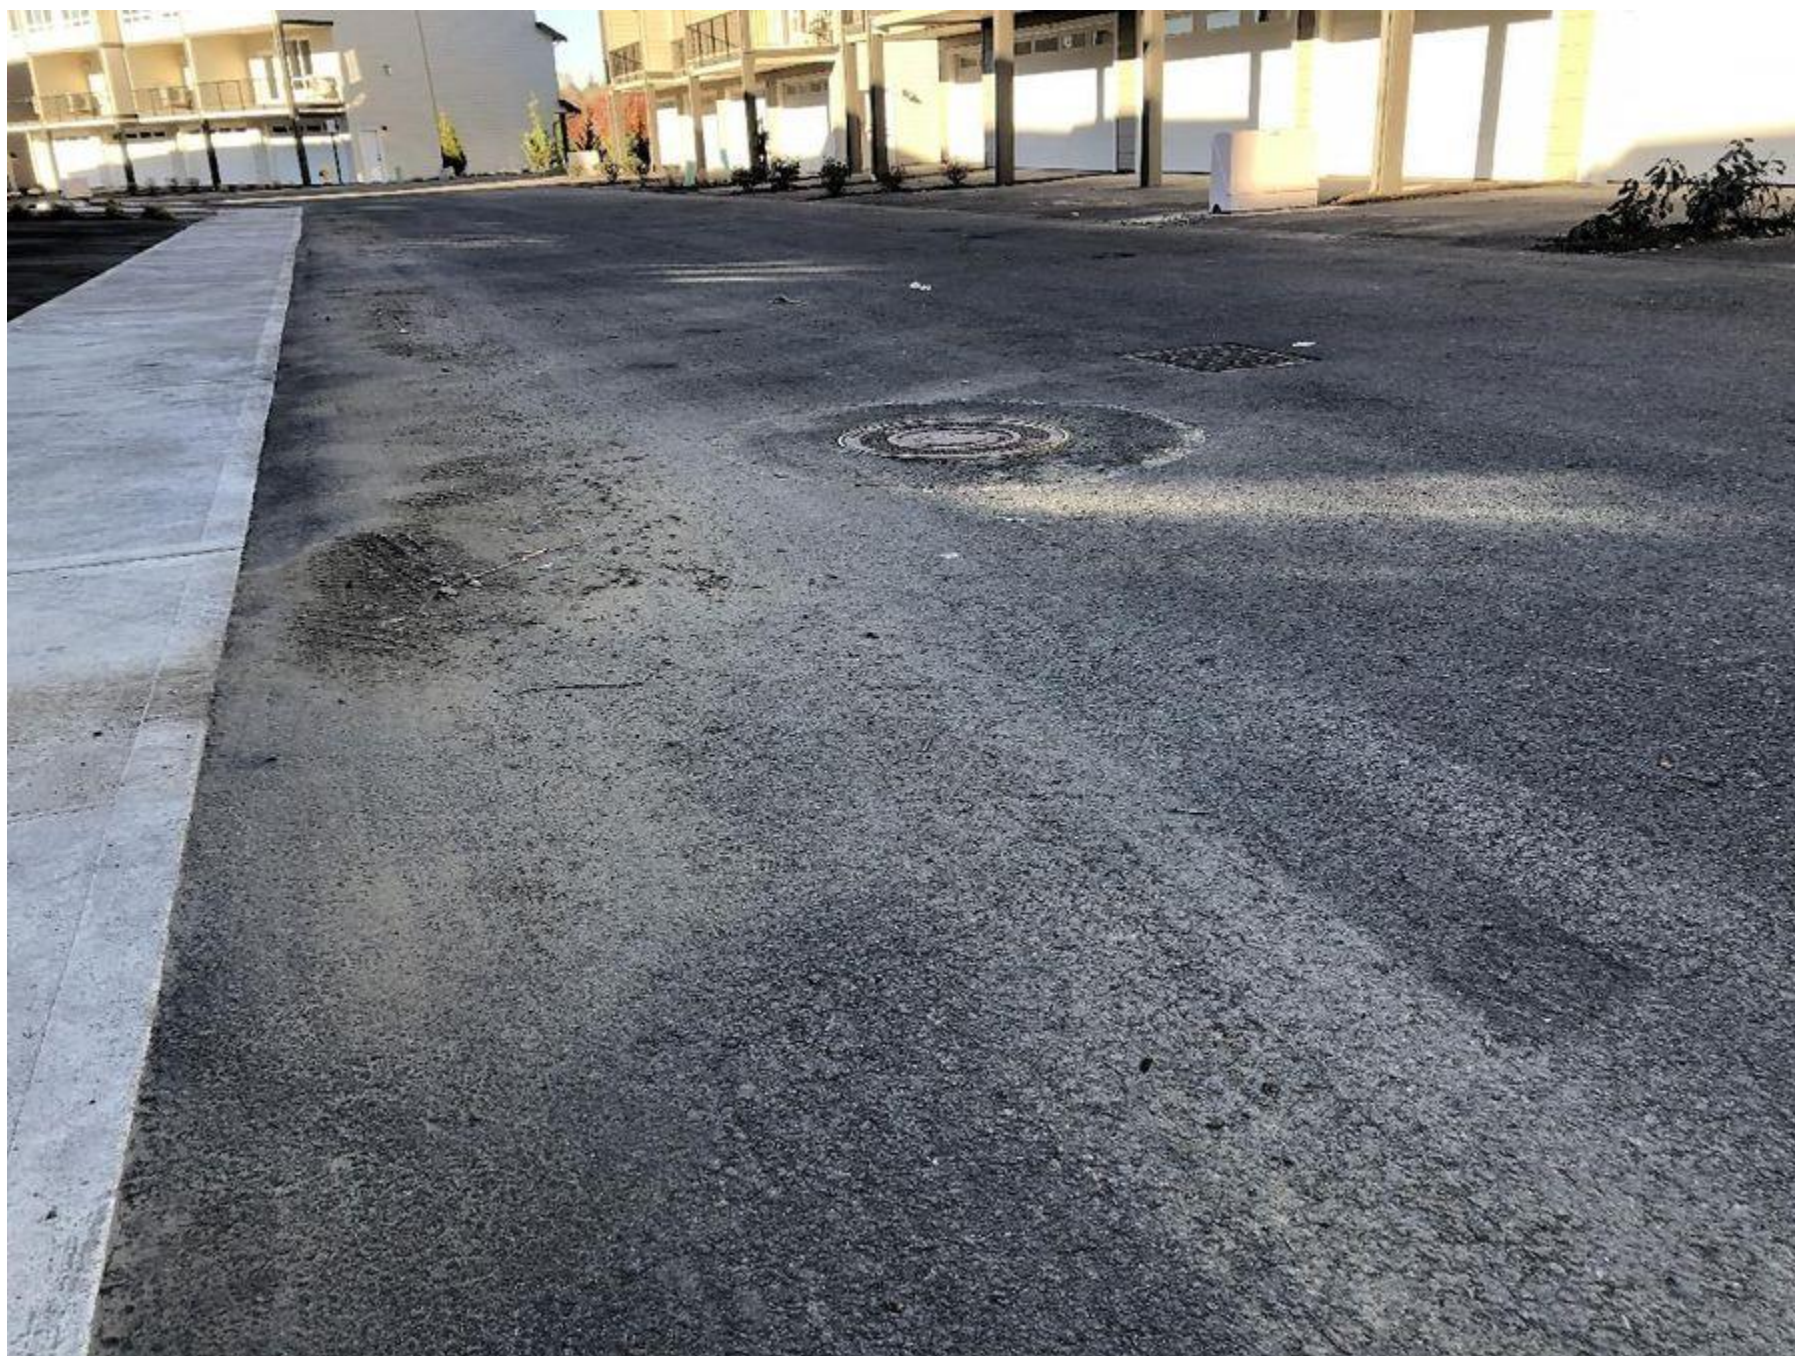
### Photo 2

Photo Description: Location of catch basin from **Photo 1**. Heavy sediments noted on the street near the catch basin.

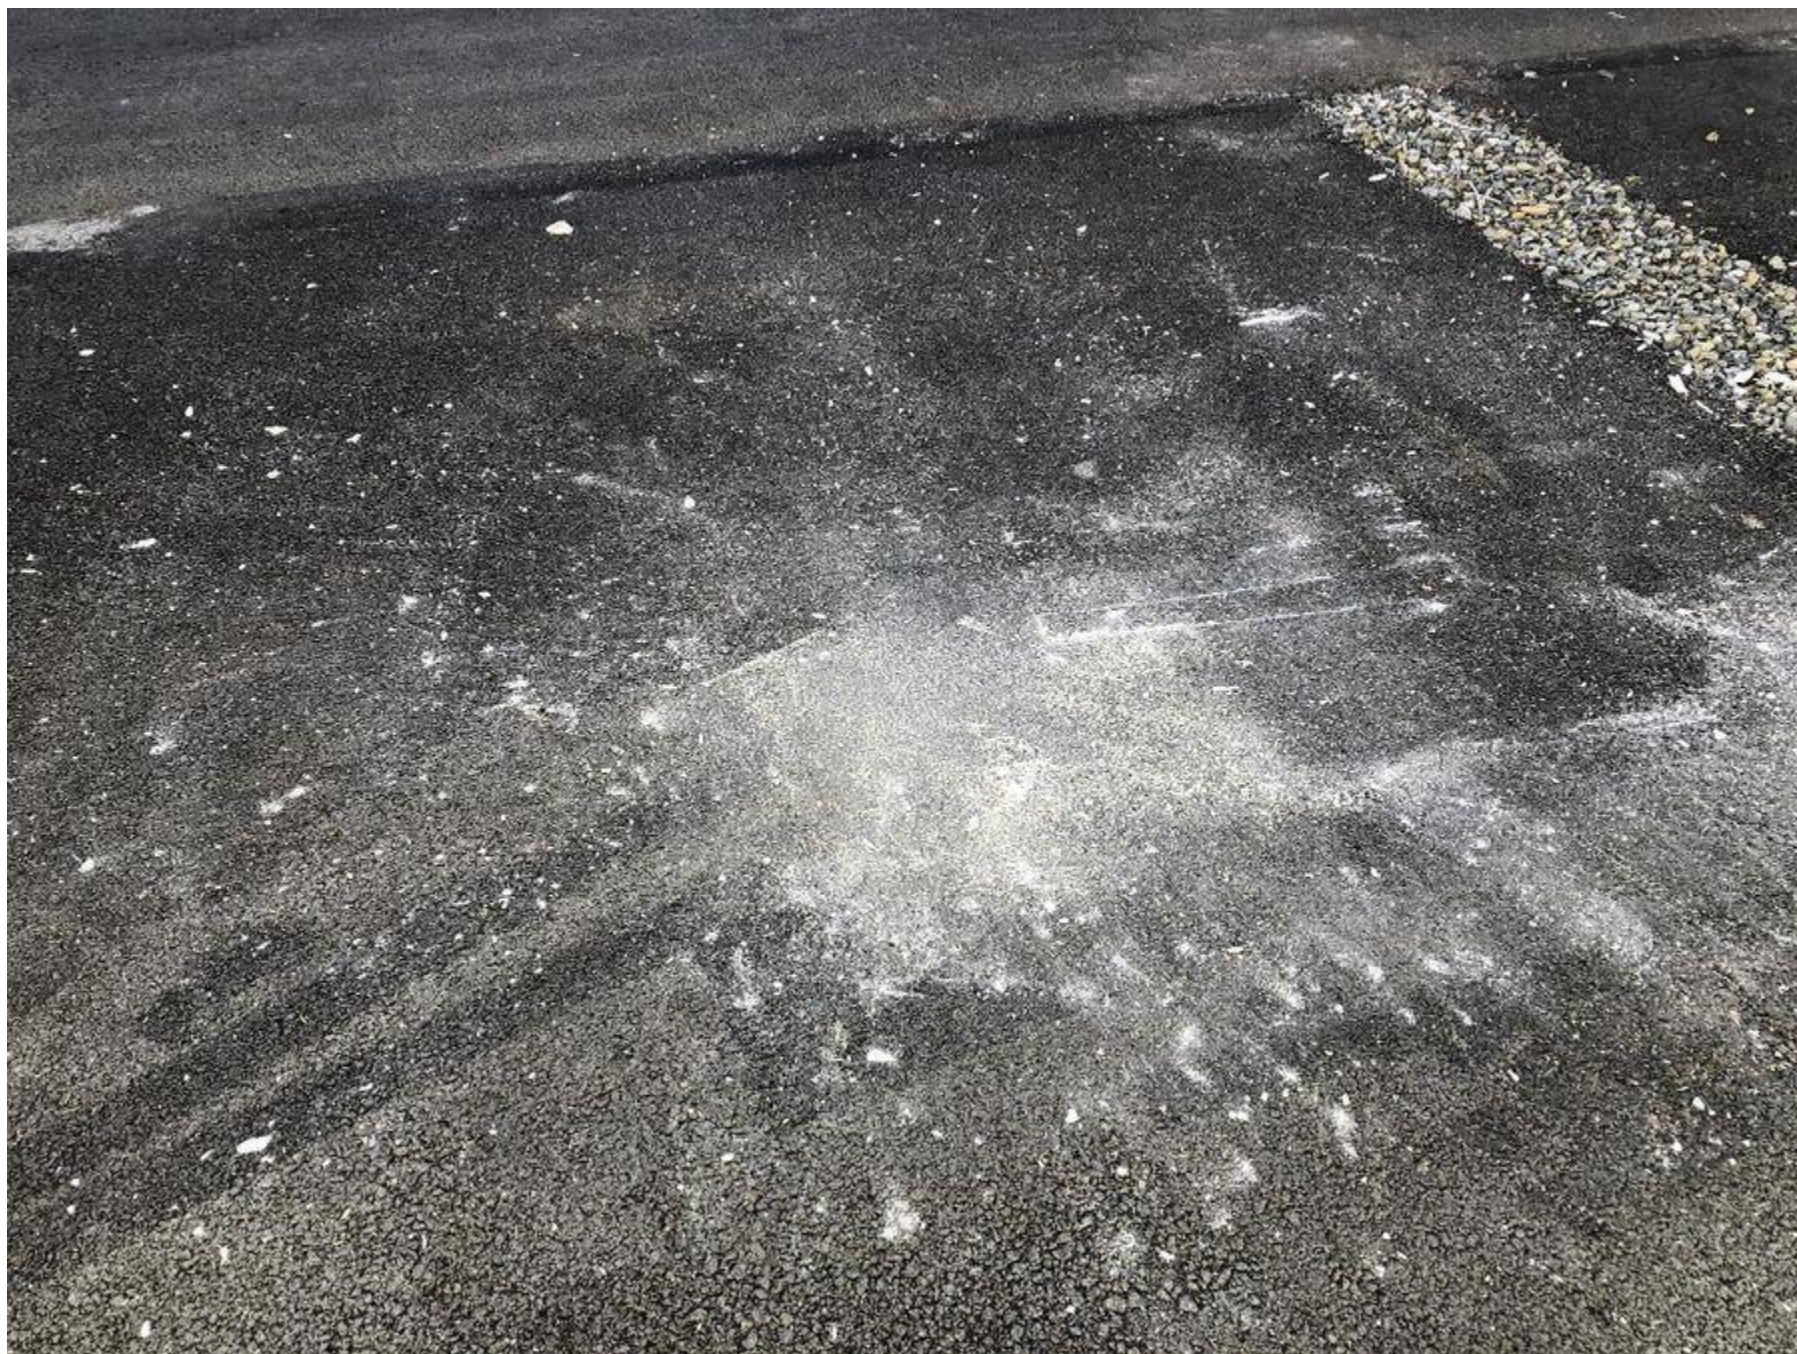
**Photo 3**

Photo Description: Drywall debris found in some parking stalls.

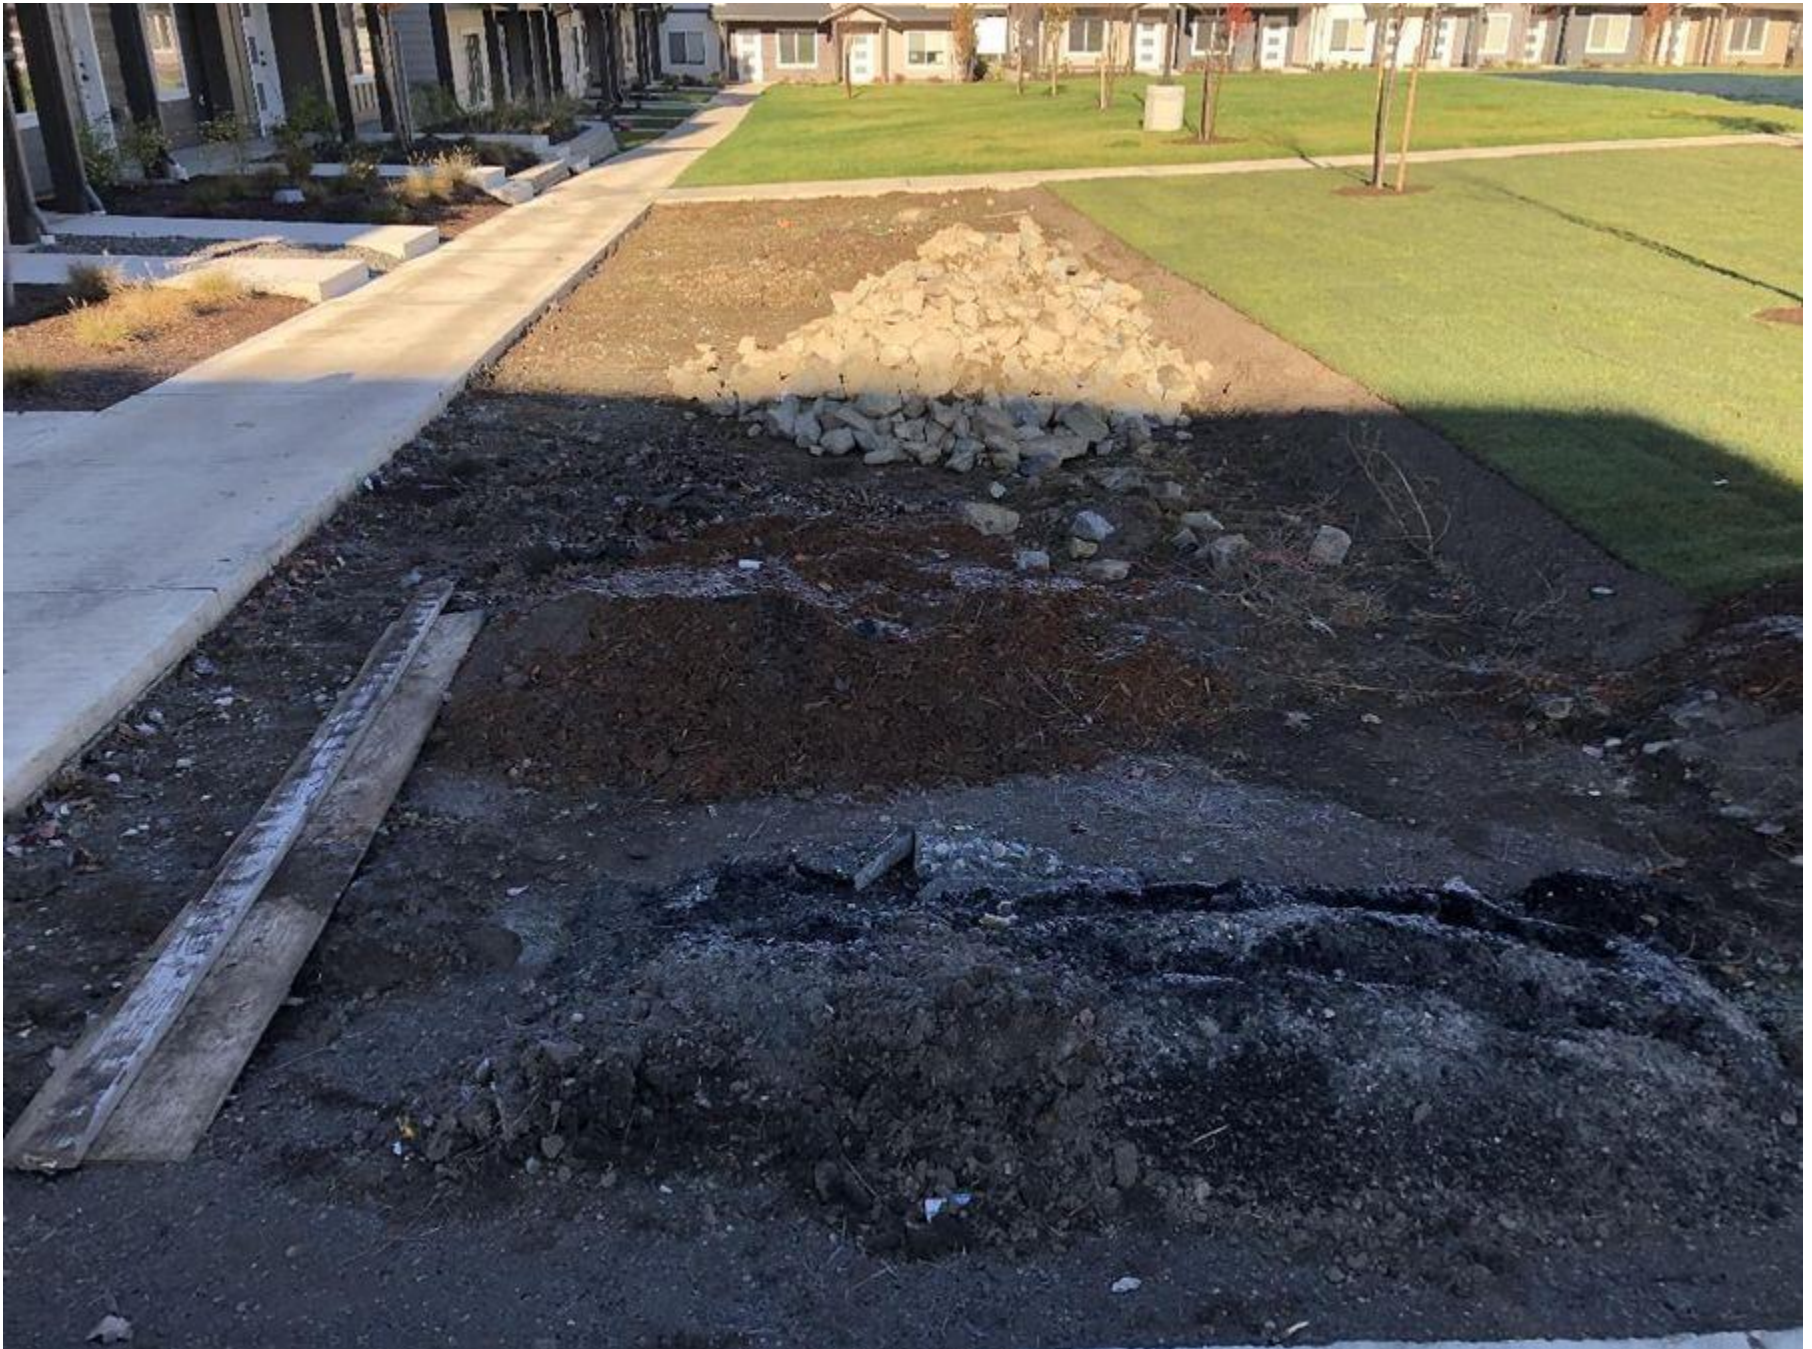
**Photo 4**

Photo Description: Some areas on site have not been landscaped. Small pile of quarry spalls and asphalt littered dirt pile has not been removed.

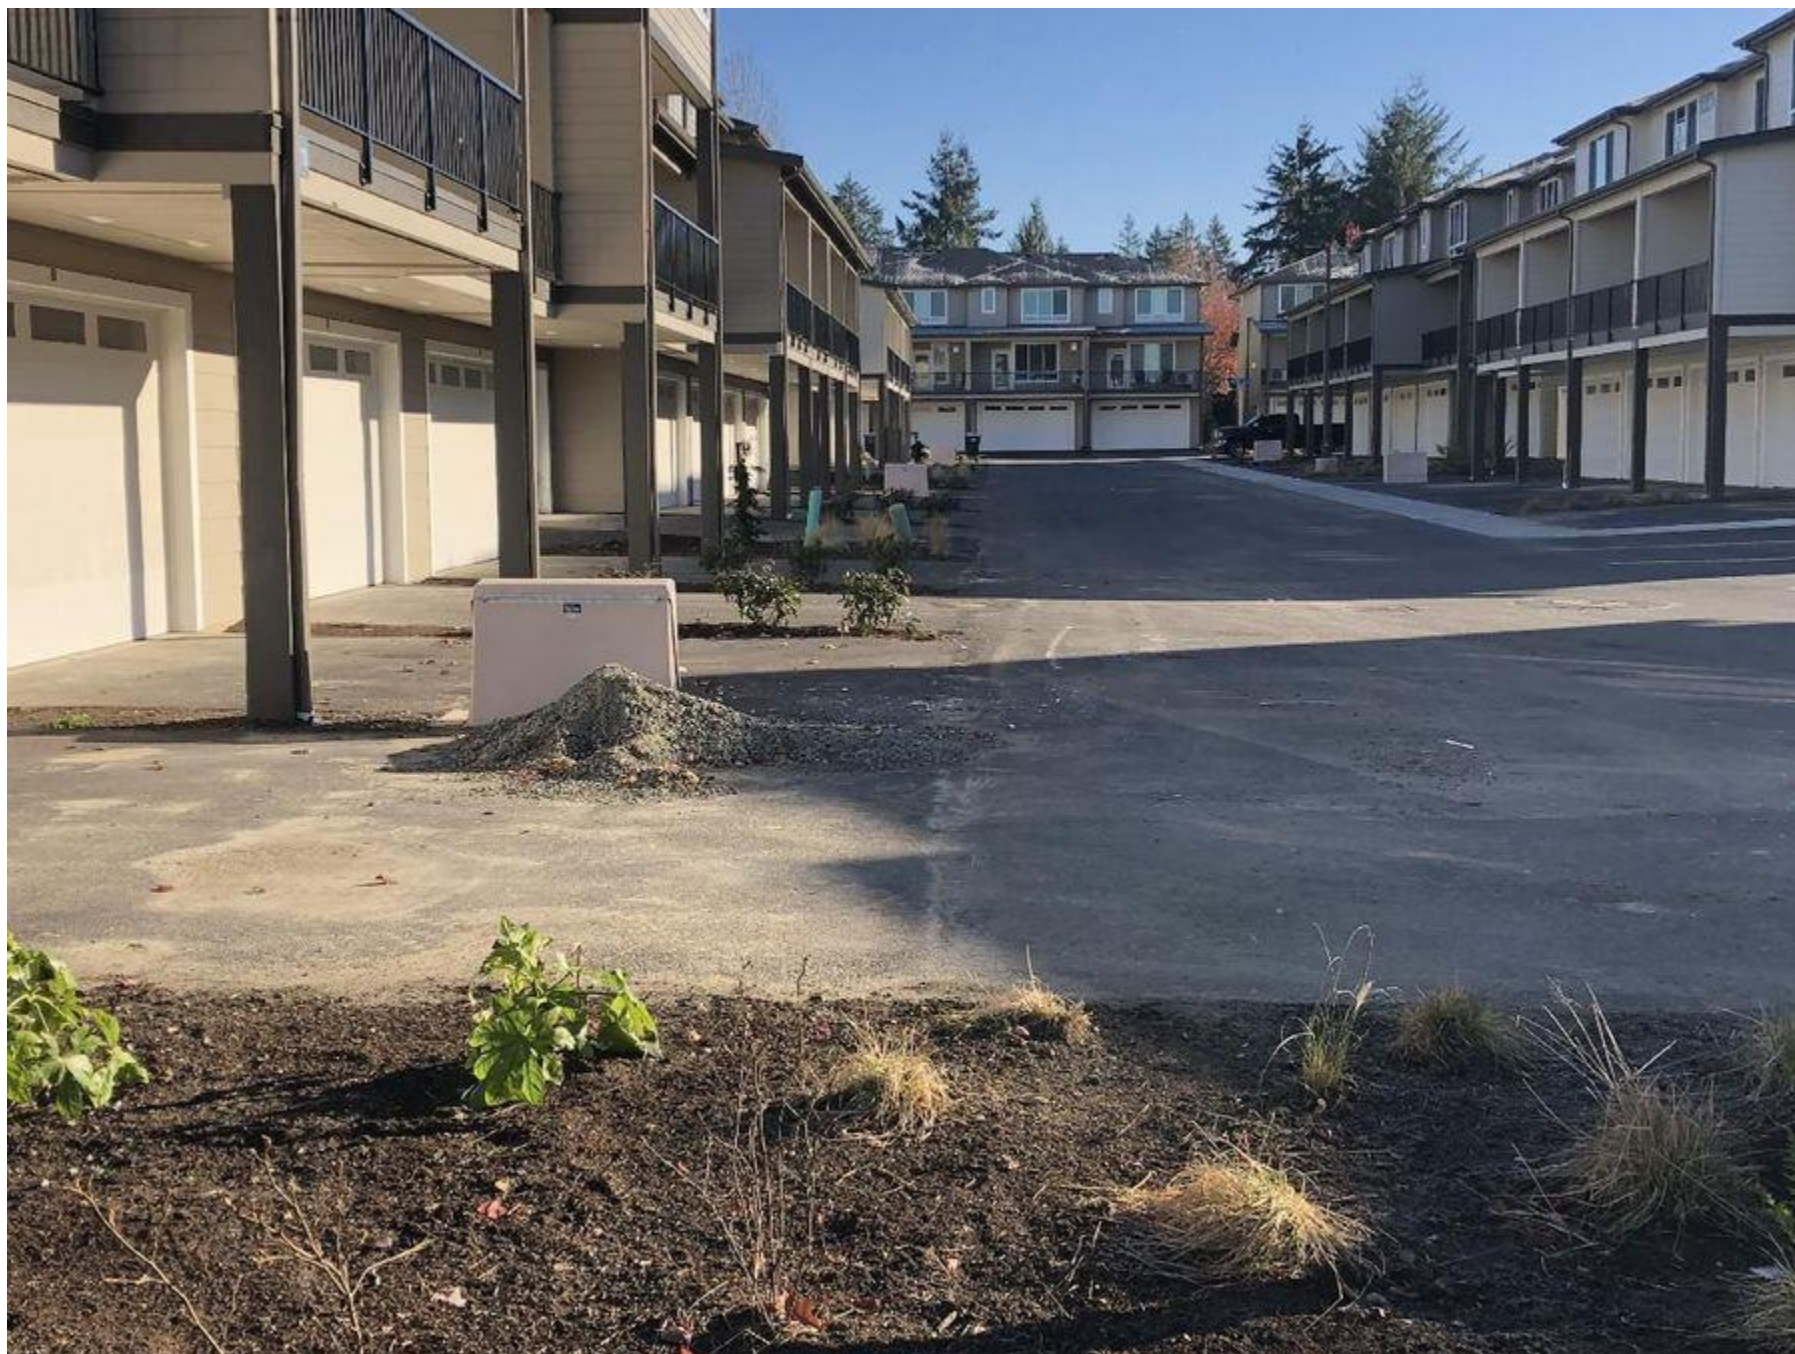
**Photo 5**

Photo Description: Small pile of crushed rock has yet to have been cleaned up.
