King County

Department of Natural Resources and Parks
Wastewater Treatment Division

Re: Release of Reclaimed Water, York Pump Station, June 21, 2023

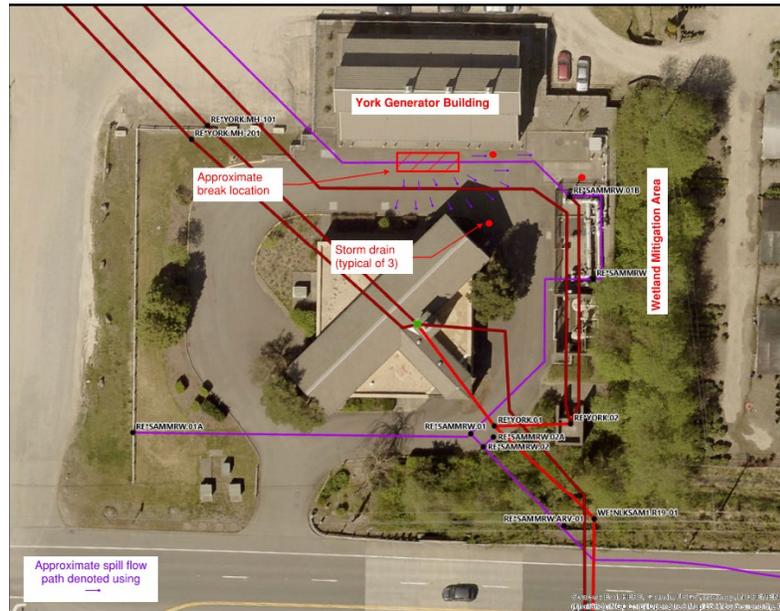
Figure 2: York Pump Station Reclaimed Water Release Map

The 30-inch reclaimed water pipeline is approximately 11 feet below surface at the York Pump Station. The leak was identified as water was bubbling up through the asphalt and flowing into an adjacent stormwater catch basin on the property. The catch basin drains to a mitigation area on King County property, due east of the pump station.

Purple line denotes East NCFM used for RW Distribution; Red line denotes West NCFM used for intermittent sewer service from North Creek Pump Station to York Pump Station

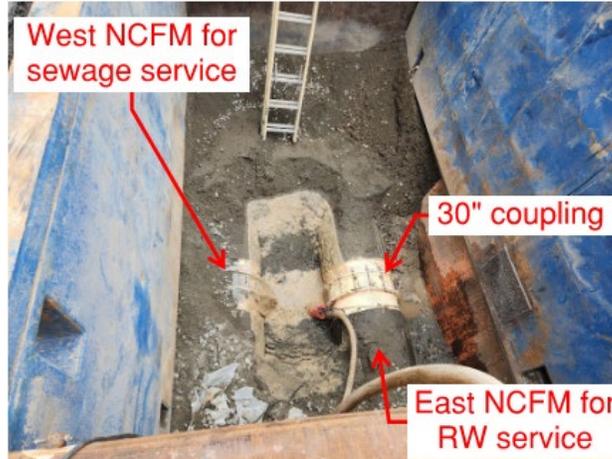
Figure 3: Exposed East and West NCFMs

Upon mobilizing onto the site on June 22nd, the contractor began excavation and dewatering operations at the approximate location where water was found to be bubbling up through the asphalt. The leak was discovered adjacent to a direct buried, 30-inch coupling between two sections of the force main (Figure 3). The cause of the leak was a small hole (approx. 1/4 inches in diameter) at the invert of the

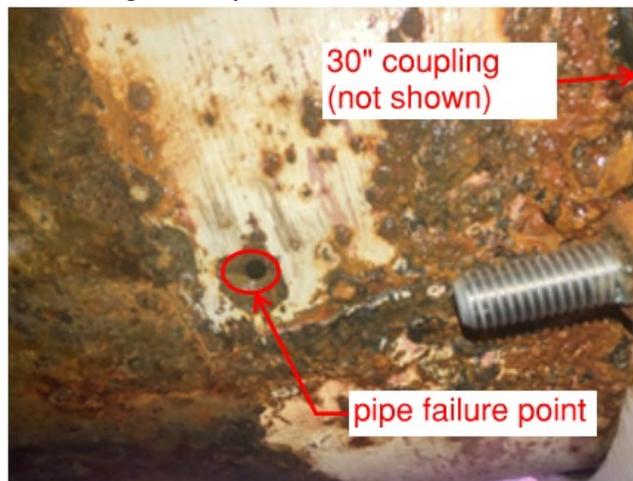
Figure 4: 30-inch RW piping failure point

force main, adjacent to the coupling (Figure 4). Additional observations at the point of the leak: the coupling did not have any cement mortar lining and appeared to have a corroded interior epoxy lining at this location.

The existing 30-inch coupling was damaged during the course of the investigation thus requiring a more engineered repair of this entire section of this line. King County has ordered parts to support this repair: a new engineered repair coupling (TC400 Romac coupling) and a rolled 30-inch epoxy lined steel spool piece; the new coupling is scheduled to arrive on site during the week of August 7th, 2023

Once materials arrive onsite, King County’s contractor will remove the damaged section of piping and complete the repair using the solution described above. Staff also plan to conduct a partial CCTV investigation in the vicinity of this location of the force main to evaluate the condition of the interior epoxy coating and neighboring joints. Following repair work, the East NCFM will then be pressure tested and flushed to prepare for reclaimed water customer distribution by the end of August.
