Heidelberg Materials (a.k.a. Lehigh Cement Co)
Permit Number WA0045586

Metalline Falls, WA

Inspection Date: May 4, 2023

Department of Ecology

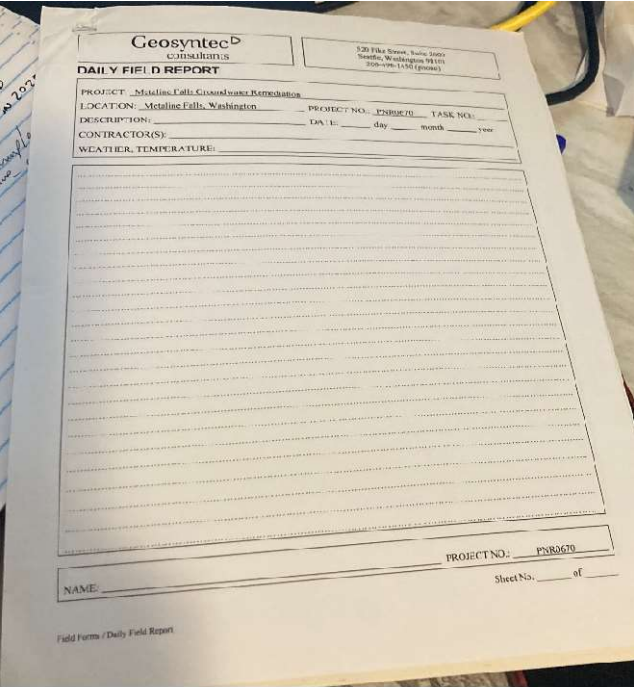
<p>The image shows a 'Geosyntec consultants DAILY FIELD REPORT' form. The form is filled out with the following information: PROJECT: Metalline Falls Closed water Remediation; LOCATION: Metalline Falls, Washington; PROJECT NO.: 12080670; TASK NO.:; CONTRACTOR(S):; WEATHER, TEMPERATURE:; NAME:; PROJECT NO.: 12080670; Sheet No. of. The form is dated 10/20/2021.</p>	<p>O&M checklist package provided to Ecology during inspection.</p>

The most recent version of the O&M manual with updated checklists for site evaluation should be made available to Ecology.

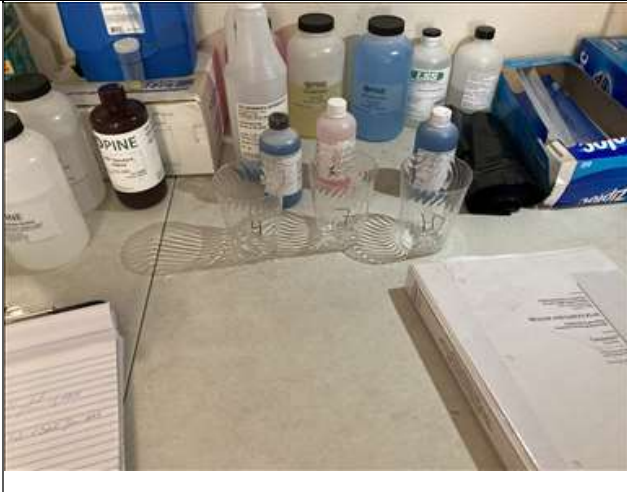
- The pH probe calibration solutions were available, as was the log with the calibration records (Photo 6).
- All onsite field measurements are made using a YSI Pro DSS 4 port sampler. The sampler has probes for dissolved oxygen, pH, temperature, and turbidity (Photo 7).
- Sample bottles are ordered and maintained at the site (Photo 8).
- Extra pH probes for the two-inch (Photo 9) and four-inch (Photo 10) wells are stored on the counter. The pH probe manufacturer O&M was not available. Ecology asked if the probes should be in solution, and the representatives at the site did not know at the time of inspection. Given the salt ring around the tops, it appears that the probes were stored in solution but there was not any solution in the probe storage containers.

pH and DO calibration station.
7

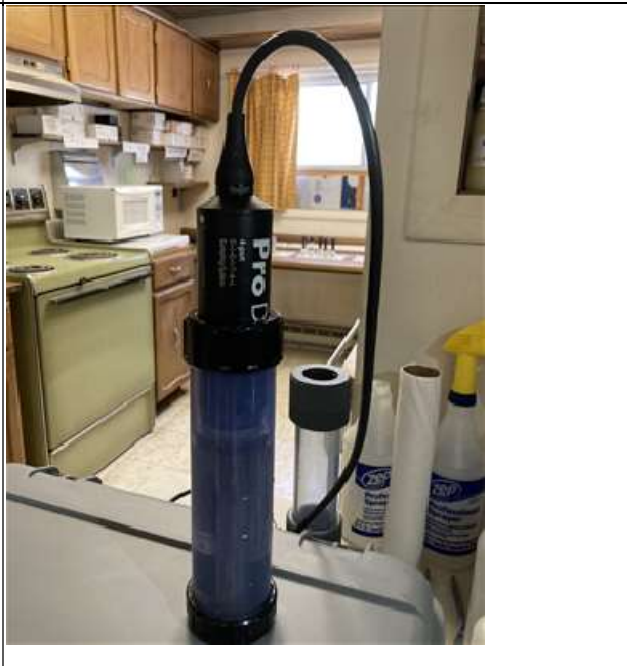
YSI Pro DSS 4 port sampler. Samples DO, pH, temperature, and turbidity.
8

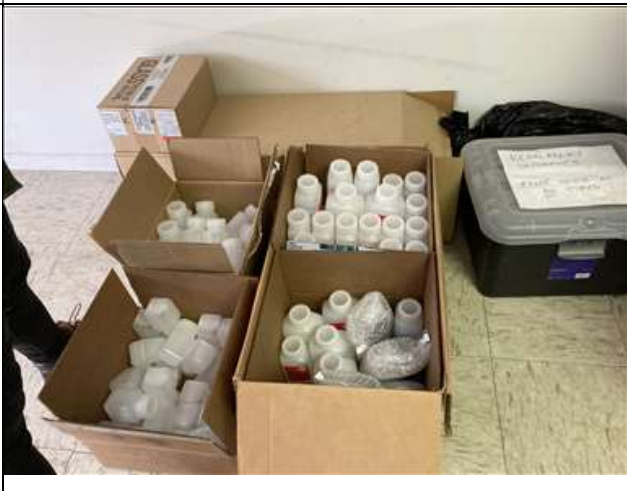
Sample bottles are stored on site in boxes. Some of the bottles have preservative.

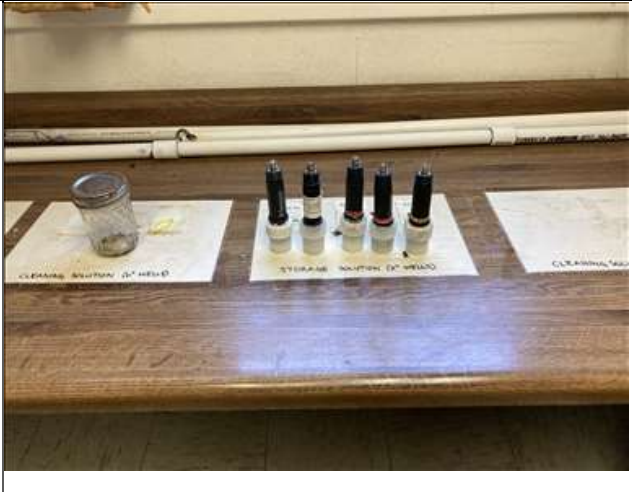
A photograph showing five pH probes standing upright on a wooden table. To the left of the probes is a small glass jar. Labels on the table include 'CLEANING SOLUTION (2" WELLS)', 'STORAGE SOLUTION (2" WELLS)', and 'CLEANING SOLUTION'. The probes have black caps and white bodies.	<p>pH probes used for 2" wells. Probes have salt around the rim of the cover and 3 did not have solution.</p>
10

Heidelberg should identify the proper storage requirements for pH probes when not in use.

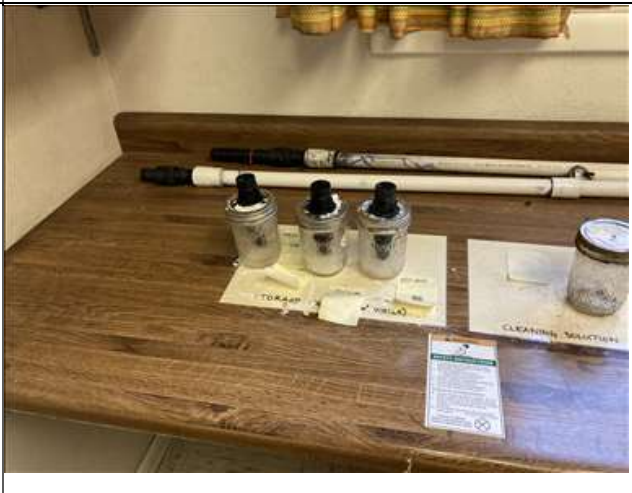
A photograph showing three pH probes and two glass jars on a wooden table. Labels on the table include 'TOKA4P', 'STORAGE SOLUTION (2" WELLS)', and 'CLEANING SOLUTION'. A small white card with text is also visible on the table.	<p>pH probes used for 6" wells. Jars did not have any storage solution.</p>
11

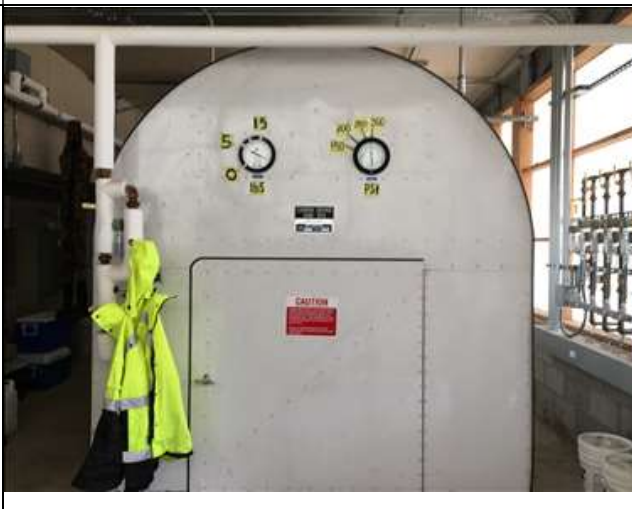
- Carbon dioxide (CO₂) is stored in bulk on site (Photo 11). The tank is stored on the ground floor of the same building as the lab and meeting area, second floor. The building is equipped with CO₂ sensor and warning system. The CO₂ is piped to the subsurface to the distribution system.

A photograph of a large, white, cylindrical carbon dioxide storage tank. The tank has two pressure gauges on its front panel, one labeled '15' and the other '50'. A red 'CAUTION' label is visible on the tank door. A yellow safety vest is hanging on the left side of the tank.	<p>Carbon dioxide storage tank.</p>

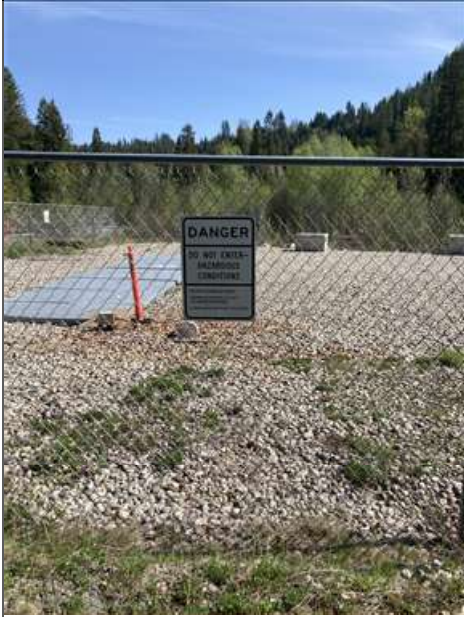
- The treatment system is fenced (Photo 12) and secured (Photo 13). The signage shows Bill Fees phone number (509) 329-3589 as the Ecology emergency contact and Timothy Matz phone number (972) 653-3787 as the Lehigh emergency contact. These phone numbers and contacts are no longer valid.

A photograph showing a gravel-covered area, likely a treatment facility. A chain-link fence runs across the middle ground. A black sign with white text is posted on the fence. The sign reads "DANGER" in large letters, followed by "NO WY, EXCESSIVE", "SUNSHINE", and "CONDITIONS". In the background, there are trees and a clear blue sky.	<p>Fence on the south, west and east sides of the treatment facility. Open on the north side next to the Sullivan Creek. Sign provides warning and emergency contact information.</p>
13

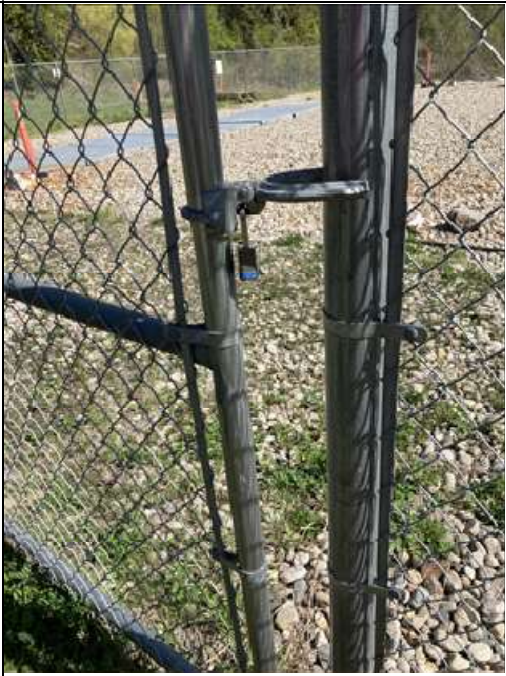
A close-up photograph of a chain-link fence gate. The gate is closed and locked with a metal padlock. The fence is made of metal posts and chain-link mesh. The ground behind the fence is covered in gravel and some sparse vegetation.	<p>Gate at the site is locked.</p>

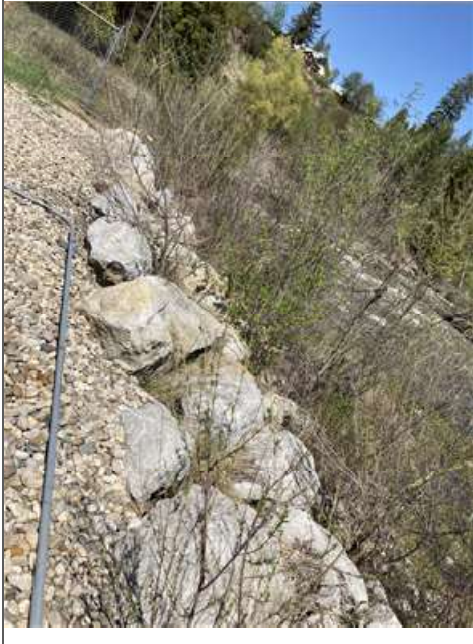
- The fence is only located on three sides of the site and ends near the edge of the rip rap covered diffusion area. (Photos 14-15).
- The site provides access panels to the CO₂ distribution tubing, programable logic controllers (PLCs) and sampling access locations to the pipes going to the diffuser (Photo 16-17).

<p>Northwest corner of the site. The fence ends at the edge of the riprap on the north side of the site along Sullivan Creek.</p>
15

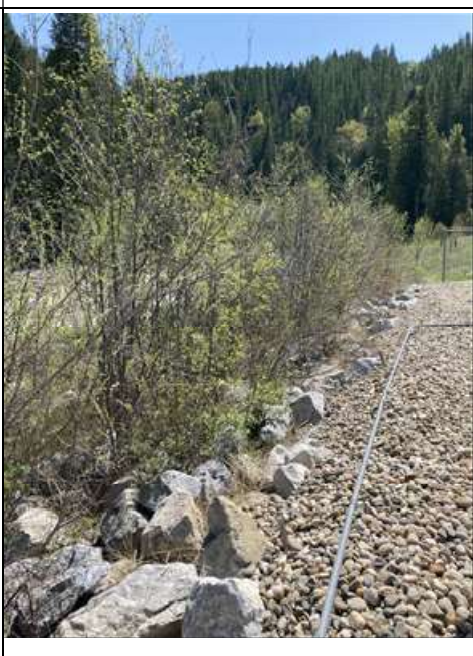
<p>North edge of the site. The fence ends at the northeast corner of the site at the edge of the riprap along Sullivan Creek.</p>

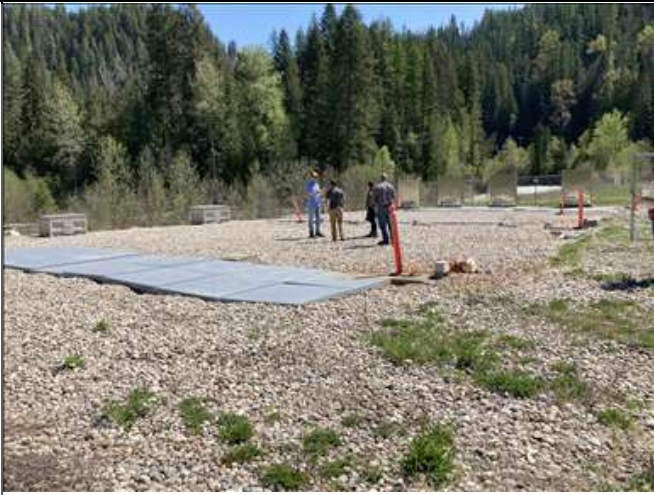
Subsurface carbon dioxide addition pH treatment system. The control panels are east of the staff and sampling locations 2 and 3 are in the bunkers to the north of the staff.
17

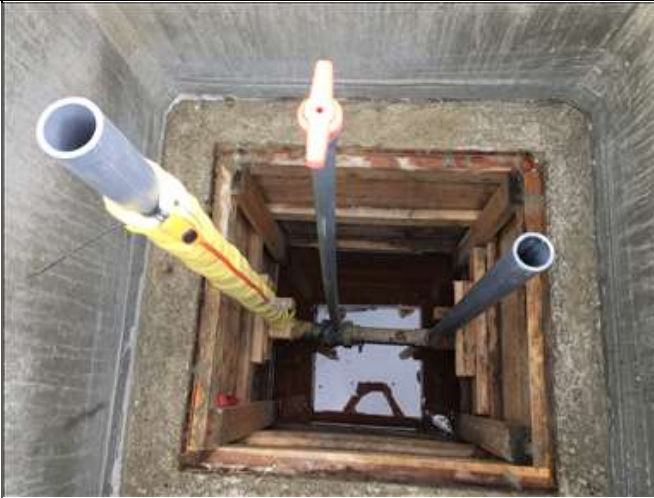
Sampling sump
18

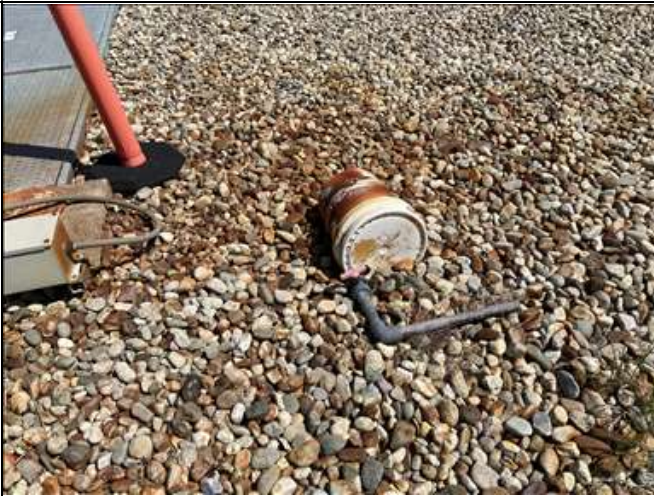
- Geosyntec piloted increased oxygen to effluent to precipitate additional arsenic. They did not implement the full-scale change to the treatment process. The remnants of a recent pilot project were still onsite (Photo 18).

Remnants of a pilot treatment system intended to improve arsenic removal by adding dissolved oxygen. The project was abandoned.

Pilot treatment systems should be closed, and solid wastes should be recovered for reuse or discarded.

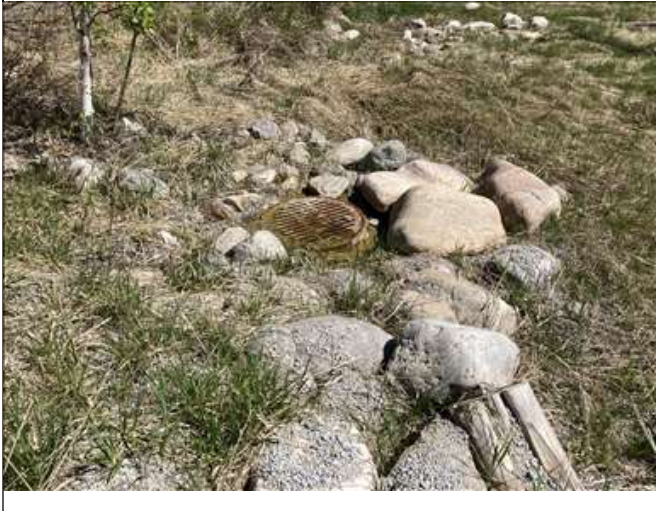
<p>Manhole located at the south end of the constructed stormwater drainage channel.</p>
20

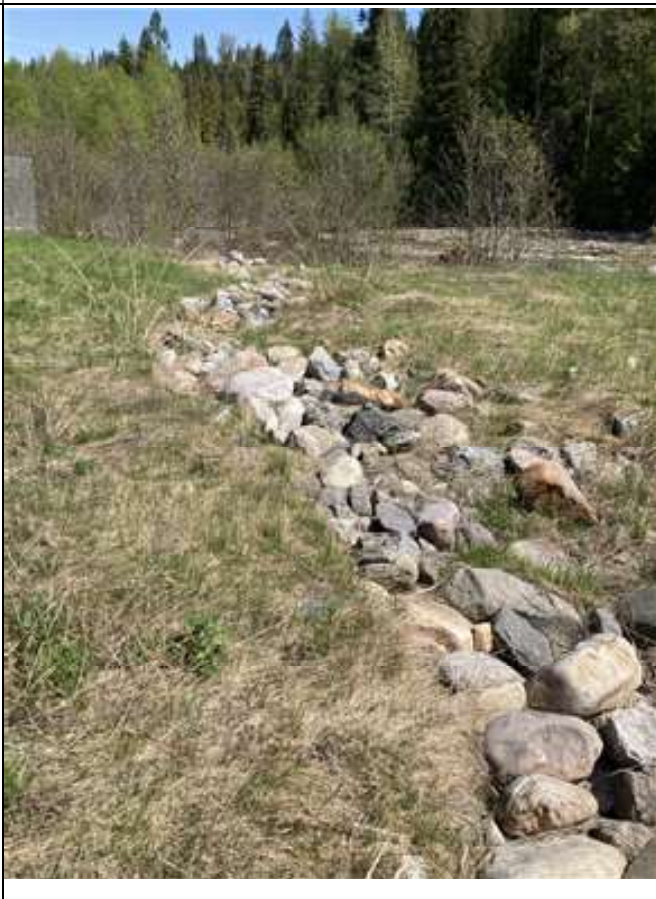
<p>Constructed stormwater drainage channel runs north to the creek in the background.</p>

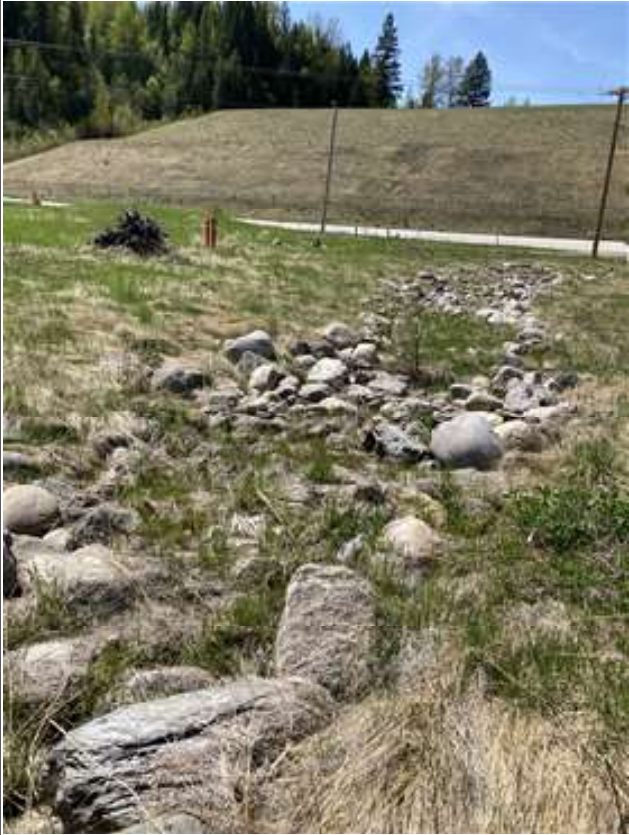
<p>Constructed rock stormwater drainage channel runs from the road to the creek. The covered kiln dust pile is in the background.</p>
22

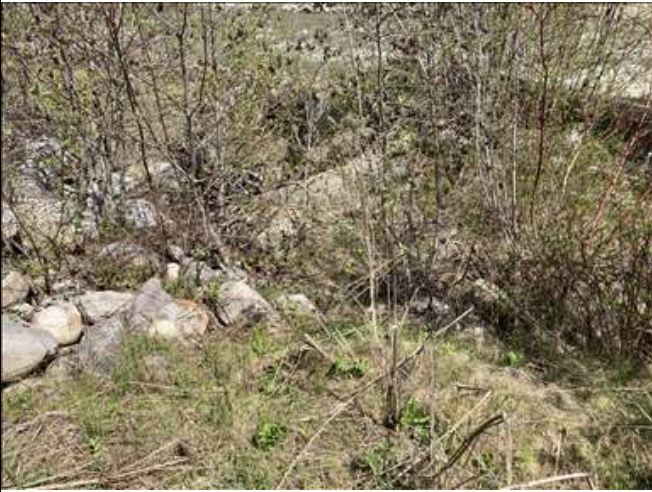
<p>The constructed stormwater drainage system ends at the creek. No discharge visible.</p>

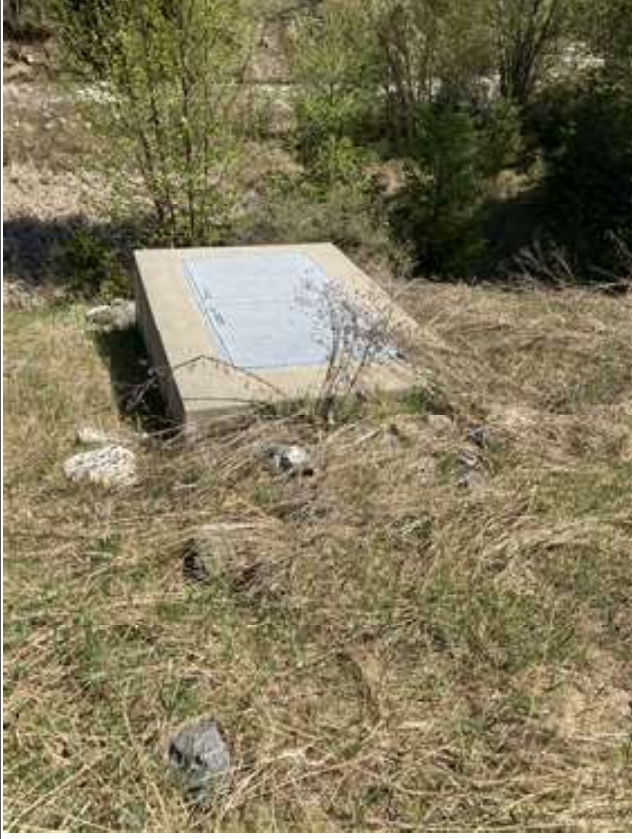
- The site was originally constructed with a distribution box (Photo 23) that would send groundwater from a French drain to either a constructed wetland (Photo 24) or the treatment system capture zone. After years of monitoring the decision was made to leave the valve in the discharge to the capture zone mode.

<p>Valve box contains a valve that may be used to discharge to either the wetland or the treatment system. The valve is left in the position directing water to the treatment system.</p>
24

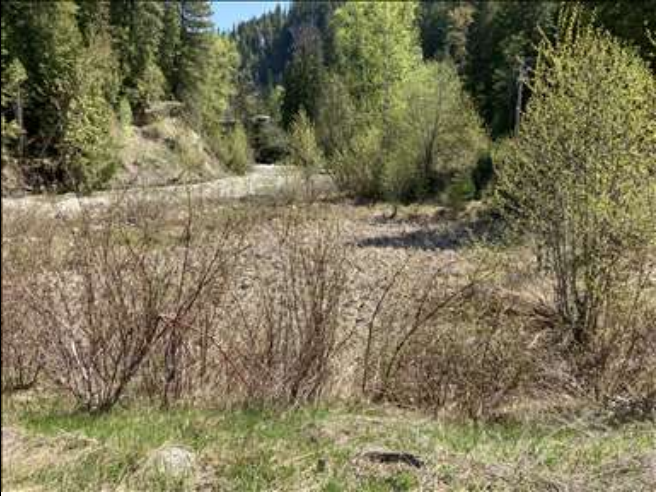
<p>Constructed wetland northeast of the treatment system in the floodplain along the south bank of Sullivan Creek.</p>

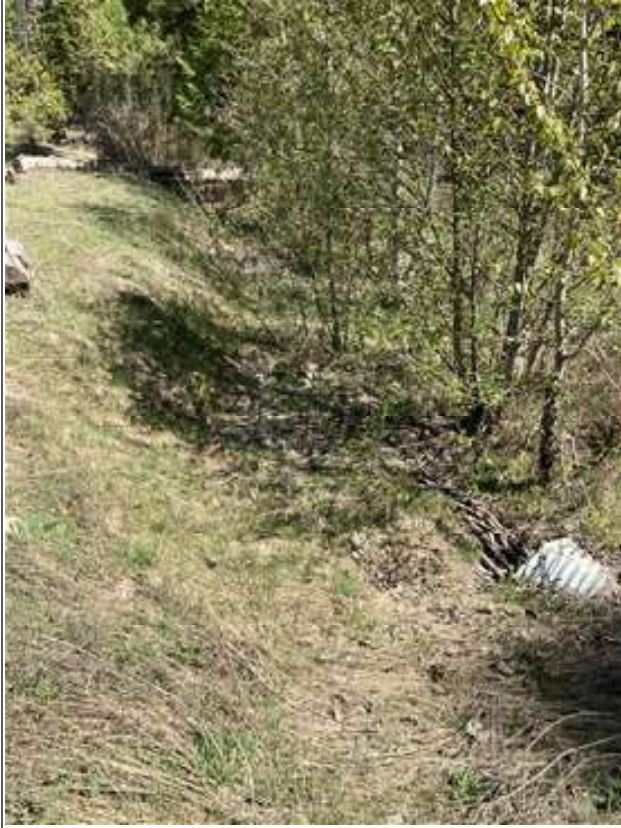
- Ecology walked the drainage on the eastern boundary of the site. Ecology observed a drainage channel that appeared to be constructed (Photo 25). A culvert at the south end of the channel runs under Highway 31 (Photo 26). The channel appears to have standing water in it near the culvert (Photo 27). The drainage channel discharges to Sullivan Creek.

Stormwater/snow melt discharge channel from east culvert runs to Sullivan Creek.
26

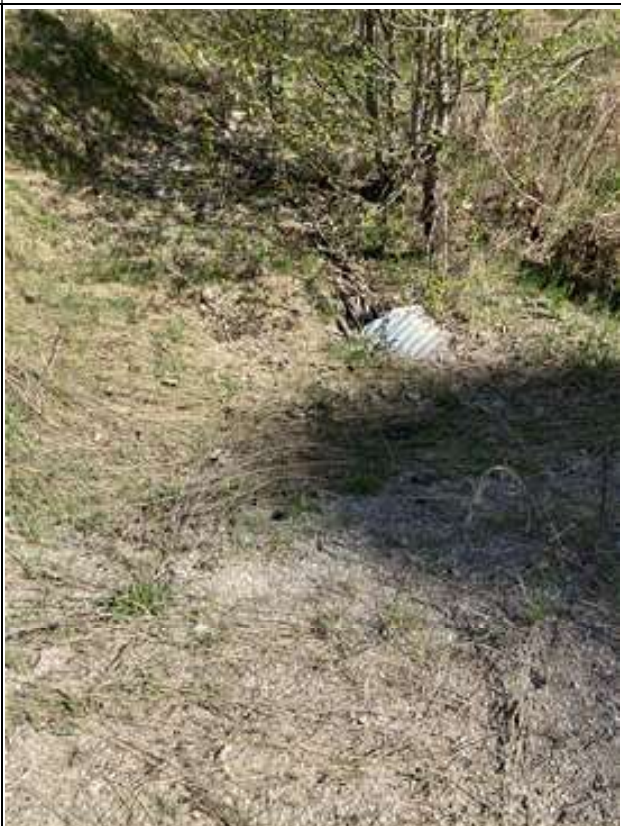
East culvert has standing water at the discharge point.

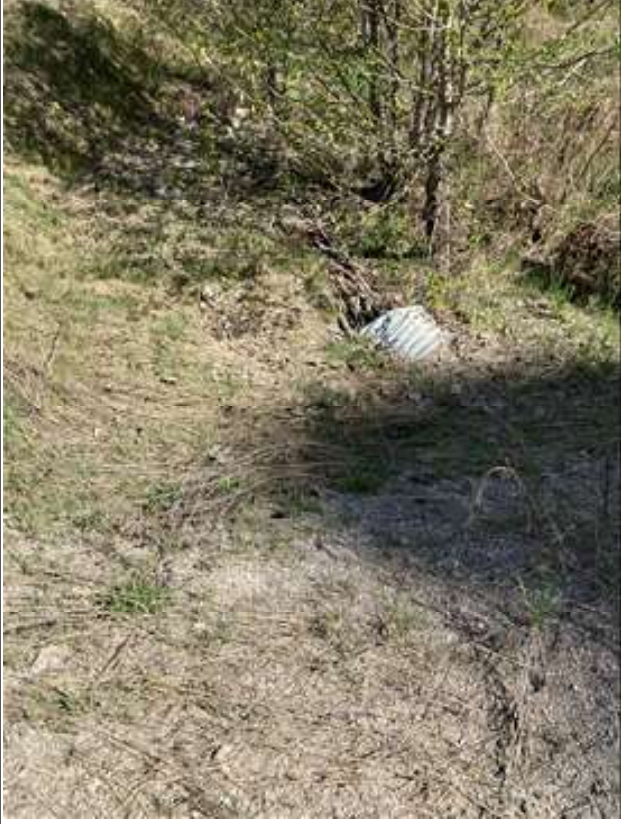
<p>Culvert on the east edge of the Heidelberg site, runs under Highway 31. Culvert discharges stormwater and snow melt from the south side of Highway 31.</p>
28

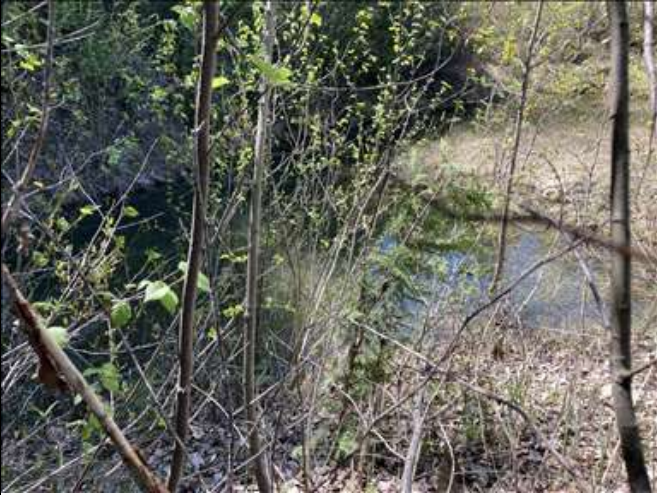
- On the northeast toe of the CKD pile there was what appeared to be a wetland with standing water (Photo 28-29). Review of the construction documents, upon return to the office, indicated that this was constructed as a sedimentation basin when the other work at the site was completed. This area is growing vegetation and is acting as a wetland. It was not possible to tell where the geomembrane cover for the repository cover began. As a result, it was not possible to tell if roots from small trees and other vegetation may impact the cover for the repository.

<p>Pond of water collected on the southside of Highway 31 at the toe of the repository. The pond appears to discharge through the east culvert to avoid flow over Highway 31. This was not discharging at the time photo was taken.</p>

Ecology discussed sampling the pH of this wetland if there was still standing water when Geosyntec returns to the site to conduct sampling and quarterly site inspection. The results of the pH sampling were provided to Ecology via email on July 10, 2023, with the DMR. The pH for the sediment pond on May 9, 2023, was 8.2 standard units.

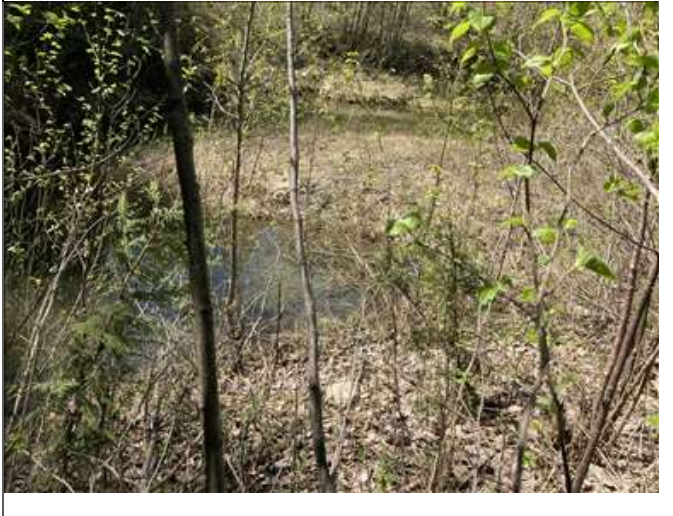
A photograph showing a small, shallow pond of water in a wooded area. The water is surrounded by dry grass and some green foliage. The background shows more trees and a slight rise in the ground.	<p>Ponding water at the northeast toe of the repository and north of the ravine running along the eastside of the repository.</p>
30

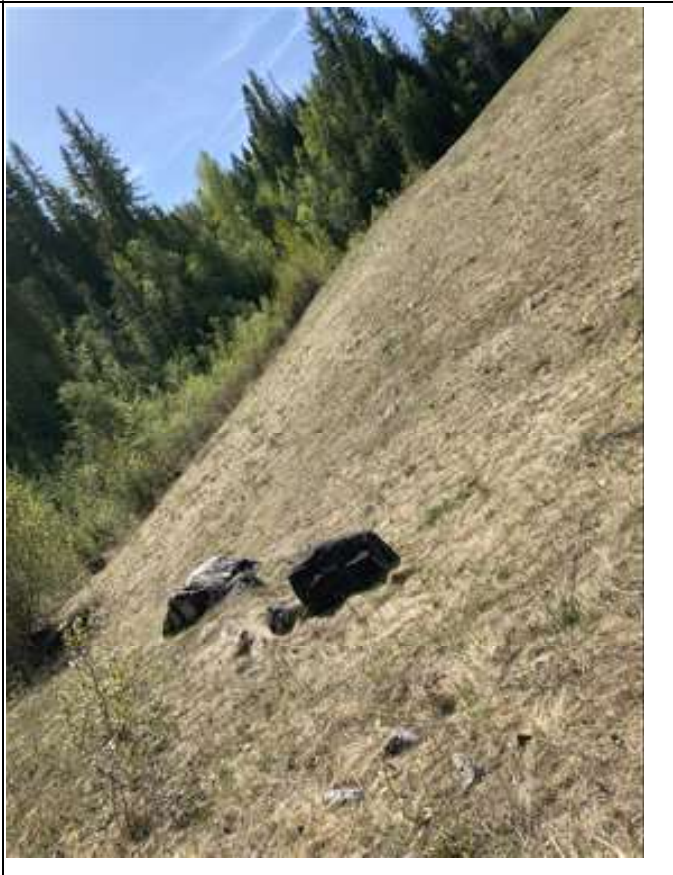
- Ecology viewed the north side of the repository. The soil and vegetation covering the repository geomembrane appeared to be intact (Photos 30-31). There was some woody vegetation starting to grow at the toe of the repository. It is not possible to tell where the repository cover begins. There should be markers so that vegetation that may negatively impact the cover could be identified and removed.
- Upon reentering the site on the north side of Highway 31, Ecology identified pipes and tubing sticking out of the ground. Geosyntec identified the remnants of the original in situ pilot for the full-scale groundwater treatment system (Photos 32-35). These pipes potentially provide direct access to the groundwater on the site. The old pilot should be properly closed with appropriate disposal of the waste materials.

A photograph showing a steep, grassy hillside. The hillside is covered in dry, yellowish-brown grass. In the background, there is a dense forest of tall evergreen trees under a clear blue sky. A few dark, irregular shapes are visible on the grassy slope.	<p>Northeast side of the repository.</p>

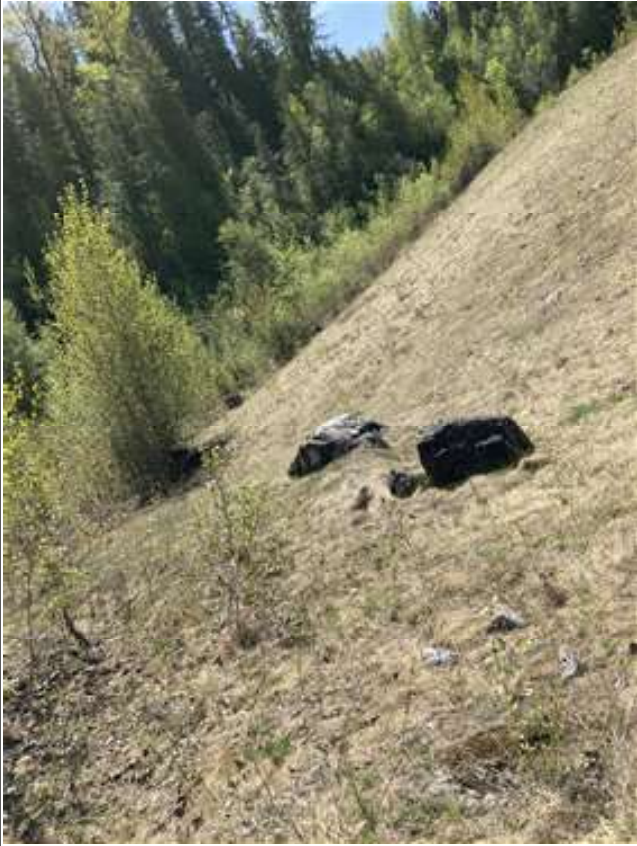
Northeast corner of the repository.
32

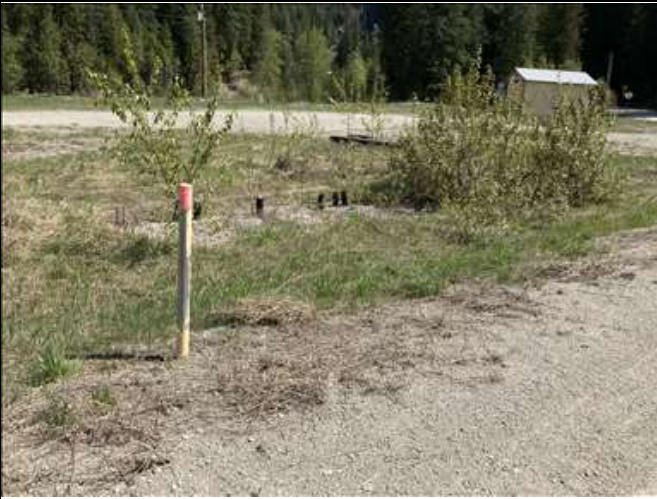
Residual infrastructure of the original treatment pilot. This part of the site is not fenced.

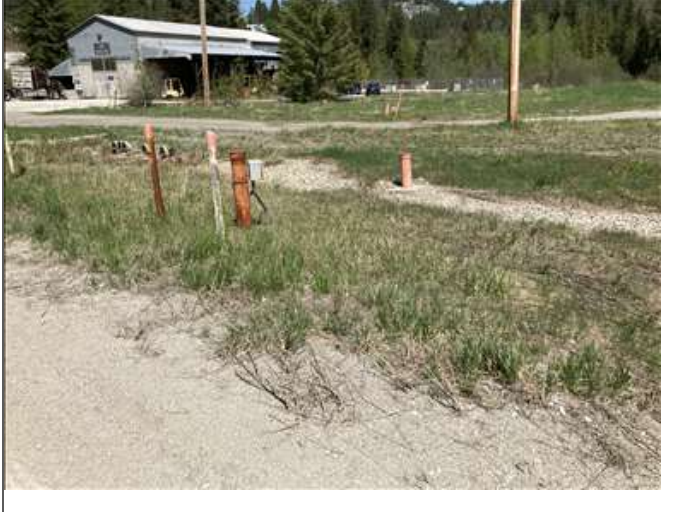
A photograph showing a monitoring well in a grassy field. The well is a vertical pipe with a cap, surrounded by some gravel. In the background, there is a large industrial building and some trees.	Monitoring well next to the residual treatment pilot.
34

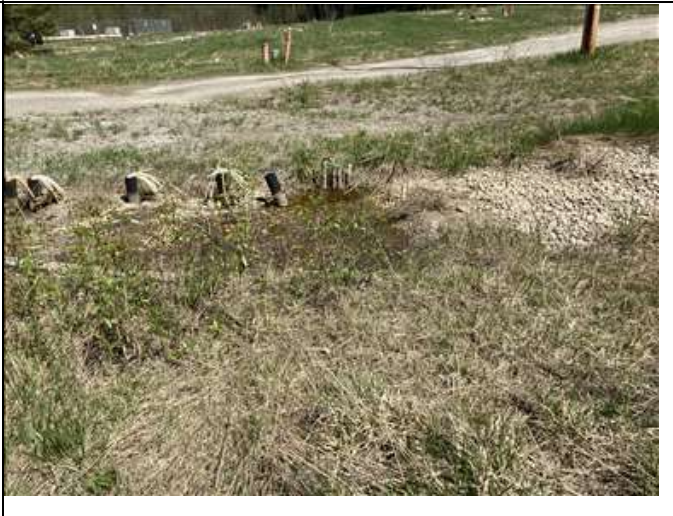
A photograph showing abandoned infrastructure for a carbon dioxide treatment pilot. Several open pipes are visible in the ground, surrounded by grass and gravel. In the background, there is a dirt road and some trees.	Original carbon dioxide treatment pilot abandoned infrastructure. Open pipes in the ground.
