WATER COMPLIANCE INSPECTION REPORT

WADOE Inspection Form

Name and Location of Site Washington State Fire Training Academy 50810 SE Grouse Ridge Road North Bend, WA 98045	Entry Time 11:20 am	Permit Effective Date 09/15/2016
	Exit Time 2:27 pm	Permit Expiration Date 09/30/2021
On-Site Representative(s): Name(s)/Title(s) Katie Rasmussen Assistant Commander	Additional Participants: Liora Llewellyn and Bryan McKinnon from King County Stormwater Compliance Unit	
Responsible Official(s): Kelly Merz, Interim Commander	Weather: Cloudy and light rain Photos Taken? Yes

PHOTO ADDENDUM –WA STATE FIRE TRAINING ACADEMY,. WA0031836

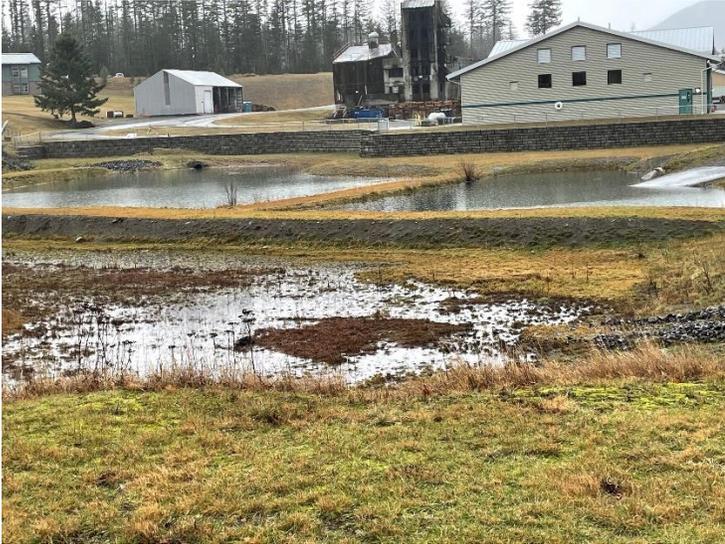
PHOTO #:01 DATE: 02/01/2024
 TAKEN BY: JEANNE TRAN
 DESCRIPTION: STORMWATER DETENTION POND CONSISTING OF 5 CELLS. THIS PICTURE SHOWS CELLS #1-3.

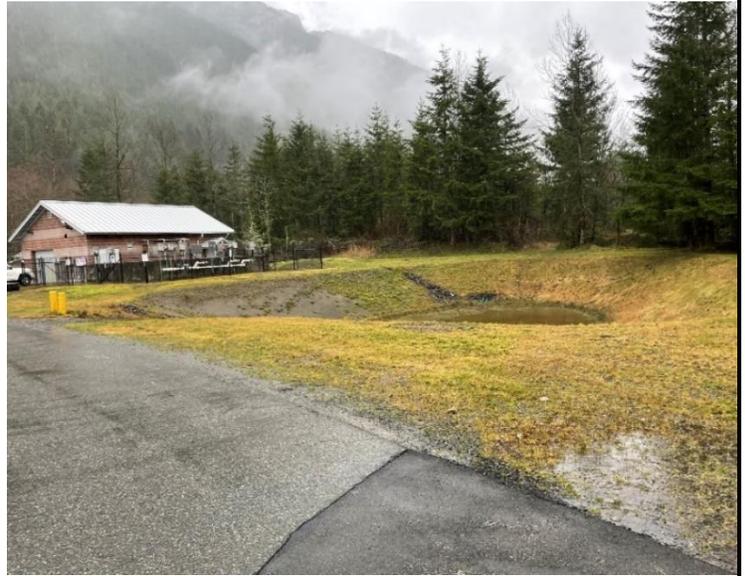
PHOTO #:02 DATE: 02/01/2024
 TAKEN BY: JEANNE TRAN
 DESCRIPTION: THE PHOTO SHOWS STORMWATER DETENTION POND CELL #4, LOCATED ACROSS THE ROADWAY FROM CELLS #1-3, NEXT TO THE MEMBRANE BIOREACTOR (MBR) TREATMENT SYSTEM FOR THE FACILITY’S DOMESTIC WASTEWATER.

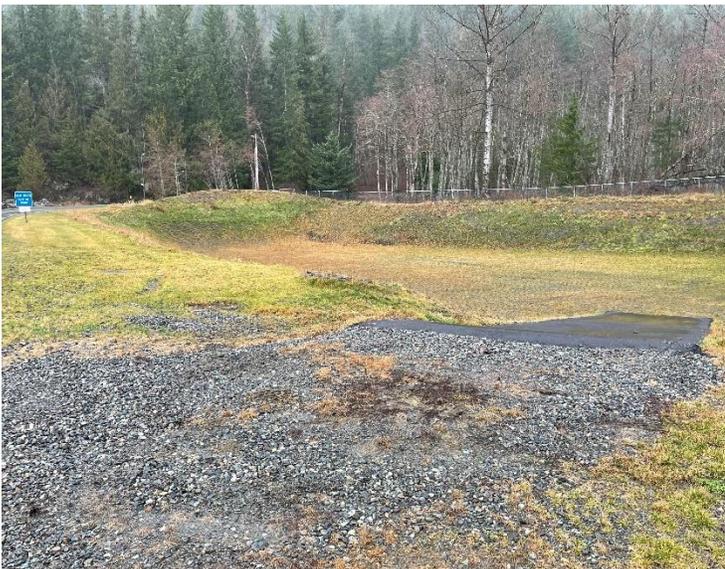
We began our inspection tour at the stormwater pond which consists of 5 cells with Cells 4 and 5 being newly constructed in 2022. The cells are connected in series where water flows from Cells 1 to 5 through underground connecting/equalizing pipes. Cells 1 and 2 are lined, and Cells 3-5 are not lined where water can infiltrate into the ground or flow from one cell to the next when the water level is above the outlet pipe elevation. During the inspection, there was water observed in Cells 1 and 2 and some water in Cells 3 and 4 as seen in photos 1-2. Cell 4 is located on the east side of the MBR treatment building. Cell 5 is located west of the MBR treatment building, and no water was observed in Cell 5 during the inspection (photo 3).

PHOTO #:03 DATE: 02/01/2024
 TAKEN BY: JEANNE TRAN
 DESCRIPTION: THIS PHOTO SHOWS CELL #5 WHICH IS LOCATED ON THE OTHER SIDE OF THE MBR SYSTEM. SEE THE ATTACHED STORMWATER FLOW DIAGRAM.

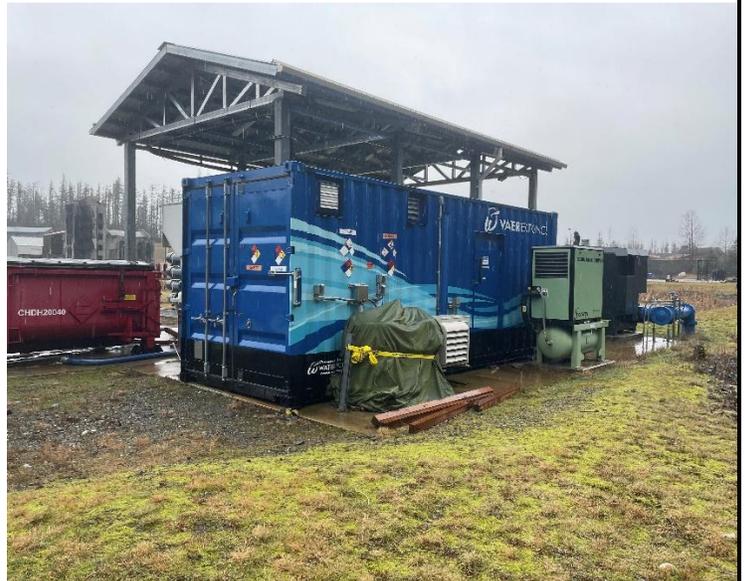
PHOTO #:04 DATE: 02/01/2024
 TAKEN BY: JEANNE TRAN
 DESCRIPTION: DISSOLVED AIR FLOATATION SYSTEM (DAF). THE DAF ALONG WITH THE AERATION SYSTEM WAS APPROVED IN LATE 2019 AND THIS UPGRADE TO THE EXISTING SYSTEM WAS CONSTRUCTED IN 2020.

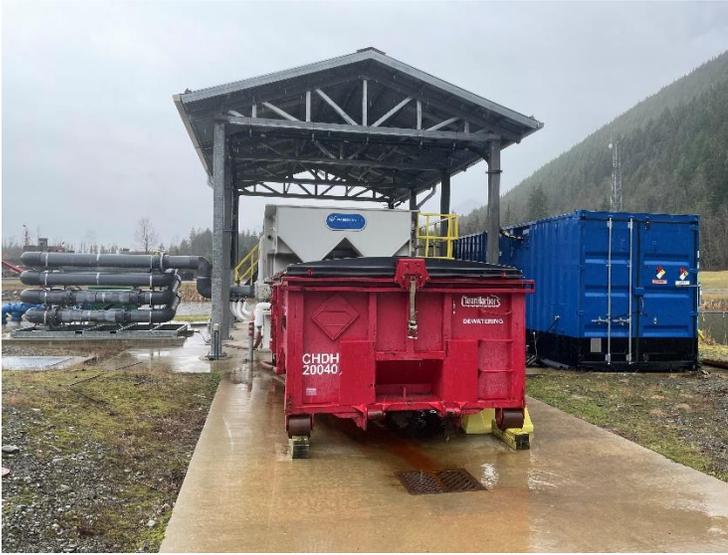
the facility to conduct training exercises using firefighting training foam. After the upgrade was completed in late 2020, the facility began to use the approved fluorine-free firefighting foam known as MicroBlaze Out for training exercises at the site. The DAF and the aeration system were being winterized and not in operation during the inspection. WaterTectonics is contracted to operate the DAF system for the facility. Katie informed us that the DAF was not winterized during the first year after it was installed which led to frozen and busted pipes and required extensive repair. WaterTectonics recommended the system be winterized from December to March every year (See photos 4-7 of the DAF system) due to the low frequency of training exercises during the winter months along with the aforementioned frozen pipes. The DAF treatment system was installed on a paved pad with a drain that connects to the oil water separator (photo 5).

PHOTO #:05 DATE: 02/01/2024
 TAKEN BY: JEANNE TRAN
 DESCRIPTION: ANOTHER VIEW OF THE DAF. THE RED COVER BIN STORES SLUDGE BUILDUP.

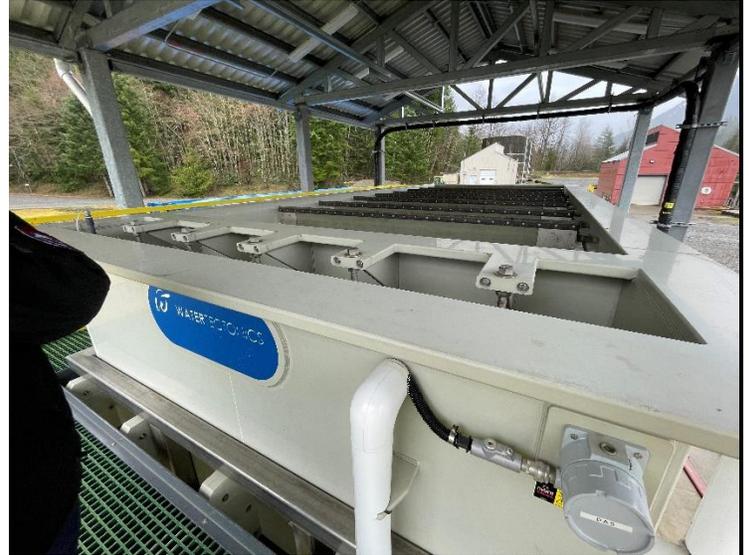
PHOTO #:06 DATE: 02/01/2024
 TAKEN BY: JEANNE TRAN
 DESCRIPTION: THE TOP VIEW OF THE DAF UNIT. THE UNIT WAS BEING WINTERIZED AND NOT IN OPERATION DURING THE INSPECTION.

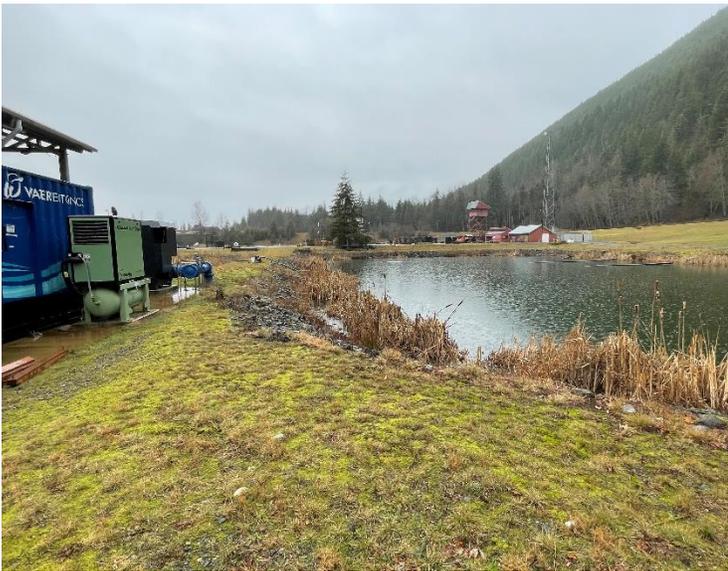
Photos 7 and 8 show training pond 2 with an array of 5 aerators in the pond.

PHOTO #:07 DATE: 02/01/2024
 TAKEN BY: JEANNE TRAN
 DESCRIPTION: THE TREATED WATER FROM THE DAF SYSTEM IS PUMPED TO POND 2 WHERE IT RECEIVES AERATION. SINCE THE DAF WAS BEING WINTERIZED, THE AERATION SYSTEM WAS NOT TURNED ON.

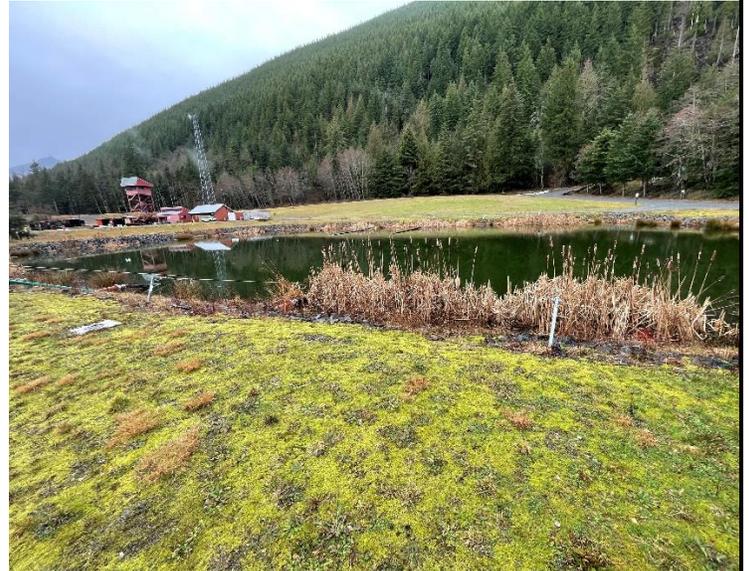
PHOTO #:08 DATE: 02/01/2024
 TAKEN BY: JEANNE TRAN
 DESCRIPTION: A CLOSE-UP VIEW OF AN ARRAY OF FIVE LATERALS AERATION SYSTEM INSTALLED AT POND 2. AERATION ALLOWS INCREASED CONTACT TIME TO REDUCE CONTAMINANT LEVELS.

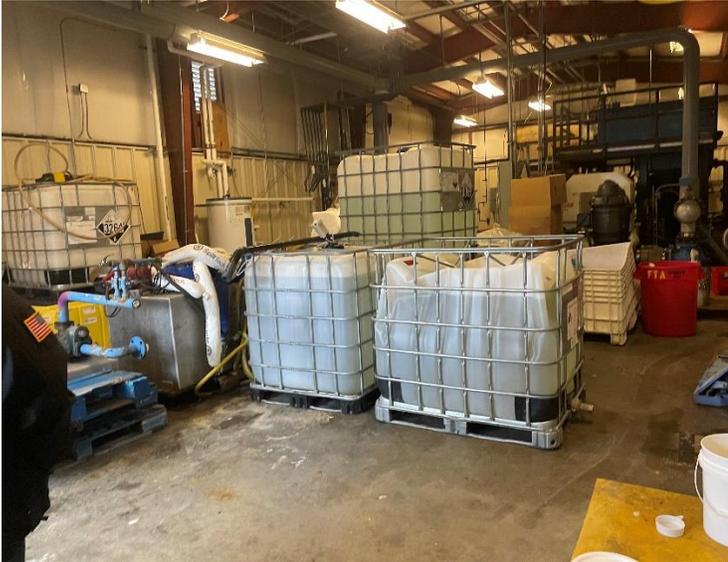
PHOTO #:09 DATE: 02/01/2024
 TAKEN BY: JEANNE TRAN
 DESCRIPTION: THE OLD TREATMENT BUILDING LOCATED IN THE ARFF AREA ON THE UPPER PLATEAU IS USED TO STORE TREATMENT CHEMICALS.

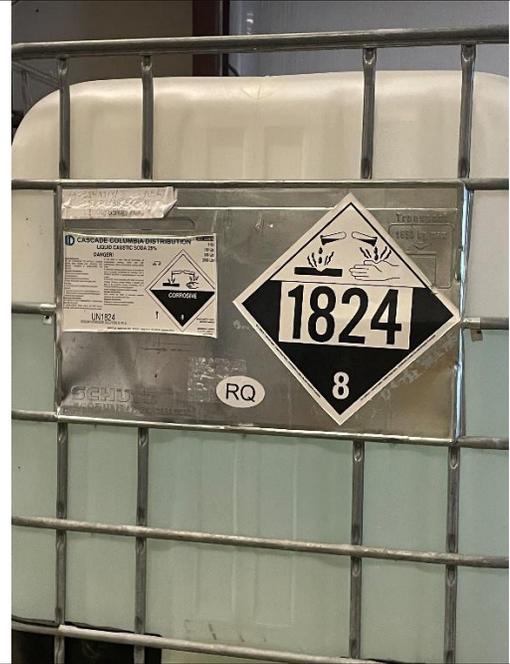
PHOTO #:10 DATE: 02/01/2024
 TAKEN BY: JEANNE TRAN
 DESCRIPTION: LIQUID CAUSTIC FOR THE DAF SYSTEM.

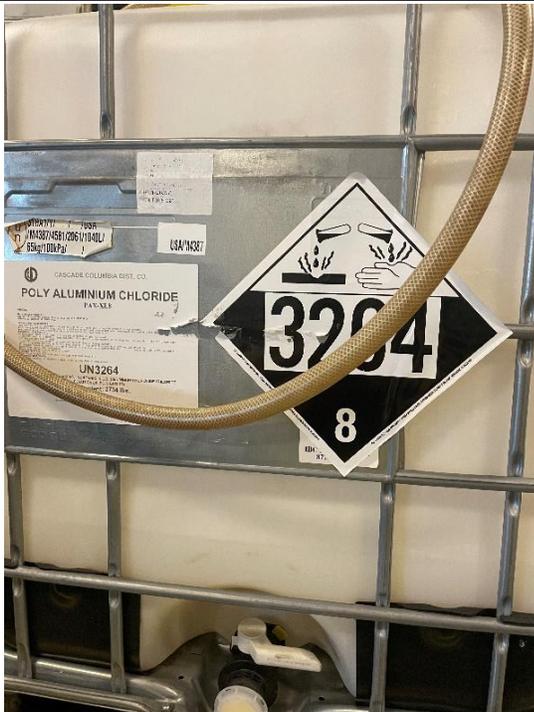
PHOTO #:11 DATE: 02/01/2024
 TAKEN BY: JEANNE TRAN
 DESCRIPTION: FLOCCULANT POLY ALUMINUM CHLORIDE IS USED FOR THE DAF SYSTEM.

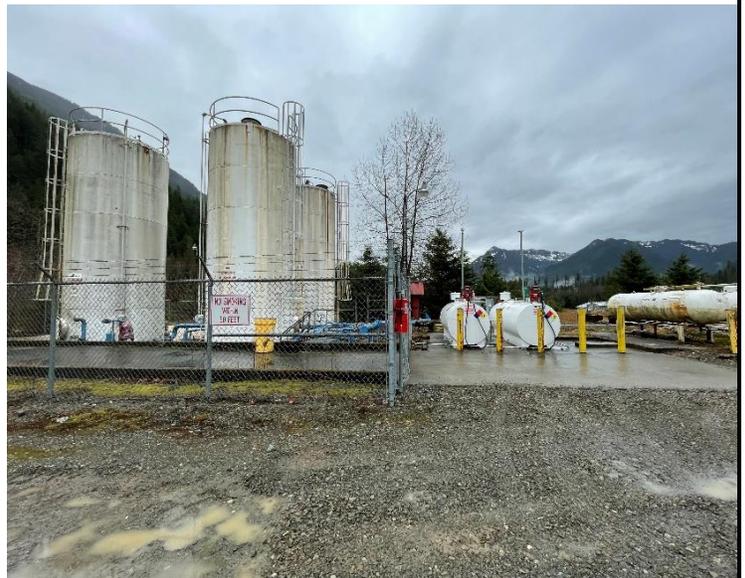
We then walked toward the fuel tanks (See photos 12-14). There are 3 aboveground fuel tanks but only two are being used to store off-spec diesel. The far-left tank shown in photo 12 is empty. Each tank has a storage capacity of 20,000 gallons. All three tanks are stored within a containment dike. There is a metal grated drain in this containment which drains to the oil water separator located in the lower yard. No standing water was observed in the containment area.

PHOTO #:12 DATE: 02/01/2024
 TAKEN BY: JEANNE TRAN
 DESCRIPTION: THREE UPRIGHT FUEL TANKS, 2 DOUBLE-WALLED HORIZONTAL FUEL TANKS, AND 2 PROPANE TANKS ARE STORED ON THE ARFF, UPPER PLATEAU AREA.

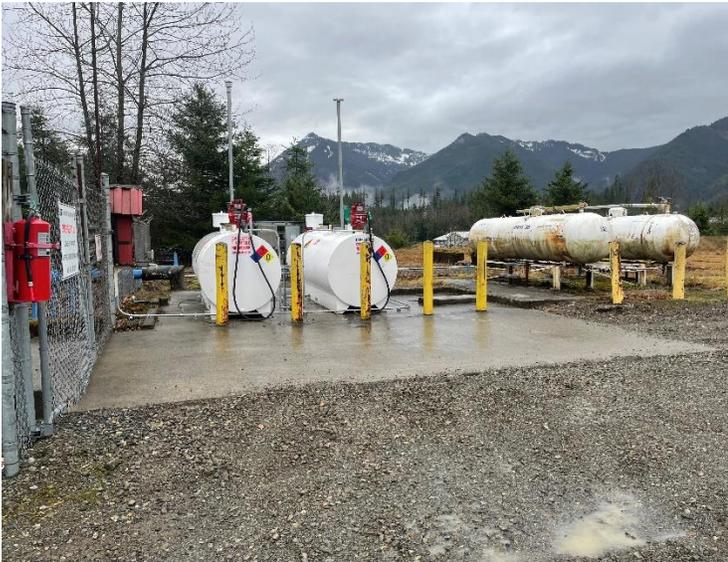
Next to the aboveground tanks are two double-walled 1,000-gallon horizontal fuel tanks. These horizontal tanks store roadway fuel for the facility. As can be seen in photo 13, these two tanks are situated on a paved ground with a floor drain located adjacent to the 3rd metal pole from the left. This drain line is plumbed into the containment area, so any spills or water from the paved area can be collected and eventually drained to the oil water separator.

PHOTO #:13 DATE: 02/01/2024
TAKEN BY: JEANNE TRAN
DESCRIPTION: A CLOSEUP VIEW OF THE HORIZONTAL DOUBLE-WALLED FUEL TANKS AND THE PROPANE TANKS.

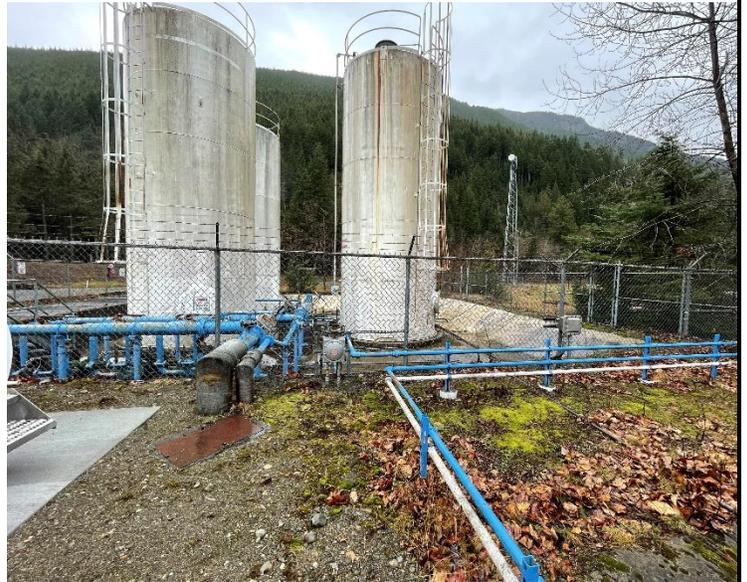
PHOTO #:14 DATE: 02/01/2024
TAKEN BY: JEANNE TRAN
DESCRIPTION: OUTDOOR TANKS IN CONTAINMENT.

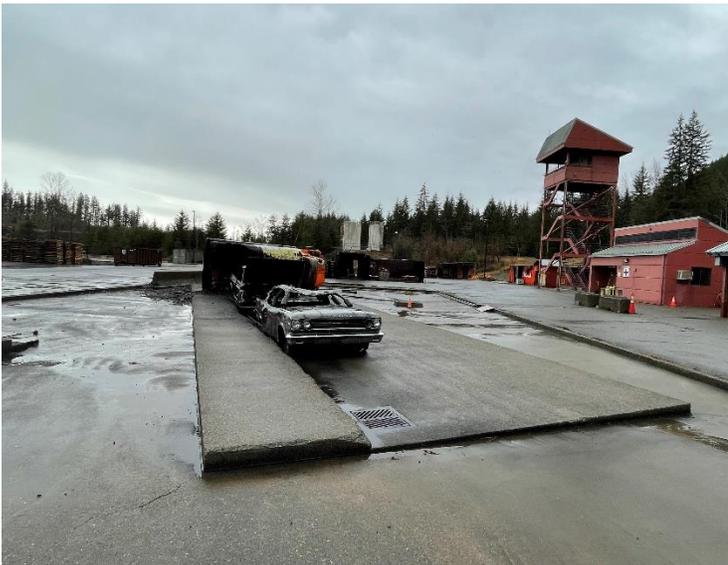
Next, Katie gave Jeanne a ride back to the lower yard. There were no training exercises that occurred that day. We walked to several burn pads with props. Each dedicated burn pad contains a metal grated drain to route firefighting oily water to the oil water separator (See photos 15 to 17). Photo 18 shows the fuel meter (in yellow) to measure the amount of fuel for use in each training exercise.

PHOTO #:15 DATE: 02/01/2024
TAKEN BY: JEANNE TRAN
DESCRIPTION: ONE OF THE BURN PADS WITH PROP. NOTE THE DRAIN WITHIN THE BURN PAD TO COLLECT FIRE FIGHTING OILY WATER TO THE OIL WATER SEPARATOR.

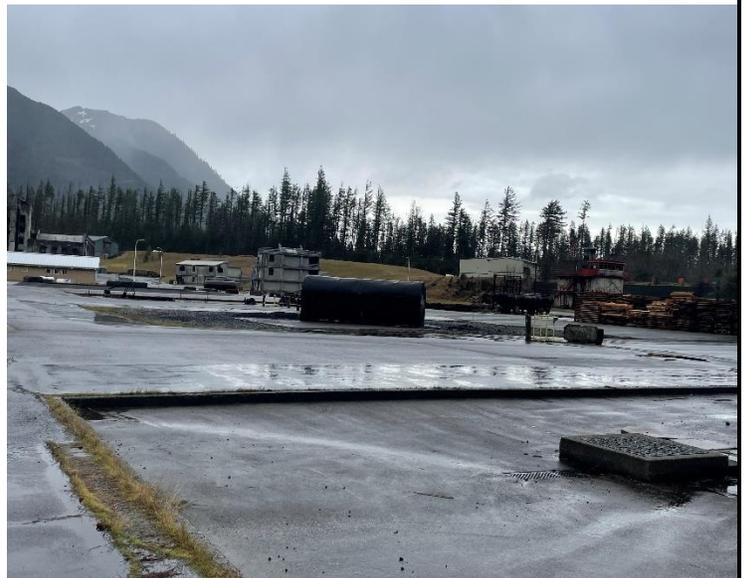
PHOTO #:16 DATE: 02/01/2024
TAKEN BY: JEANNE TRAN
DESCRIPTION: ANOTHER BURN PAD WITH DRAIN.

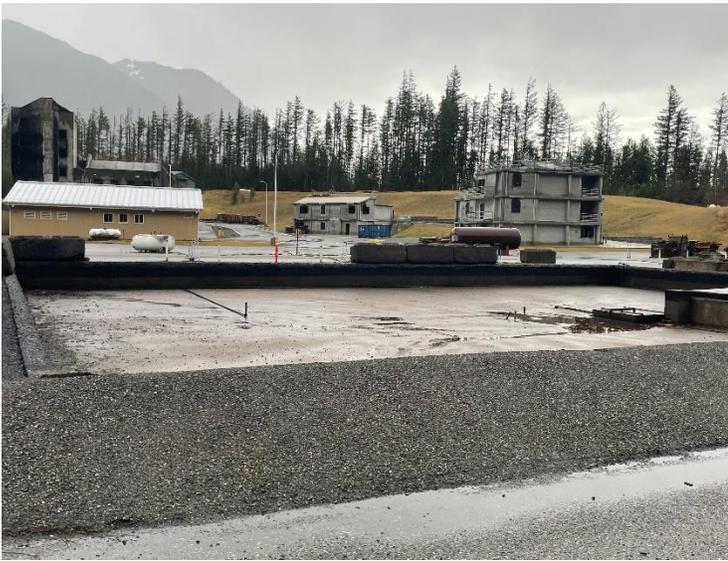
PHOTO #:17 DATE: 02/01/2024
 TAKEN BY: JEANNE TRAN
 DESCRIPTION: ANOTHER BURN PAD WITH DRAIN.

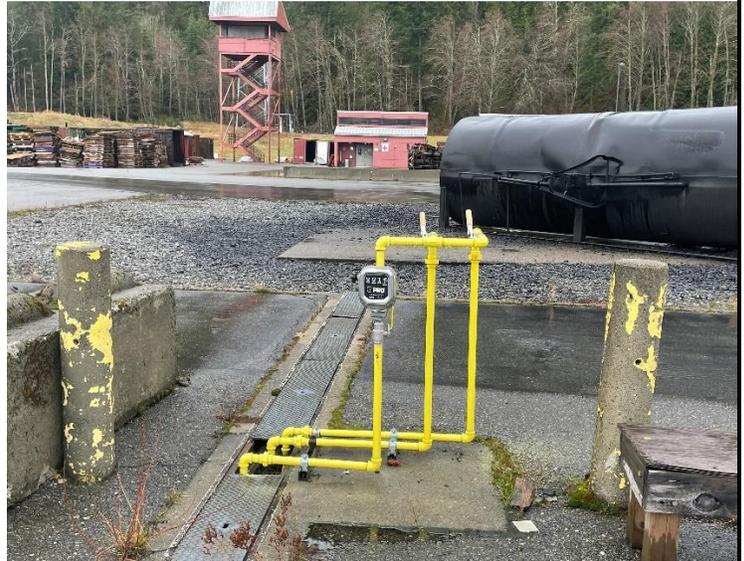
PHOTO #:18 DATE: 02/01/2024
 TAKEN BY: JEANNE TRAN
 DESCRIPTION: FUEL METER TO MEASURE THE AMOUNT OF FUEL USED AT BURN PAD FOR EACH FIREFIGHTING EXERCISE.

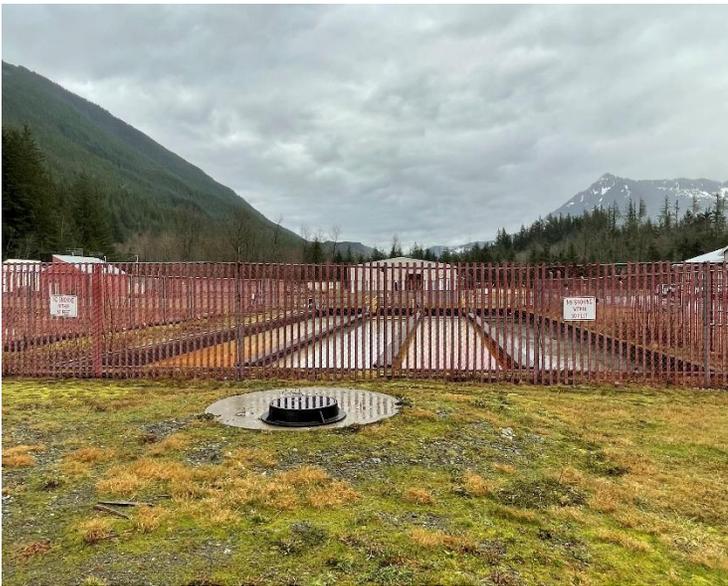
We walked to the oil water separator. The oil water separator consists of 4 bays with 2 not working since December 2023. The two bays out of commission were due to the failure of the skimmer pumps. The facility is waiting for parts to come in for repair. Next to the 4-bay oil water separator is the underground waste oil vault. This vault collects the skimmed floating oil and a mixture of oily water. The dissolved oily water accumulates at the bottom of the vault and is pumped back to the oil water separator. This vault pump was not working and waiting for repair. Clean Harbor was contracted to remove the mixture of oily wastewater and buildup sludges off-site for disposal.

PHOTO #:19 DATE: 02/01/2024
 TAKEN BY: JEANNE TRAN
 DESCRIPTION: OIL WATER SEPARATOR (OWS) WITH 5 BAYS. THE SKIMMER PUMP WAS NOT WORKING AND WAITING FOR REPAIR. THEY ARE ALSO WAITING FOR CLEAN HARBOR TO COME REMOVE THE WASTE OIL AND GET THE SEPARATOR BACK ONLINE.

Since the inspection, the skimmer pumps have been repaired and have been brought back online since February 19, 2024. The vault pump was repaired and back in service on March 27, 2024.

Ecology recommends the facility have at least one backup pump available onsite to swap out the failed pump during emergencies.

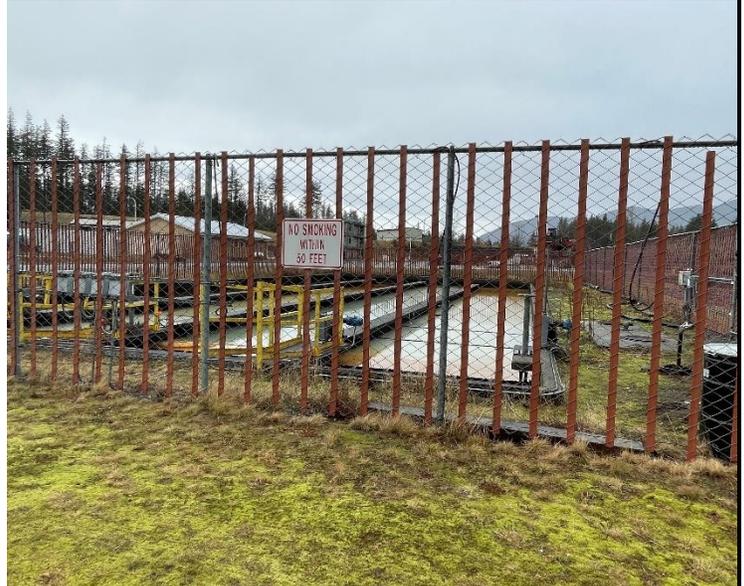
PHOTO #:20 DATE: 02/01/2024
 TAKEN BY: JEANNE TRAN
 DESCRIPTION: A CLOSE-UP VIEW OF THE OWS AND THE UNDERGROUND VAULT TO COLLECT SKIMMED WASTE OIL.

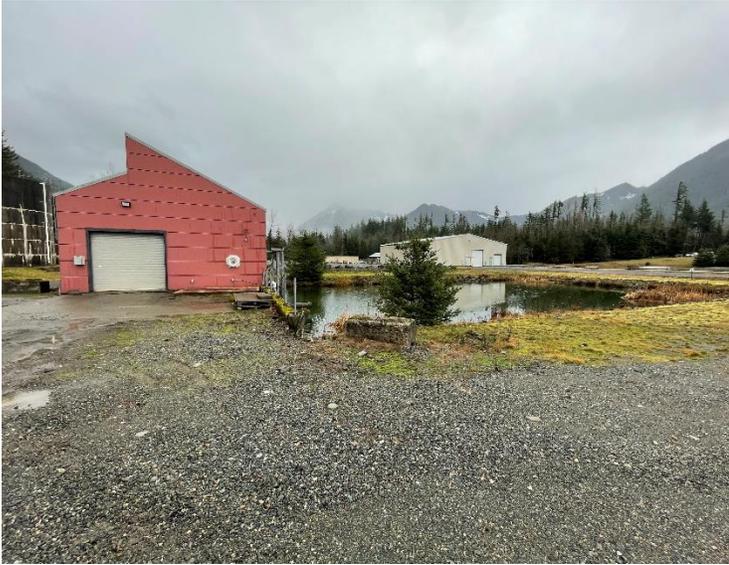
We continued the walk-through inspection at the lower yard to the training ponds and the pump house (photo 21). We entered the pump house (red building) and looked at the pumps and the control panel for the pumps (photo 22). Besides the pumps, a spill kit, and a few equipment, nothing else was observed in this building.

PHOTO #:21 DATE: 02/01/2024
 TAKEN BY: JEANNE TRAN
 DESCRIPTION: A VIEW OF THE PUMP HOUSE AND TRAINING POND #3.

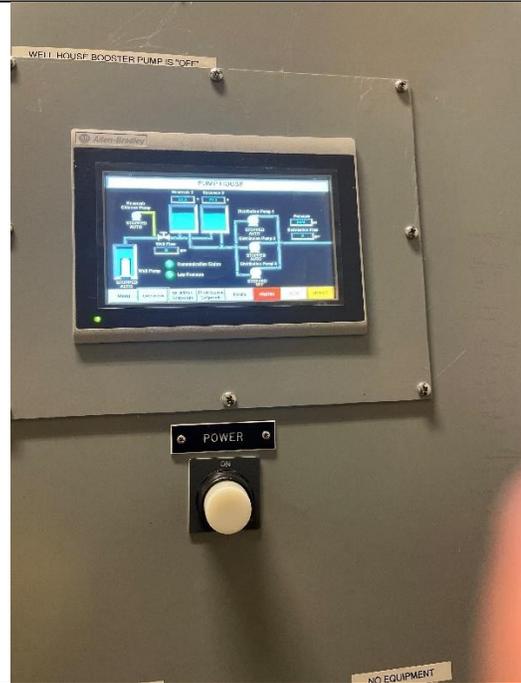
PHOTO #:22 DATE: 02/01/2024
 TAKEN BY: JEANNE TRAN
 DESCRIPTION: PUMP HOUSE CONTROL PANEL.

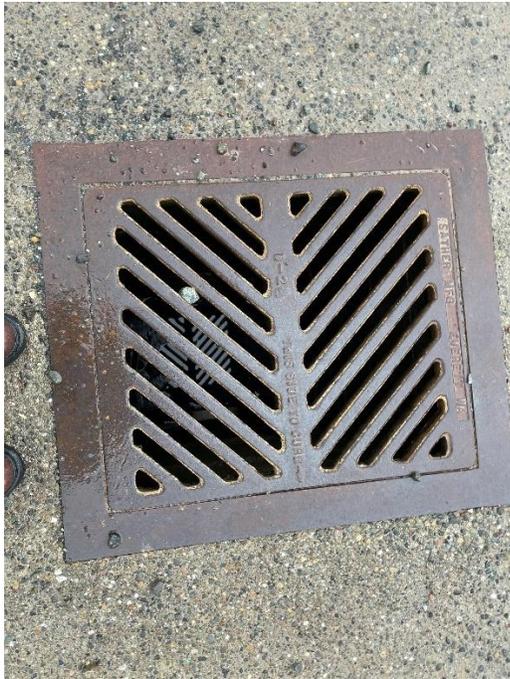
PHOTO #:23 DATE: 02/01/2024
 TAKEN BY: JEANNE TRAN
 DESCRIPTION: ONE OF THE YARD DRAINS. NO OILY SHEEN WAS OBSERVED ON THE WATER INSIDE THE DRAIN.

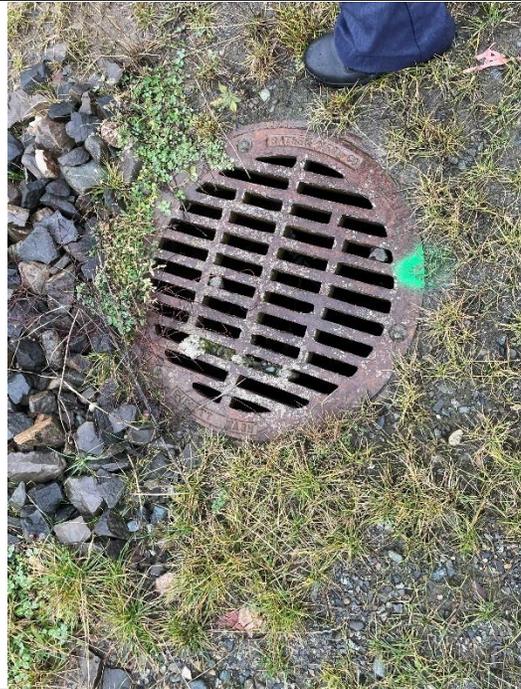
PHOTO #:24 DATE: 02/01/2024
 TAKEN BY: JEANNE TRAN
 DESCRIPTION: ANOTHER DRAIN AND NO OILY SHEEN WAS OBSERVED AT THIS DRAIN EITHER.
