STATE OF WASHINGTON
DEPARTMENT OF ECOLOGY

Re: Weyerhaeuser Raymond Lumber Mill, State wastewater discharge permit no.
ST0006167 Compliance Inspection Report

Waste Discharge Compliance Inspection Report

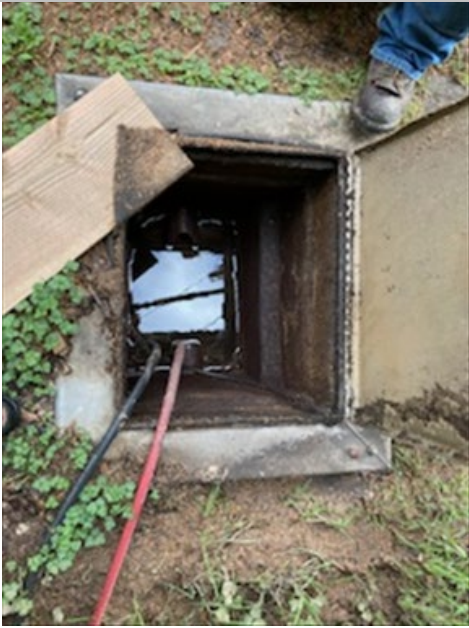
Description	Photographs	Image Name
Drain access and sample location

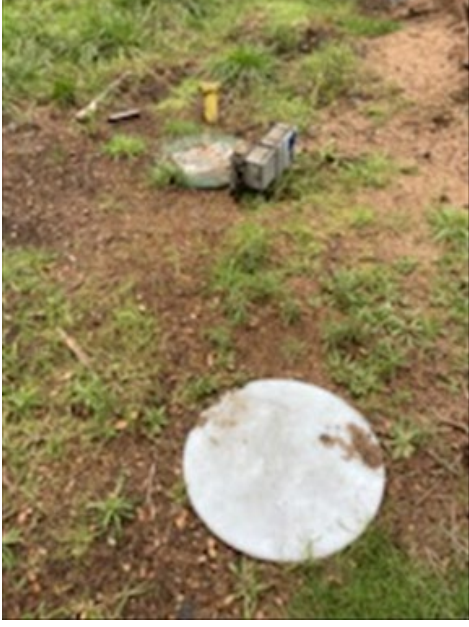
Ctrl+Click HERE to view full size image	WEYERHAEUSER RAYMOND LUMBER MILL
Drain accesss

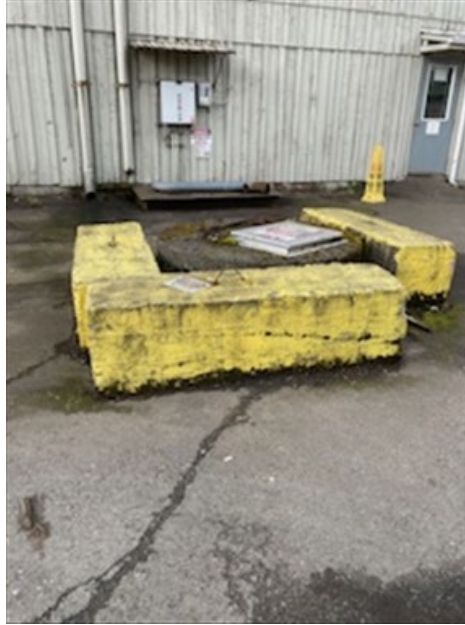
Wastewater access point

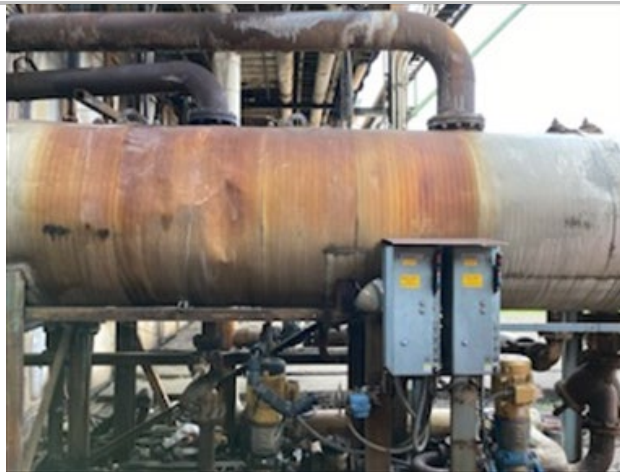
Condensate tank and
panels

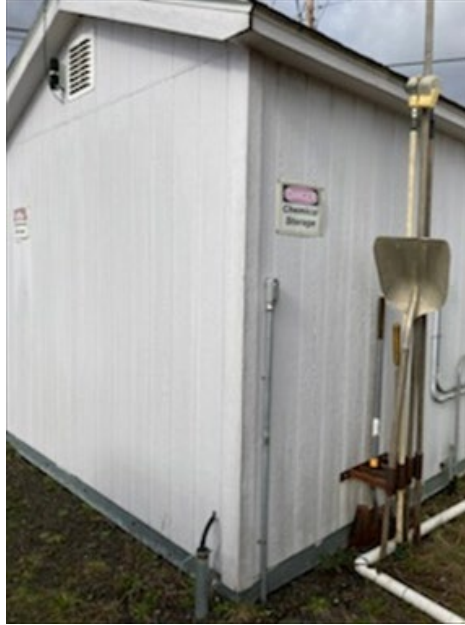
Chemical Storage house

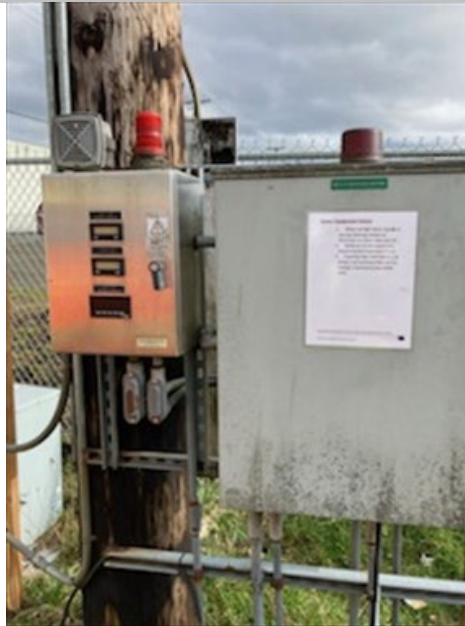
Flow meter

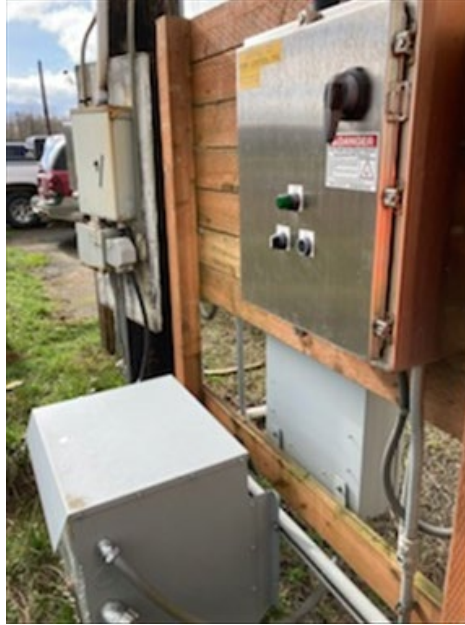
Outfall pump control panel

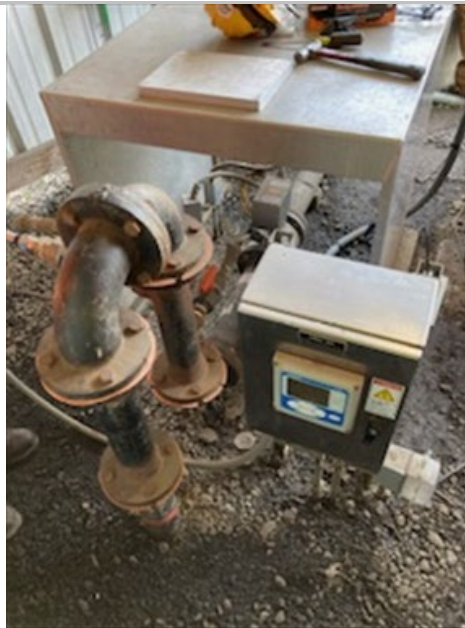
Wastewater discharge
pump display screen

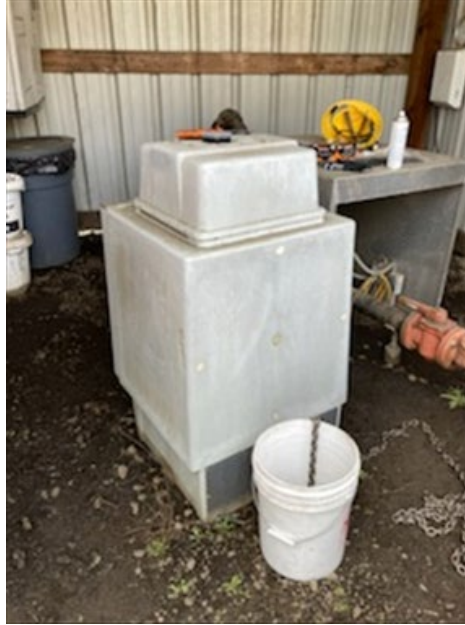
Auto Composite Samper
Housing Unit
