Permit Compliance Inspection Report  
Water Quality Program  
Northwest Region Office

Facility Name and Address: Terramar Brewery  
5712 Gilkey Ave  
Bow WA, 98232

Permit Number: ST0501319

Type of Inspection: Announced  
Technical Assistance Visit

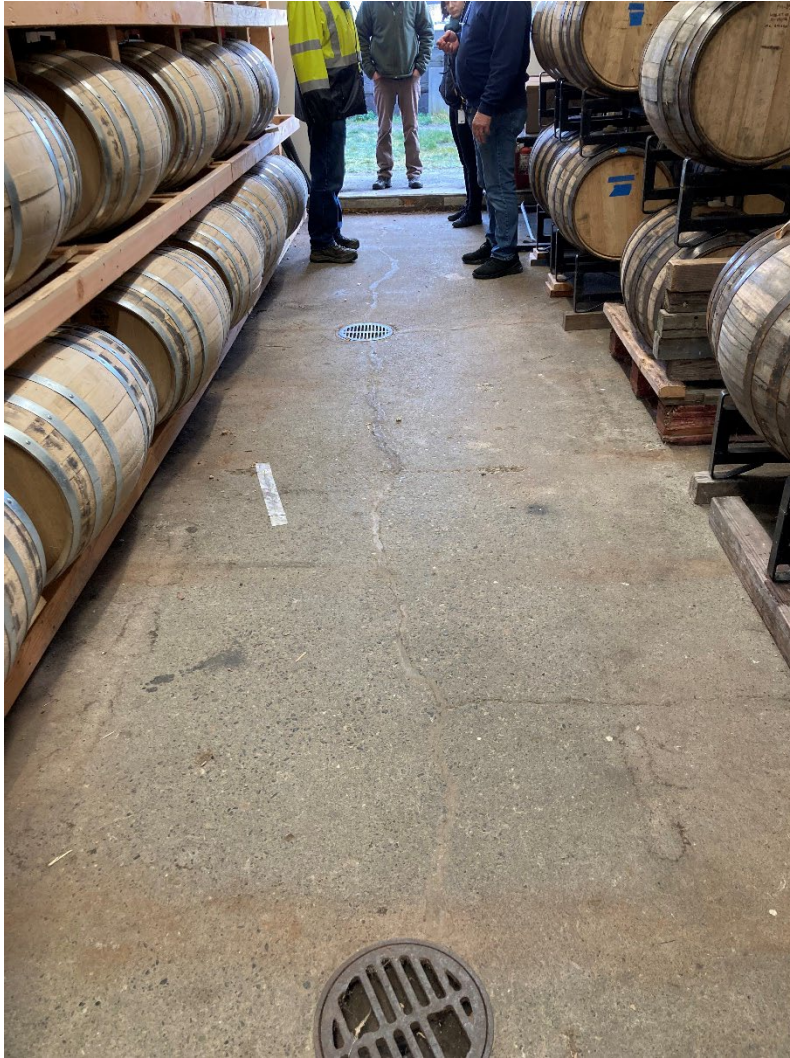
**Photo [1] [IMG\_0242]**

**Description:** Floor drains inside the barrel storage room.

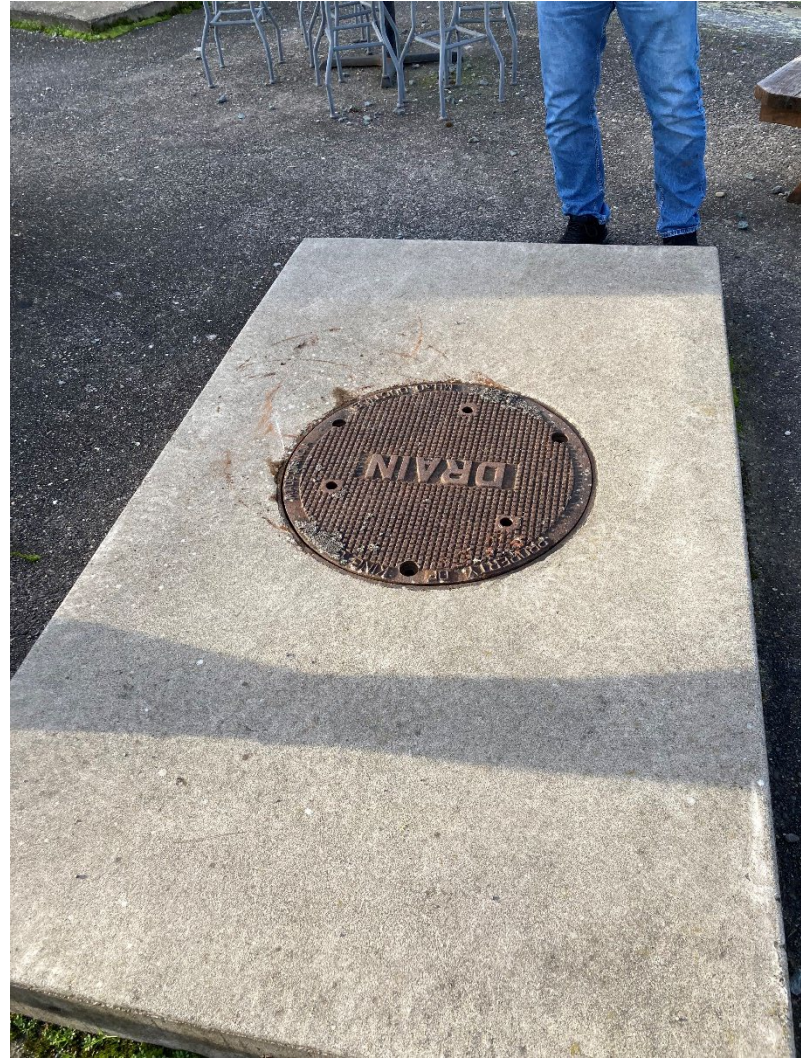
**Photo [2] [IMG\_0244]**

**Description:** Manhole cover for the 30,000-gallon "blood tank".

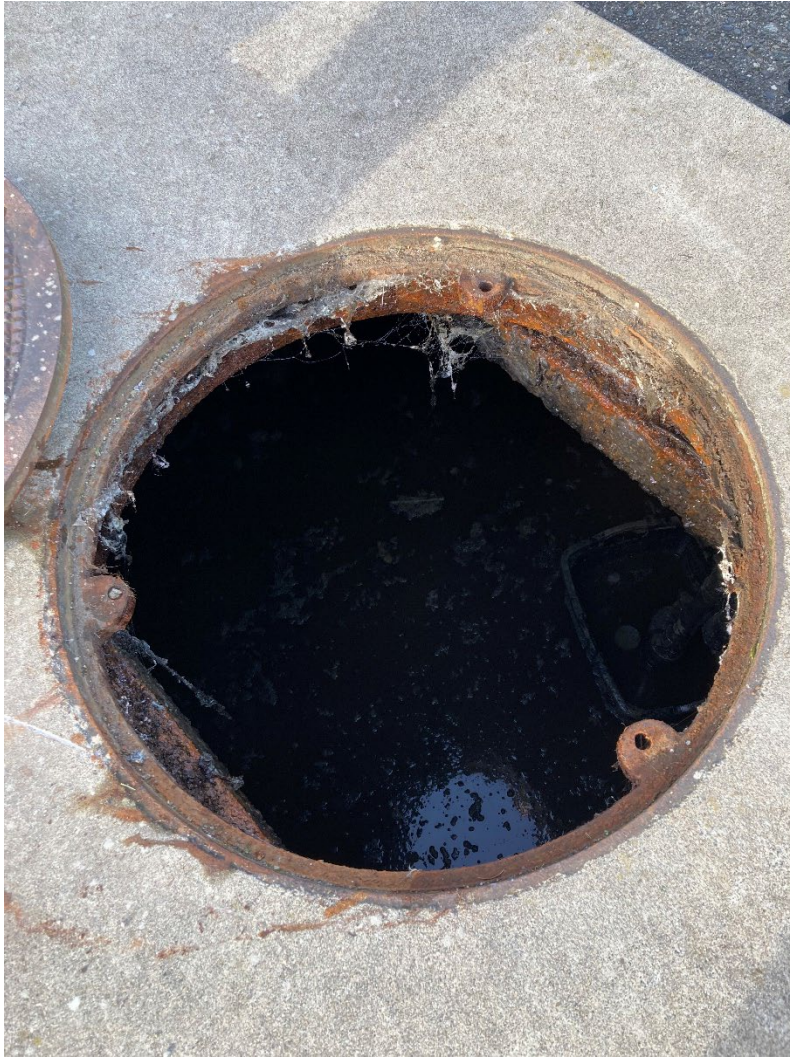
**Photo [3] [IMG\_0245]**

**Description:** Looking down into the “blood tank”.

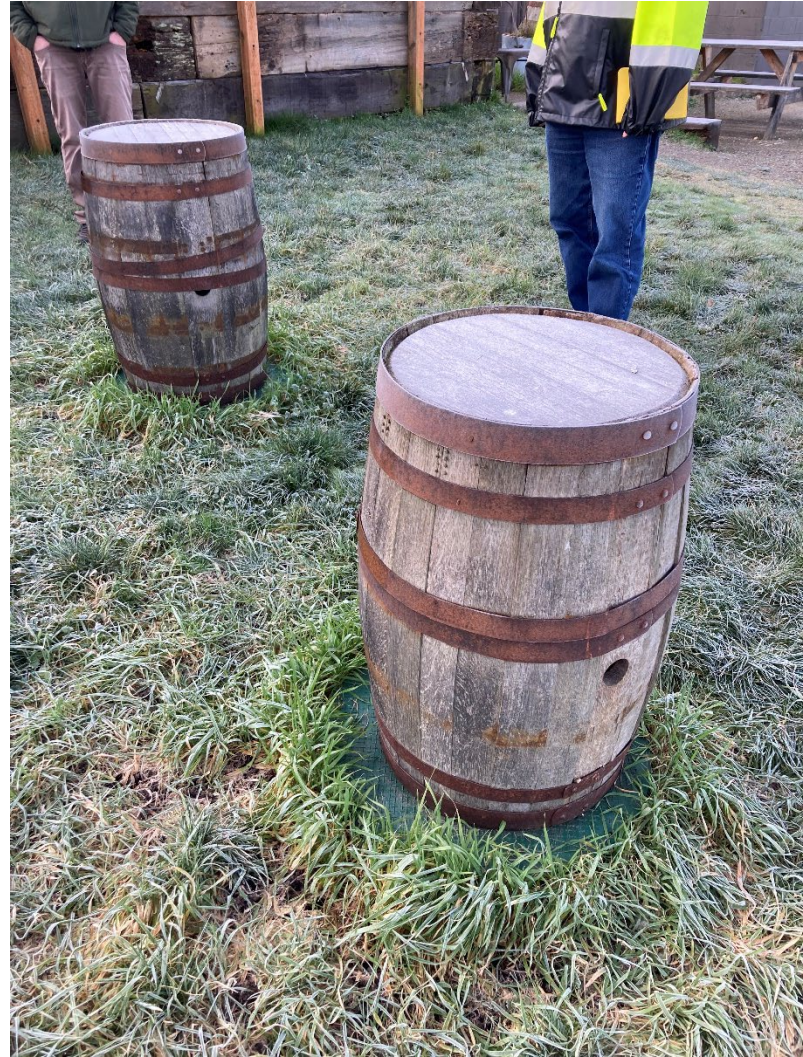
**Photo [4] [IMG\_0246]**

**Description:** Empty barrels on top of two-chamber storage tank next to the “blood tank”.

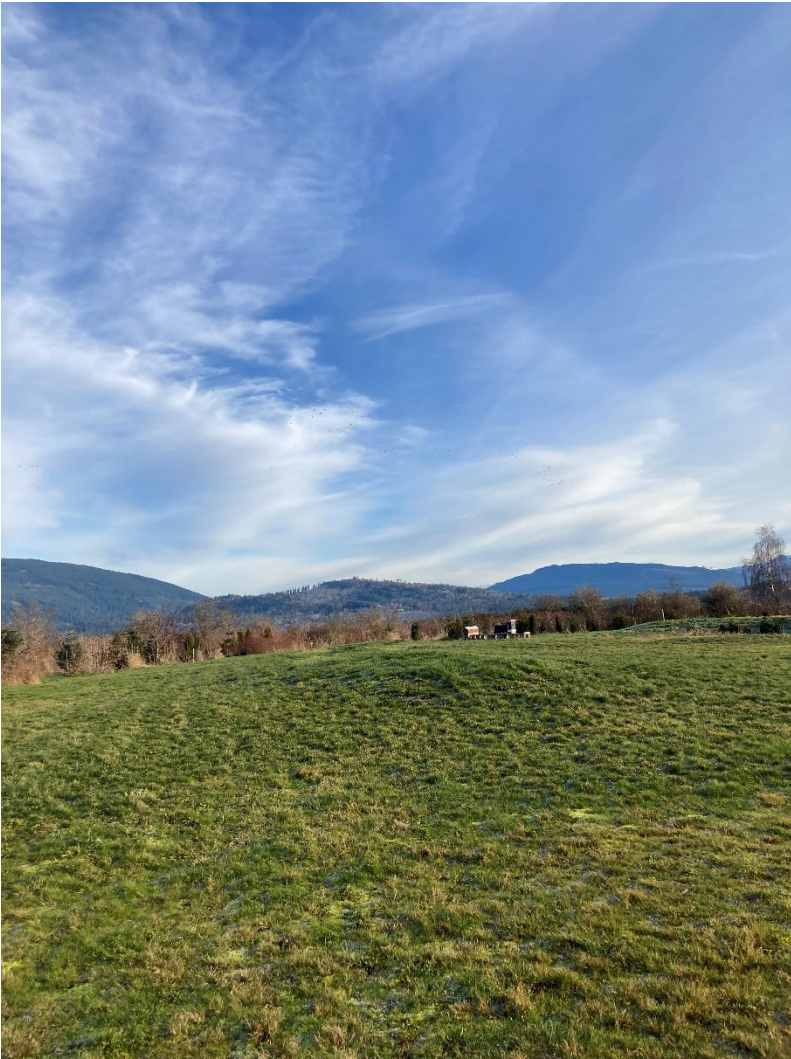
**Photo 6 [IMG\_0251]**  
**Description:** Looking north at the land application area.

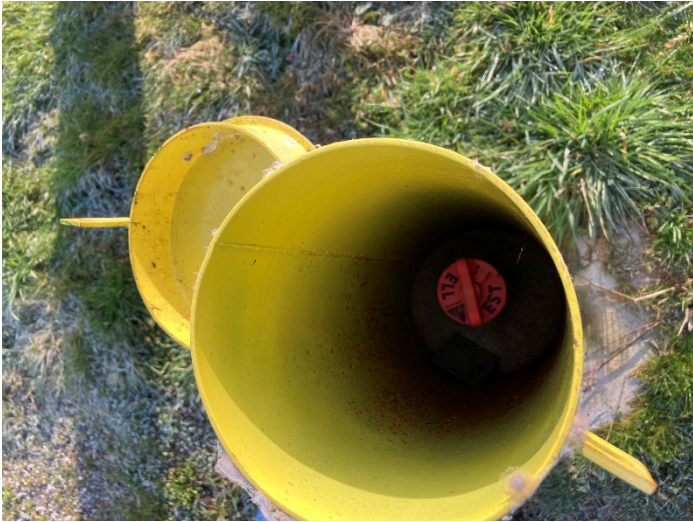
**Photo 7 [IMG\_250]**  
**Description:** Groundwater monitoring well MW-1.

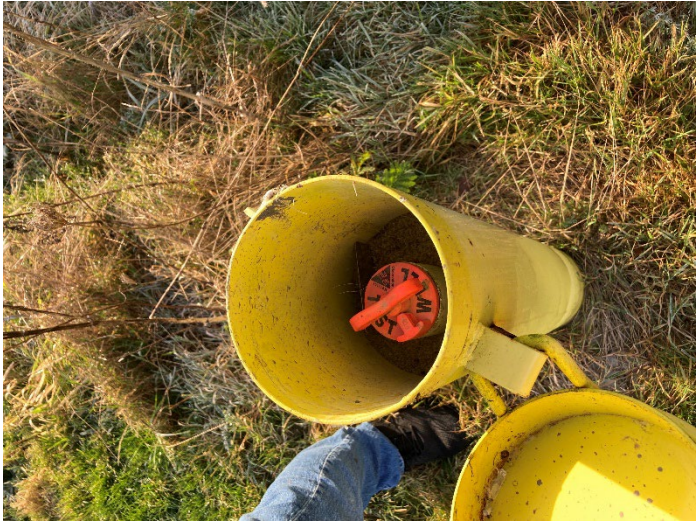
**Photo 8 [IMG\_0252]**  
**Description:** Groundwater monitoring well MW-3.

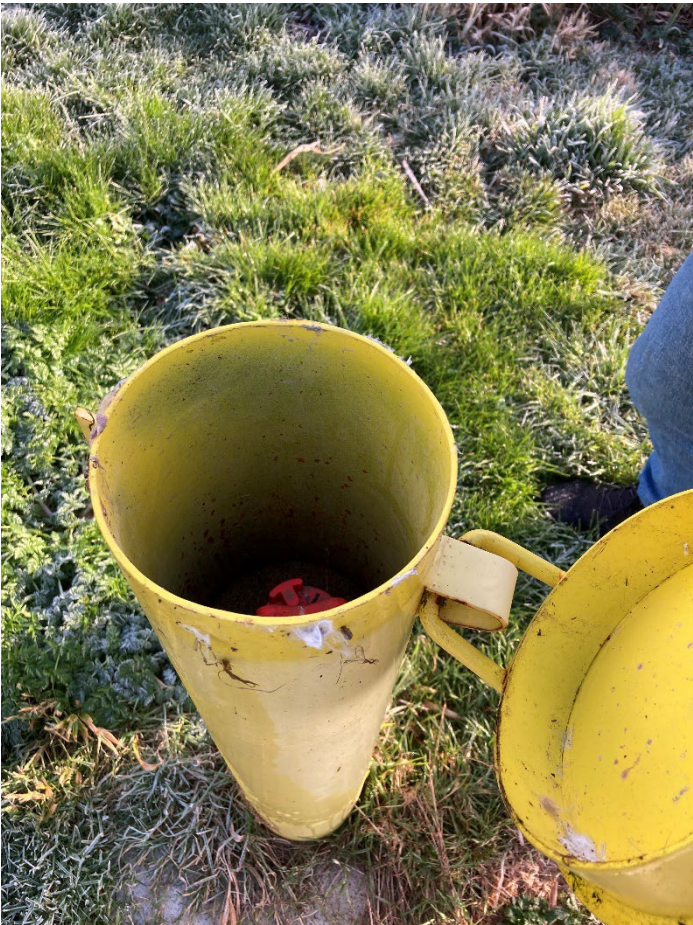
**Photo 9 [IMG\_0253]**  
**Description:** Groundwater monitoring well MW-4.

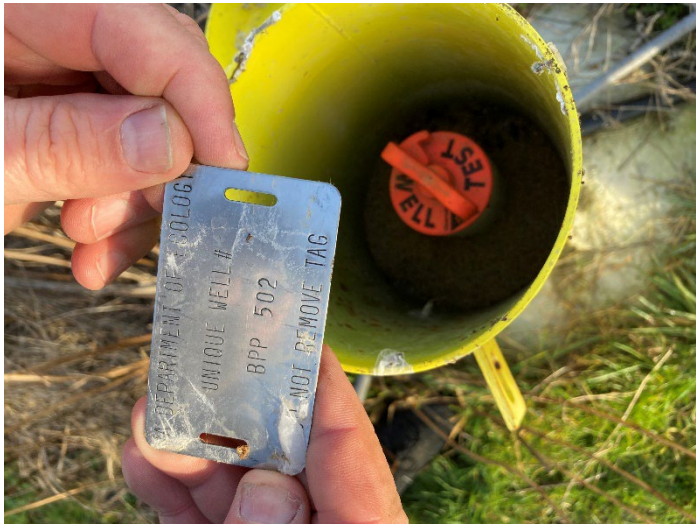
**Photo 10 [IMG\_0255]**  
**Description:** Groundwater monitoring well MW-2.
