STATE OF WASHINGTON
DEPARTMENT OF ECOLOGY

Re: State Waste Discharge Permit No. ST0006178, February 27, 2025

Permit Compliance Inspection Report

Facility Name and Address: Simpson Door
400 West Simpson Ave
McCleary, WA 98557

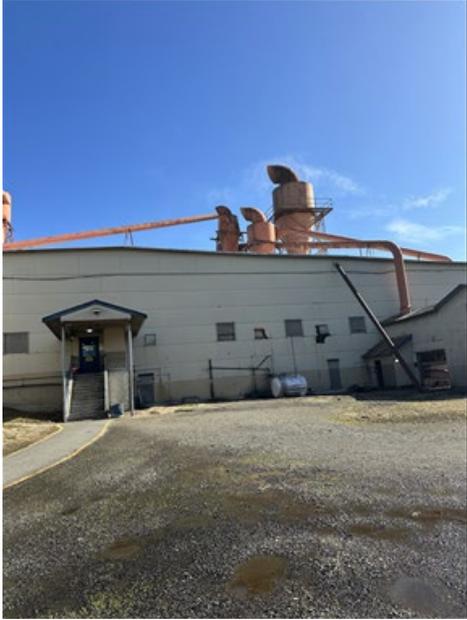
Description	Photographs	Facility
Photo 1. Cutting building

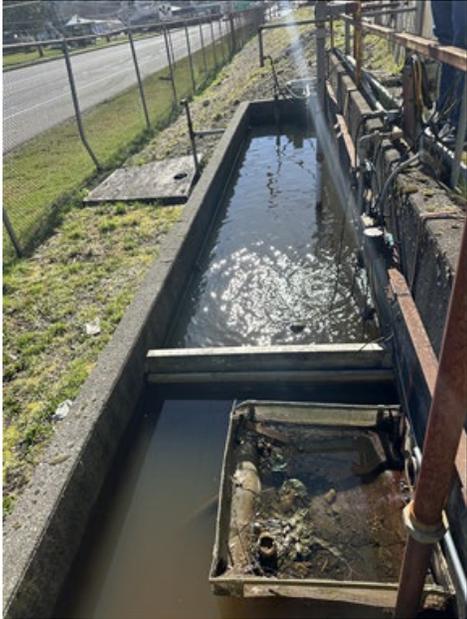
After the records review and discussion, we started the site walk through. We began at the cutting building (Photo 1). And made our way to the outfall (Photo 2). The outfall looked clean, and there was no process water violations observed.

<p>Ctrl+Click HERE to view full size image</p>	SIMPSON DOOR COMPANY
Photo 2. Sample site, outfall.

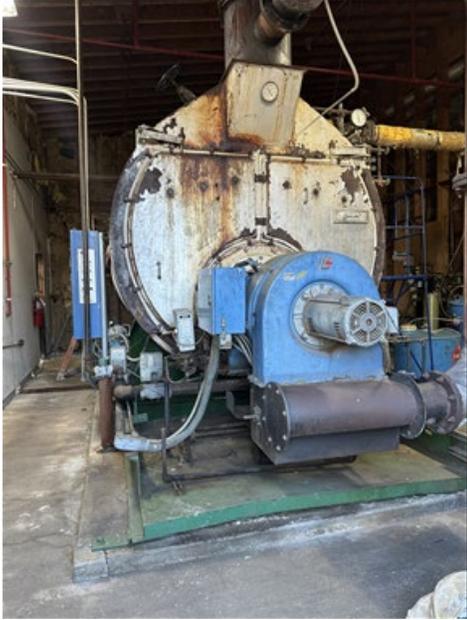
Description	Photographs	Facility
<p>Photo 3. Boiler</p>

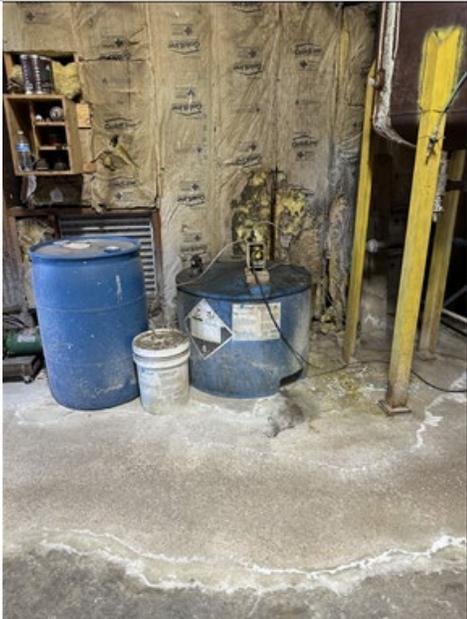
We then circled around to the boiler room (Photo 3). Simpson is no longer using diesel to operate the boiler but have switched to propane. In the boiler room there were several different barrels of corrosive chemicals (Photos 4, 6-10 and 12). These chemicals are used to keep the boiler lining from corroding. The boiler is checked once per year to ensure that the lining is in good shape. Simpson contracts with a company who comes to check this and makes sure that the chemicals are dosing properly. I noted that the barrels in the boiler room did not have secondary containment and suggested that Simpson obtain secondary containment for all the barrels and buckets of chemicals in the boiler room.

<p>Ctrl+Click HERE to view full size image</p>	<p>SIMPSON DOOR COMPANY</p>
<p>Photo 4. Chemicals for treating inside of boiler. The chemicals help prevent erosion on the inside of the boiler.</p>

- 1) Please provide secondary containment for all the corrosive and otherwise hazardous materials in the boiler room (Photos 4, 6-10 and 12).
- 2) Provide hard copies of SDS for all materials stored in the boiler room. Ensure that the SDS are clearly labeled and in readable condition.

- 4) Provide a hard copy of the SPCC plan in the boiler room.
- 5) Please label the black container in the boiler room (Photo 11).
- 6) Please label the blue 55-gallon drum on the left in Photo 4.

- 9) Please address the corrosion, leaking and of pipes etc. of the metal barrel attached to yellow metal stilts in photo 4.

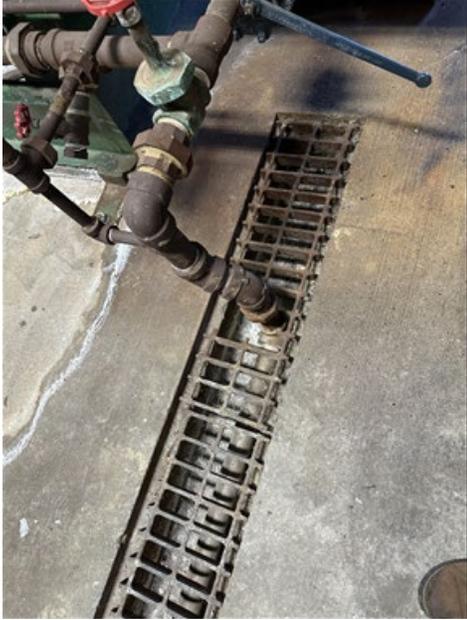
Description	Photographs	Facility
<p>Photo 5. Grate in boiler room. Does not drain to anything. Collects minor spills.</p>

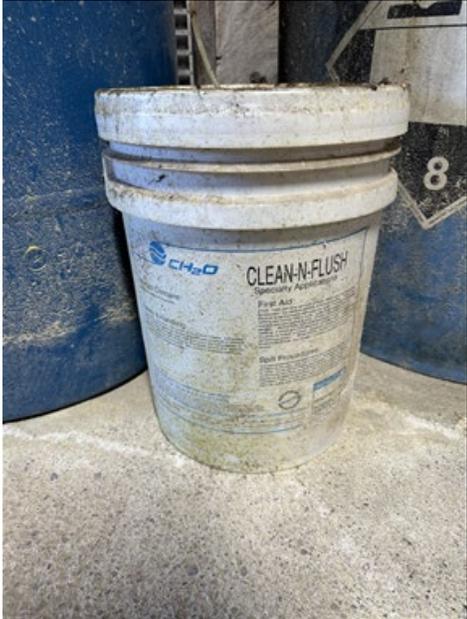
<p>Ctrl+Click HERE to view full size image</p>	<p>SIMPSON DOOR COMPANY</p>
<p>Photo 6. Chemicals in boiler room.</p>

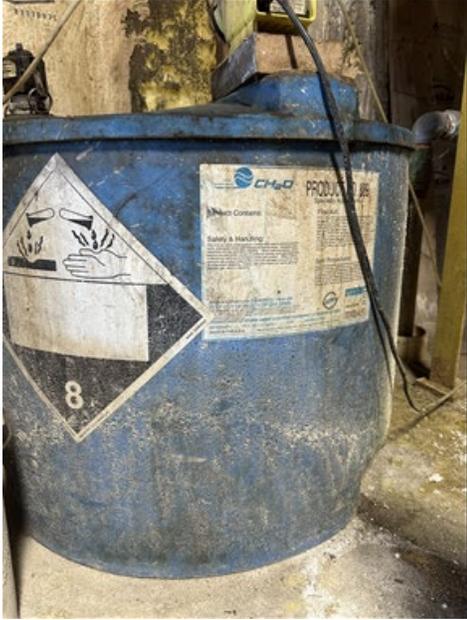
Description	Photographs	Facility
<p>Photo 7. Corrosive chemical. DOT classified hazard 8 pH less than 2 or greater than 12.</p>

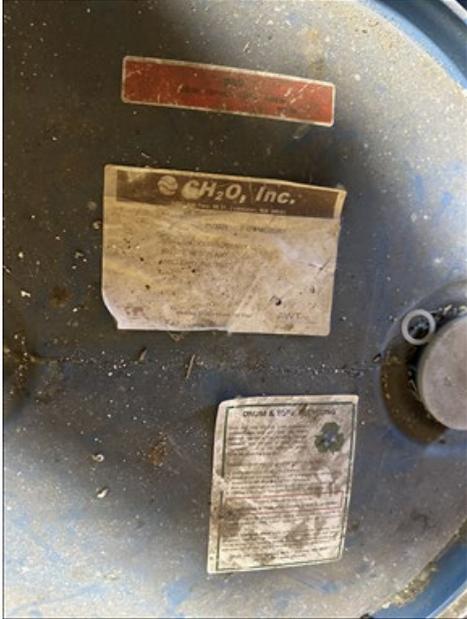
<p>Ctrl+Click HERE to view full size image</p>	<p>SIMPSON DOOR COMPANY</p>
<p>Photo 8. Chemicals in boiler room</p>

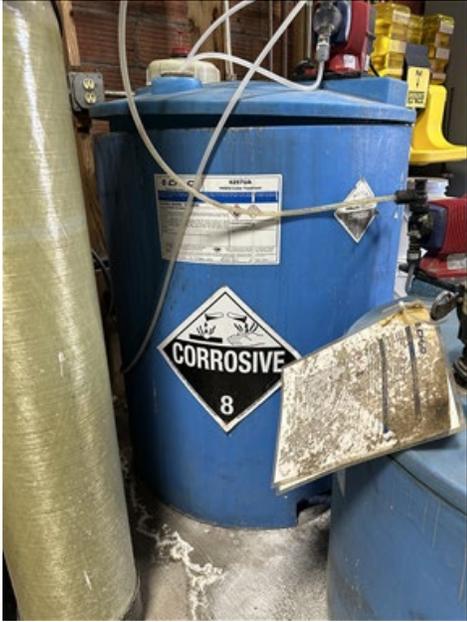
Description	Photographs	Facility
<p>Photo 9. More DOT class 8 corrosive chemicals</p>

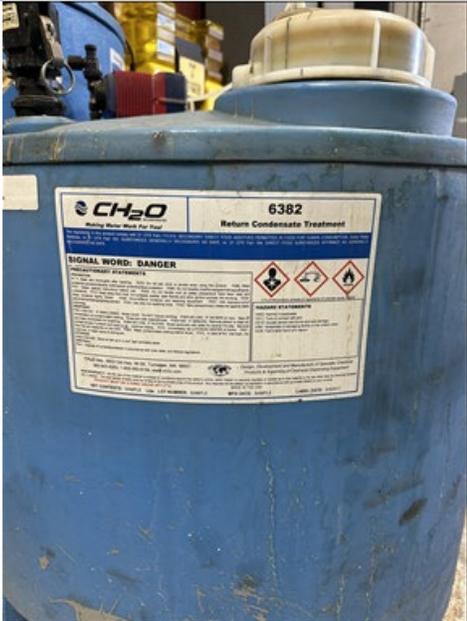
<p>Ctrl+Click HERE to view full size image</p>	<p>SIMPSON DOOR COMPANY</p>
<p>Photo 10. Chemicals in Boiler room</p>

- 8) The barrel in photo 10 is labeled “return condensate treatment” is this spent chemical for disposal or chemical provided to treat the boiler. Please label as such.

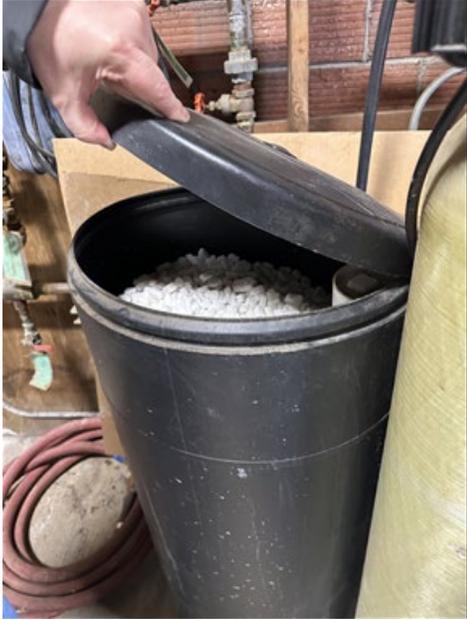
There was also a water softener system in the boiler room. The black barrel full of white chunks is assumed to be the water softening agent (Photo 11). However, there was not a visible label. I encouraged Simpson to put a visible label on this barrel. Just inside the boiler room, there was a pallet of Sure Soft cubes for water softening (Photo 13). Just outside of the boiler room was another boiler under a cover (Photo 14).

Description	Photographs	Facility
<p>Photo 11. Bucket of white material. Label not visible. Assumed to be water softening agent. Advised to label visibly.</p>

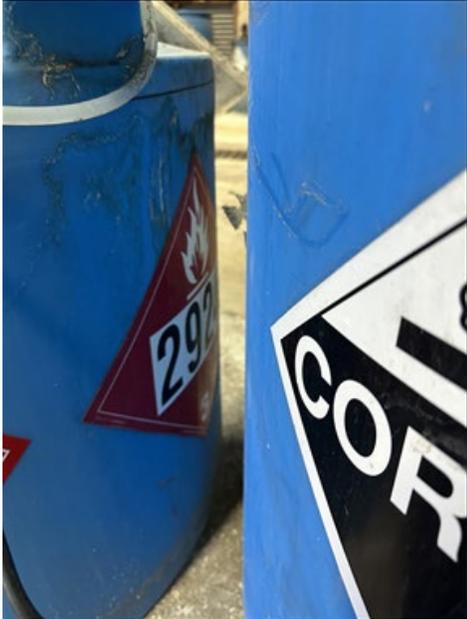
<p>Ctrl+Click HERE to view full size image</p>	<p>SIMPSON DOOR COMPANY</p>
<p>Photo 12. Flammable liquid, also corrosive DOT number 2924.</p>

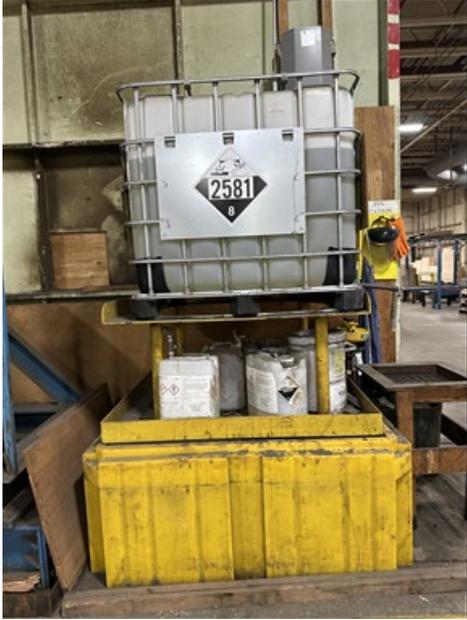
The DOT 2581 class 8 corrosive material (aluminum chloride) is a catalyst used for activating the glue (Photo 17). All of it is recycled so there is no hazardous waste (Photo 18). The tote and other chemical stored beneath are all in secondary containment (Photo 19).

Description	Photographs	Facility
<p>Photo 17. Aluminum chloride hazard class 8 corrosive chemical. They use very little each year. All of it is recycled so there is no hazardous waste generated.</p>

- 10) Buckets of toxic and other chemicals are improperly stored underneath the tote of $AlCl_3$ (Photo 17). A spill from the $AlCl_3$ could contaminate the buckets and cause greater problems for cleanup. Please provide separate secondary containment for the buckets of chemicals, this includes ensuring that the

chemicals stored together are compatible (e.g. oxidizers cannot be stored with flammable chemicals etc.).

- 11) There is not secondary containment for the spigot that dispenses AlCl_3 . Please expand the secondary containment for the AlCl_3 to ensure that all spills are contained.

- 12) Kert shared that 100% of the AlCl_3 is recycled, thus no hazardous waste is generated. It is unusual that there would never be spent or otherwise uncontaminated AlCl_3 . Please provide documentation as to how 100% of the AlCl_3 is recycled.

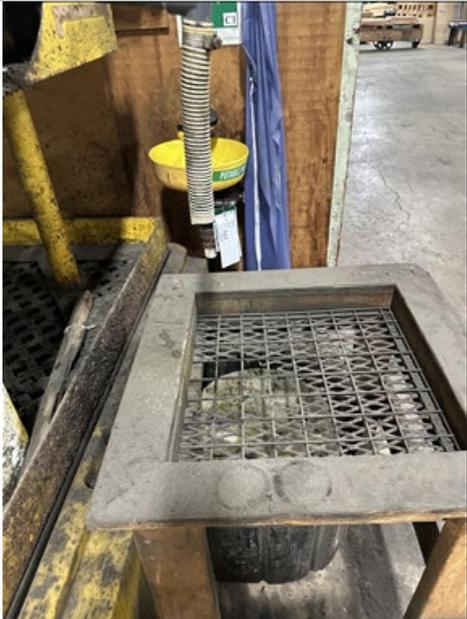
<p>Ctrl+Click HERE to view full size image</p>	<p>SIMPSON DOOR COMPANY</p>
<p>Photo 18. Container for catching spills from the aluminum chloride tote</p>

- 13) Photo 18 shows an eyewash station behind the AlCl_3 tote. The eyewash station is not accessible and could also be contaminated by a spill or splashes from dispensing AlCl_3 . Please ensure a safe and accessible eyewash station.

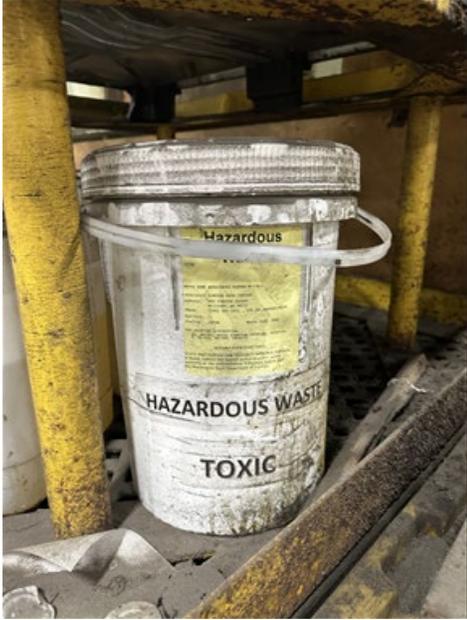
Description	Photographs	Facility
<p>Photo 19. Hazardous waste stored beneath the aluminum chloride tote</p>

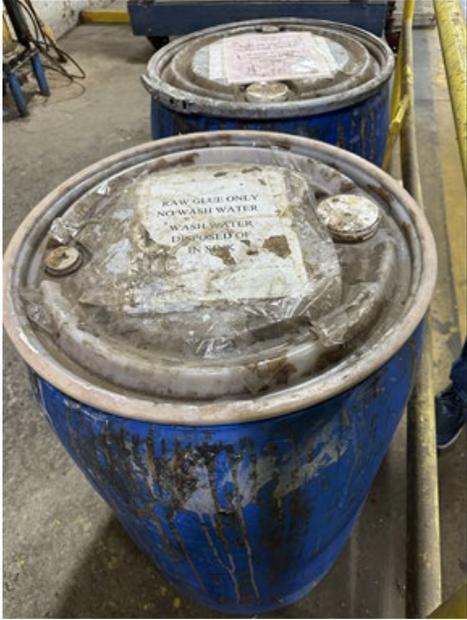
Description	Photographs	Facility
<p>Photo 23. Barrels of chemicals</p>

- 14) Ensure that there is a spill response kit close to the AlCl_3 tote.
- 15) Please verify that sink disposal is the proper method for disposing of the of the material contained in the barrels in Photo 23.

- 16) Please label the barrels in Photo 23.
- 17) Photo 28 shows a dirty sink next to a drinking water fountain. Ensure health and safety for the use of the drinking water fountain.

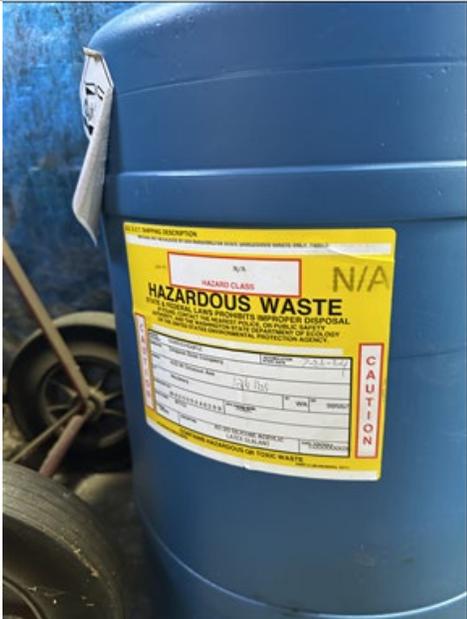
Hazardous waste is generated from cleaning the saw blades. They work to keep the grinding fluid under 250 lbs./month to stay in the “small quantity generator (SQG)” classification (note that the regulation for a SQG is 220 lbs. or less). Photo 24 shows a 126 lbs. of hazardous waste. Simpson door has moved to sonic wash for cleaning the blades to eliminate hazardous waste (Photo 27).

<p>Ctrl+Click HERE to view full size image</p>	<p>SIMPSON DOOR COMPANY</p>
<p>Photo 24. Hazardous waste generated from cleaning saw blades</p>

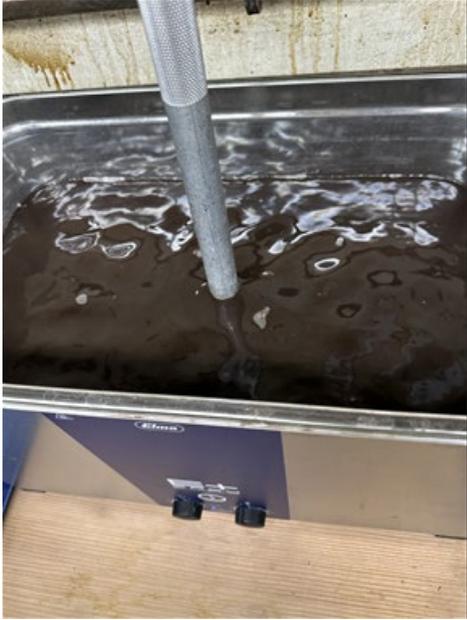
Description	Photographs	Facility
Photo 27. Small sonicator for cleaning saw blades

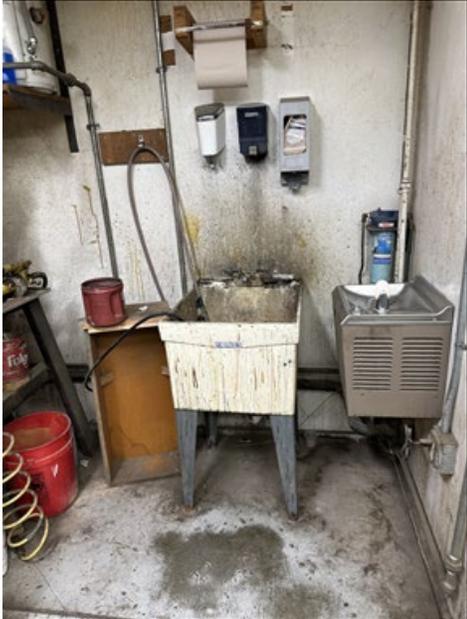
<p>Ctrl+Click HERE to view full size image</p>	SIMPSON DOOR COMPANY
Photo 28. Washing station
