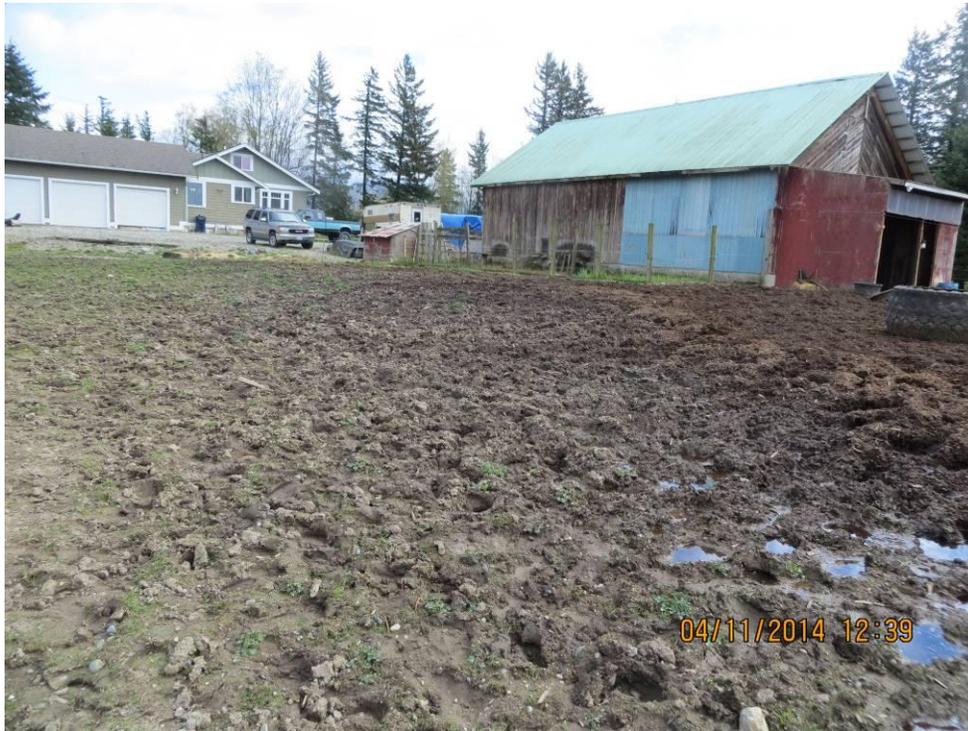
Photo 1 – This photo shows the barn area. There are heavy accumulations of mud and manure, as well as standing water visible in the bottom right of the photo. Water discharges down this slope and to the stream.

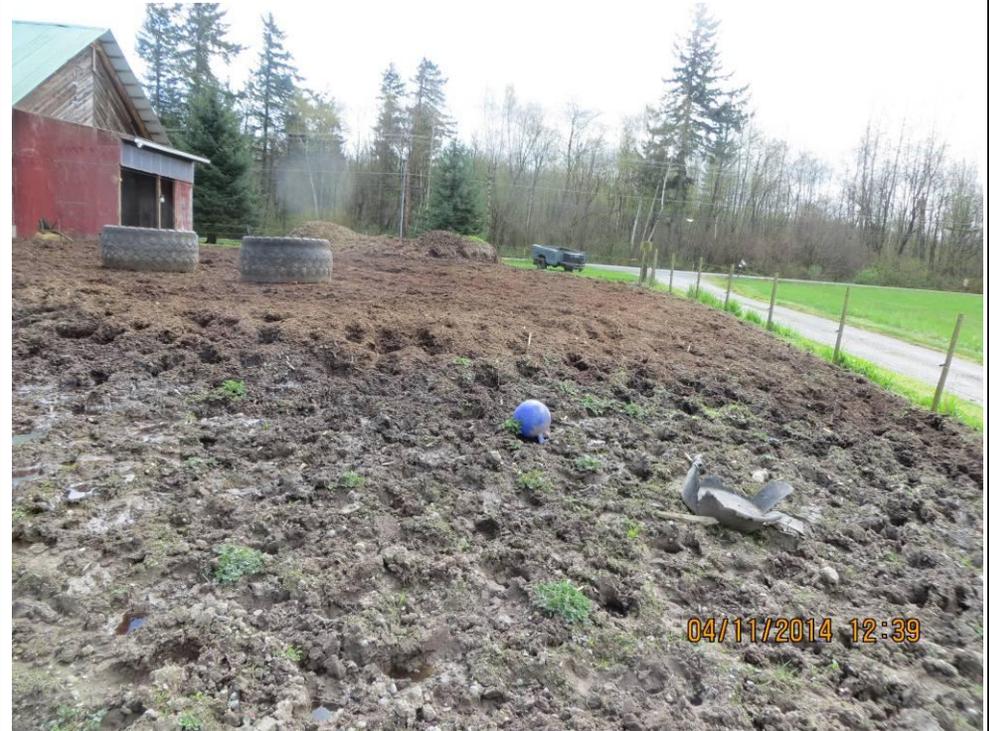
Photo 2 – This photo shows the barn area and manure piles.

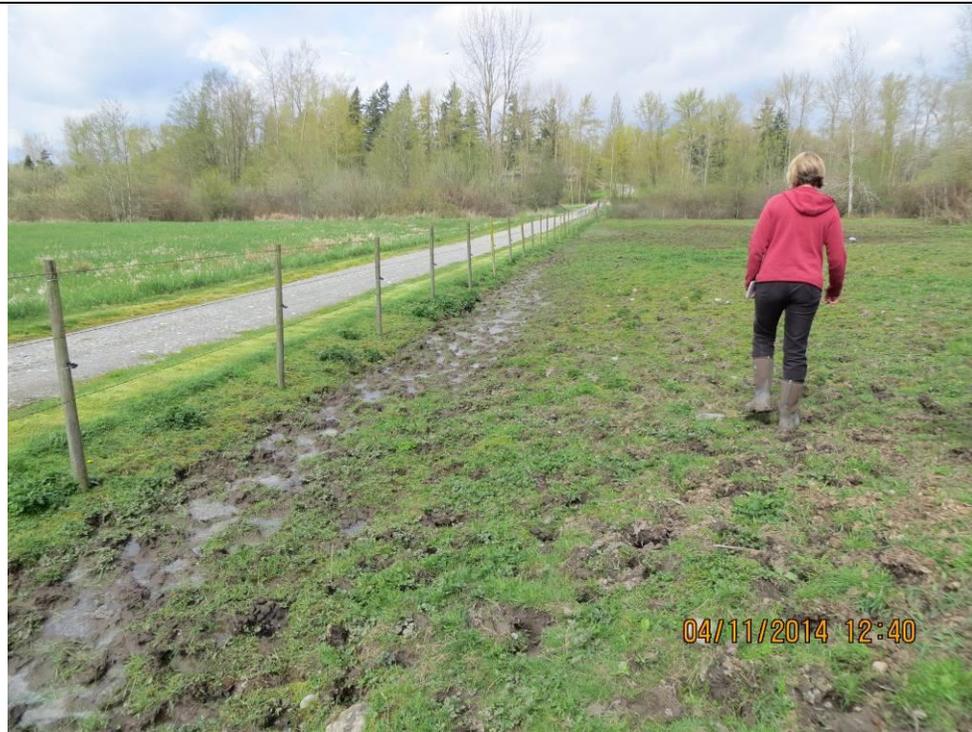
Photo 3 – This photo shows the area of concentrated flow along the west fence that originates just below the area of heavy manure accumulation near the barn and at the point that a tile drain discharges to the surface. This concentrated flow is visible discharging into the stream below.

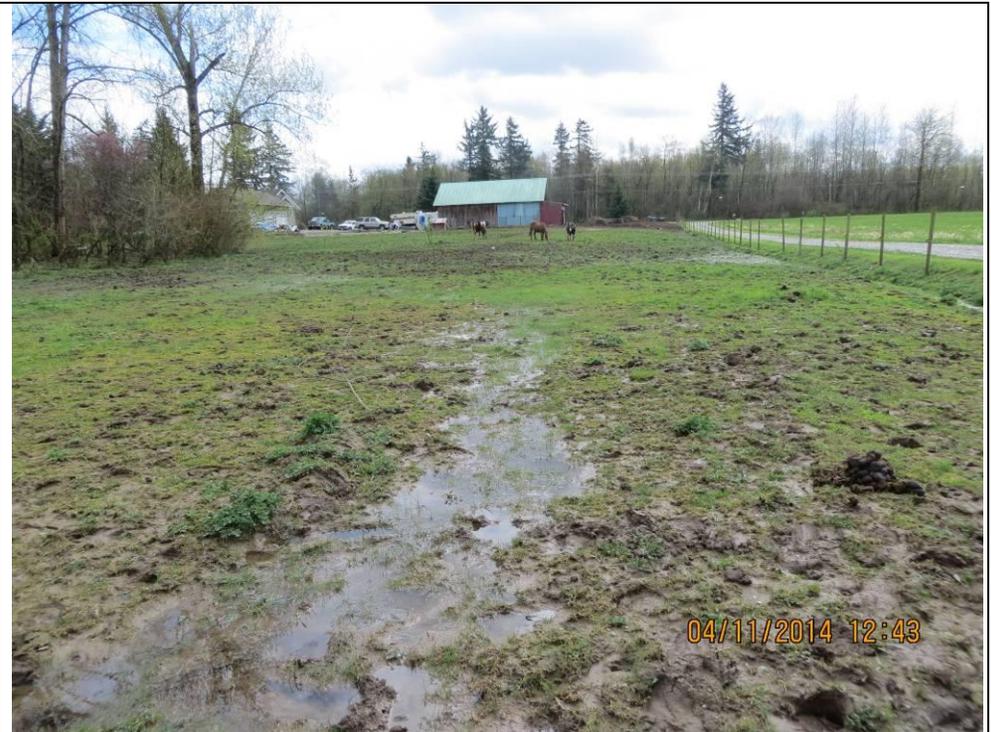
Photo 4 – This photo shows the south confinement area and barn from just above the stream bank.

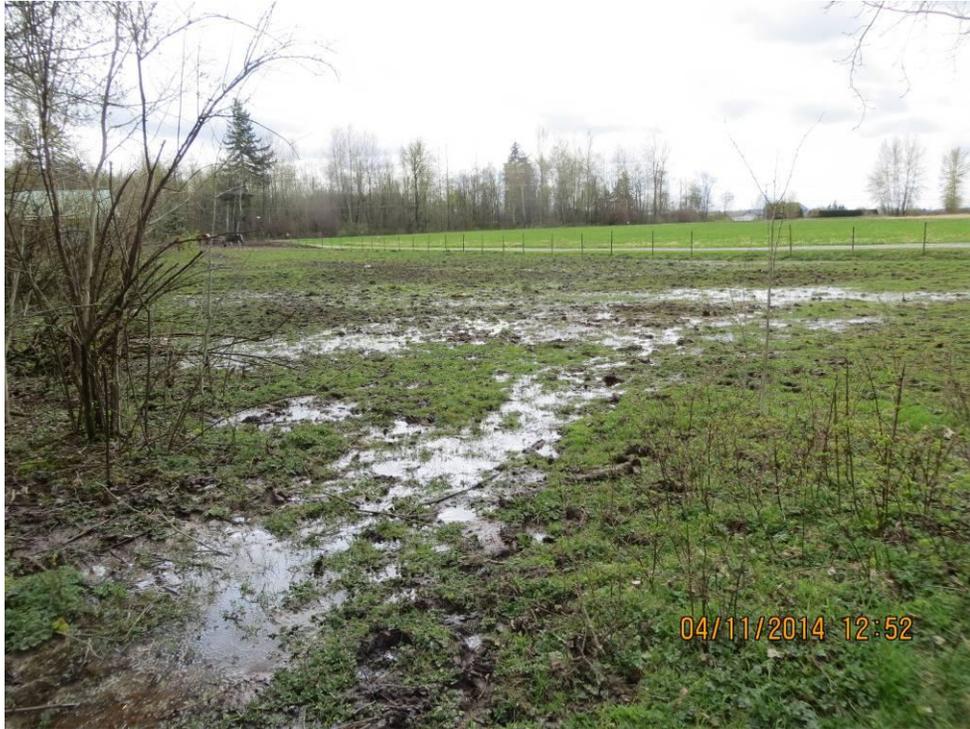
Photo 5 – This photo shows an area near the stream bank. The water visible is surfacing groundwater, which is flowing into the stream just behind the photographer.

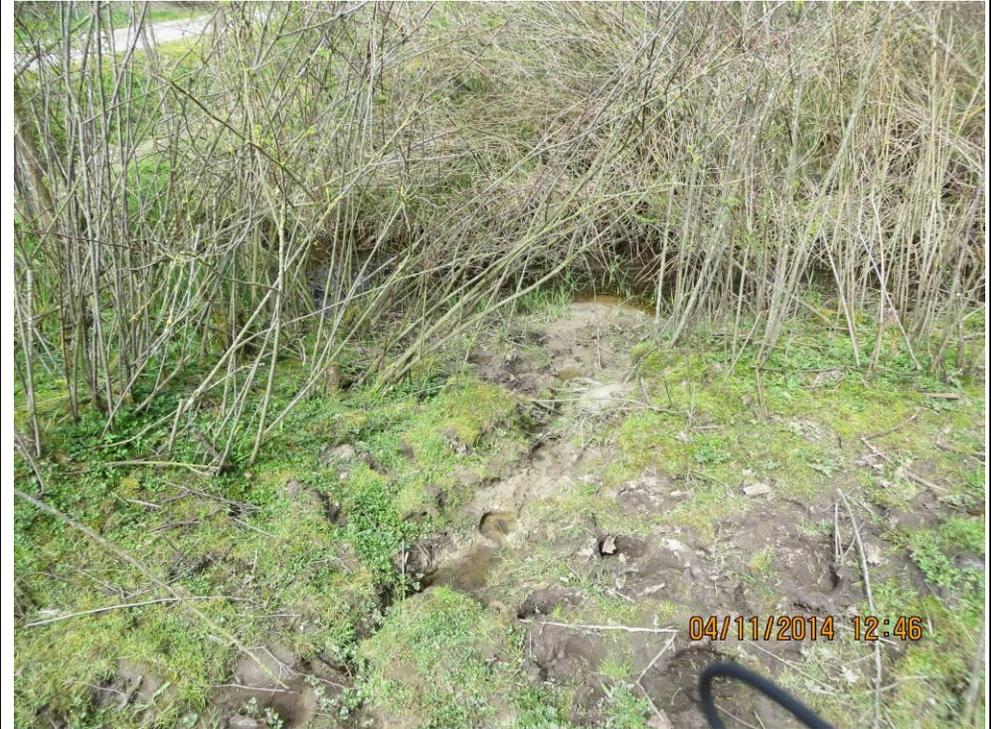
Photo 6 – This photo shows one point where surface water from the confinement area was actively discharging into the stream during the site visit.

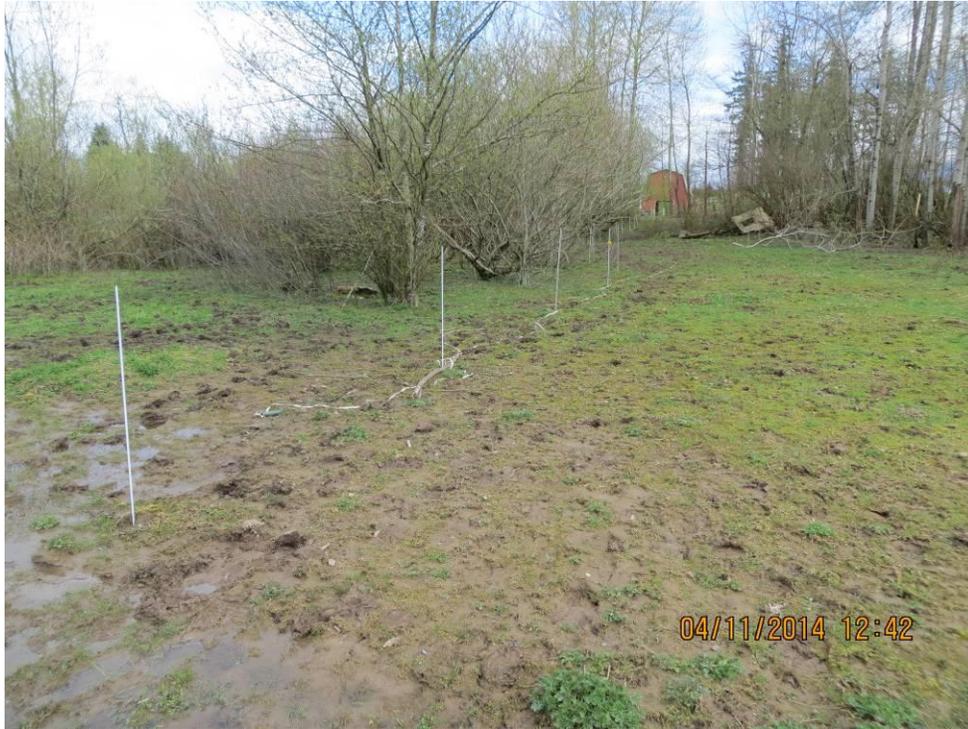
Photo 5 – This photo shows an area near the stream where an electric fence had been installed. The fence has repeatedly been knocked down by deer and falling branches and is not functional. Horses have access to the stream and have denuded and eroded its banks, and left accumulations of manure in the stream corridor.

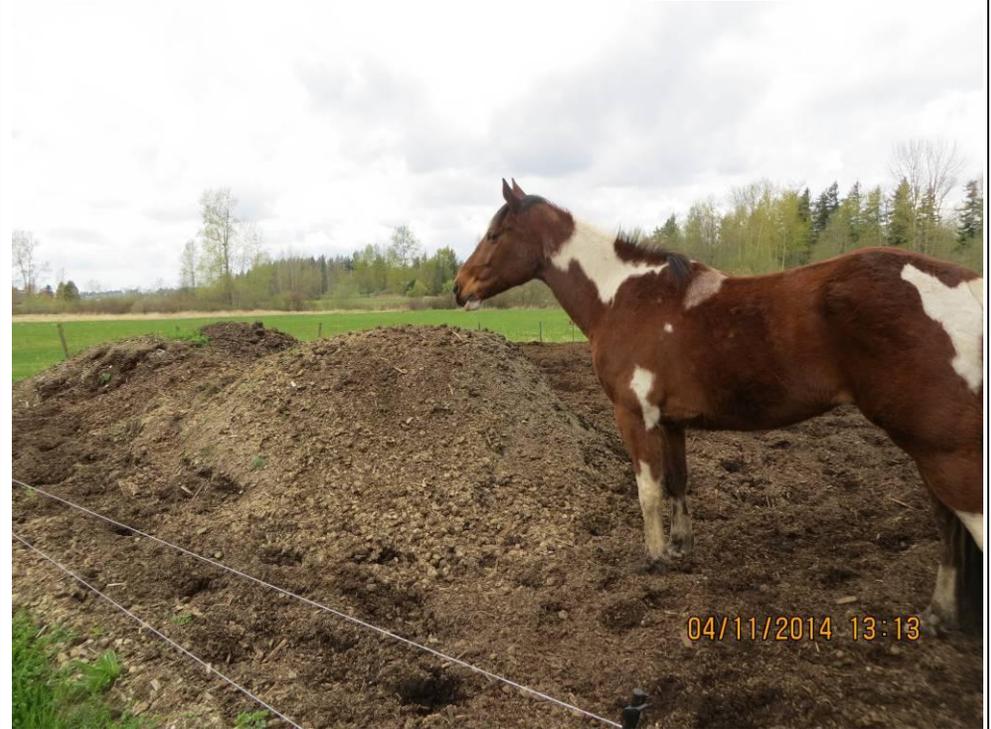
Photo 6 – This photos shows the manure piles near the barn. The manure in these piles has been removed from the barn. The ground slopes away from the manure piles on the north side leading toward the area of concentrated flow shown in photo 3 and the stream. The ground also slopes away from the manure piles on the south side, leading through a short section of lawn grass and to the Hampton Road roadside ditch approximately 50 feet away.
