Attachment A:
Photographs of Jim Snyder's farm.
February 2010 through September 2014
Administrative Order, Docket #11079

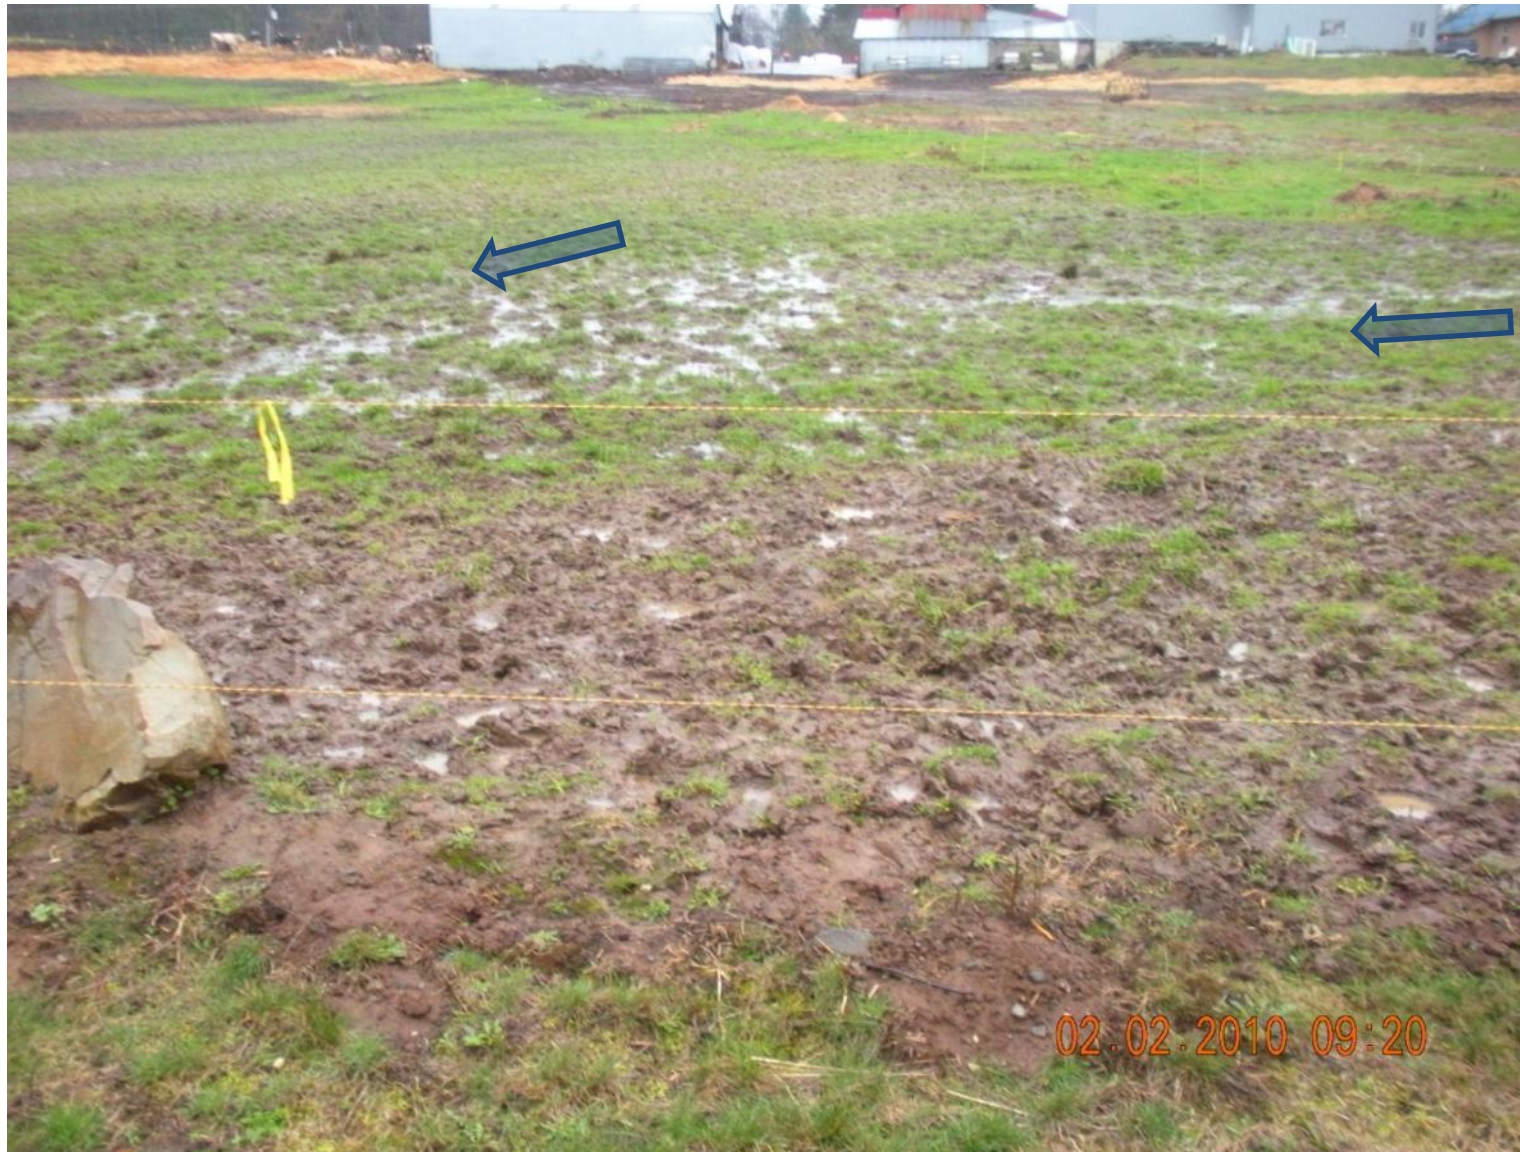
Photo 1: Photo taken on 2/2/2010 near Sample Site B - Downstream. Image primarily shows Pasture B and mud covered areas near the barn where animals are confined. Image shows surface water flowing heavily grazed areas and muddy contaminated areas. The arrow indicates the general direction of surface water flow. On this day "Sample Site B – downstream" had a concentration of 470,000 FC/100 mL.

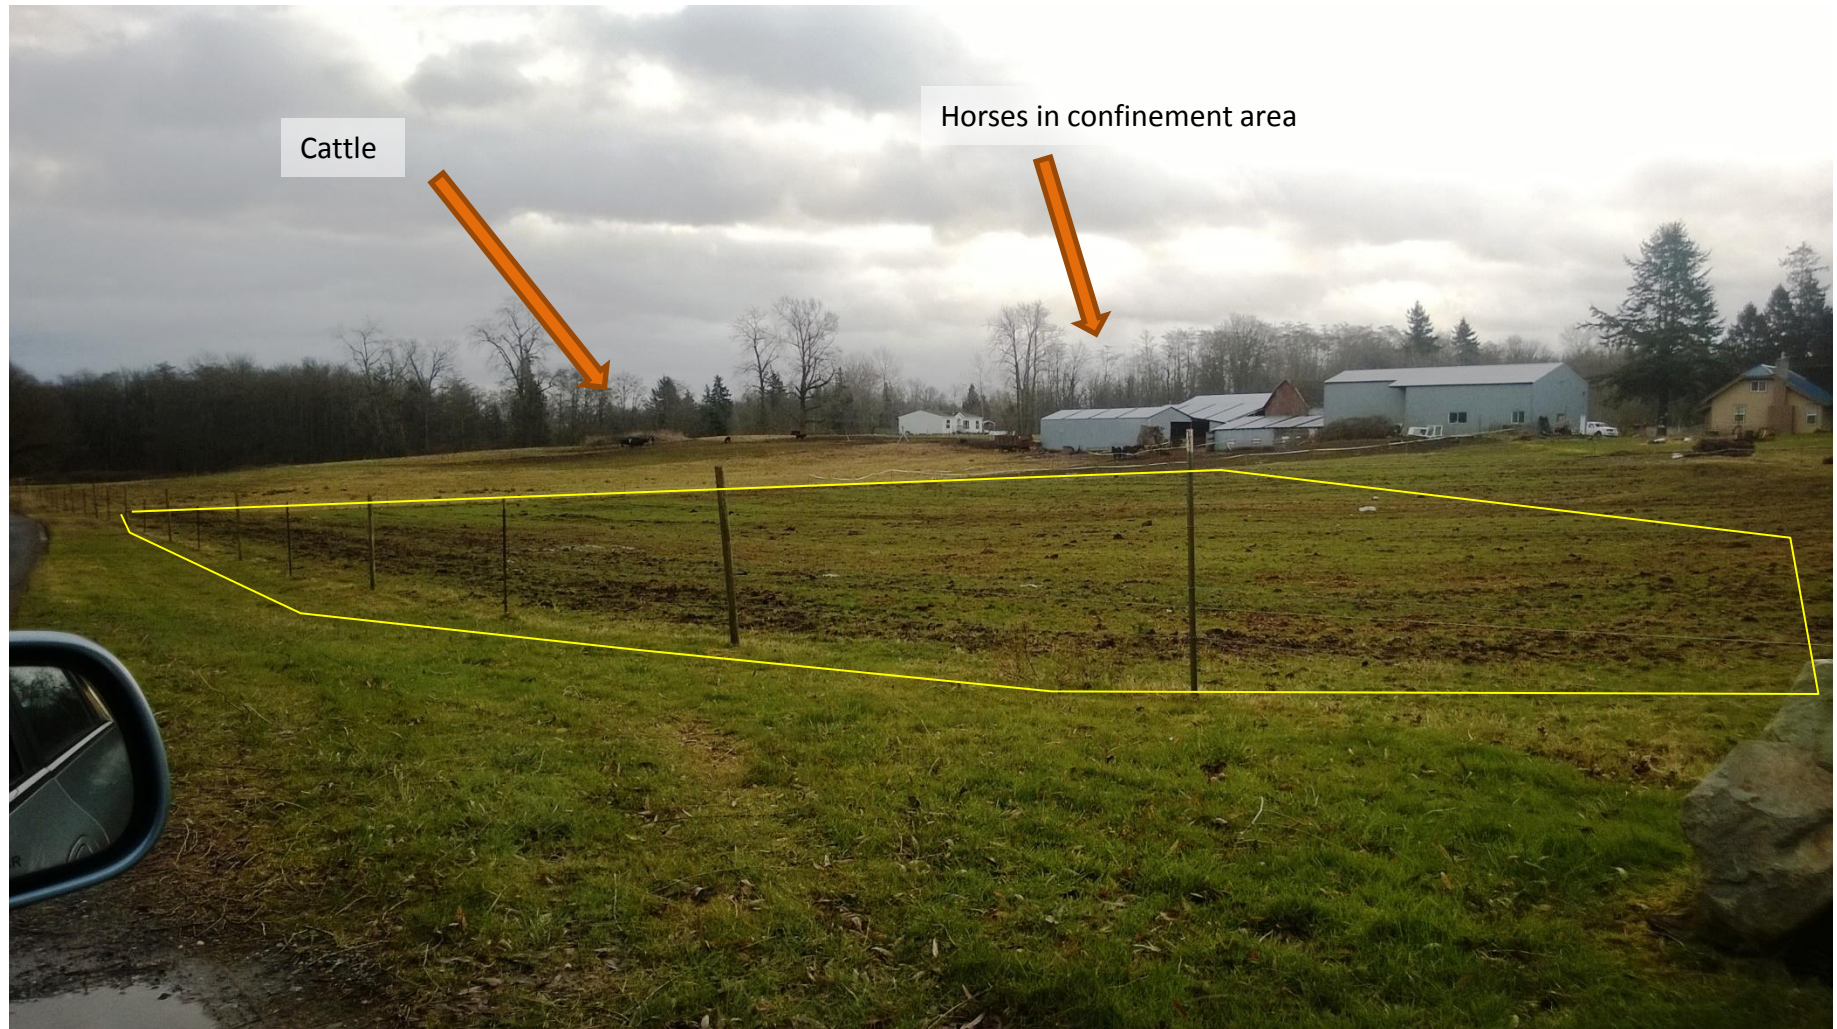
Photo 2: This photograph of Pasture A was taken near the northwest corner of Mr. Syndar's farm by Washington State Department of Agriculture (WSDA) on February 13, 2014. The yellow polygon highlights a portion of the field where WSDA indicated manure solids had been spread. Photo 3 shows surface water flowing through this portion of Pasture A during a subsequent rain event and discharging from this property. Cattle can also be seen on pasture that is largely denuded of vegetation and slopes to surface water.

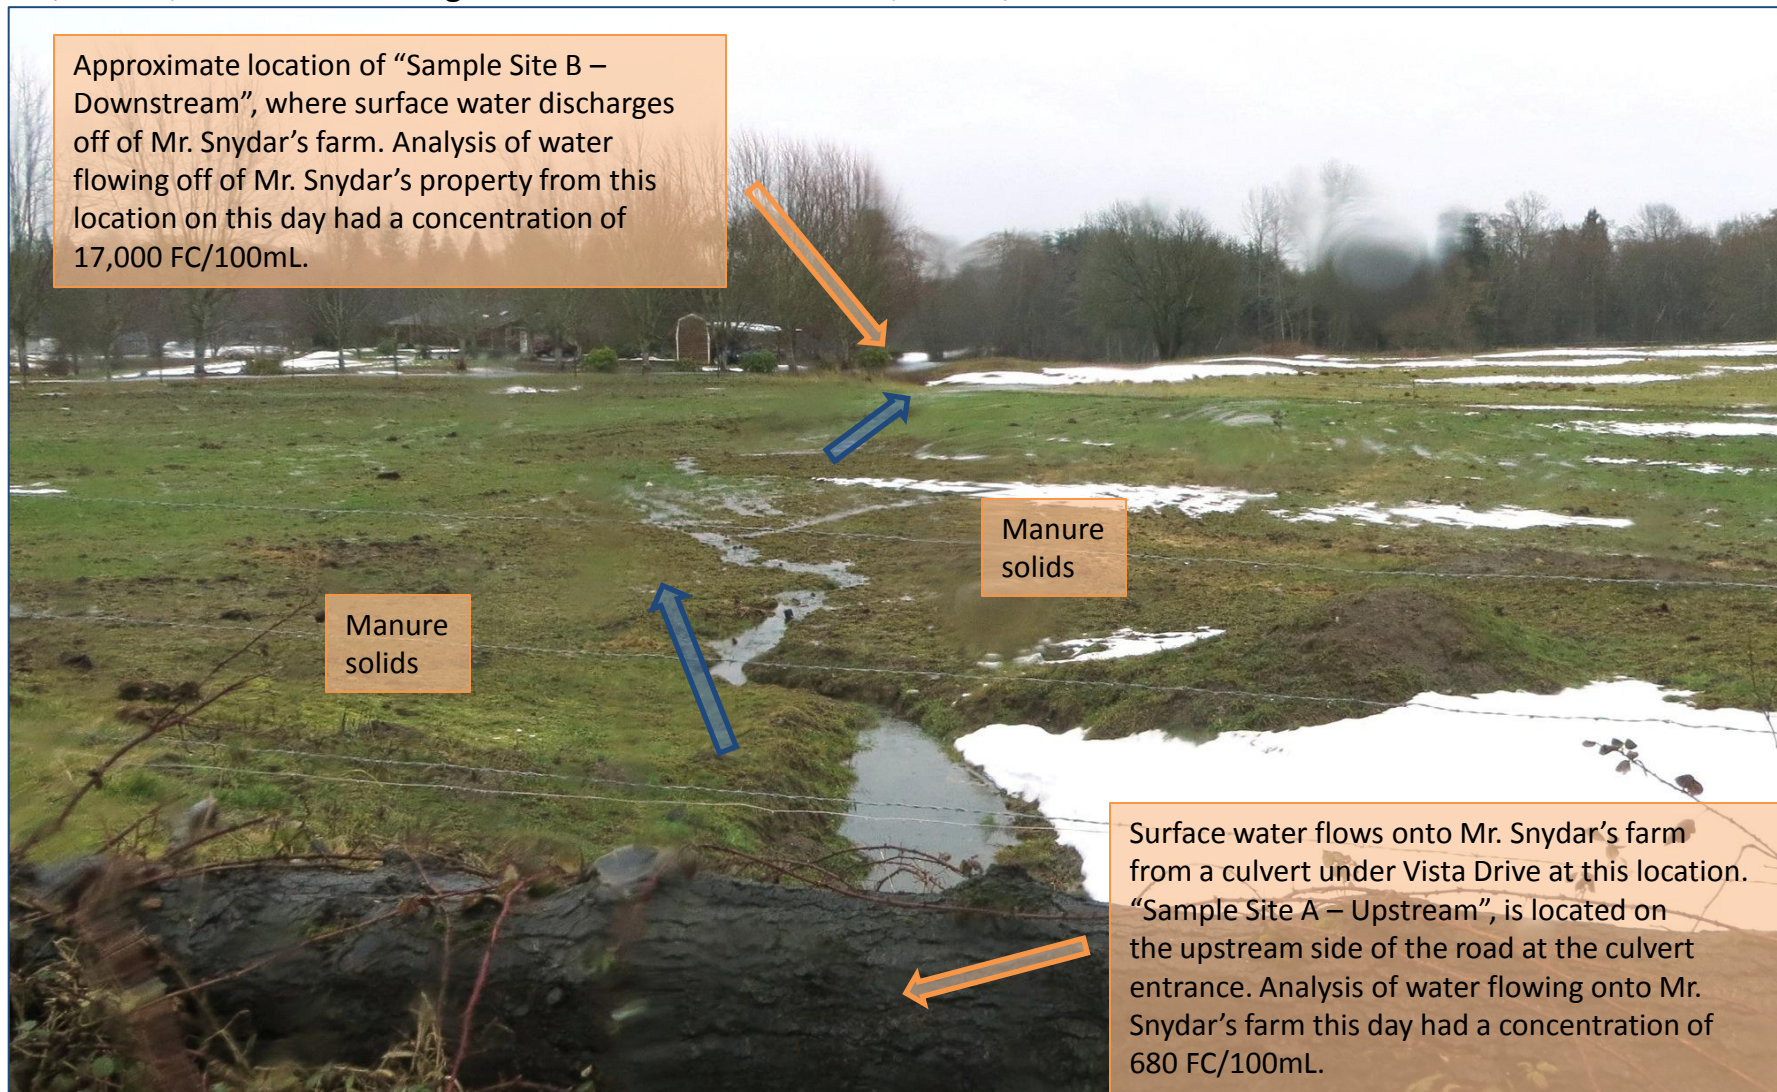
Photo 3: This photo, taken from Vista Drive on 3/3/2014, shows conditions Pasture A during a runoff event following the solid manure application documented in Photo 2. Trib W can be seen flowing immediately downstream of the culvert under Vista Drive that it discharges from. Manure solids can be seen spread over portions of pasture where there is field runoff and immediately adjacent to Trib W. The blue arrows show the direction of surface water flow. On this day, water flowing onto Mr. Snyder's property had a concentration of 680 FC/100mL, and water flowing off the farm increased to 17,000 FC/100mL.

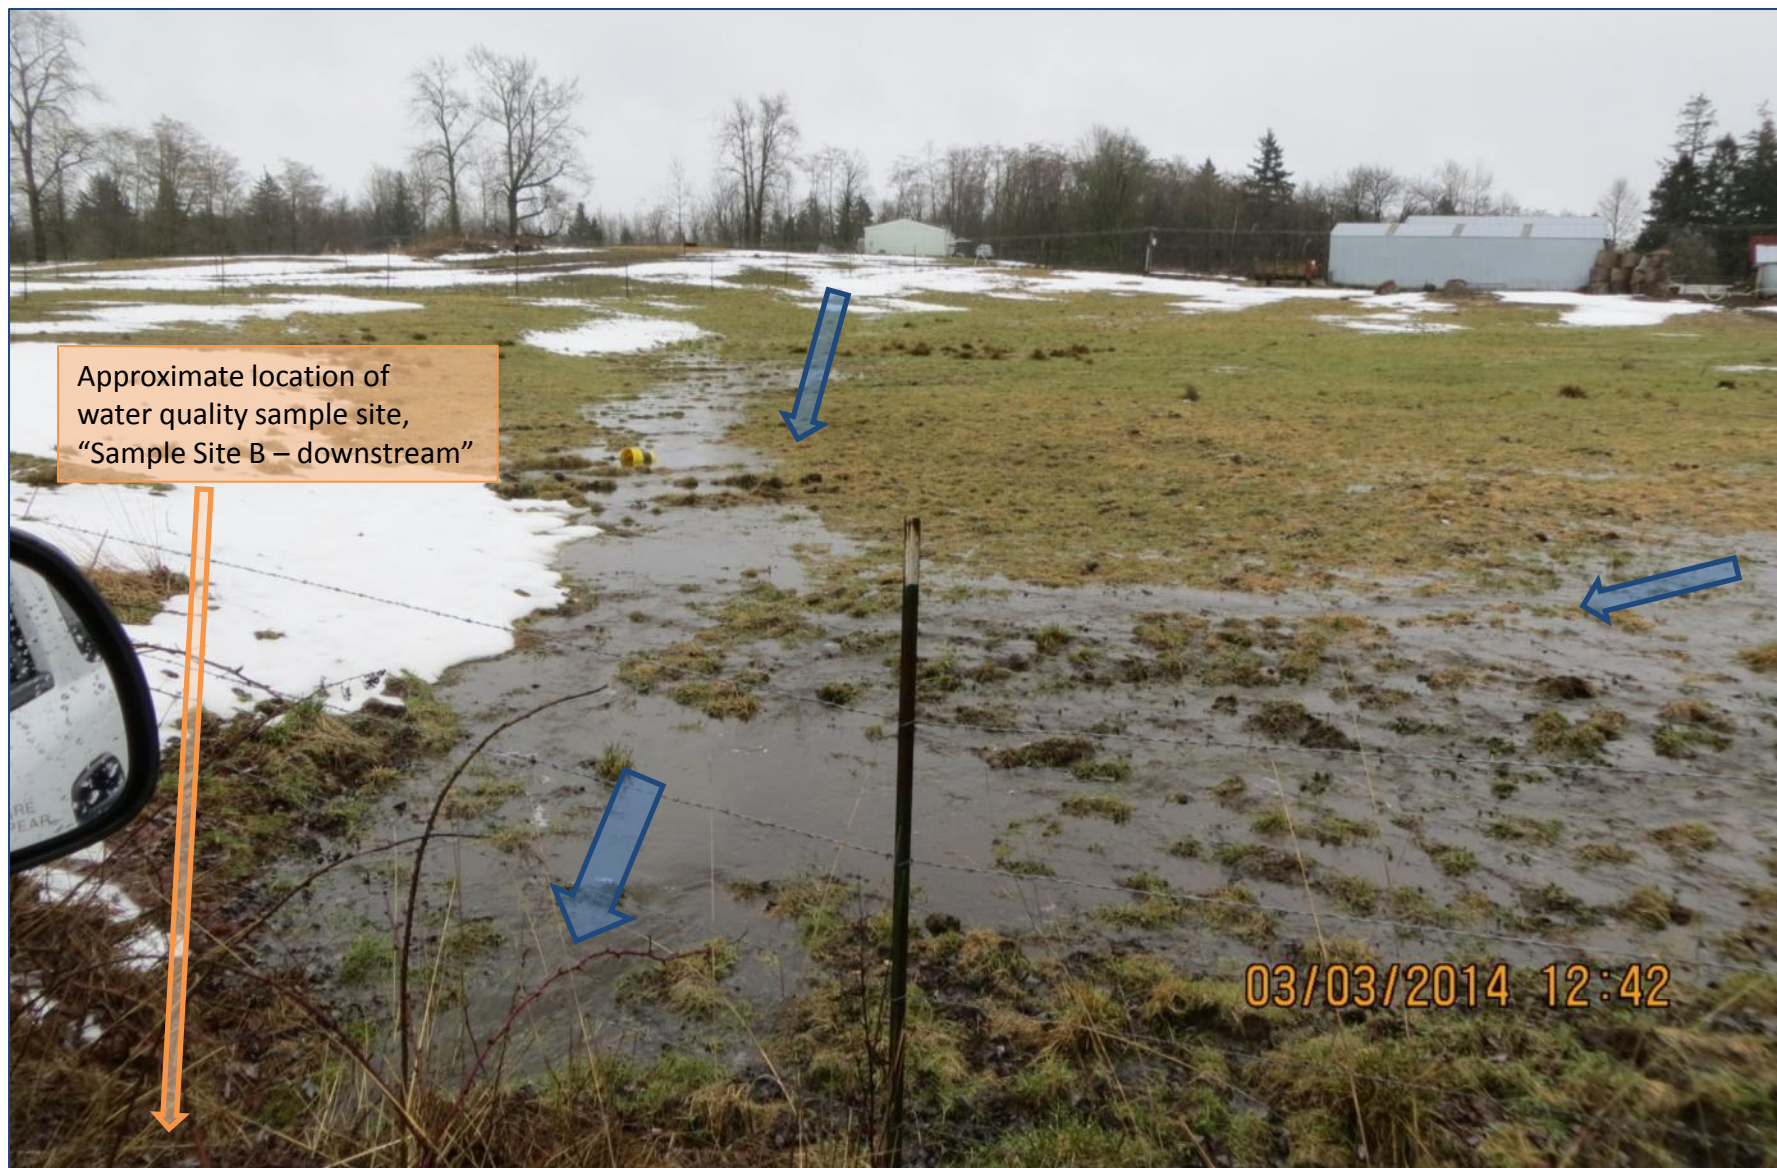
Photo 4: This photo from 3/3/2014 was taken at approximately the same location as Photo 1 (dated 2/2/2010) and shows heavily grazed pasture and manure accumulations similar to conditions documented four years earlier in Photo 1. This photo was taken on the same day and downstream of Photo 3. The blue arrows show the direction of surface water flow. Runoff collected from “Sample Site B – Downstream” on this day had a concentration of 17,000 FC/100mL.

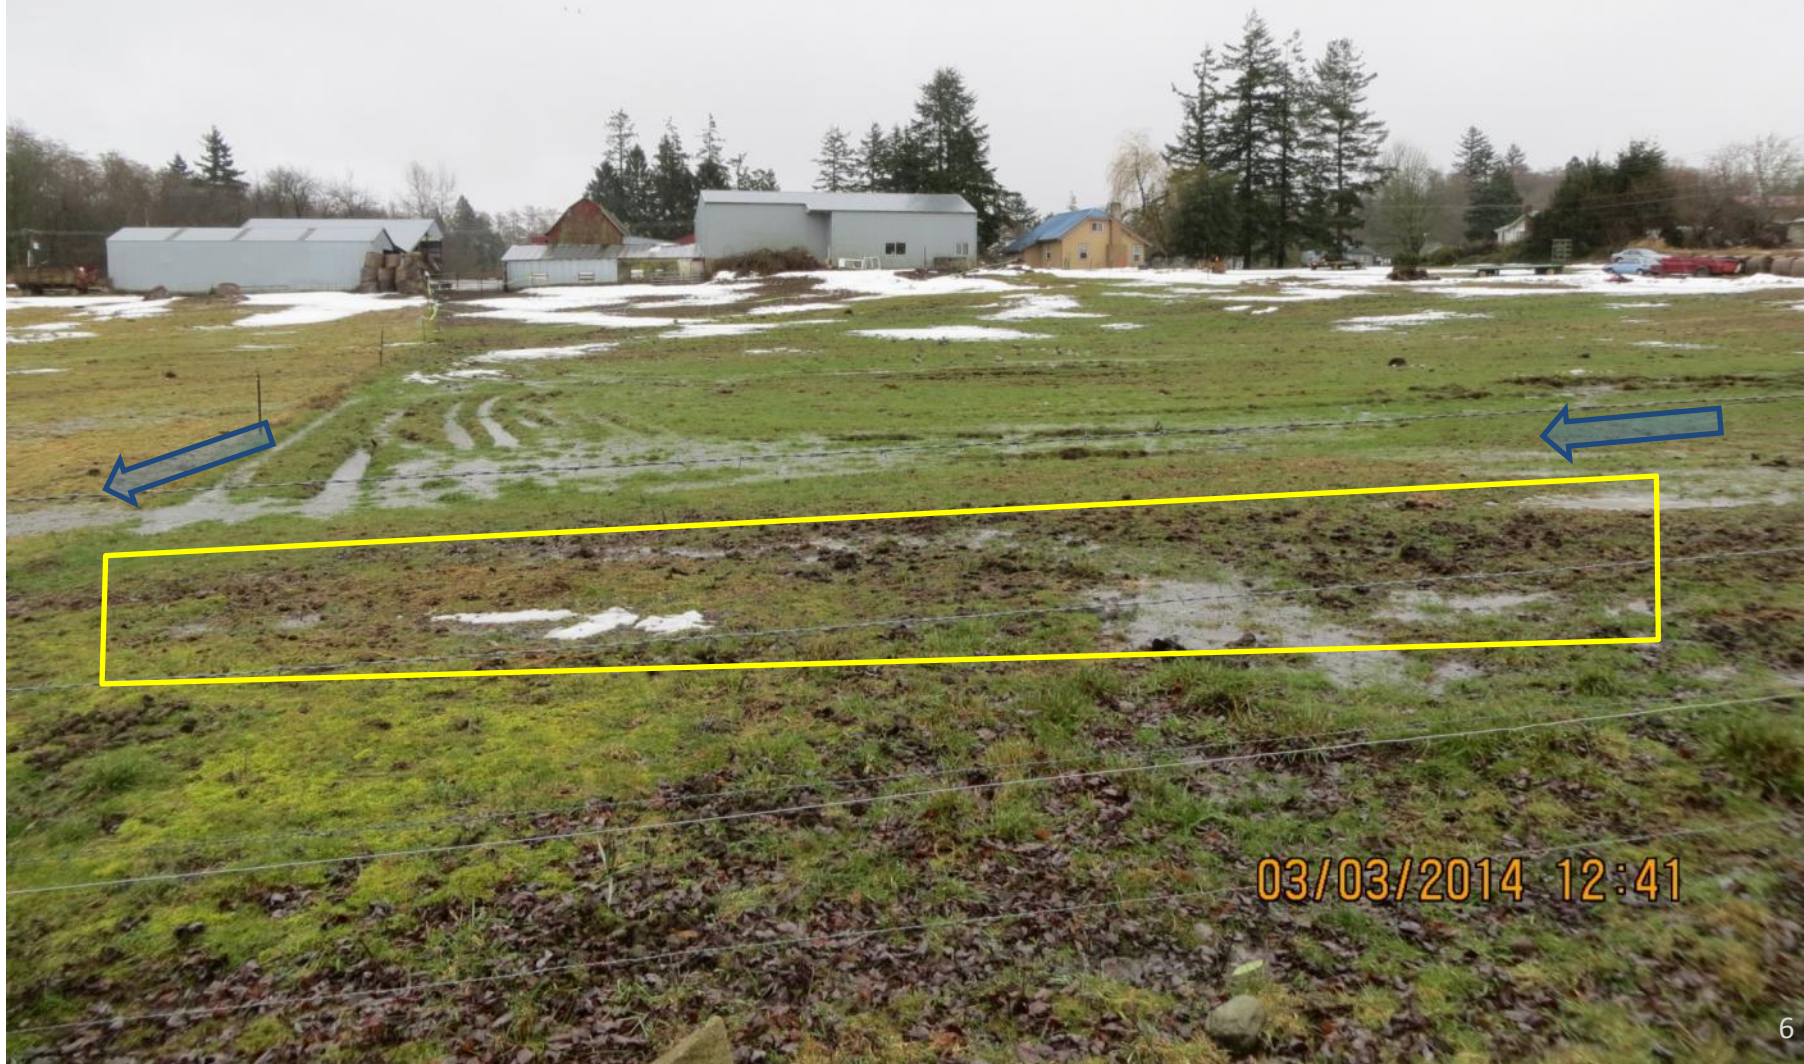
Photo 5: This photo shows manure accumulations on the Pasture A (in yellow polygon) in vicinity of standing and flowing surface water. The arrows indicate direction of surface water flow. The water quality sample from Sample Site B- Downstream, which is downstream of the photographed area, had a concentration of 17,000 FC/100mL.

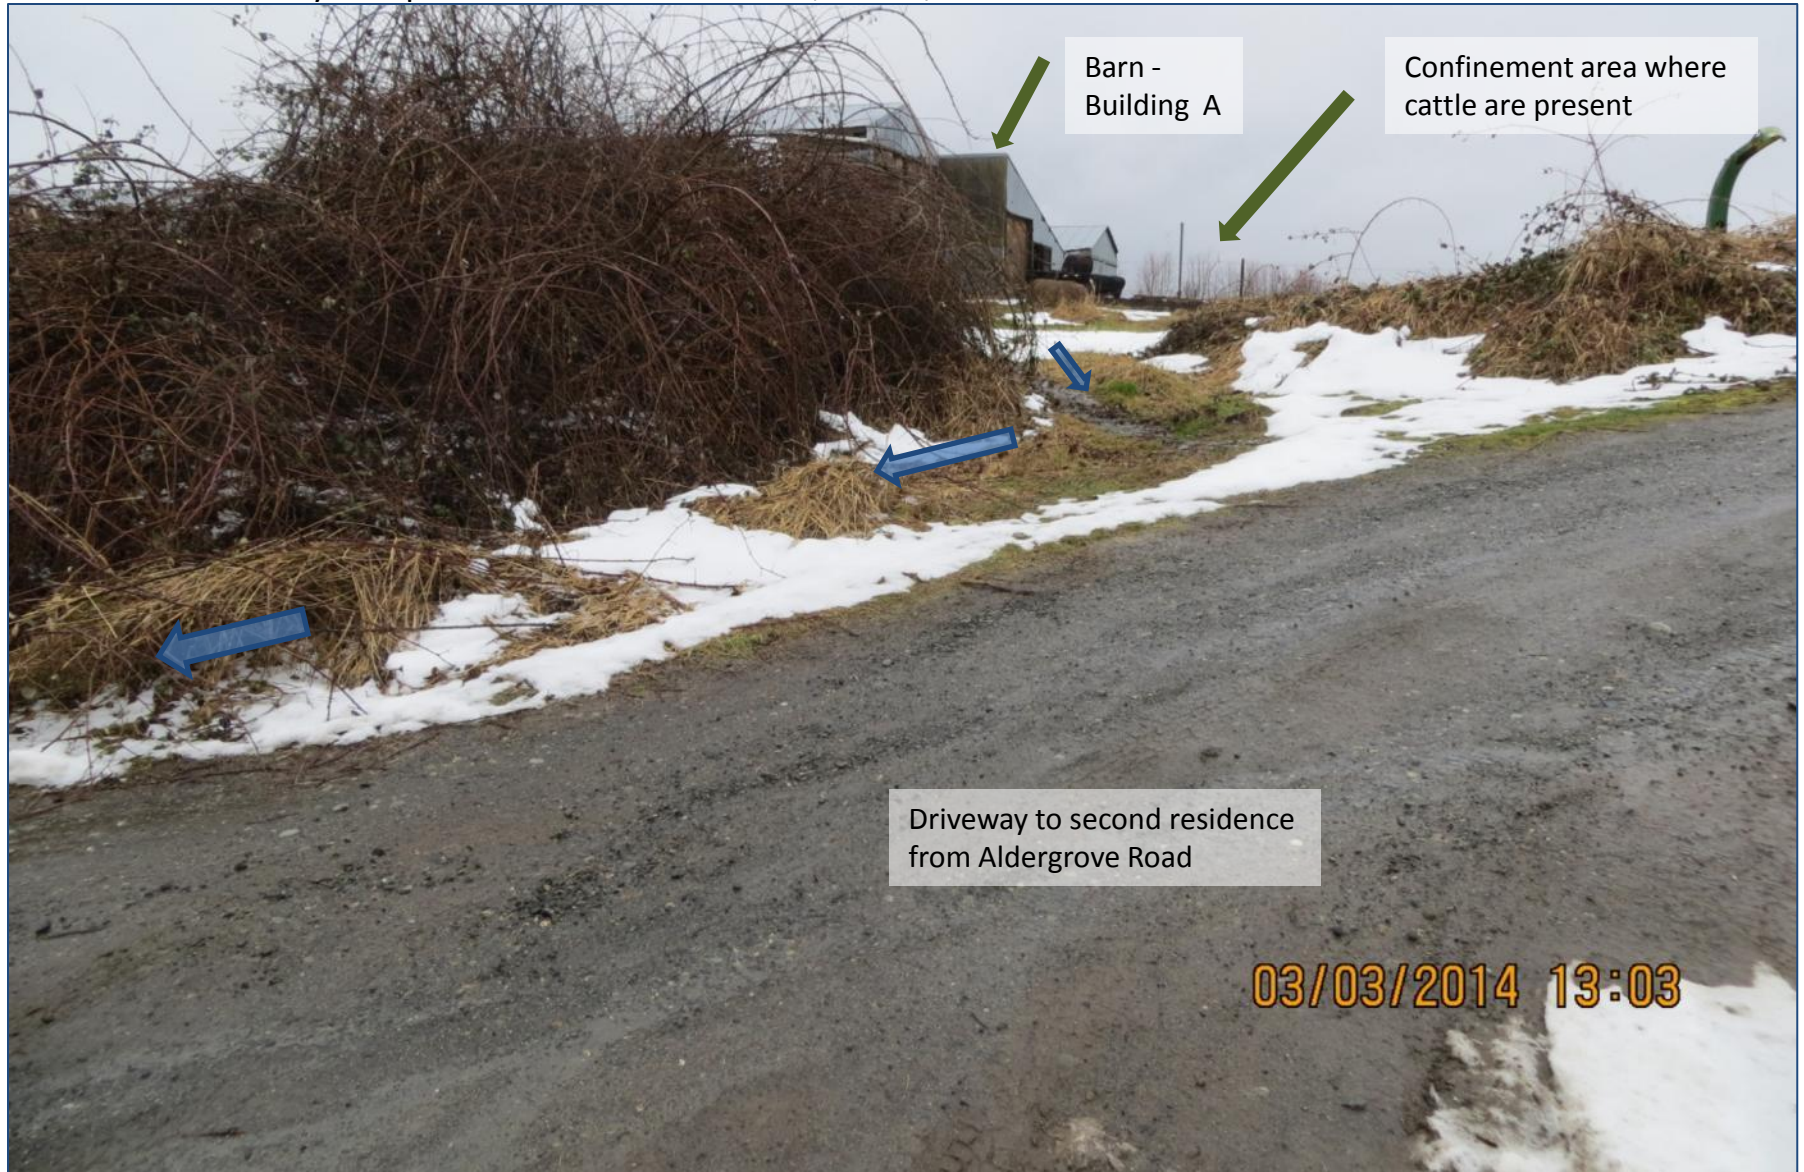
Photo 6: This photo shows where surface water was observed flowing from near the confinement area to the roadside ditch along Aldergrove Road (Ditch NW). Ditch NW drains to an unnamed tributary of California Creek (Trib E). Blue arrows indicate flow to the Ditch NW., which was largely hidden under the grass canopy. A sample of this runoff from Mr. Snyder's farm was collected in the roadside ditch at Sample Site C – Aldergrove prior to mixing with surface water in the ditch. Lab analysis reported concentration of 38,000 FC/100mL.

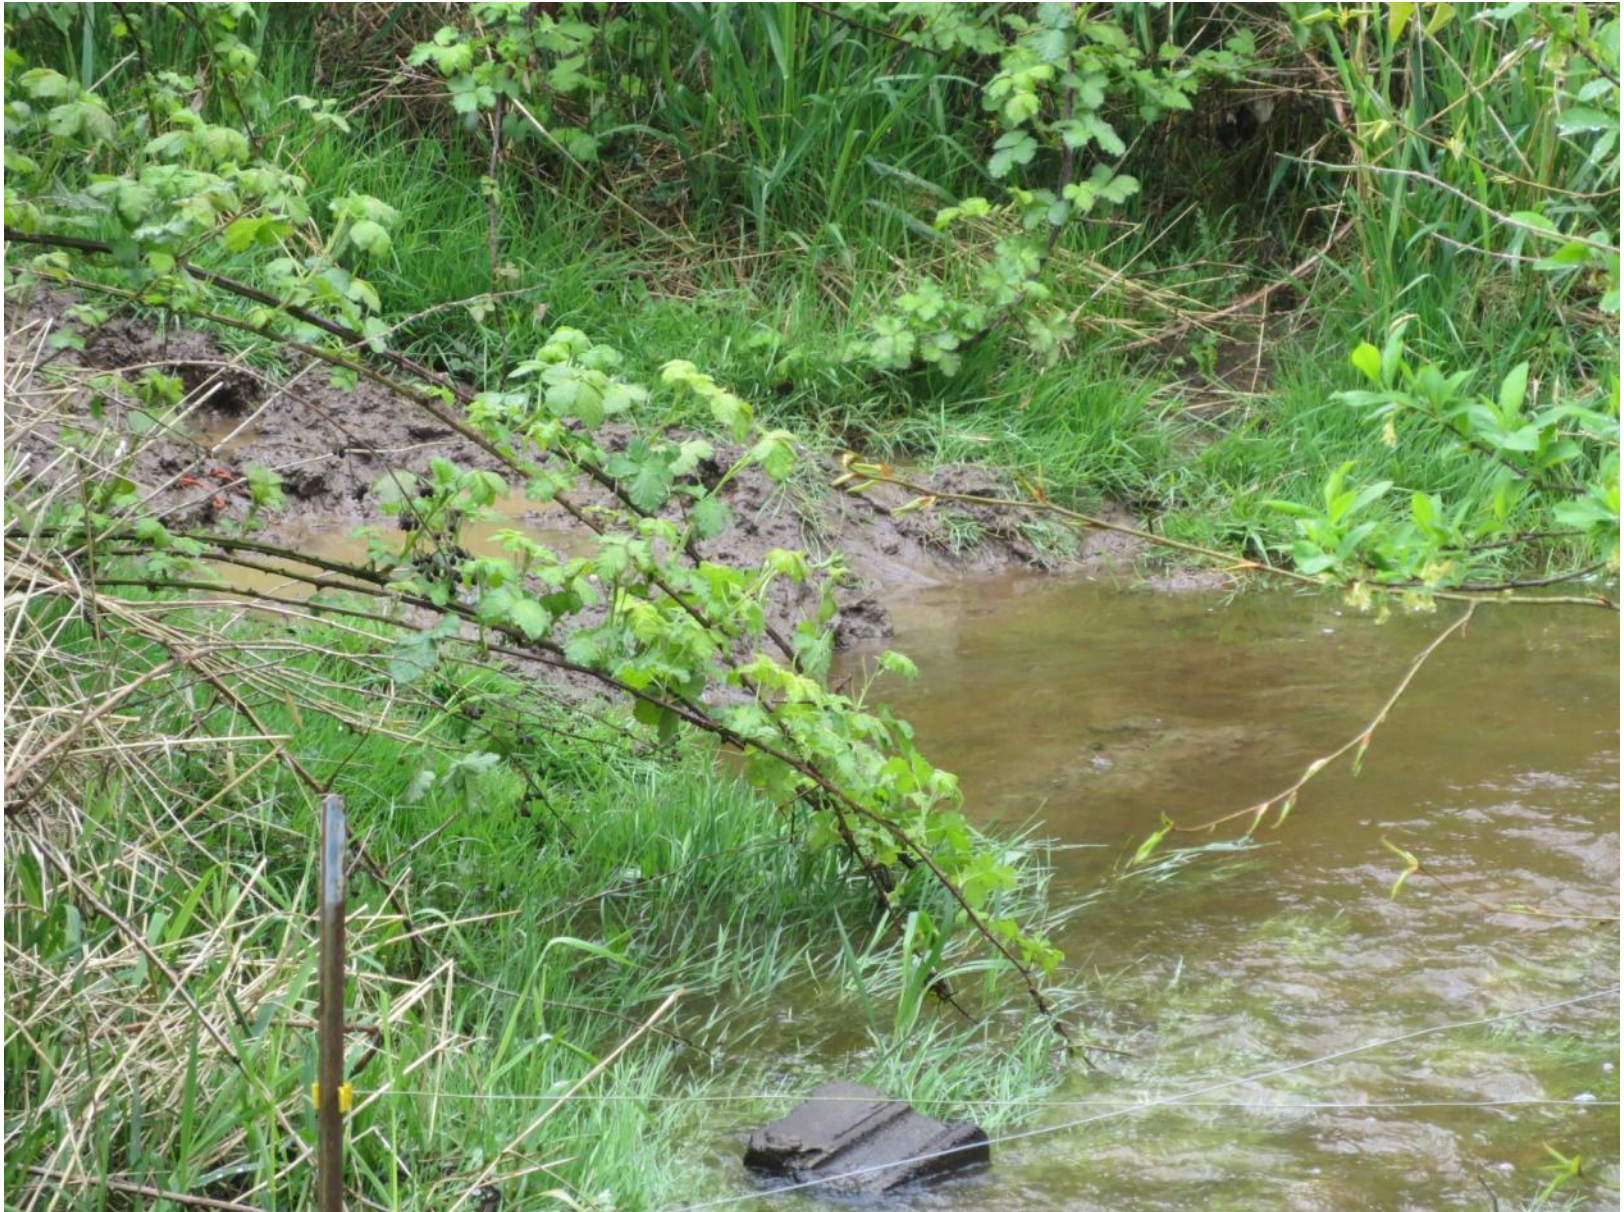
Photo 7: Photo of unnamed tributary to California Creek (Trib E) taken on 4/24/2014, from Aldergrove Road. and shows that cattle have access to an unnamed tributary of California Creek. Hoof markings indicate recent cattle access to the creek. No fencing was present to exclude livestock access to the stream.

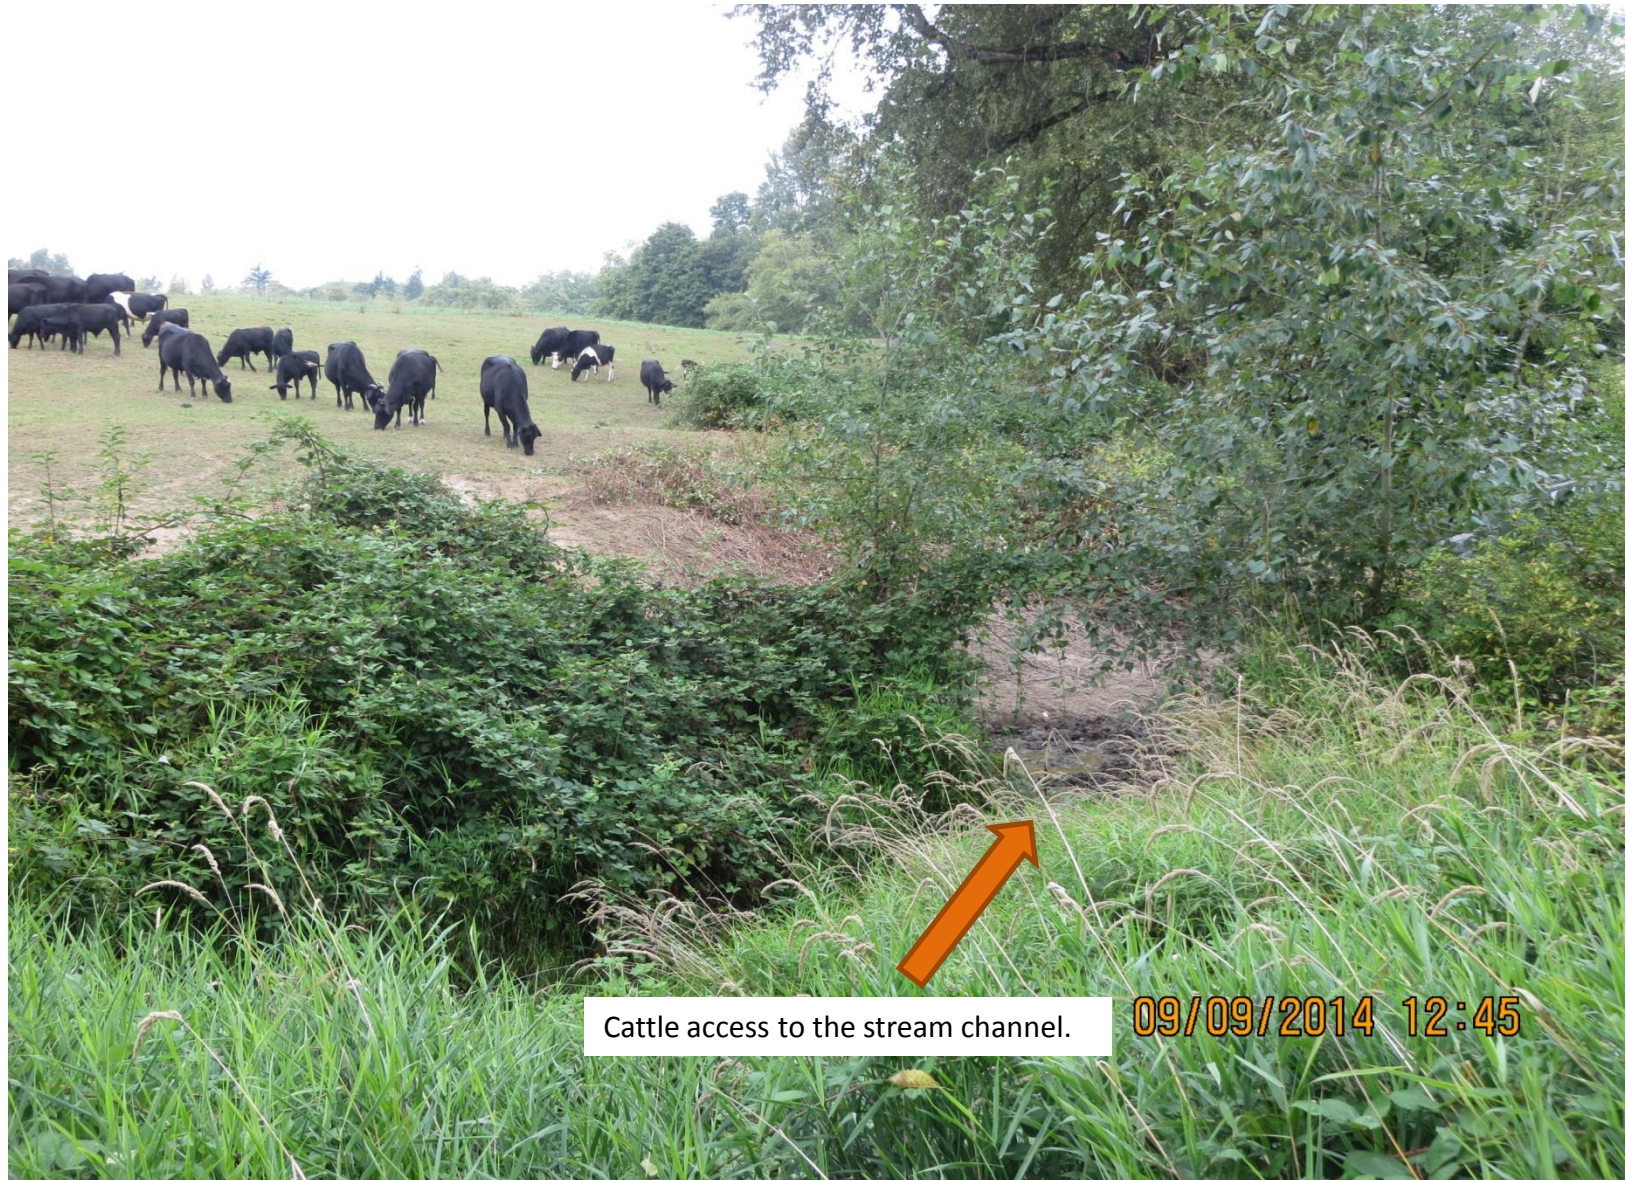
Photo 8: Photo taken on 9/9/2014, from Aldergrove Road. Cattle have access to stream channel. Livestock access to the stream has destroyed vegetation and caused exposed, bare soil that slopes to the stream. This bare slope will become muddy during rain events and is a substantial potential to pollute.

Cattle access to the stream channel.
