STATE OF WASHINGTON
DEPARTMENT OF ECOLOGY

RE: Echo Bay Minerals Company - State Waste Discharge Permit No. ST0008033
March 30, 2015 Site Inspection

WASHINGTON STATE DEPARTMENT OF ECOLOGY WASTEWATER TREATMENT FACILITY SITE VISIT REPORT

Water Quality Photolog

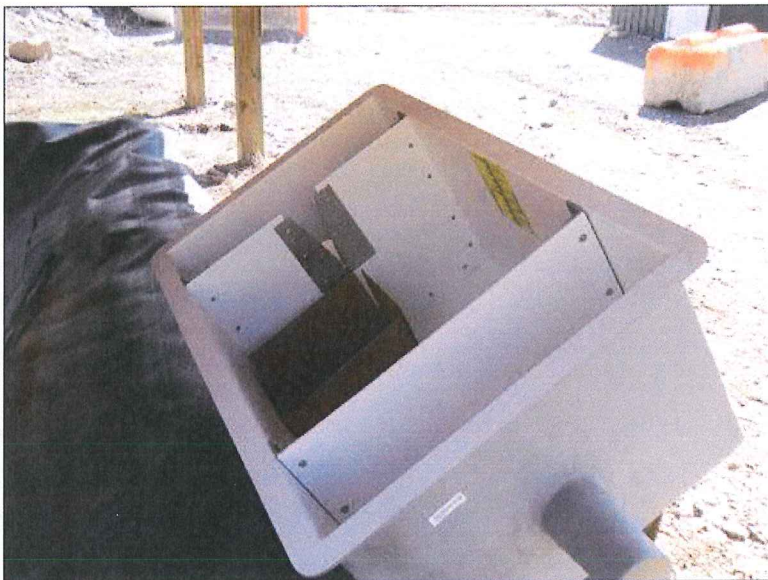
#	Description	Photographs
1	Distribution box with v-notch weir that Kinross plans to install prior to new infiltration galley at the Key Mine water treatment system.

Echo Bay plans to install a new distribution box on the inlet to the new infiltration area. The new box includes a v-notch weir for flow measurement.

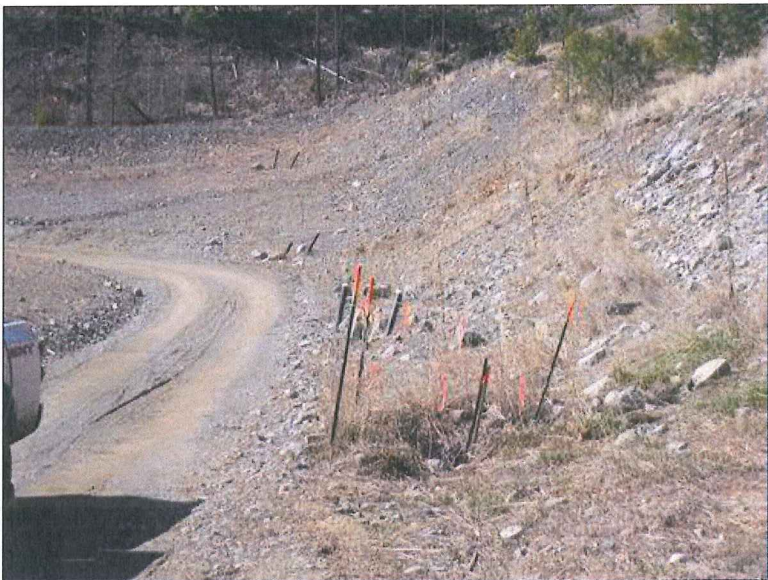
2	Groundwater collection trench along base of waste rock dump at Key Mine site.

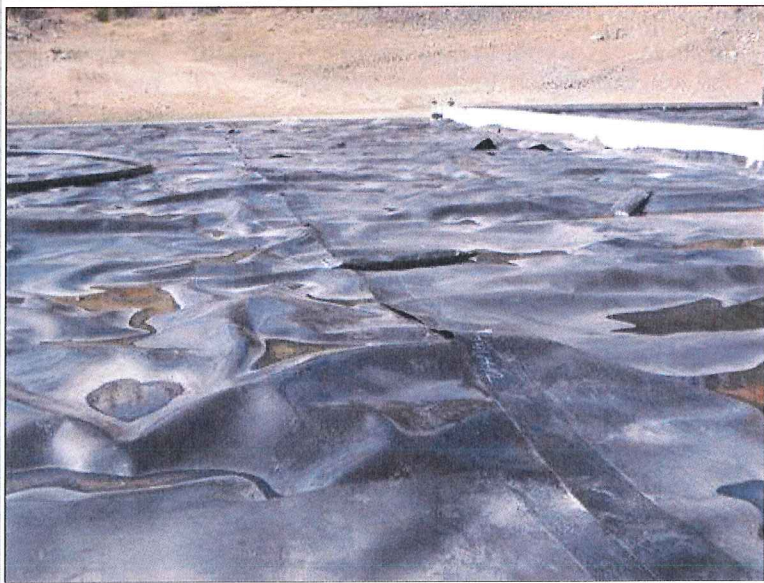
#	Description	Photographs
3	Top of concrete biotreatment basins at the Key Mine water treatment system. The Permittee had used HDPE liner to cover the insulation material that lie on the water surface of the basins.

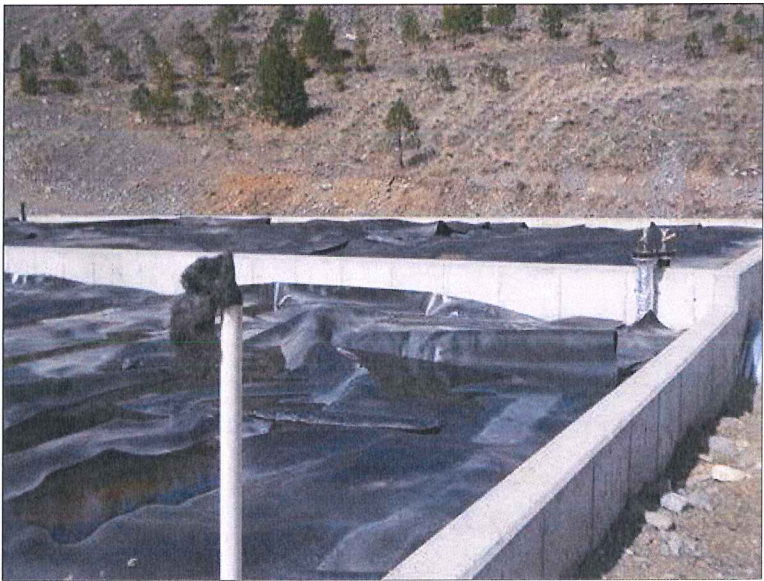
4	Concrete biotreatment basins at the Key Mine water treatment system.

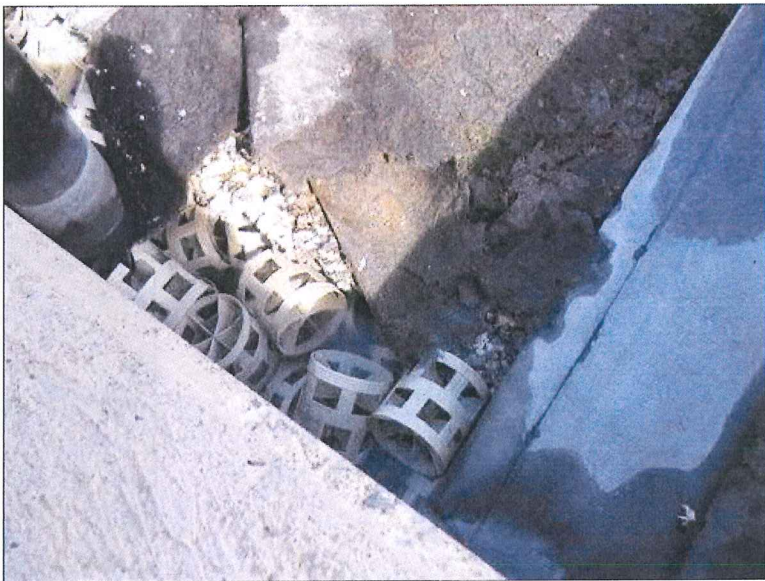
#	Description	Photographs
5	Plastic media in the first biotreatment tank at the Key Mine water treatment system.

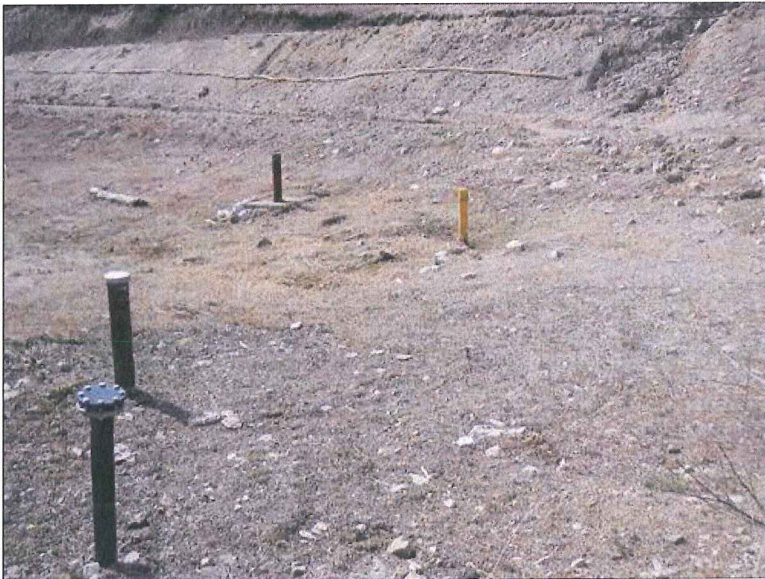
A close-up photograph showing white, cylindrical plastic media with a grid-like pattern, partially submerged in water within a concrete-lined tank. The media is clustered together, and the water surface is visible on the right side of the frame.
6	Monitoring well KW1-A (yellow casing) downgradient of the waste rock dump at the Key Mine site.

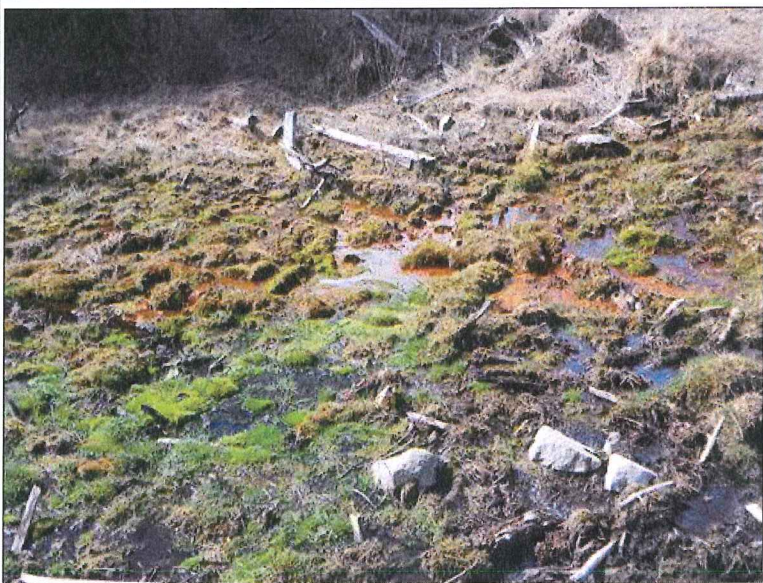
#	Description	Photographs
7	Headwaters of unnamed tributary to the North Fork of the Sanpoil River at the Key Mine site.

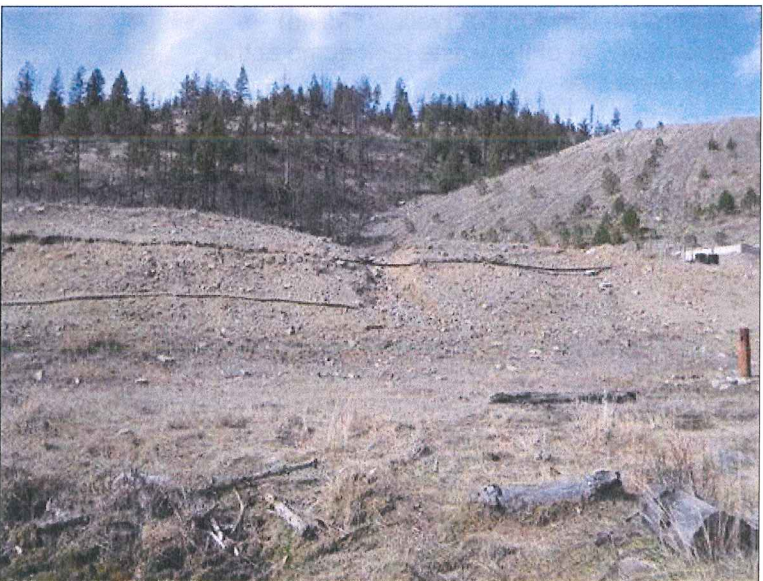
8	Area to the south of the biotreatment basins. An erosion area due to a natural drainage can be seen in the hillside.

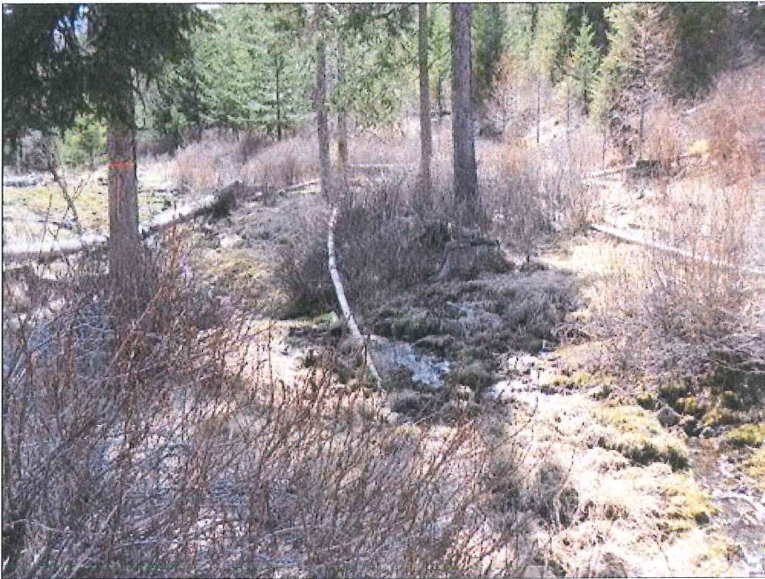
#	Description	Photographs
9	Monitoring location SW-16 on the unnamed tributary to the North Fork of the Sanpoil River, downgradient of the wasterock dump and water treatment system at the Key Mine site.

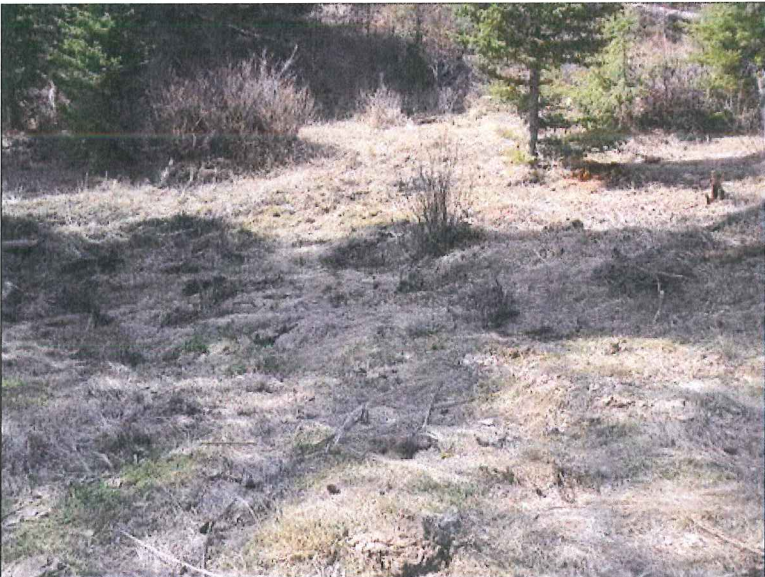
10	The unnamed creek below the Key Mine site disappears beneath the ground before resurfacing further downstream.

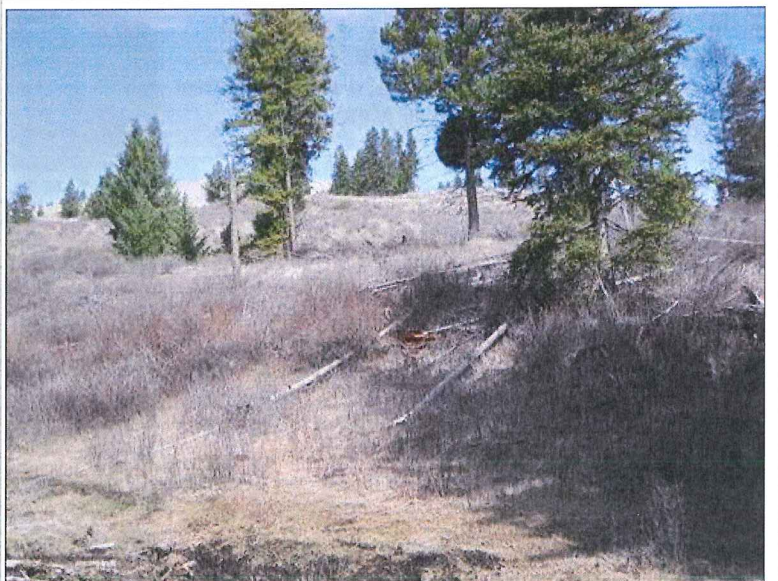
#	Description	Photographs
11	From the stream channel, looking toward the area of the older, last infiltration gallery for the Key Mine water treatment system.

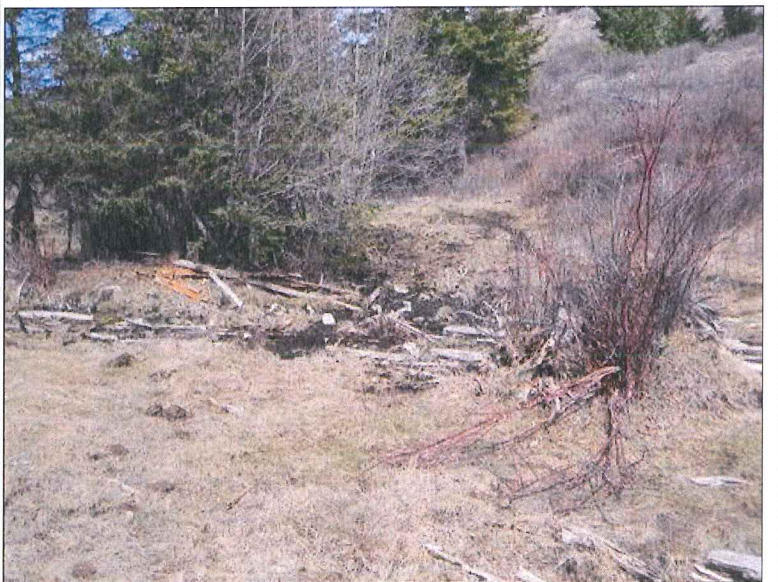
12	Approximate area where unnamed creek resurfaces below Key Mine site.

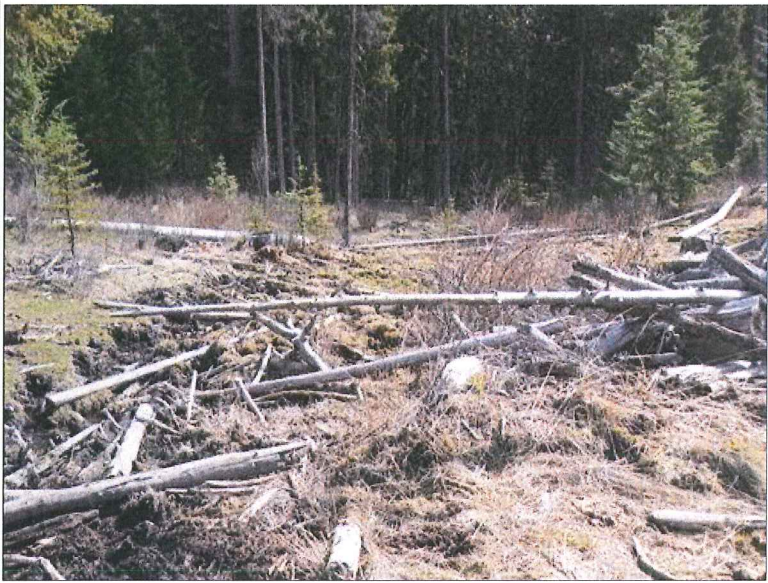
#	Description	Photographs
13	Looking down the stream channel for the unnamed tributary to the North Fork of the Sanpoil River. The property boundary (USFS land) runs left to right in the background.

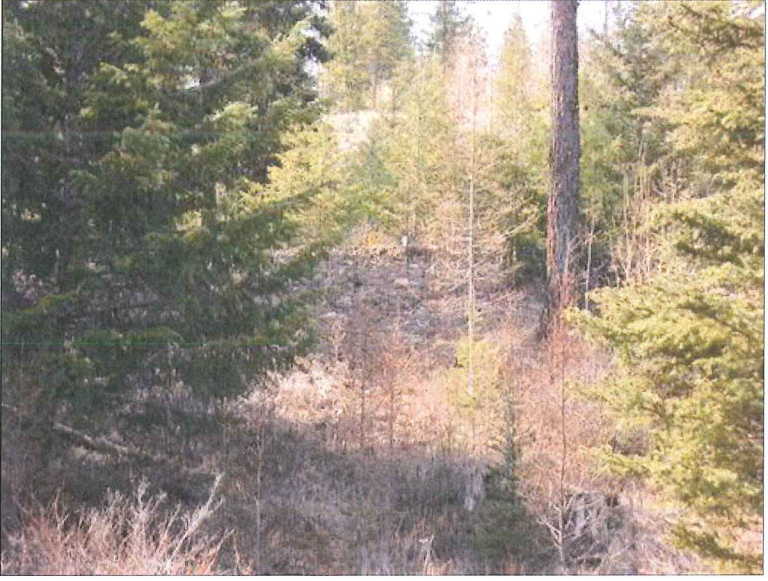
14	From the stream channel, looking up toward location of new infiltration galley for the Key Mine water treatment system.

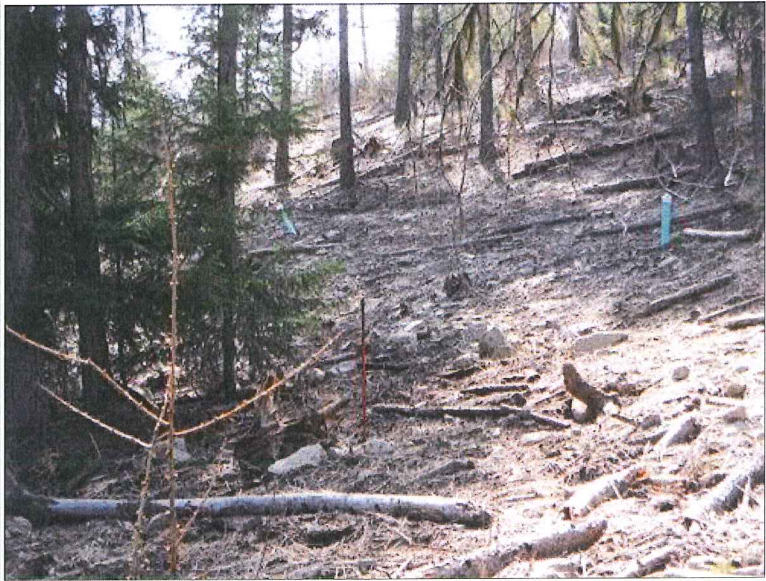
#	Description	Photographs
15	Risers (cleanout and observation port) donating the area of the new infiltraiton gallery for the Key Mine water treatment system. A settlement stake lies in the foreground.

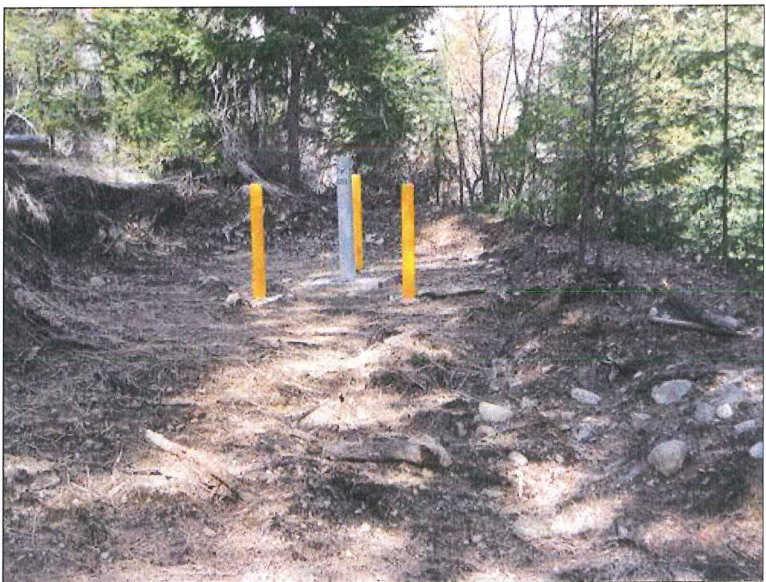
16	Piezometer KPI-03 at the new infiltration gallery for the Key Mine water treatment system.

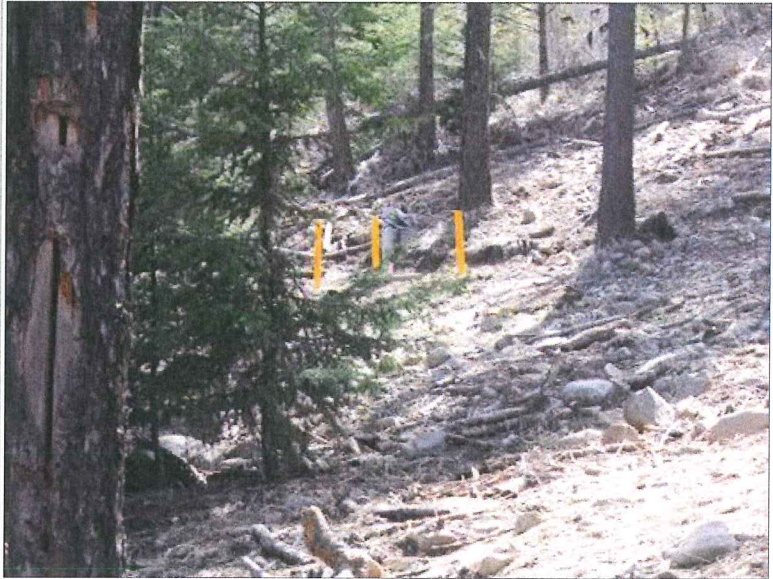
#	Description	Photographs
17	Piezometer KPI-04 at the new infiltration gallery for the Key Mine water treatment system.

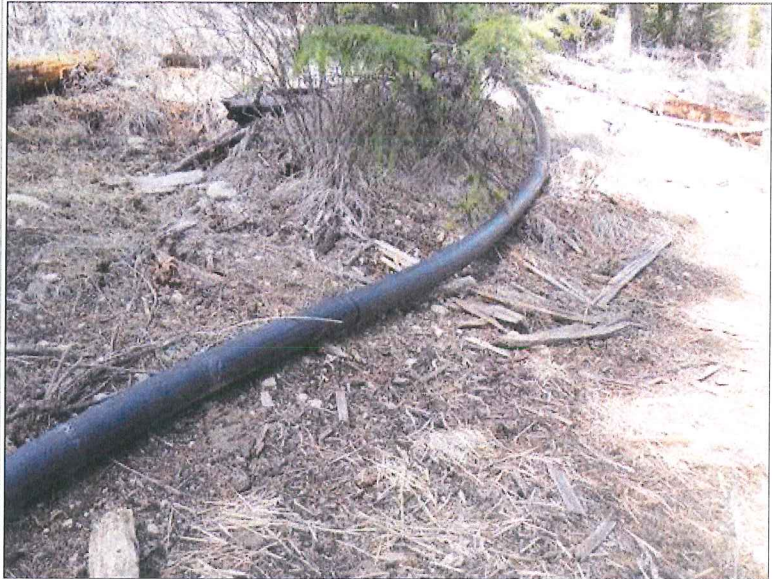
A photograph showing a forest floor with several yellow survey stakes driven into the ground. The stakes are arranged in a line, marking the location of piezometer KPI-04. The ground is covered with dry leaves, twigs, and some rocks. Trees are visible in the background.
18	Above ground HDPE pipeline for the new infiltration gallery at the Key Mine water treatment system.

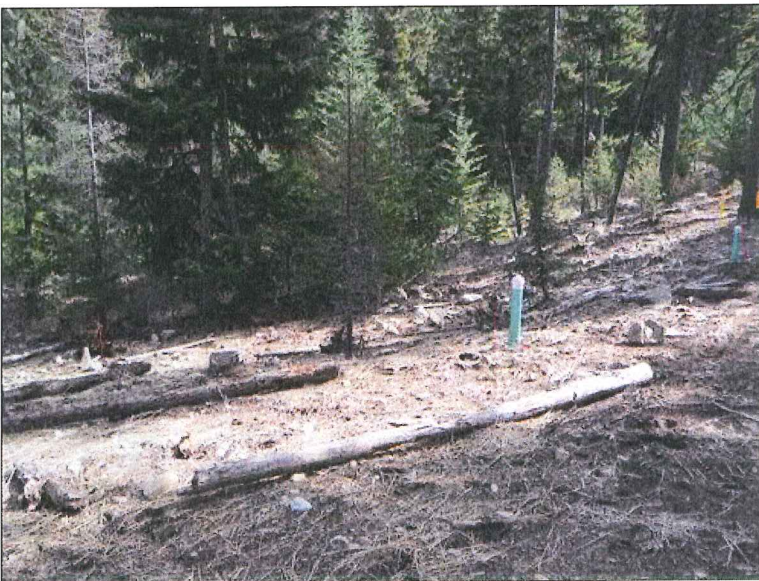
#	Description	Photographs
19	Observation ports and settlement stakes at the new infiltration gallery for the Key Mine water treatment system.
