STATE OF WASHINGTON
DEPARTMENT OF ECOLOGY

RE: Echo Bay Minerals Company - State Waste Discharge (SWD) Permit No. ST0008033
Site Inspection - October 8, 2015

WASHINGTON STATE DEPARTMENT OF ECOLOGY WASTEWATER TREATMENT FACILITY SITE VISIT REPORT

Water Quality Photolog

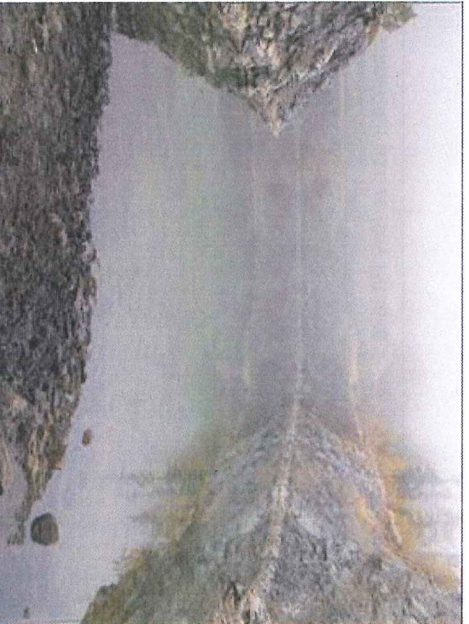
Key Pit at outlet berm.

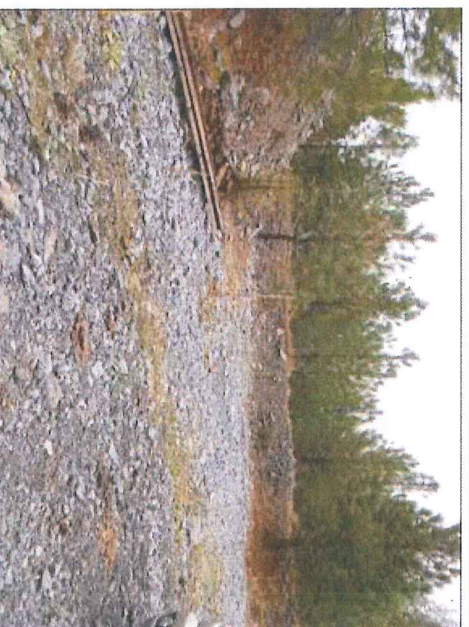
Key Pit outlet channel.

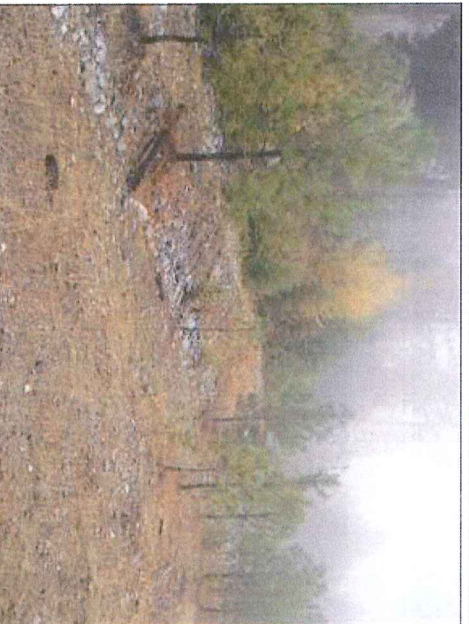
Lower portion of Key Pit outlet channel.

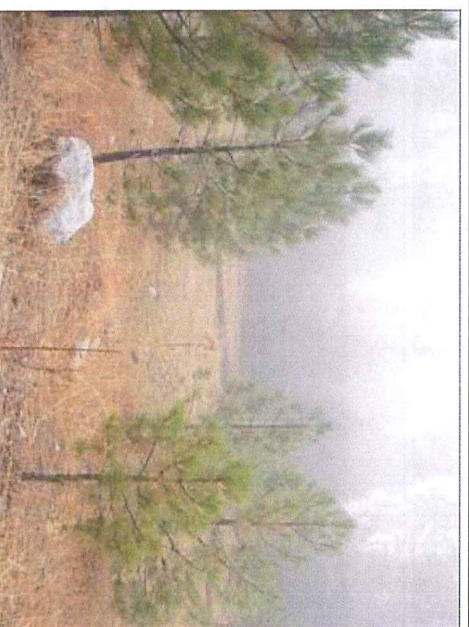
Infiltration area for Key Pit outlet channel.

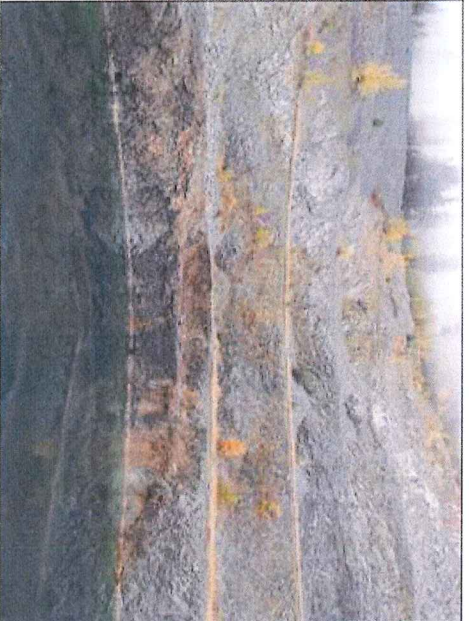
Key Pit.

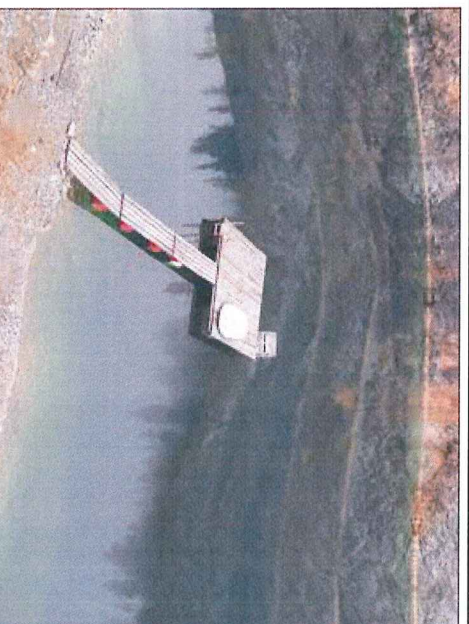
Private dock on Key Pit lake.

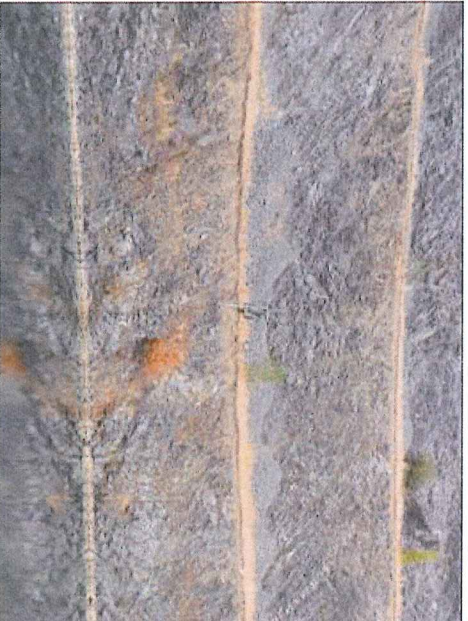
Fish food dispenser above Key Pit lake.

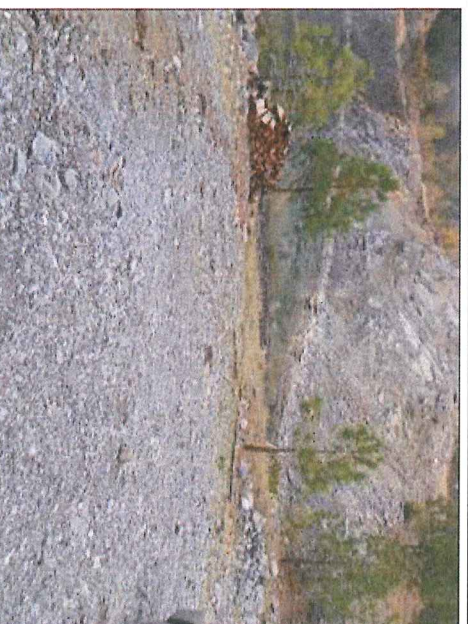
Key Pit outlet berm.

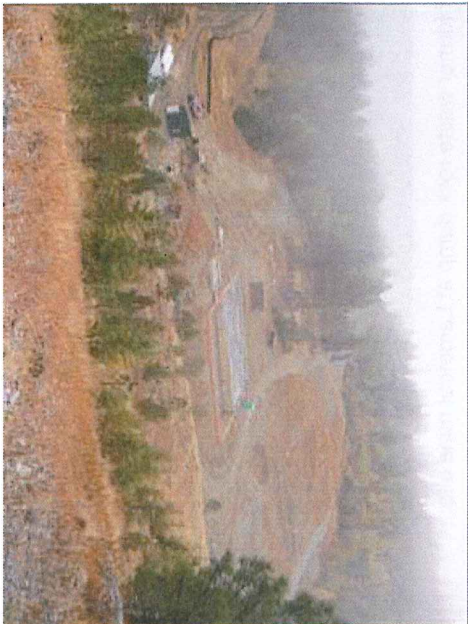
At the Key water treatment system, located in the southern portion of the mine site, Echo Bay was in the process of replacing river rock media in biotreatment tank #2 (with wood chips) and refurbishing one of the four infiltration areas for treated groundwater (see attached photos).

Key Pits water treatment system. Echo Bay was in the process of changing media in one of the biotreatment system tanks and refurbishing an infiltration gallery at the site.

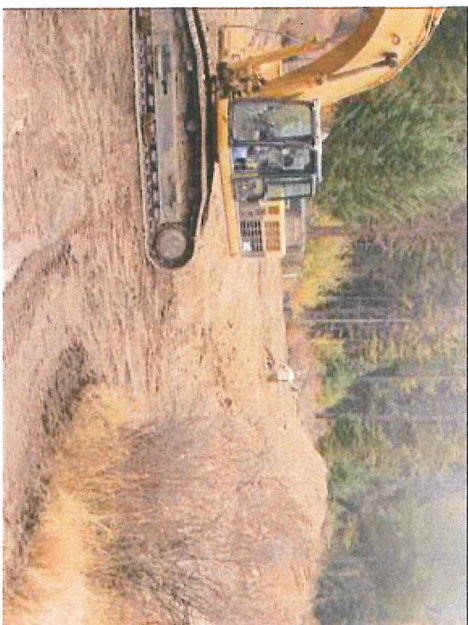
Earthwork at one of the four infiltration galleries at the Key Pits water treatment system. This gallery lies at the eastern portion of the site.

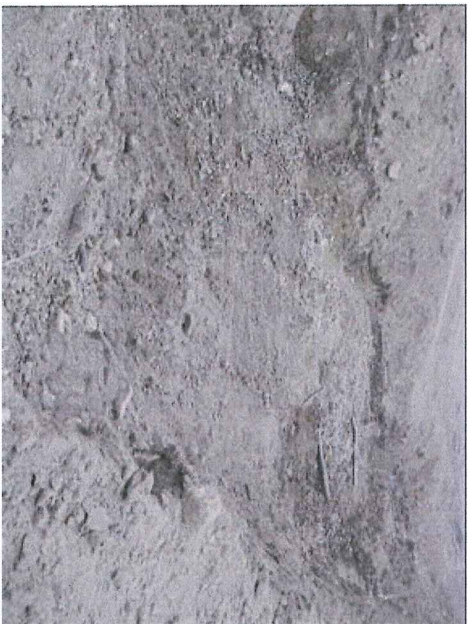
First cell of the eastern infiltration gallery.

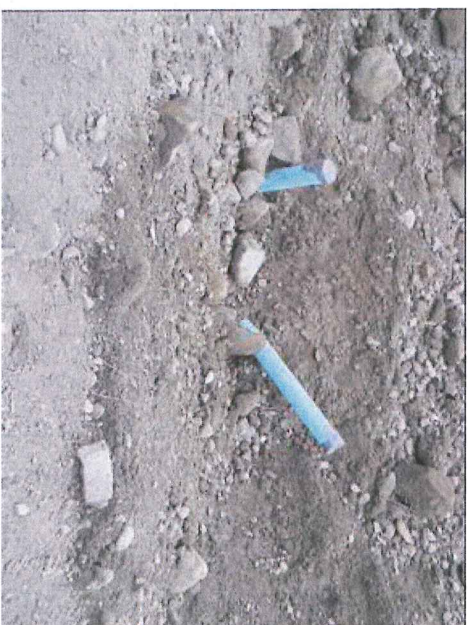
Cleanout between cells 1 and 2 of the eastern gallery.

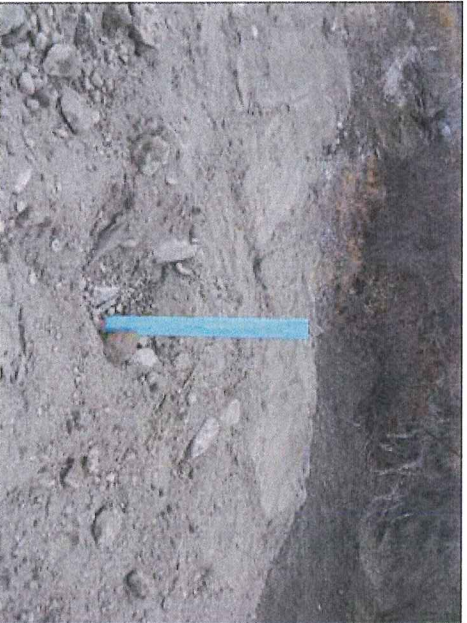
Water level observation port at cell 2 of the eastern gallery.

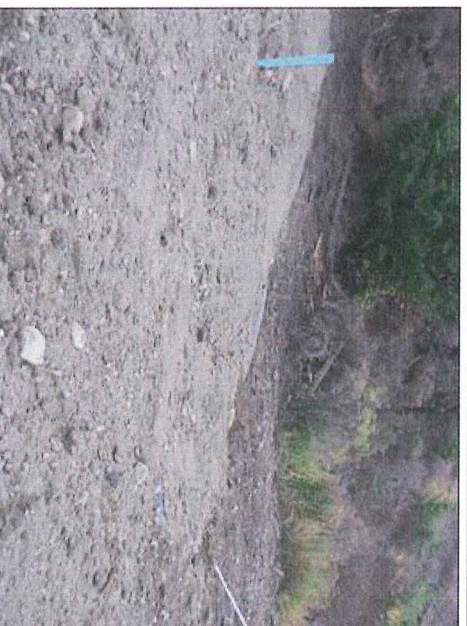
Downstream end of eastern infiltration gallery, cell 2. Echo Bay placed a membrane liner on the downstream edge to prevent any surface expression/exfiltration of treated groundwater.

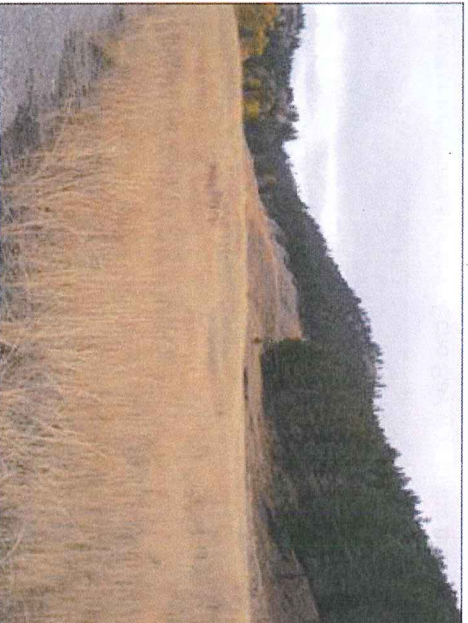
Area of former waste rock dump at Lamefoot mine site.

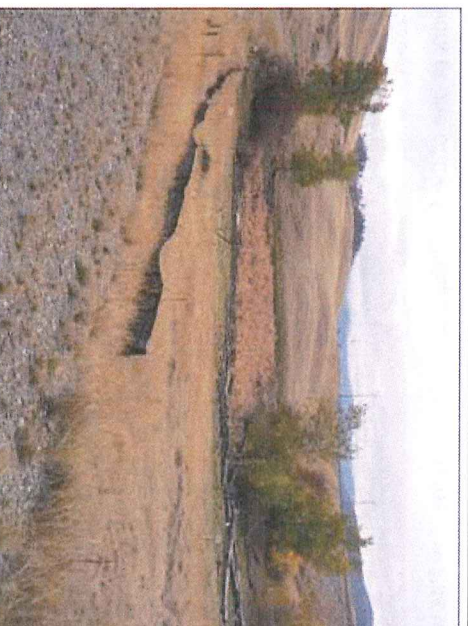
Wetland #4 lies near the former waste rock storage area for the mine site. To mitigate potential impacts from leaching of contaminants from the waste rock, Echo Bay had previously removed waste rock material from the storage area and along the access road adjacent to Wetland #4 and well LF-12. The fill material for the access road bed appeared to contain rounded material, with only minor amounts of angular rocks toward the north end of the road, closest to the former waste rock disposal area.

Wetland #4 at Lamefoot mine site.

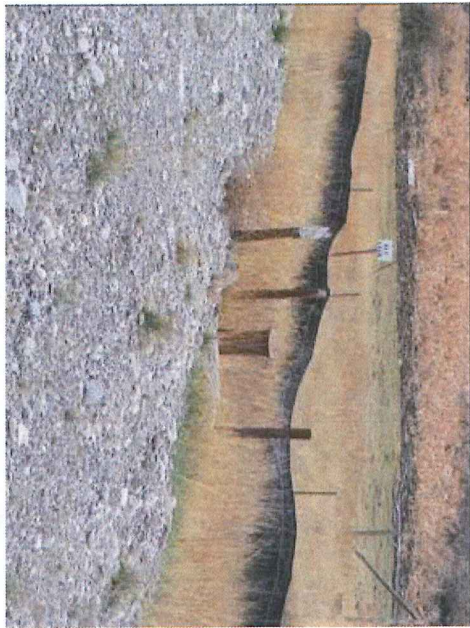
Monitoring well LF-12 adjacent to Wetland #4 at Lamefoot mine site.

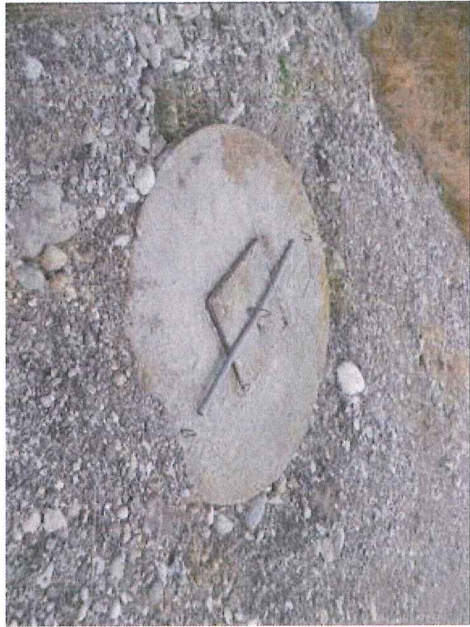
Livestock monitoring well adjacent to Wetland #4 at Lamefoot mine site.

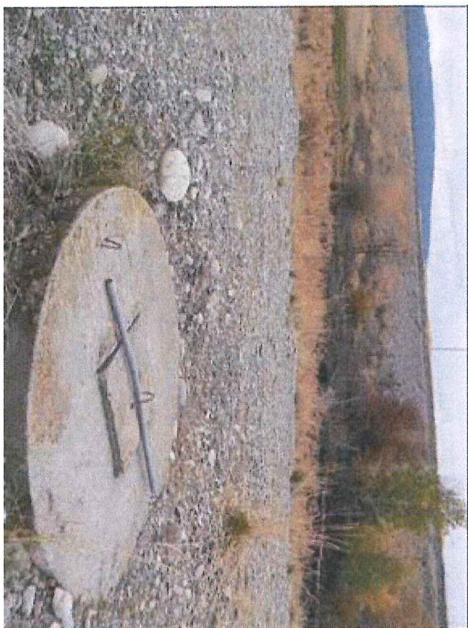
Livestock monitoring well with Wetland #4 in background at Lamefoot mine site.

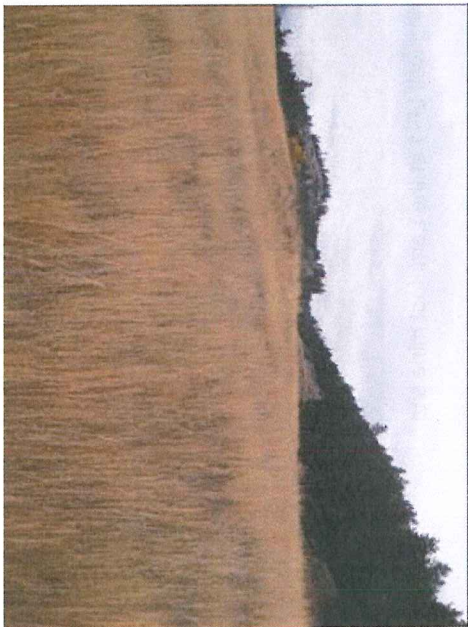
Area of former waste rock dump at Lamefoot mine site.

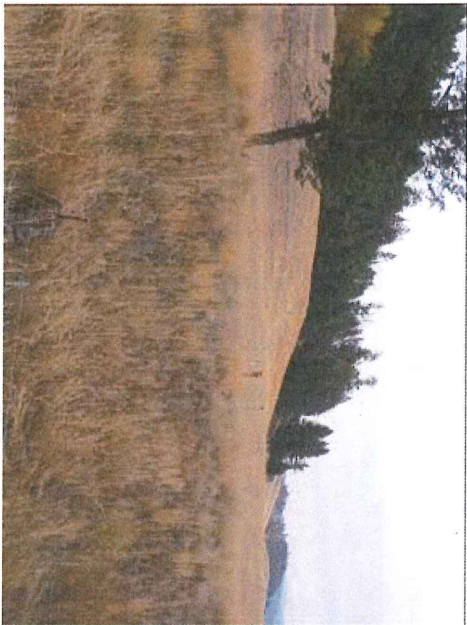
Along Wolf Camp Road, monitoring well MSWOB2 at the Lamefoot mine site. Monitoring well LF-5 lies across the road at this location.

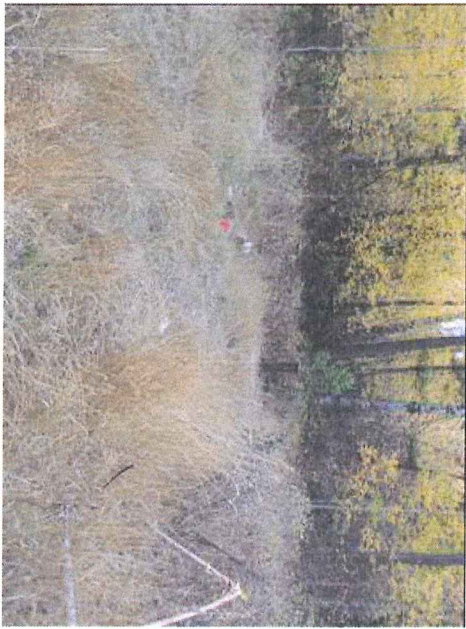
Monitoring well LF-1 at the Lamefoot mine site.

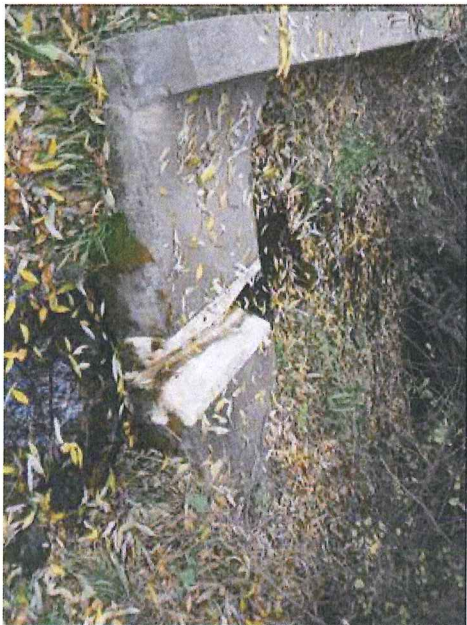
Monitoring point for Wolf Camp Spring at Lamefoot mine site.

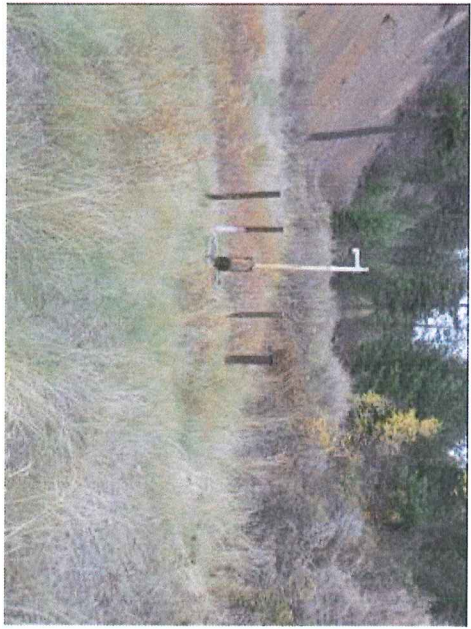
Nested wells LF-1 and LF-4 at Lamefoot mine site. LF-4 is an artesian well.

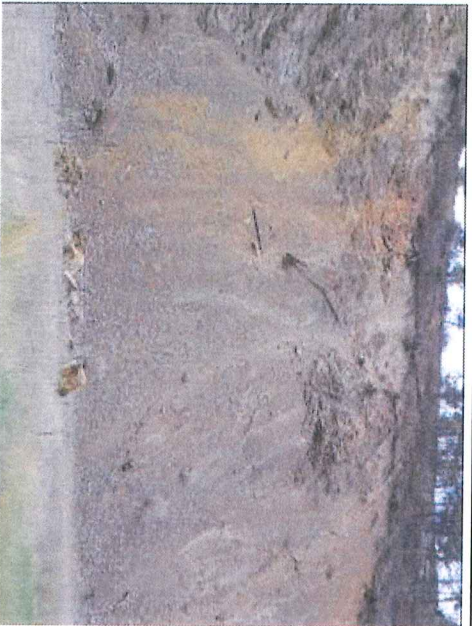
Steep slopes to the west of monitoring wells LF-2 and LF-4.

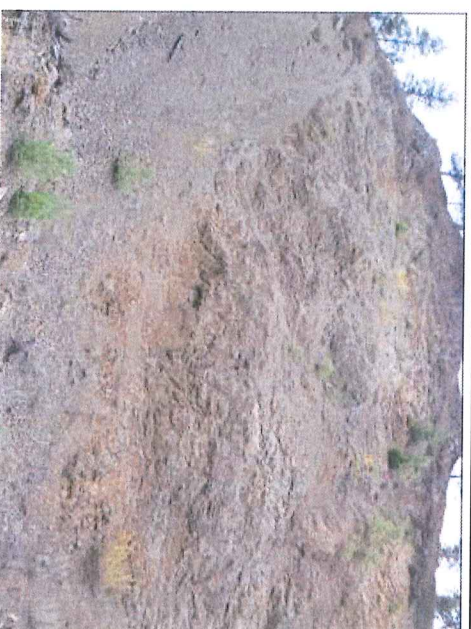
Steep slopes to the west of monitoring wells LF-2 and LF-4.

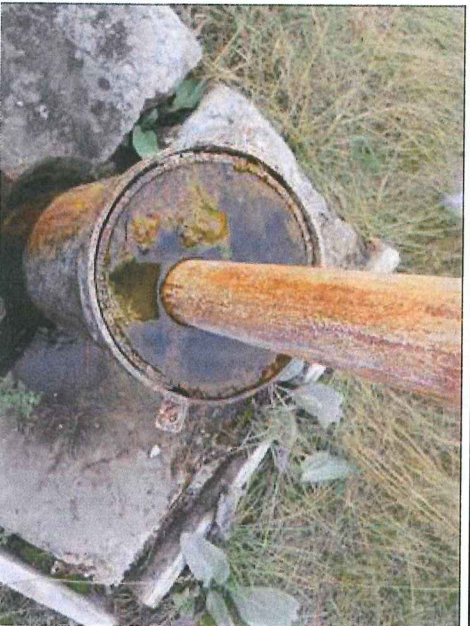
LF-4 (artesian) well and standpipe.

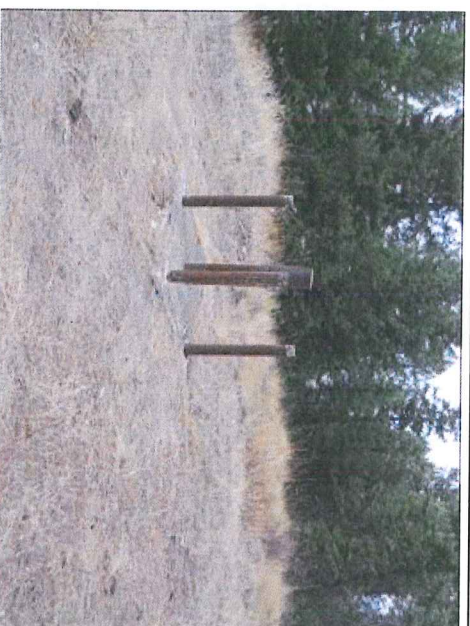
Monitoring well LF-14 at Lamfoot mine site.

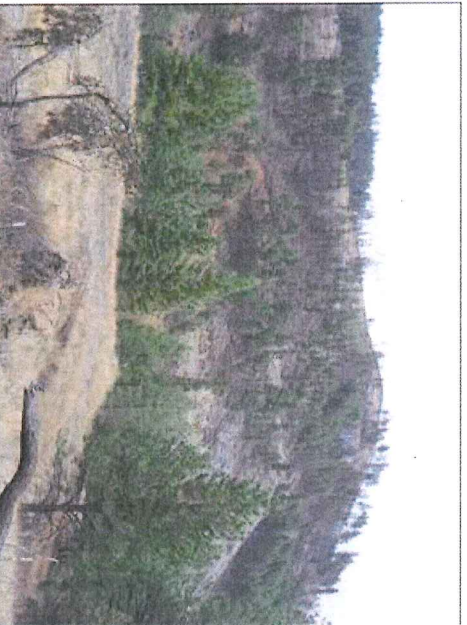
Near monitoring well LF-14, view of the eastern slopes of Wolf Camp drainage.

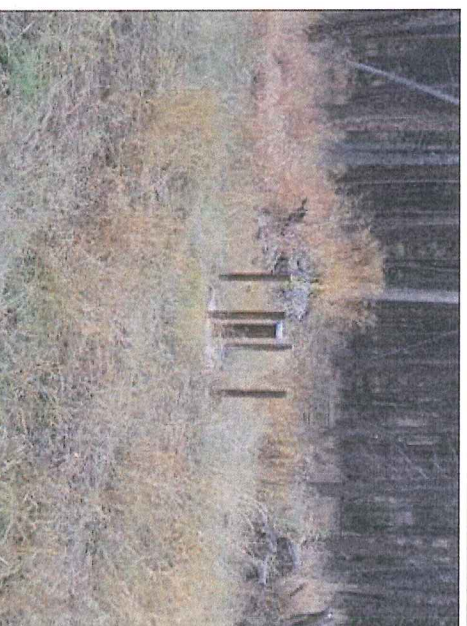
Monitoring well LF-13 at Lamfoot mine site.

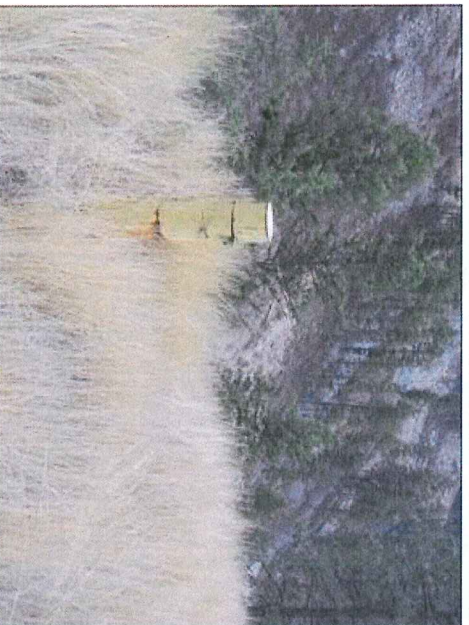
Monitoring well LF-Tunnel-Well at Lamfoot mine site. View of eastern slopes of Wolf Creek drainage in background.
