STATE OF WASHINGTON  
DEPARTMENT OF ECOLOGY

RE: NPDES Permit Number WAR004491

Enclosure: Industrial Stormwater Inspection Report

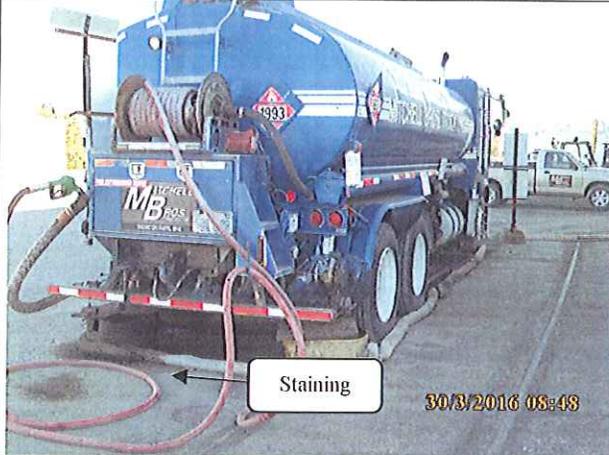
Photo 1 of 5: There is a tanker parked to fuel diesel. There are BMPs in place that require maintenance.

1. Certify the updated SWPPP using the certification form found on page 63 of the permit, and keep it in the SWPPP.
2. The fueling truck Best Management Practice (BMP) oil booms are contaminated. There is oil leaving the contained area (see pictures 1, and 2). Immediately maintain the BMPs to prevent a discharge in accordance to your spill plan, and monthly inspections.

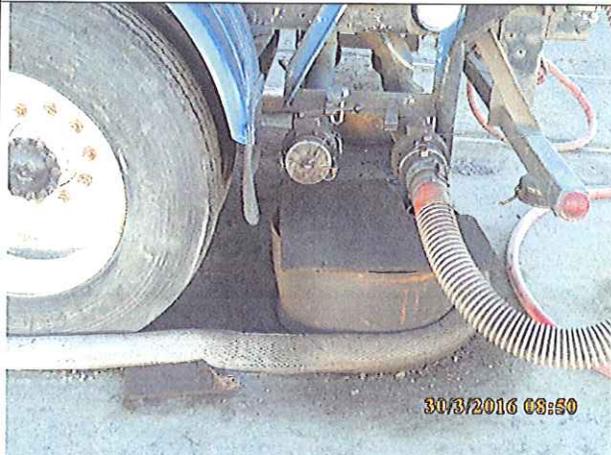
Photo 2 of 5: Oil staining and BMP needs maintenance.

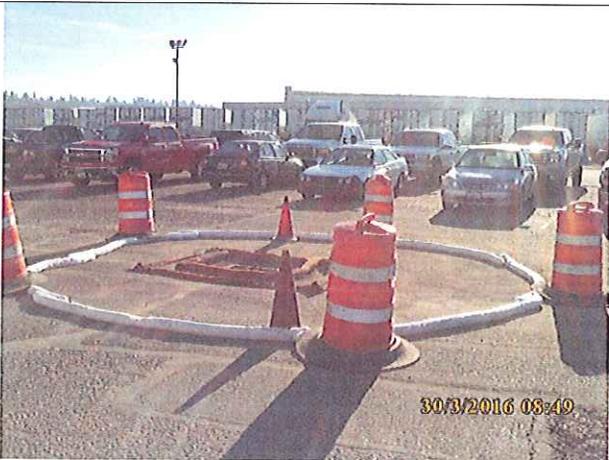
Photo 3 of 5: The monitored outfall with treatment.

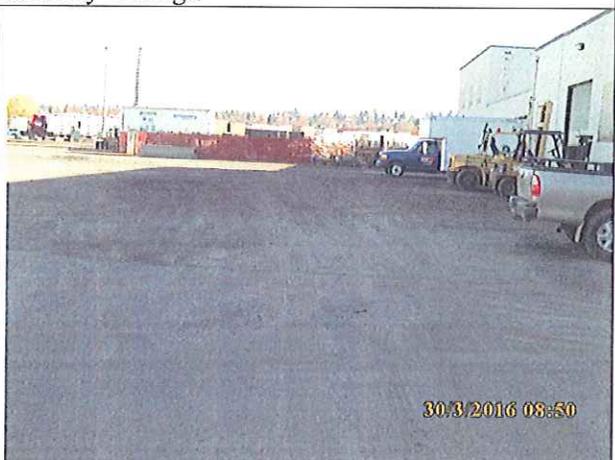
Photo 4 of 5: There is dirt from a gravel area around the entrance to the shop. This will contribute to high turbidity readings.

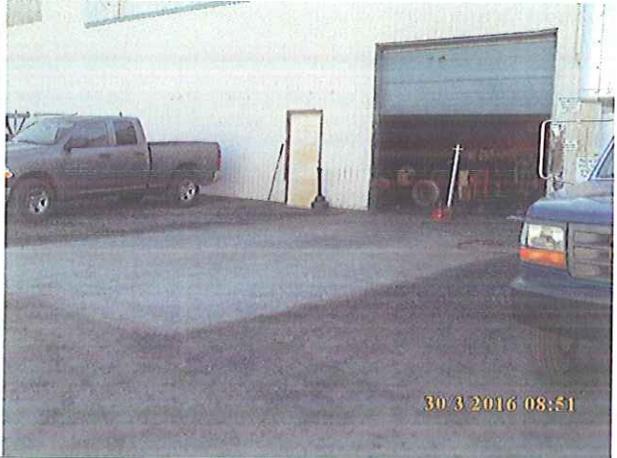
Photo 5 of 5: The entrance into the shop is being maintained.
