State of Washington Department of Ecology  
Northwest Regional Office  
**STORMWATER COMPLIANCE INSPECTION REPORT**

Inspection Date 8/23/2005	NPDES Permit # <b>SO3-002152</b>	County Snohomish	Receiving Waters Allen / Quilceda creek	Inspector(s) Jaron Smith	Facility Type <b>Industrial</b>
------------------------------	-------------------------------------	---------------------	--	-----------------------------	------------------------------------

<b>Name and Location of Facility Inspected</b> Pacific Coast Feather Company Marysville 14524 40 <sup>th</sup> Avenue NE Marysville, WA 98271	Entry Time	Date	Permit Effective Date

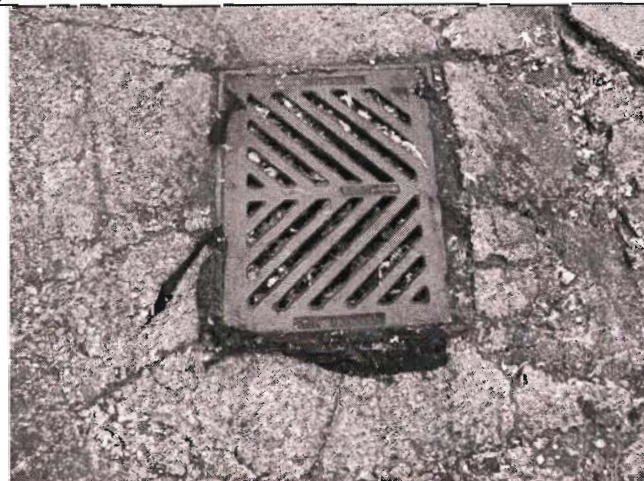
P8230048

Truck washing is done onsite. A curb separates the truck wash area from a stormwater CB and ensures the process water from truck washing discharges to the onsite treatment system; which then discharges to the sanitary sewer (photo P8230048). While onsite improvements were being made to extend the curbing in this area. They informed us that there were occasions where some of the water escaped this area and discharged to the storm system CB.

Description: Storm system CB. Note the curbing in place to prevent truck wash water from getting into the CB.
