State of Washington Department of Ecology
Northwest Regional Office
**STORMWATER COMPLIANCE INSPECTION
REPORT**

Facility Type:
 Industrial Boatyard
 Construction S & G

Name and Location of Facility Inspected Iron Mountain Quarry 20800 Wayside Mine Road Granite Falls, WA 98252	Entry Time 0900	Permit Effective Date 2/14/2005
	Exit Time 1145	Permit Expiration Date 2/14/2010

UNANNOUNCED Inspection

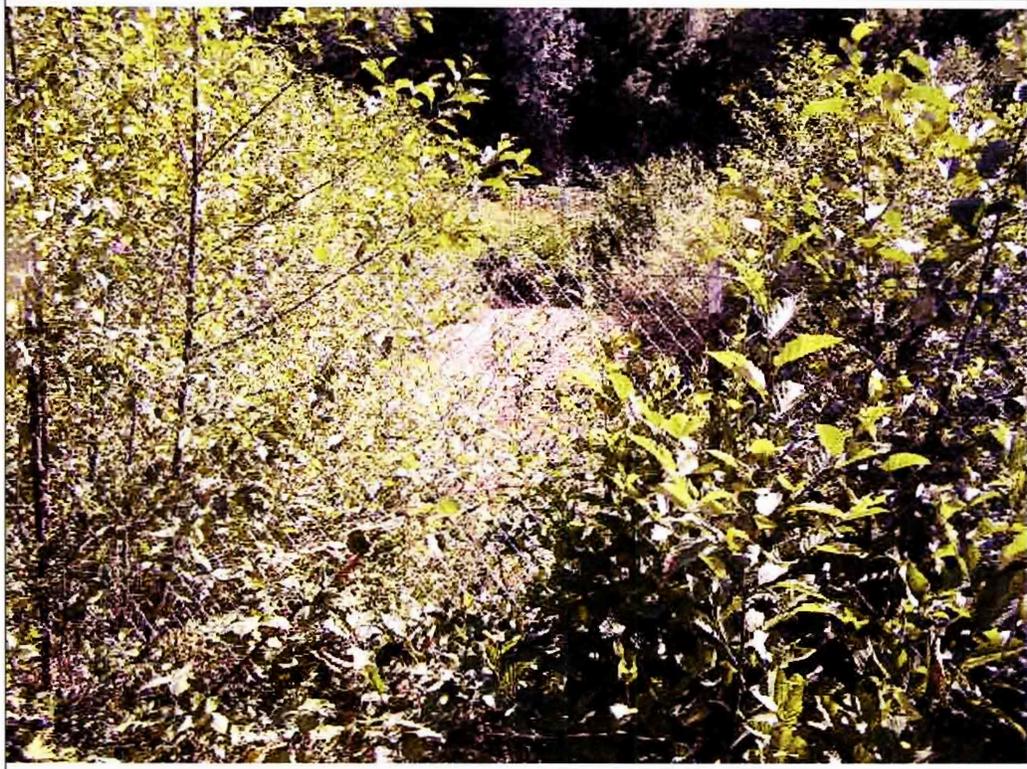
- **This is a violation of S9.A. The SWPPP must be fully implemented and updated.**
- Water is used in the washing process therefore the excess water and sediment is collected at the end. The pond is currently filled to the top with sediment and needs to be cleaned to maintain capacity. The water then runs a long way down the hillside to a conveyance and a sedimentation pond. The pond should be moved closer to the wash facility to decrease the amount of sediment picked up by the water and source control BMP's should be employed in the ponds and conveyance. This is a violation of **S7.A. Any impoundment shall have adequate capacity.....**

Photo #: 1
Description:
Stormwater ponds capacity must be cleaned out and maintained.

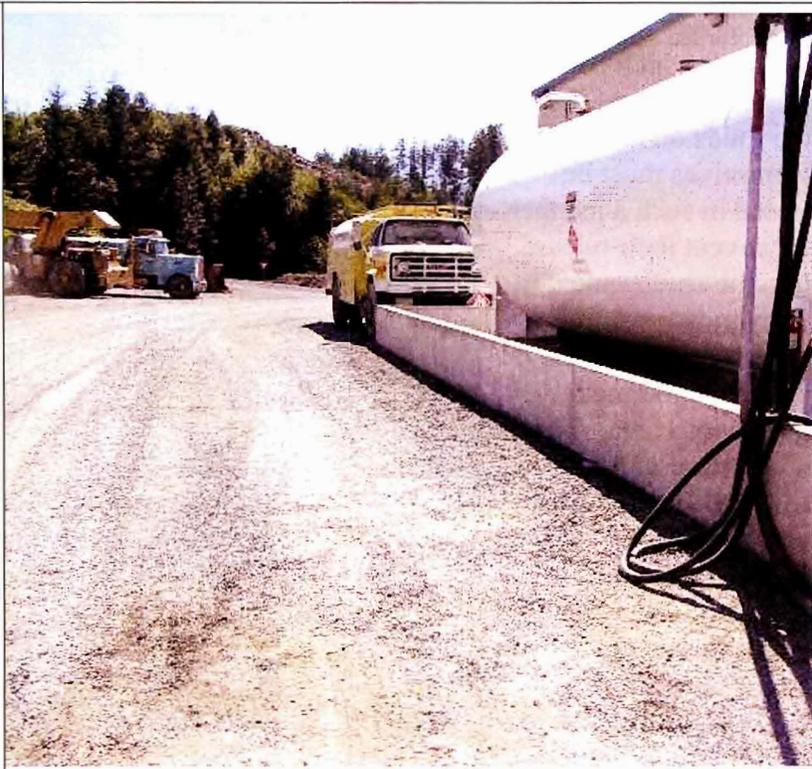
Photo #: 2

- **S4.D. requires monitoring for oil sheens each day that equipment operates.....**
- The secondary containment area where their large fueling tanks are placed has no roof and stormwater is able to pool. Mr. Miska stated that the stormwater is pumped out and used for dust control. Since we observed hydraulic leaks into the containment area the stormwater is considered contaminated and may not be

discharged. This water must be taken off the property and disposed of by a qualified disposal company. No discharge of pollutants to ground is allowed.

Description:
The secondary containment area where their large fueling tanks are placed has no roof over and stormwater is able to pool. Mr. Miska stated that the stormwater is pumped out and used for dust control. Since we observed hydraulic leaks into the containment area the stormwater is considered contaminated and may not be discharged. This water must be taken off the property and disposed of by a qualified disposal company. No discharge of pollutants to ground is allowed.

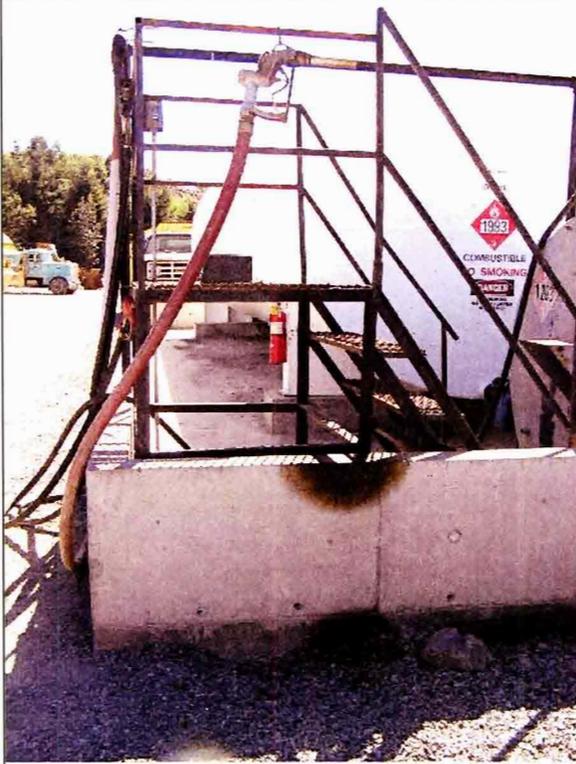
- Fuel was found dripping from a fueling hose onto the containment and onto the ground. This must be cleaned up immediately and the hose must be stored in such a way so no discharge can occur. A fueling pad or containment procedures must be put in place where all spills can be contained when fueling. **This is a violation of 90.48.080.....**

Photo #: 1 Description:
Fuel was found dripping from a fueling hose onto the containment and onto the ground. This must be cleaned up immediately and the hose must be stored in such a way so no discharge can occur. A fueling pad and containment procedures must be put in place where all spills can be contained when fueling. **This is a violation of 90.48.080.....**

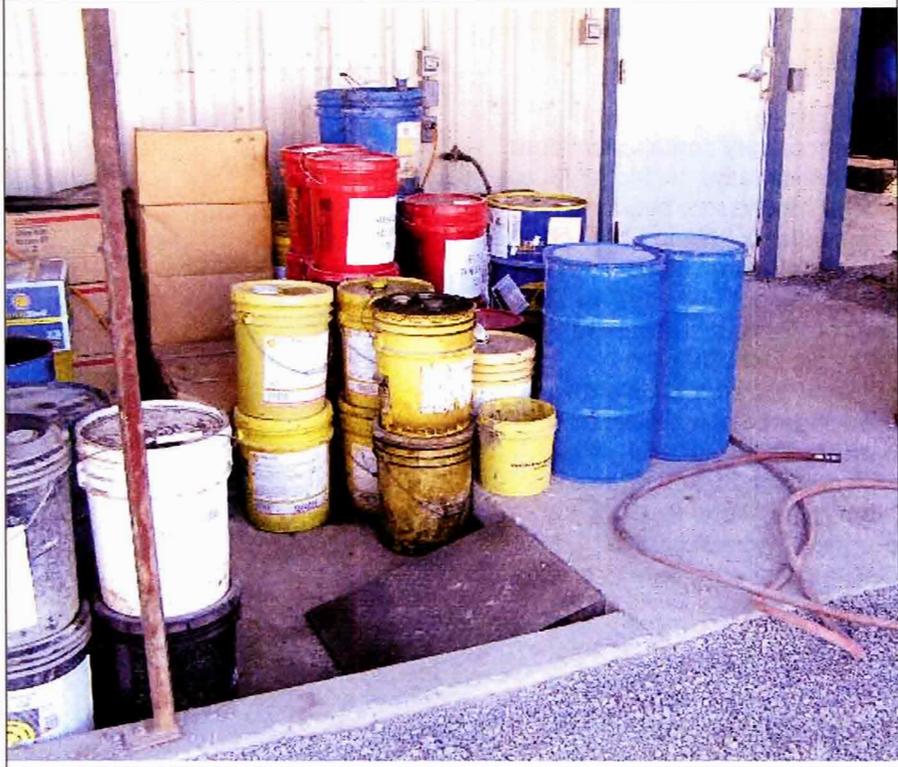
- All parts which contain fluids and oils as well as the fluids oil and fuels themselves must be stored in such a manner to prevent their release into the environment. They must be stored under cover and on a contained, bermed impervious area. **This is a violation of S7.G.fuels, lubricants and petroleum products must be stored under cover and containment to prevent stormwater contamination....**

Photo #: 2
Description:
All parts which contain fluids and oils as well as the fluids oil and fuels themselves must be stored in such a manner to prevent their release into the environment. They must be stored under cover and on a contained, bermed impervious area. **This is a violation of S7.G.fuels, lubricants and petroleum products must be stored under cover and containment to prevent stormwater contamination....**

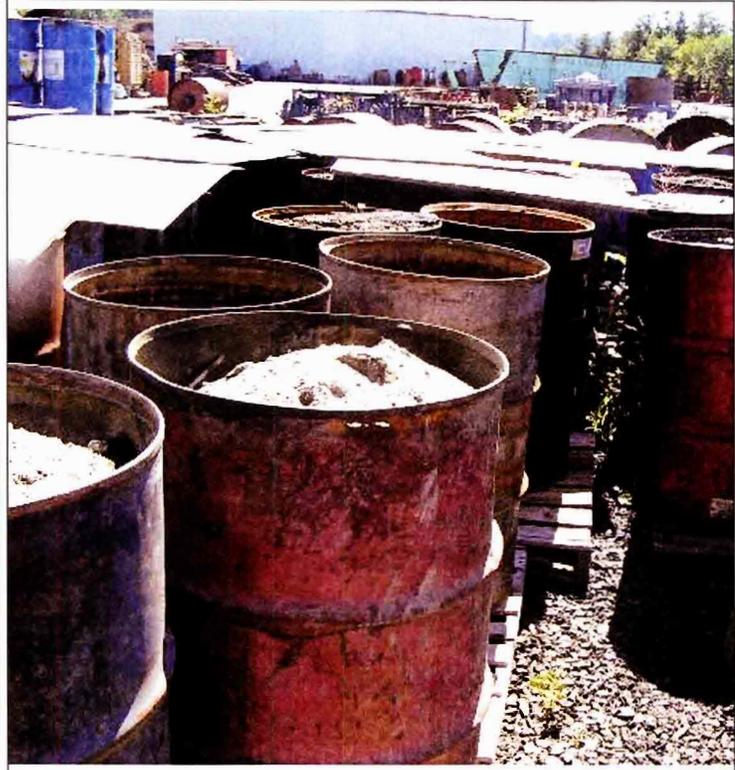
Photo #: 1 Description:

- Contaminated soil and other waste products are being stored in barrels in the storage yard. The barrels were found uncovered and without proper containment. Discharges to ground were observed. Proper and full containment must be put in place along with BMP's to avoid any discharge of any contaminants. This must be addressed immediately. **This is a violation of RCW. 90.48.080.**

Contaminated soil and other waste products are being stored in barrels in the storage yard. The barrels were found uncovered and without proper containment. Discharges to ground were observed. Proper and full containment must be put in place as well as BMP's to avoid any discharge of any contaminants. This must be addressed immediately. **This is a violation of RCW. 90.48.080.**

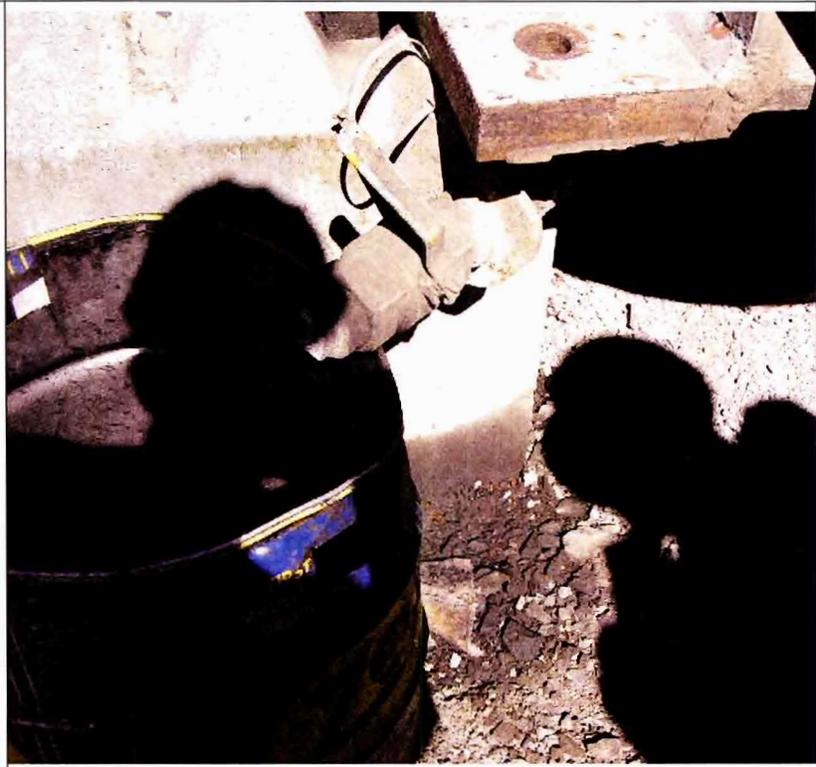
Photo #: 2

A crusher in the yard was being taken apart. Open barrels of oil and spills and parts with petroleum products were found left open for stormwater intrusion. This area must be maintained so there is no potential to discharge to ground or surface water. The oil and fuel as well as parts that can leak must be stored under cover with proper containment. Some type of containment must be implemented under the crusher as well to trap any leaks.

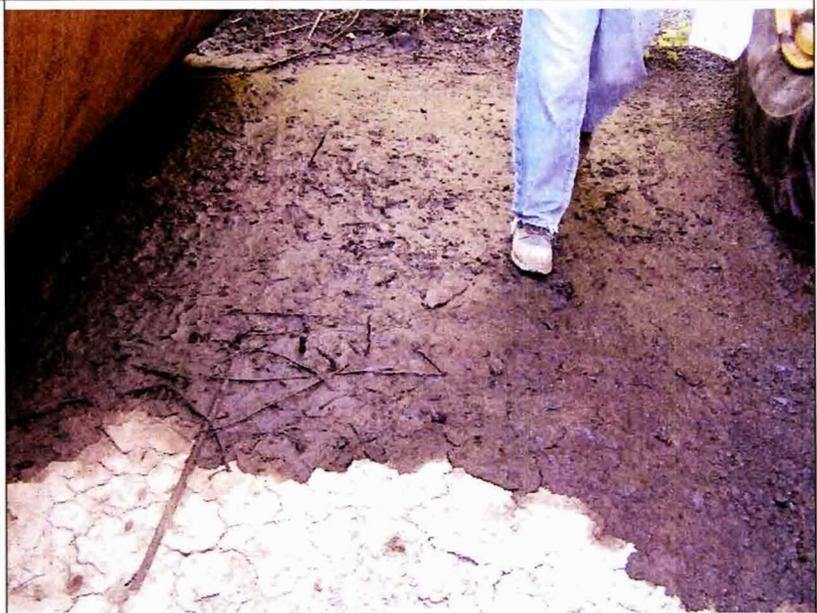
- Most of the trucks are too large to be brought inside for repairs and therefore repairs occur outside. Many if not all of these trucks were found to be leaking petroleum products to ground. These leaks need to be contained and cleaned up immediately. Discharge of pollutants on the ground can infiltrate to ground water and also stormwater run-off can discharge to surface water. **This is a violation RCW 9048.080 (please see definition below) and S8.B. The site must be managed to prevent unauthorized discharges to waters of the state**

Photo #: 1 Description:
Most of the trucks are too large to be brought inside for repairs and therefore repairs occur outside. Many if not all of these trucks were found to be leaking petroleum products to ground. These leaks need to be contained and cleaned up immediately. Discharge of pollutants on the ground can infiltrate to ground water and also run-off with stormwater discharge to surface water. **This is a violation RCW 9048.080 (please see definition below) and S8.B. The site must be managed to prevent unauthorized discharges to waters of the state S4.D. requires monitoring for oil sheens each day that equipment operates.....**

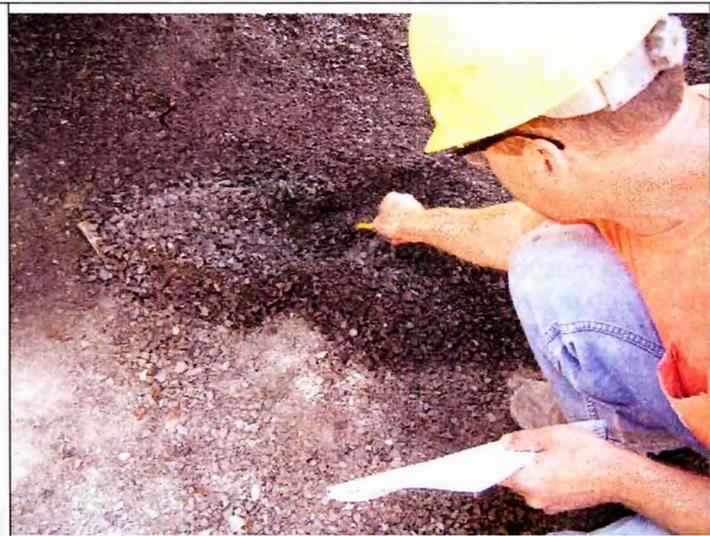
Photo #: 2

Description:
Oil and hydraulic leaks were observed throughout the site. Pictured here is a discharge which has penetrated more than a few inches down into the soil. This must be cleaned up immediately. This is a violation of RCW 90.48.080.

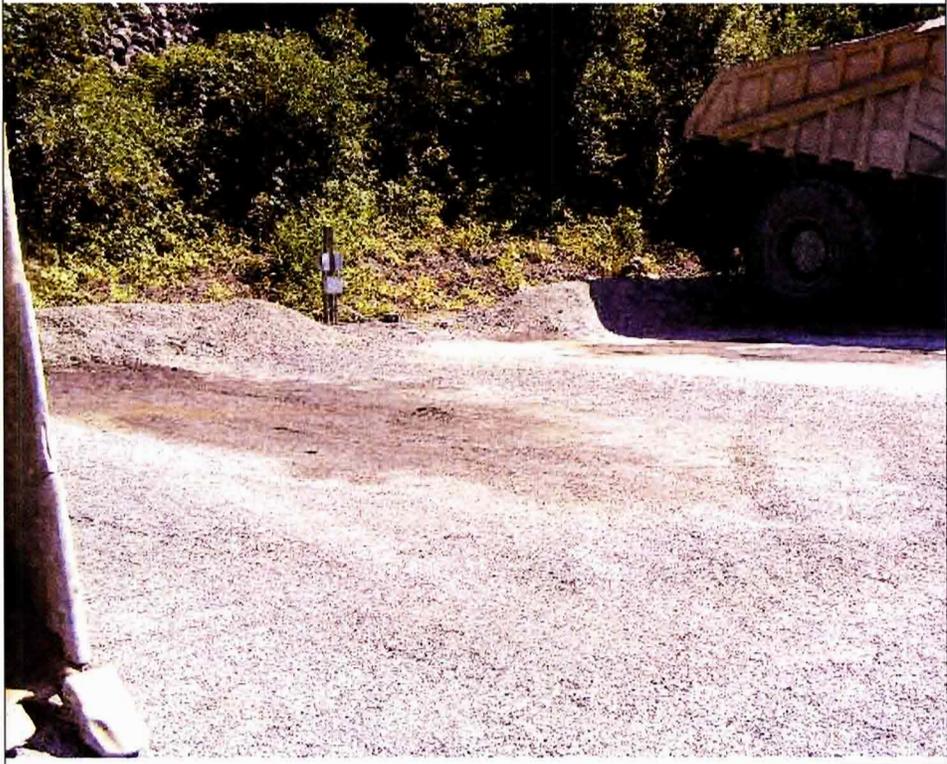
Photo #: 1 Description:

S8.B. The site must be managed to prevent unauthorized discharges to waters of the state

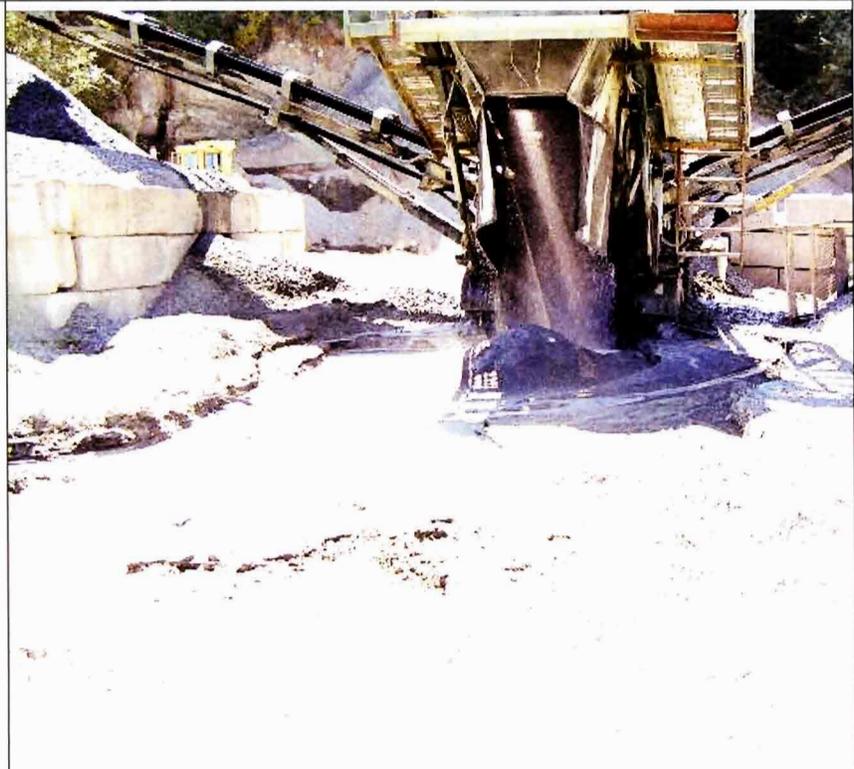
Photo #: 2

Water is used in the washing process therefore the excess water and sediment is collected at the end. The pond is currently filled to the top with sediment and needs to be cleaned to maintain capacity.

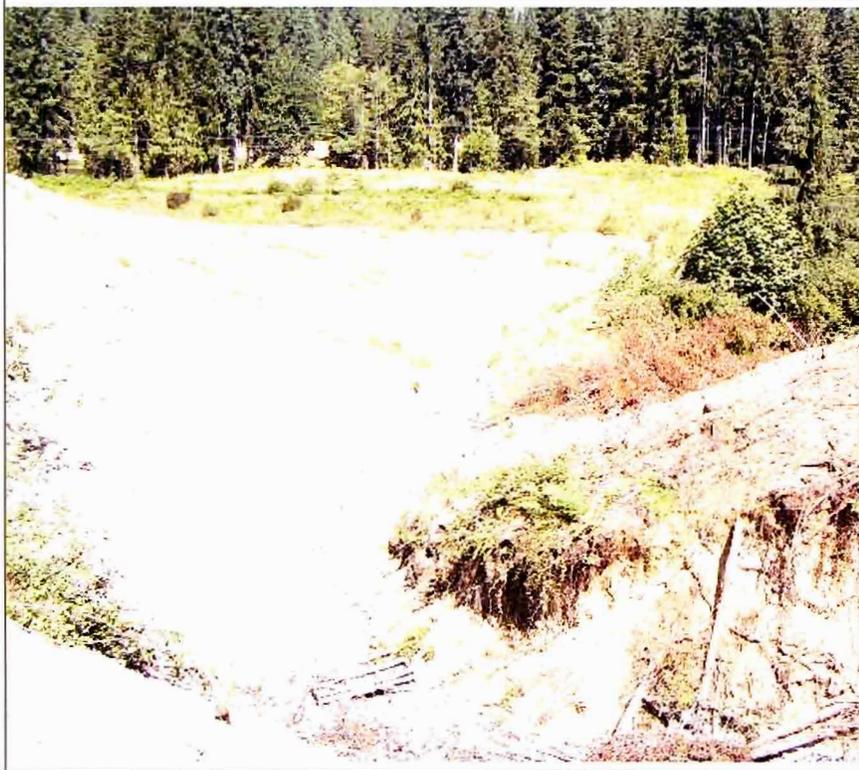
Photo #: 1

The water then runs a long way down the hillside to a conveyance and a sedimentation pond. The pond should be moved closer to the wash facility to decrease the amount of sediment picked up by the water and source control BMP's should be employed in the ponds and conveyance. This is a violation of **S7.A. Any impoundment shall have adequate capacity.....**
