Construction Stormwater General Permit INSPECTION REPORT

Washington State Department of Ecology

Stetson Heights
S and SW of Glenwood Rd
Port Orchard, WA 98367

PHOTO ADDENDUM – STETSON HEIGHTS - 12/18/2018

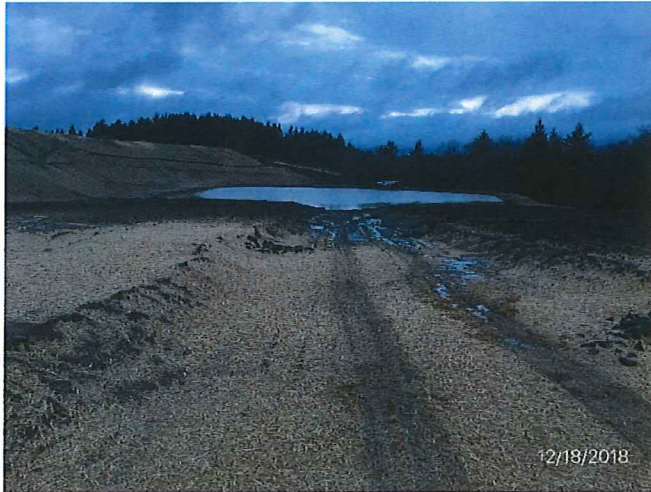
01 **DESCRIPTION:** 1ST POND NEAR OVERTOPPING.

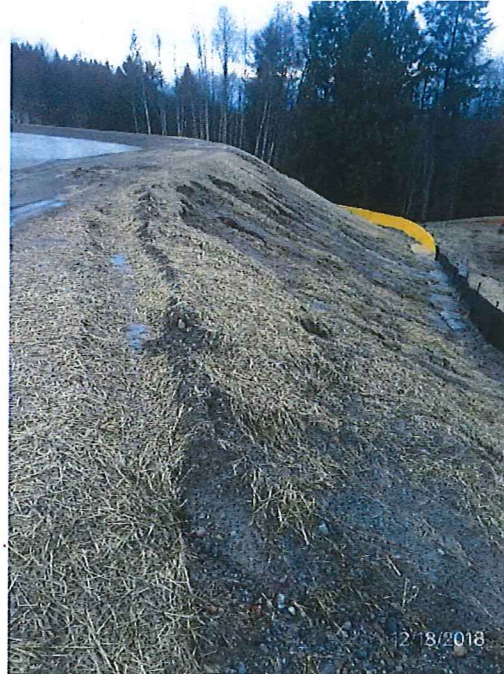
02 **DESCRIPTION:** 1ST POND SE SIDE SHOWING SIGNS OF SOIL SATURATION AND SLUFFING ISSUES.

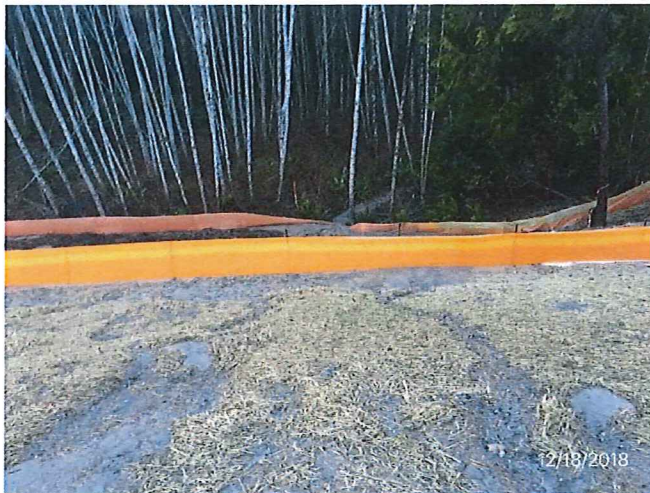
03 **DESCRIPTION:** DISCHARGE OF STORMWATER AND SEDIMENT INTO WETLAND BELOW 1ST POND.

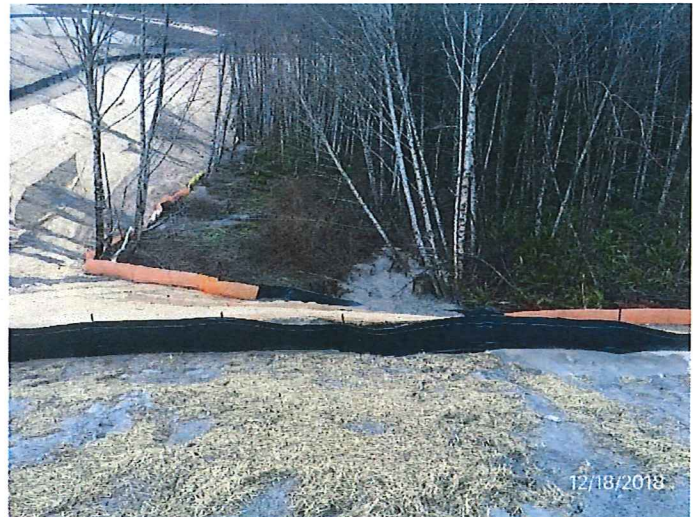
04 **DESCRIPTION:** DISCHARGE OF STORMWATER AND SEDIMENT IN MANY LOCATIONS INTO ADJACENT WETLANDS.

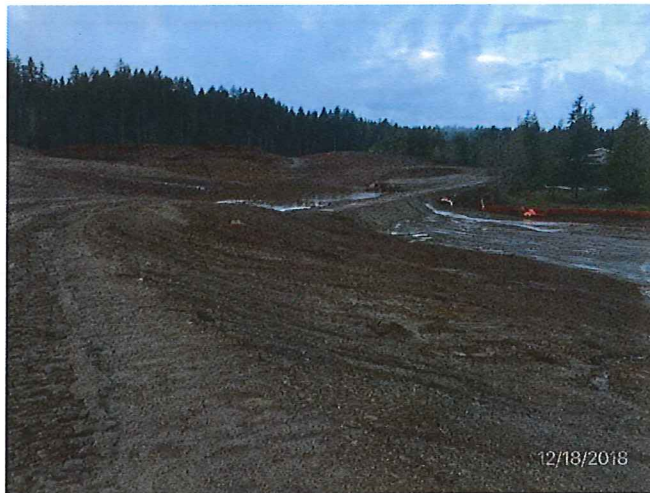
05 DESCRIPTION: BACKSIDE OF PROJECT STILL COMPLETELY BARE SOIL WITH NEW ROADWAY AND POND BEING FILLED FROM LOWER PONDS.

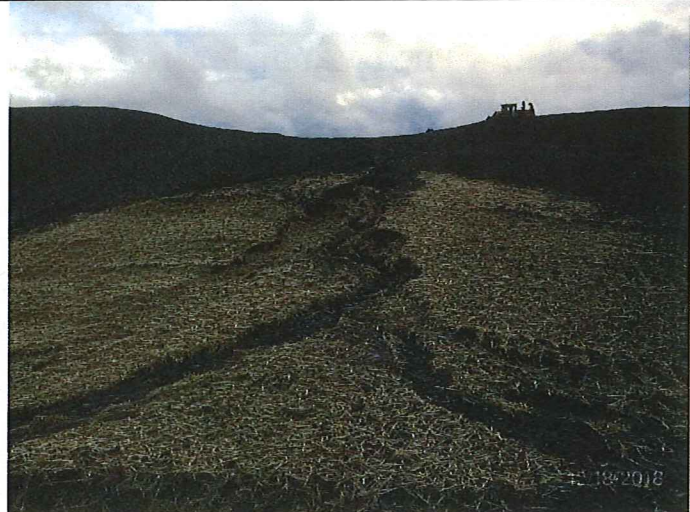
06 DESCRIPTION: HEAVY RILLING ON SLOPES ALONG BACKSIDE OF PROJECT. INADEQUATE SLOPE BMPs OR NO BMPs PRESENT.

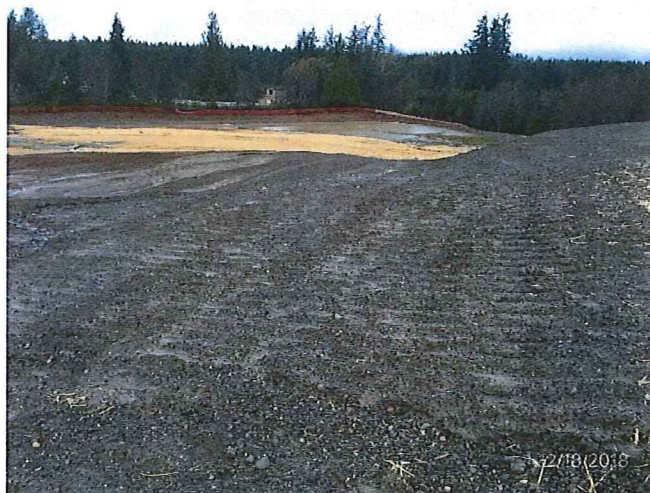
07 DESCRIPTION: POND ON BACKSIDE OF PROJECT NEAR OVERTOPPING.

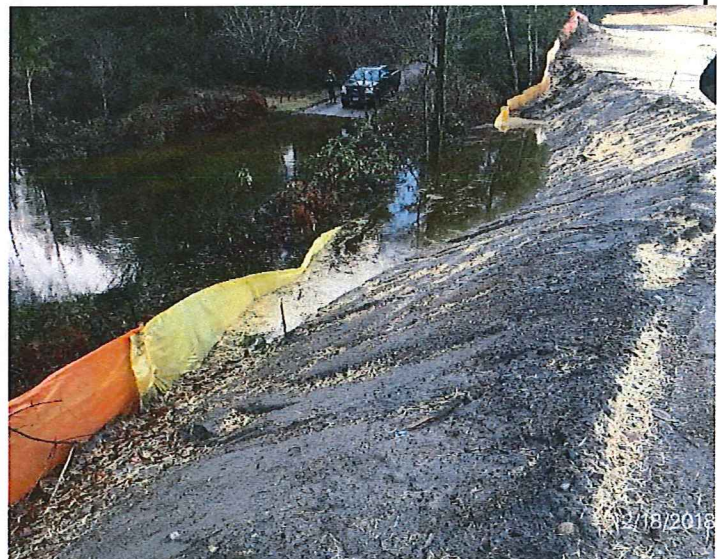
08 DESCRIPTION: FRONT OF SITE HAS CAUSED FLOODING ON NEIGHBORS PROPERTY. DRIVEWAY INACCESSIBLE WITH PICKUP TRUCK.

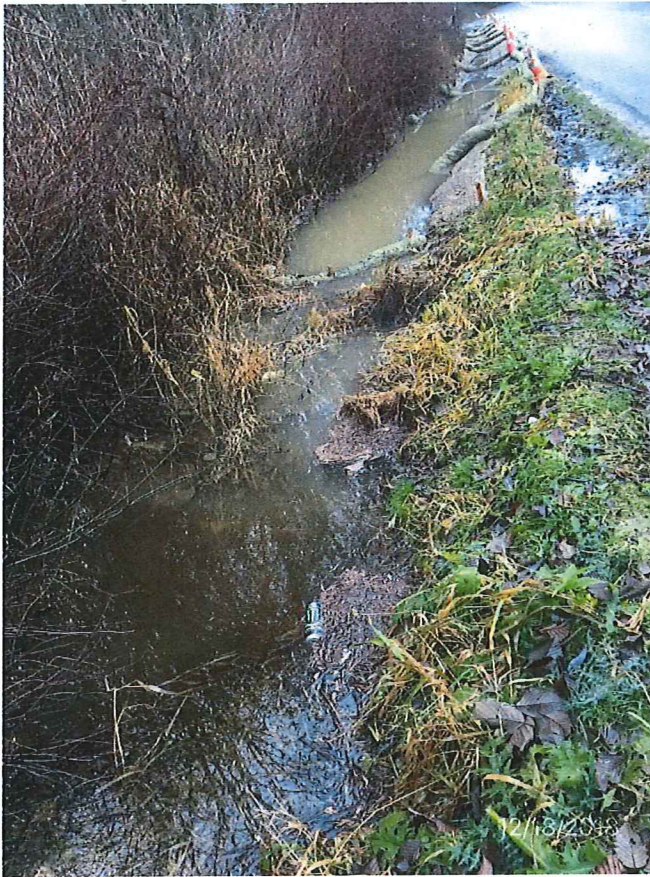
09 **DESCRIPTION:** PHOTO OF DISCHARGE FROM SITE ONTO GLENWOOD RD INTO RUBY CREEK TRIBUTARY.

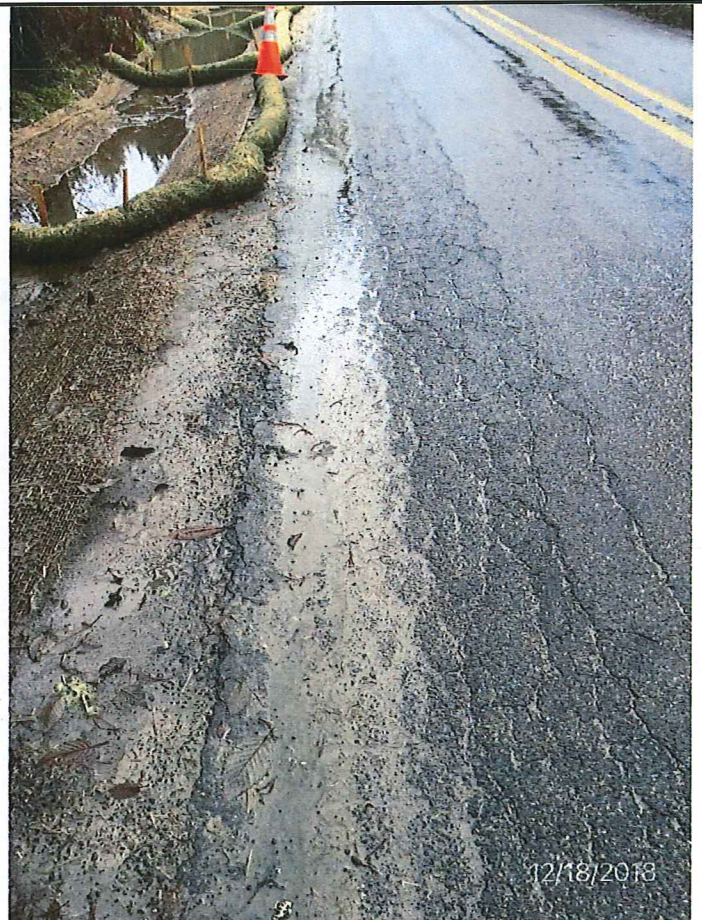
10 **DESCRIPTION:** SEDIMENT PRESENT ON ROADWAY SHOWING SIGNS OF LARGER DISCHARGE RECENTLY.

- **Violation: S9.D.2.d Track out.** Sediment was observed on the roadway adjacent to the site which should be cleaned thoroughly at the end of each work day..

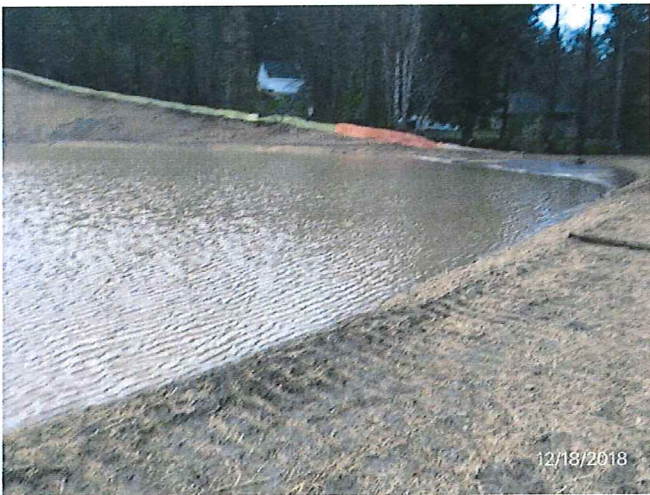
11 **DESCRIPTION:** LOWEST POND NEAR OVERTOPPING.

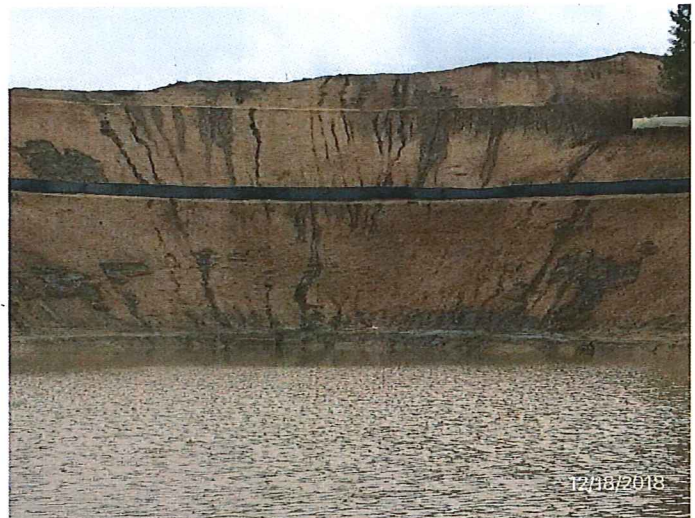
12 **DESCRIPTION:** LARGE AMOUNT OF RILLING ON HILLSIDE AND INADEQUATE SLOPE BMPs.

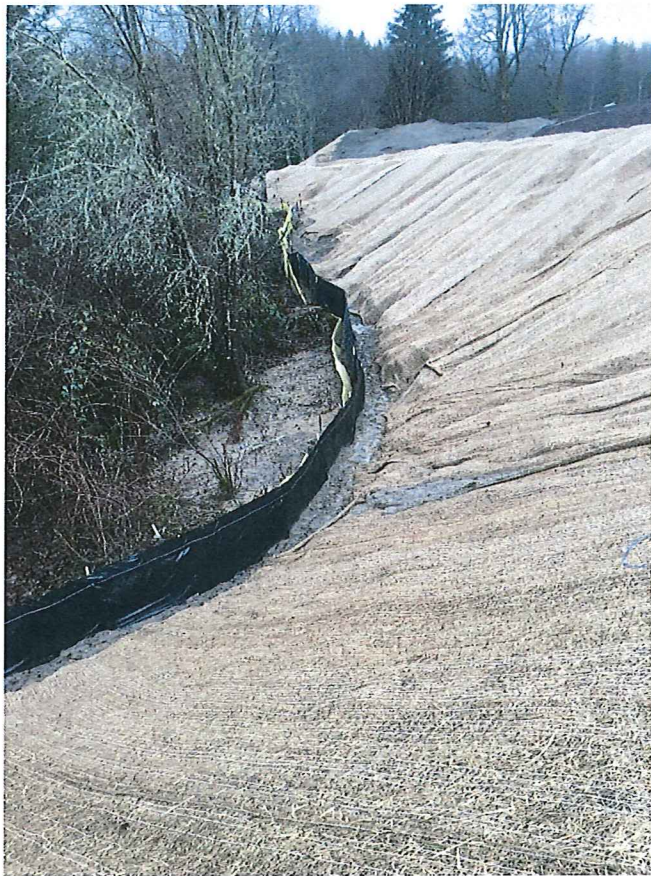
01 **DESCRIPTION:** DISCHARGE OFFSITE OF STORMWATER AND SEDIMENT VIA OVERTOPPING SILT FENCING INTO WETLANDS.

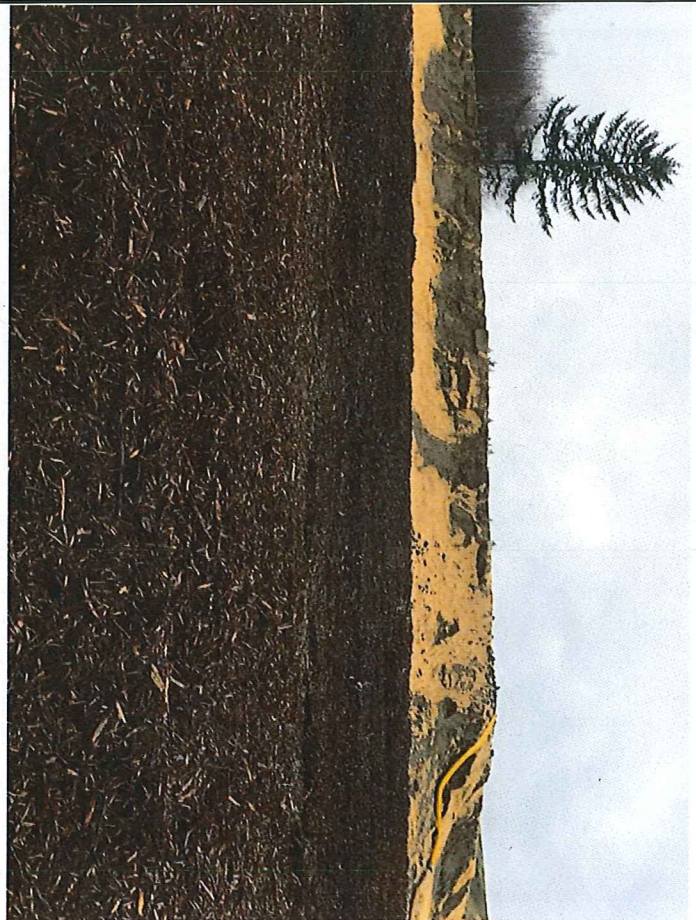
02 **DESCRIPTION:** SLUFFING ON OUTSIDE WALLS OF LOWER POND SHOWS SIGNS OF POTENTIAL FAILURE.
