CONSTRUCTION STORMWATER COMPLIANCE INSPECTION REPORT

State of Washington Department of Ecology

Water Quality Name: Stetson Heights

Inspection Date: 12/21/2018

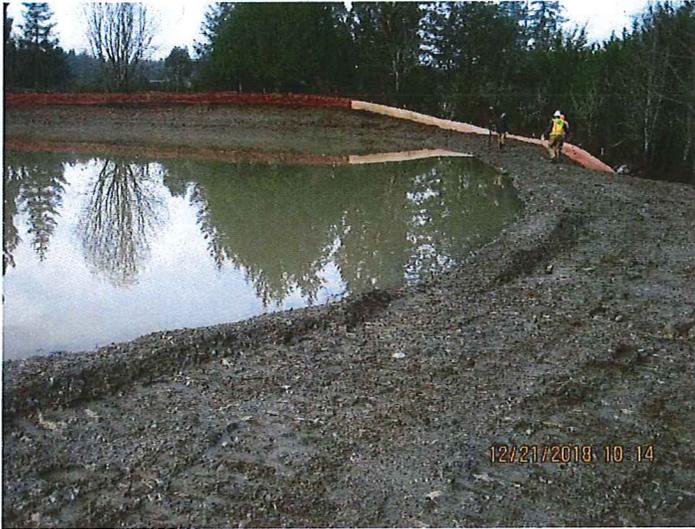
Photo 1 Description: Pond in the Northwest corner of site is full. Soils around pond are bare.

The site is in violation of permit condition S9.D.5.d. for failure to stabilize all exposed and unworked soils within 2 days between October 1 and April 30. Unworked soils must be stabilized or protected with a BMP like a seeding, mulching, plastic covering, or erosion control fabrics. **This must be corrected within 2 days of the date you receive this document.**

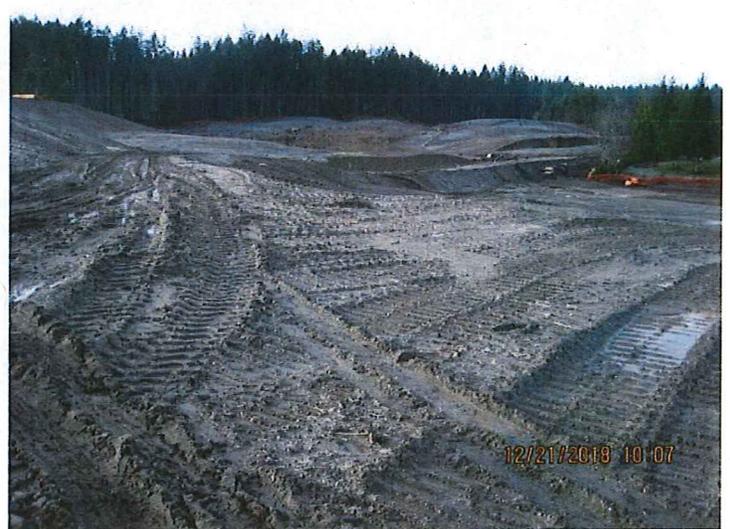
Photo 2 Description: Pond south of the northwest pond. The soils on the back side of the site are bare.

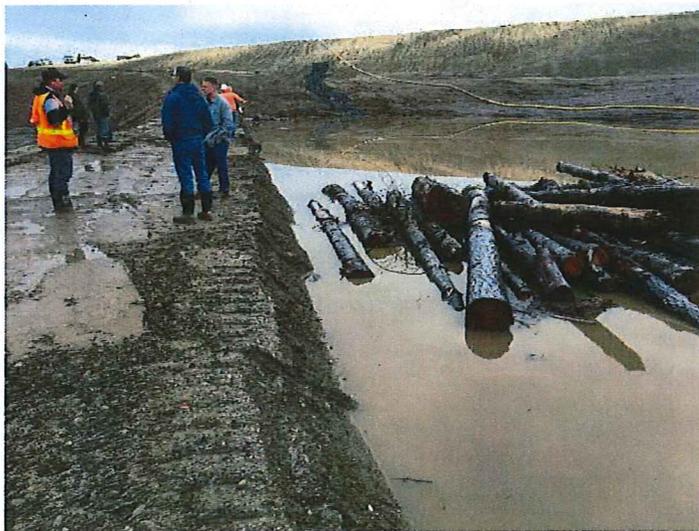
Photo 3 Description: Pond south of the northwest pond.

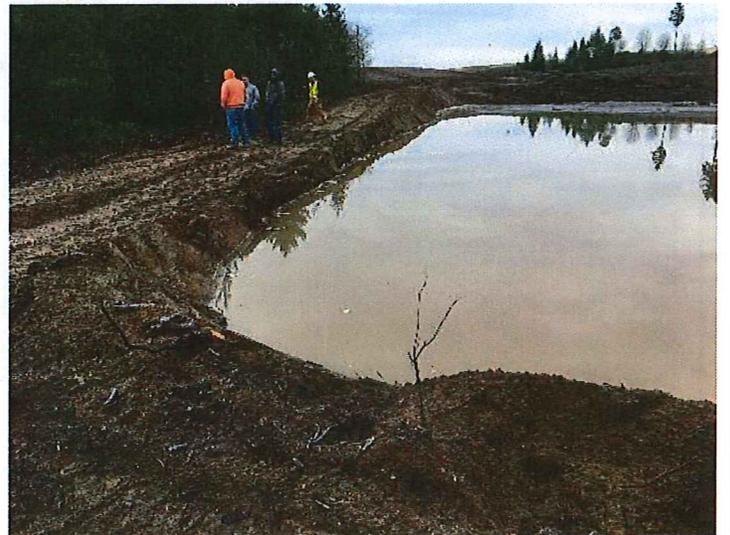
Photo 4 Description: Western pond on the back side of the site.

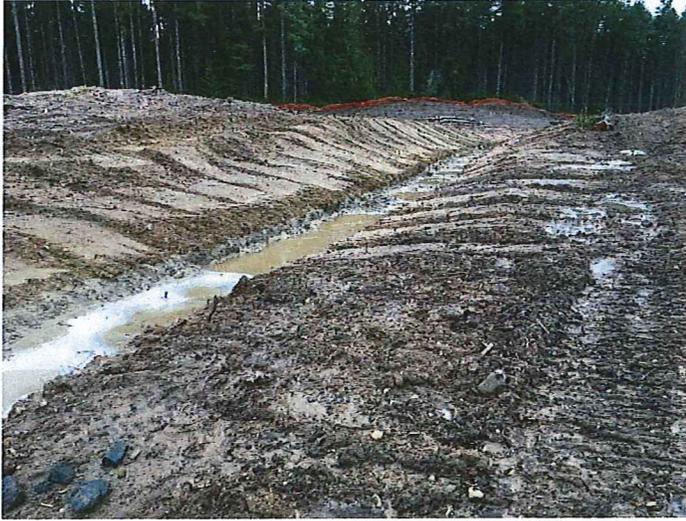
Photo 5 Description: Channel to western pond is not lined.

The site is in violation of permit condition S9.D.8.a. for failure to stabilize channels. Stabilize all on-site conveyance channels to prevent erosion. **This must be corrected within 7 days of the date you receive this document.**

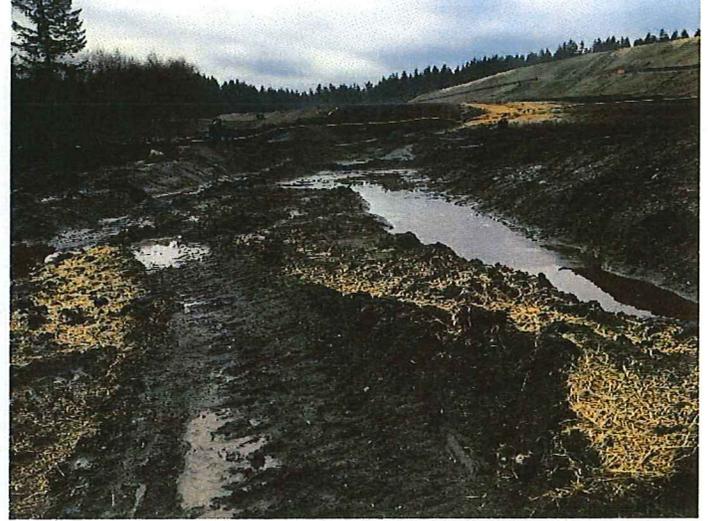
Photo 6 Description: The channels to pond between the two eastern ponds have rock check dams, but are not lined.

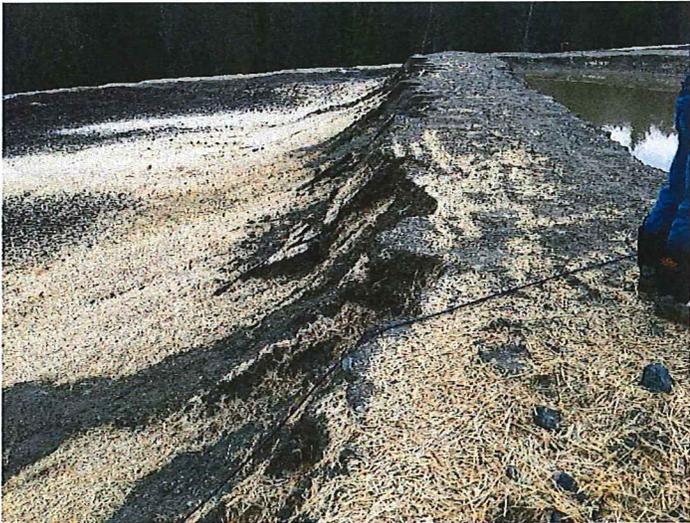
Photo 7 Description: Slope of the pond between the two eastern ponds is not stabilized.

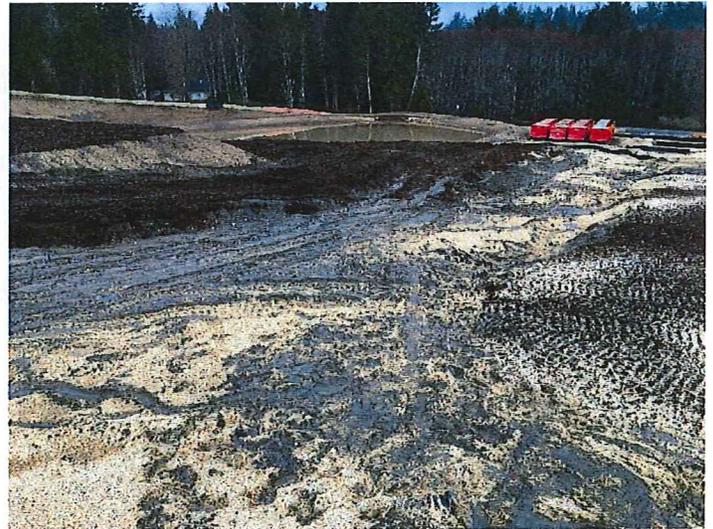
Photo 8 Description: Northeast pond level is several feet below the top of the pond. There are four baker tanks beside it.

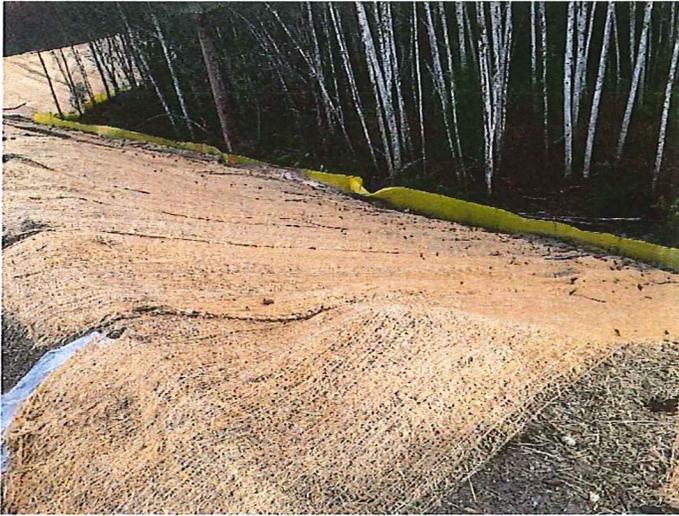
Photo 9 Description: Silt fence around wetland needs maintenance.

The site is in violation of permit condition S9.D.11.a. for failure to maintain BMPs. Maintain and repair all temporary and permanent erosion and sediment control BMPs as needed to assure continued performance of their intended function in accordance with BMP specifications. **This must be corrected within 7 days of the date you receive this document.**

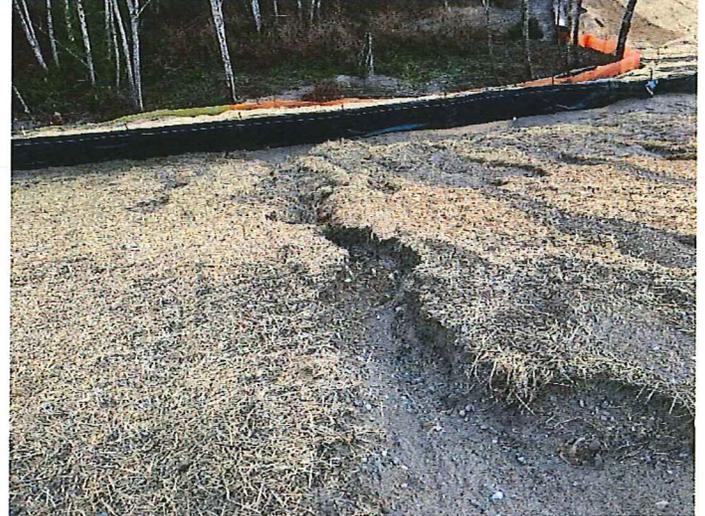
Photo 10 Description: Slope above wetland needs to be stabilized.

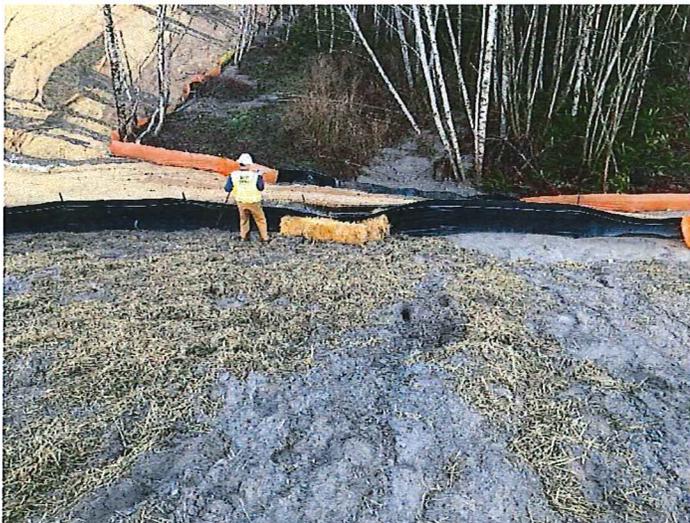
Photo 11 Description: Slope above wetland needs to be stabilized.

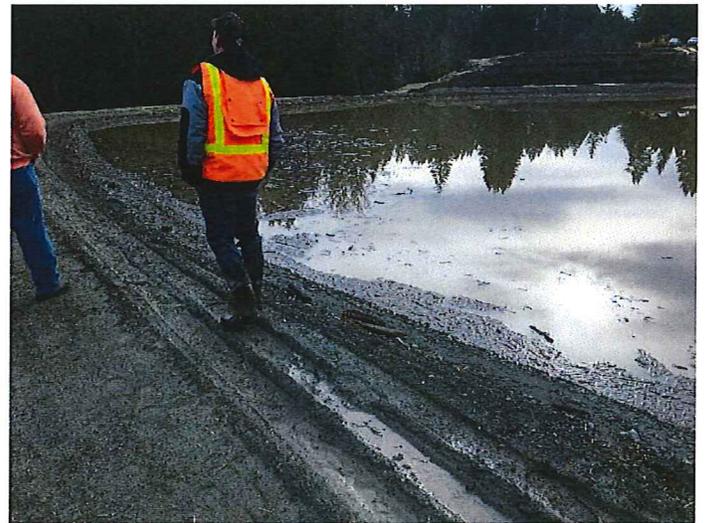
Photo 12 Description: Southeast pond is nearly full.
