WATER COMPLIANCE INSPECTION REPORT

Name and Location of Facility Inspected (For industrial users discharging to POTW, also include POTW name and NPDES permit number) Hughes Farms 1325 Farm to Market Road Mount Vernon, WA 98273	Entry Time/Date 10:48 am 01/16/19	Permit Effective Date 01/01/2017
	Exit Time / Date 12:00 pm 01/16/19	Permit Expiration Date 12/31/2021

PHOTO ADDENDUM – HUGHES FARMS, WA0991008

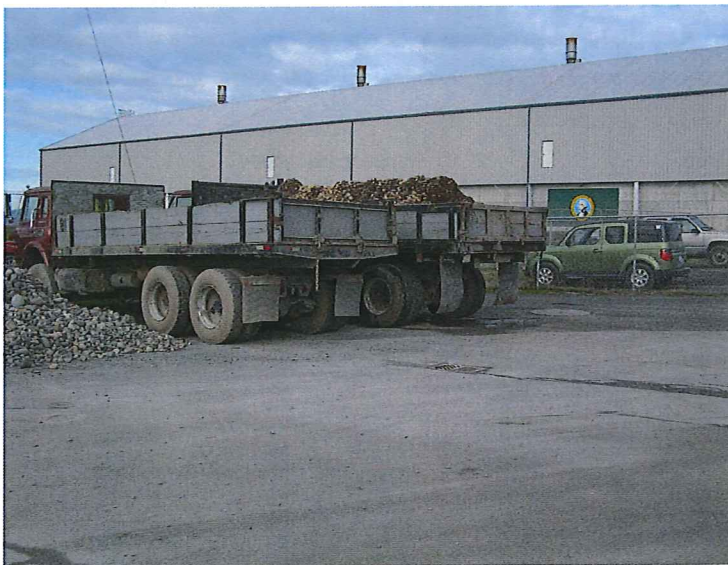
PHOTO #:01 DATE: 01/16/19

DESCRIPTION: TWO POTATO TRUCKS, ONE FILLED WITH DIRT AND OFF-SPEC POTATOES WAITING TO BE TRUCKED BACK TO THE FIELD, AND ONE WAS EMPTY WAITING TO BE FILLED. THEY WERE FOUND PARKED ADJACENT TO THE UNLINED SHARED POND. TWO STORM DRAINS IN THIS DRIVEWAY WHICH IS USED MOSTLY BY HUGHES FARMS ARE DRAINED DIRECTLY TO THE UNLINED SHARED POND.

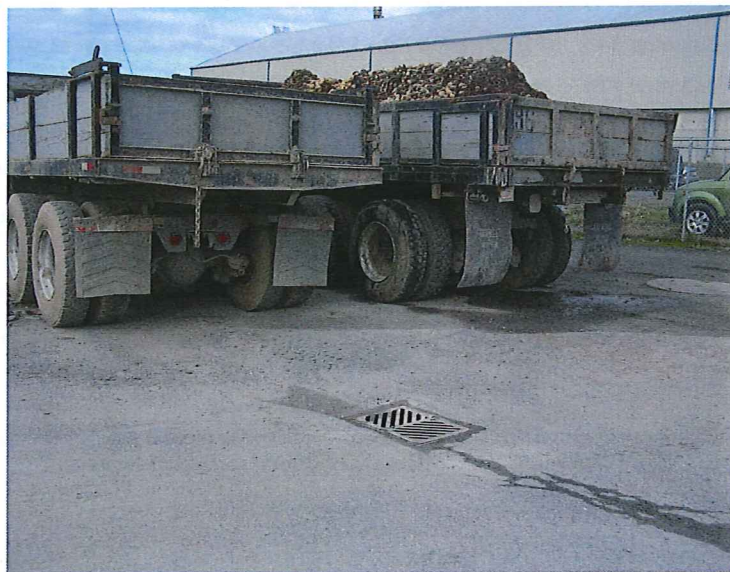
PHOTO #2 DATE: 01/16/19

DESCRIPTION: A CLOSE UP PICTURE OF PHOTO #1 WHICH SHOWS THE TRUCKS PARKED NEXT TO THE STORM DRAIN. I TOLD JOSE TO MOVE THE TRUCKS AND THAT THEY CANNOT PARK THERE. IF IT RAINS, STORMWATER COMING IN CONTACT WITH THE SOIL WILL DRAIN DIRECTLY TO THE POND THROUGH THE STORM DRAINS.

runoff drains to the facility's lagoons for treatment. I requested Jose to move both of the two trucks currently parked by the shared pond to the designated parking area. Jose gave an order to his staff to move the trucks.

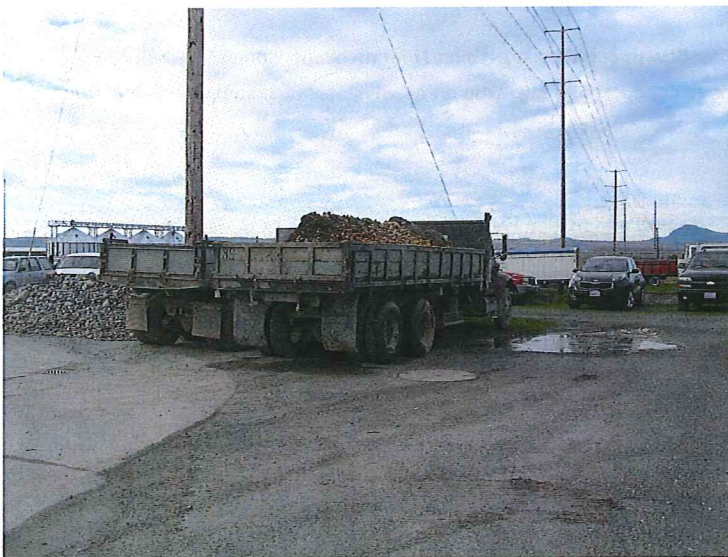
PHOTO #:03 DATE: 01/16/19

DESCRIPTION: ANOTHER VIEW OF THE TRUCKS PARKED NEXT TO THE UNLINED SHARED POND.

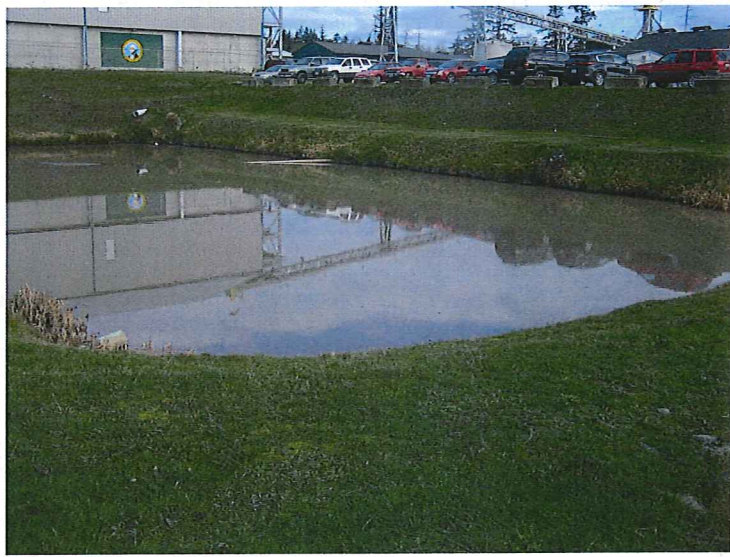
PHOTO #:04 DATE: 01/16/19

DESCRIPTION: THE WATER IN THE UNLINED SHARED POND WAS TURBID.

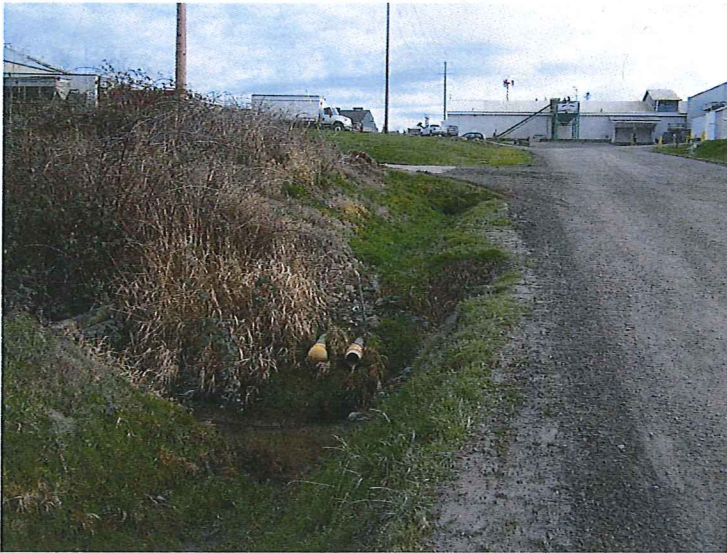
3), Then Jose and I walked down the shared access road to look at the shared pond's outlet pipe. I observed two 8" PVC white pipes downstream from the pond (see photos # 4-6), one was capped and one was discharging turbid water to the existing man-made ditch which flows north and across under the road to the Little Indian Slough. These two outlet pipes travel underground, approximately 150 feet from the pond to the existing man-made ditch. Between the pond and the outlet pipes is a pasture area, I observed cars, a trailer and two white vans parked in this area, on the west side of the pond. I informed Jose that the vehicles should be moved and not parked there because the area is so close to the shared pond.

PHOTO #05 DATE: 01/16/19
 TAKEN BY: JEANNE TRAN
 DESCRIPTION: TWO WHITE 8" PVC PIPES DRAINING THE UNLINED SHARED POND, ONE WAS CAPPED BUT THE OTHER WAS DISCHARGING. THE DISCHARGE WAS TURBID LOOKING.

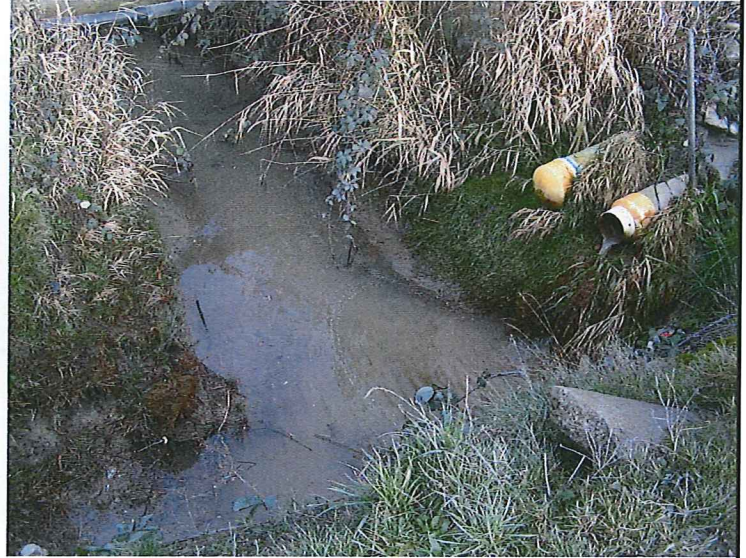
PHOTO #06 DATE: 01/16/19
 TAKEN BY: JEANNE TRAN
 DESCRIPTION: A CLOSE UP PICTURE OF PHOTO #5, WHICH SHOWS ONE PIPE WAS CAPPED AND THE OTHER WAS DISCHARGING TURBID WATER.

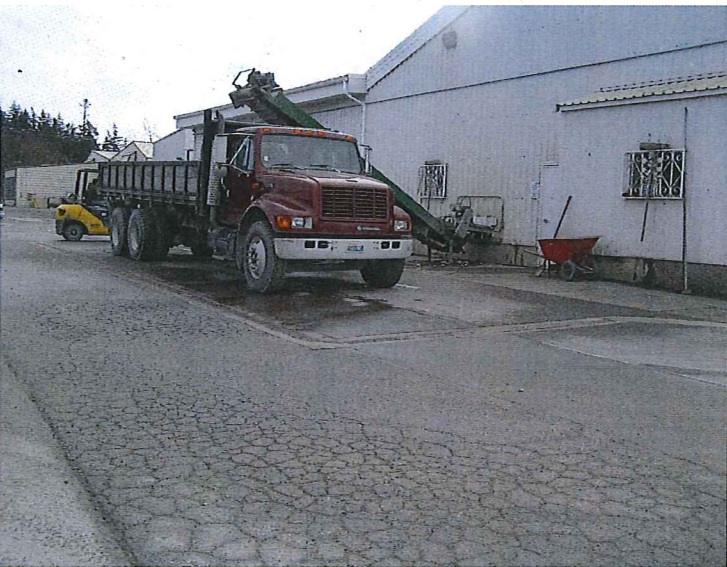
4) Next, we walked toward Hughes Farms' processing buildings. I noticed soil and off-spec potatoes were conveyed through a conveyor belt from the wash plant to the truck (see photos #7 and #8), to be taken back to the field. As can be seen on photos #7 and #8 where the potato truck was parked and being loaded with soil, this area is part of the drive way and stormwater runoff from this area drains to the shared pond.

PHOTO #07 DATE: 01/16/19
 TAKEN BY: JEANNE TRAN
 DESCRIPTION: THIS PICTURE SHOWS PART OF HUGHES FARMS' DRIVEWAY. DIRT AND OFF-SPEC POTATOES WERE CONVEYED FROM THE WASH BUILDING TO THE TRUCK. THE FULLY LOADED TRUCK WILL THEN BE TAKEN BACK TO FIELD.

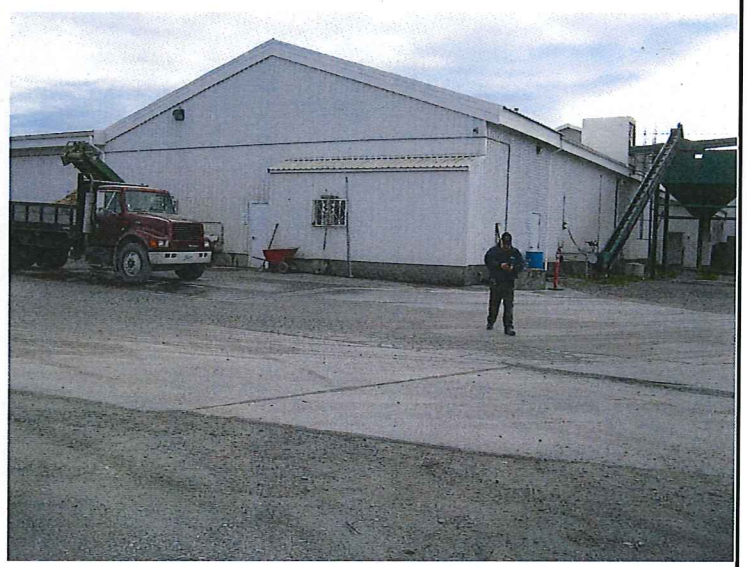
PHOTO #08 DATE: 01/16/19
 TAKEN BY: JEANNE TRAN
 DESCRIPTION: ANOTHER VIEW OF HUGHES FARMS' DRIVE WAY.

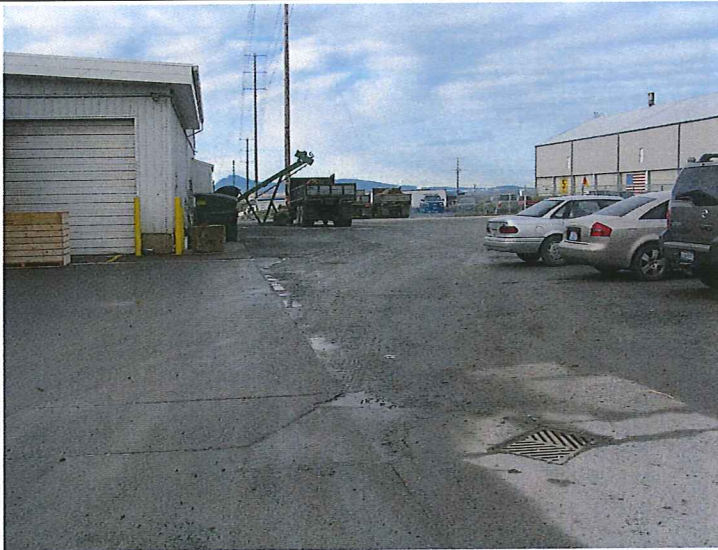
PHOTO #:9 DATE: 01/16/19

DESCRIPTION: ENTERING THE FACILITY, THE WASH PROCESSING OPERATION IS LOCATED IN A BUILDING ON THE RIGHT. THE LEFT SIDE ALONG THE FENCE LINE WAS USED FOR EMPLOYEE PARKING. ACCORDING TO JOSE, ALL THE STORMWATER DRAINS IN THIS AREA ARE CONNECTED TO THE LAGOONS.

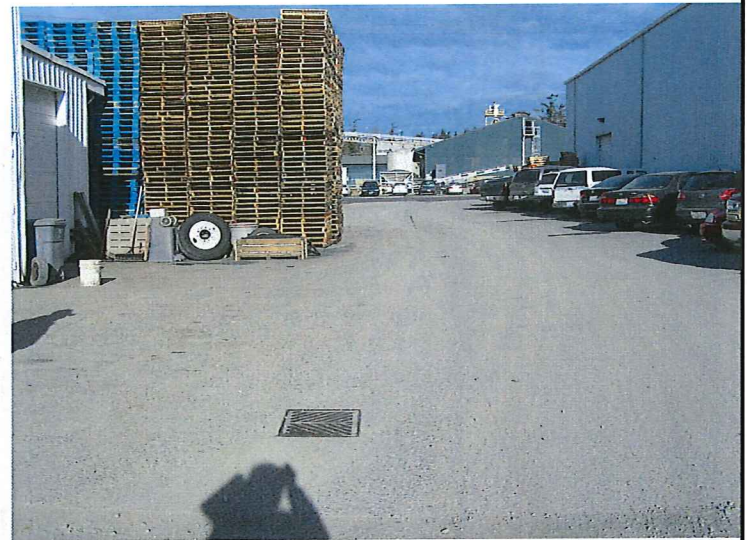
PHOTO #:10 DATE: 01/16/19

5) As we walked further, behind the processing buildings, behind the wash plant and storage buildings, I observed more employees' cars parked there, wooden pallets and miscellaneous items stored outside the buildings (see photos #9 and #10).

DESCRIPTION: ALONG THE BACK OF THE PROCESSING BUILDINGS, I OBSERVED MORE CARS PARKING AND STORAGE OF PALLETS, CONTAINER BINS, AND MISCELLANEOUS ITEMS.

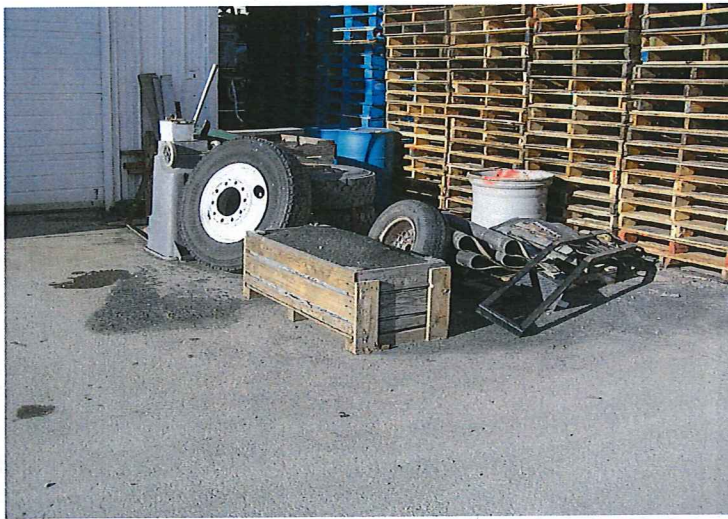
PHOTO #:11 DATE: 01/16/19

6) I observed a box of spent sand blasting grit stored outside the maintenance shop with no cover. The box was full with sand blasting grit which had spilled over onto the ground (see photo #11). I informed Jose that the spent sand blasting grit should be stored undercover to prevent rain water from coming in contact with it or hauled off-site for disposal. The sand blasting grit on the ground should be scooped up and disposed of properly.

DESCRIPTION: A BOX OF SAND BLASTING GRIT FOUND OUTSIDE OF THE MAINTENANCE SHOP, AND BLASTING GRIT FOUND ON THE GROUND. I INFORMED JOSE TO UTILIZE BETTER BEST MANAGEMENT PRACTICE BY STORING THE FRESH SAND BLASTING GRIT IN A CONTAINER, AND INDOOR IN ORDER TO PREVENT RAIN WATER FROM COMING IN CONTACT WITH THE GRIT. THE BLASTING GRIT ON THE GROUND SHOULD BE SCOOPED UP AND DISPOSED OF PROPERLY.

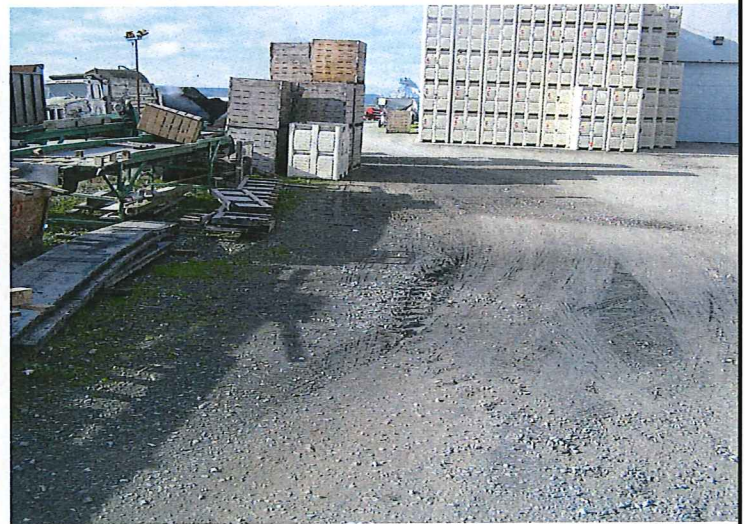
PHOTO #:12 DATE: 01/16/19

7) As we proceeded to the south end of the property, southwest of the facility boundary, I observed sand blasting grit and tire skid marks with dark greasy soil in this area (see photo #12). It appeared that car repair had been conducted in this area. The nearby storm drain was only a few feet away (see photo #13). Looking into this storm drain, I observed a substantial amount of sediment build-up in the drain. Even though this drain is draining to the lagoons for treatment, with this amount of sediment build-up, stormwater would most likely not able to drain well and might flood the area. I informed Jose that the storm drain needs to be cleaned out, and car repair cannot be conducted without tarping the area first. Car repairs should be conducted in an enclosed shop. I expressed my concerns to Jose that bad management practices can lead to polluting state water, and that housekeeping needs to be improved at the site.

DESCRIPTION: AS I WALKED FURTHER ALONG THE BACK BUILDINGS, ALONG SOUTHWEST AREA OF THE FACILITY PROPERTY BOUNDARY, MORE SAND BLASTING GRIT, TIRE SKID MARKS, AND DARK GREASY SOIL WERE FOUND IN THIS UNPAVED AREA. JOSE HAS ACKNOWLEDGED THAT CAR MAINTENANCE WAS PERFORMED THERE RECENTLY, AND TARPING WAS NOT USED. A NEARBY STORM DRAIN WAS ALSO FOUND IN THIS AREA. I INFORMED JOSE THAT CAR/TRUCK MAINTENANCE CANNOT BE PERFORMED ON AN UNPAVED AREA WITHOUT TARPING.

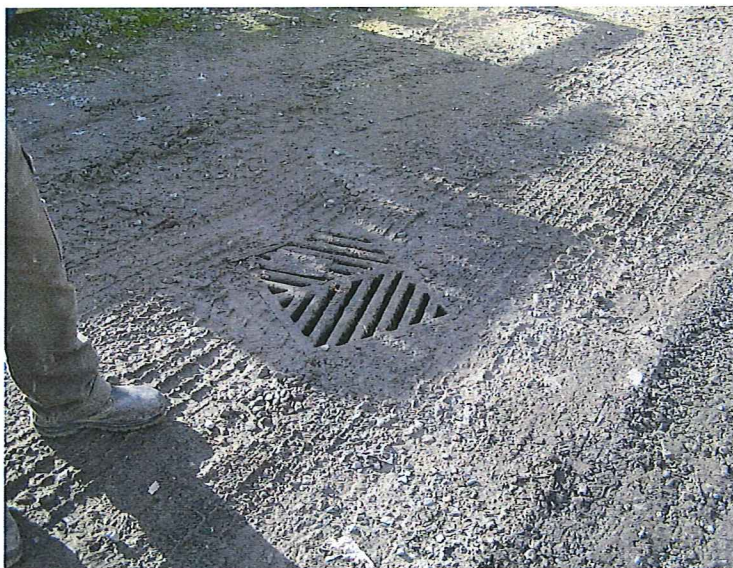
PHOTO #:13 DATE: 01/16/19
 TAKEN BY: JEANNE TRAN
 DESCRIPTION: A CLOSE UP PICTURE OF THE NEARBY STORM DRAIN MENTIONED IN PHOTO# 12. THIS DRAIN WAS PLUGGED WITH SEDIMENT, AND THE AREA WAS MUDDY AS CAN BE SEEN ON THE PHOTO. ACCORDING TO JOSE, THIS DRAIN IS CONNECTED TO THE LAGOONS.

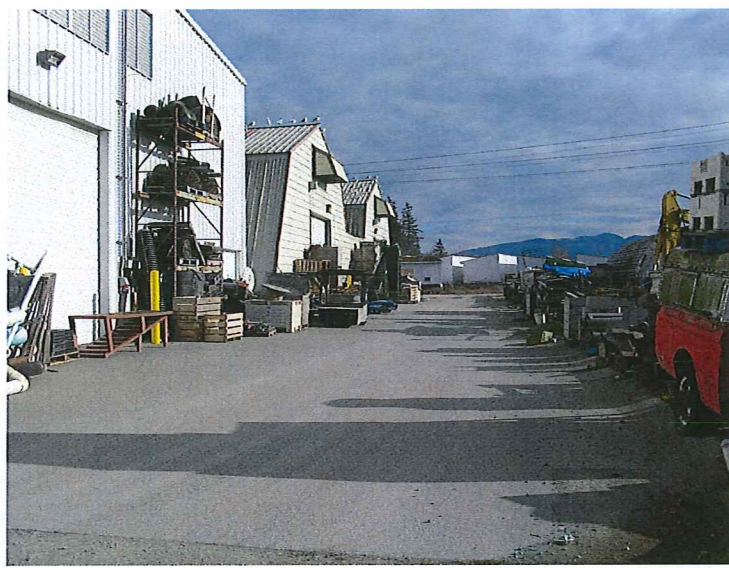
8) Southeast of the facility property boundary was used to store miscellaneous equipment (see photo #14). This area is paved.

PHOTO # 14: DATE: 01/16/19
 TAKEN BY: JEANNE TRAN
 DESCRIPTION: SOUTH EAST OF THE FACILITY PROPERTY BOUNDARY IS PAVED AND IS USED FOR STORING MISCELLANEOUS EQUIPMENT.

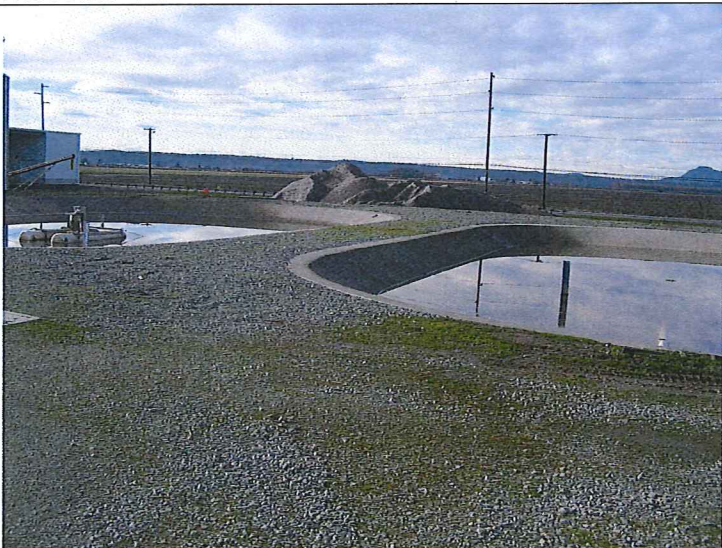
PHOTO #:15 DATE: 01/16/19
 TAKEN BY: JEANNE TRAN
 DESCRIPTION: HUGHES FARMS'S TWO LAGOONS.

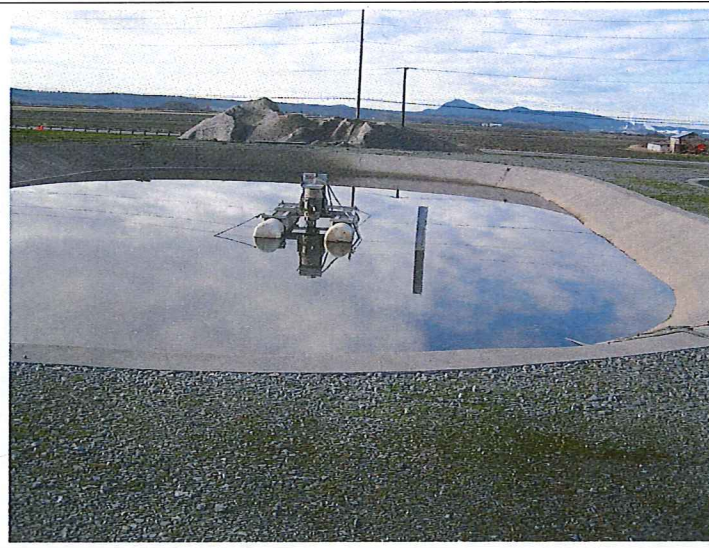
PHOTO #:16 DATE: 01/16/19
 TAKEN BY: JEANNE TRAN
 DESCRIPTION: A CLOSE UP PICTURE OF THE LAGOON SHOWING THE WATER IN THE LAGOON WAS $\frac{3}{4}$ FULL. THE WATER WAS CLEAR WITH SOME FLOATING MATERIAL ON TOP. JOSE MENTIONED THEY WILL NEED TO DISCHARGE SOON.

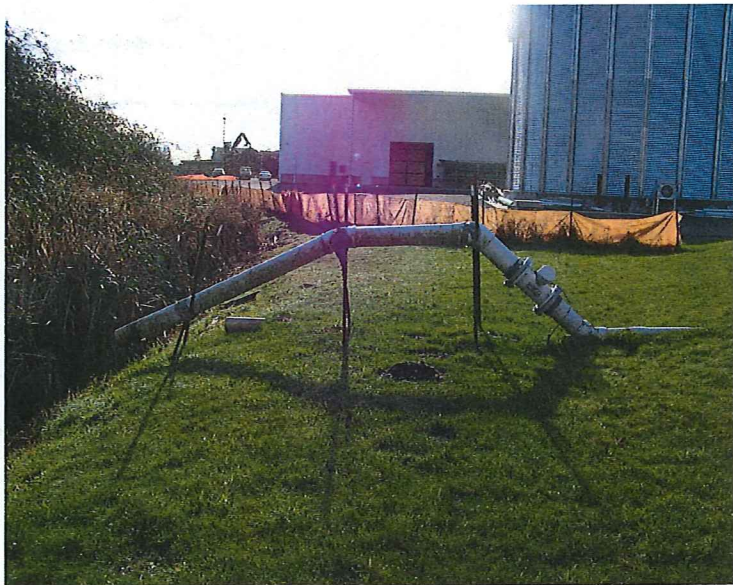
PHOTO #:17 DATE: 01/16/19
 TAKEN BY: JEANNE TRAN
 DESCRIPTION: THIS PICTURE SHOWS THE WHITE PVC DISCHARGE PIPE WITH A FLOW METER MOUNTED ON THE ELEVATED PIPE AND DISCHARGED TO THE EXISTING DITCH WHICH FLOWS NORTHWEST UNDER ACROSS FARM TO MARKET ROAD TO LITTLE INDIAN SLOUGH.

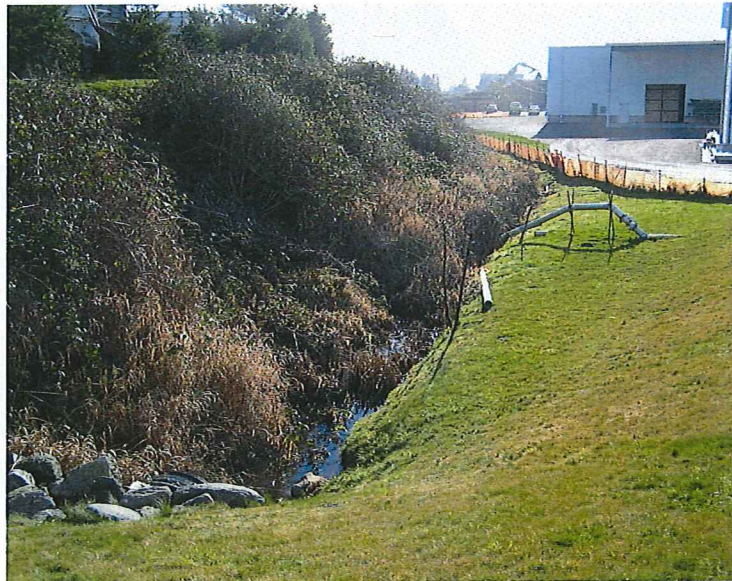
PHOTO #:18 DATE: 01/16/19
 TAKEN BY: JEANNE TRAN
 DESCRIPTION: ANOTHER VIEW OF THE EXISTING DITCH WHICH FLOWS NORTHWEST AND ULTIMATELY TO LITTLE INDIAN SLOUGH.

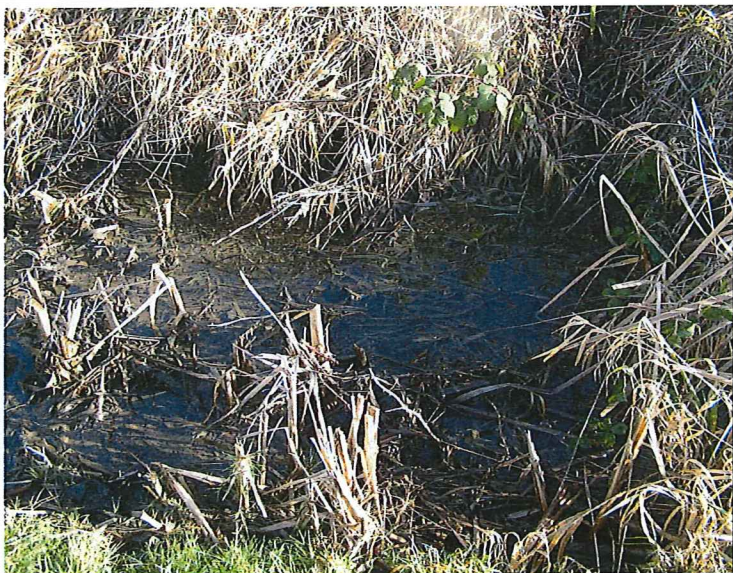
PHOTO #:19 DATE: 01/16/19
 TAKEN BY: JEANNE TRAN
 DESCRIPTION: A CLOSE UP PICTURE OF THE WATER IN THE DITCH. THE WATER LOOKED CLEAR.

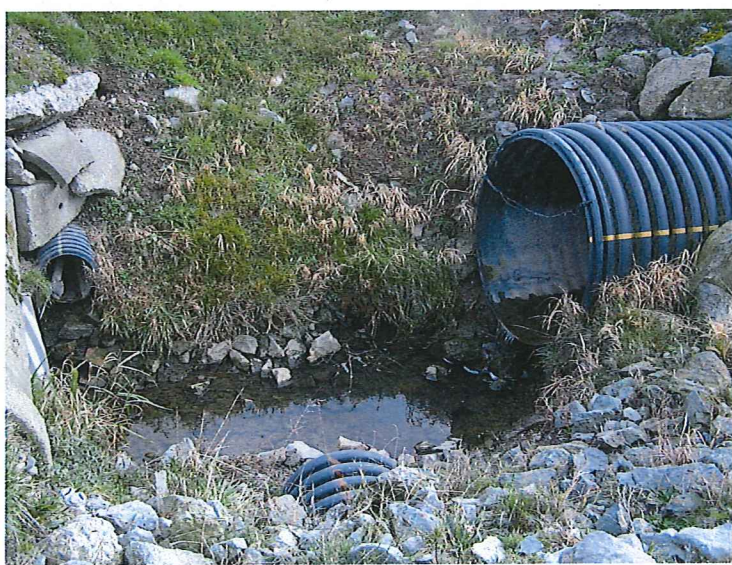
PHOTO #:20 DATE: 01/16/19
 TAKEN BY: JEANNE TRAN
 DESCRIPTION: WATER FROM THE MAN-MADE DITCH FLOWS TO A LARGE CULVERT (BLACK PLASTIC PIPE) WHICH ROUTES THE WATER THROUGH, UNDER AND ACROSS THE FARM TO MARKET ROAD AND TO THE LITTLE INDIAN SLOUGH.
