State of Washington Department of Ecology
Northwest Regional Office
**STORMWATER COMPLIANCE INSPECTION
REPORT**

Inspection Date March 26, 2019	NPDES Permit # WA-00 30830	County King	Receiving Waters Mud Lake Creek, Ginder Lake, Lake 12
-----------------------------------	--------------------------------------	----------------	---

Name and Location of Facility Inspected PACIFIC COAST COAL COMPANY, 30700 Black Diamond-Ravensdale Road Black Diamond, WA 98010	Entry Time 1:10 pm	Permit Effective Date March 01, 2008
	Exit Time 6:00 pm	Permit Expiration Date January 11, 2013 Permit extended

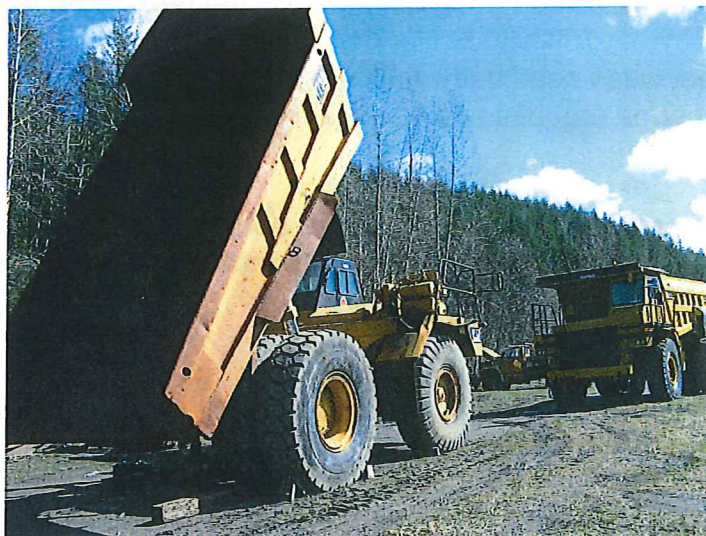
Photo 1: Pacific Coast Coal Company

- 2) We saw heavy earth moving equipment on site (Photo 1). Mr. Morris informed us that he has purchased some equipment from other states and he is in the process of getting some more. He was planning to get all the equipment up and running for reclamation. Mr. Eric Wheeler, who is an independent contractor, will be working on the site for reclamation.

Description: Newly purchased on-site equipment.

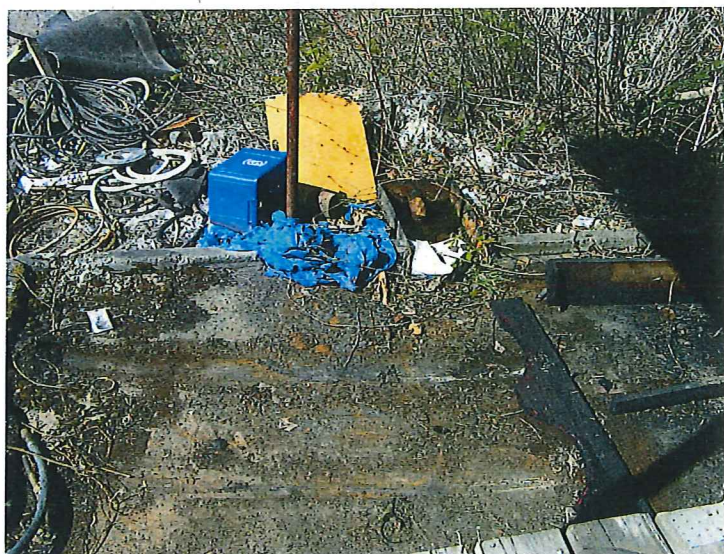
Photo 2: Pacific Coast Coal Company

- 7) After Mr. Morris left we walked to the fuel and oil storage area. Most of the containers were removed from the area but we saw a few containers lying all around the fuel storage area. Berm around this storage area was damaged at a few locations and the cover was too high to prevent rain from falling in this area. (Photo 2, 3, 4).

Description: Berm around the fuel and oils storage area was damaged at few locations. Overall cleaning and maintenance needed in this area. Either clean this area prior to decommissioning or provide better secondary containment and cover to avoid rain exposure.

PCCC must store or dispose of oil containers appropriately. Fuel storage area should either be cleaned before decommissioning or repairs/maintenance must be done prior to using this area for any kind of fuel storage

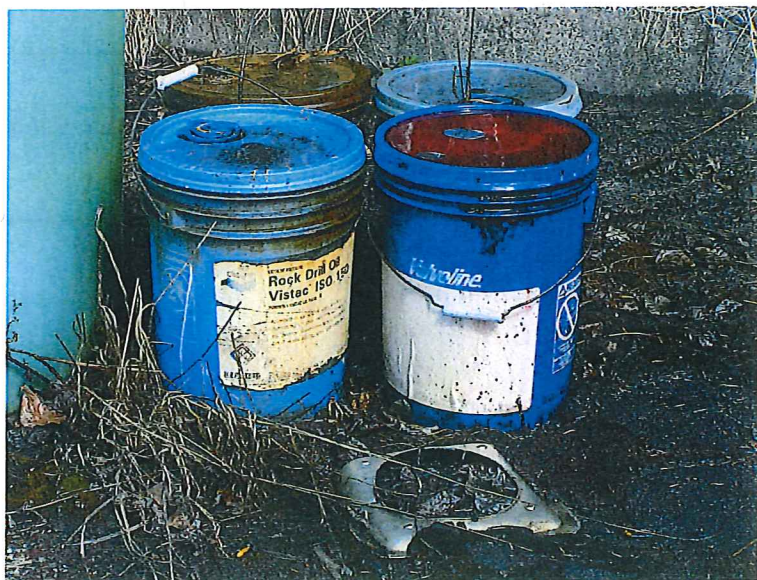
Photo 3: Pacific Coast Coal Company

Description: Oil lubricant containers on site. These containers need to be disposed-off properly or moved to a covered area.

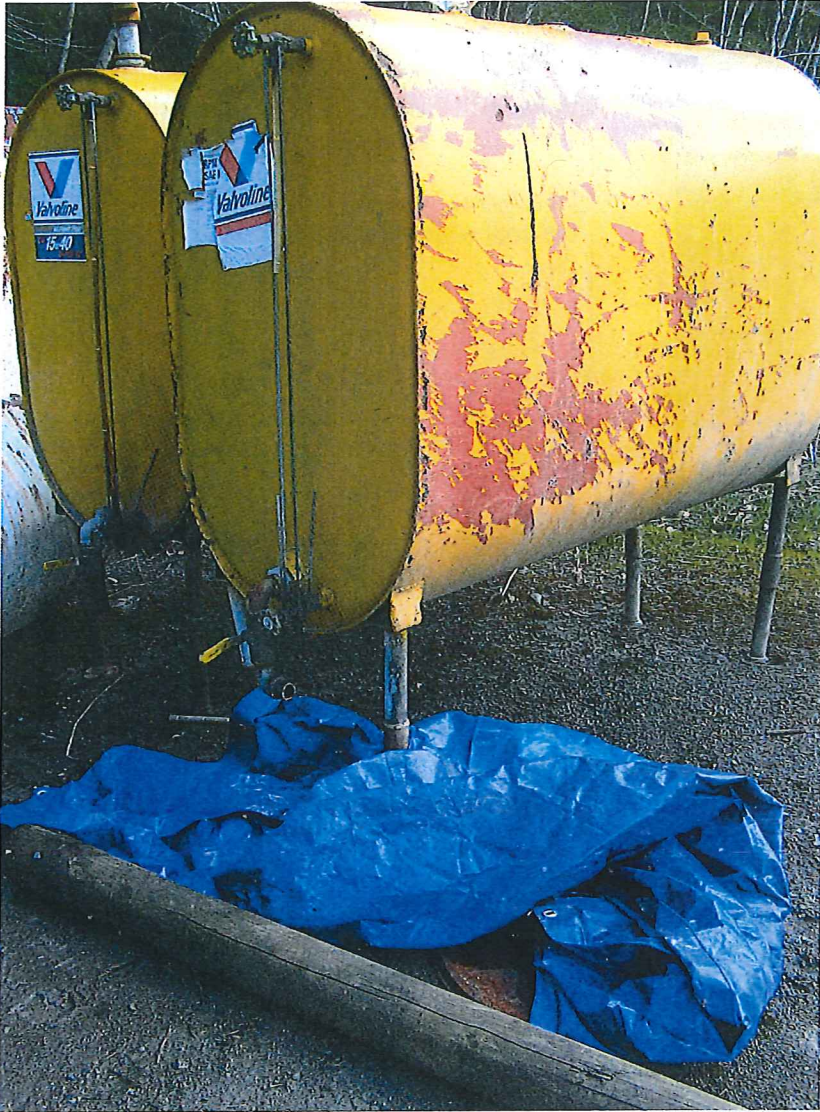
Photo 4: Pacific Coast Coal Company

Description: Oil tanks. Crumpled tarpaulin was placed under the tap to capture drips. We could not find whether the tanks were empty or filled. BMPs should include cover and containment as well as drip pans.

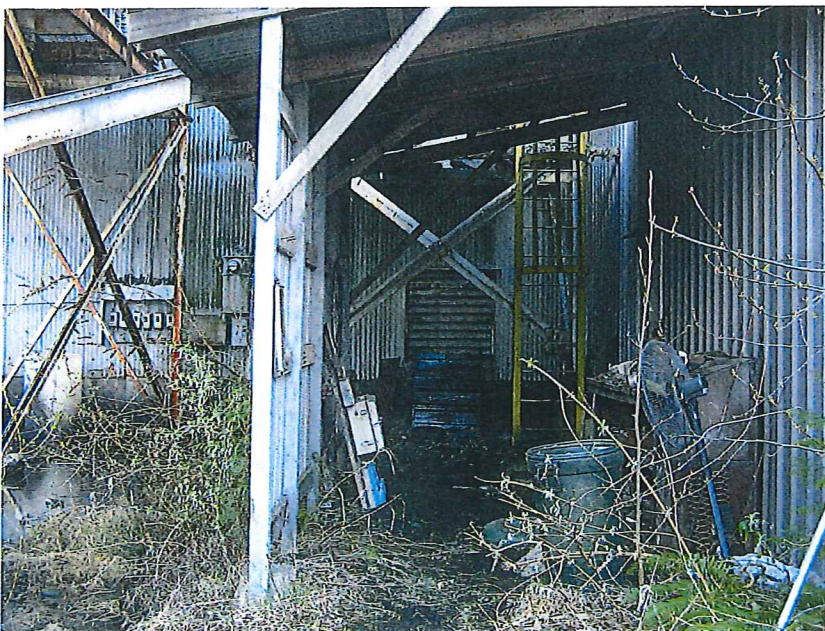
Photo 5: Pacific Coast Coal Company

- 8) We noted water flowing out of the coal washing plant (Photo 5, 6). This water was flowing downhill in the direction of Ginder Lake. We also observed sheen on the water. Later when we met Mr. Smith, he informed us that there is a leakage in the coal washing plant and he is working to fix it.

Description: Water Leakage from the Coal Washing Plant. This is a closed circuit plant with no process water discharge. No coal washing was happening at the time of the inspection. Mr. Smith was working to find the source of the leakage.

Based upon visual inspection it appeared that wheel wash and coal washing plant need significant maintenance before beginning operation. Current permit requires wheel wash to be improved before resuming hauling offsite.

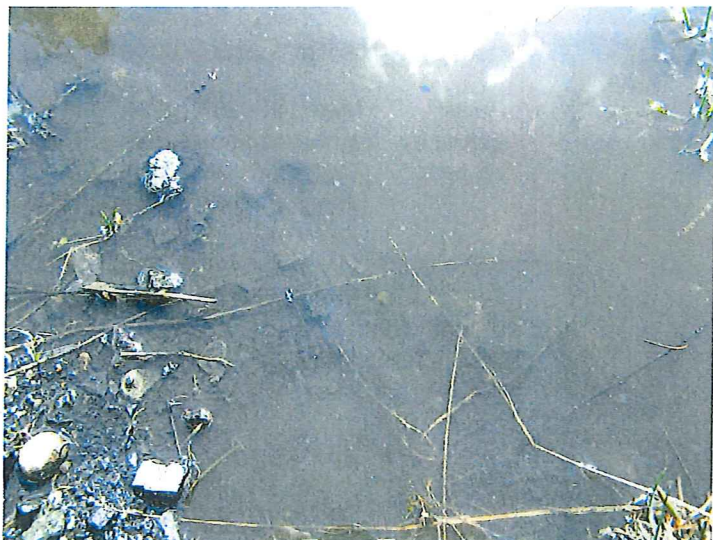
Photo 6: Pacific Coast Coal Company

Description: Sheen on the water flowing out of the coal washing plant.

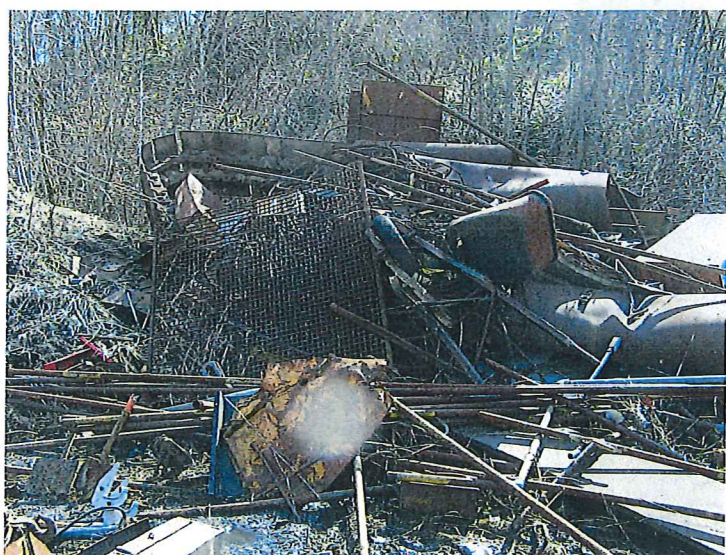
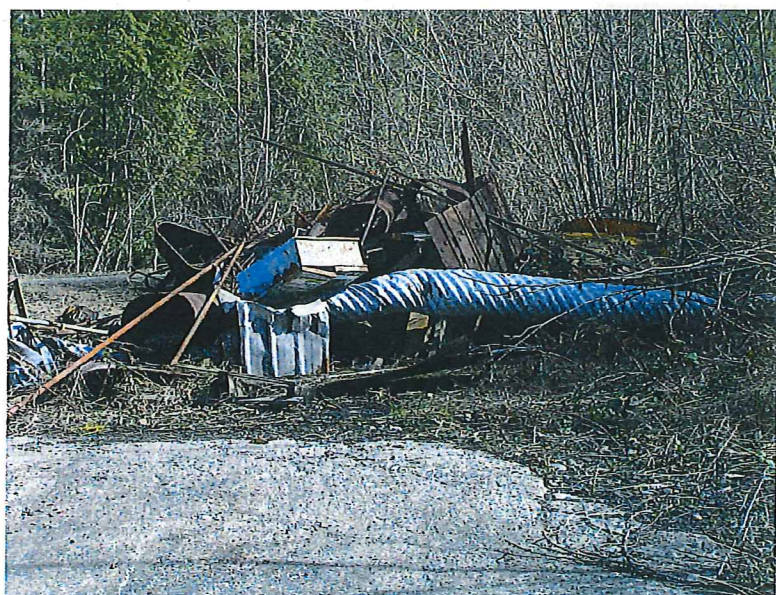
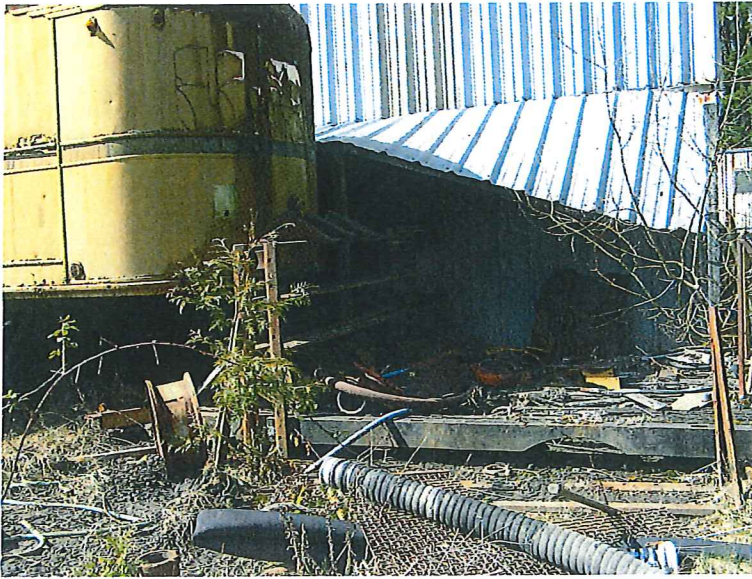
- 9) There was metallic waste piled up in coal processing area, fuel storage area and few other places on site (Photo 7, 8, 9).
 - 10) We drove around the site and did not see any mining or reclamation activities. Then we drove to the Water Quality monitoring locations. We did not observe anything out of the ordinary at these locations.

Description: Metallic and other waste around the site.

Metallic waste and other waste should be stored or disposed of appropriately. Ecology recently sent warning letter to PCCC for not meeting copper effluent limits. Better maintenance and storage of metallic waste on site can improve compliance with the permit limits.
