CONSTRUCTION STORMWATER COMPLIANCE INSPECTION REPORT

State of Washington Department of Ecology

Facility Name and Location of Site Inspected: Stetson Heights Northwest of Glenwood Rd SW & SW Sedgwick Rd Port Orchard, WA 98367	Coordinates 47.49266 -122.66501	Entry Time 1:05 pm Exit Time 1:55 pm
On-Site Representative Name: Robert Terhune Title: CESCL Phone: (253) 561-1569 Email: terhune.robert.clyde.4@gmail.com	Additional Participants: Darren and Ian with Port Orchard

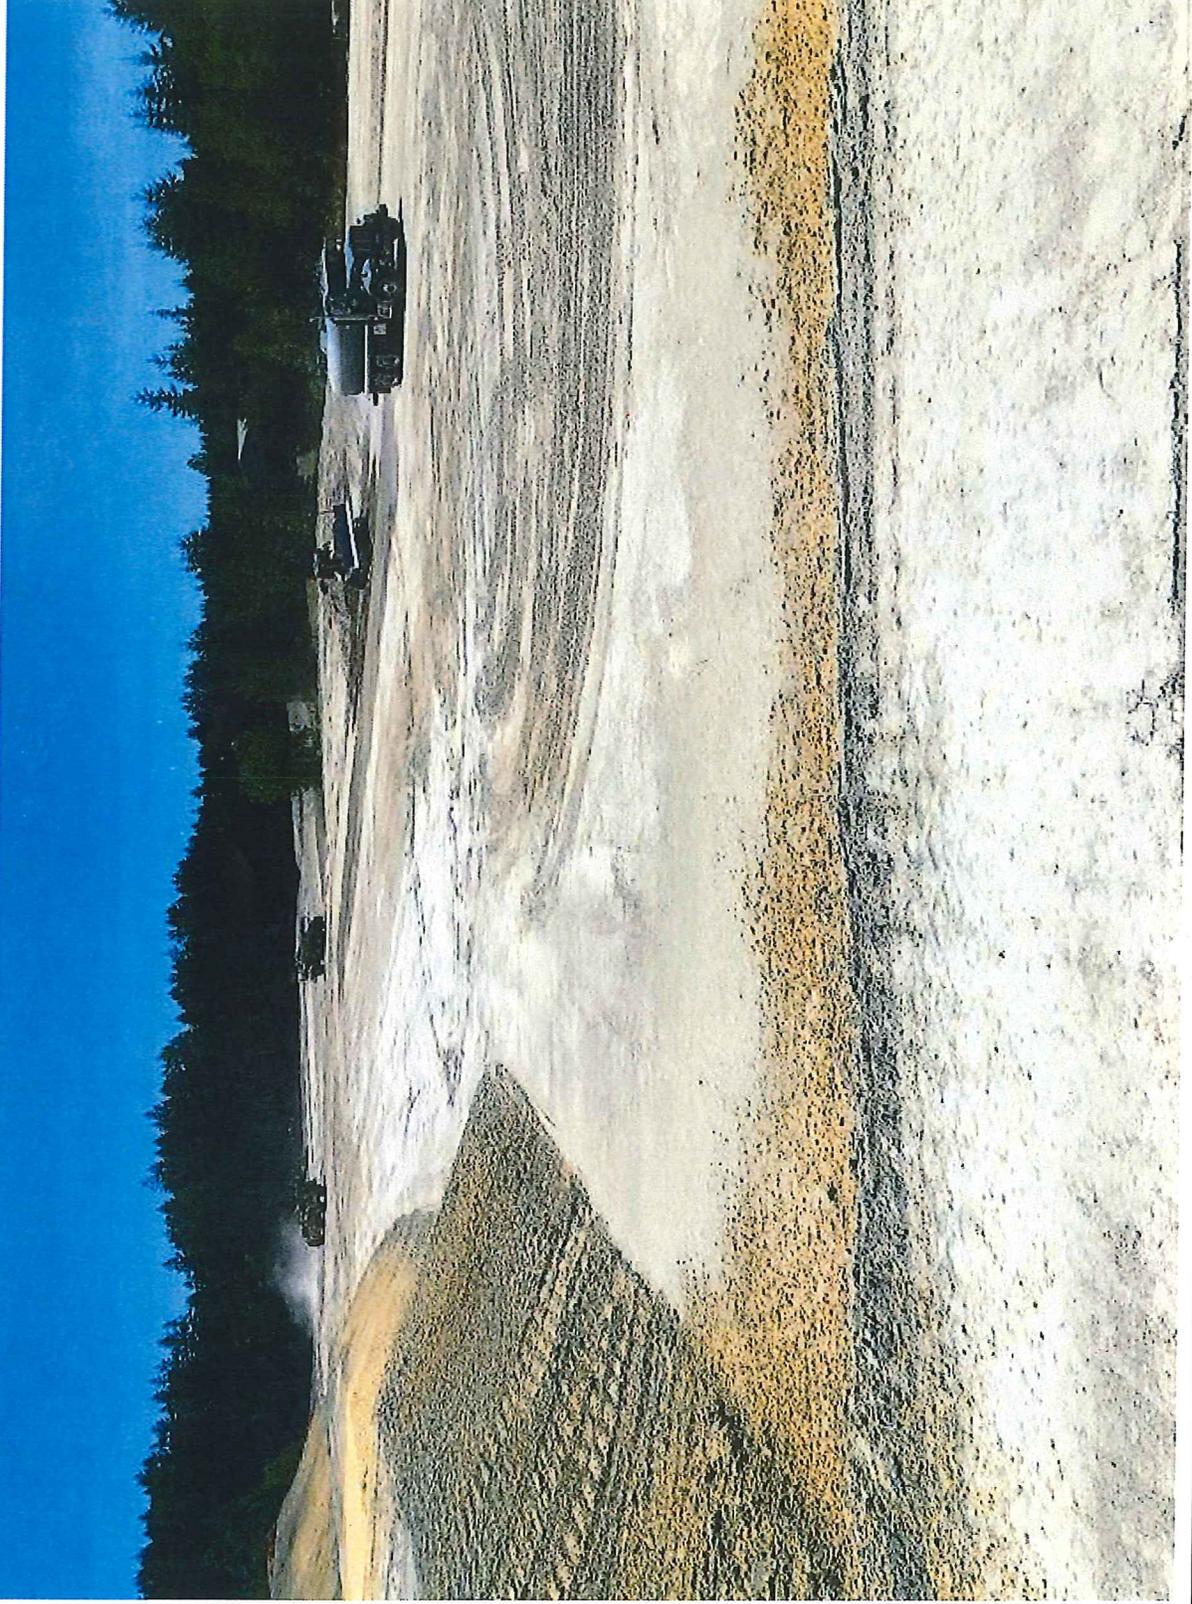
Photo 1

I met with the CESCL as their dust control product was being delivered. He said he planned to apply this product on Friday because it takes 72 hours to set up. One of two water trucks on site that was being utilized (Photos 1-2). The water truck was just covering the roads and equipment was still producing dust (Photo 1). Hydroseed applied previously this spring has sparse growth and more recently applied areas are dry and not yet growing (Photos 1 & 3).

Photo Description: Equipment still producing dust with one water truck running. Hyrdoseed in this area was dry and not growing yet.

<u>Violations and action required to achieve compliance</u>	<u>Complete or submit date</u>	<u>Guidance</u>
<u>S9.D.5 Stabilize Soils</u> Failure to meet S9.D.5.a: The Permittee must stabilize exposed and unworked soils by application of effective BMPs that prevent erosion. Applicable BMPs include, but are not limited to: temporary and permanent seeding, sodding, mulching, plastic covering, erosion control fabrics and matting, soil application of polyacrylamide (PAM), the early application of gravel base on areas to be paved, and dust control. Increase use of water trucks or dust control applications as needed.	Immediately begin. Address the problems no later than 7 days from the date of this inspection.	C120 , C121 , C122 , C123 , C124 , C125 , C126 , C130 , C131 , C140
<u>S9.D.11 Maintain BMPs</u> Failure to meet S9.D.11.a: Permittee must maintain and repair all temporary and permanent erosion and sediment control BMPs as needed to assure continued performance of their intended function in accordance with BMP specifications. Continue to water hydroseed to ensure seed growth and soil stability.	Immediately begin. Address the problems no later than 7 days from the date of this inspection.	SWMMWW, Chapter II-4 Best Management Practices Standards and Specifications

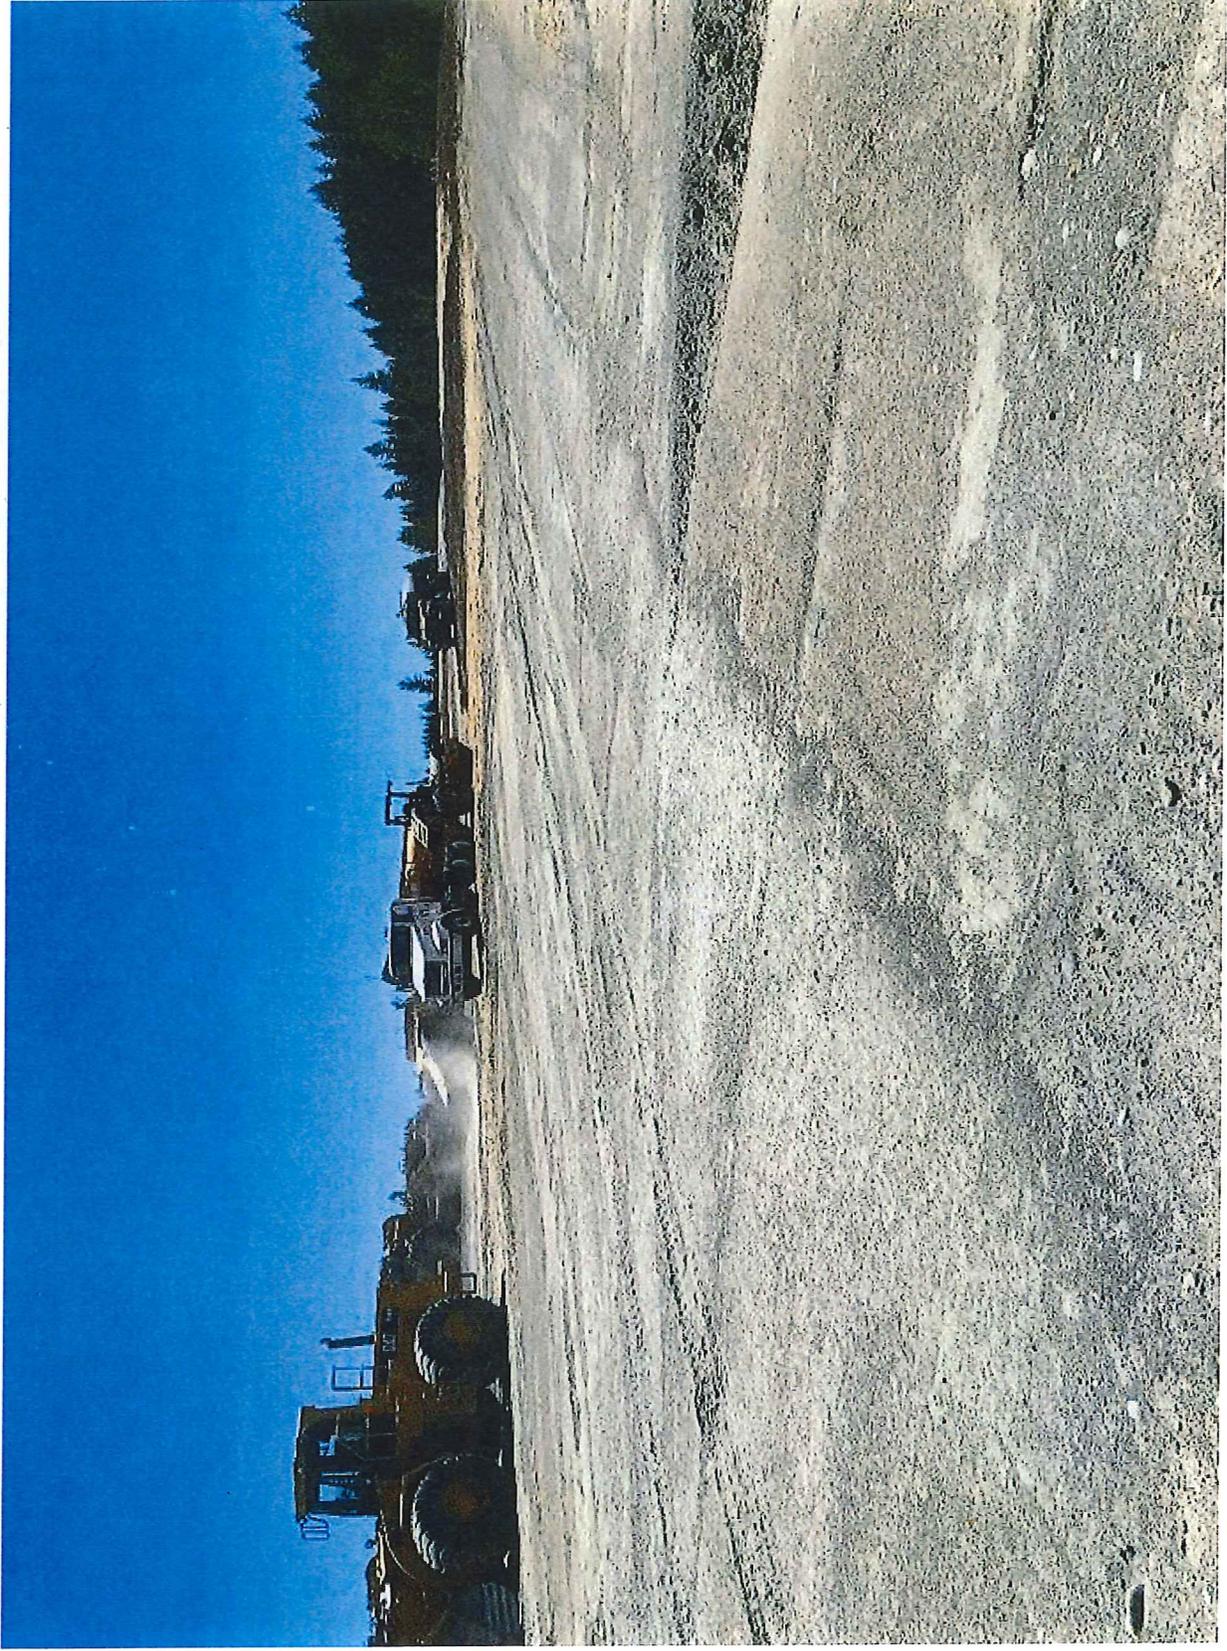
Photo 2

Photo Description: A second water truck was on site but not being utilized.

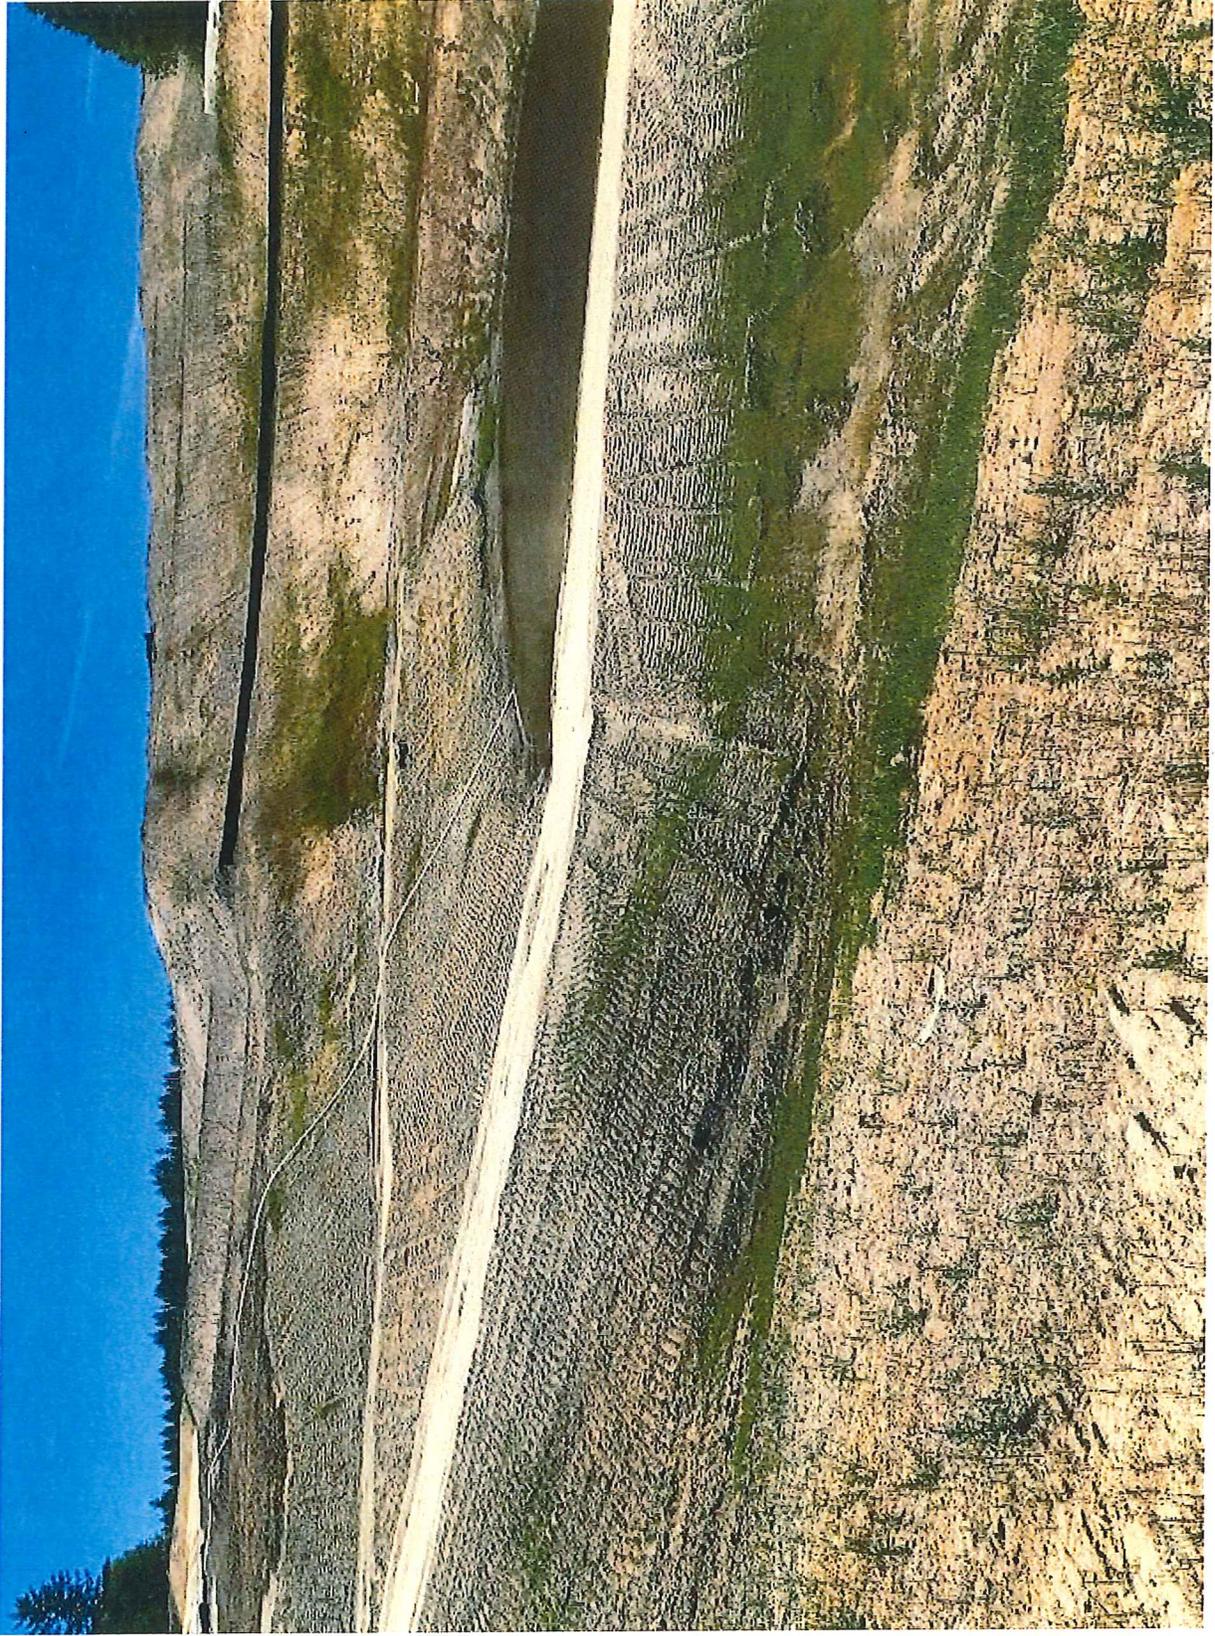
Photo 3

Photo Description: Sparse hydroseed growth.
