STORMWATER COMPLIANCE INSPECTION REPORT

State of Washington Department of Ecology
3190 – 160th Avenue SE, Bellevue, WA 98008-5452

Name and Location of Site inspected Meltec Division of Young Corp 3444 13 th Ave SW Seattle, WA 98134-1031	GPS datum: NAD83 Entrance: Lat:47°34'21.8" Long:122°21'07.2"	Discharge: Lat:47°34'20.7" Long: 122°21'06.8"	Entry Time 9:30 am	Permit Effective Date
On-Site Representative(s): Name(s)/Title(s)/Contact number(s) or E-mail Alan Casebere / Safety & Environmental Director / (206) 624-1071			Exit Time 11:05 am	Permit Expiration Date 9/20/2007
Responsible Official(s): Alan Casebere Young Corporation Meltec PO Box 3522 Seattle, WA 98124-3522 Phone: (800) 321-9090			Additional Participants:	
			Samples Taken? <input type="checkbox"/>	Yes <input type="checkbox"/> No <input checked="" type="checkbox"/>
			Photos Taken? <input checked="" type="checkbox"/>	<input type="checkbox"/>

PHOTO ADDENDUM – MELTEC DIVISION OF YOUNG CORP / SO3000639D

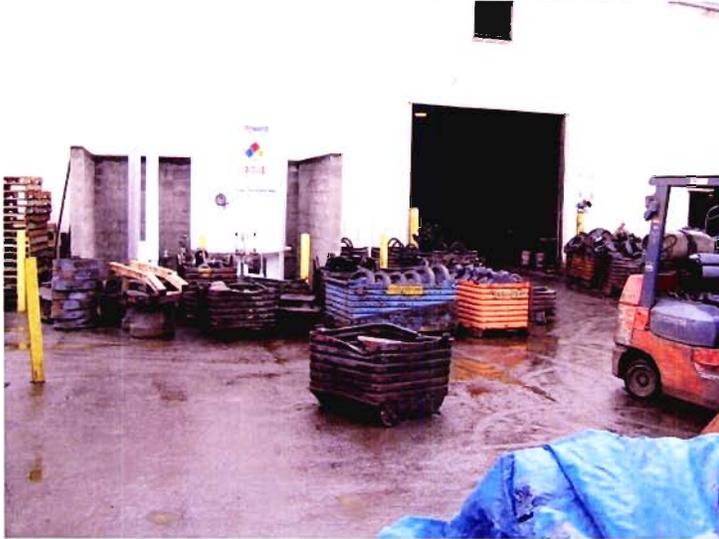
Recycled metal parts, finished metal forms, metal slag, wood, and waste sand were stored in exposed metal crates throughout the facility's outside lot (photos P2280394, P2280408, P2280406, P2280407, P2280417, P2280414, & P2280409). Inspectors told Mr. Casebere that if more of these crates were covered, especially those that appeared to be the most polluting, the amount of turbidity and zinc contamination in stormwater could possibly be reduced (photo P2280408).

P2280394.JPG **DESCRIPTION:** OUTSIDE METAL STORAGE. DIRT ACCUMULATION ON LOT.

- Good Housekeeping practices should be implemented on-site in order to reduce stormwater pollution potential from items such as stored leaky barrels collecting stormwater on site. Ensure that all chemical drums (including empty drums) are properly sealed and clean on their exteriors. If the drums are stored outdoors consider storing them under cover if possible. Consider covering crates that hold materials with the highest potential to contaminate stormwater.

- There was sediment and debris accumulated on the facility's lot especially at the eastern end. Increase the sweeping and cleaning frequency of the lot to prevent discharges of turbid water and contamination from industrial waste to the catch basins.

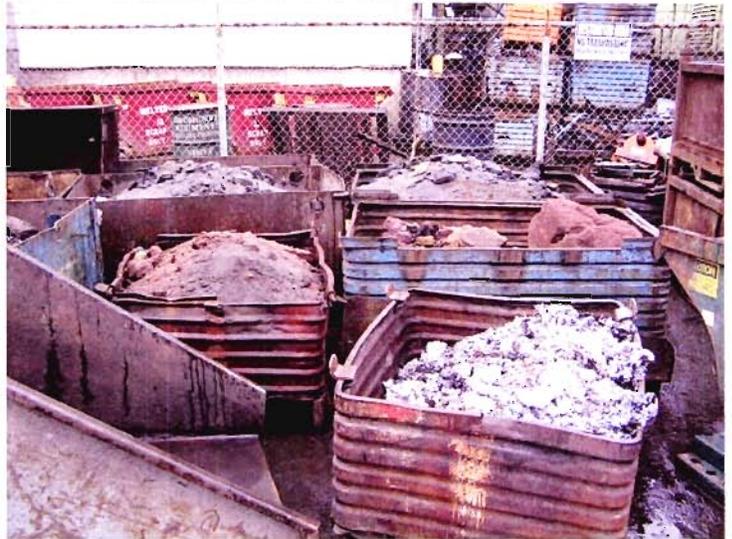
P2280408.JPG **DESCRIPTION:** EXPOSED CRATES OF WASTE SAND AND SLAGG STORED OUTSIDE.

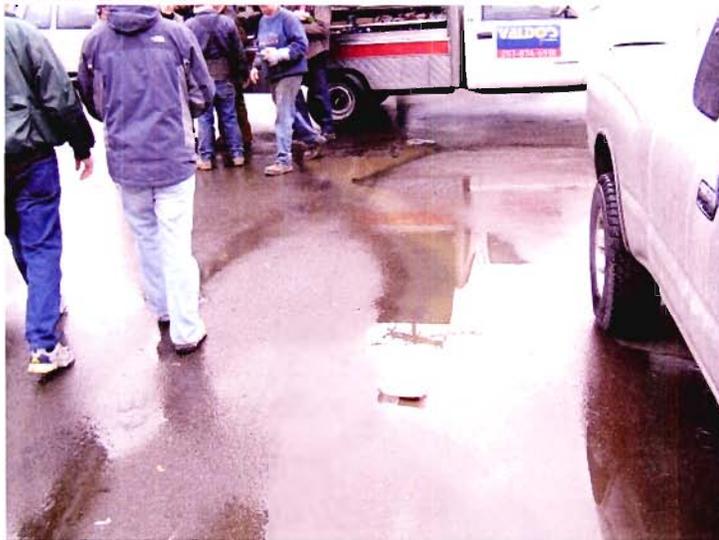
All catch basins onsite were fitted with filter socks and oil booms. Mr. Casebere said that these inserts were changed frequently. Inspectors observed turbid stormwater discharging to catch basins (photos P2280399 & P2280400). Inspectors observed dirt and industrial debris accumulating on the asphalt surface of the facility's lot (photos P2280394 & P2280425). Most of the dirt accumulation was observed behind the main building at the east end of the facility. Mr. Casebere said that the lot was swept approximately every other day. Mr. Casebere said that in November the facility's lot had been power-washed, and the captured wash water had been disposed of by the contractor. This power-washing operation had not treated the east end of the facility.

P2280399.JPG **DESCRIPTION:** TURBID WATER FLOWING INTO THE PARKING LOT AND DISCHARGING INTO STORM DRAIN.

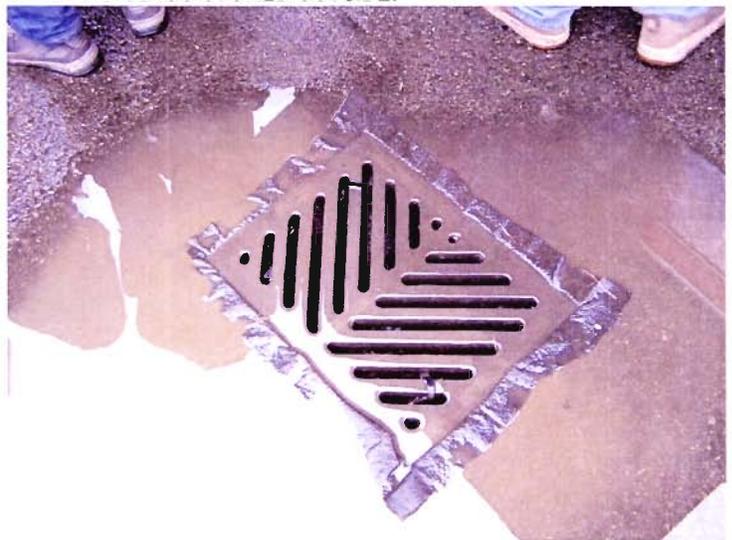
P2280400.JPG **DESCRIPTION:** TURBID WATER DISCHARGING TO STORM DRAIN. STORM DRAIN FITTED WITH FILTER INSERT AND OIL BOOM.

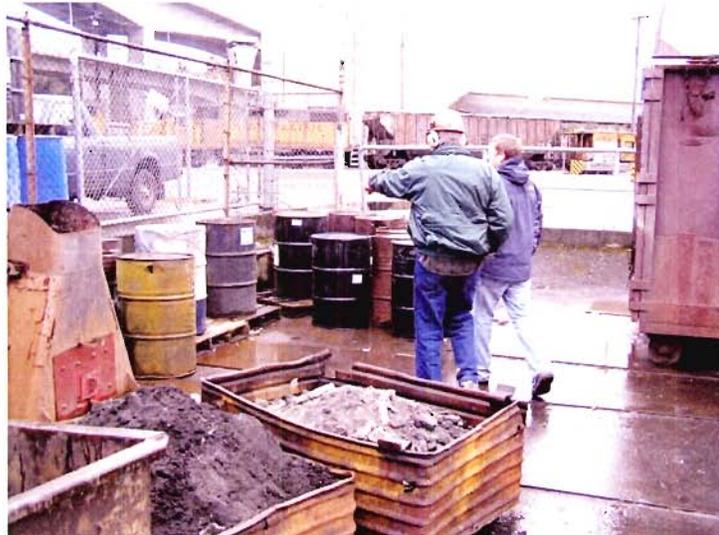
Several empty barrels with multiple punctures were stored outside at the southwestern corner of the facility (photo P2280406). Mr. Casebere said that these barrels once held a binding material for the sand molds. The punctures were inflicted as part of the process of draining the barrels. Inspectors told Mr. Casebere that stormwater could enter these barrels through the punctures and become contaminated with the binding material. This contaminated stormwater could then leak out and discharge offsite.

P2280406.JPG **DESCRIPTION:** SOUTHWEST CORNER WHERE PUNCTURED EMPTY BARRELS ARE STORED.

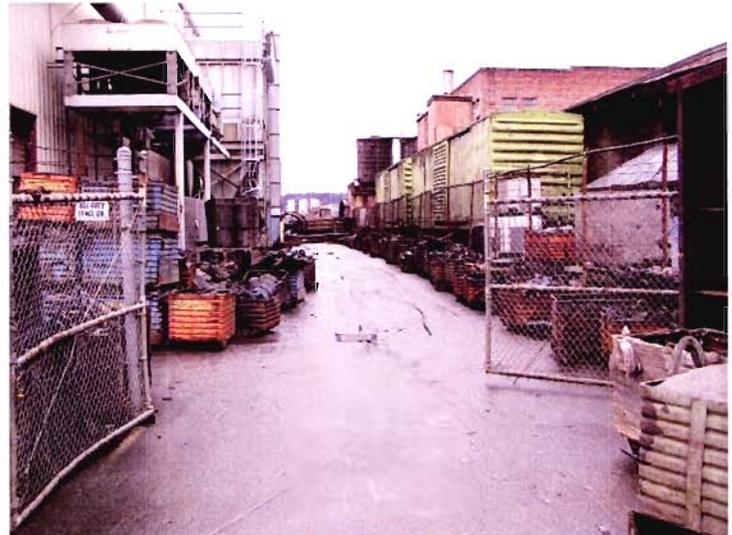
P2280407.JPG **DESCRIPTION:** LOOKING EAST ALONG THE SOUTH SIDE OF FACILITY MAIN BUILDING.

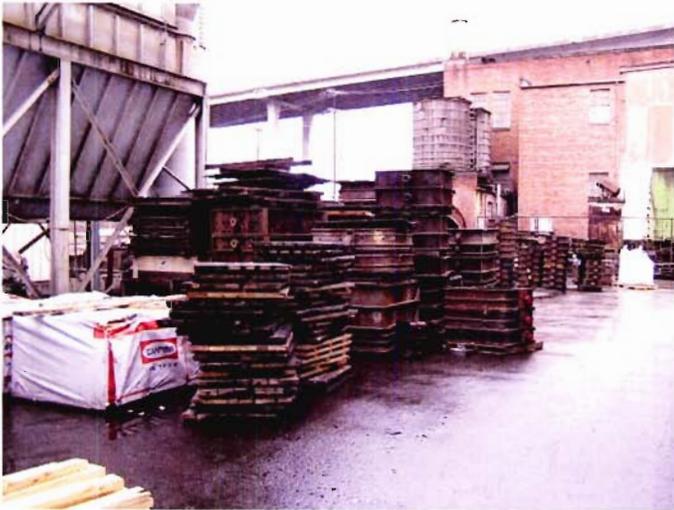
P2280417.JPG DESCRIPTION: EAST SIDE OF FACILITY. STORAGE OF WOOD FORMS, AND METAL CASINGS.

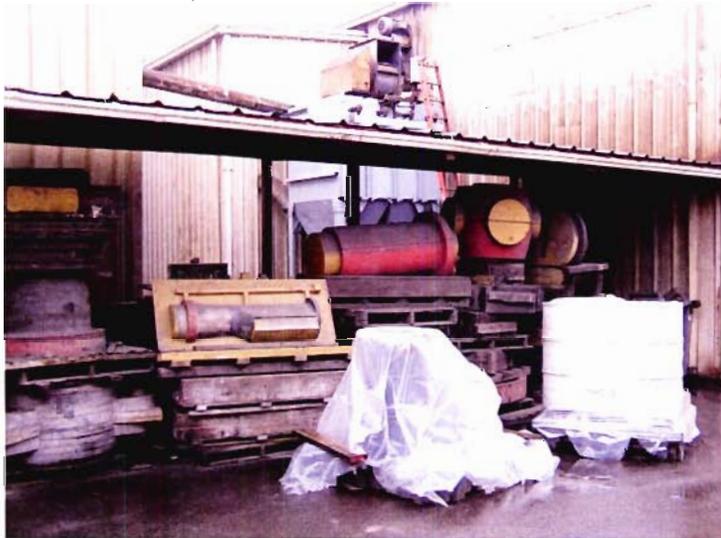
P2290420.JPG DESCRIPTION: BARRELS FILLED WITH BINDING MATERIAL STORED UNDER COVER AND IN SECONDARY CONTAINMENT.

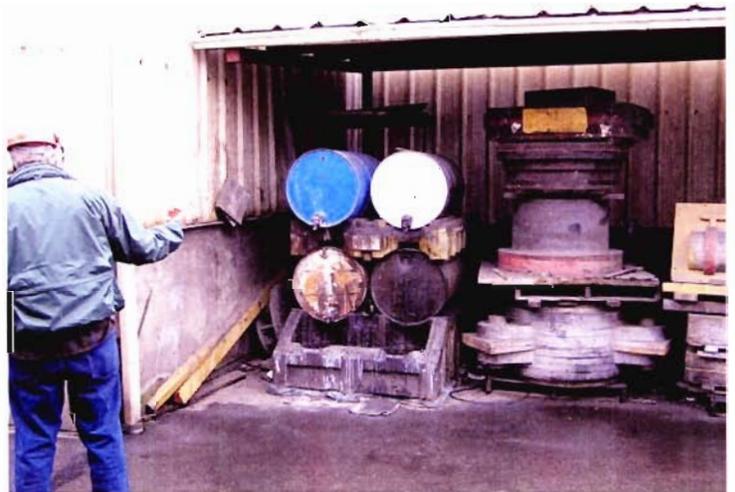
The full barrels of binding material were stored within secondary containment, and covered in plastic (photo P2280419). Those barrels being actively used were stored under cover with secondary containment and drip pans (photo P2280419).

P2280419.JPG DESCRIPTION: ADEQUATE CHEMICAL HANDLING PROCEDURE; COVER, SECONDARY CONTAINMENT, AND DRIP PANS.

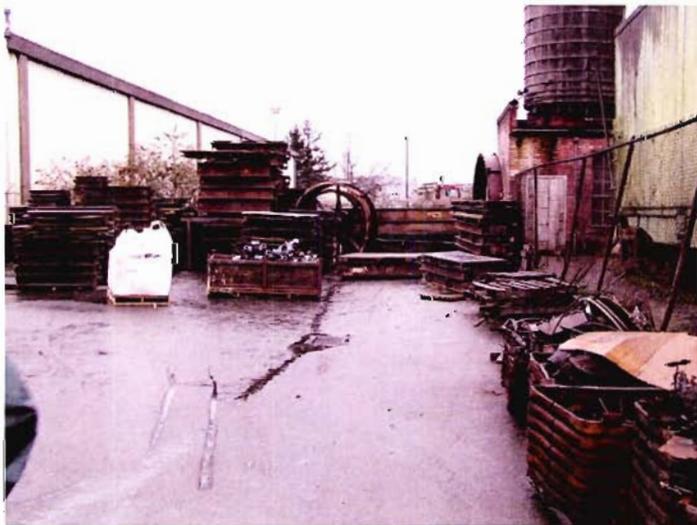
P2280414.JPG DESCRIPTION: SOUTHEASTERN PORTION OF FACILITY. OUTSIDE METAL STORAGE.

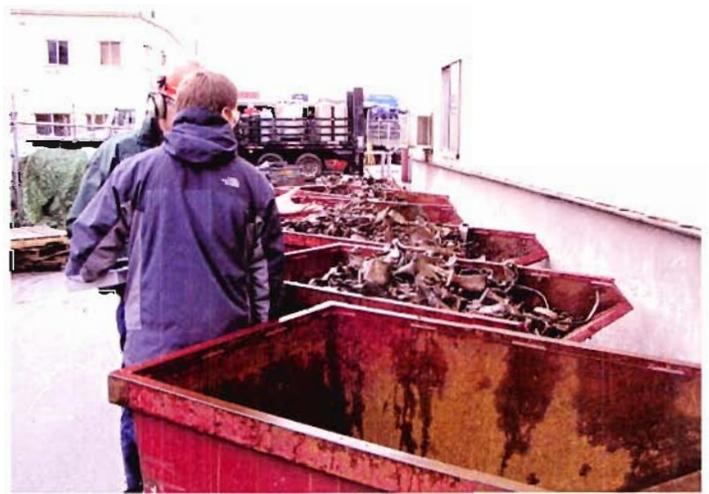
P2280409.JPG DESCRIPTION: WEST SIDE OF FACILITY BUILDING. STORAGE OF INCOMMING SCRAP METAL.
