WA0020729 Dayton STP OO Visit of 04-10-2012

Report Date: 04-25-2012

Re: Technical Assistance

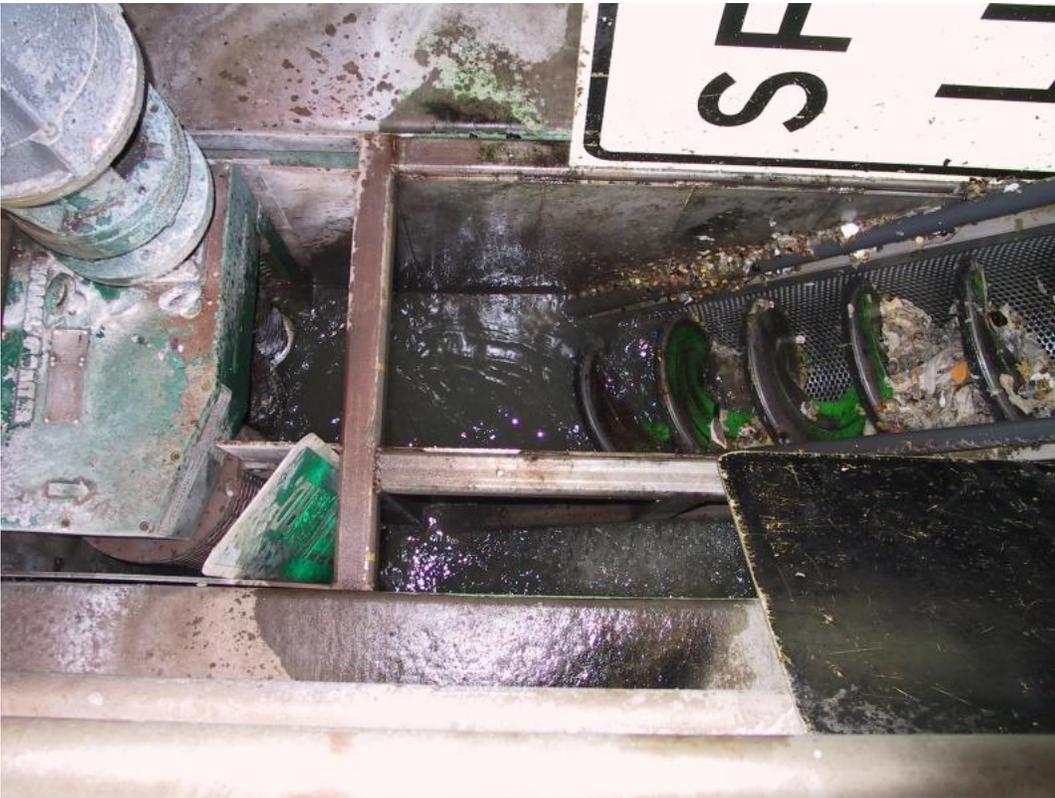
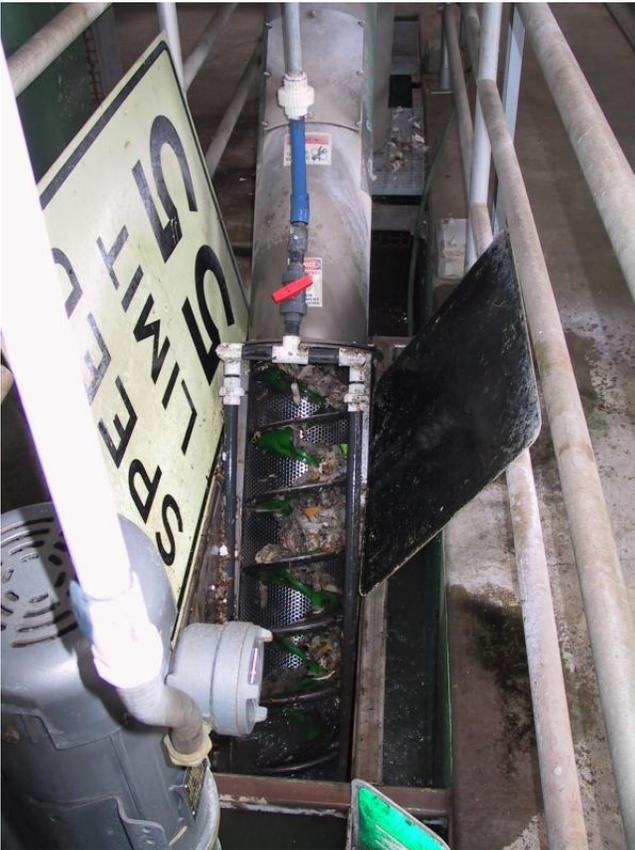
Then we toured the plant. I mainly wanted to see what they'd done in the influent channel ahead of the fine screen. They've attached a street sign in the 1/3 of the channel where it was bypassing the screen before. Some flow was still getting through. But more importantly, the rags and debris caught and transported by the fine screen appeared dryer than before (which is a good thing). Two other signs are being used to reduce splashing from the screening device.

Photos below are of the screening area.

Some small debris and grease balls still get through, but an inspection of the downstream wet well showed a definite improvement from previous visits.

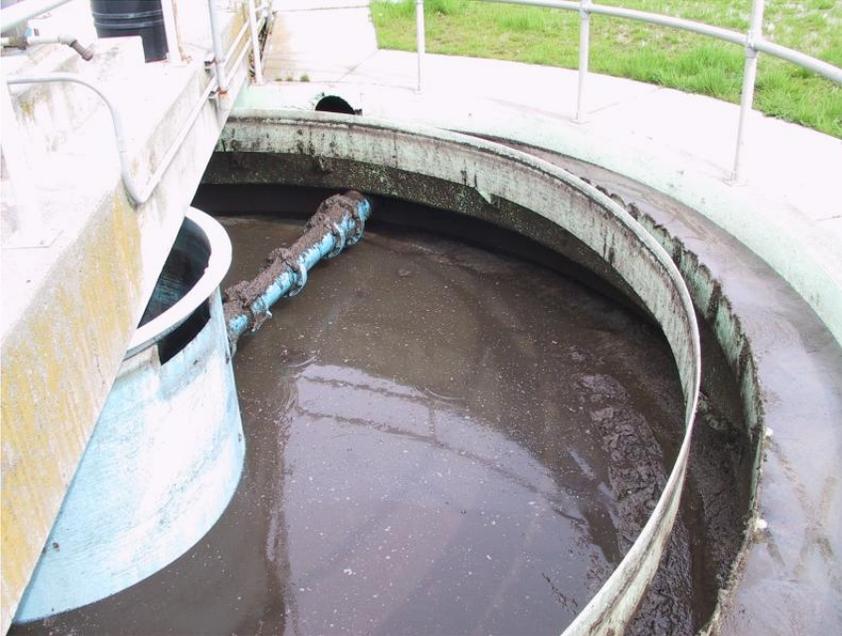
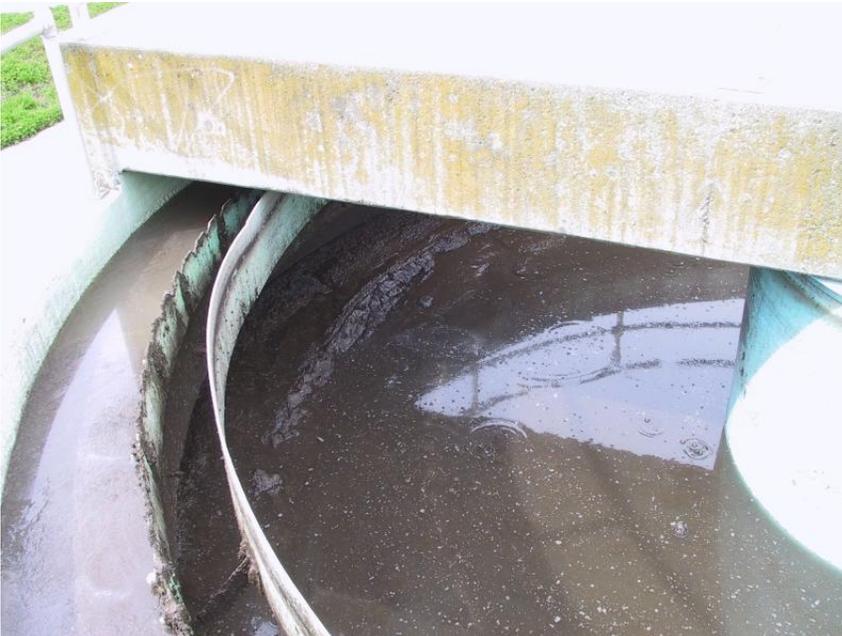
The sludge thickener looked lots better than before; there had been a lot of rubber and plastic goods floating on the surface. The two photos below of that vessel show lots more sludge and lots less debris.
