DEPARTMENT OF <b>ECOLOGY</b> State of Washington	<h1>CONSTRUCTION STORMWATER COMPLIANCE INSPECTION REPORT</h1>	
State of Washington Department of Ecology		
<b>Section A: General Data</b>		
Inspection Date(s): Sep 17, 2019	Ecology Inspector(s): Morgan Maupin Lorie Hammerli	Inspection Type: Announced
Permittee Name: William Salvesen Lennar Northwest, Inc Permittee Mailing Address: 33455 6th Ave S Ste 1-B Federal Way WA 98003-6074	NPDES Permit #: WAR308267	
	Permit Type: Construction	
	Total Acres/Disturbed Acres: 9.4/9.4	
Discharges to: <i>(Please check all that apply)</i> <input checked="" type="checkbox"/> Groundwater <input type="checkbox"/> Surface Water	Receiving waters: Groundwater	
Weather at time of inspection: Overcast, rainy		
<b>Section B: Facility Data</b>		
Facility Name and Location of Site Inspected: Wellington - Lennar OLYMPIA, WA 98502	Coordinates 47.04764 -122.80896	Entry Time 12:45

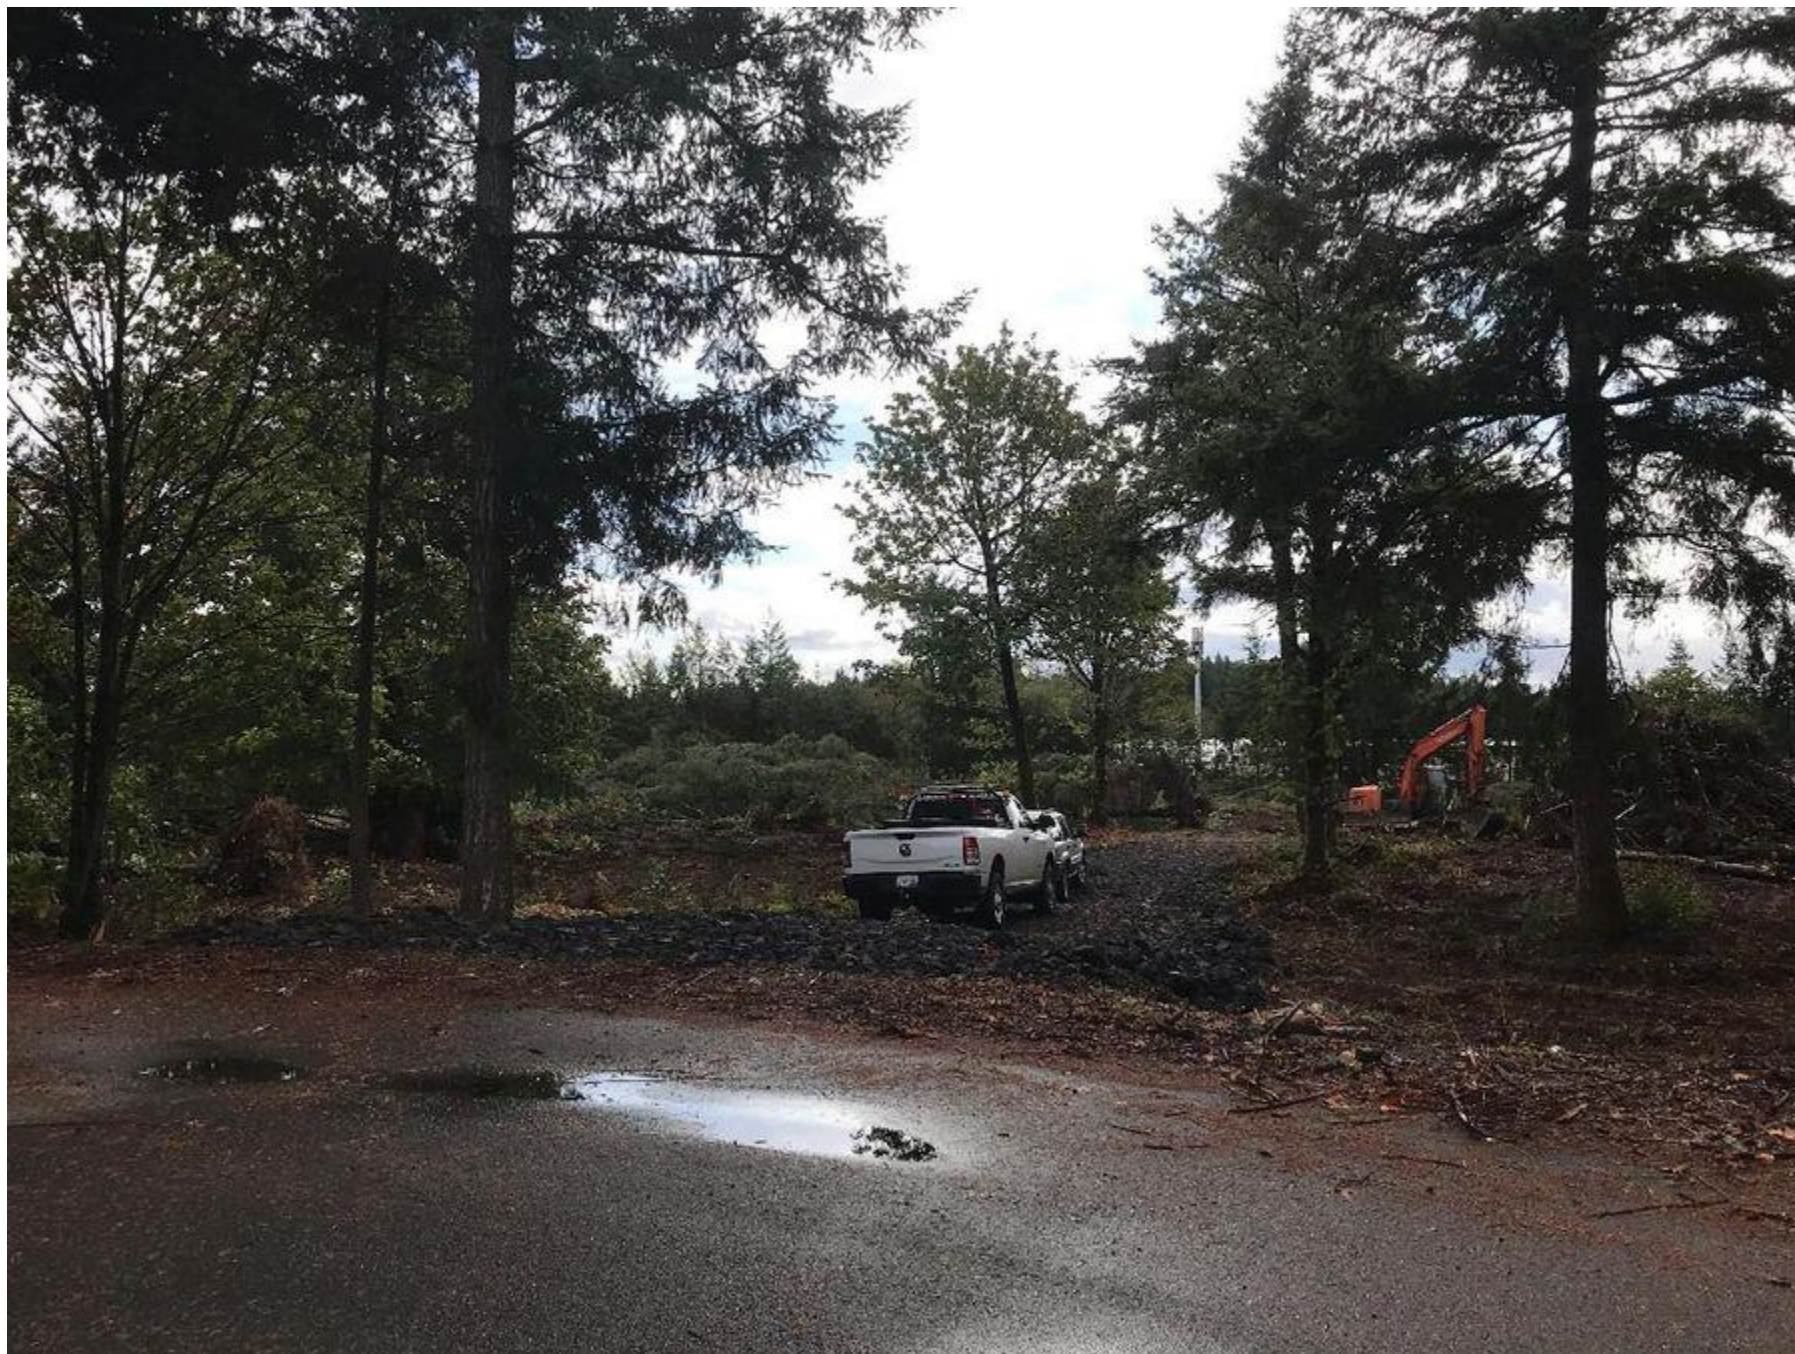
**Photo 1**

Photo Description: Site entrance

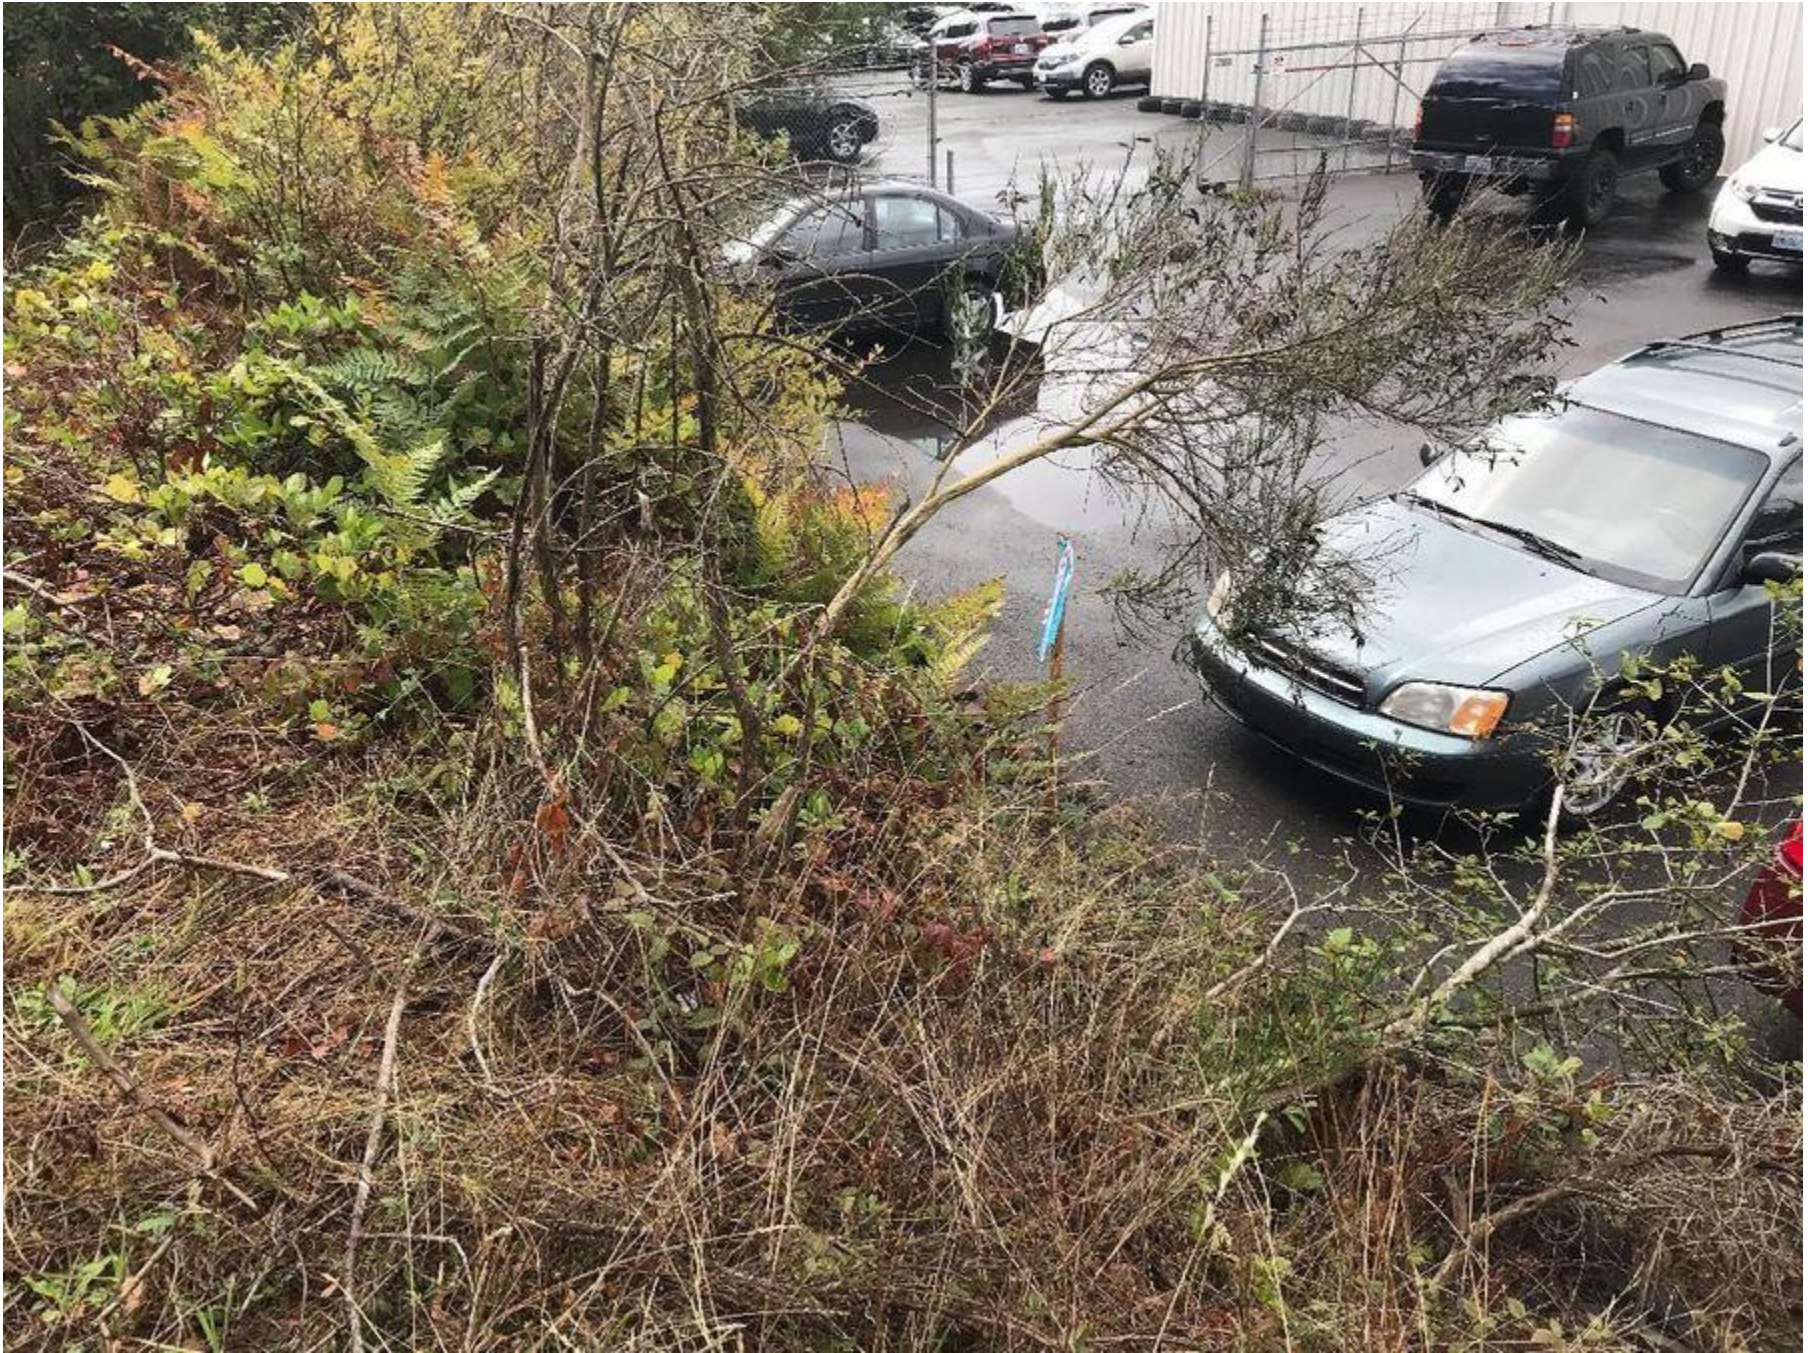
**Photo 2**

Photo Description: Steep slope on west boundary. Stake shows clearing limits.

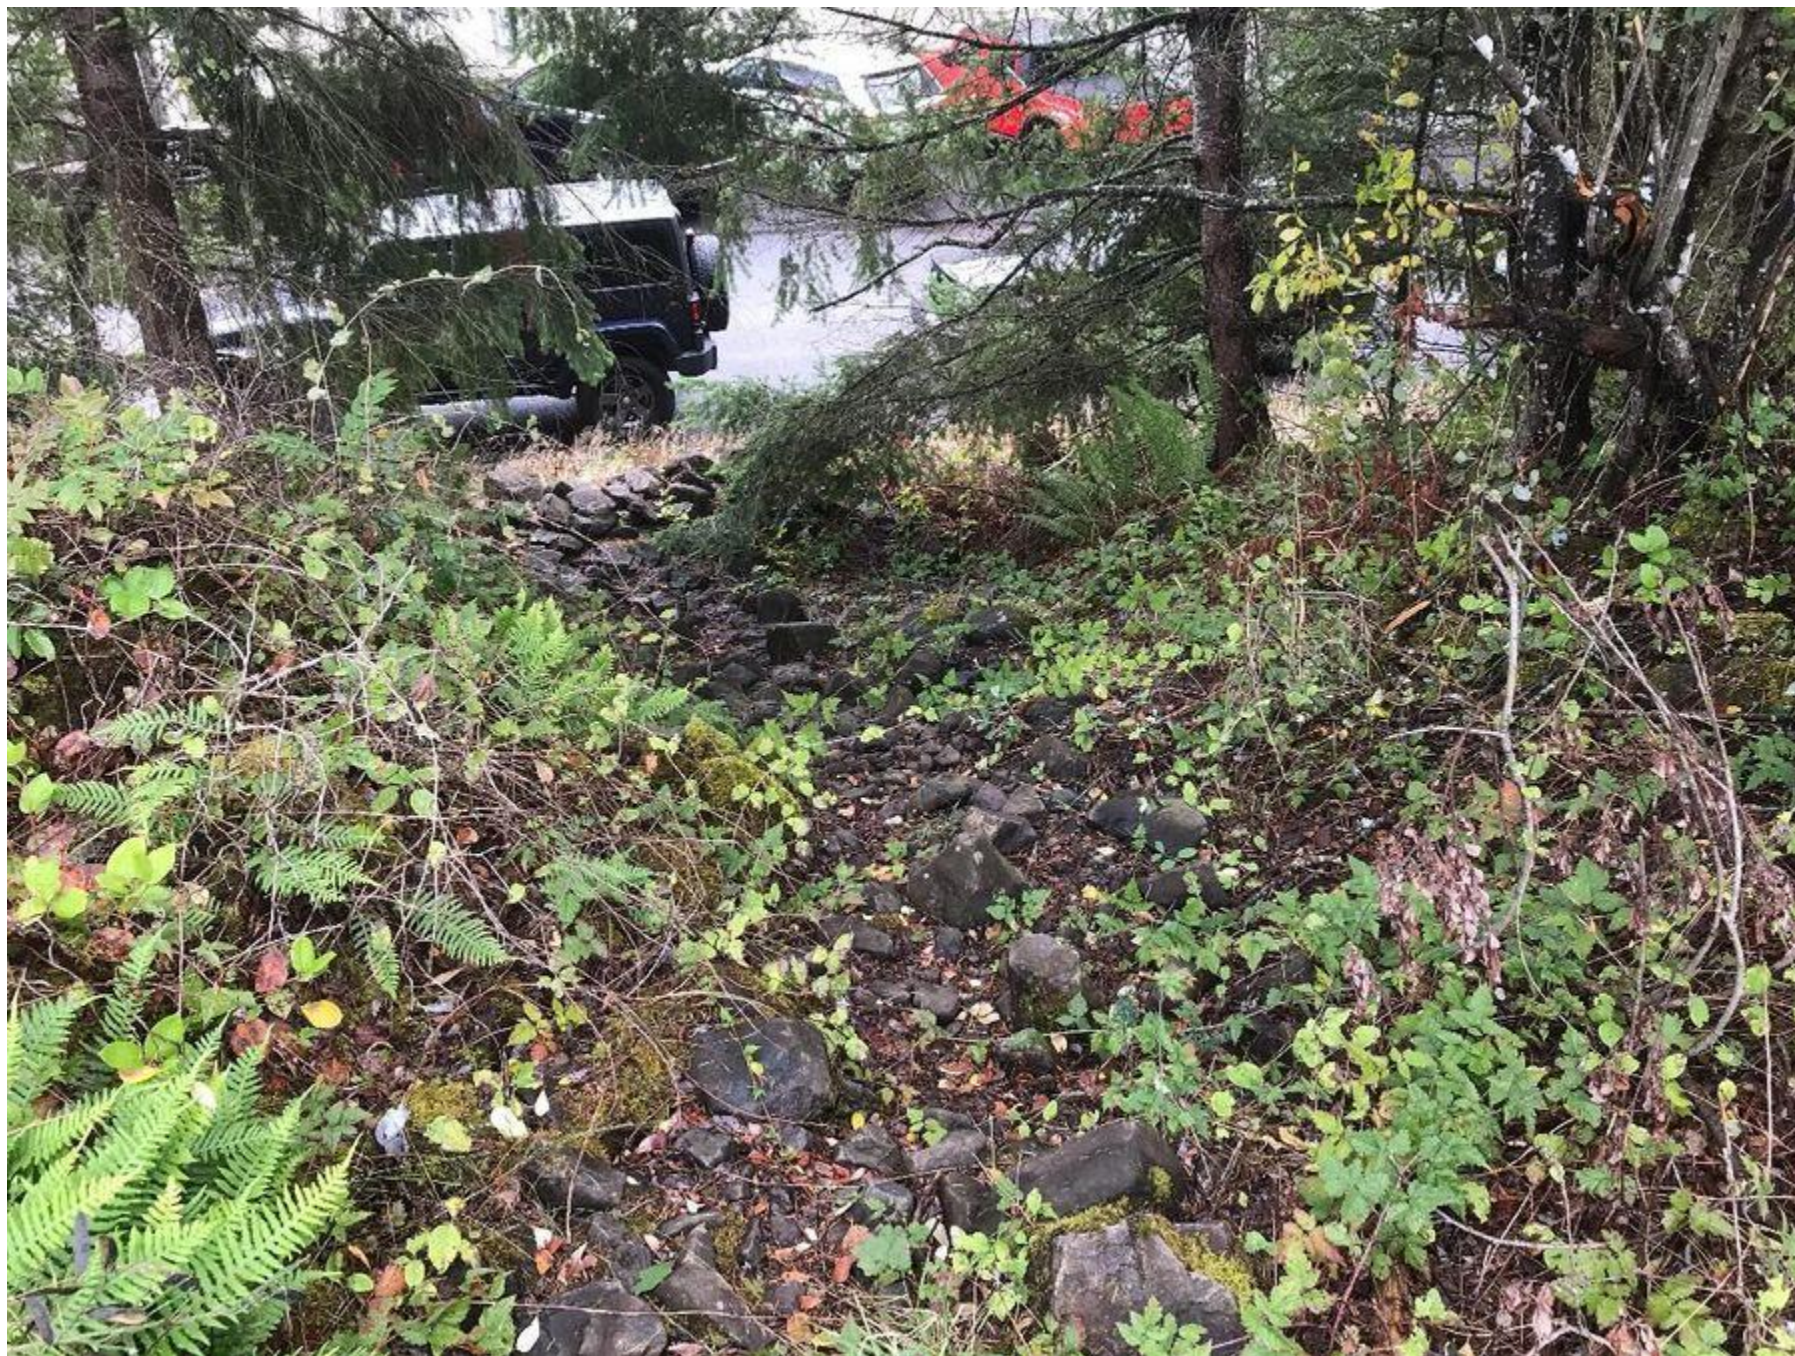
**Photo 3**

Photo Description: Rip rap lined conveyance channel on south side of site.

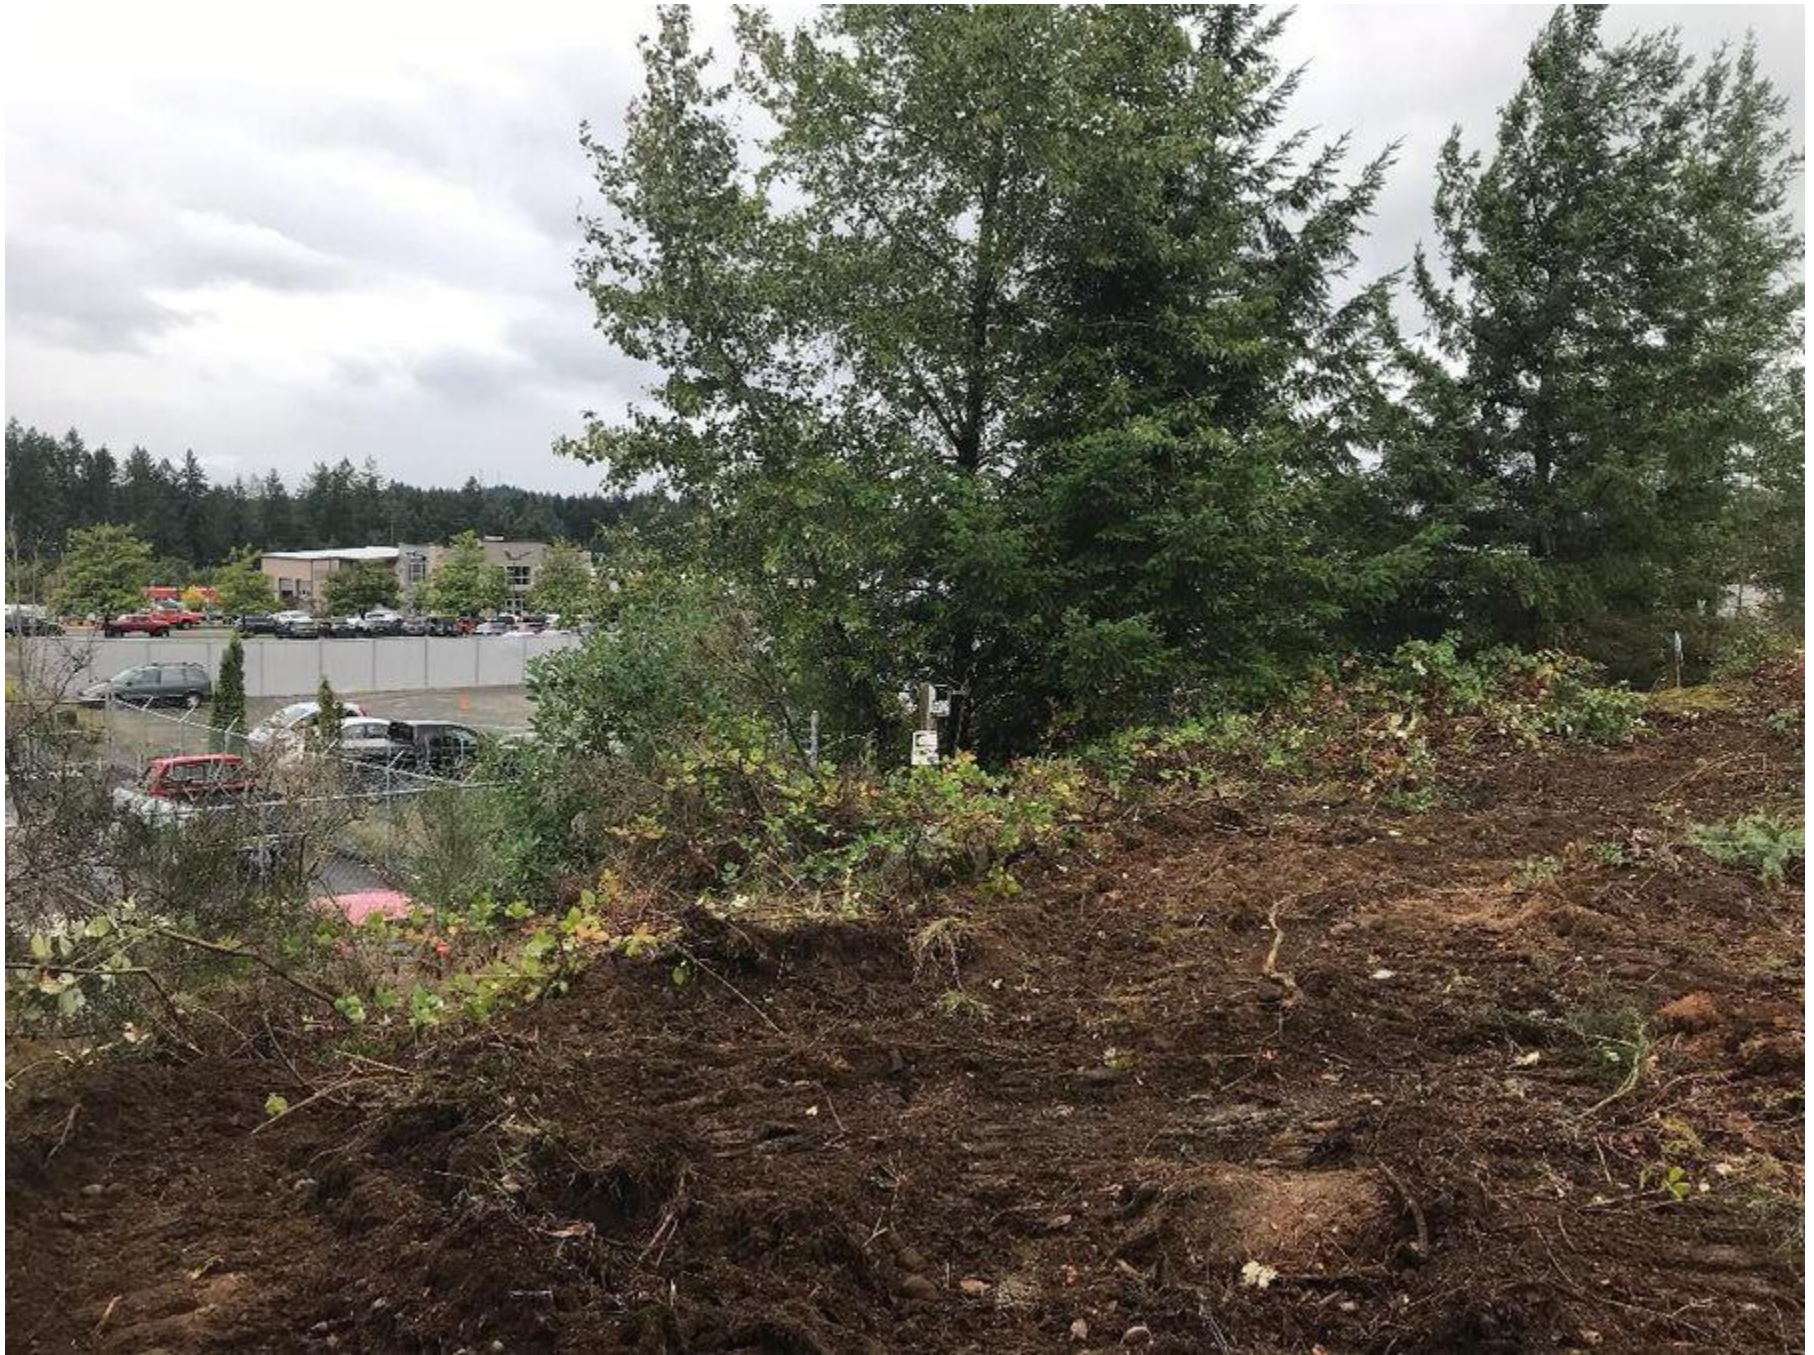
**Photo 4**

Photo Description: Steep slope on south boundary.

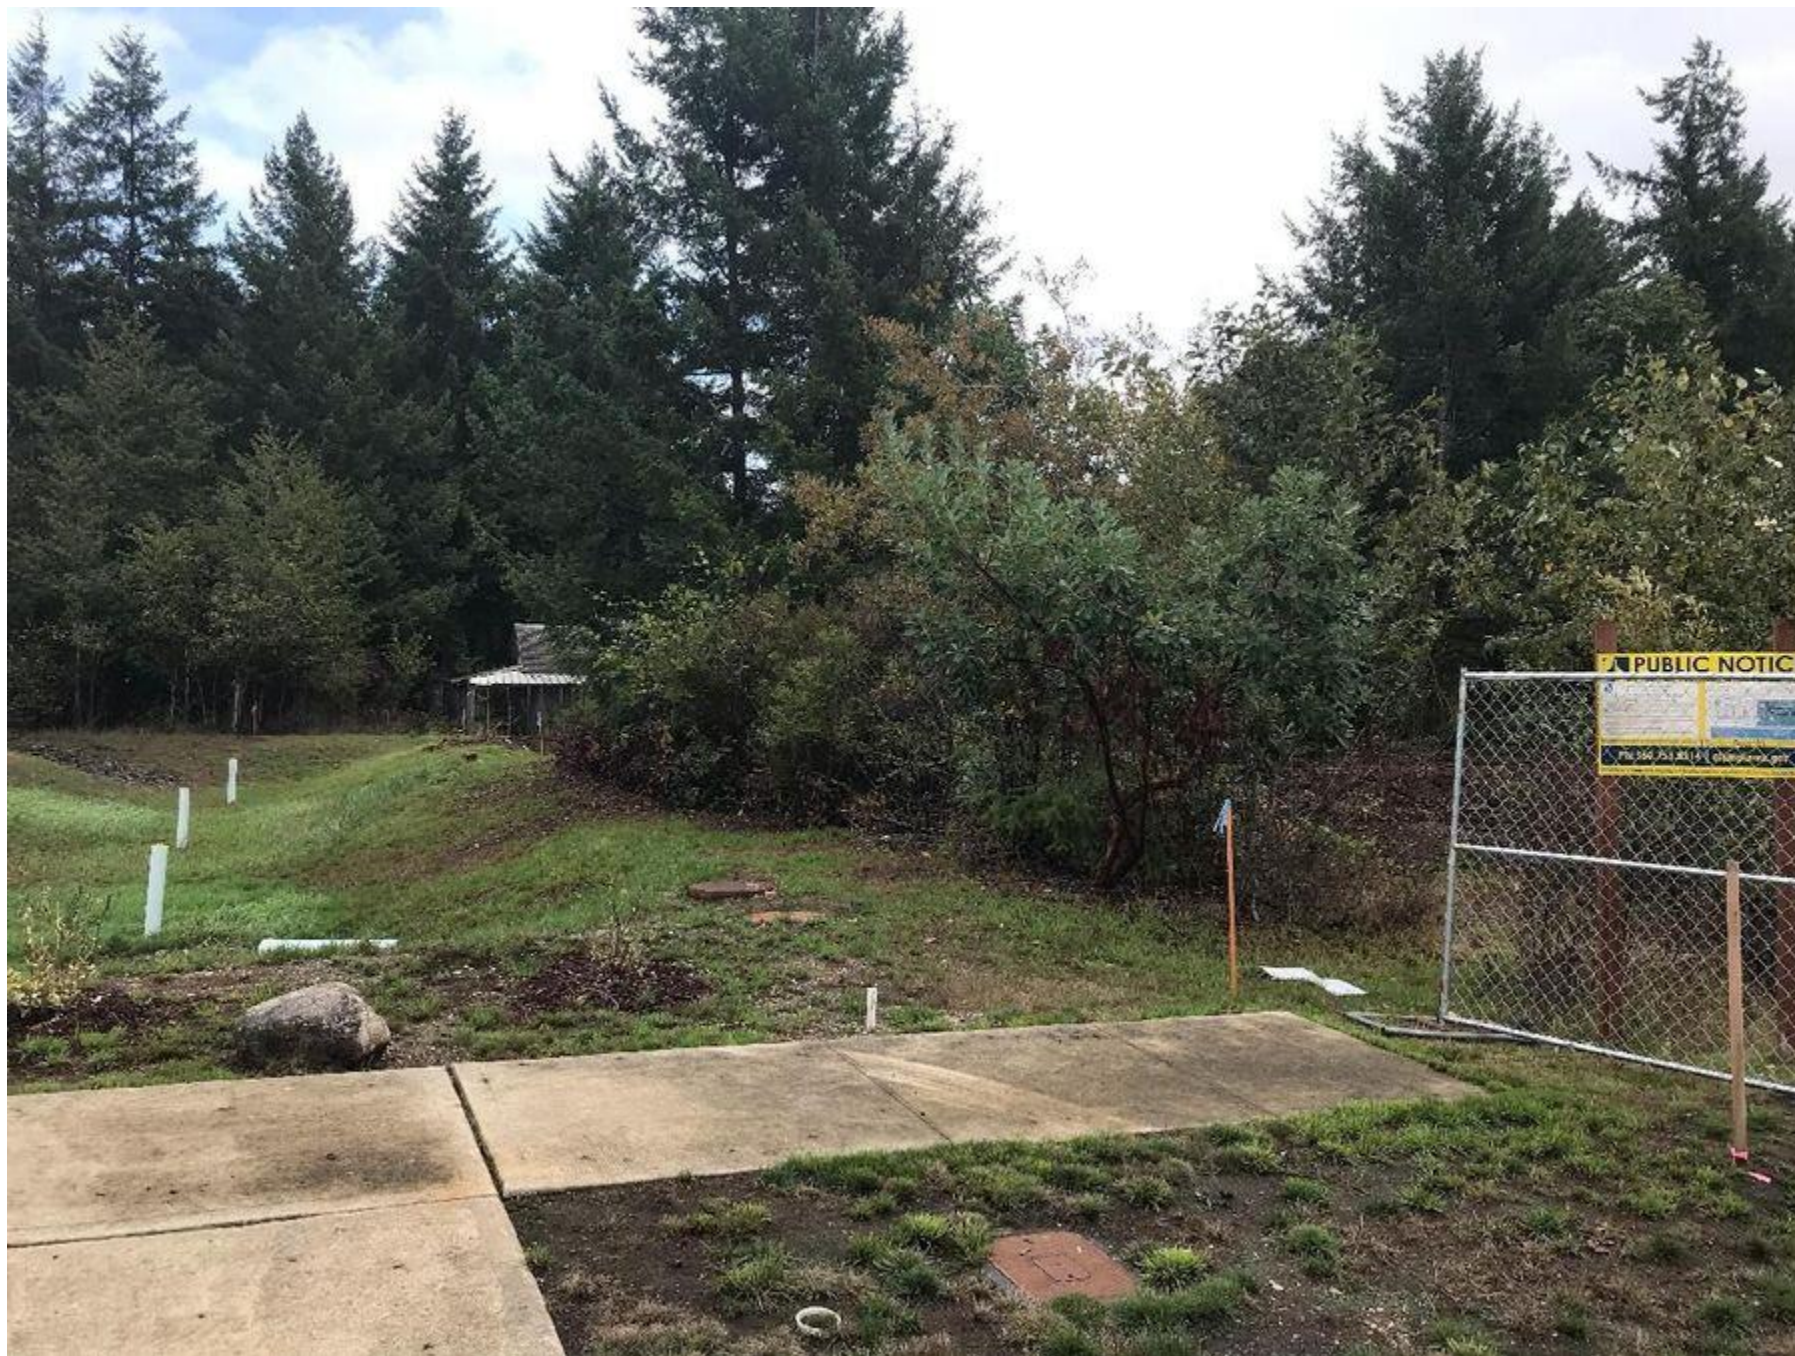
Photo 5

Photo Description: Small stormwater pond adjacent to NW corner of site.

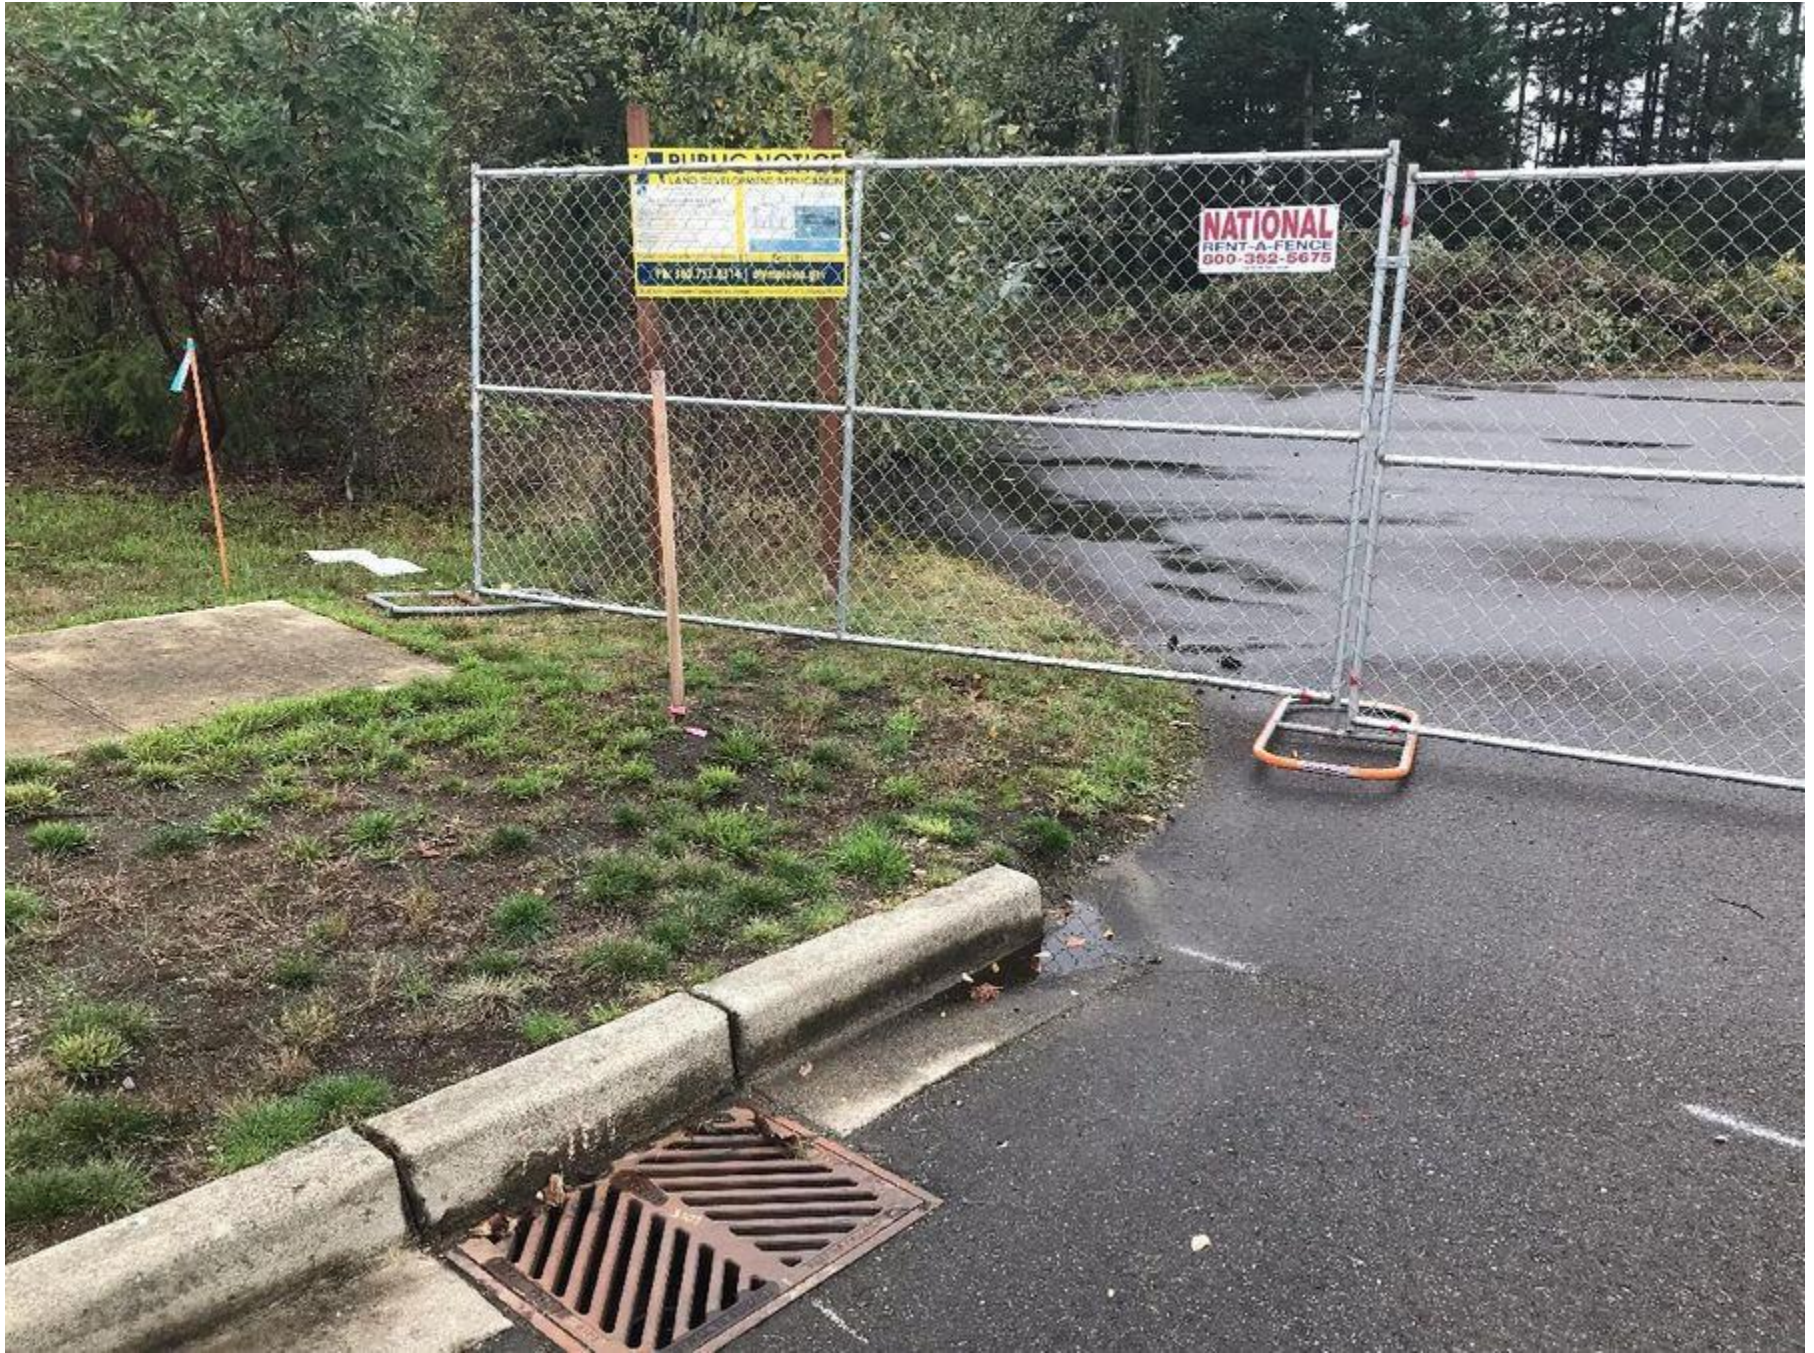
Photo 6

Photo Description: Drain inlet will require protection.

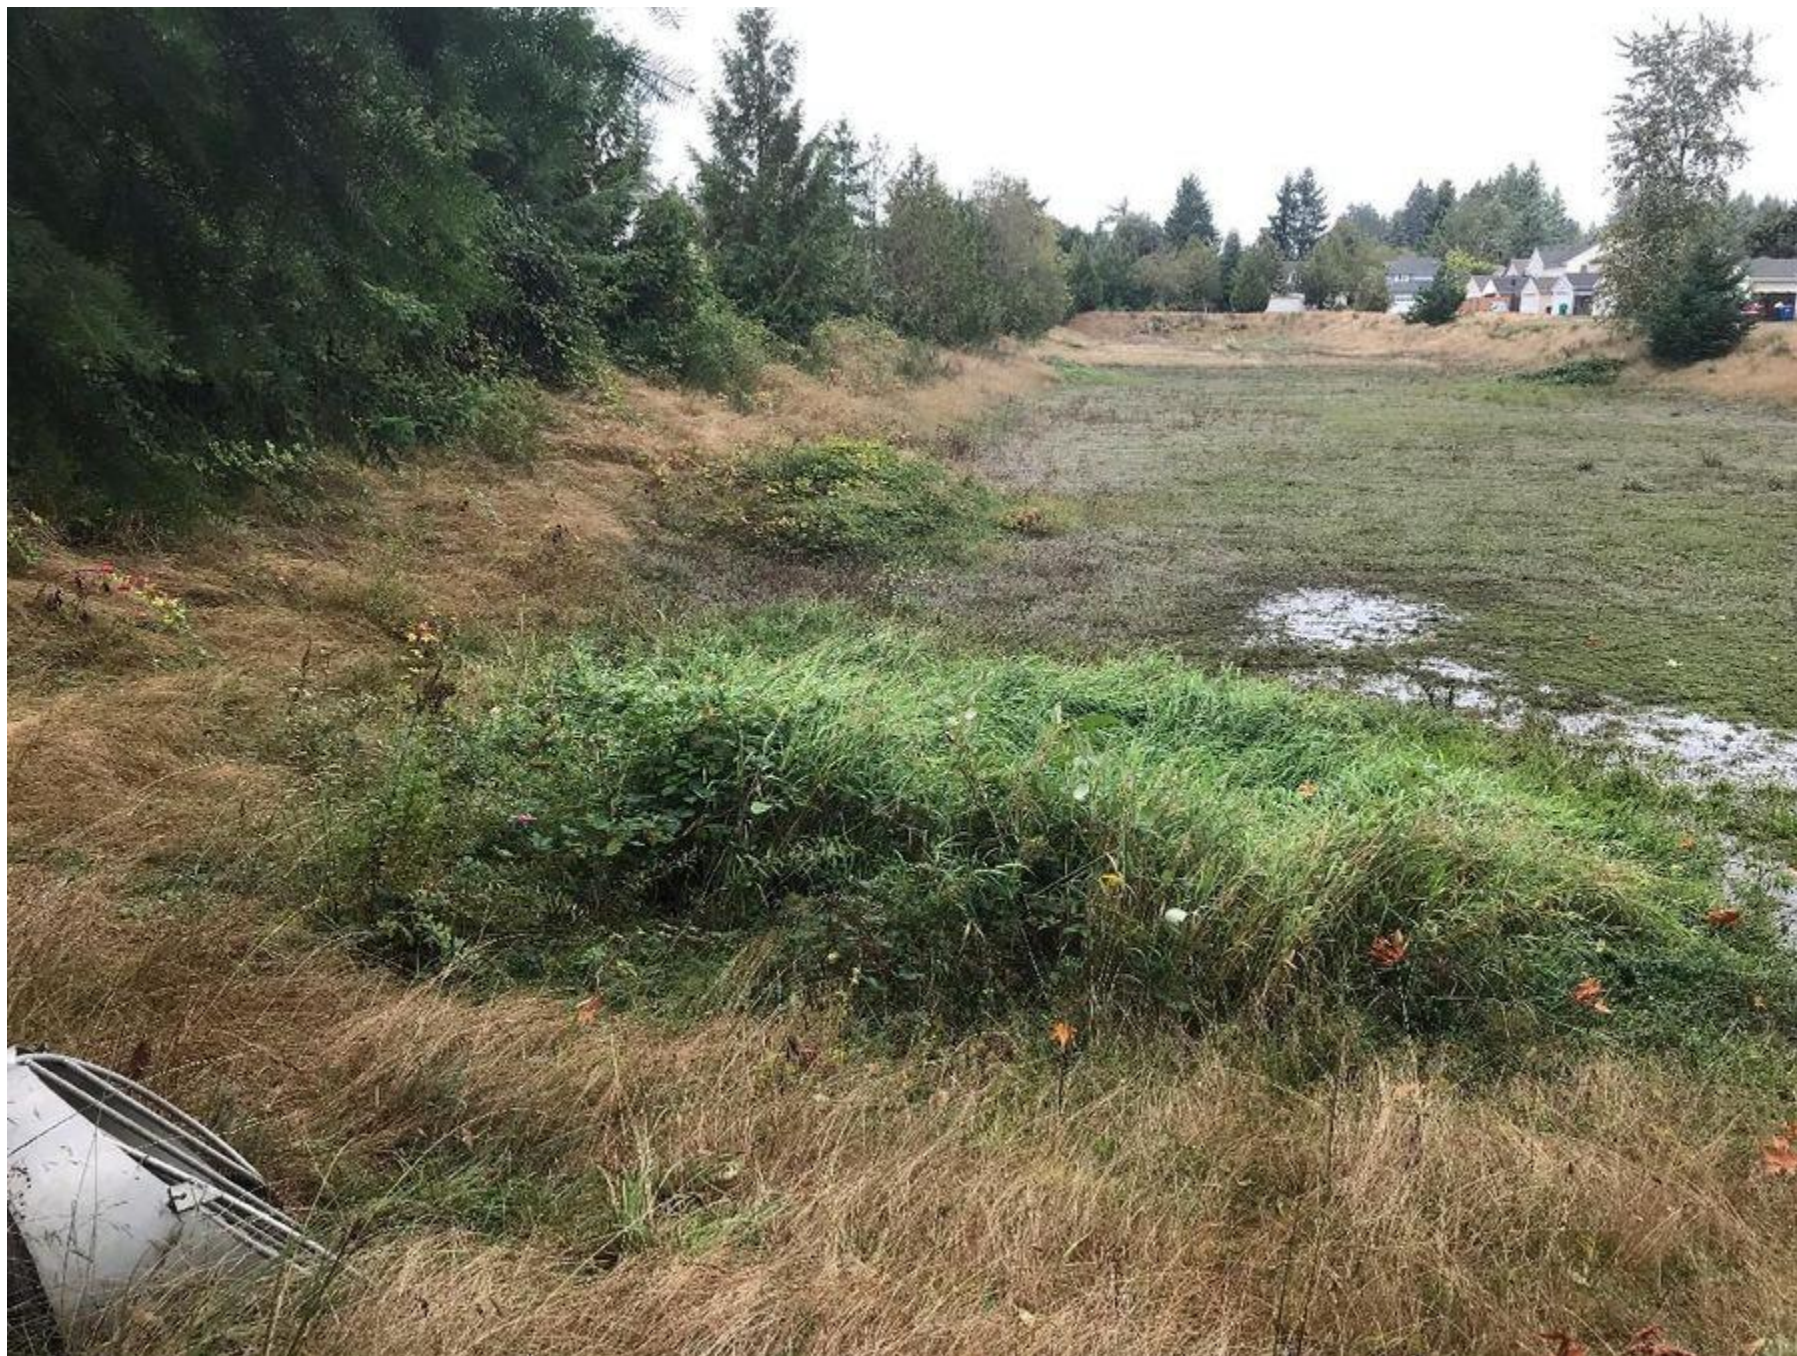
**Photo 7**

Photo Description: Stormwater pond adjacent to north side of site.

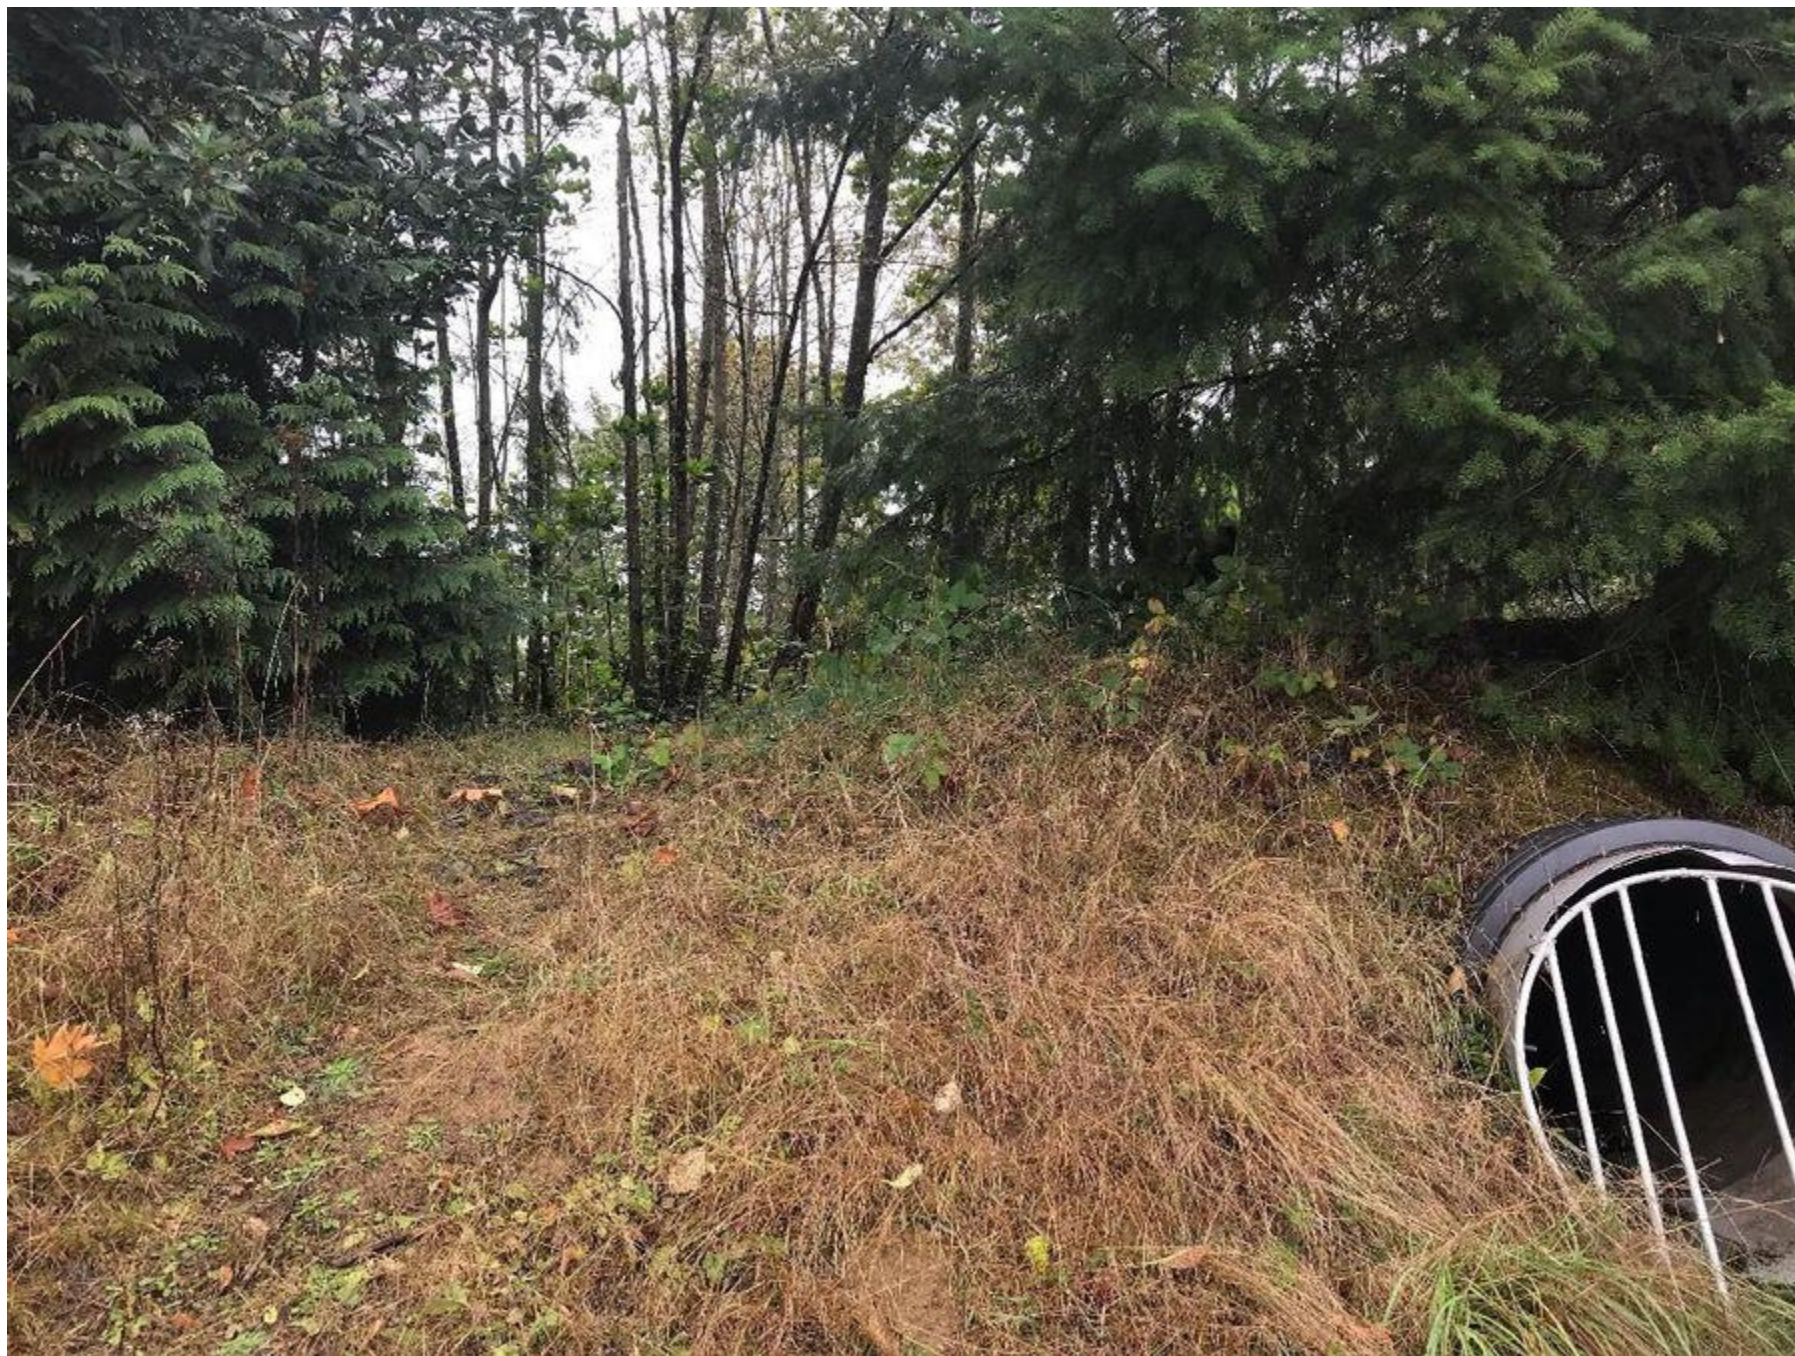
**Photo 8**

Photo Description: Stormwater pond outlet facing the site.

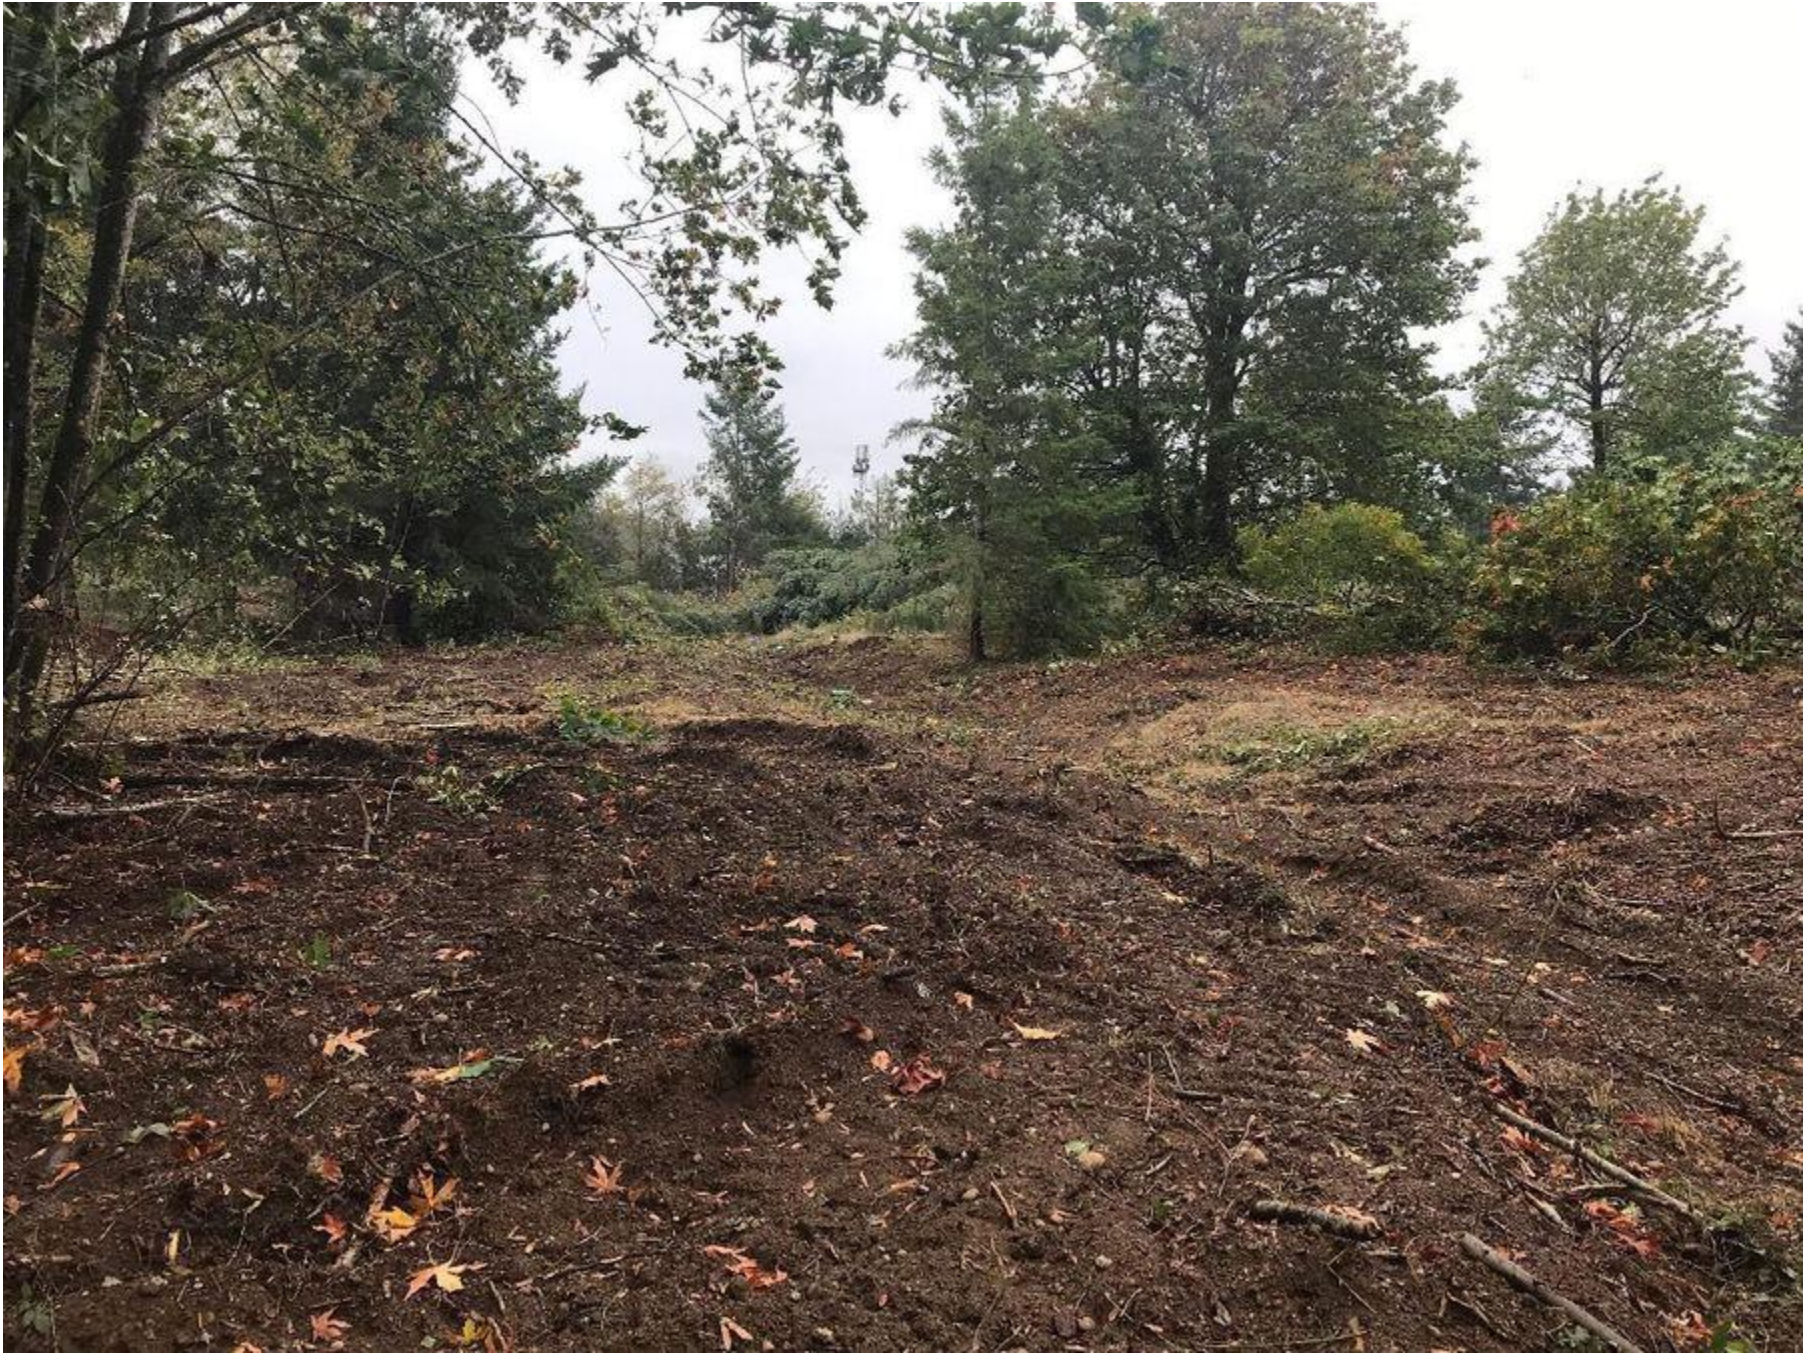
**Photo 9**

Photo Description: Conveyance channel between stormwater pond (photo 7) and rip rap lined conveyance channel (photo 3) facing south.
