<h1>STORMWATER COMPLIANCE INSPECTION REPORT</h1> <p>State of Washington Department of Ecology 1250 W Alder St, Union Gap, WA 98903</p>					WADOE Stormwater Compliance Inspection Form Last updated (6/19)	
						Phone: (509) 575-2434 Cell: (509) 480-1277 kdol461@ecy.wa.gov	
Section A: General Data							
Inspection Date	NPDES Permit #	County	Receiving Waters	Inspector	Facility Type		
10/2/19	WAR001307	Yakima	Moxee Creek	Kevin Dolan	Industrial		
Discharges to: Ground				ANNOUNCED Inspection			
Section B: Facility Data							
Name and Location of Site Inspected Farwest Fabricators 7537 POSTMA RD Moxee, WA				Entry Time 11am			
				Exit Time 12pm			
				GPS Lat: Long:			
				Entrance: 46.562899, -120.399286			
				Discharge: 46.562712, -120.399188			
On-Site Representative(s): Name(s)/Title(s)/Contact number(s) or E-mail				Additional Participants:			
Debbie Dougherty							
Responsible Official(s):

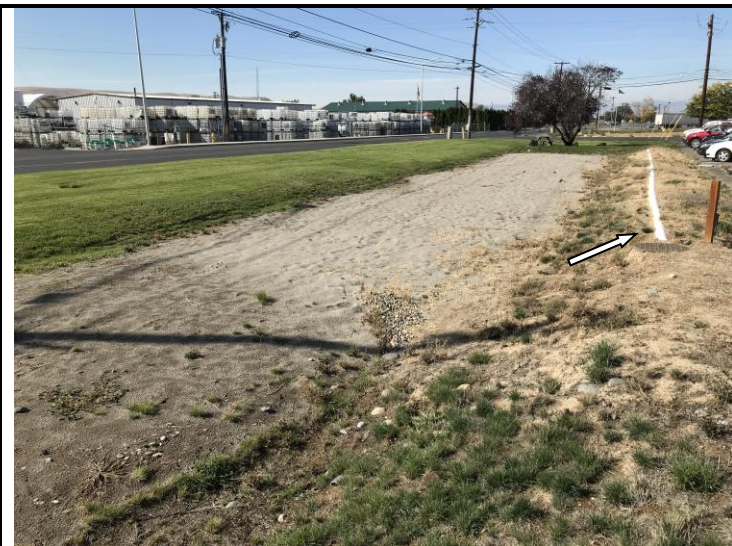
FIGURE 1: INFILTRATION SWALE TO SOUTH HAS PUMP AND AN EXPOSED PERFORATED PIPE.

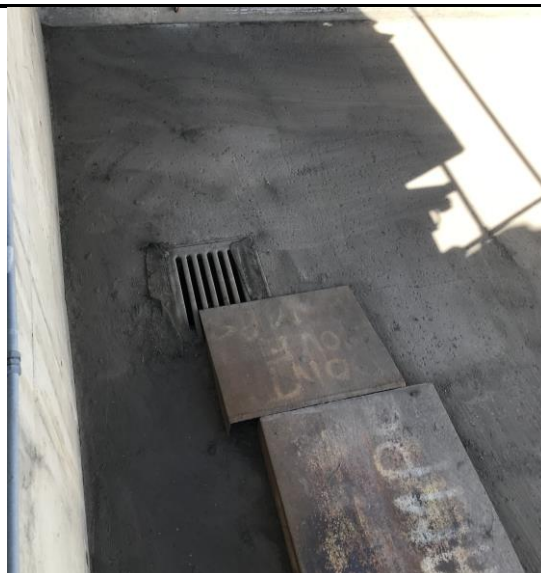
FIGURE 2: EAST LOADING DOCK CATCHBASIN HAS INSERT CLOTH AND DRAINS TO BIO SWALE.

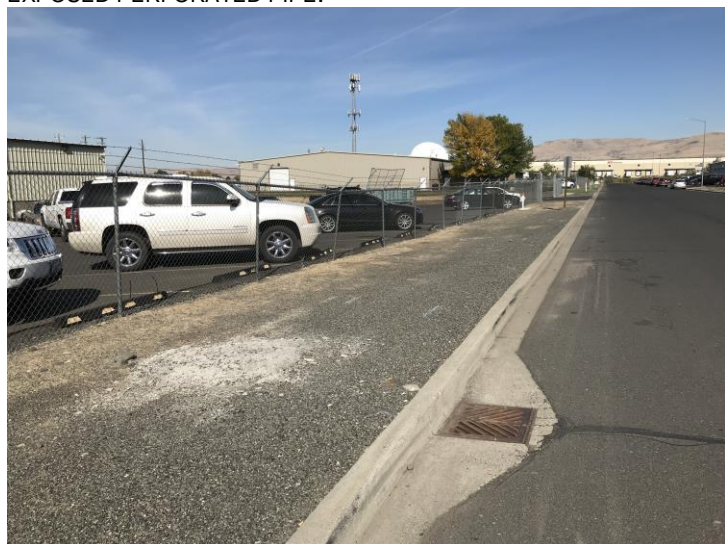
FIGURE 3: GRANT WAY CATCHBASINS LEAD TO DID#11 AND MOXEE CREEK.

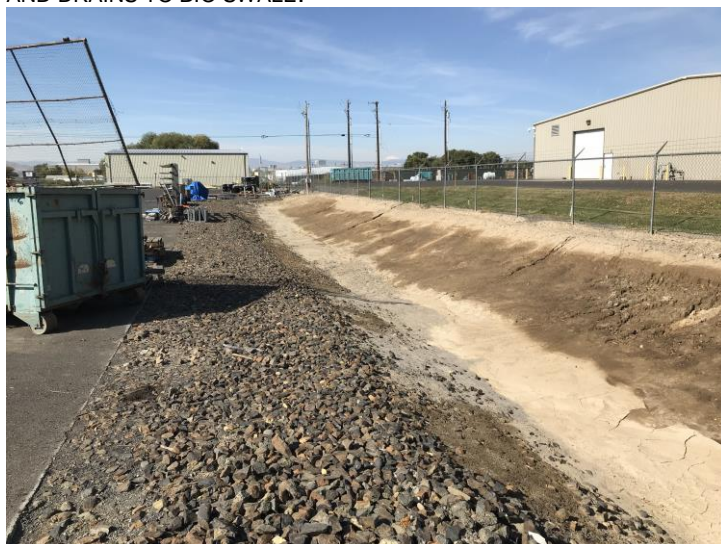
FIGURE 4: INFILTRATION SWALE TO THE NORTH HAS EROSION FROM NEIGHBORS ON-FLOW IRRIGATION

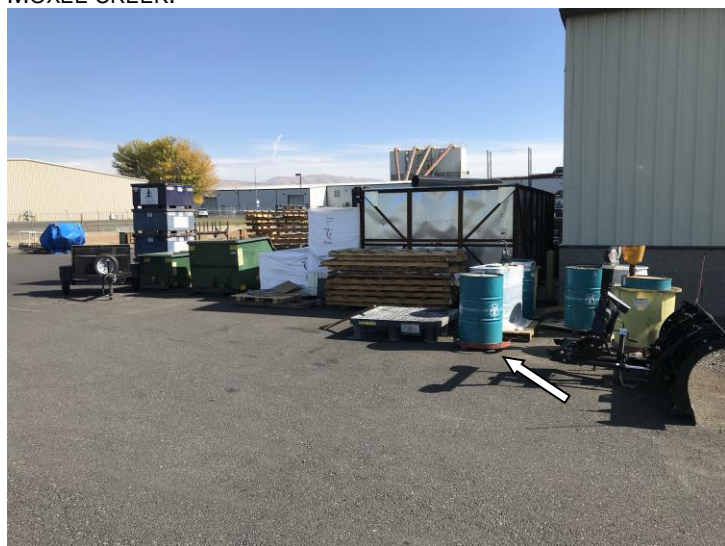
Figure 5: Chemical fluids stored outside.

INSPECTION/OBSERVATIONS							
<p>In 2017 two surface infiltration swales were installed. Two existing catchbasins, which used to run to the DID #11 drain network, now run to a vault which is then pumped into a perforated pipe in the southern infiltration swale. The north impervious surfaces are graded to sheet flow to the northern infiltration swale. The west side of the building surface infiltrates to gravel.</p> <p>Outside space is used for staging various equipment and materials, including several chemical fluid barrels (figure 5). Waste material bins have lid coverings at this inspection. It appears the catchbasins on grant way that connect to the DID #11 drain are not receiving this site's stormwater.</p>							
Section D: Compliance/Recommendations							
Citation reference	Page #	Specific Violation	Action		Due date		
Condition S3.B.4.A	Pg. 15	Store all chemical liquids, fluids, and petroleum products, on an impervious surface that is	Provide secondary containment for chemical fluids on site.		August 31 st 2020

surrounded with a containment berm or dike that is capable of containing 110% of the largest enclosed tank volume		
Condition S3.B.4.b.i.4	Pg. 14	Maintain ponds, tanks/vaults, catch basins, swales, filters, oil/water separators, drains, and other stormwater drainage /treatment facilities in accordance with the Maintenance Standards set forth in the applicable Stormwater Management Manual	Maintain your catchbasins and swales in accordance with appendix 5.A, page 494, of the Stormwater Management Manual for Eastern WA	60 days from receipt of report
S3.B.4.b.ii.2	Pg. 17	Minimize the exposure of manufacturing, processing, and material storage areas (including loading and unloading, storage, disposal, cleaning, maintenance, and fueling operations) to rain, snow, snowmelt, and runoff by either locating these industrial materials and activities inside or protecting them with storm resistant coverings.	Cover exposed industrial materials	60 days from receipt of report

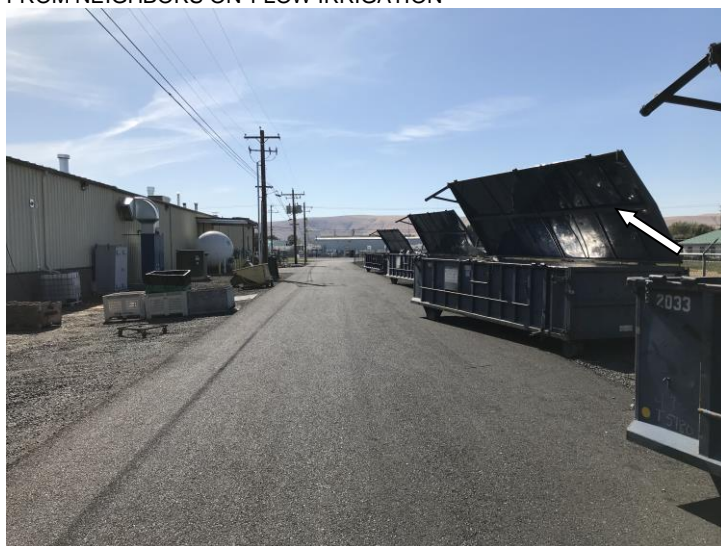
Figure 6: Material dumpsters now have lid coverings.
