# STORMWATER COMPLIANCE INSPECTION REPORT

WADOE Stormwater  
Compliance Inspection Form  
Last updated (01/06)

| Union Pacific Railroad Co Dawson St<br>402 S Dawson St<br>Seattle, WA, 98108 - 2257 | Entrance: Lat:                      Long:<br>Discharge: Lat:                      Long: | 1:20 pm | 04/07/93 |

# **PHOTO ADDENDUM – UNION PACIFIC RAILROAD CO DAWSON ST. 12/05/06**

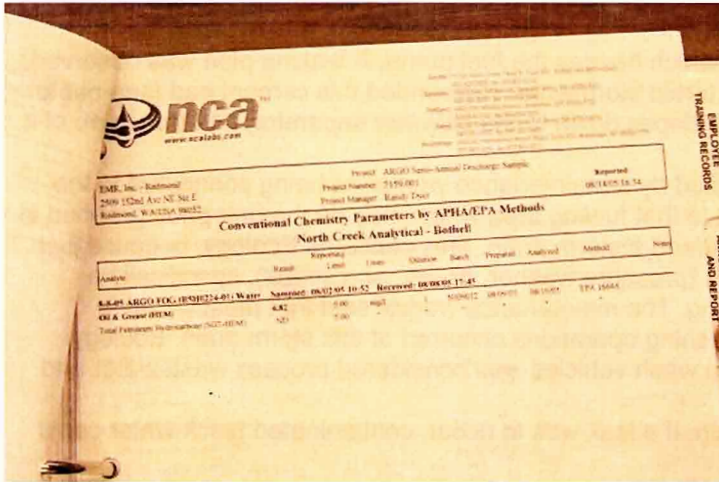
The DMR results in the SWPPP present some discrepancies with those entered into Ecology's DMR database. It was not immediately obvious why there was a discrepancy with the data and the submittals to Ecology; they will be further explored and discussed with the permittee. Records in the permittee's SWPPP show that in the 4<sup>th</sup> quarter of 2003 the sampling point was changed. Attached to this are DMR forms from presumably separate sampling points though they are labeled as the same. The SWPPP DMR for the 3<sup>rd</sup> quarter of 2005 is incorrectly filled out with the box checked indicating a sample was not taken. A sample had been taken for the 3<sup>rd</sup> quarter of 2005 but only analyzed for Fats Oil and Grease. (see photo PC050052.jpg).

PC050052.JPG **DESCRIPTION:** PAGE FROM DMR LAB RESULTS FOUND IN THE SWPPP WHICH SHOWS ONLY OIL & GREASE BEING TESTED FOR IN THE 3<sup>RD</sup> QUARTER OF 2005.

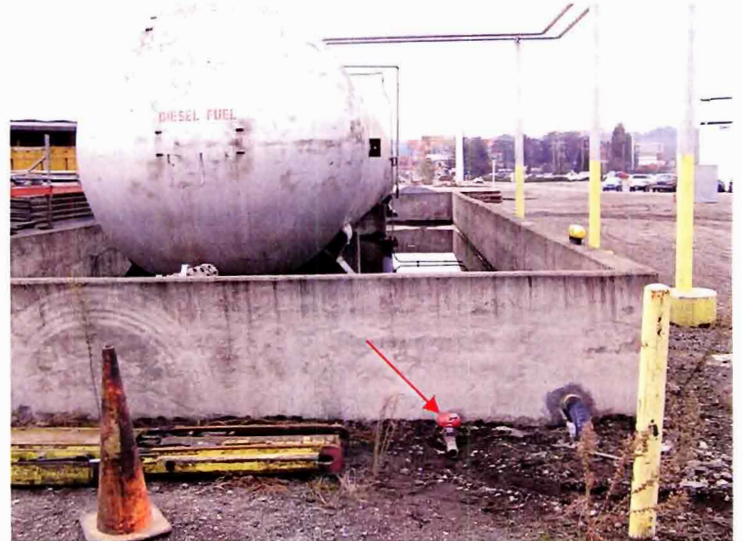
The north end of the property (N47°33.795' by W122°20.197') consists of a gravel parking lot with parts storage, a diesel tank, a fuelling area over the tracks, and a maintenance garage over the tracks. There is an outlet from the containment around the diesel fuel tank which shows evidence of use as a discharge point (see photo: PC050053.jpg). A maintenance worker informed Ecology that when this containment became full of stormwater, a hose was attached to this outlet and the water was spread over the gravel lot to allow for infiltration into the soil.

PC050053.JPG **DESCRIPTION:** EVIDENCE OF DISCHARGE FROM DIESEL TANK CONTAINMENT INTO GRAVEL LOT.

- Take the necessary precautions to reduce the potential of fuel contaminating soil and/or stormwater at the stationary fueling area. Also visually inspect for oily sheens in the stormwater captured by the diesel tank containment before discharging it to the gravel lot for infiltration.

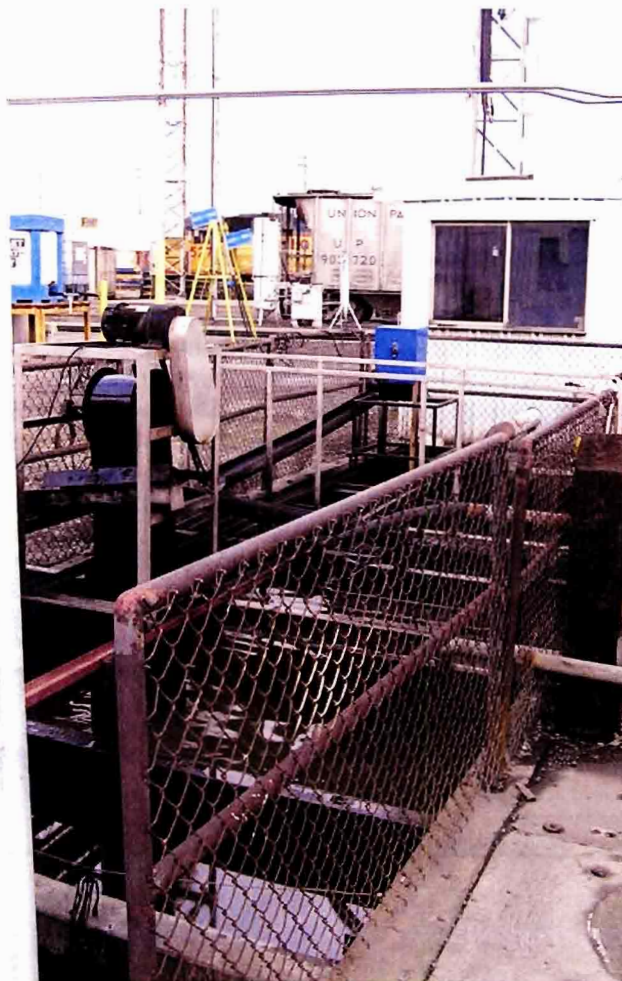
- Many metal and rubber parts are stored on the lot exposed to the elements. One exposed dumpster contains oily metal parts, and a used gas tank (see photo PC050063.jpg). Contaminants could leech from these materials and contaminate stormwater and soil.
- The oil/water separator is encircled by a small fence, and is uncovered and exposed to stormwater (see photo:PC050059.jpg). Ecology is concerned that during heavy rainfall this oil/water separator may overflow and without

secondary containment would contaminate the surrounding soils.

PC050059.JPG **DESCRIPTION:** EXPOSED OIL/WATER SEPERATOR WITH NO SECONDARY CONTAINMENT.

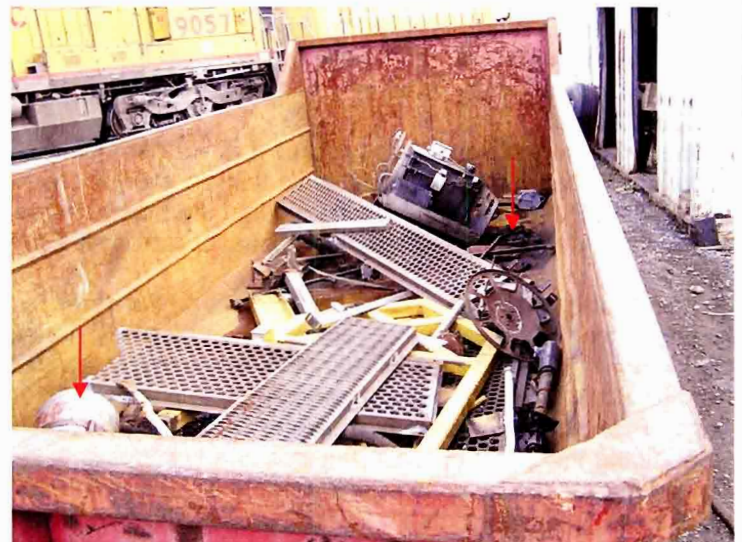
PBC050063.JPG **DESCRIPTION:** EXPOSED DUMPSTER CONTAINING METAL PARTS, OILY PARTS, AND A GAS TANK.

- Good Housekeeping practices should be implemented on-site in order to reduce stormwater pollution potential from items such as stored leaky barrels (see photo: PC050100.jpg), exposed trash (see photo: PC050063), and contaminated buckets collecting stormwater on site (see photo: PC050079.jpg).

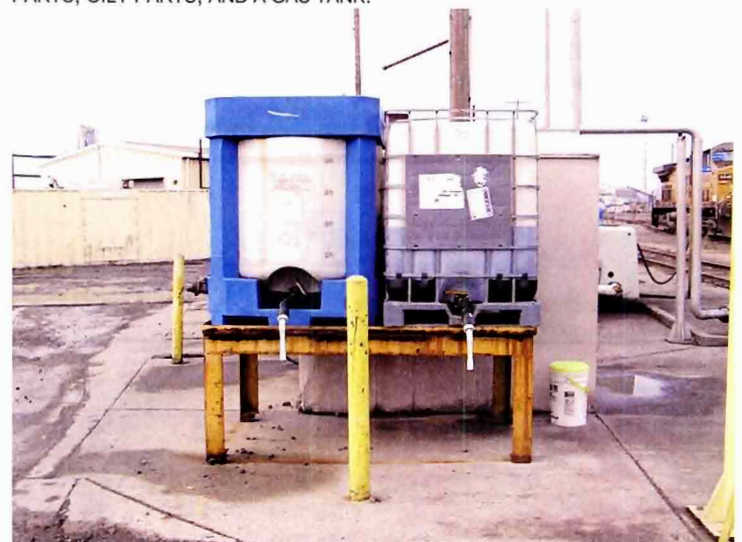
- Two totes of toilet cleanser/disinfectant are stored outside near the oil/water separator on a table without secondary containment, or other proper chemical handling BMPs in place (such as drip pans, or bermed containment) (see photo: PC050067.jpg).

PC050067.JPG **DESCRIPTION:** CHEMICAL STORAGE WITHOUT SECONDARY CONTAINMENT OR PORPER CHEMICAL HANDLING BMPs IN PLACE (DRIP PANS).

- Implement the proper chemical handling BMPs (such as cover and containment) for all chemicals at the site.
- Consider implementing and maintaining catch basin socks in all the catch basins on site to reduce contaminants entering the storm drains.

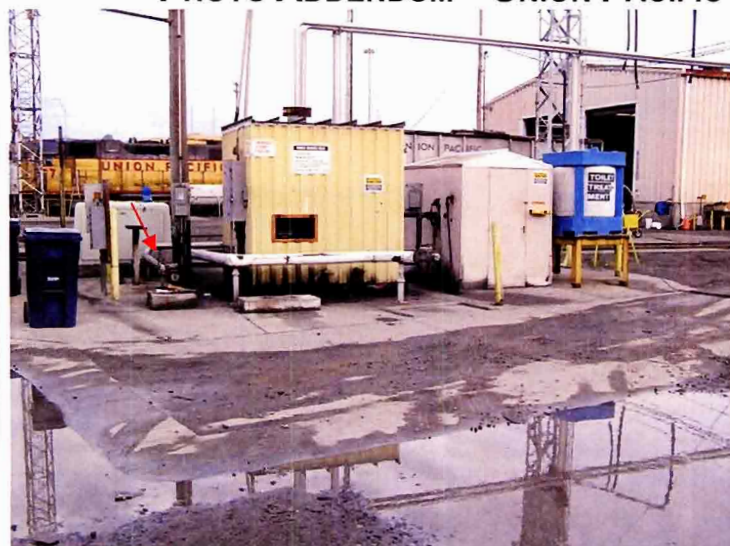
- Oily residue coats the cement pad and the side of the building which houses the fuel pump. A leaking pipe was observed dripping red liquid onto a saturated absorbent cloth. Puddles of turbid stormwater surrounded this cement pad (see photo PC050072.jpg). A maintenance worker said that this whole area slopes down to the oil/water separator, and that none of it runs to storm drains.

PC050072.JPG **DESCRIPTION:** OILY RESIDUE FROM FUELING OPERATIONS COAT THE BASE OF THE FUEL PUMP BUILDINGS AND THE PAD OF CEMENT. A LEAKING PIPE DRIPS RED LIQUID ONTO A SATURATED ABSORBANT CLOTH. OIL SHEENS SEEN THROUGHOUT THE PUDDLE.

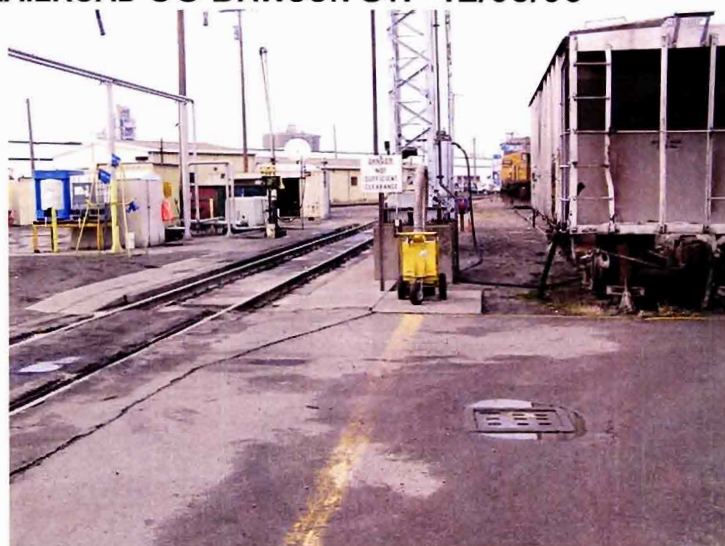
- The drain between the tracks under the fueling area was identified by a maintenance worker as being connected to the oil/water separator. The SWPPP map shows a storm drain next to that fueling area which may be the one photographed in PC050082.jpg. A maintenance worker said he believed it was indeed a storm drain. This concerns Ecology, because just slightly up slope from the storm drain were vehicle washing tools (pressure washer, hoses, and soaps), specifically a bucket filled with a red soap mixture that was close to overtopping. The maintenance worker said that most washing occurred in containment or over pervious surfaces, but small washing operations occurred at this storm drain. Ecology stressed to the maintenance worker that water and soap used to wash vehicles was considered process wastewater and was not allowed to discharge into storm drains.

PC050082.JPG **DESCRIPTION:** STORM DRAIN RECEIVING RUNOFF FROM CLEANING OPERATIONS PERFORMED IN CLOSE PROXIMITY (SEE PHOTO PC050079.JPG).

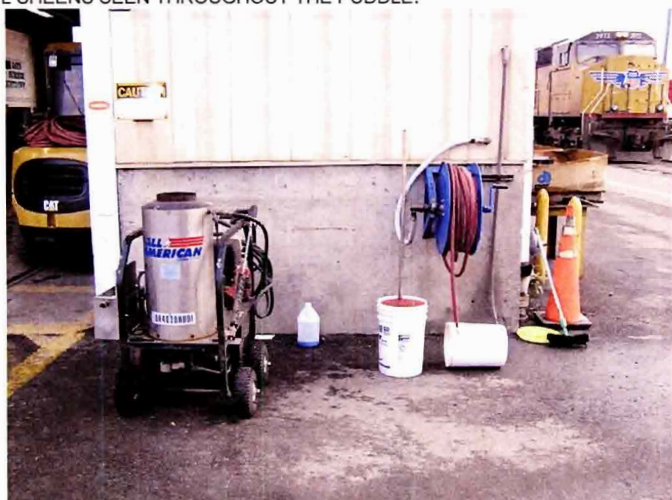
PC050079.JPG **DESCRIPTION:** EXPOSED SOAP MIXTURE CLOSE TO OVERTOPPING ITS CONTAINER. EVIDENCE OF WASHING TAKING PLACE IN AN AREA WHICH DRAINS TO A STORM DRAIN.

• **Condition S3.B** of the permit prohibits the discharge of process wastewater. Vehicle wash water is process wastewater and cannot be discharged to storm drains or surface waters of the state. Prevent the discharge of process wastewater, from your vehicle washing operations (see photo: PC050079.jpg & PC050099.jpg), into storm drains. Consider greatly enlarging your Packer washing pad or devising a system to eliminate oily residue and wash water from splashing out onto the lot and to nearby storm drains.

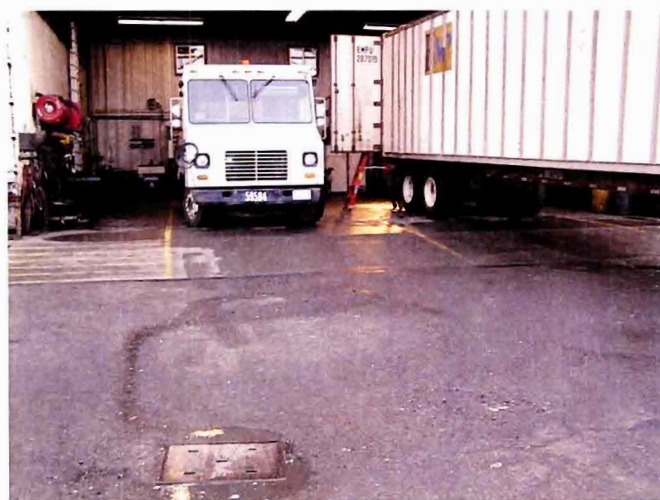
- The four storm drains labeled on the SWPPP were identified, and drain stormwater from the contaminated asphalt. The three storm drains near the maintenance garage are fitted with a filter of unknown quality. The storm drain directly outside of the garage appears to be receiving run-off from the maintenance activities performed within the building (see photo PC050090.jpg).

PBC050090.JPG **DESCRIPTION:** MAINTENANCE GARAGE WITH TURBID RUNOFF TO STORM DRAIN.

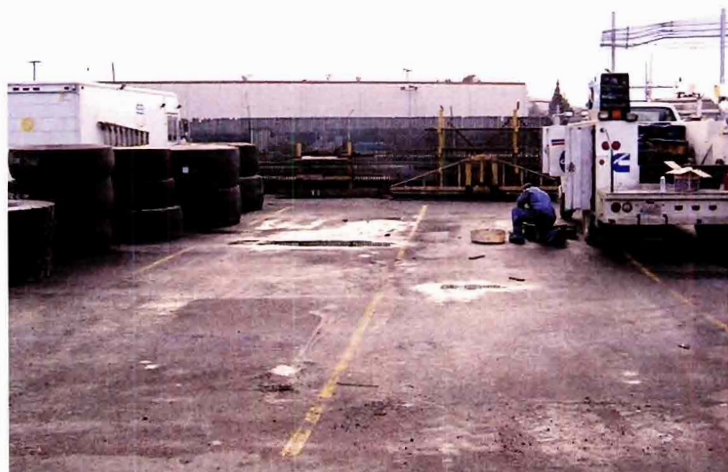
- One of the supervisors, Dave, told us that vehicle maintenance was only performed in the garage. This concerned Ecology, because what seemed to be vehicle maintenance involving fuel containers and drip pans was observed outside (see photo PC050097.jpg). Dave said that the maintenance observed outside of the building was a warranty issue that an outside vendor conducted and not a usual occurrence. The ground where this was observed is heavily inundated with oily residue.

PC050097.JPG **DESCRIPTION:** WHAT APPEARS TO BE VEHICLE MAINTENANCE WORK BEING PERFORMED OUTSIDE WITHOUT CONTAINMENT.

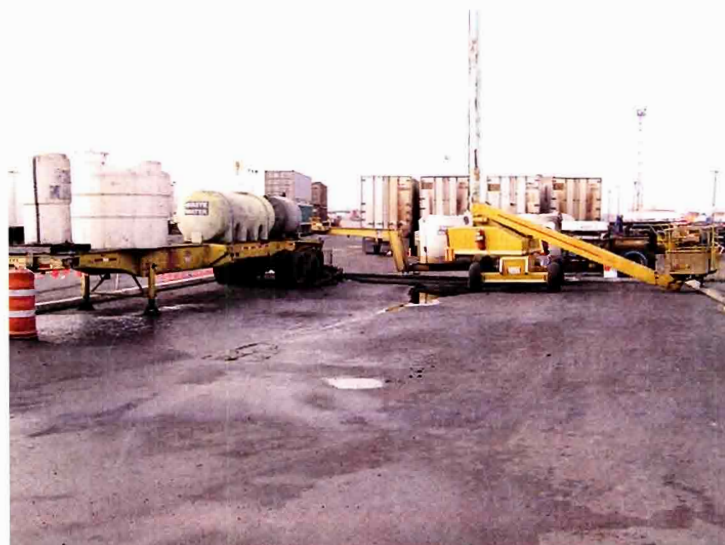
- The vehicle wash pad is contained by a curb-like berm. In the middle is a dead-end sump which receives process wastewater. This sump was overtopped, and a small, dark-black pool had formed in the wash pad. There was a pump hose in this puddle. When in operation, process wastewater would be pumped through this hose into tanks on a trailer stored within the wash pad containment (see photo: PC050099.jpg). The vehicle wash pad seems to be of an insufficient size to contain the process wastewater which splashes off the large Packer trucks. The onsite supervisor, Dave, confirmed that during the washing process it was nearly impossible to keep process wastewater from splashing outside of containment. The trailer which held the fresh water, and the pump for the pressure washer is located outside of the wash pad containment (see photo: PC050100.jpg). The whole trailer is splattered with oily residue, and its water tanks are leaking into a storm drain located directly below (see photo: PC050103.jpg). The liquid that was leaking is considered process wastewater and cannot be legally discharged into stormwater. There is thick layer of sediment deposition around this storm drain. Such large amounts of sediment build-up were not observed at the other storm drains. The sediment at this storm drain most probably derived from the cleaning operations in the area. Dirt washed from vehicles was somehow escaping containment and entering the storm drain.

PC050099.JPG **DESCRIPTION:** PACKER TRUCK VEHICLE WASH PAD.

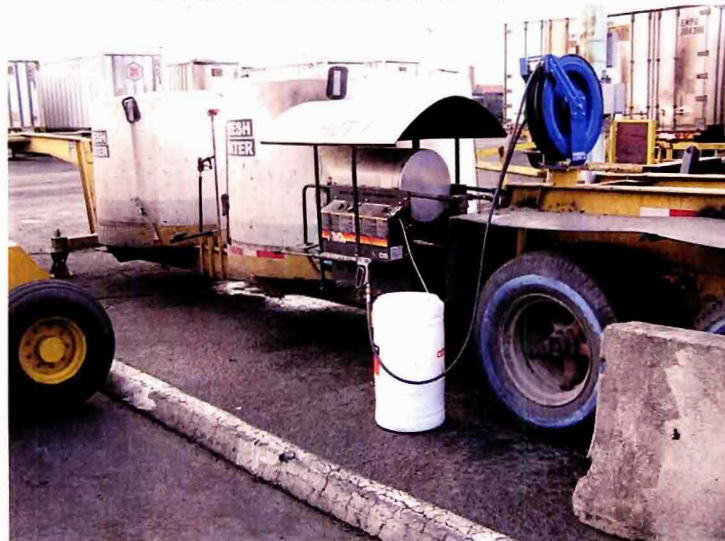
PC050100.JPG **DESCRIPTION:** FRESH WATER AND PRESSURE WASHER STORED ON A TRAILER OUTSIDE OF WASHING PAD CONTAINMENT. NOTICE OILY RESIDUE ON TRAILER AND THE GROUND BELOW, AS WELL AS A LEAK.

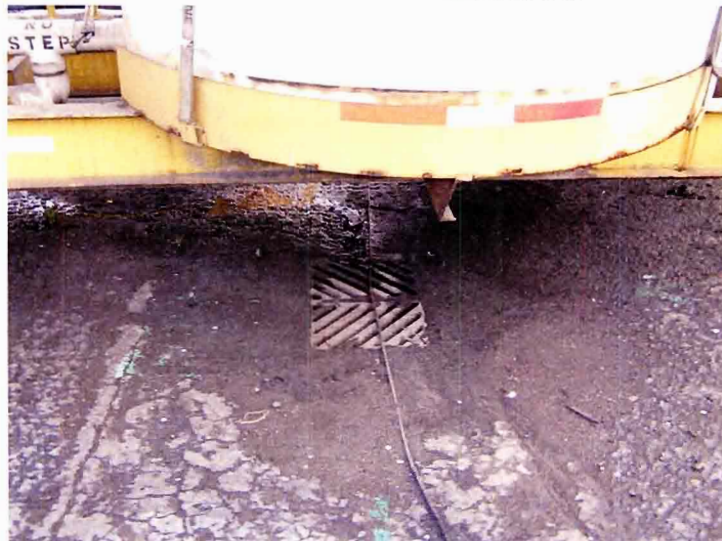
PC050053.JPG **DESCRIPTION:** STORM DRAIN, LOCATED UNDER PREASURE WASHING TRAILER, RECEIVING PROCESS WASTEWATER FROM LEAK. THICK SEDIMENTATION DEPOSITION HAS ACCUMULATED AROUND THE STORM DRAIN.
