Re: NPDES Permit Number WAR000074

Enclosed is a report from the Department of Ecology's recent National Pollutant Discharge Elimination System (NPDES) Industrial Stormwater General Permit (ISGP) compliance inspection conducted at your facility on January 24, 2020. Thank you for the time your personnel spent with me during my visit.

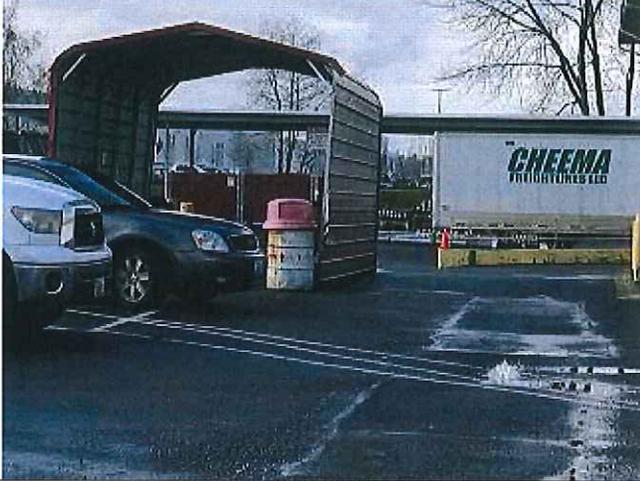
Image 1: Roofed sheds are used to protect materials and equipment from stormwater.

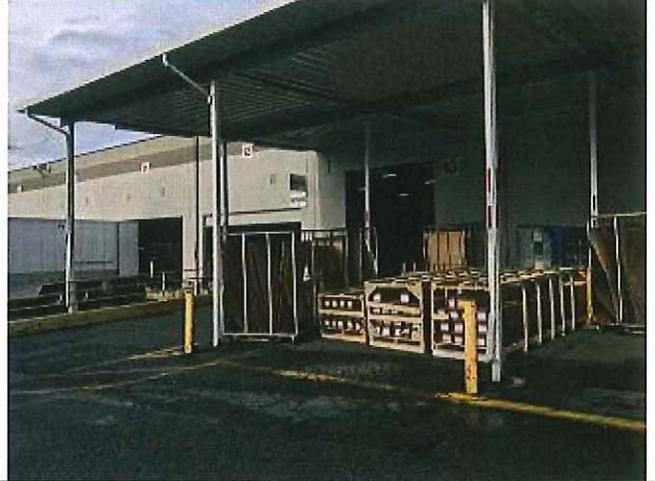
Image 2: Materials stored under cover.

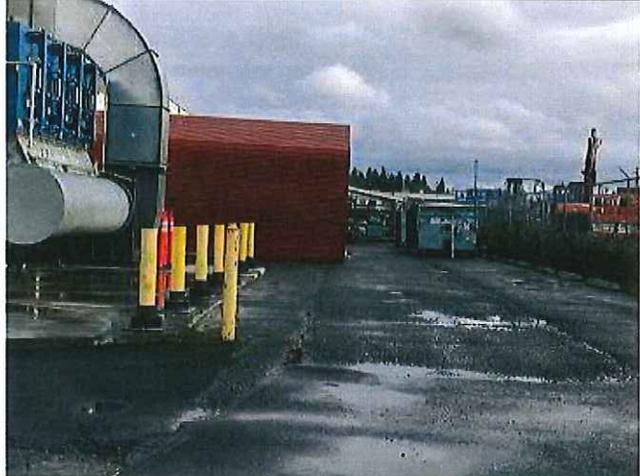
Image 3: Dumpsters are lidded and located as far from storm system as possible.

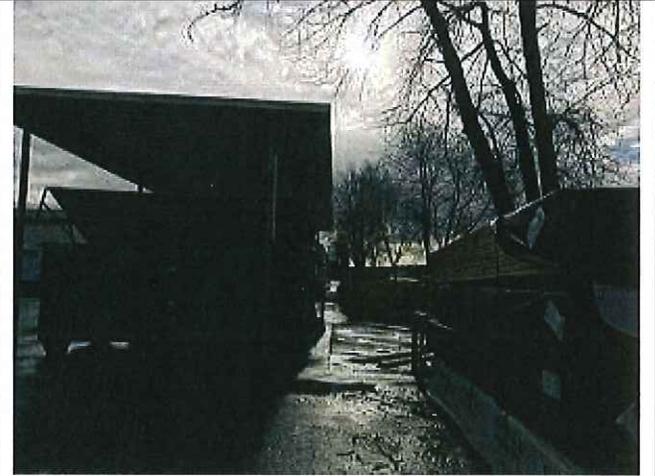
Image 4: Lidded dumpster is stored under a roofed area.

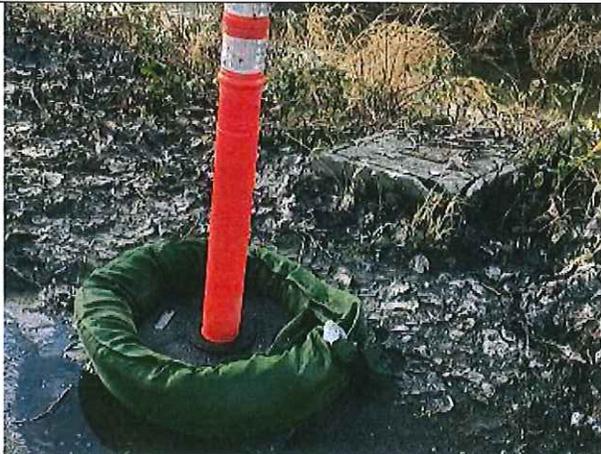
Image 5: Marker helps identify submerged catch basin next to outfall.
