# CONSTRUCTION STORMWATER GENERAL PERMIT INSPECTION REPORT

State of Washington Department of Ecology

The Wellington - Lennar project is covered under the State of Washington's Construction Stormwater General Permit (CSWGP). The CSWGP is a National Pollutant Discharge Elimination System (NPDES) and a State Waste Discharge permit for discharge of construction-related stormwater. The purpose of this inspection is to conduct a compliance inspection and to provide technical assistance as appropriate.

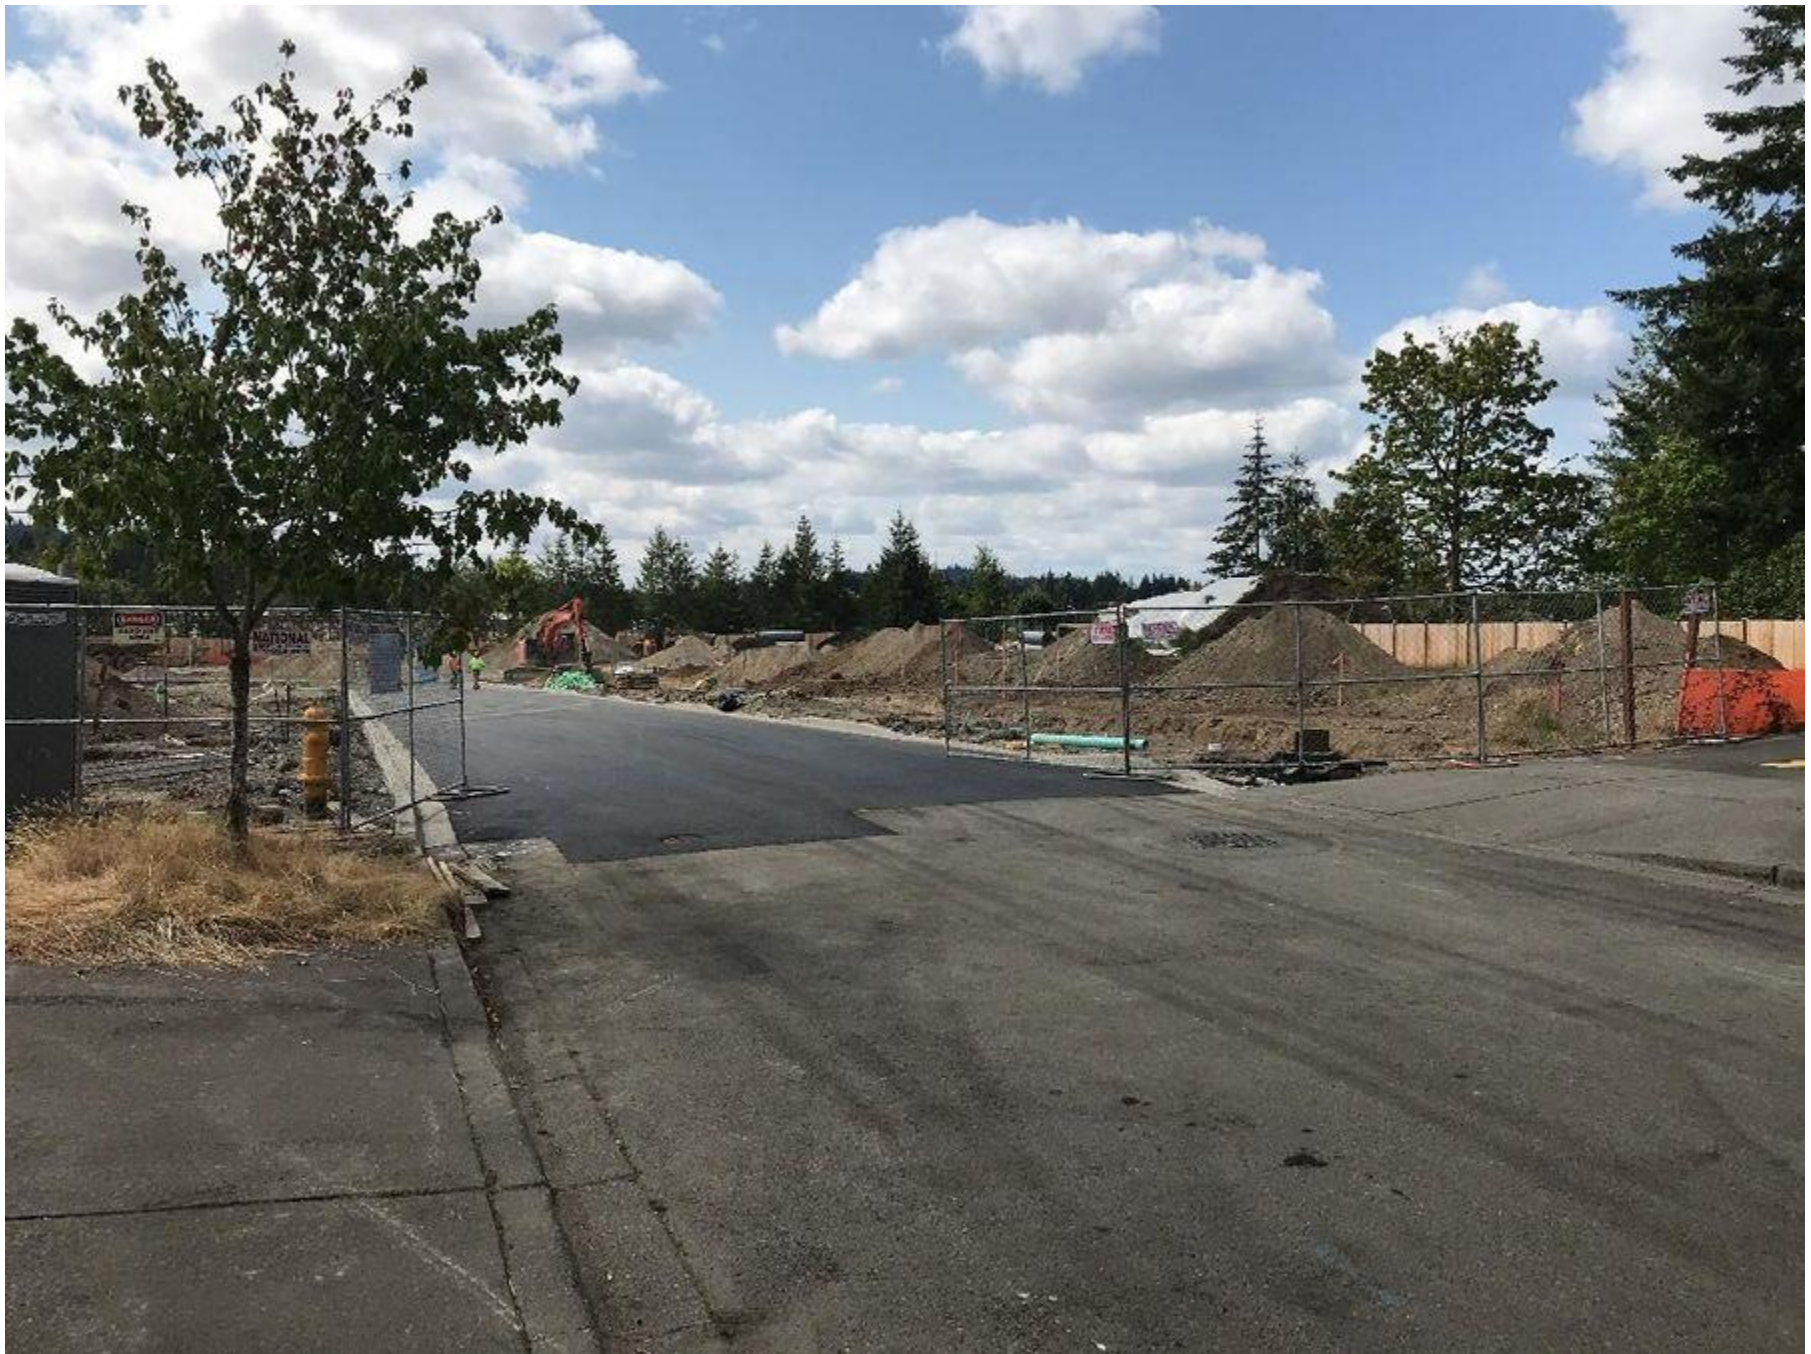
**Photo 1**

Photo Description: Site entrance is now paved.

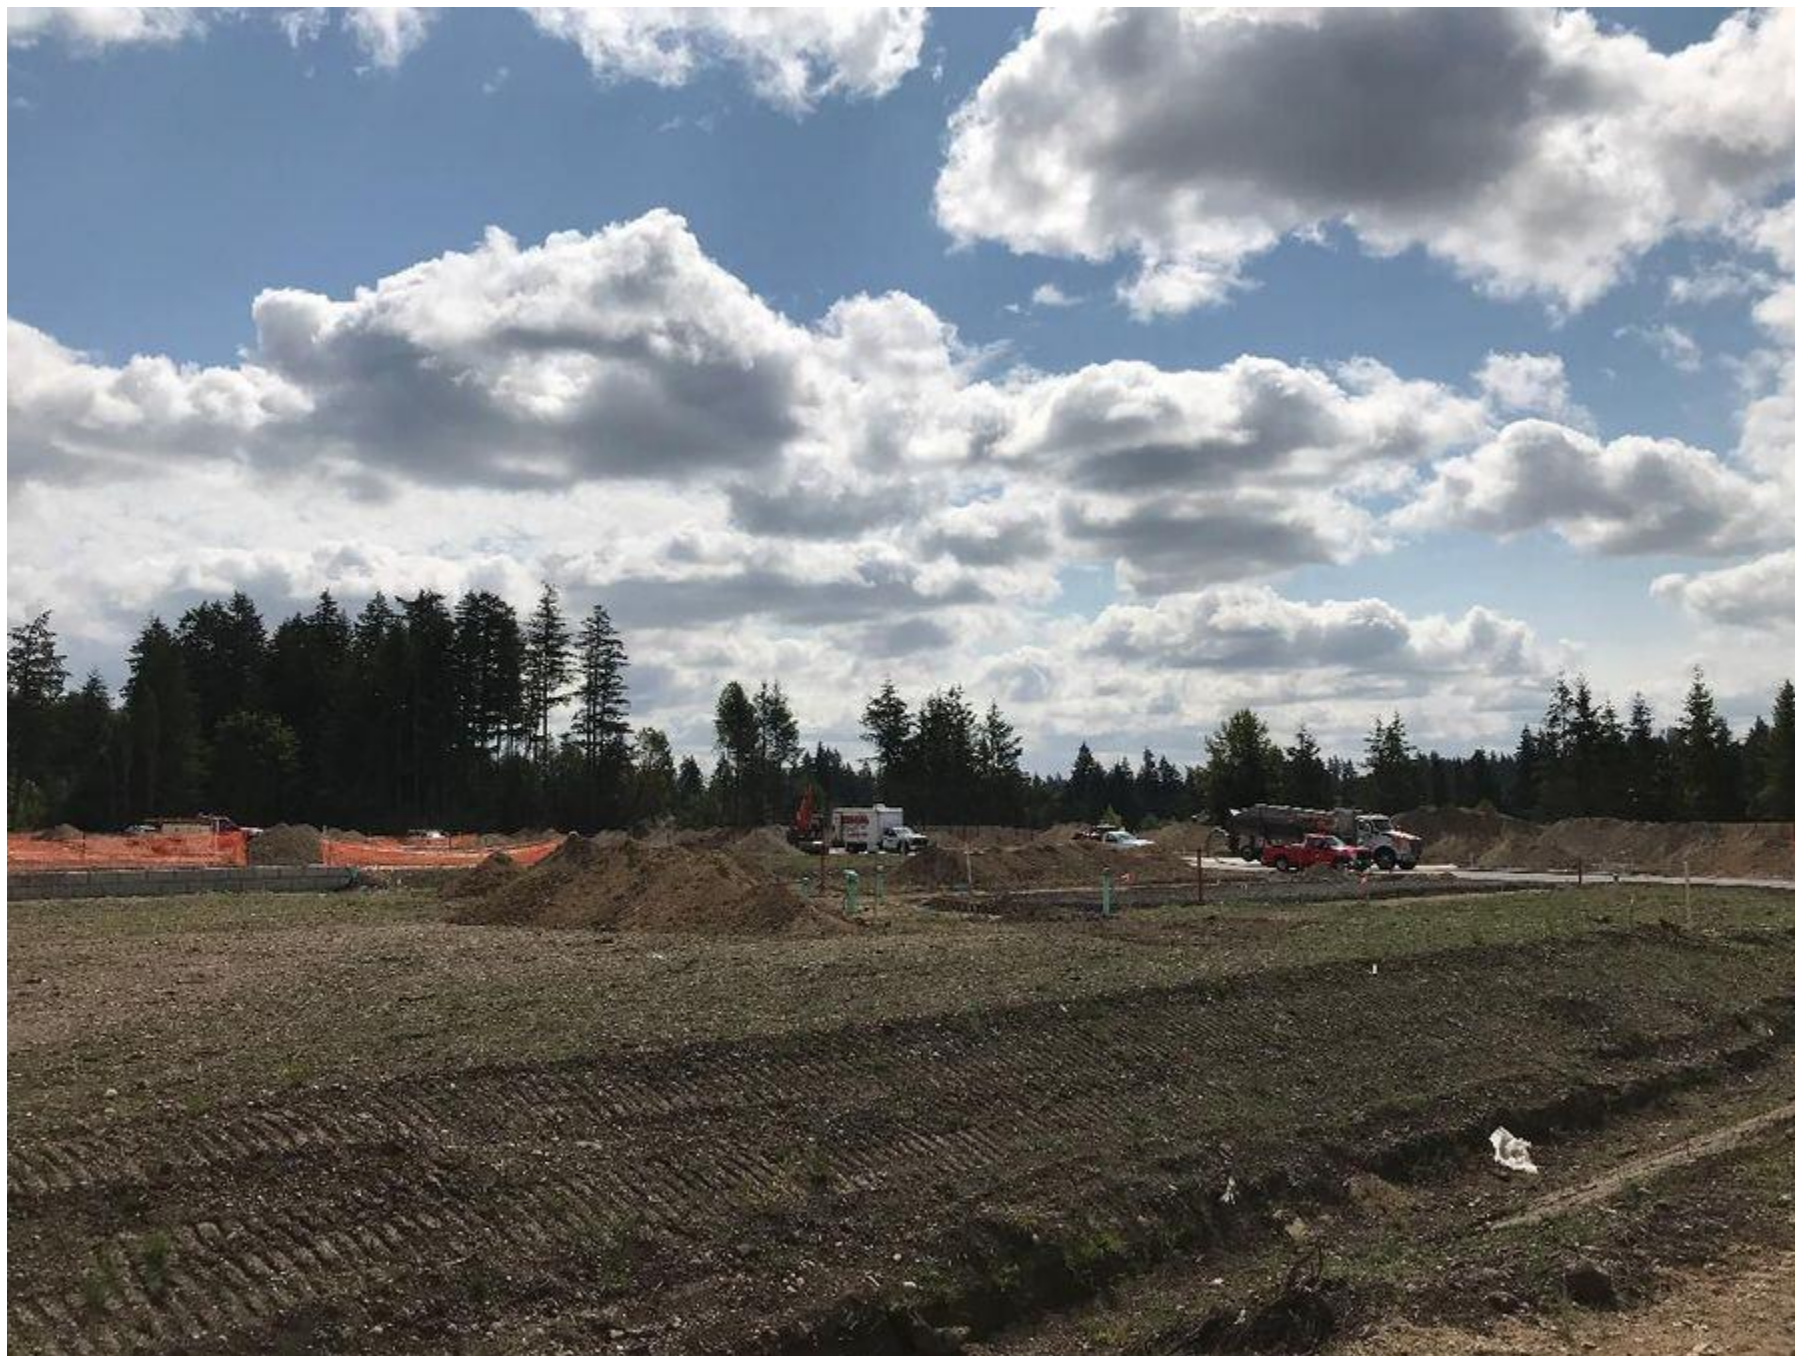
**Photo 2**

Photo Description: Site overview.

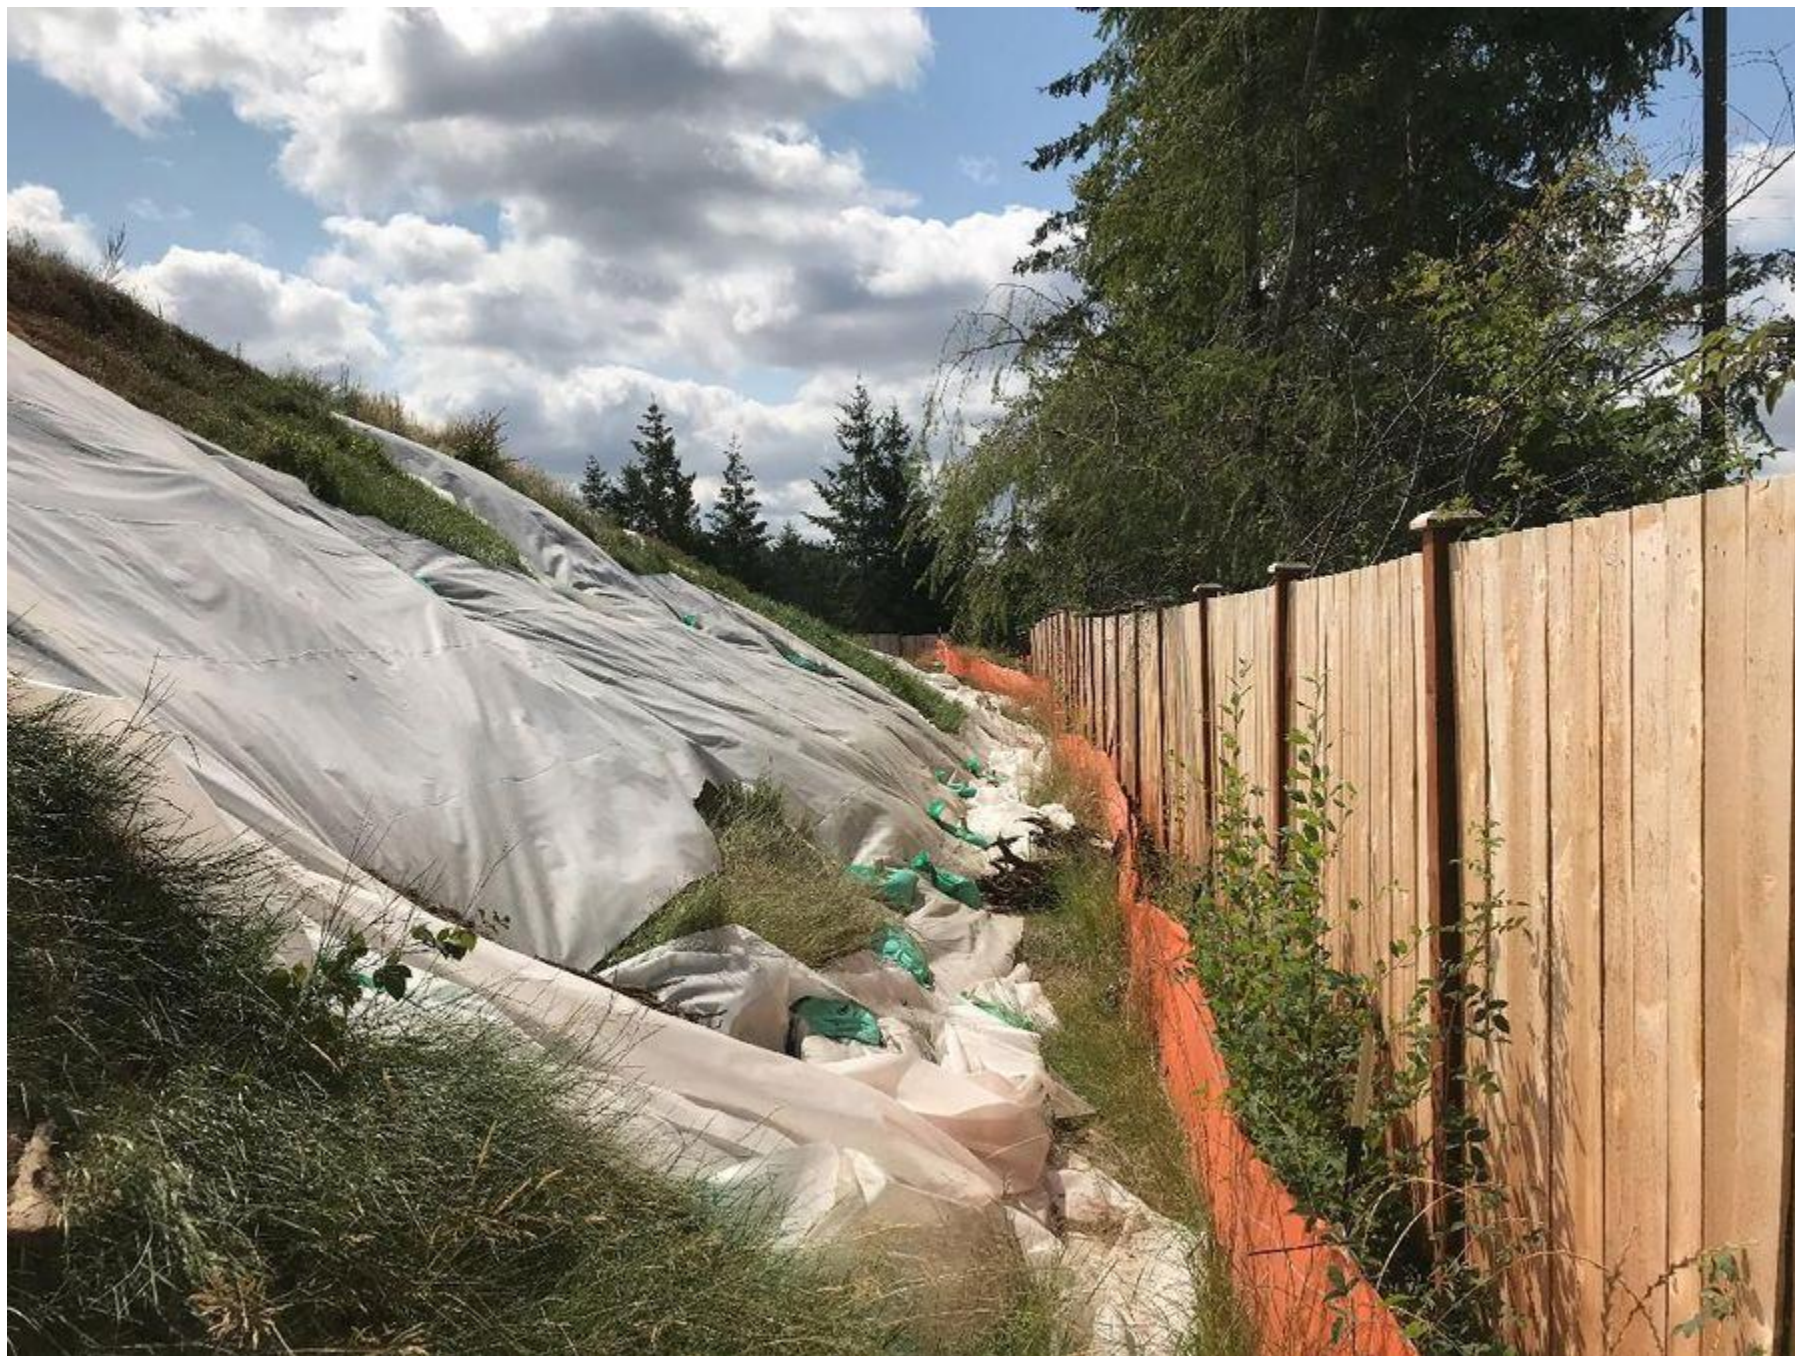
**Photo 3**

Photo Description: Eastern site boundary is stabilized.

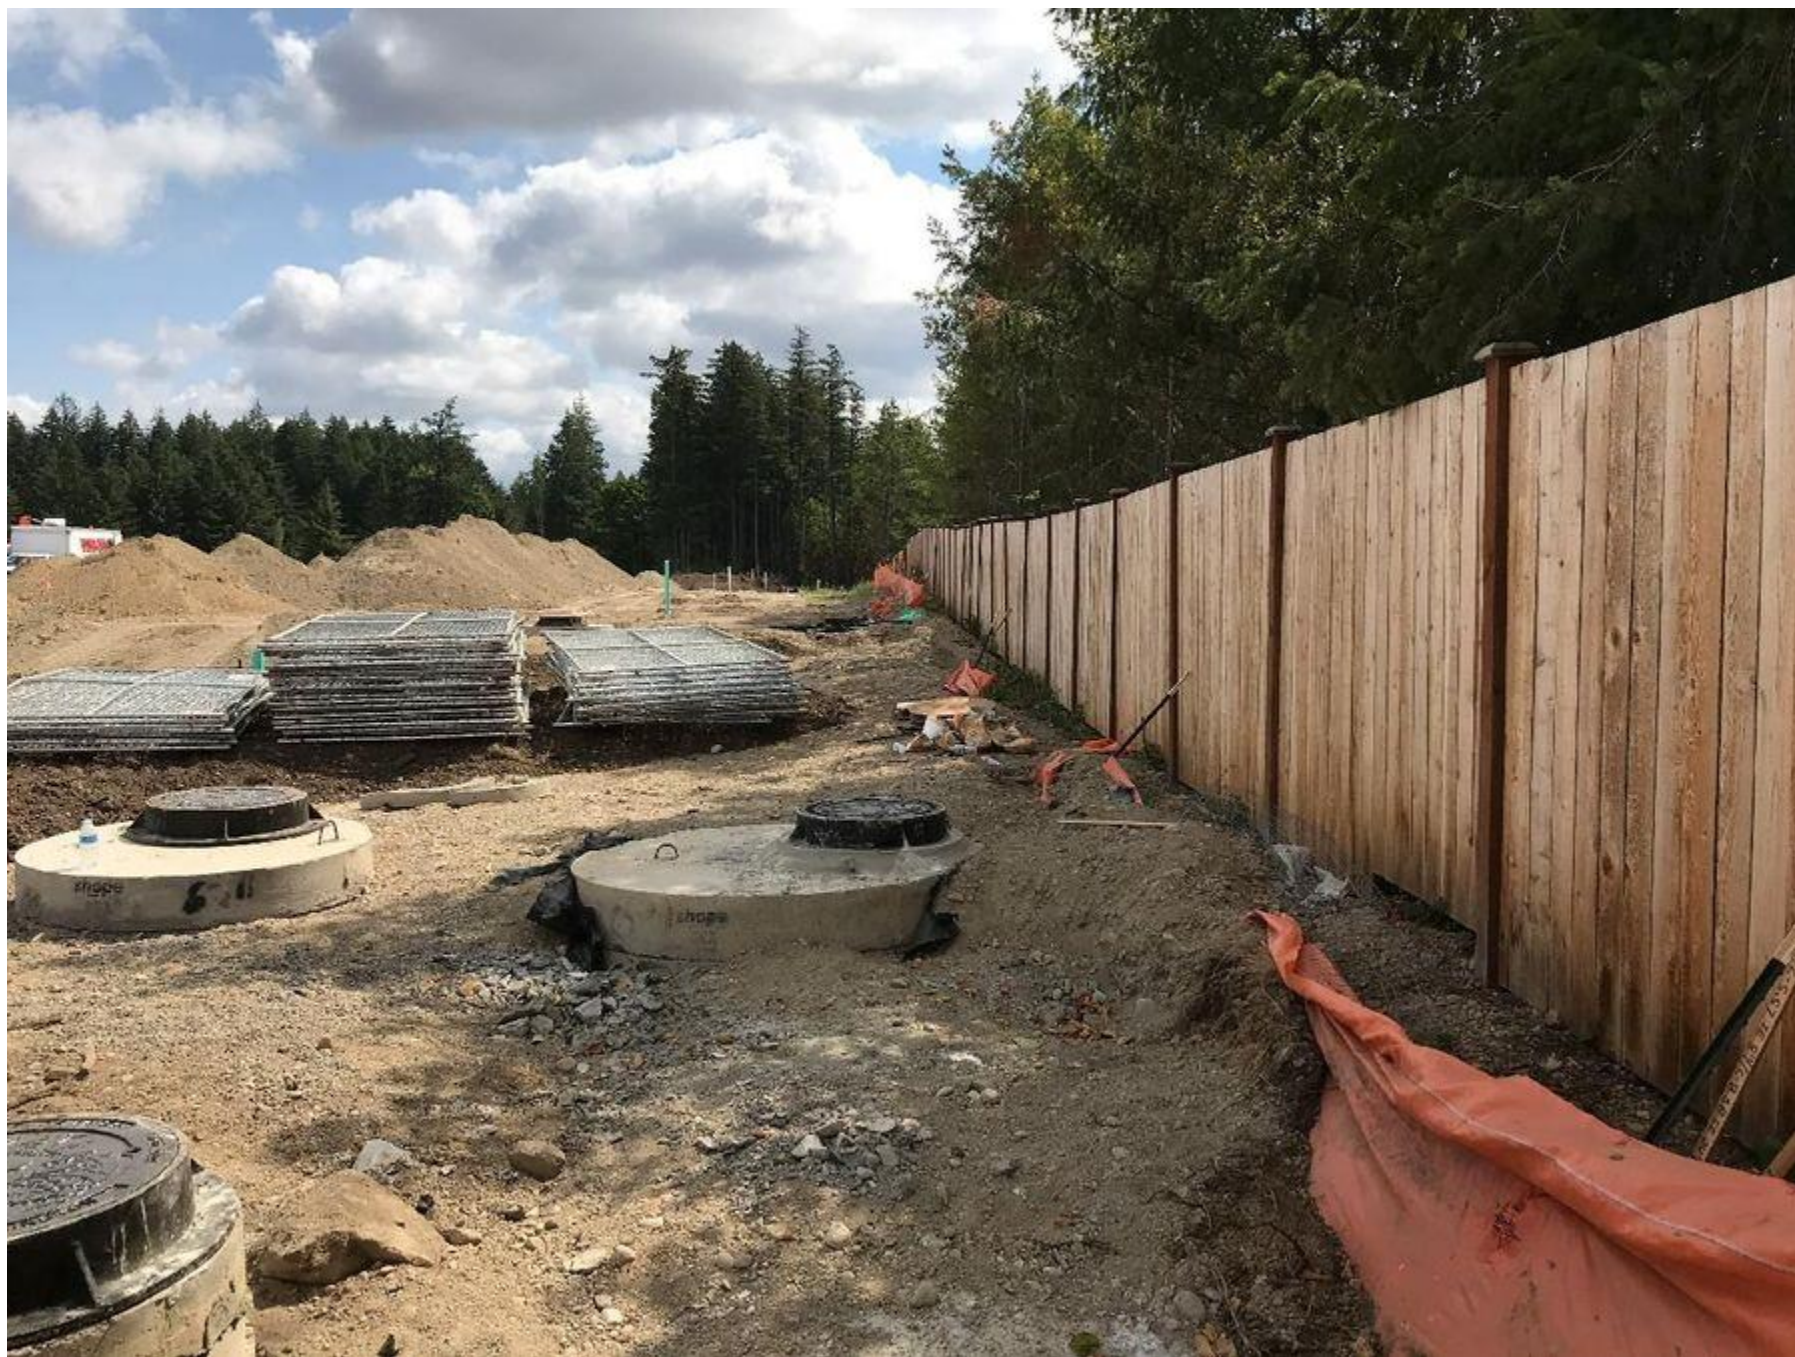
**Photo 4**

Ecology arrived onsite to conduct a routine compliance inspection. The storm system was being cleaned with vac truck at time of inspection, so inlet protection was not in place. A manager with PRD explained that silt socks are on site and ready to be installed after cleaning. A portion of silt fence along the southern boundary needs to be maintained.

Photo Description: The section of silt fence must be repaired.

<u>Violations and action required to achieve compliance</u>	<u>Complete or submit date</u>	<u>Guidance</u>
<u>S9.D.11 Maintain BMPs</u> <b>Silt fence shown in photo 4 must be repaired.</b> <b>Failure to meet S9.D.11.a:</b> Permittee must maintain and repair all temporary and permanent erosion and sediment control BMPs as needed to assure continued performance of their intended function in accordance with BMP specifications. Maintain and repair all temporary and permanent BMPs, as set forth in permit condition S9.D.11.a.	Immediately begin. Address the problems <b>no later than 10 days</b> from the date of this inspection.	SWMMWW, Chapter II-4 <a href="#">Best Management Practices Standards and Specifications, C150, C160</a>

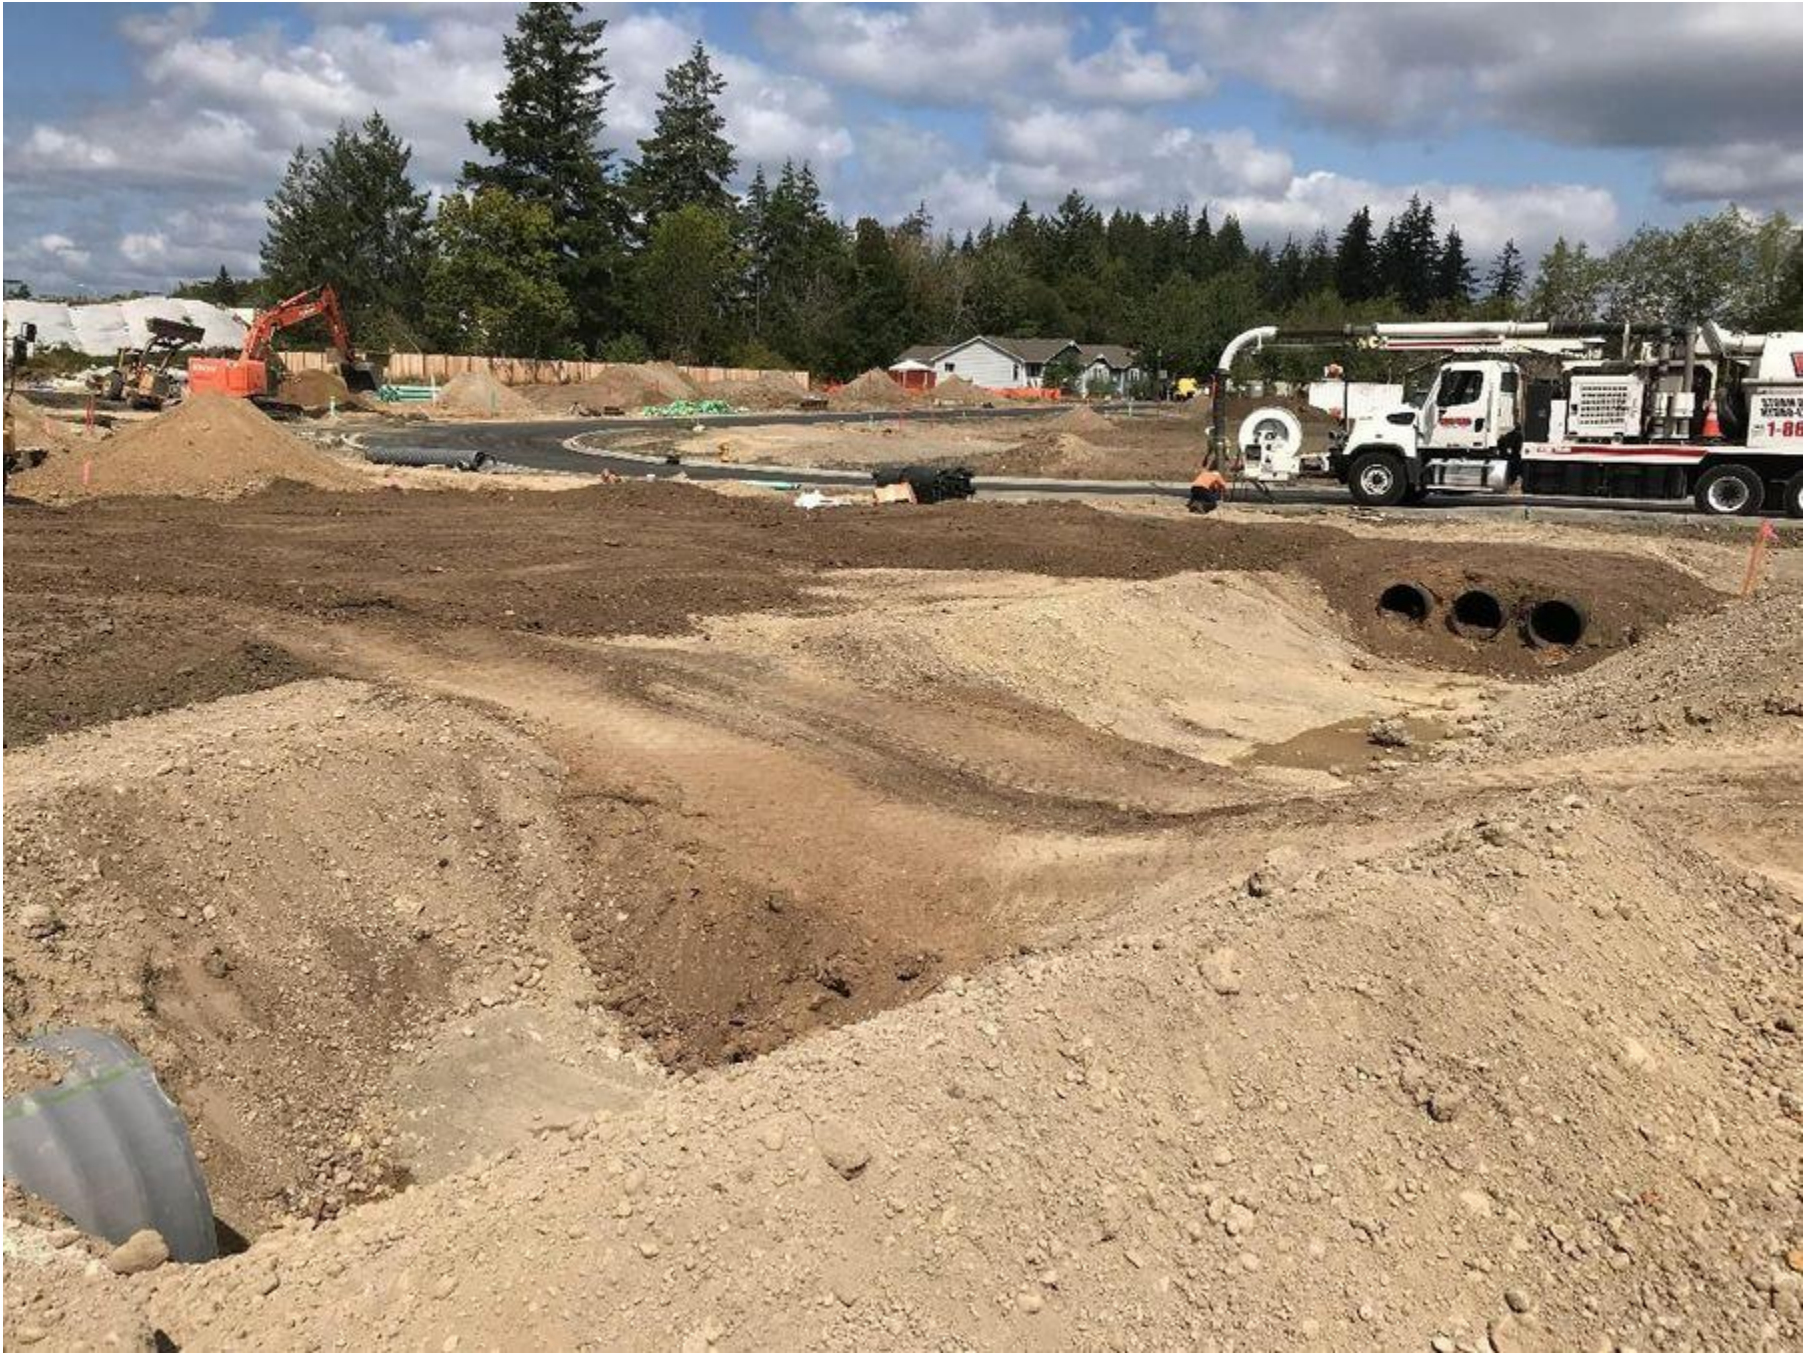
### Photo 5

Photo Description: A portion of the channel that drains the regional stormwater pond to the north of the site.

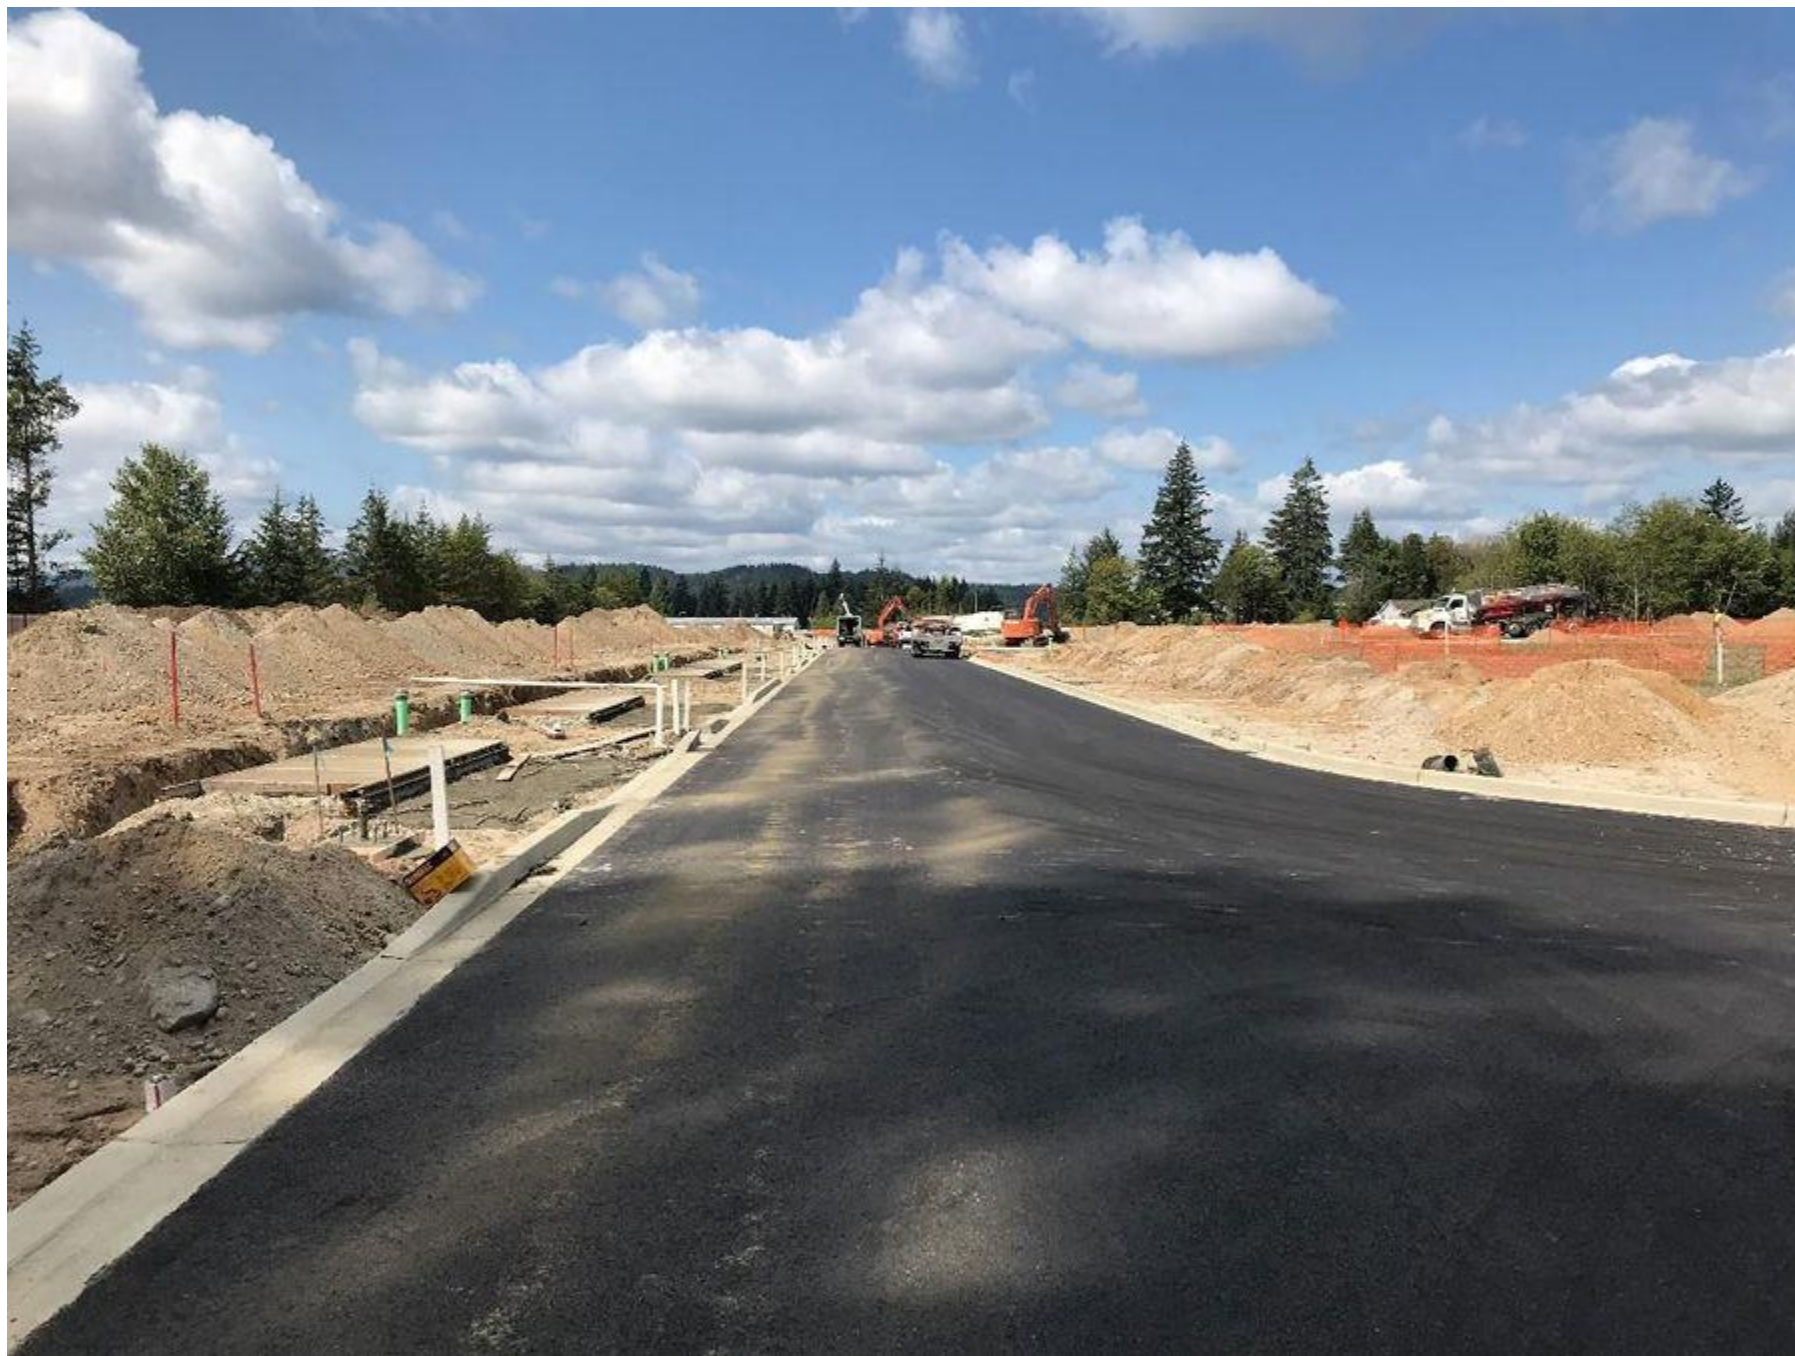
Photo 6

Photo Description: Sediment on roads must be removed.

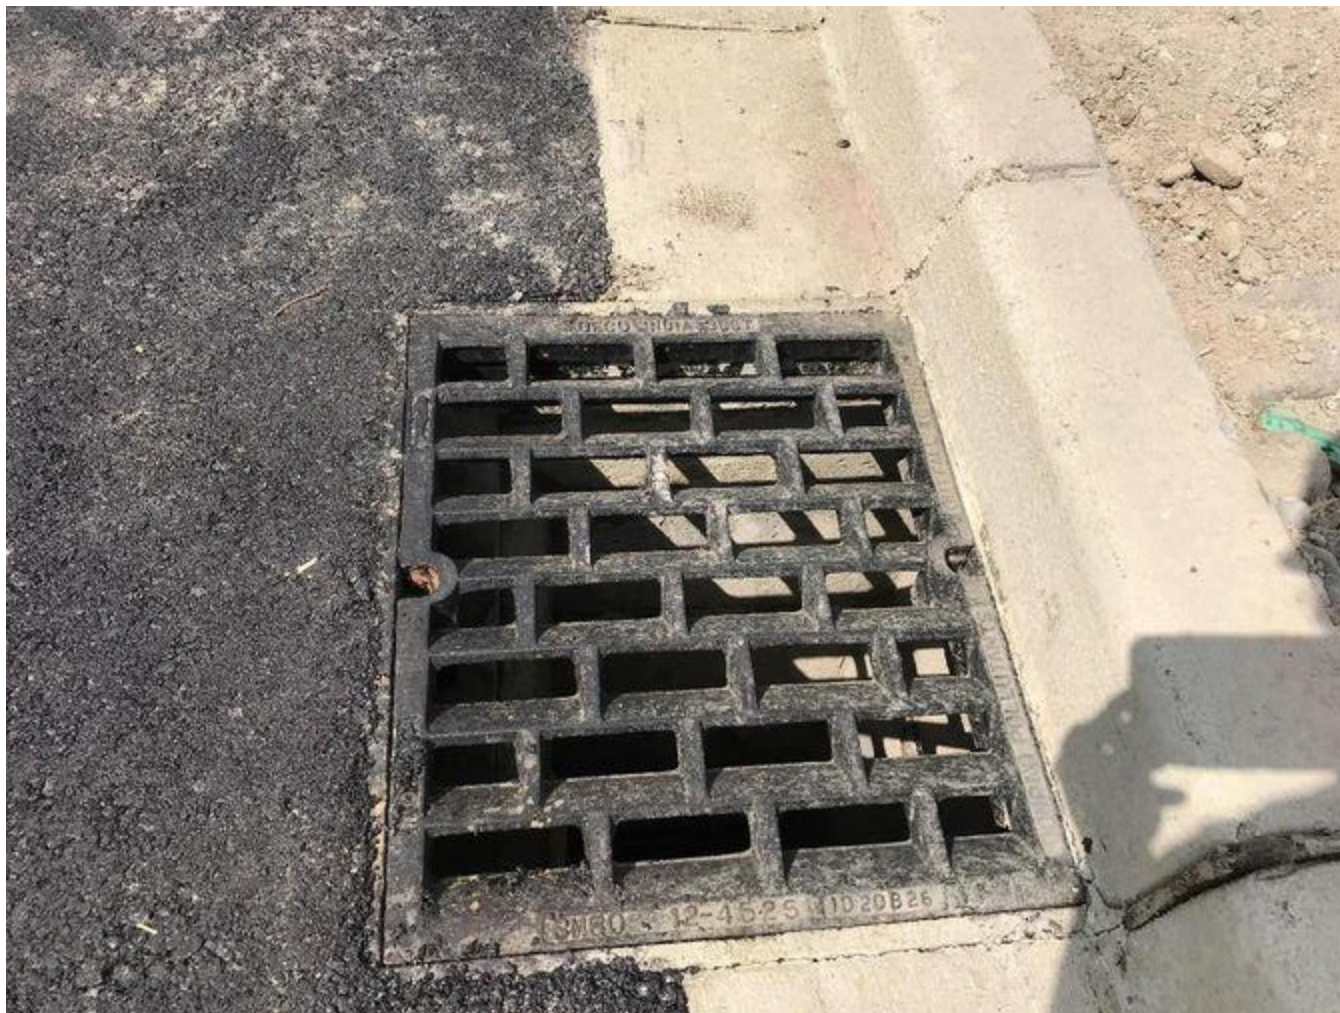
### Photo 7

Photo Description: No inlet protection at time of inspection, because storm system was actively being cleaned.
