**Subject: Washington State Department of Ecology (DOE) Construction Stormwater Compliance
Inspection for Wellington - Lennar, dated August 12, 2020, WAR308398**

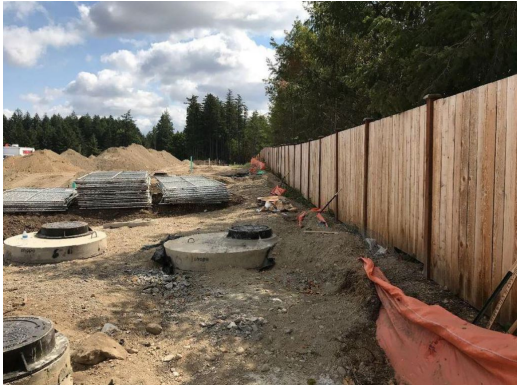
1. "Silt fence shown in photo 4 must be repaired. Failure to meet S9.D.11.a"

Ecology Photo 4: The section of silt fence must be repaired

Completed Corrective Action: On August 12, the silt fence was repaired as shown in Lennar Photo 1.

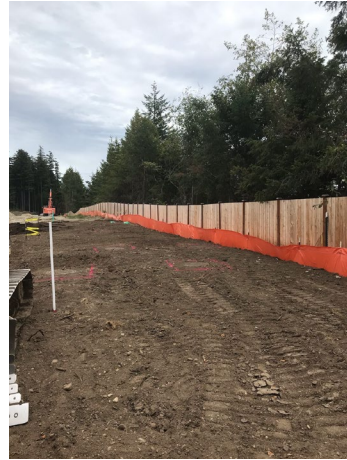
Lennar Photo 1: Section of silt fence repaired.
