CONSTRUCTION STORMWATER GENERAL PERMIT INSPECTION REPORT

State of Washington Department of Ecology

The Woodbrook Townhomes project is covered under the State of Washington's Construction Stormwater General Permit (CSWGP). The CSWGP is a National Pollutant Discharge Elimination System (NPDES) and a State Waste Discharge permit for discharge of construction-related stormwater. The purpose of this inspection is to conduct a compliance inspection and to provide technical assistance as appropriate.

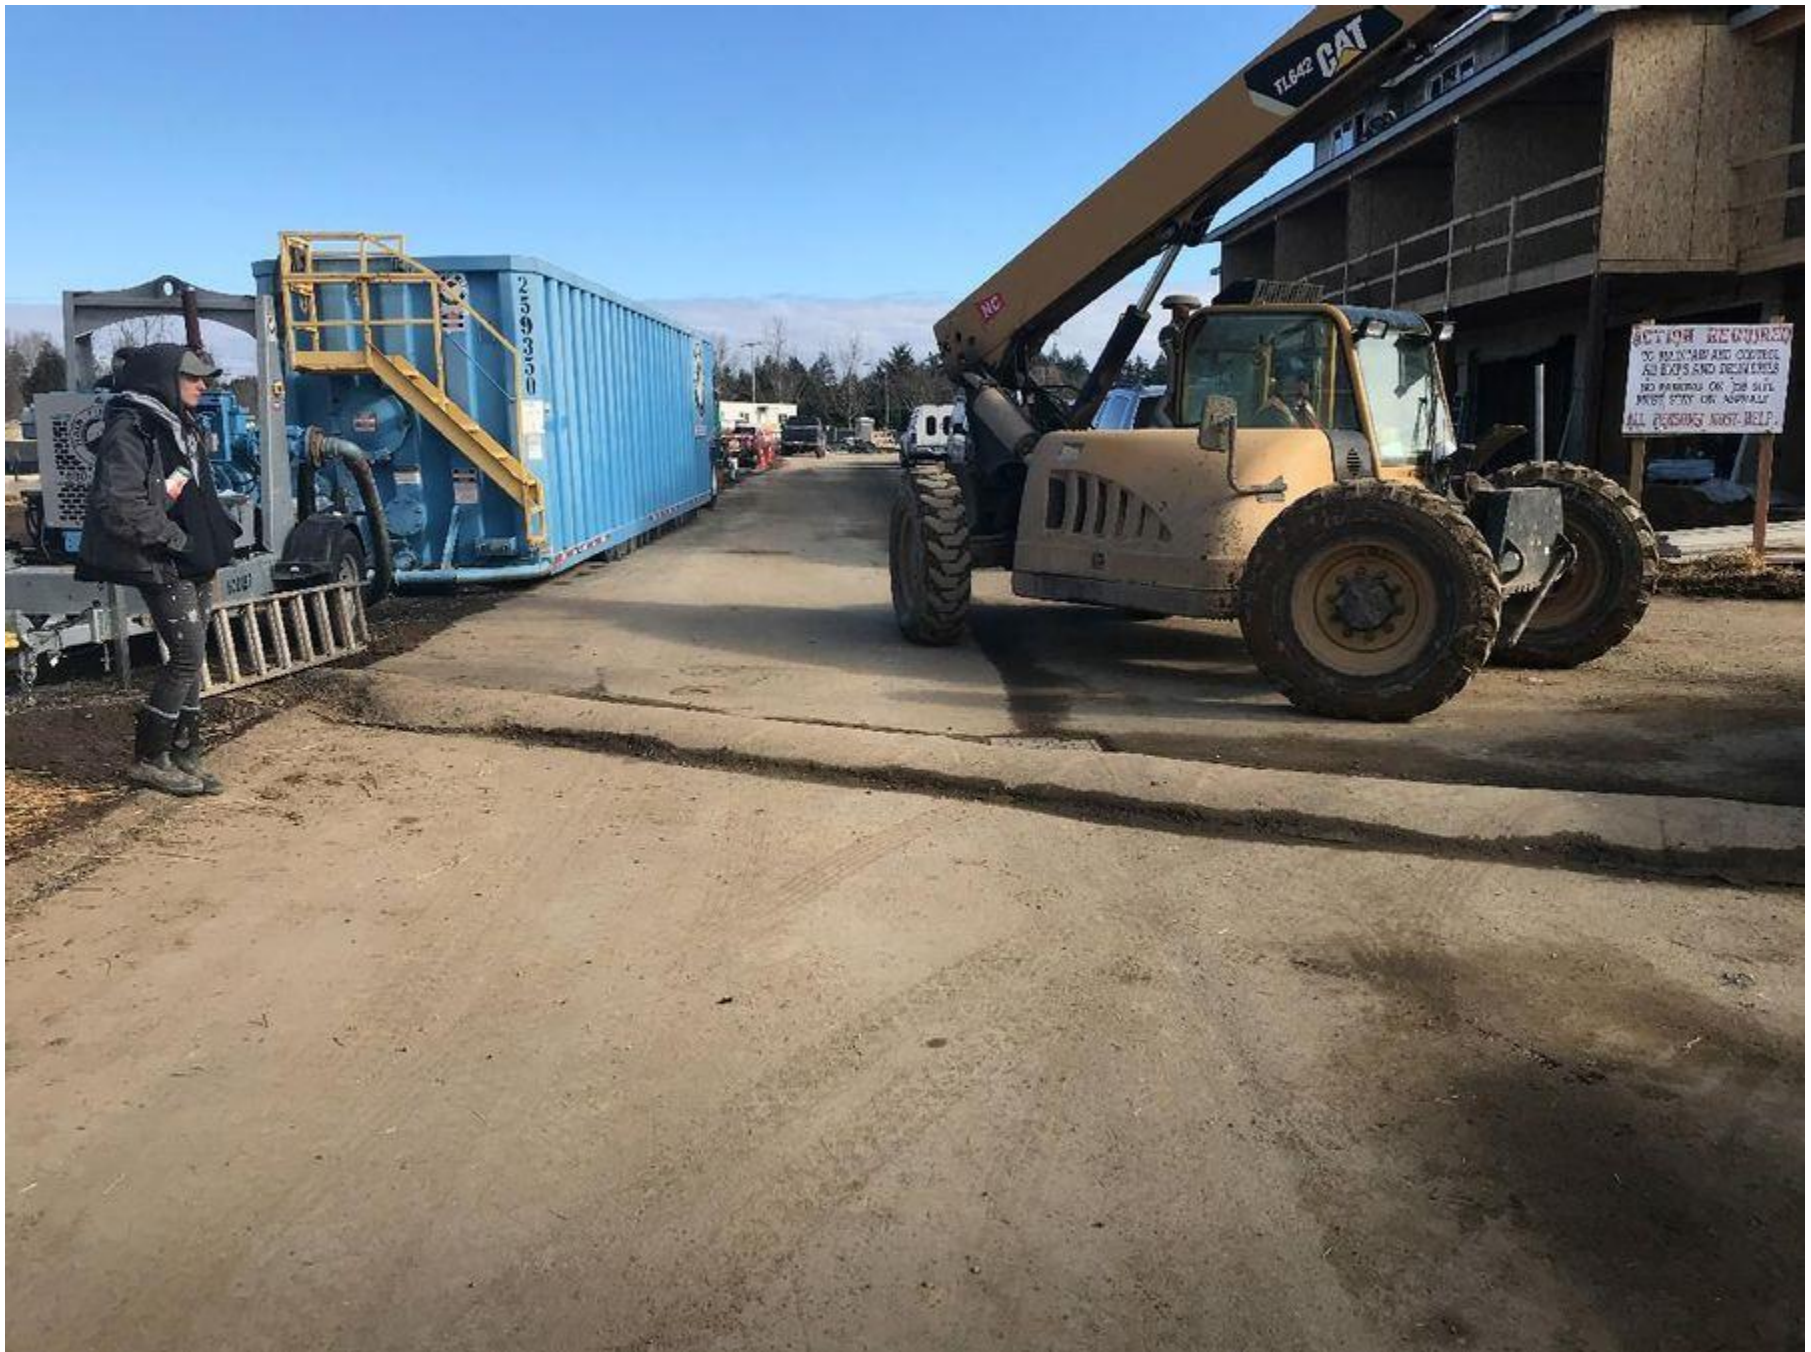
Photo 1

Photo Description: Roads are caked in dirt.

<p><u>S9.D.2 Establish Construction Access</u> No stabilized access on most lots. Failure to meet S9.D.2.b: Stabilize access points with a pad of quarry spalls, crushed rock, or other equivalent BMPs, to minimize tracking sediment onto roads., Roads are caked in dirt. Sweeper being used is not adequate to clean pavement, and should be cleaned with a high efficiency vacuum sweeper. Failure to meet S9.D.2.d: If sediment is tracked off site, clean the affected roadway thoroughly at the end of each day, or more frequently as necessary (for example, during wet weather). Remove sediment from roads by shoveling, sweeping, or pickup and transport of the sediment to a controlled sediment disposal area. Install and maintain adequate construction access to prevent track-out off-site.</p>	<p>Clean the affected roadway thoroughly at the end of each day, or more frequently as necessary. [or if it's a particular BMP] Immediately begin. Address the problems no later than 10 days from the date of this inspection.</p>	<p>BMP C105, BMP C106, BMP C107</p>

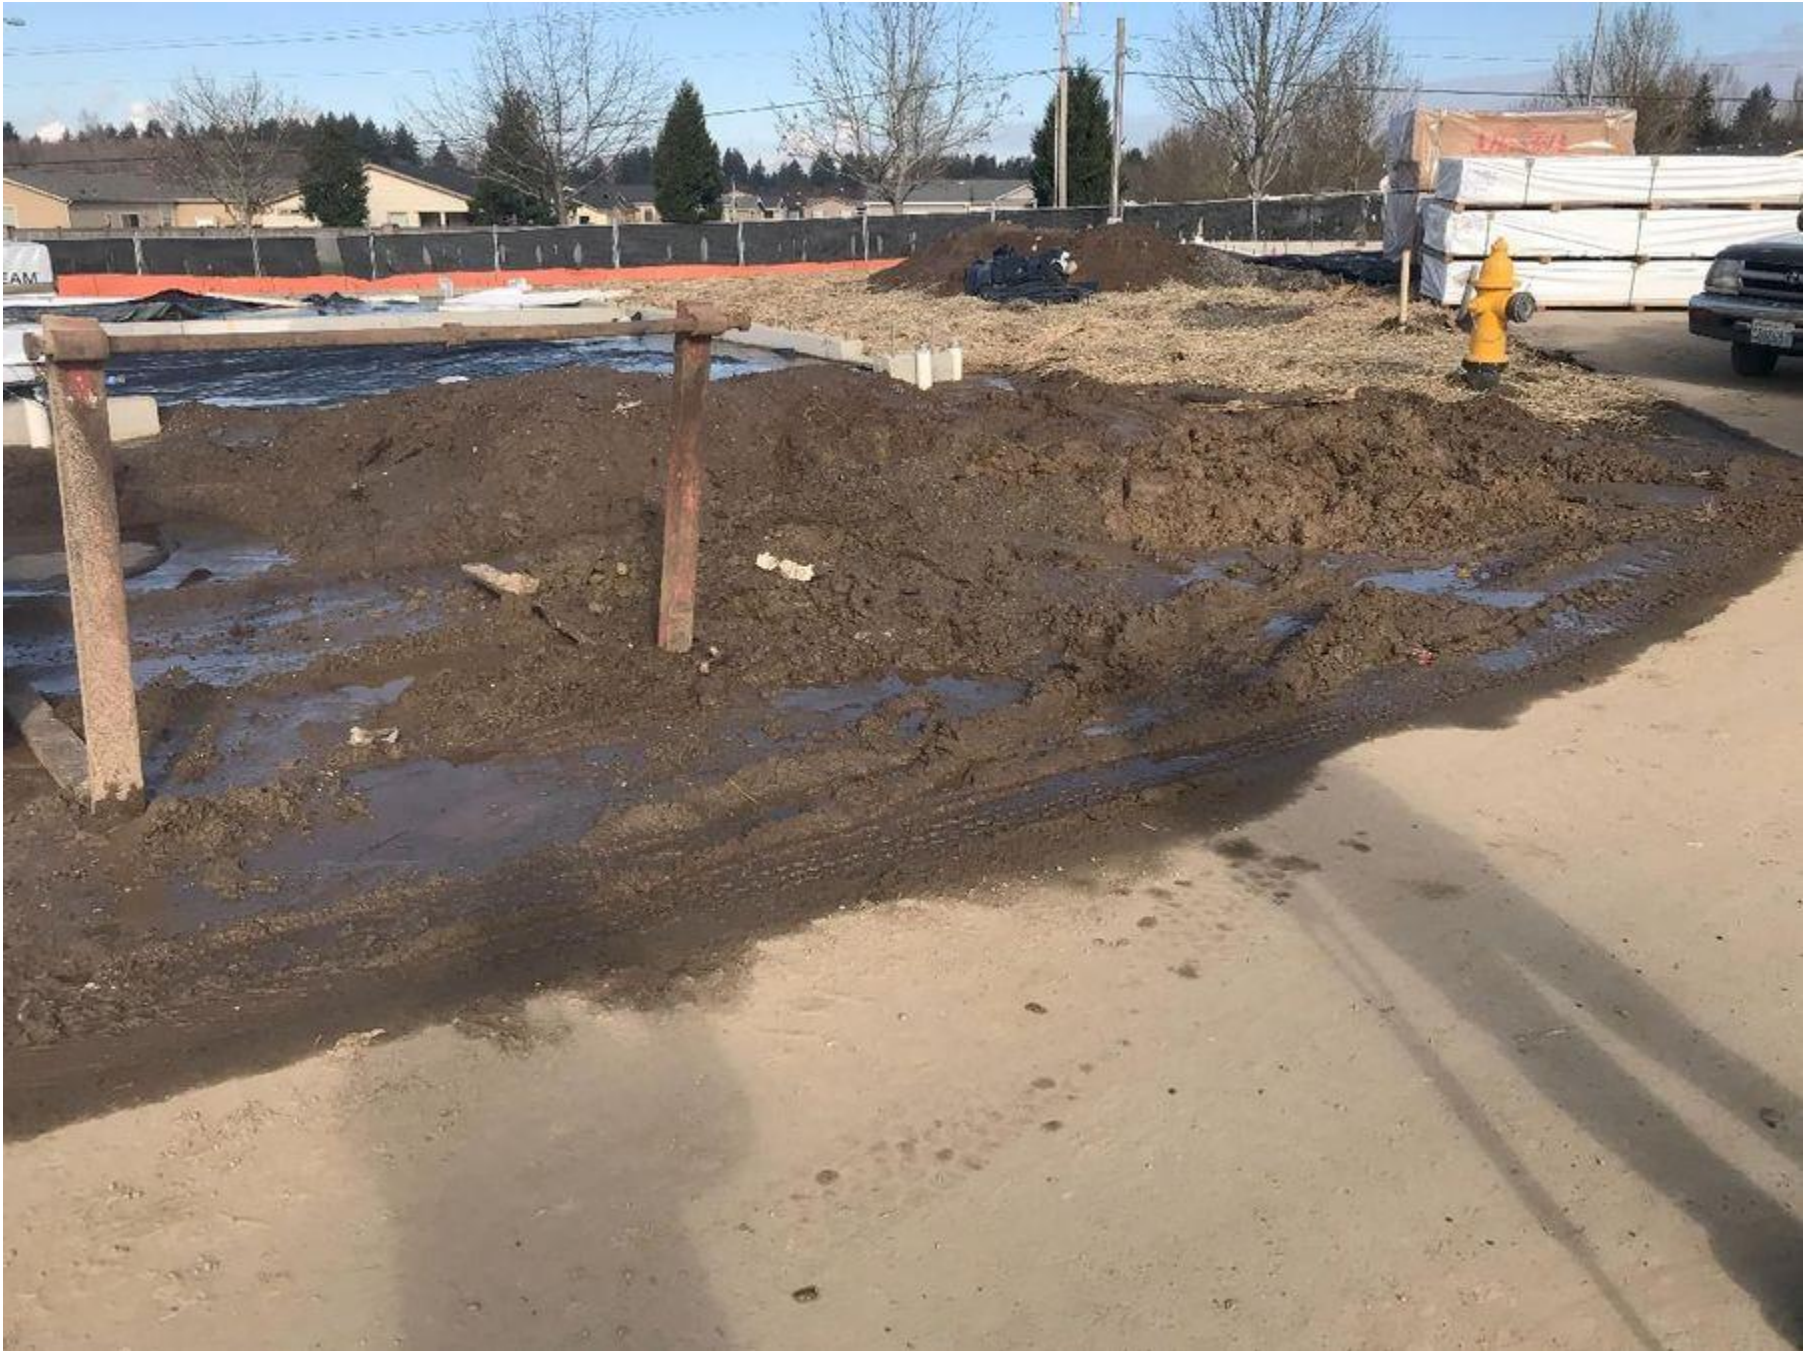
Photo 2

Photo Description: Exposed soils with no sediment controls separating them from the road.

<p><u>S9.D.4 Install Sediment Controls</u> No sediment controls (silt fence or wattles) around exposed areas. Failure to meet S9.D.4.a: Construct sediment control BMPs (sediment ponds, traps, filters, infiltration facilities, etc.) as one of the first steps in grading. These BMPs must be functional before other land disturbing activities take place. Install sediment controls to minimize the discharge of pollutants, as set forth in permit condition S9.D.4.b.</p>	<p>Immediately begin. Address the problems no later than 10 days from the date of this inspection.</p>	<p>C231, C232, C233, C234, C235, C240, C241, C250, C251</p>
<p><u>S9.D.5 Stabilize Soils</u> Exposed unworked soils throughout site. Failure to meet S9.D.5.a: The Permittee must stabilize exposed and unworked soils by application of effective BMPs that prevent erosion. Applicable BMPs include, but are not limited to: temporary and permanent seeding, sodding, mulching, plastic covering, erosion control fabrics and matting, soil application of polyacrylamide (PAM), the early application of gravel base on areas to be paved, and dust control. Stabilize exposed and unworked soils, including stockpiles, by application of effective BMPs to prevent erosion, as set forth in permit condition S9.D.5.a and timeline in S9.D.5.d.</p>	<p>Permittee must not allow soils to remain exposed and unworked for more than the time periods set forth below to prevent erosion: During the wet season (October 1 - April 30): 2 days from the date of this inspection.</p>	<p>C120, C121, C122, C123, C124, C125, C126, C130, C131, C140</p>

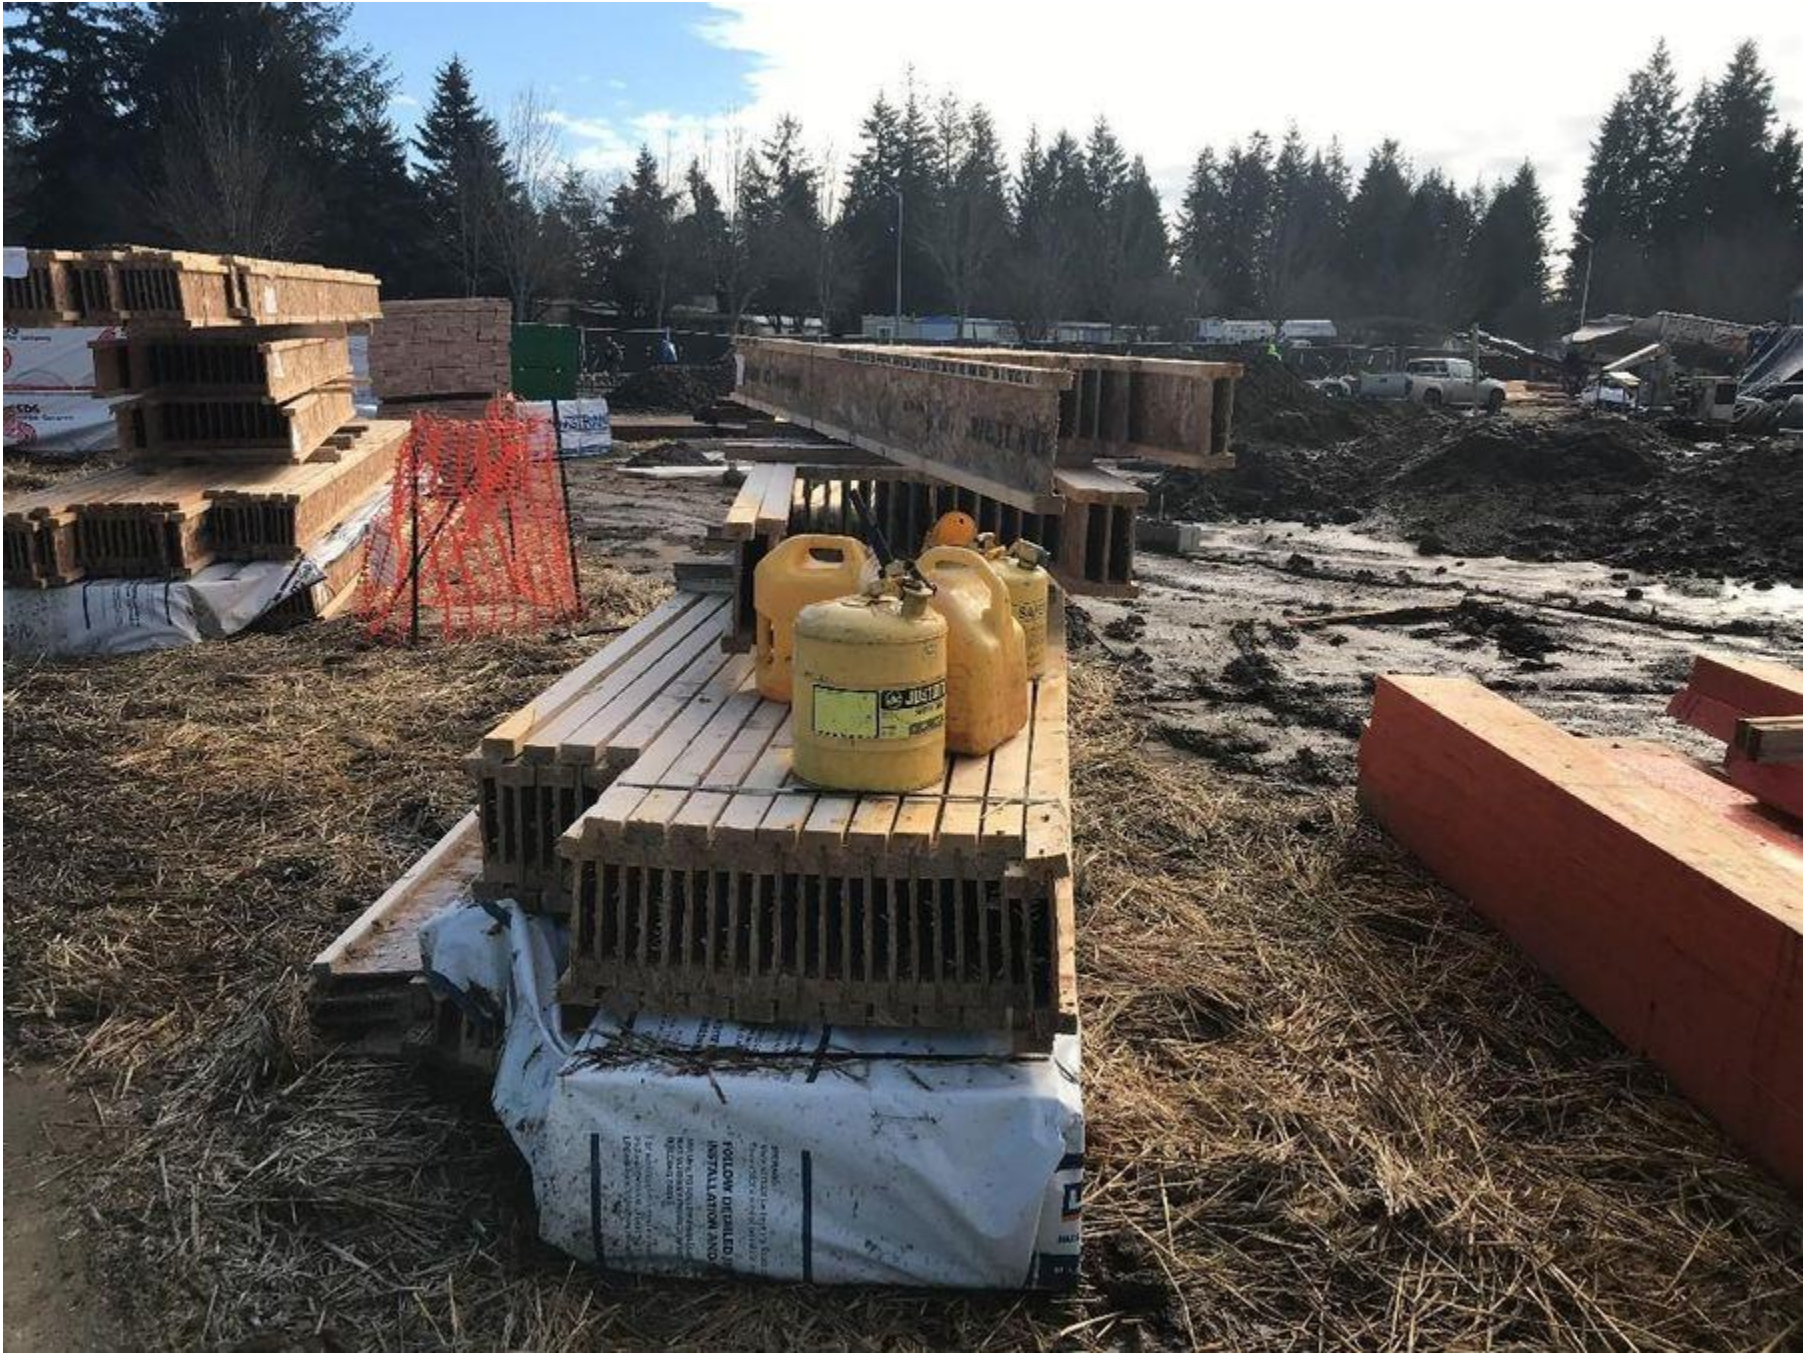
Photo 3

Photo Description: Gas cans require secondary containment or cover.

<p><u>S9.D.9. Control Pollutants</u> Gas containers sitting out without secondary containment or cover. Failure to meet S9.D.9.b: b. Provide cover, containment, and protection from vandalism for all chemicals, liquid products, petroleum products, and other materials that have the potential to pose a threat to human health or the environment. Minimize storage of hazardous materials on-site. Safety Data Sheets (SDS) should be supplied for all materials stored. Chemicals should be kept in their original labeled containers. On-site fueling tanks must include secondary containment. Secondary containment means placing tanks or containers within an impervious structure capable of containing 110% of the volume of the largest tank within the containment structure. Double-walled tanks do not require additional secondary containment</p>	<p>Immediately begin. Address the problems no later than 10 days from the date of this inspection.</p>	<p>BMP C153</p>

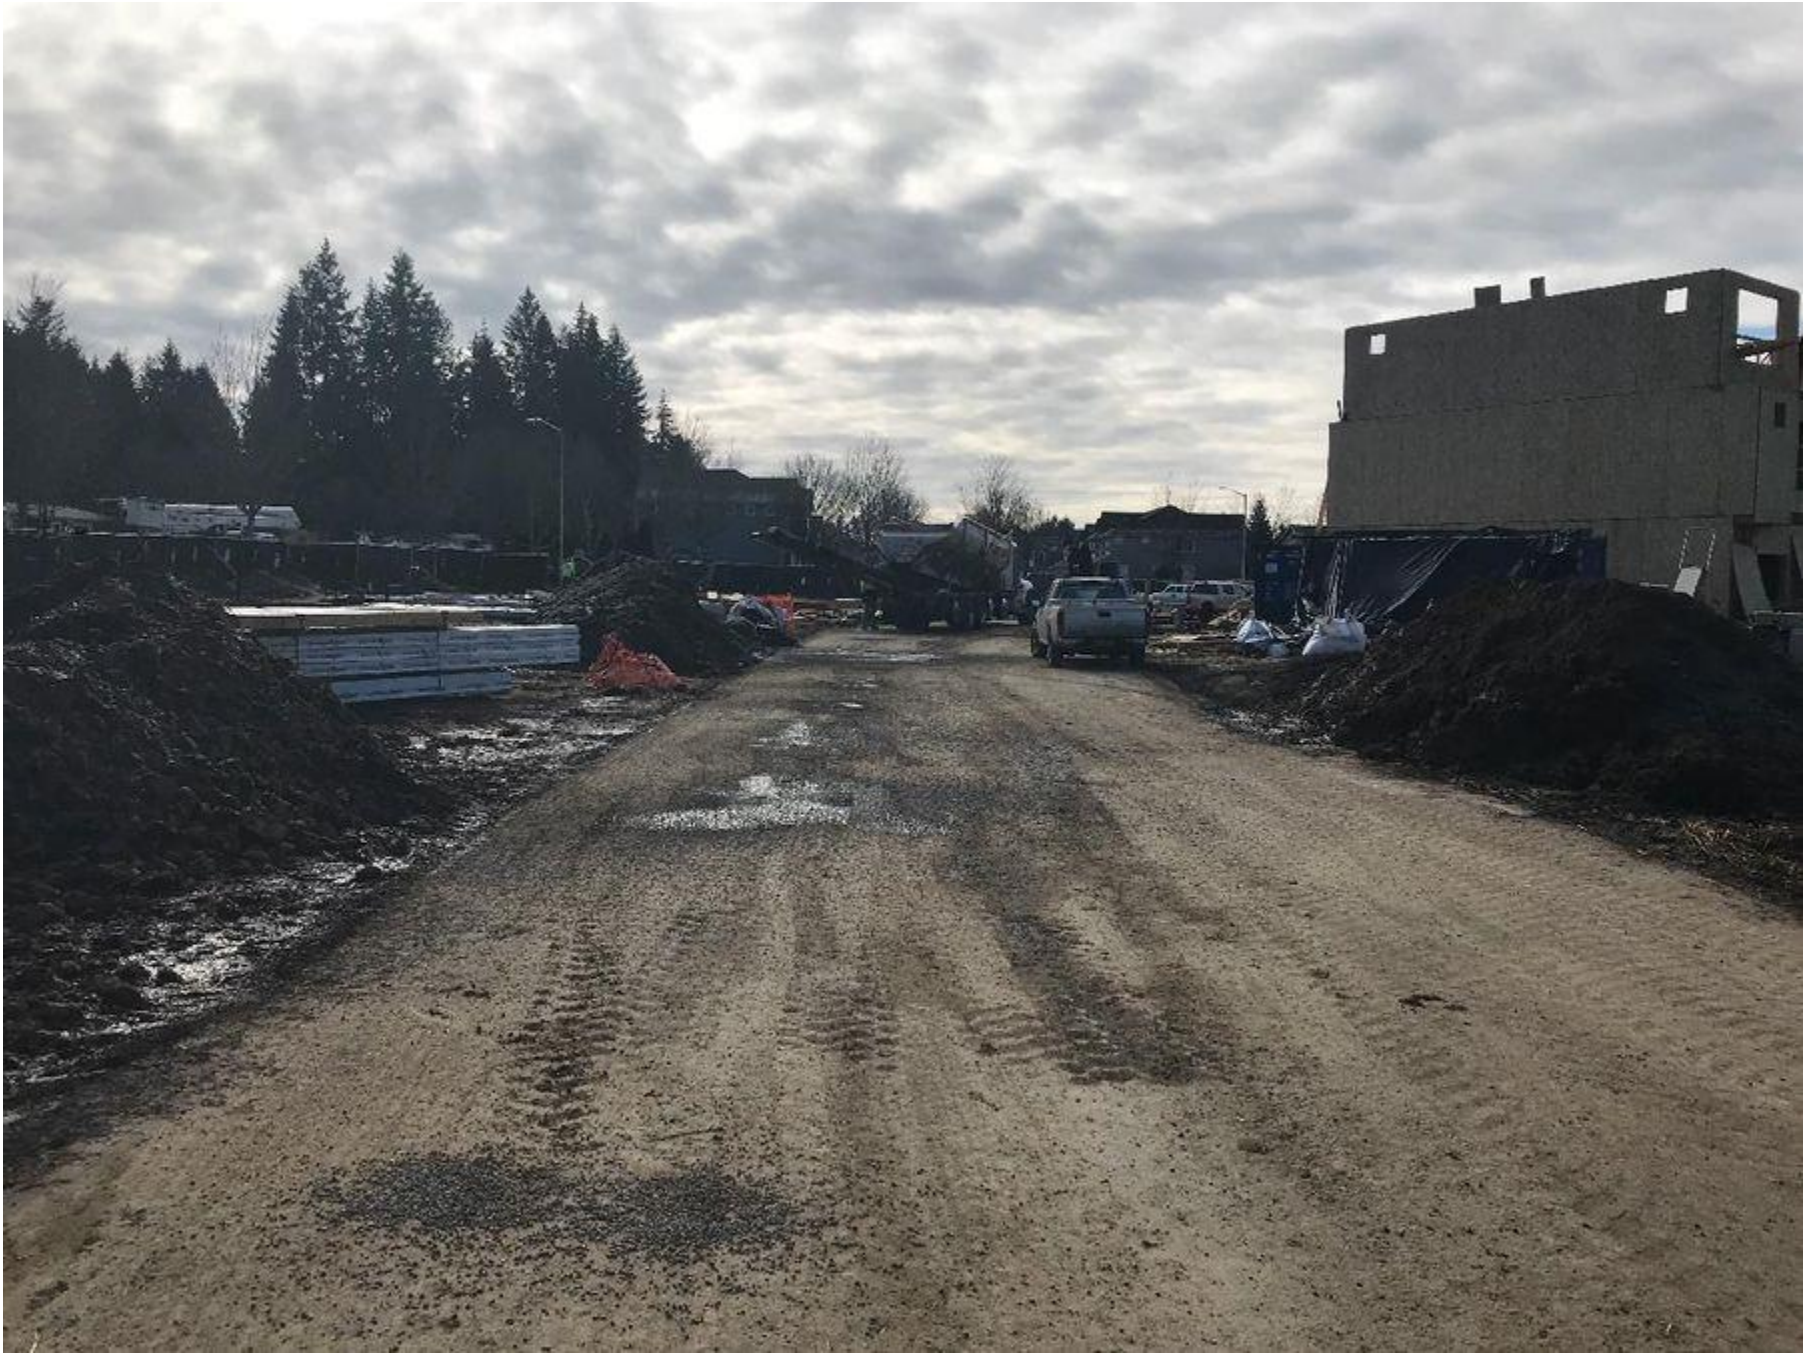
Photo 4

Photo Description: Roads are caked in dirt, with uncovered stockpiles spilling onto road.

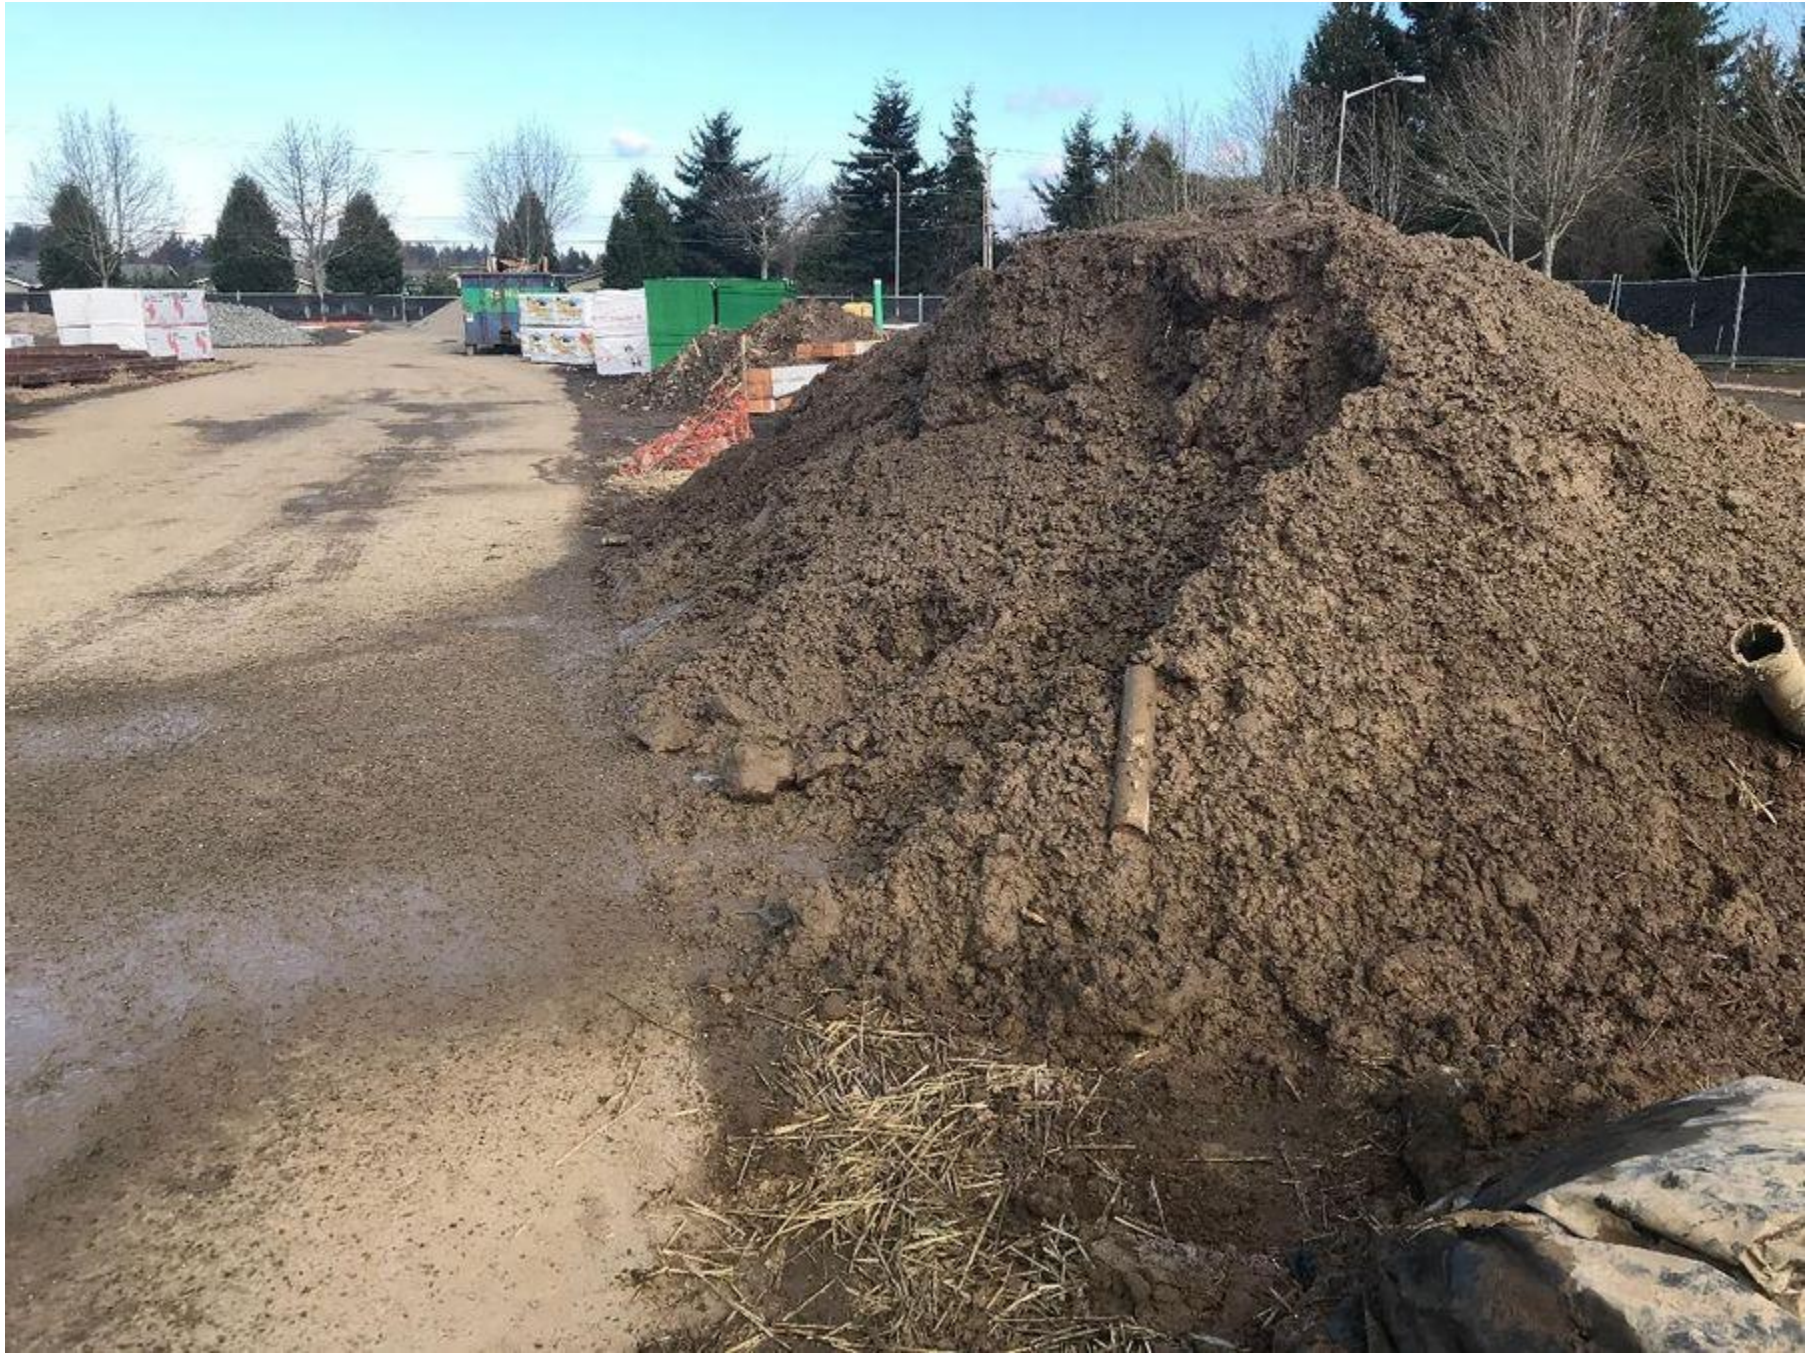
Photo 5

Photo Description: Stockpile spilling onto road.

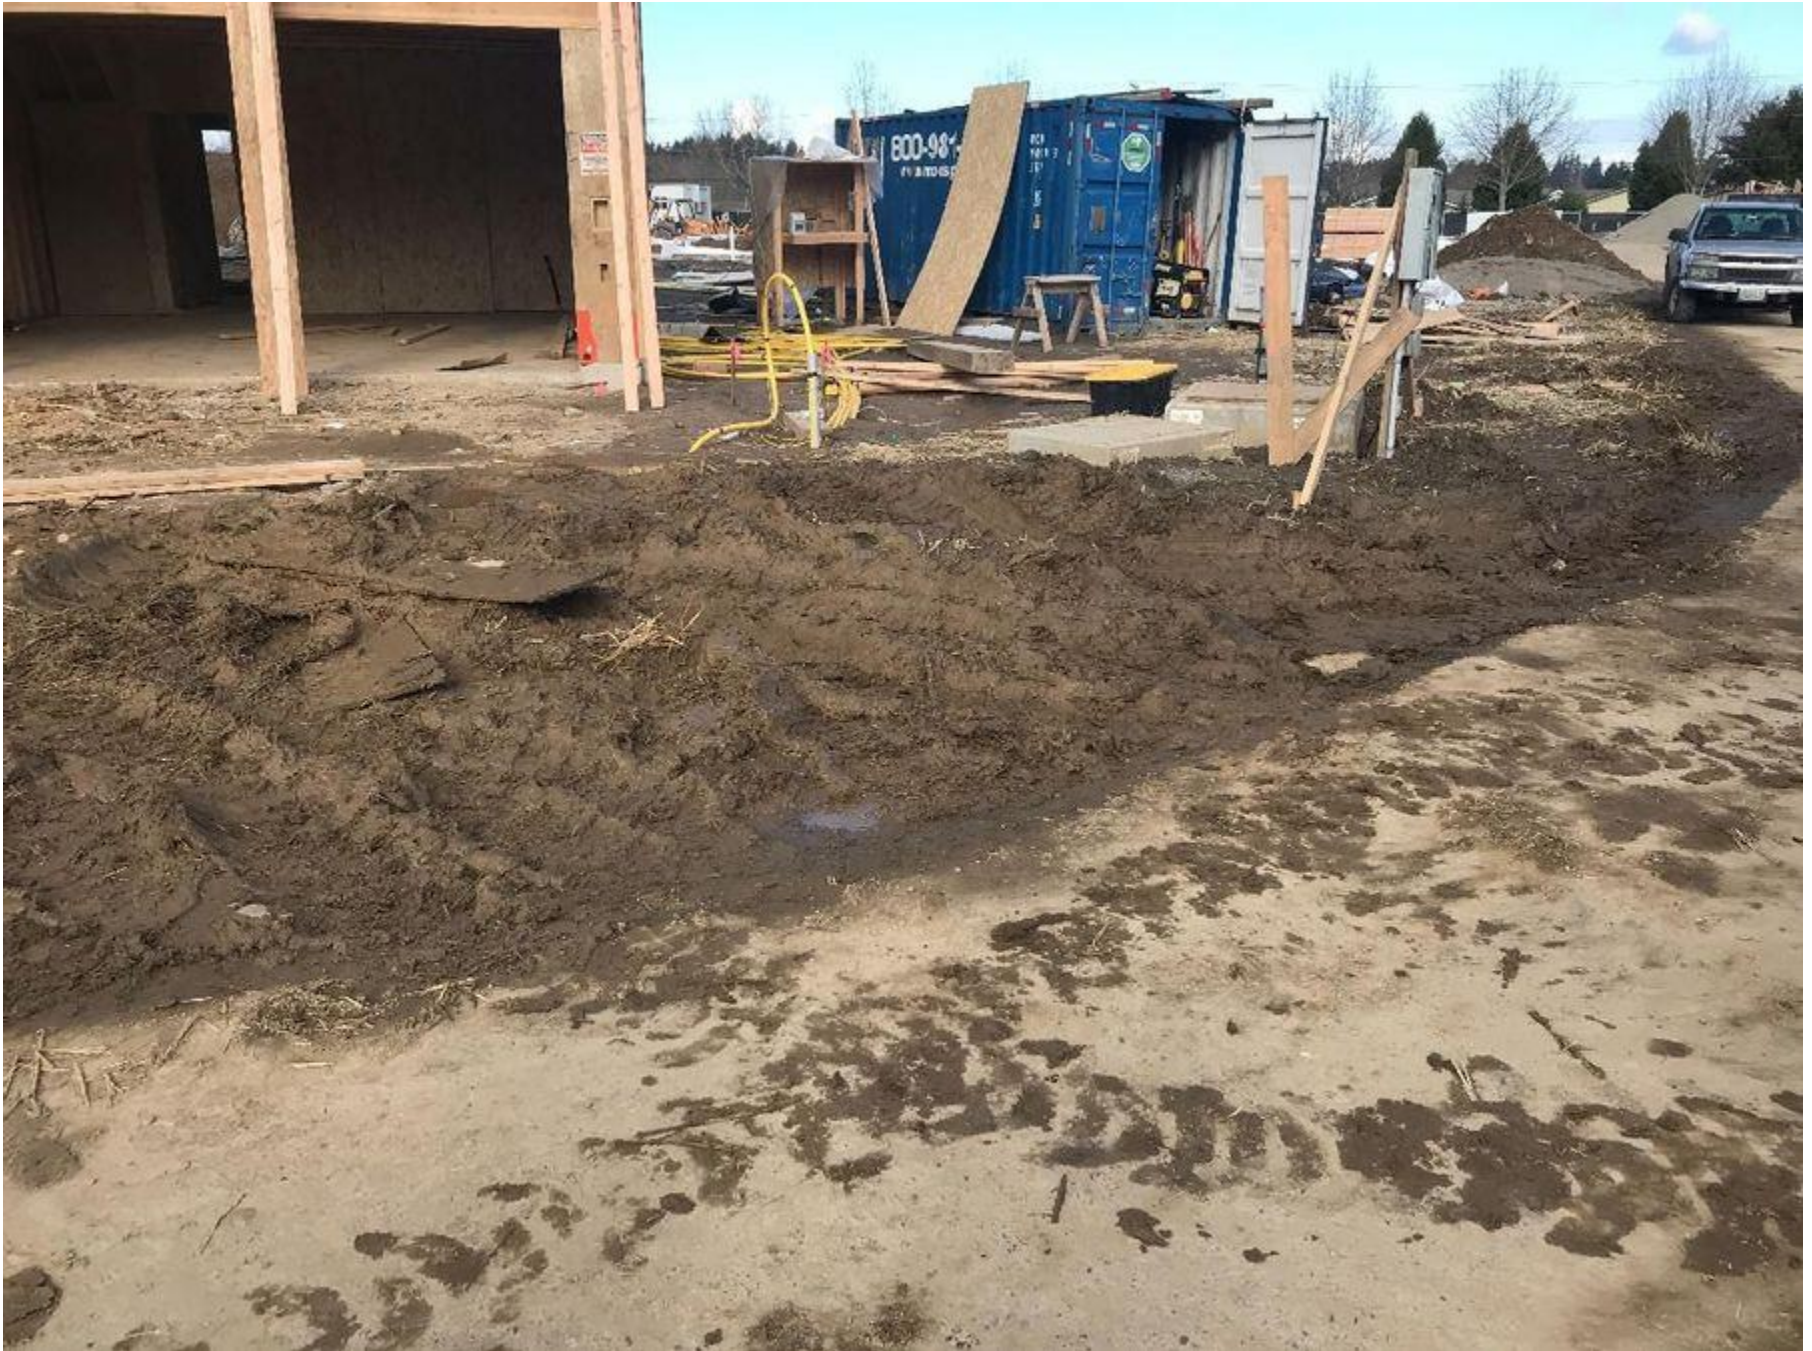
Photo 6

Photo Description: Tire tracks in dirt, tracking onto road.

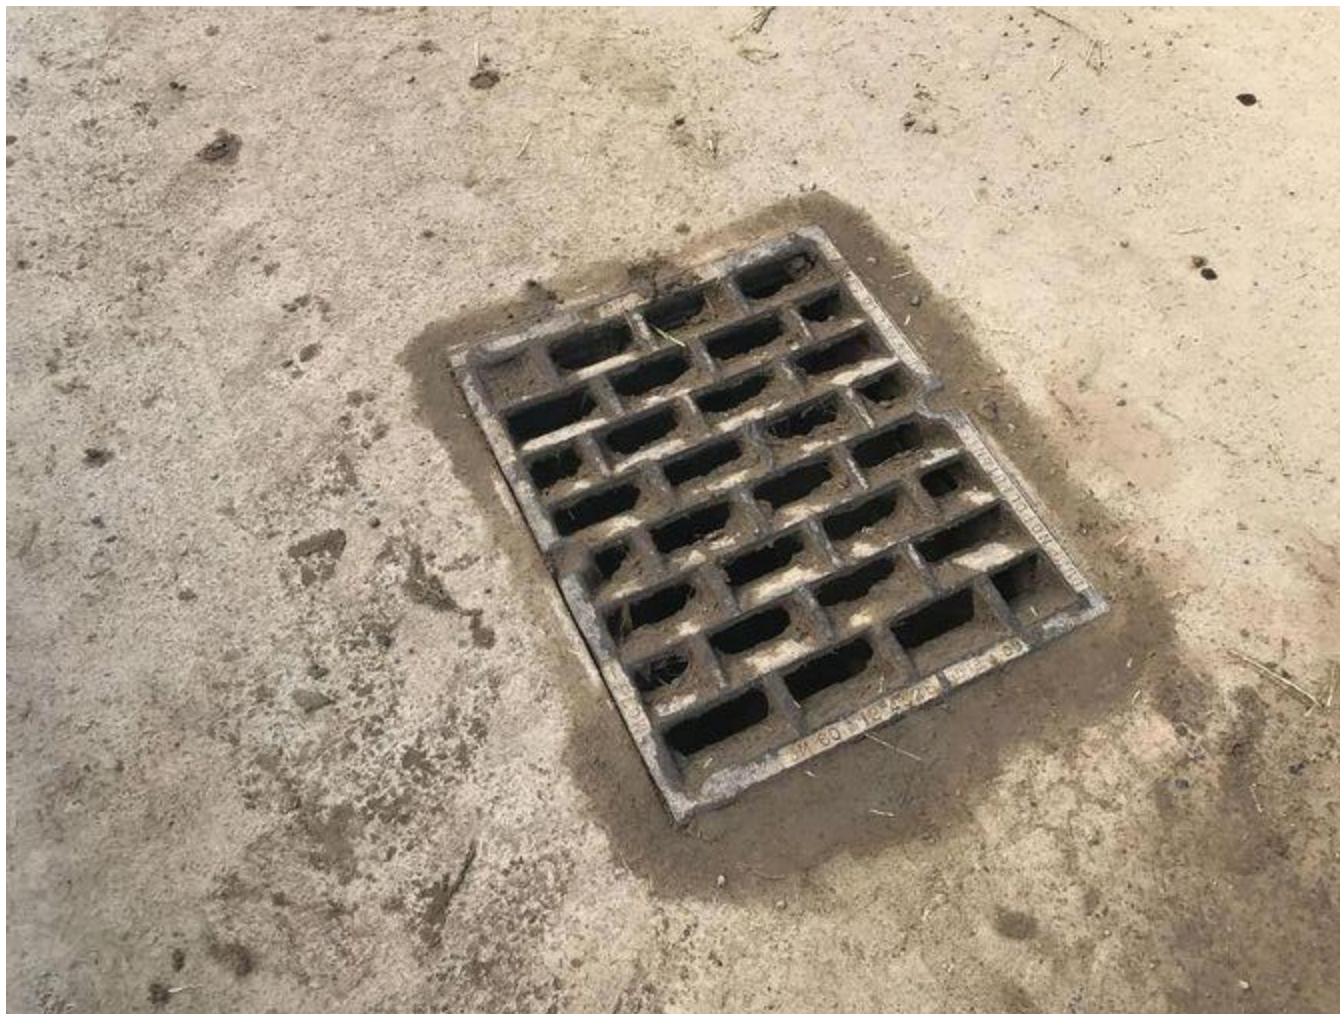
Photo 7

Photo Description: Drain inlet is caked in dirt.

<p><u>S9.D.7 Protect Drain Inlets</u> Catch basin filters throughout site require replacement. Failure to meet S9.D.7.a: Protect all storm drain inlets made operable during construction so that stormwater runoff does not enter the conveyance system without first being filtered or treated to remove sediment. Protect and maintain drain inlets, as set forth in permit condition S9.D.7.a.</p>	<p>Immediately begin. Address the problems no later than 10 days from the date of this inspection.</p>	<p>C220</p>

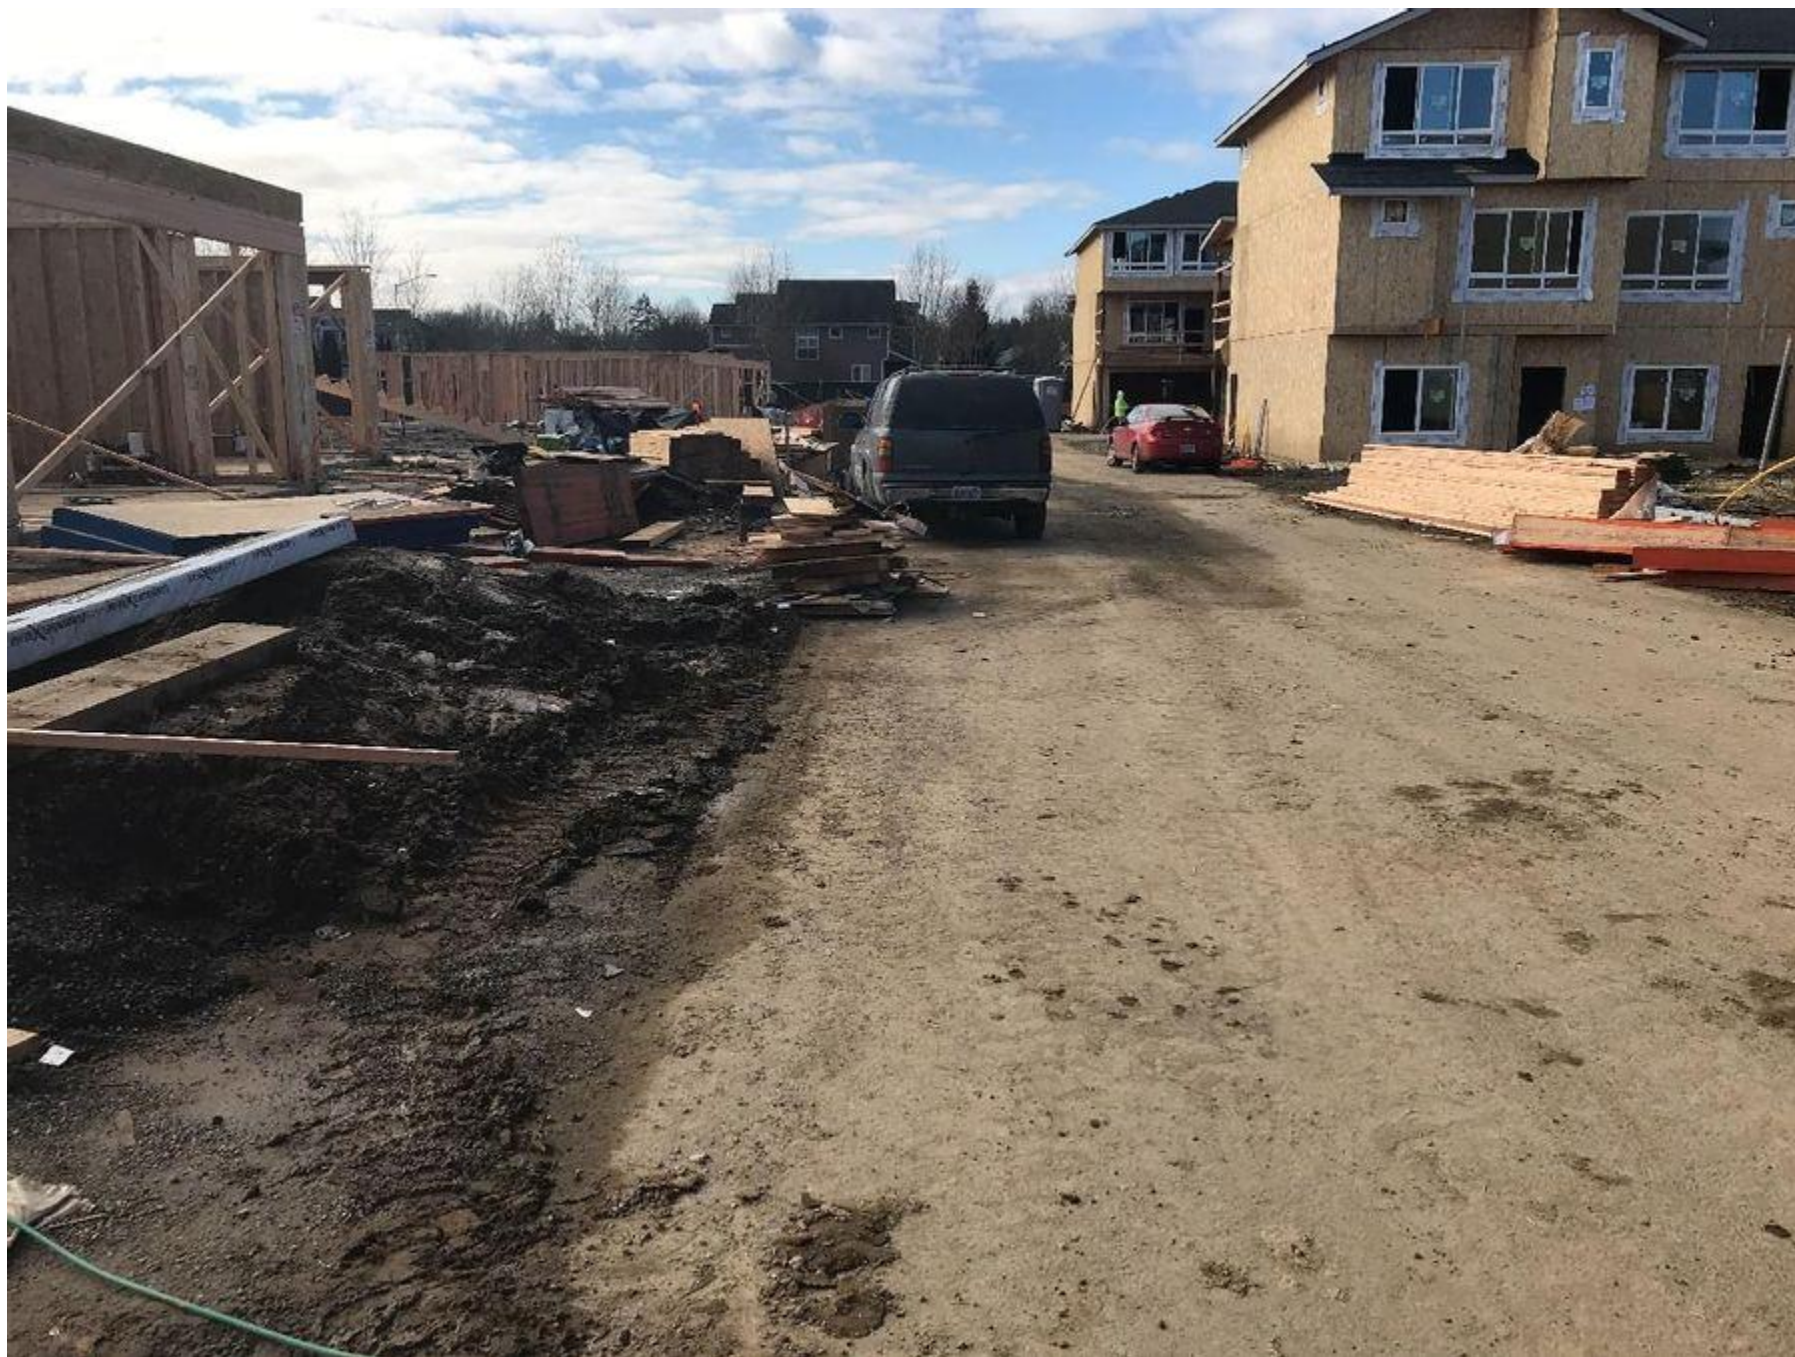
Photo 8

Photo Description: More soil spilling into road.

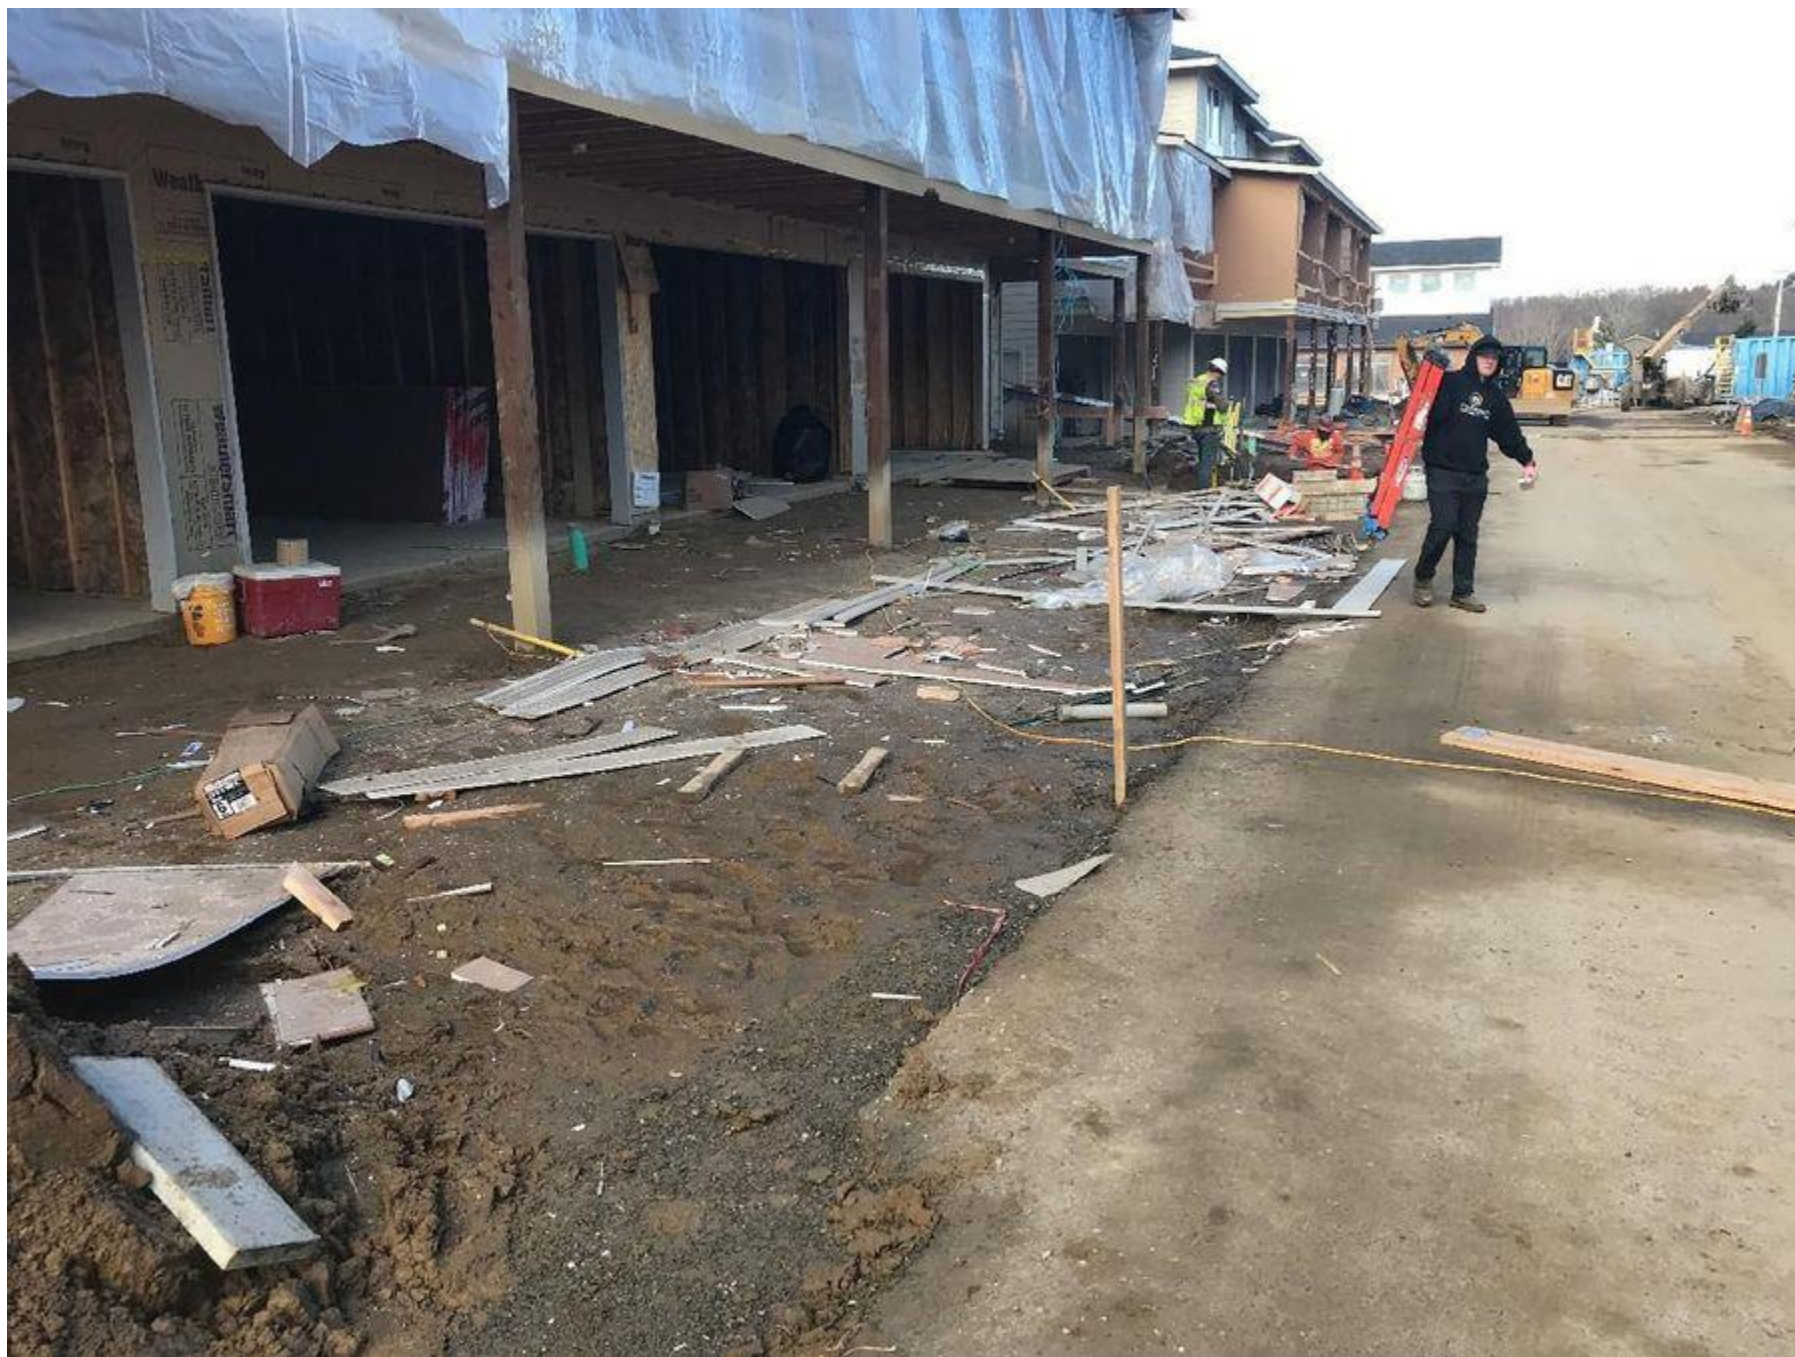
Photo 9

Photo Description: Drywall waste on bare ground.
