CONSTRUCTION STORMWATER GENERAL PERMIT INSPECTION REPORT

State of Washington Department of Ecology

The Woodbrook Townhomes project is covered under the State of Washington's Construction Stormwater General Permit (CSWGP). The CSWGP is a National Pollutant Discharge Elimination System (NPDES) and a State Waste Discharge permit for discharge of construction-related stormwater. The purpose of this inspection is to conduct a compliance inspection and to provide technical assistance as appropriate.

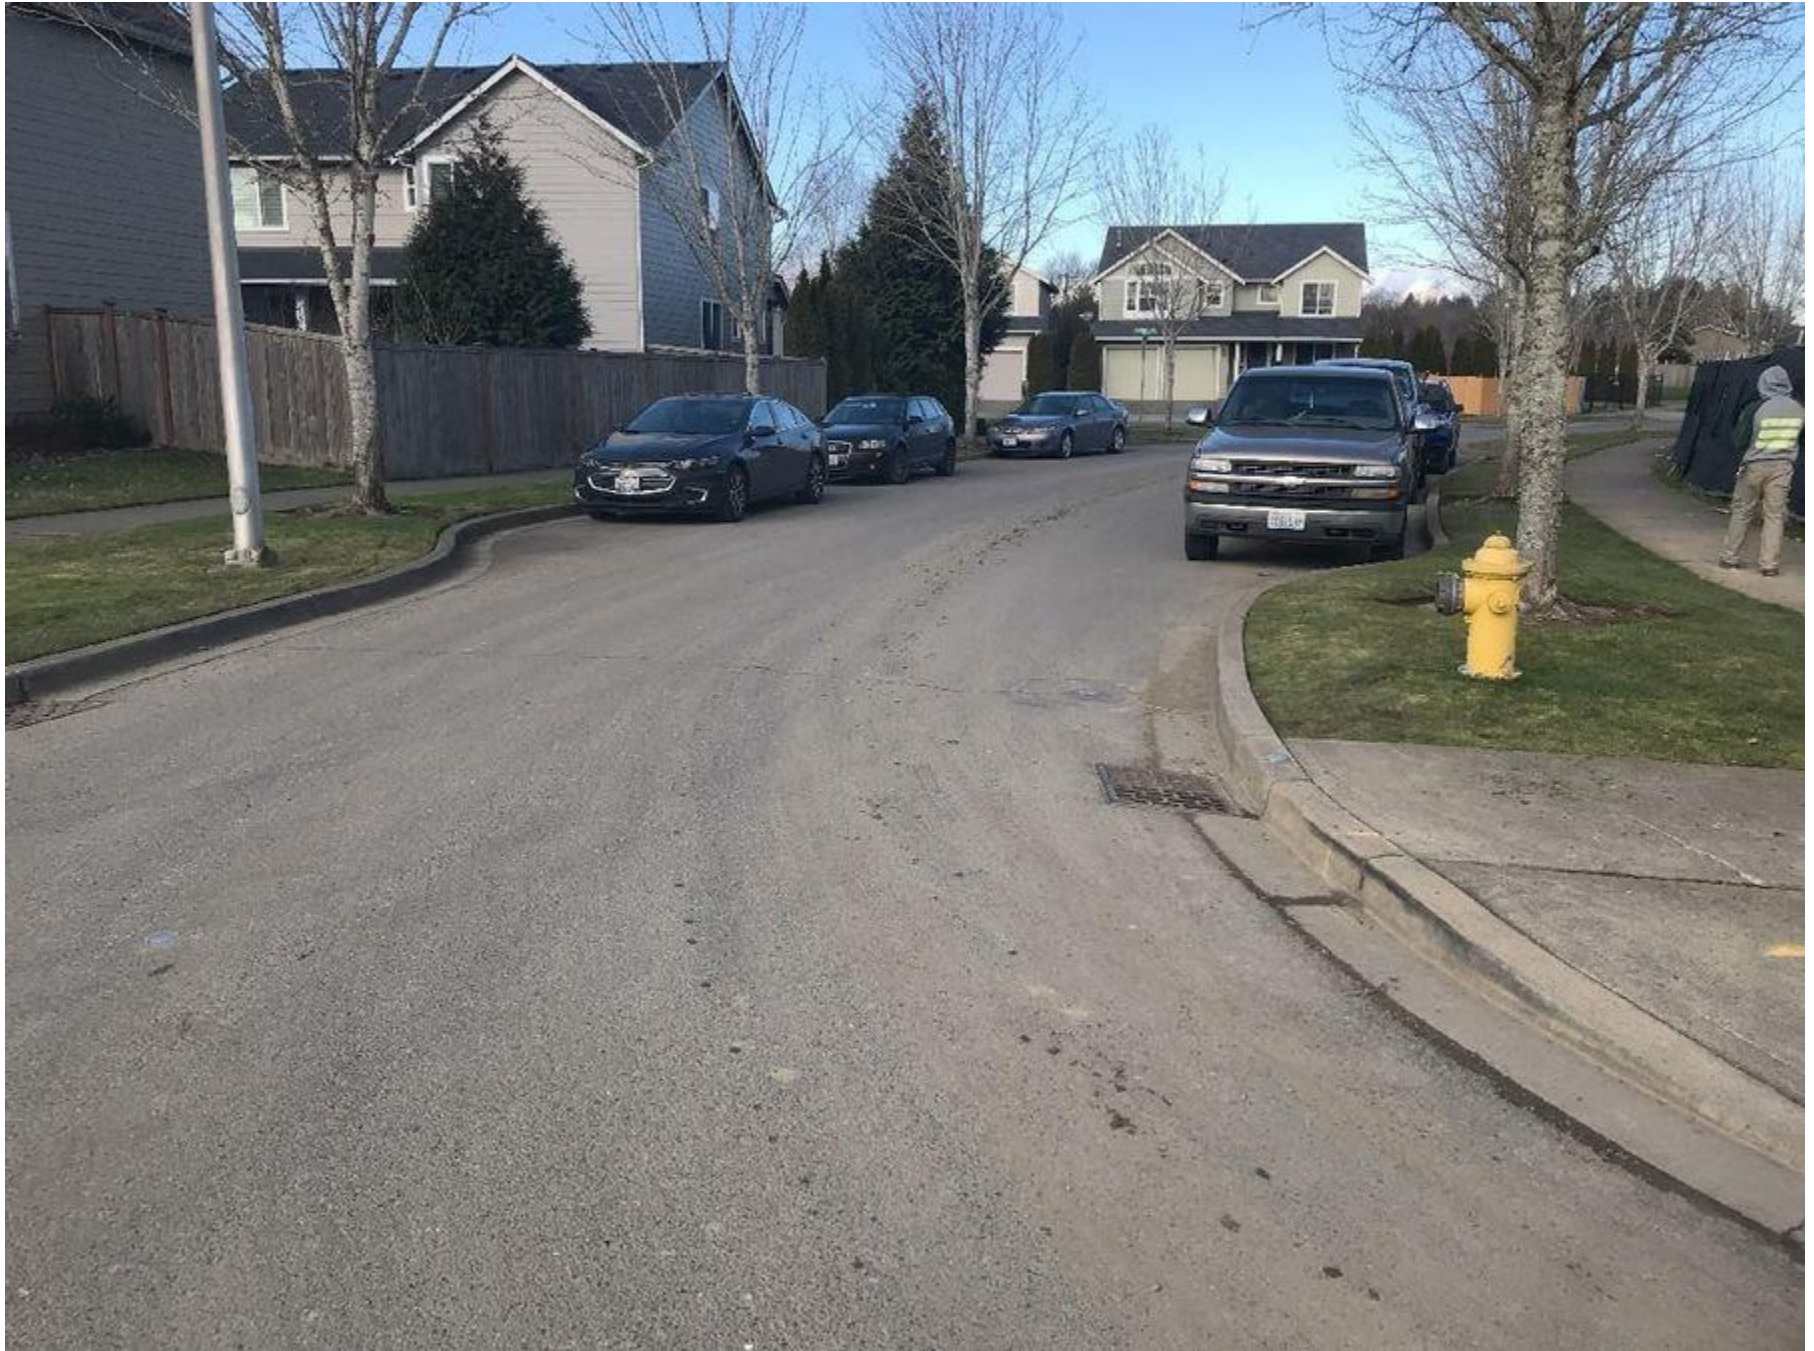
Photo 10

Photo Description: Sediment tracked onto roadway.

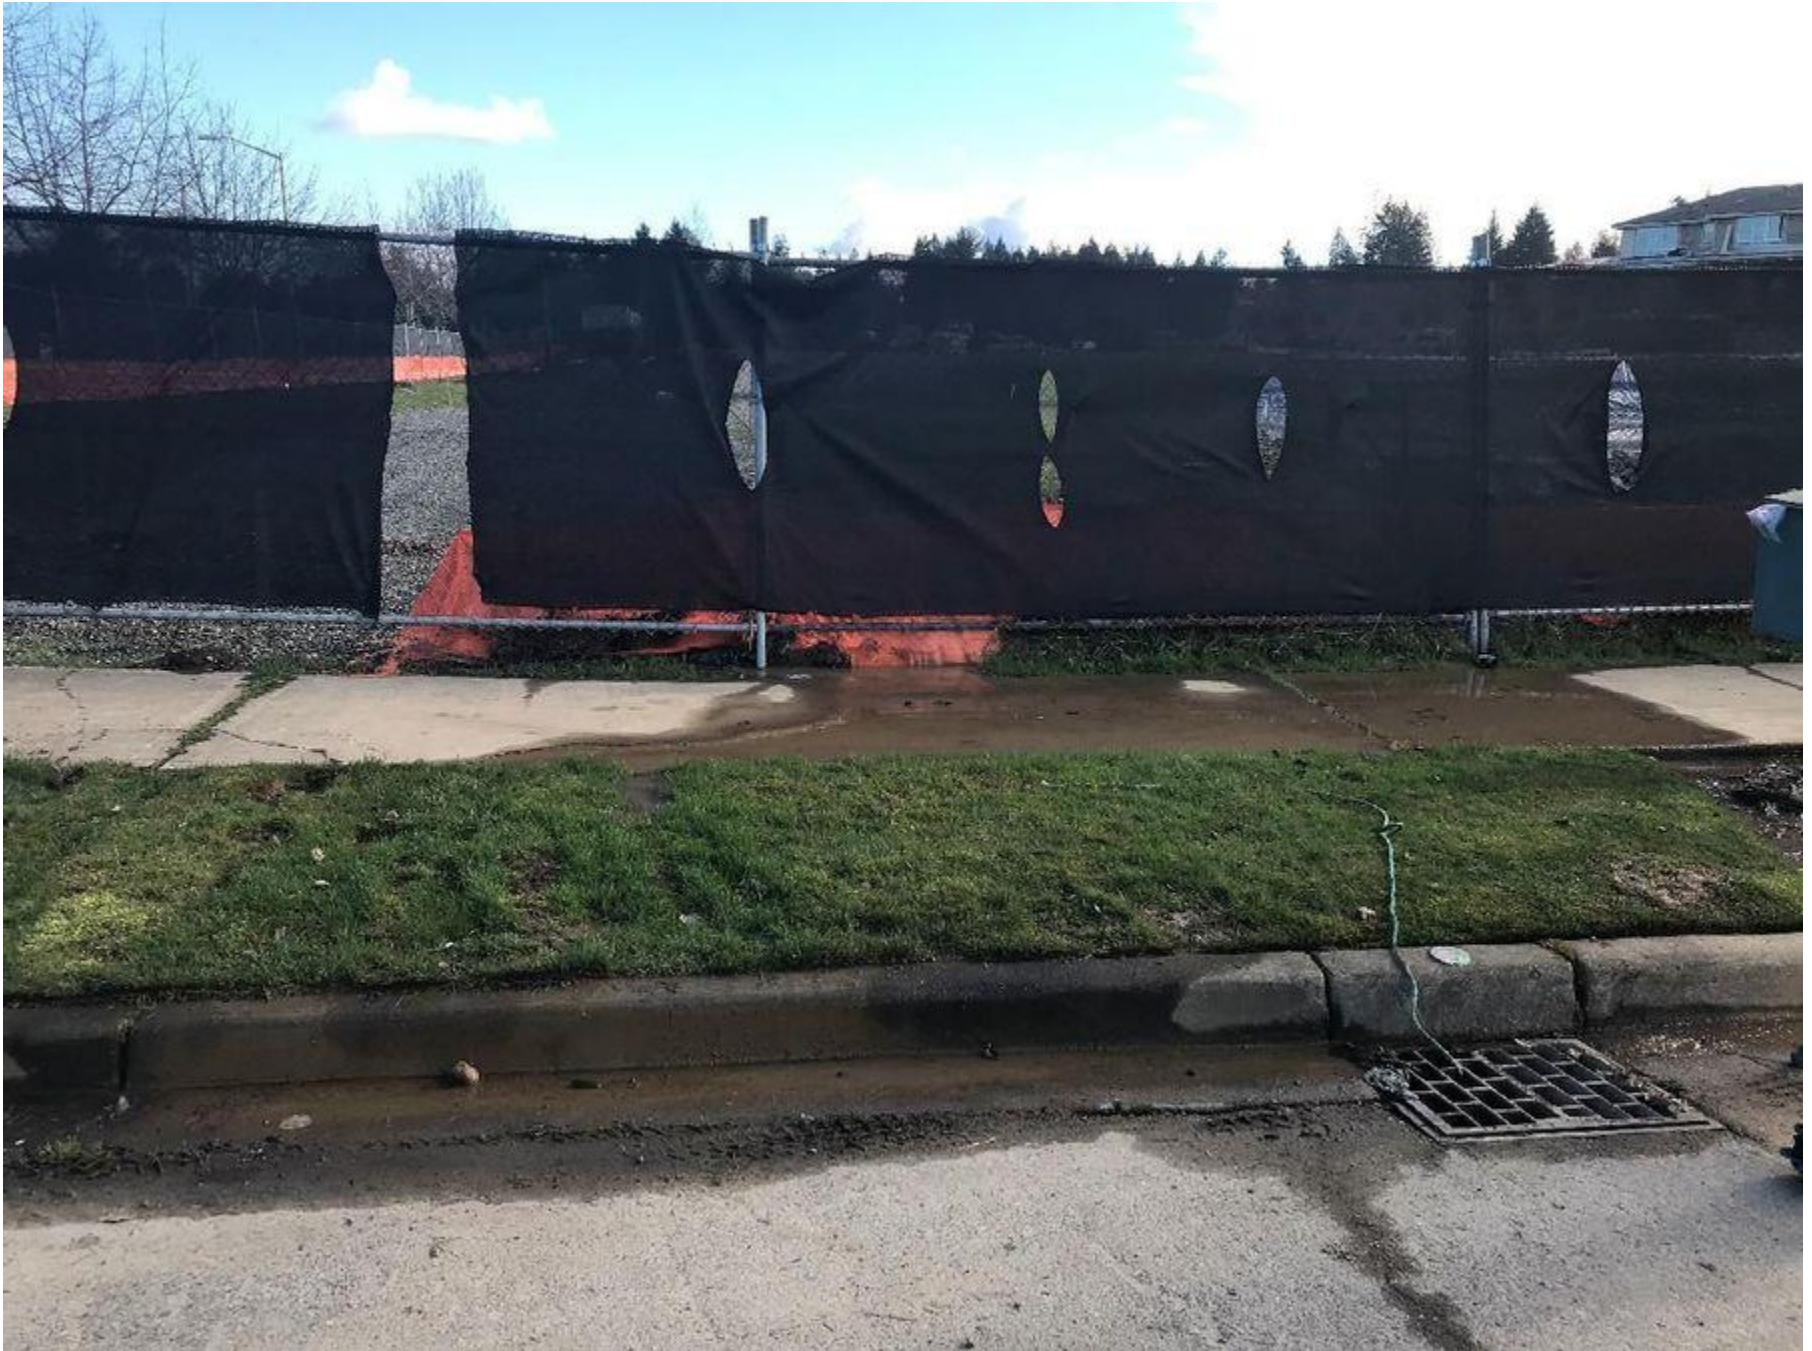
Photo 11

Photo Description: Water discharging from the storm pond. Silt fence requires maintenance.

<p><u>S9.D.11 Maintain BMPs</u> Unmaintained silt fence at discharge point. Failure to meet S9.D.11.a: Permittee must maintain and repair all temporary and permanent erosion and sediment control BMPs as needed to assure continued performance of their intended function in accordance with BMP specifications. Maintain and repair all temporary and permanent BMPs, as set forth in permit condition S9.D.11.a.</p>	<p>Immediately begin. Address the problems no later than 10 days from the date of this inspection.</p>	<p>SWMMWW, Chapter II-3 Construction Stormwater BMPs, C150, C160</p>
<p><u>S9.D.12 Manage the Project</u> SWPPP is not being followed and BMPs are not being maintained. Failure to meet S9.D.12.a: Phase development projects to the maximum degree practicable and take into account seasonal work limitations. Manage the Project to include inspecting, maintaining and repairing BMPs as needed and maintaining the SWPPP, as set forth in permit conditions S9.D.12.a and S9.D.12.c.</p>	<p>Immediately begin. Address the problems no later than 10 days from the date of this inspection.</p>	<p>C150, C160, C162</p>

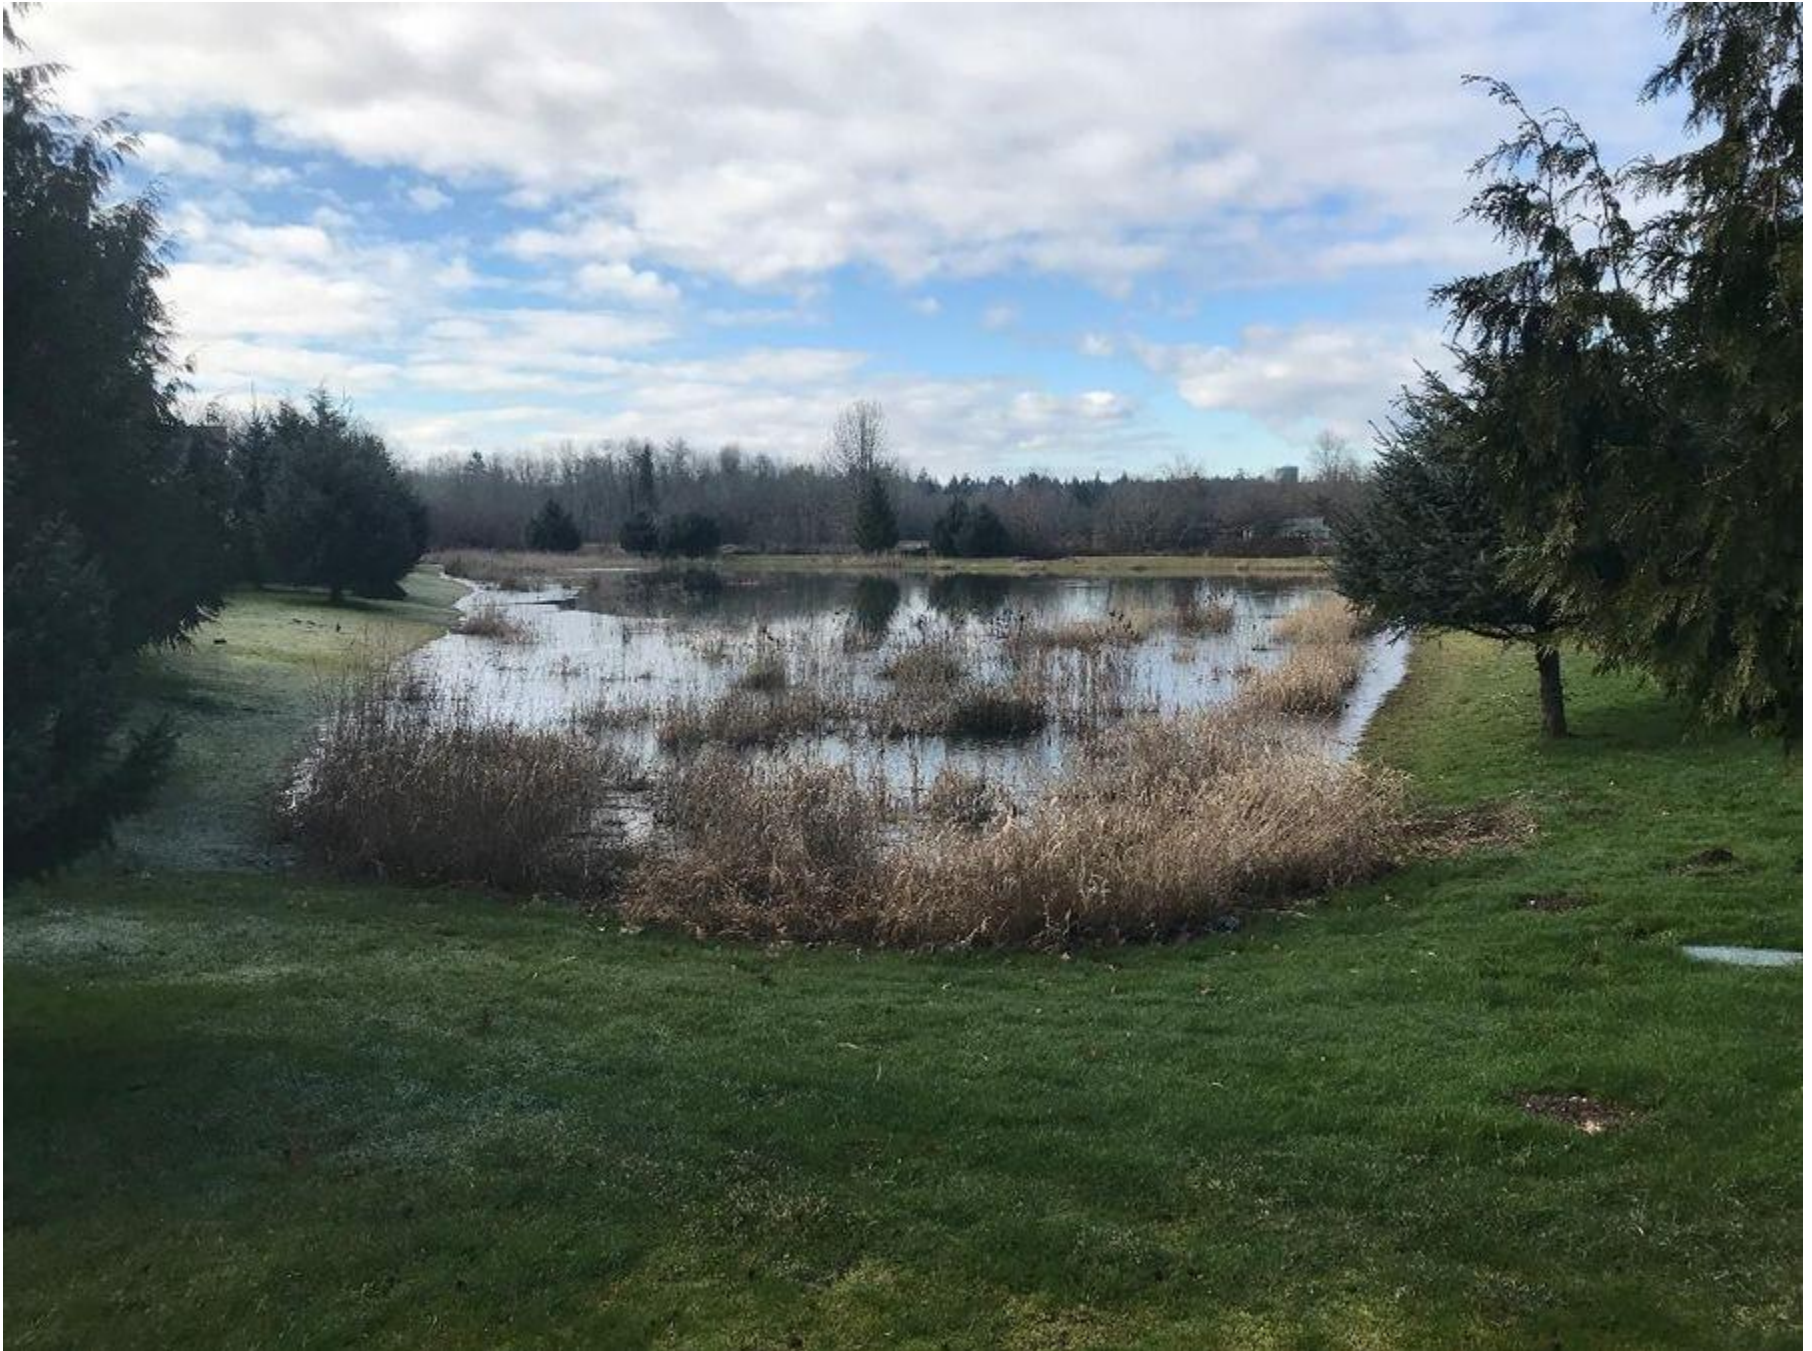
Photo 12

Photo Description: City of Lacey stormwater pond that received runoff from catch basins on surrounding roads.

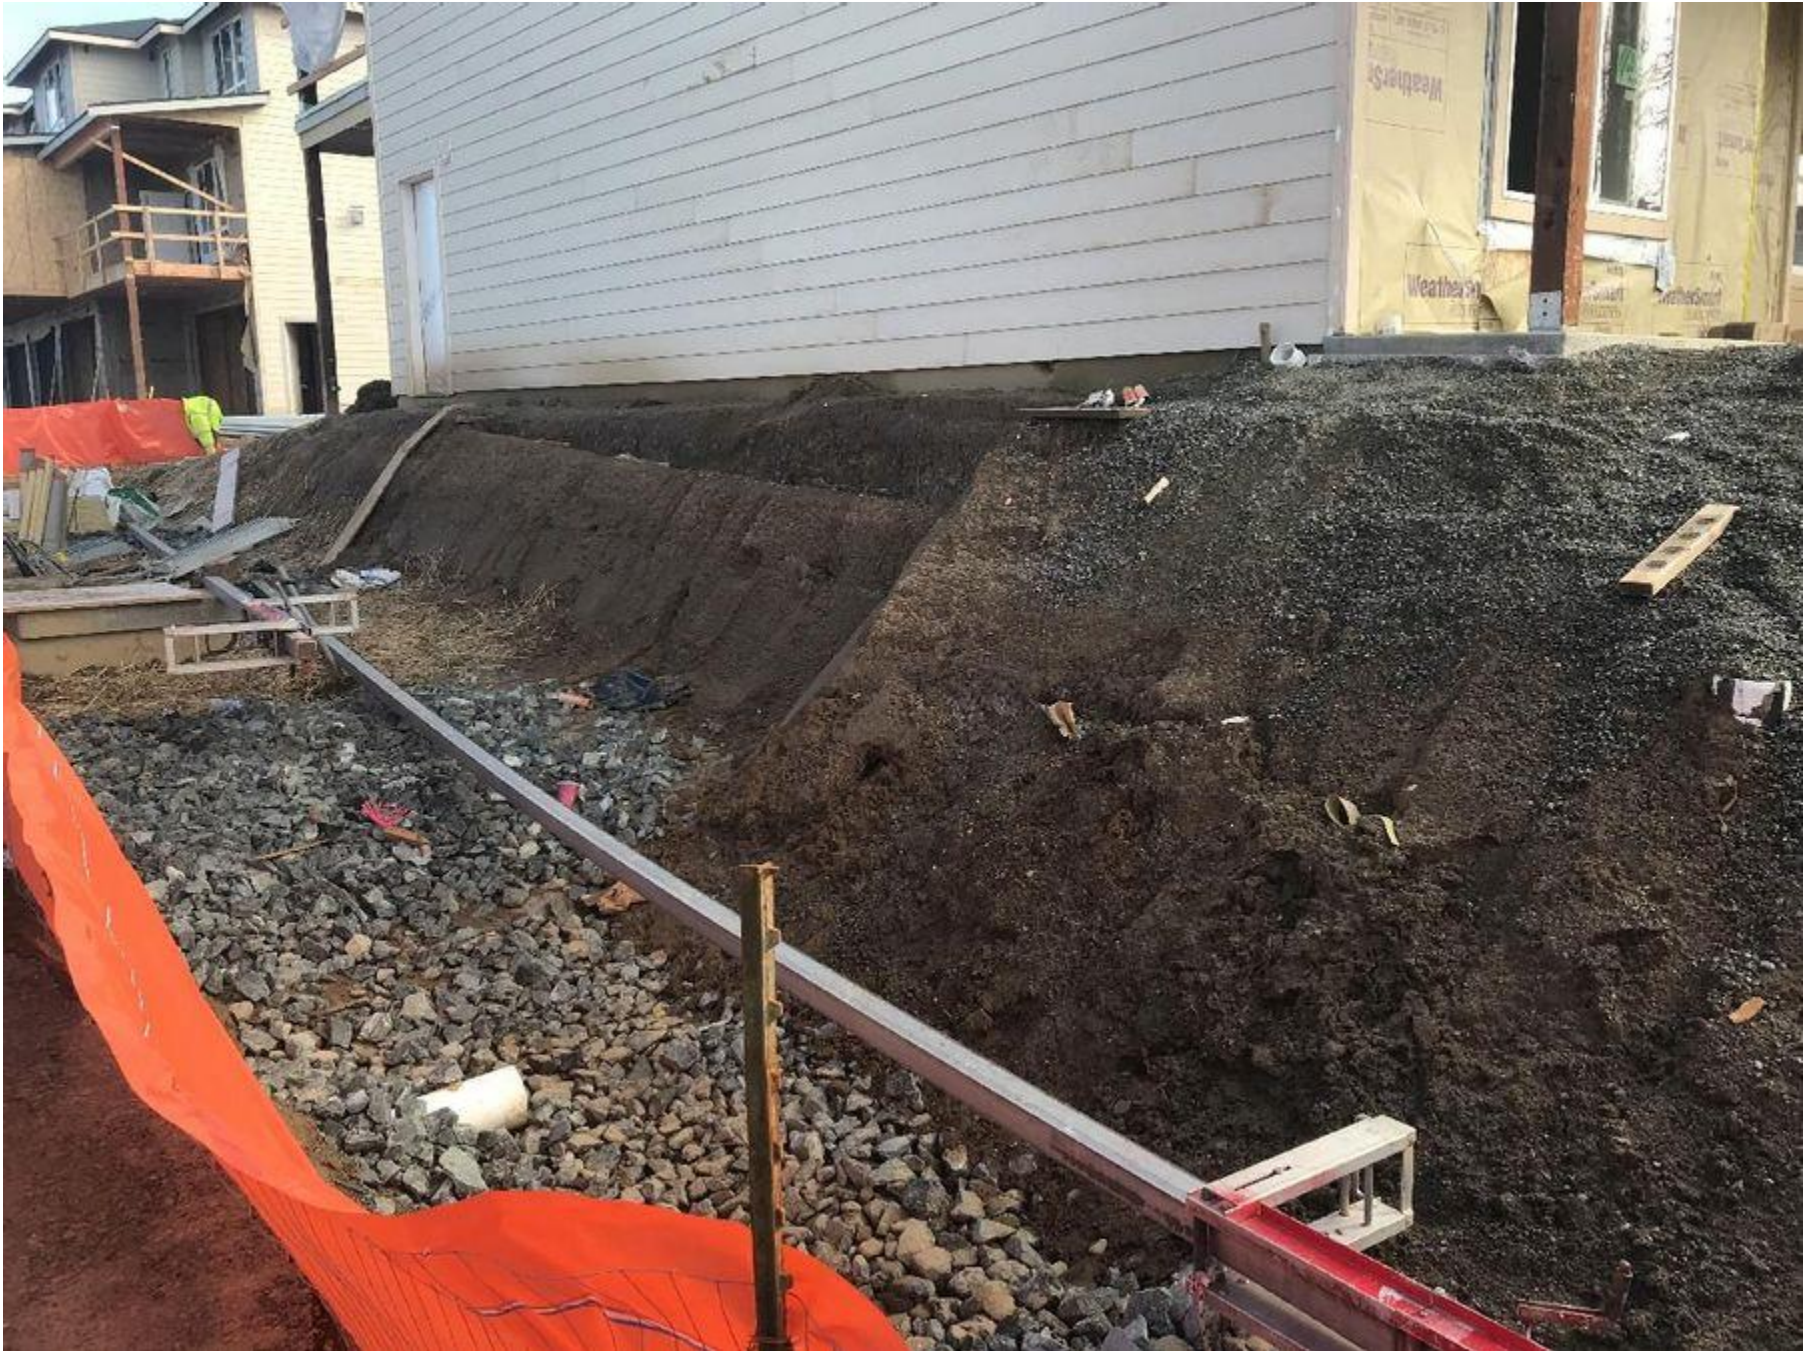
Photo 13

Photo Description: Exposed slopes.

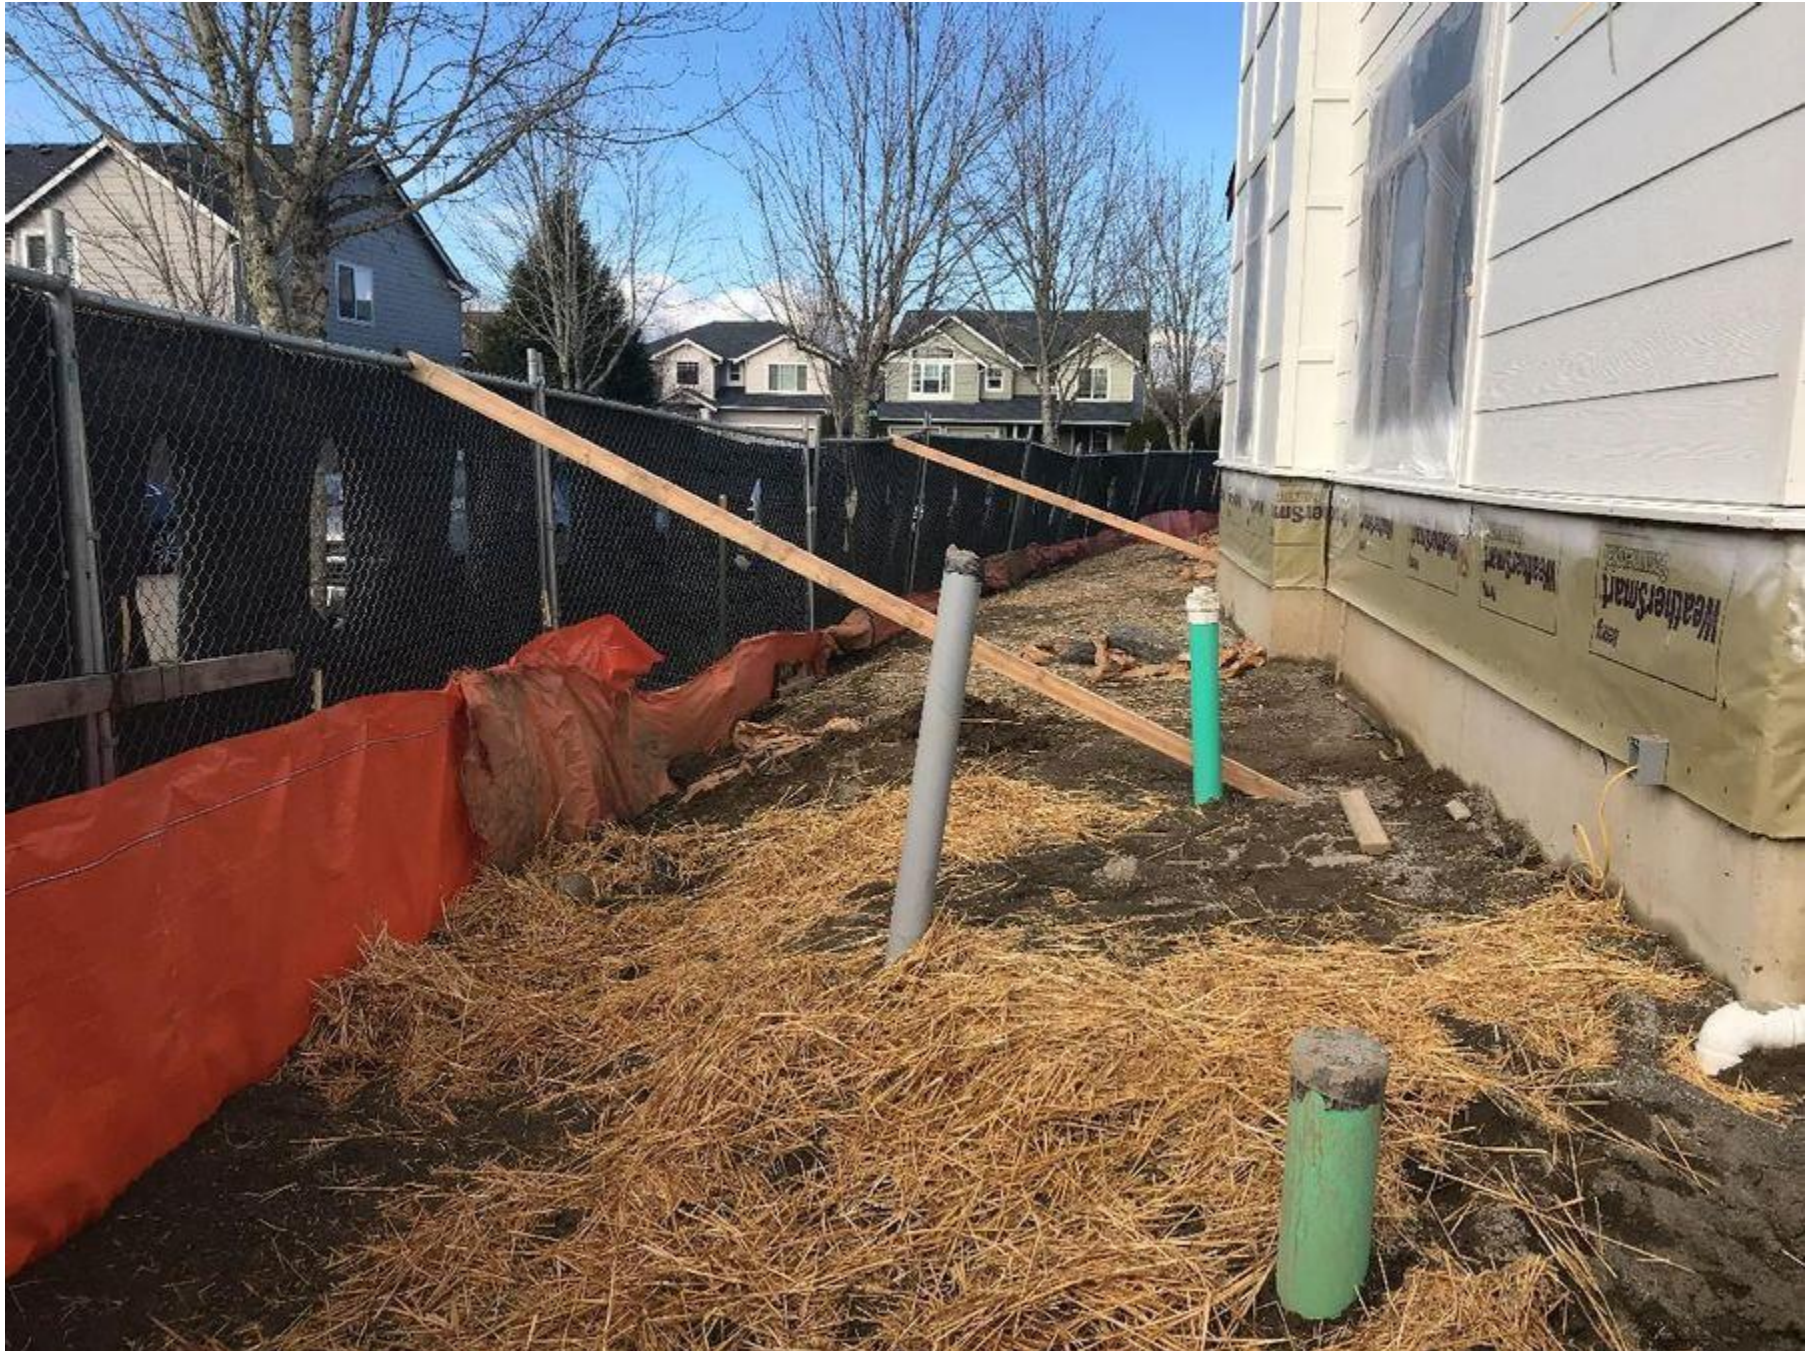
Photo 14

Photo Description: Silt fence requires maintenance.

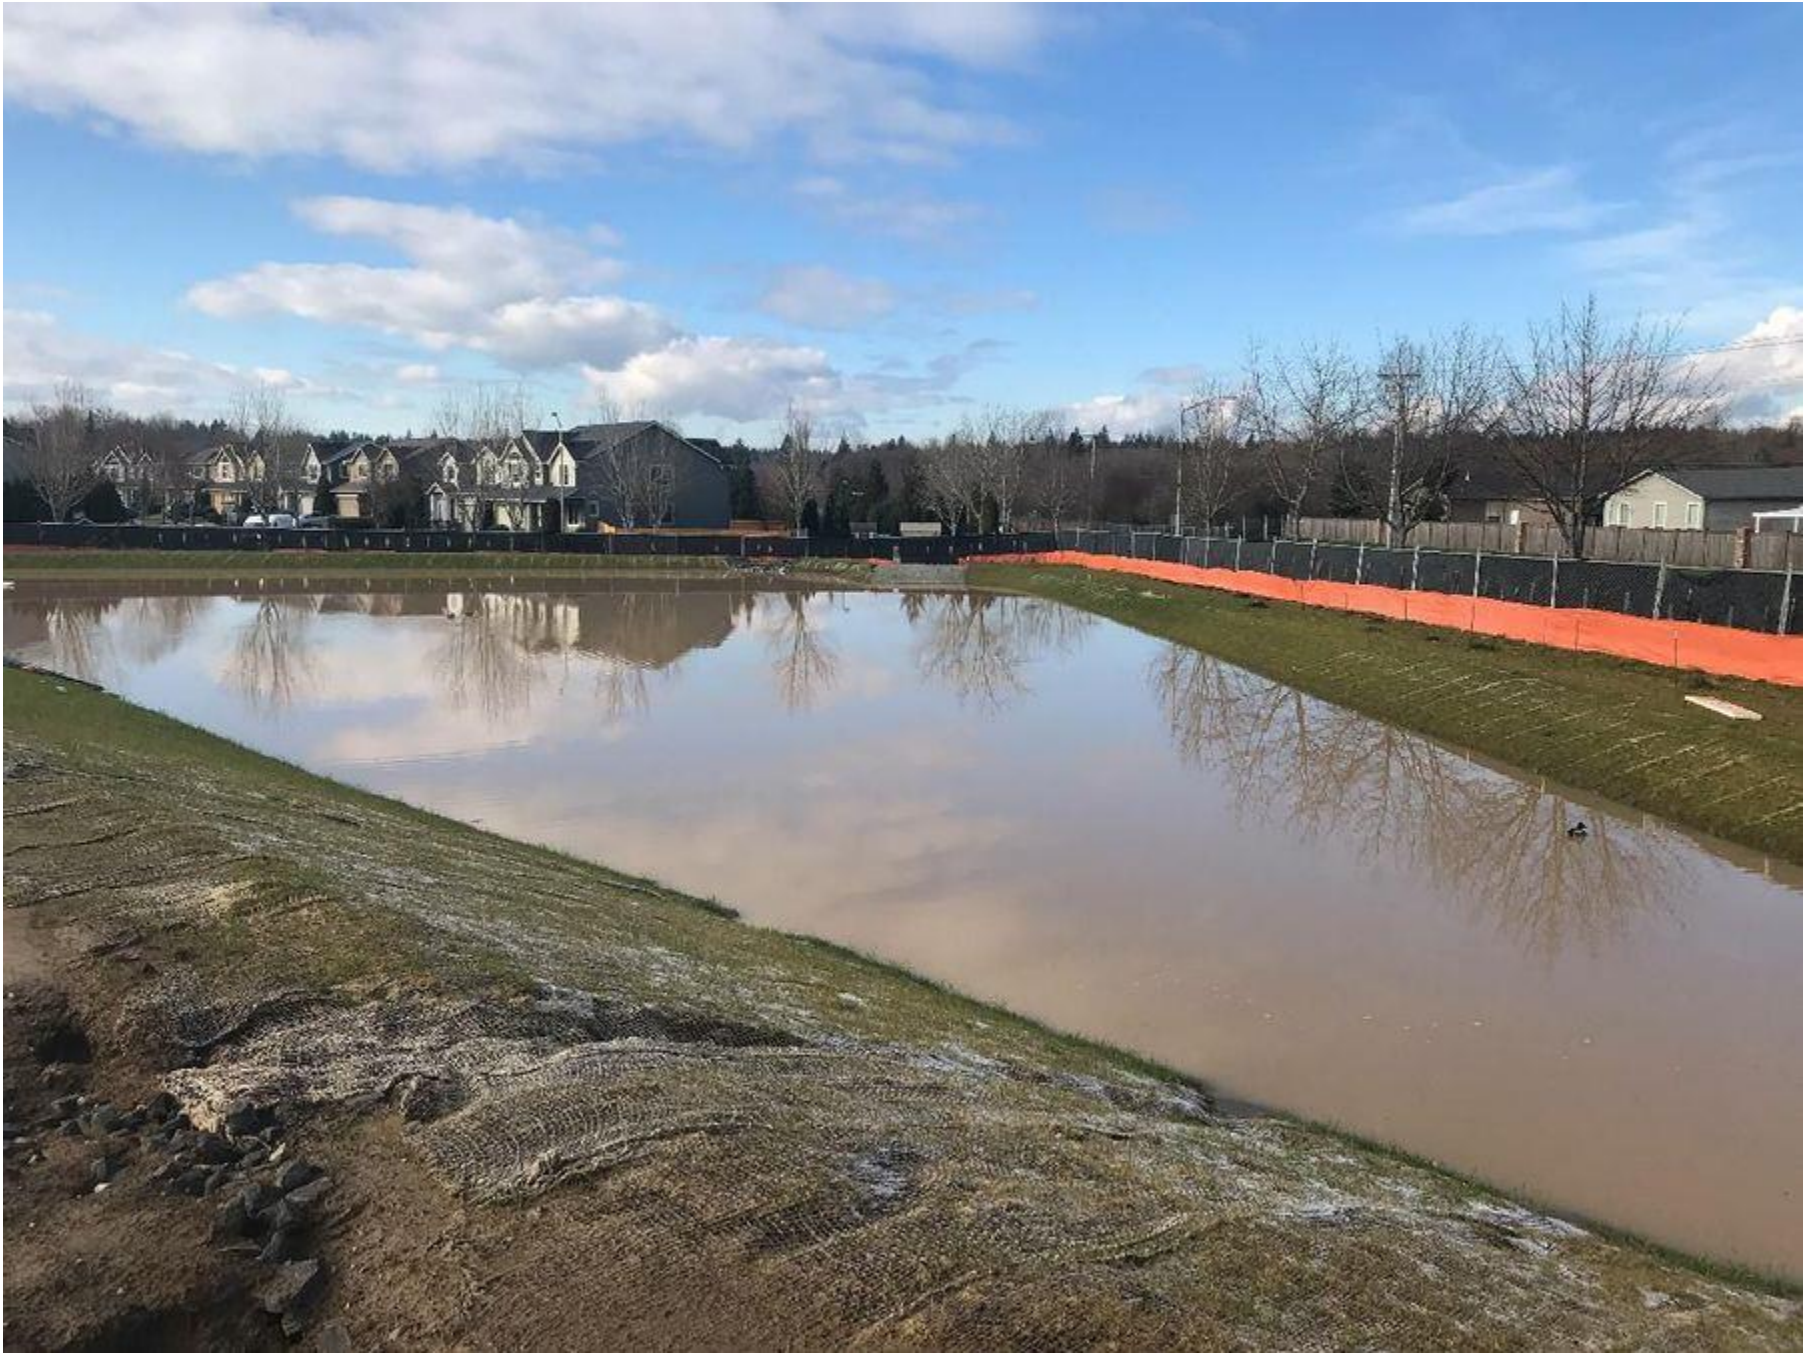
Photo 15

Photo Description: Stormwater pond is at capacity with highly turbid water, and was discharging into city catch basin at time of inspection.

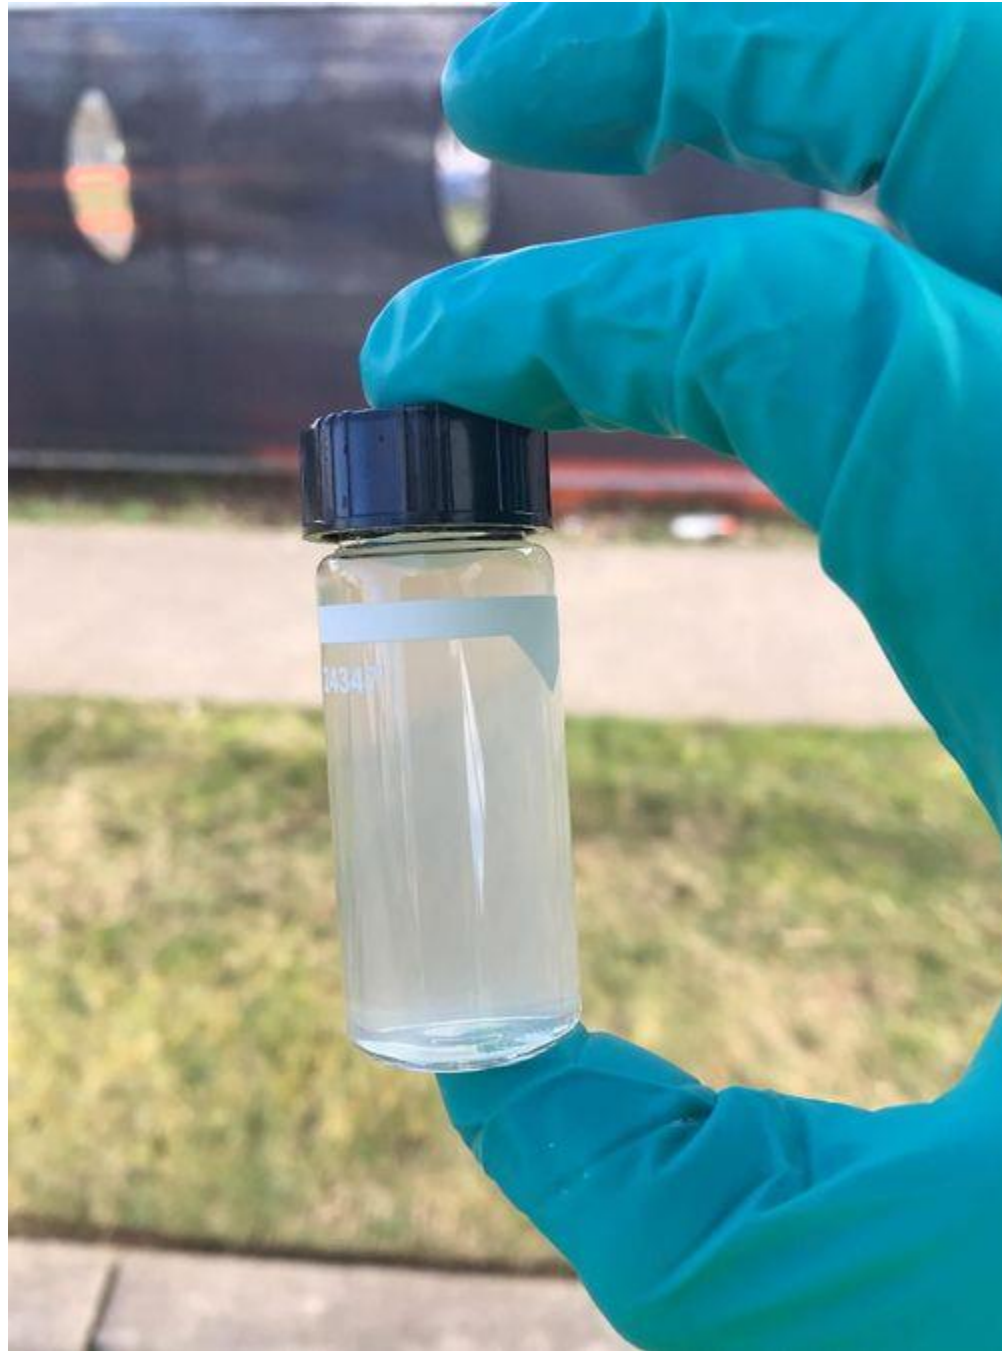
Photo 19

Photo Description: Sample of discharge at time of inspection.

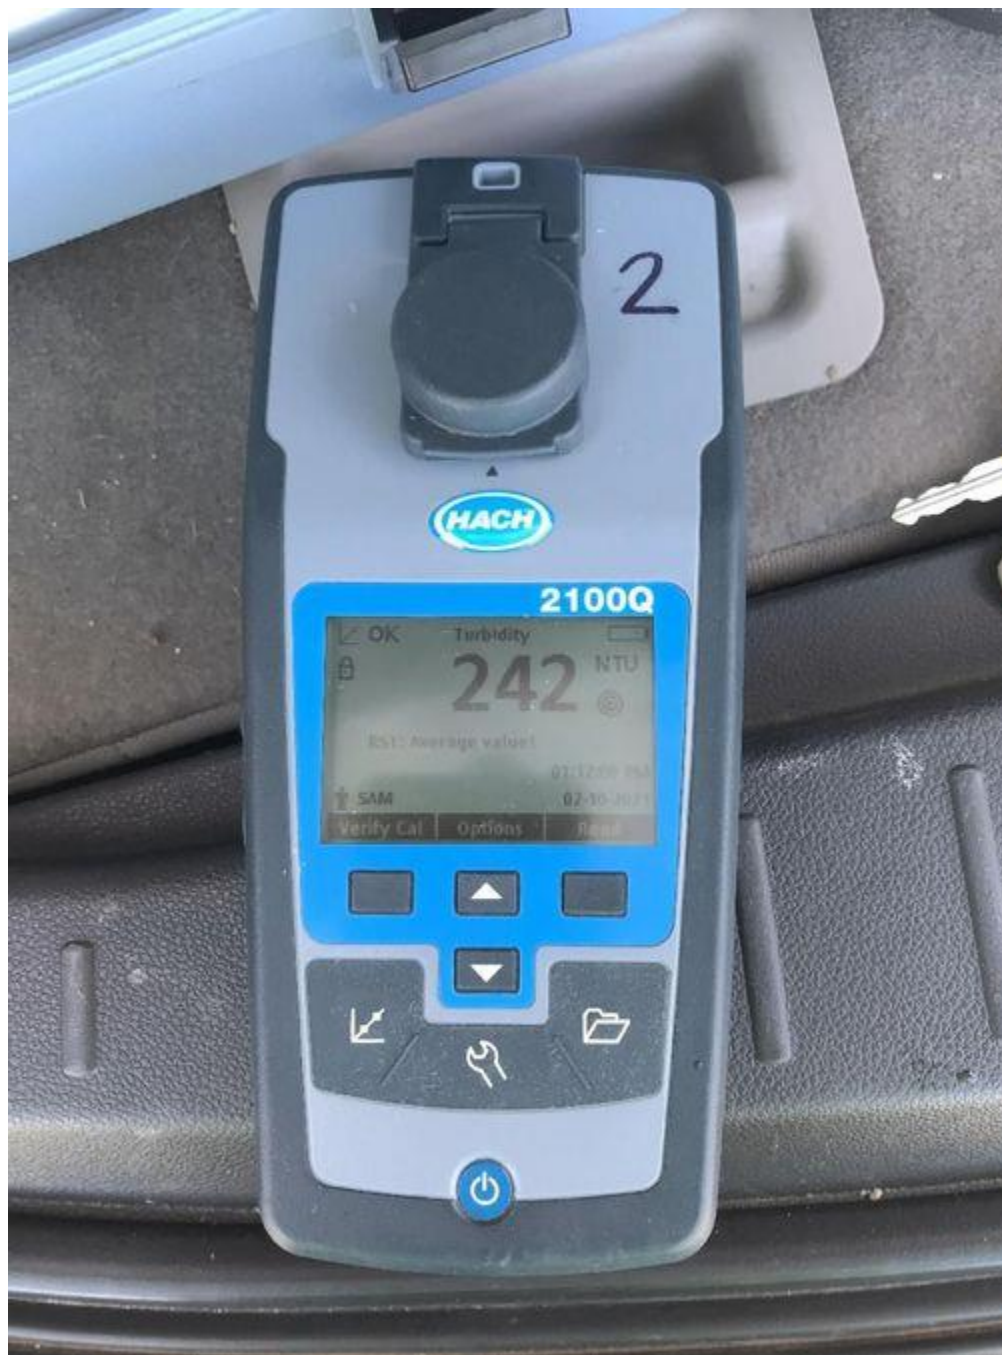
Photo 20

<p><u>S5.A High Turbidity Reporting</u> Failure to report high sediment discharge. Failure to meet S5.A: Anytime sampling performed in accordance with Special Condition S4.C indicates turbidity has reached the 250 NTUs or more (or transparency less than or equal to 6 cm), high turbidity reporting level, the Permittee must notify Ecology within 24 hours of analysis by either calling the applicable Ecology Region's Environmental Report Tracking System (ERTS) number by phone or by submitting an electronic ERTS report (through Ecology's Water Quality Permitting Portal (WQWebPortal) – Permit Submittals when the form is available).</p>	<p>Within 24 hours of analysis.</p>	<p>Ecology's ERTS homepage</p>
<p><u>S4.B Site Inspections</u> Site inspections do not include all violations. Failure to meet S4.B: The site inspections are not adequate. Retain Plans and Records on site, or within reasonable access to the site for use by the operator or for on-site review by Ecology or the local jurisdiction.</p>	<p>7 days from the date of this inspection.</p>	<p>Ecology's site inspection form template.</p>

Photo Description: Turbidity of sampled discharge was 242 NTUs.
