## INDUSTRIAL STORMWATER GENERAL PERMIT INSPECTION REPORT

State of Washington Department of Ecology

Ecology Inspector(s): Shannon Adams	On-Site Representative Name: Title: Phone: Email:	Inspection Date: March 31, 2021 Entry/Exit Time: 10:25/10:30	Inspection Type: Termination
		Receiving waters: Esquatzel Coulee Watershed	Permit webpage: <a href="#">Facility Details</a>

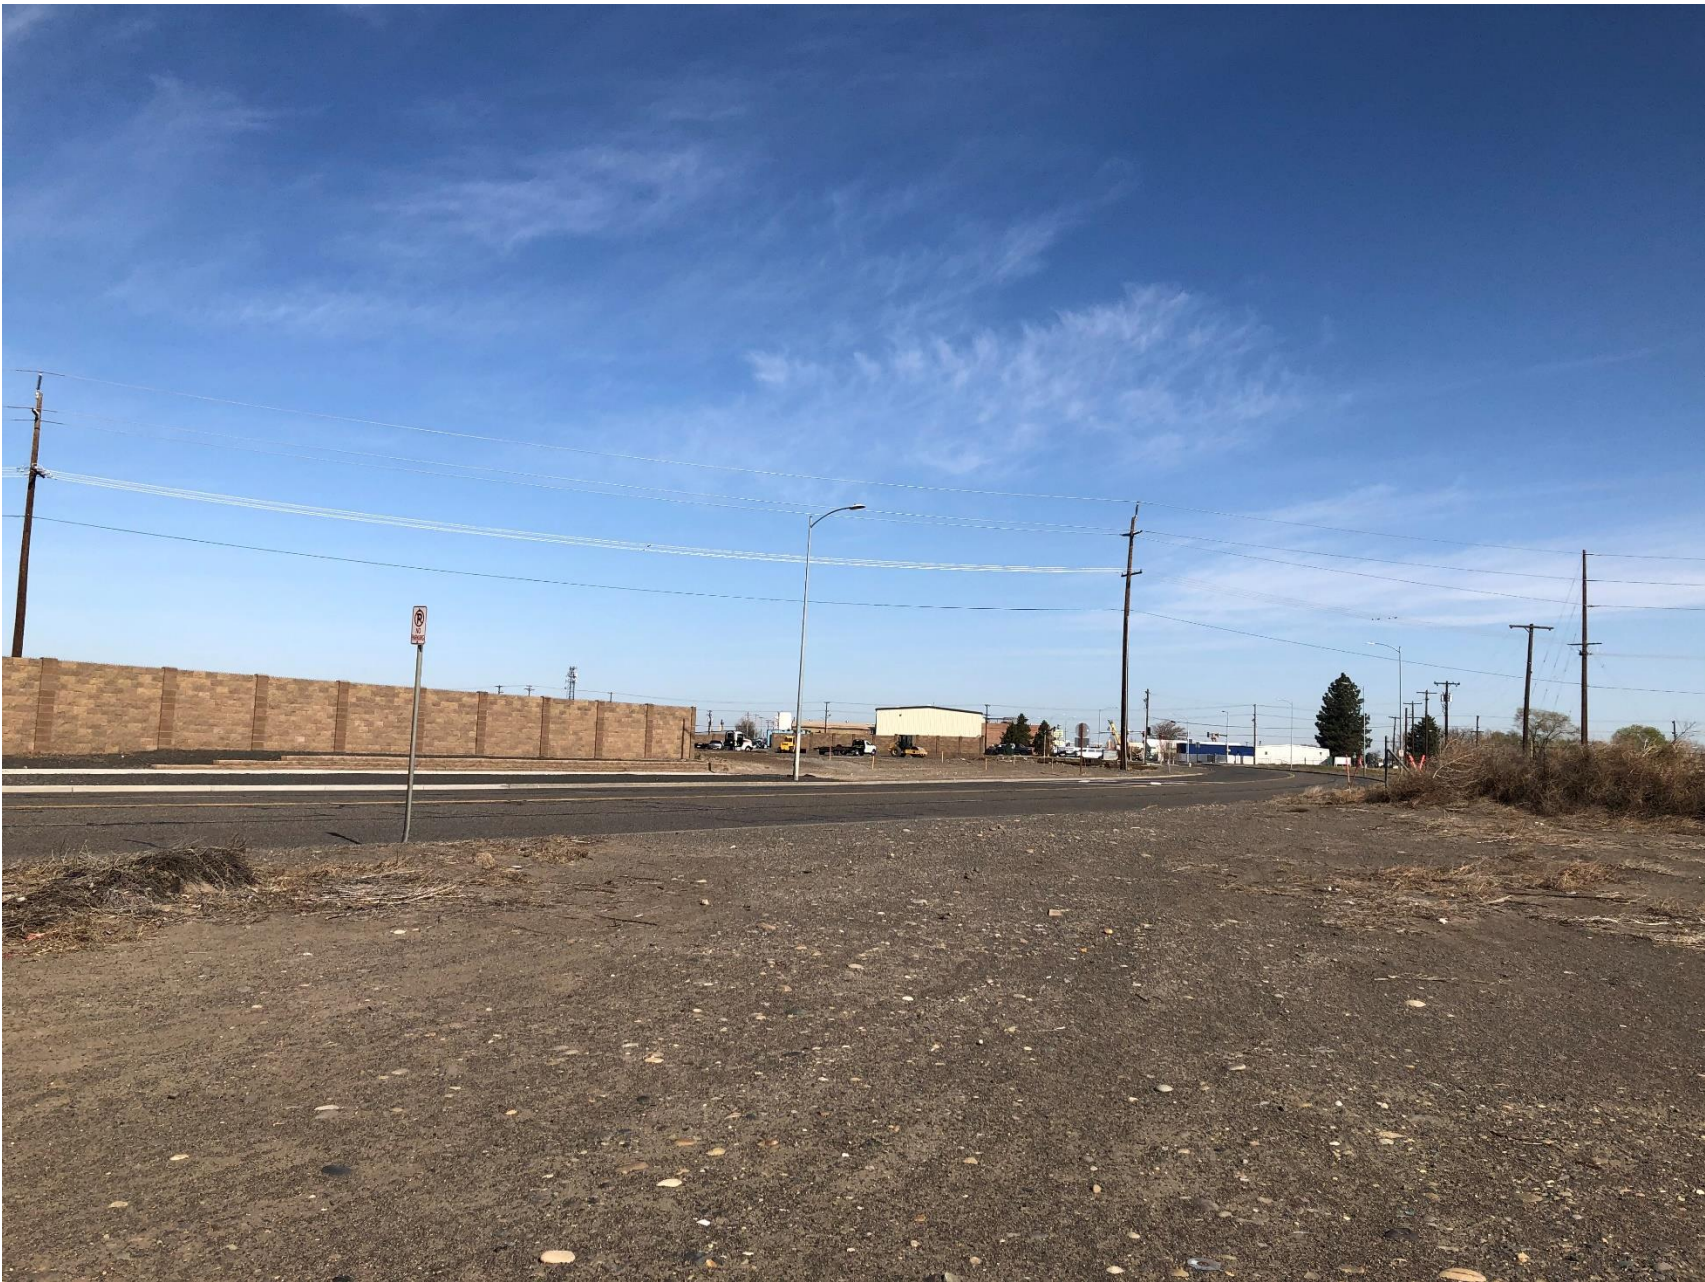
**Photo 1**

Photo Description: Site from a distance.

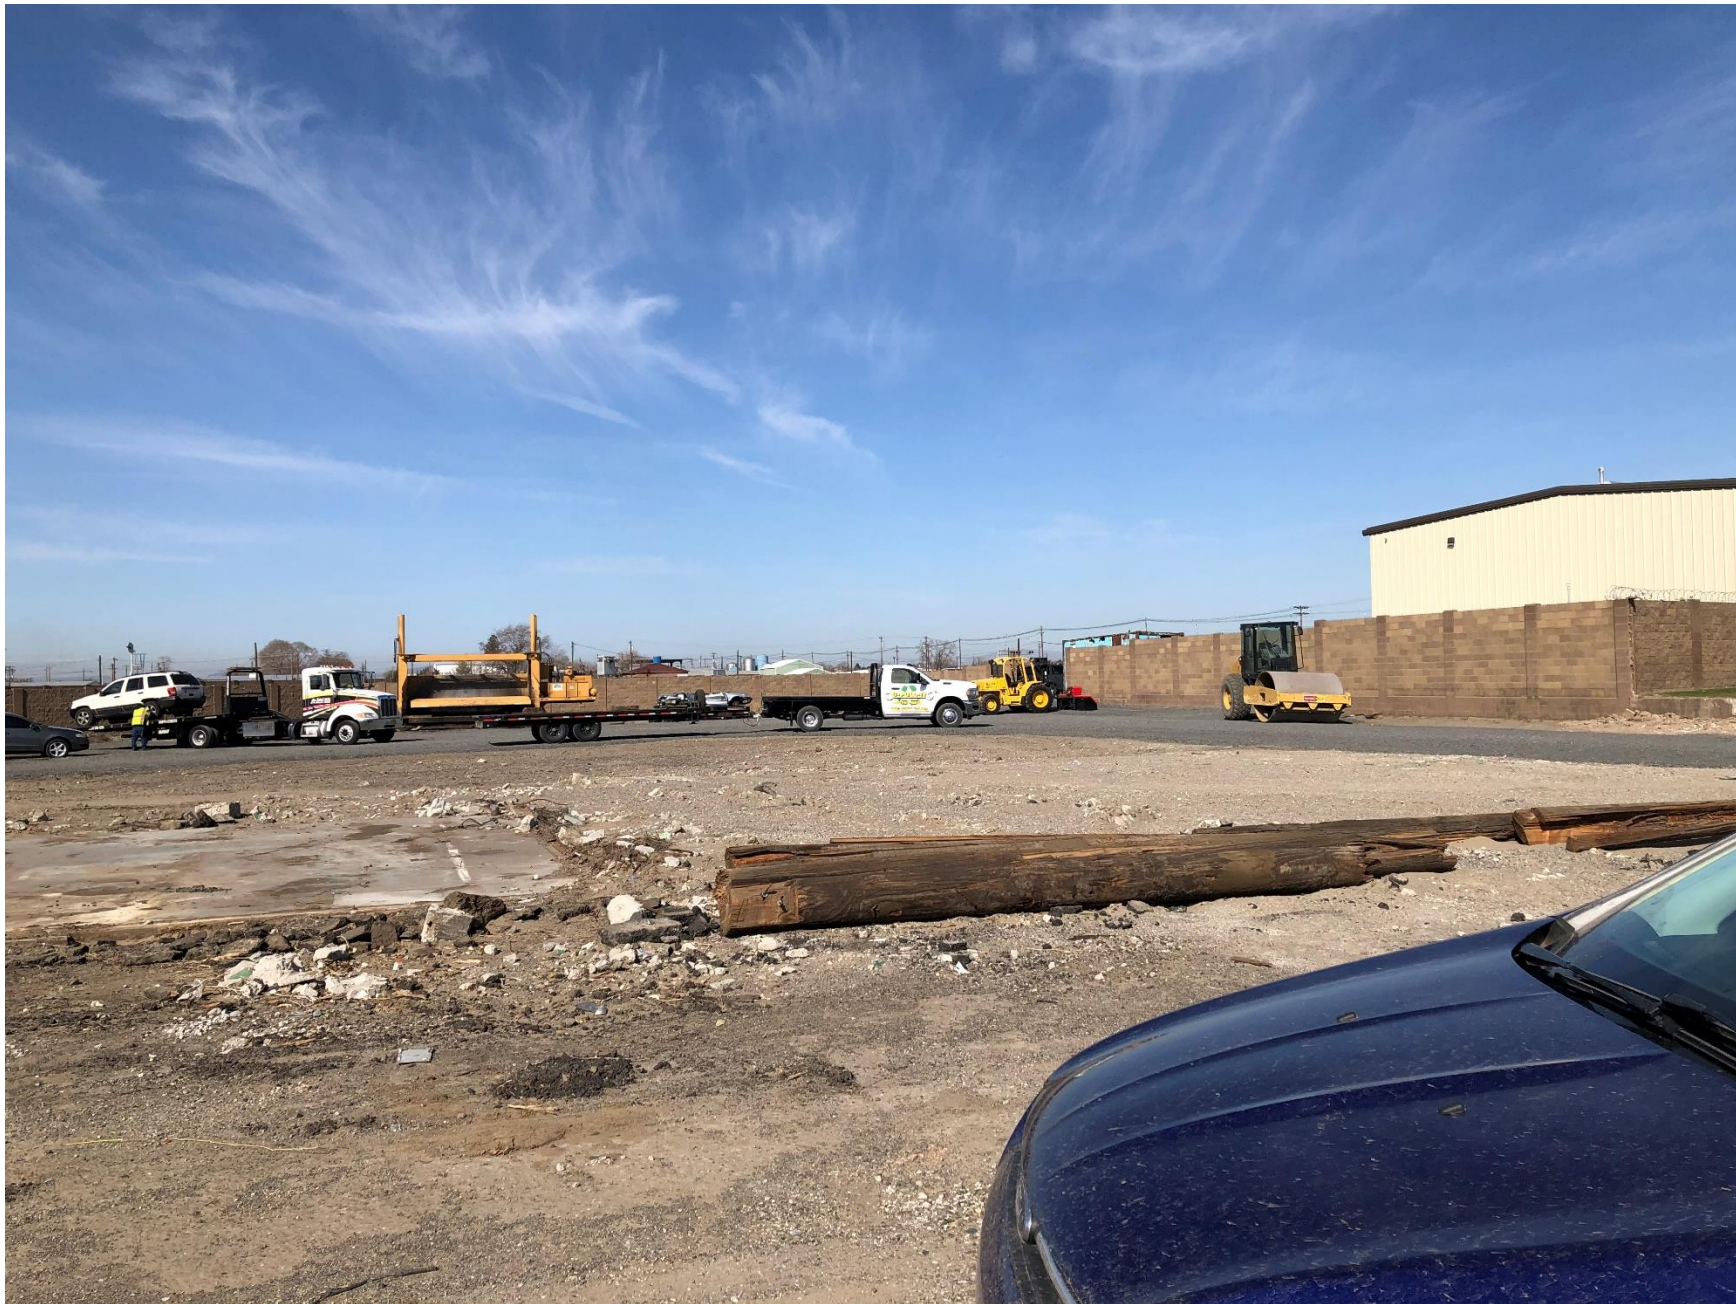
**Photo 2**

Photo Description: Building demolished.

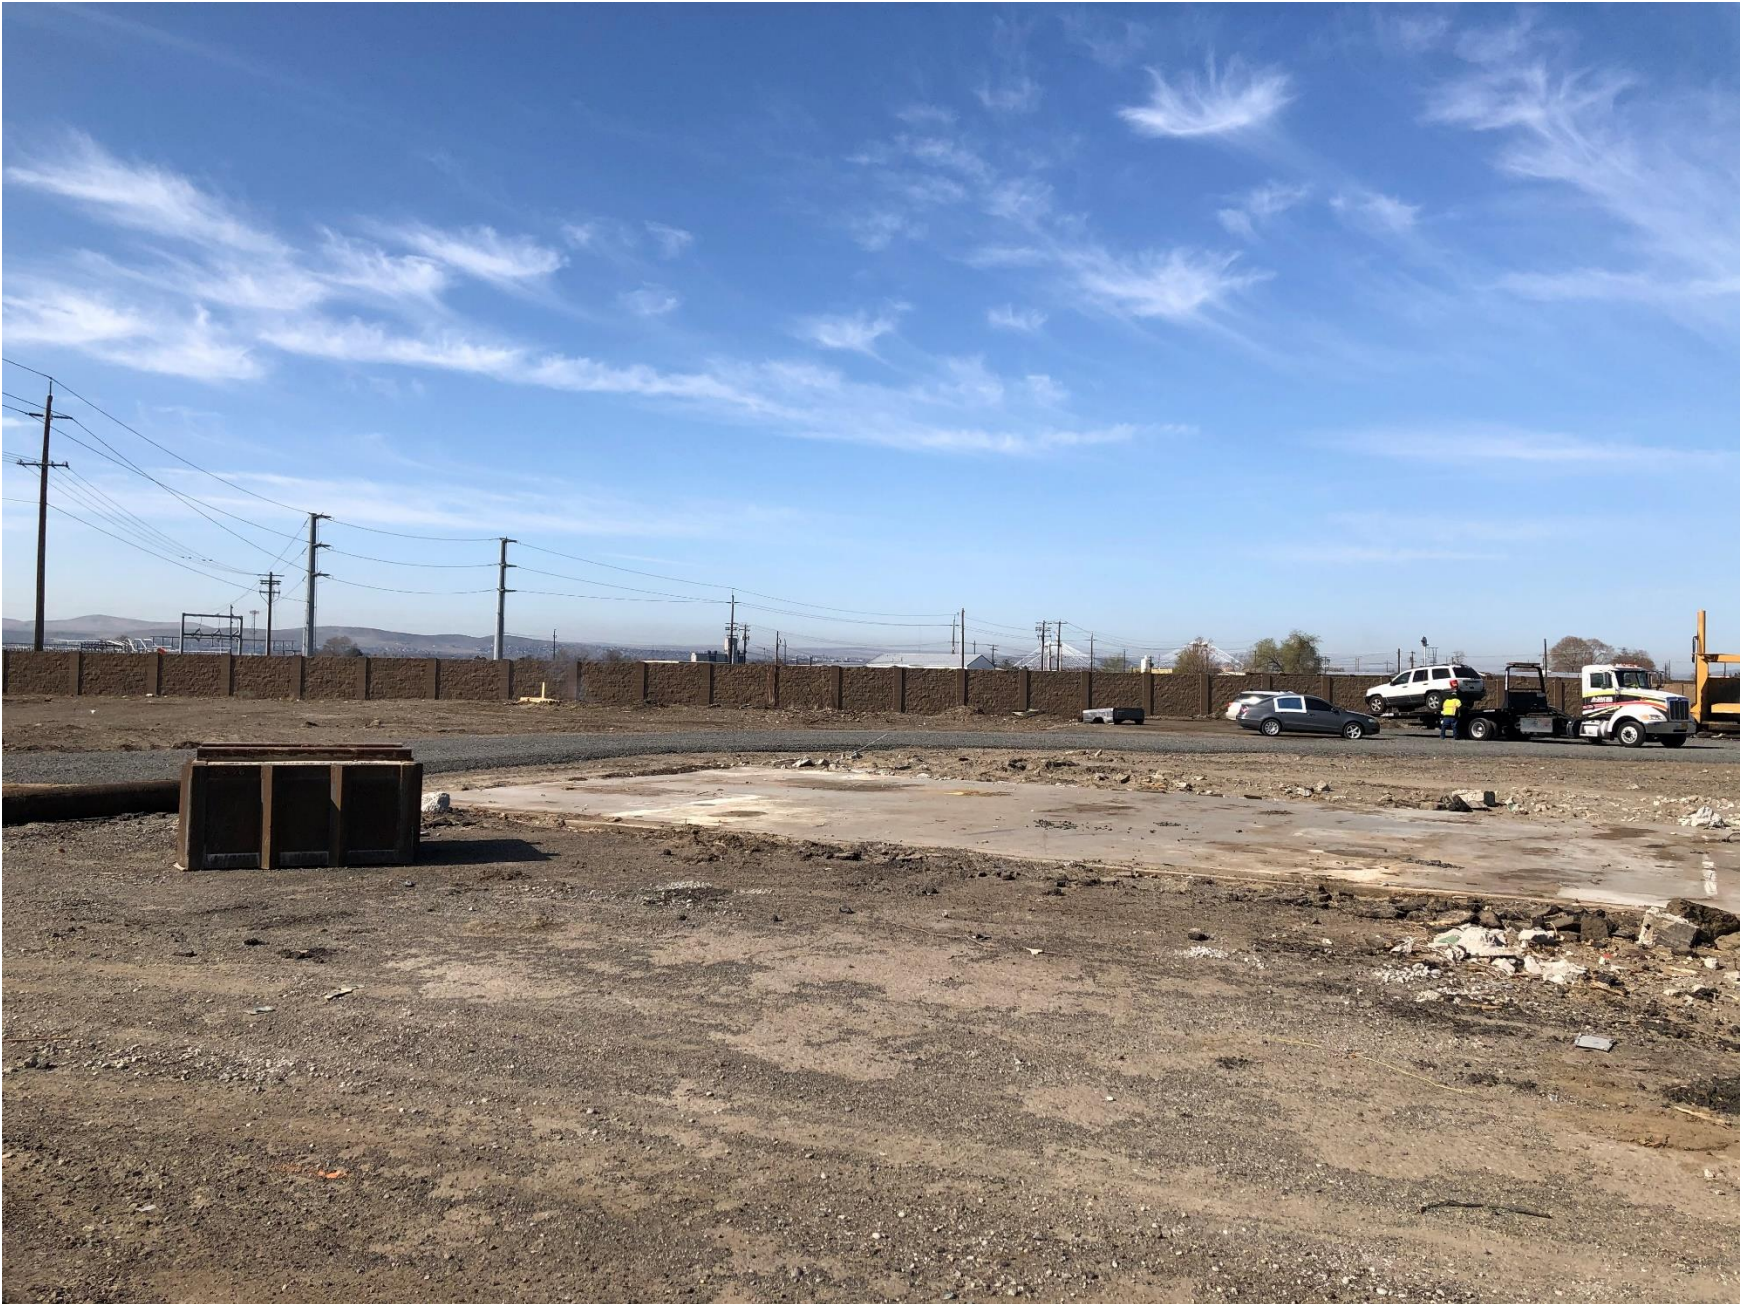
**Photo 3**

Photo Description: Building demolished. Site cleaned.

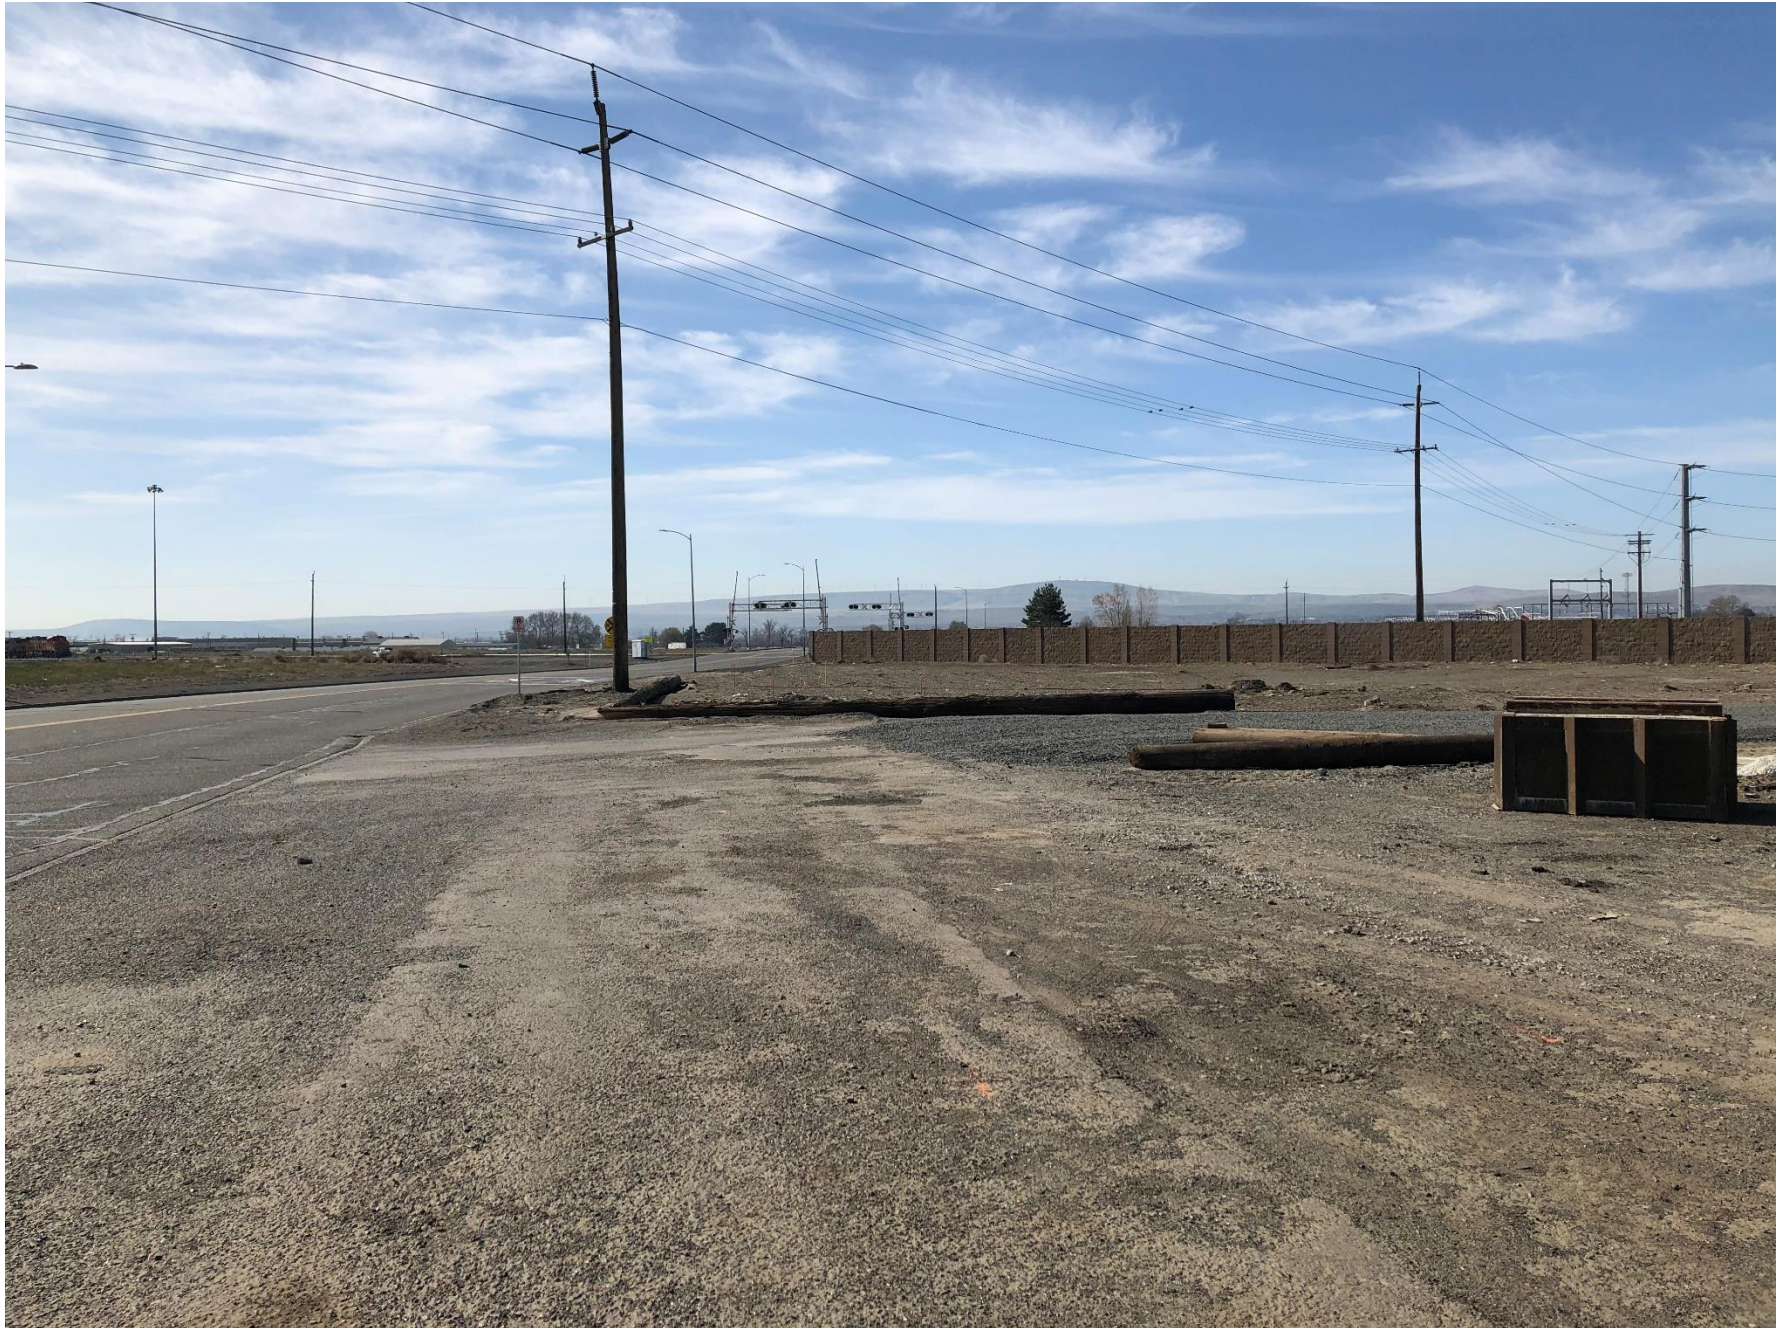
**Photo 4**

Photo Description: Site is cleaned.
