State of Washington Department of Ecology
 Central Regional Office
PERMIT COMPLIANCE INSPECTION REPORT

Inspection Date: 5/10/2021	NPDES Permit #: WAG505214	County: Klickitat	Receiving Waters:	Inspector(s): Stephanie Giesin	Facility Type: Sand and Gravel
Weather at time of inspection: Sunny 63 °			Discharges to: Surface Water <input type="checkbox"/> Ground Water <input checked="" type="checkbox"/>		
Announced? <input checked="" type="checkbox"/> Yes <input type="checkbox"/> No		Reason: <input checked="" type="checkbox"/> Routine <input type="checkbox"/> Compliant ERTS #: <input type="checkbox"/> Enforcement <input type="checkbox"/> Other			
Inspection Type: <input type="checkbox"/> Inspection w/sampling <input checked="" type="checkbox"/> Inspection w/o sampling <input type="checkbox"/> Follow-up <input type="checkbox"/> Coverage Inspection <input type="checkbox"/> Technical Assistance Visit

Name and Location of Facility Inspected Double M Enterprises Blockhouse Butte Pit 1180 Hwy 142 Goldendale, WA 98620 7 miles northwest of Goldendale	Entry Time 11:52 AM	Permit Effective Date 4/01/2021
	Exit Time 1:05 PM	Permit Expiration Date 3/31/2026
Name(s) of On-Site Representative(s)/Titl

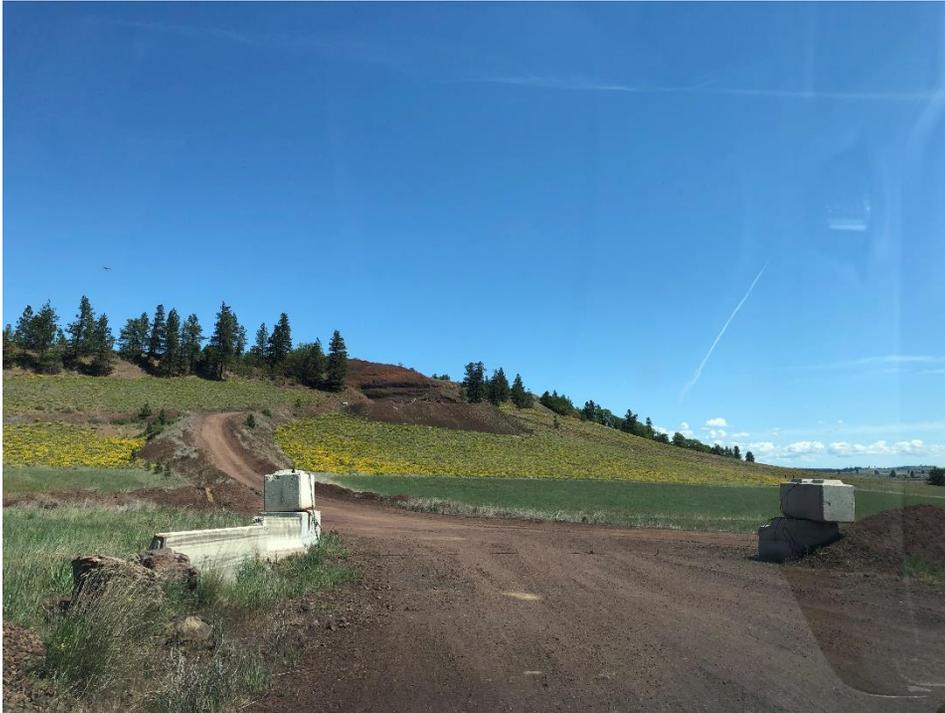
Photo 1
Site entrance

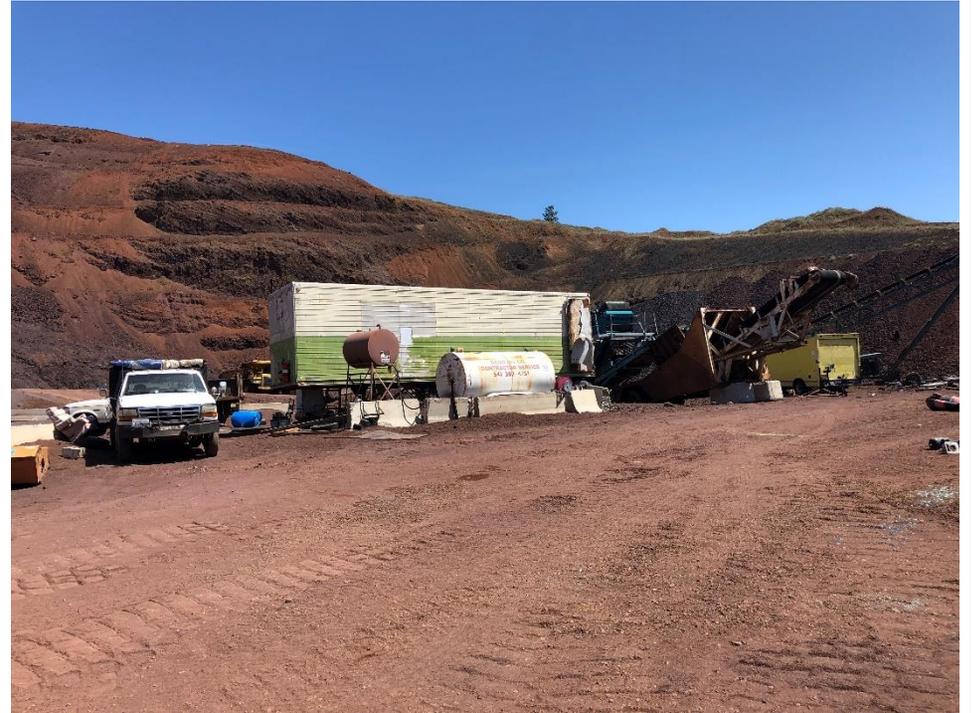
Photo 2
Single wall brown fuel tank and white double wall fuel tank

The smaller brown fuel tank should be in secondary containment if the tank is not double walled. Store all chemical liquids, fluids, and petroleum products in double walled tanks or in secondary containment. Secondary containment includes an impervious surface surrounded with a containment berm or dike that is capable of containing 10% of the total enclosed tank volume or 110% of the volume contained in the largest tank, whichever is greater (permit pg 27).

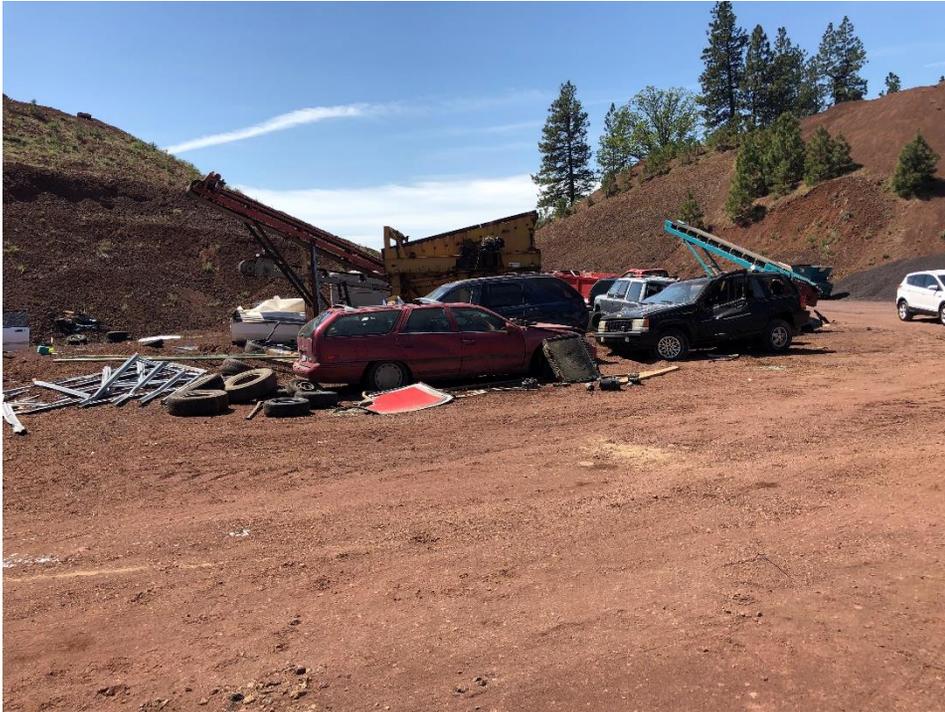
Photo 3
Cars and other solid waste material – photo taken facing site entrance

There are multiple cars, an old trailer, and other solid waste materials that should be properly disposed of. The Permittee must handle and dispose of all solid waste material. Disposal must comply with all applicable local, state, and federal regulations (permit pg 34).

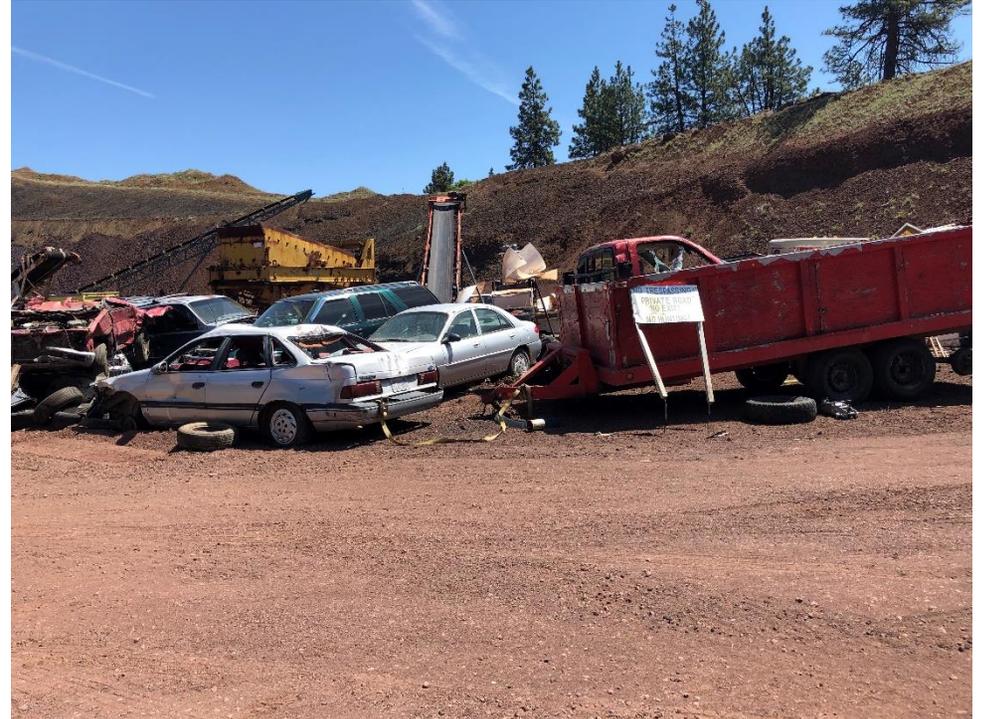
Photo 4
Cars and trailer – south end of it

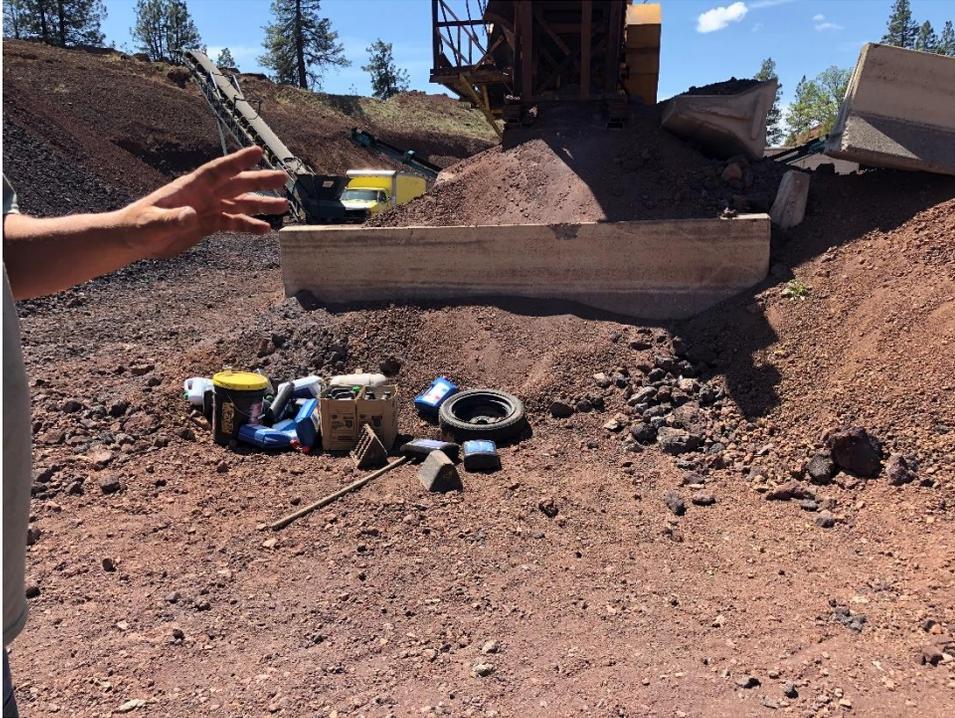
Photo 5
Empty containers on the ground

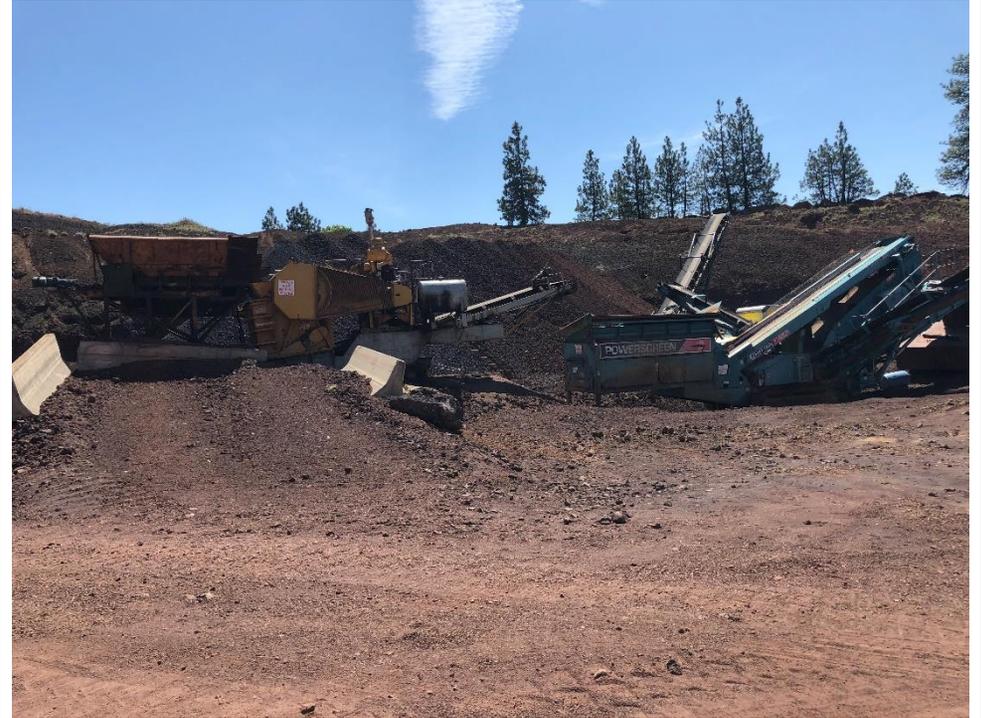
Photo 6
Equipment not currently being used

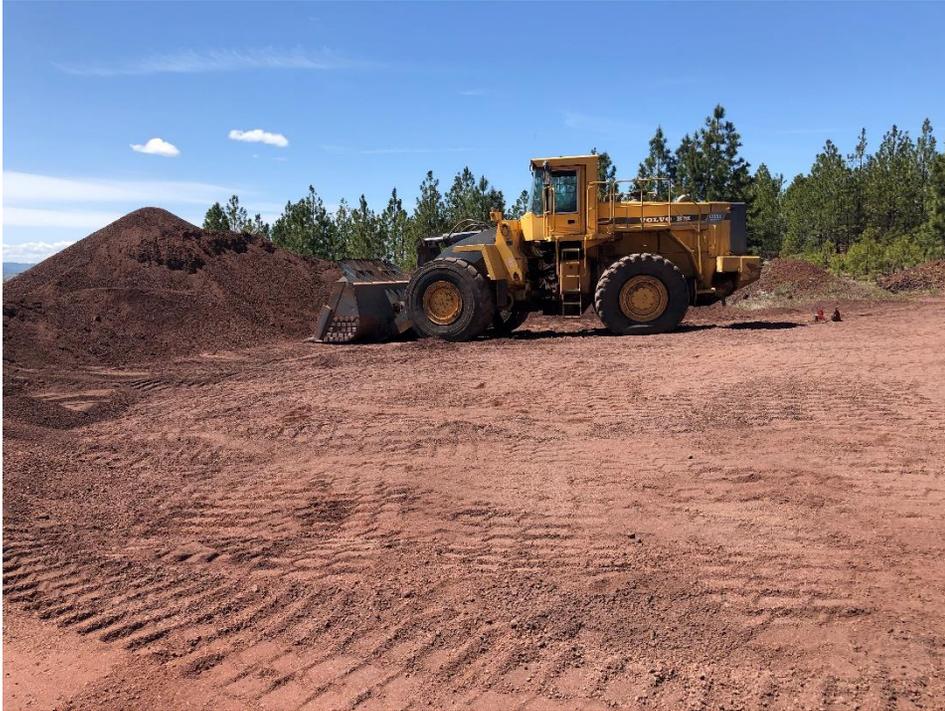
Photo 7
Loader on top level of gravel pit

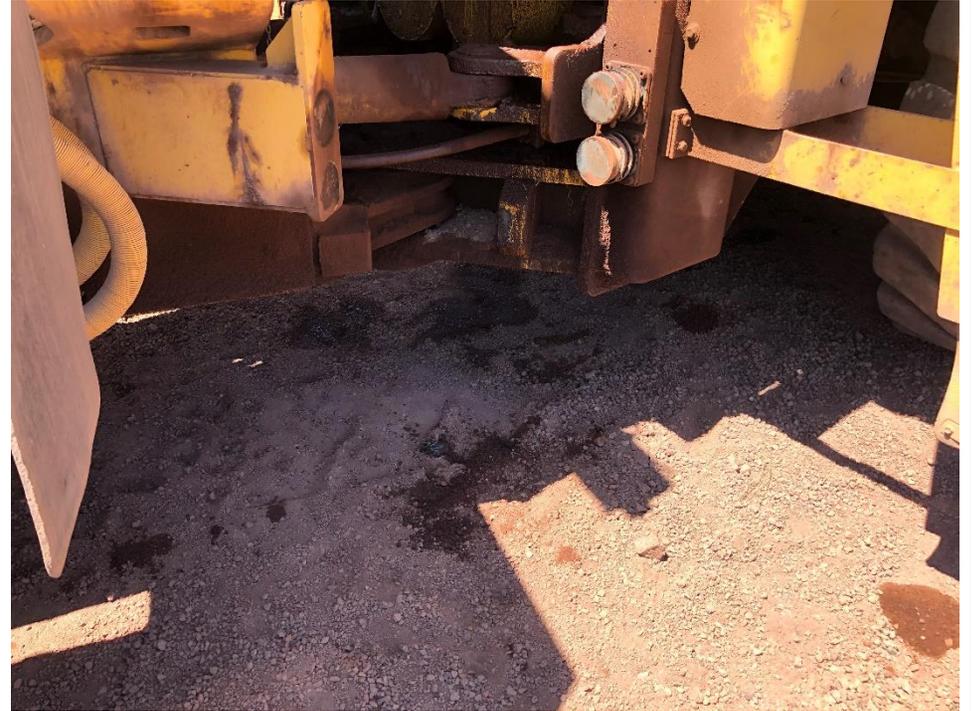
Photo 8
Oil and grease stains under loader

There are multiple oil stains and grease on the ground under the loader on the top level of the pit. Take leaking equipment out of service and prevent it from leaking on the ground until repaired. Repair all leaks before putting equipment back into service on the site (permit pg 28). The Permittee must immediately clean up all spills, leaks, and contaminated soil to prevent the discharge of pollutants to groundwater or surface waters (permit pg 31).
