## NPDES Compliance Inspection Report

### Dunlap Towing Co. – Olympia Log Yard

Permit # WAR000106

Inspection Date: September 2, 2020

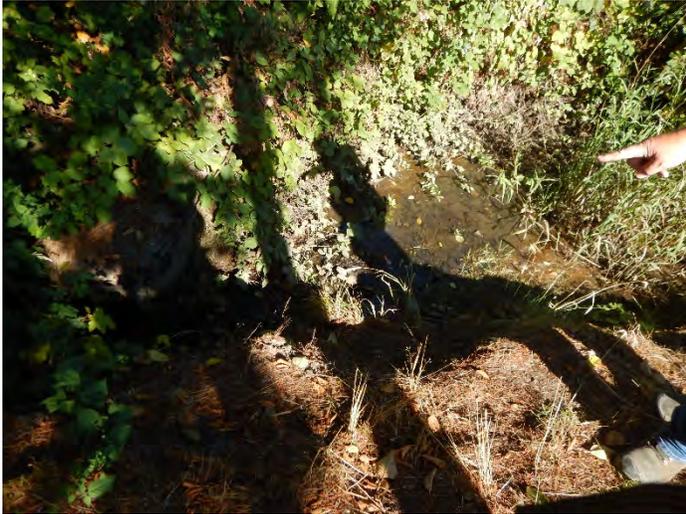
Photo #:09 (DSCN0407)  
Description: Photo of the storm ditch connected to Outfall A. Logs have been placed intermittently to reduce flow rate.

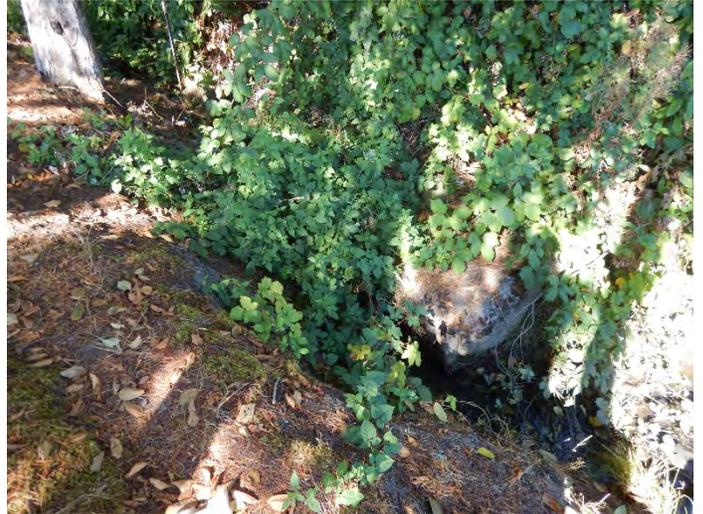
Photo #:10 (DSCN0408)  
Description: Facing west, photo of Outfall A. Stormwater samples are taken here.

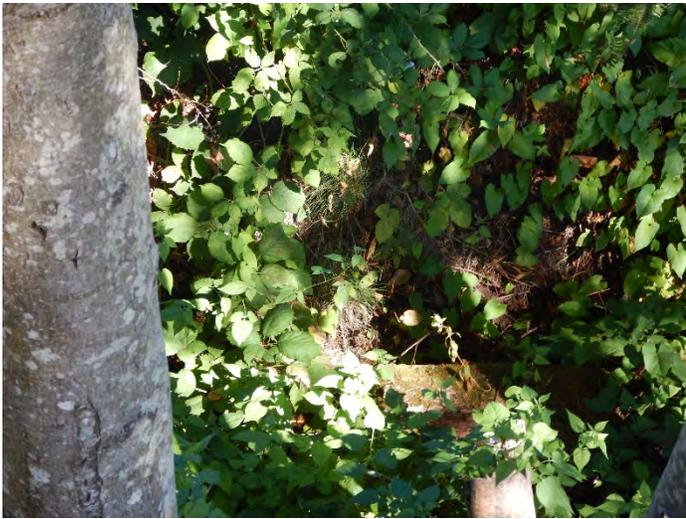
Photo #:11 (DSCN0409)  
Description: Photo of storm ditch connected to Outfall A. Logs have been placed intermittently to reduce flow rate.

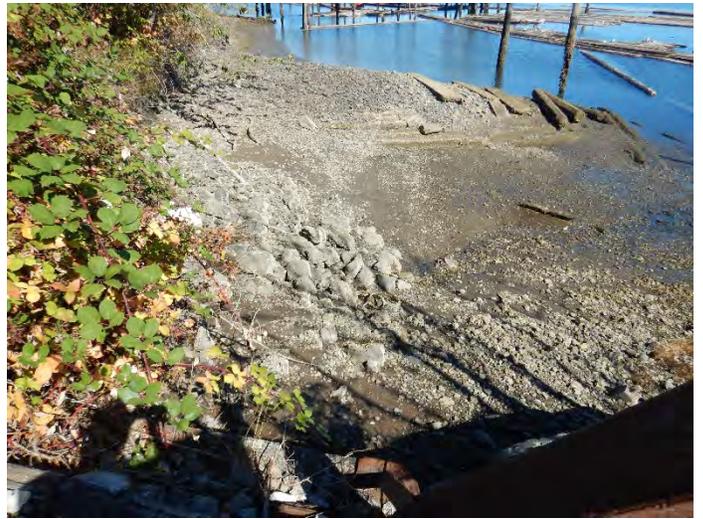
Photo #:24 (DSCN0423)  
Description: Facing north, photo of Outfall B. Stormwater samples are taken here.

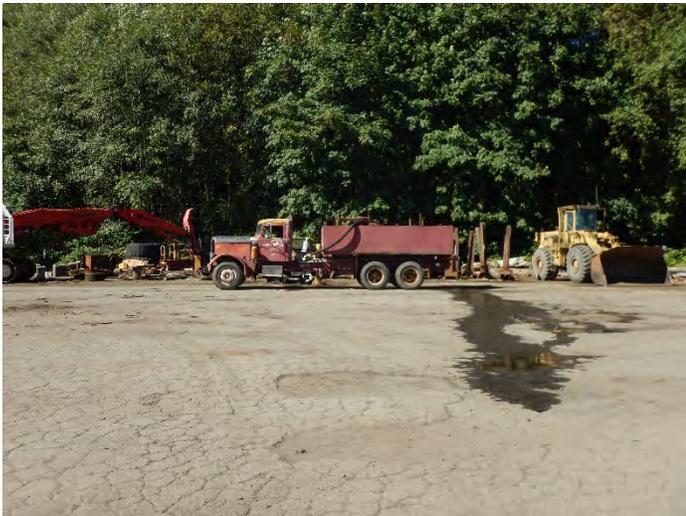
Photo #:39 (DSCN0438)  
Description: Facing west, photo of water truck with water leakage.

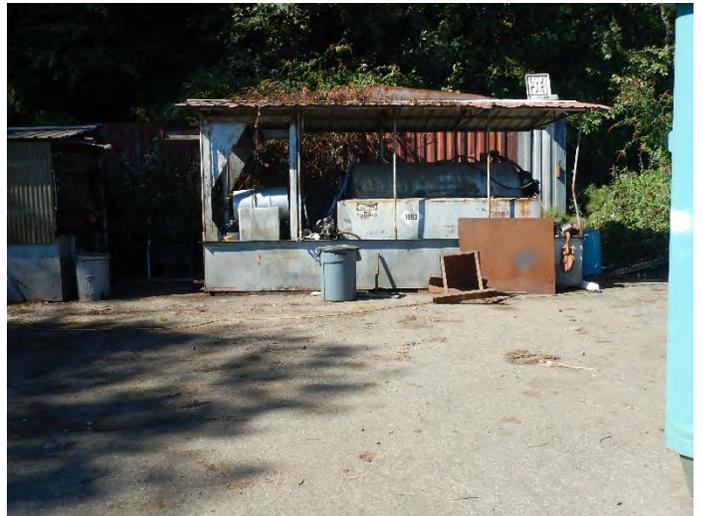
Photo #:40 (DSCN0439)  
Description: Facing west, photo of old double-walled tank and oil drums. Plan to get rid of this in the future.

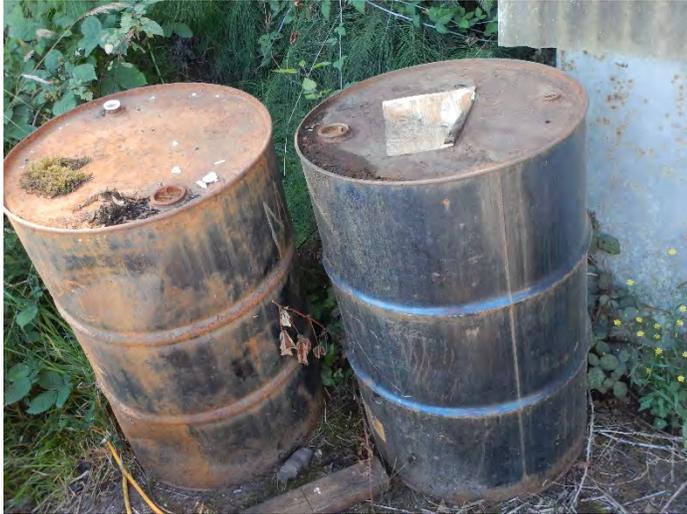
Photo #:41 (DSCN0440)  
Description: Photo of old oil drums. Plan to get rid of them in the future.

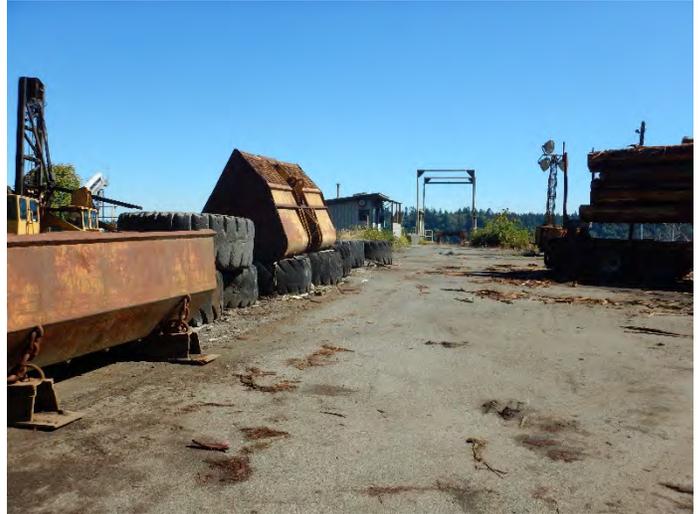
Several upgrades were recently conducted at the facility, involving both removal of old materials and installation of new equipment. The new oil water separator tank was installed a few years ago. The facility also transitioned from using a hydrant to fill their water trucks, to using a pump system. These water trucks are used to spray the facility grounds to prevent dust and wood shavings from getting swept up by the wind. Mr. McNally indicated that he plans to decommission and get rid of old equipment. He was able to have the large 2,000 gallon fuel tank removed in 2019, but he wants to have the additional double-walled tanks and drums removed over the next few years. He plans to purchase and build a shed to house the oil drums, which would allow Marine Vacuum Service, Inc. (Mar-Vac) to come in, pump, and remove the drums from the site. Olympia Log Yard used to offer a wood-chipping service, which was halted following the recession-related issues of 2008. Mr. McNally plans to decommission the old chipping equipment, as it is no longer in use.

Photo #:42 (DSCN0441)  
Description: Facing northeast, photo of old and unused equipment.

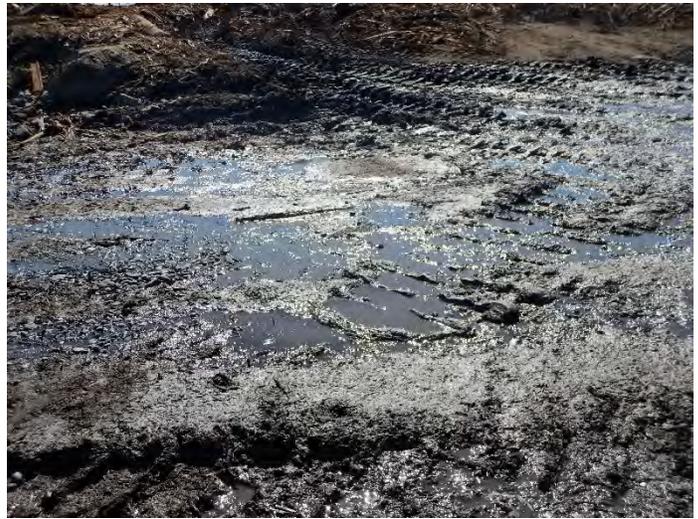
Photo #:44 (DSCN0443)  
Description: Photo of water accumulation on-site.

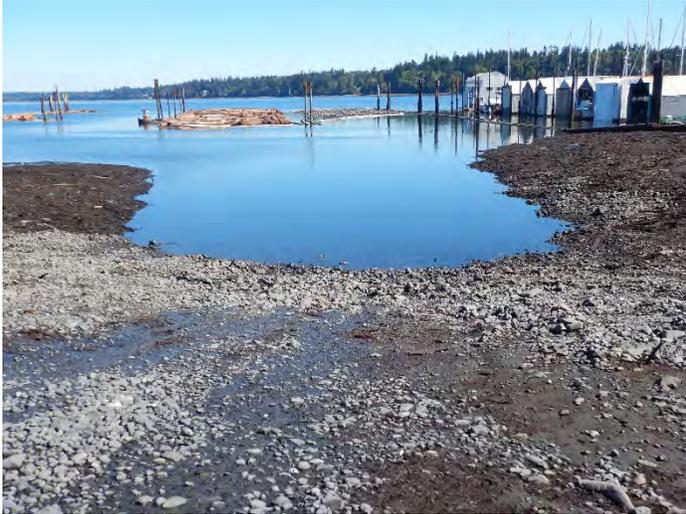
Olympia Log Yard is a towing and logging facility, with operation occurring both on land and in water. Typical daily operations involve inbound and outbound procedures. For the inbound process, a loaded truck arrives at the entrance to the facility, where it is banded (3 metal bands per load). Bundle tags and paperwork are taken care of, the truck moves to the rear of the facility, and the bundled load is transferred to skids. The load is later weighed on a scale and then placed in the water (Budd Inlet) for storage. For the outbound process, a raft from the log storage area in Budd Inlet is transferred to an area that is referred to as the "pockets". A bundle of wood is then pushed up the raft via boat, where it is picked up out of the water and placed on deck or on a shovel. The water access ramp, which is a gravel incline that allows equipment/vehicle access to Budd Inlet for log transfer, is not sampled for stormwater (**See Attachment B, Photo 45**).

Photo #:45 (DSCN0444)  
Description: Facing northeast, photo of water access ramp for loading/unloading logs.

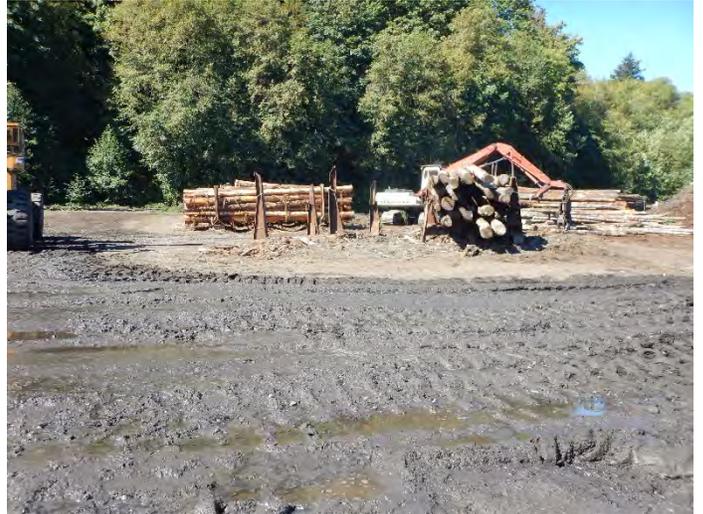
Photo #:46 (DSCN0445)  
Description: Facing west, photo of loads, skids, and water accumulation.

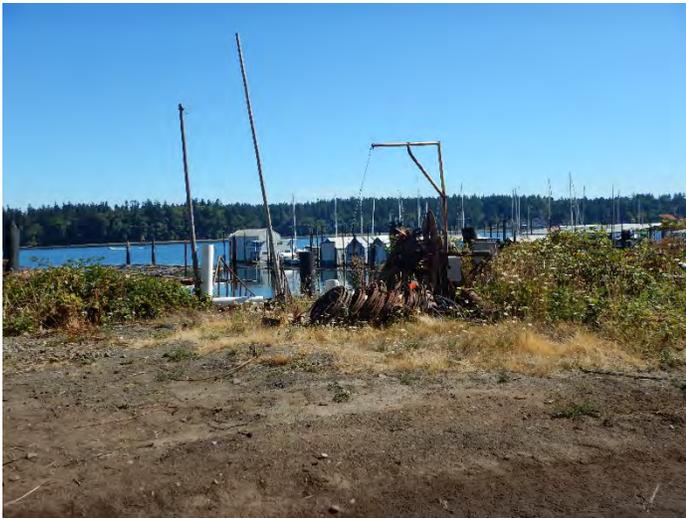
Photo #:47 (DSCN0446)  
Description: Facing east, photo of old banding materials. Plan to get rid of this in the future.
