State of Washington Department of Ecology
Northwest Regional Office
**STORMWATER COMPLIANCE INSPECTION
REPORT**

Name and Location of Facility Inspected PACIFIC COAST COAL COMPANY, 30700 Black Diamond-Ravensdale Road Black Diamond, WA 98010	Entry Time 9:30 am	Permit Effective Date March 01, 2008
	Exit Time 11:15 am	Permit Expiration Date January 11, 2013 Permit extended
Name(s) of On-Site Representative(s)/Title(s)/Phone and Fax Number(s) Erik Wheeler, Construction Project Manager 29312 SE 408th St Enumclaw, WA 98022 Black Diamond, WA 98010 Email: ewheeler@wheelercc.net	Other Participants: Daniel MacKinnon Natural Resources Specialist, OSMRE Ph: 970.310.5993; E: dmackinnon@osmre.gov	
Name, Address of Responsible Official/Title/Phone and Fax Number. Mr. David Morris Owner/Operator P.O. Box 450 Black Diamond, WA 98010	Samples Taken? <input type="checkbox"/> Yes <input checked="" type="checkbox"/> No	
Phone Number 2063215984 Fax	Photos Taken? <input checked="" type="checkbox"/> Yes <input type="checkbox"/> No

John Henry No. 1 Mine is a coal mining and processing facility owned and operated by Pacific Coast Coal Company (PCCC). This facility is located near the City of Black Diamond a

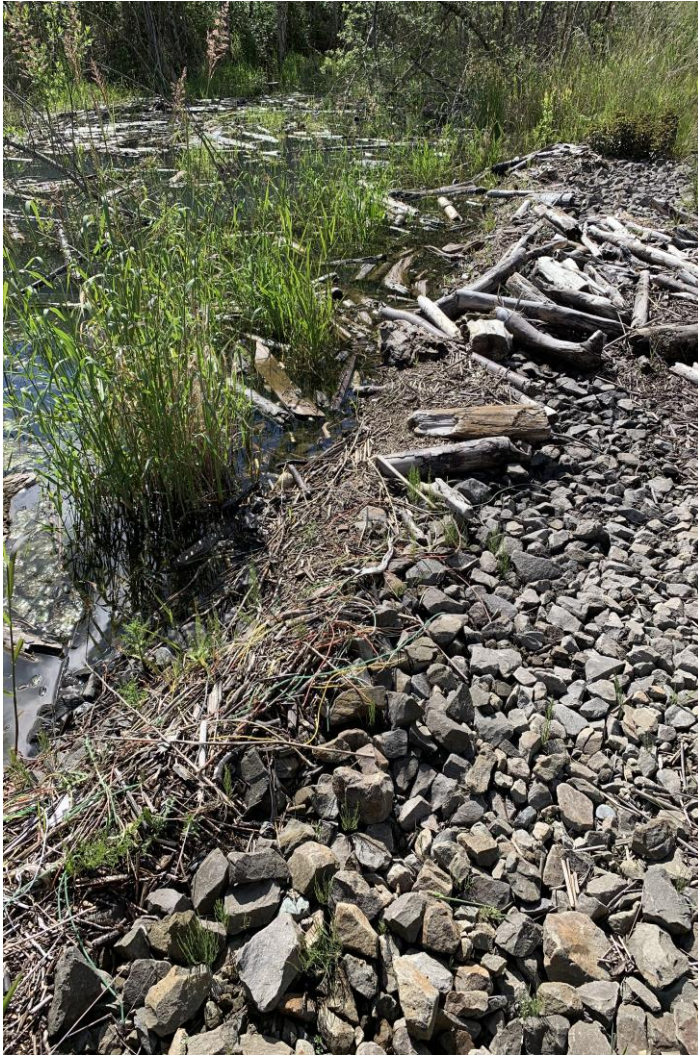
**Photo 1: [IMG_0836]**

The inspection continued on to observe PCCC's dewatering activities at Pit 1. The access road along the west side of Pit 1 consists of a rock dam/dike to prevent water from the pit from discharging into the wetlands surrounding Mud Lake. This is the location where OSMRE observed discharges during their April 21, 2021 inspection (photos 1-2)

At the time of the inspection, Ecology observed no discharges entering Mud Lake from Pit 1. Discussions with Mr. Wheeler indicated that pausing mine-dewatering at Pit 1 caused the water to overflow into Mud Lake.

Description: Access road on west end of Pit 1 functions as a dike between the pit and the wetlands surrounding Mud Lake. Woody debris and vegetation covers much of the road due to Pit 1 overflow observed by OSMRE in April 2021.

Mr. Wheeler described plans to maintain the Pit 1 dike by replacing the existing rock, adding roughly 20 tons of quarry spalls, and removing accumulated wood debris. He also stated plans to install a second dewatering pump to further lower the Pit 1 water levels. This would reduce the chance of water overtopping the dike and discharging into Mud Lake. The pump would run continuously during the planned maintenance at the Mud Lake dike, and while mine reclamation continues.

At the time of this inspection, Ecology observed no discharge into the lake. As long as mine dewatering continues as designed, Pit 1 should not be at risk of overflowing and incidentally overtopping into Mud Lake (photos 1-2) Planned or unplanned discharges into Mud Lake must be monitored to ensure discharges comply with Permit Section S1.A, and the State Water Quality Standards under WAC 173-201A.

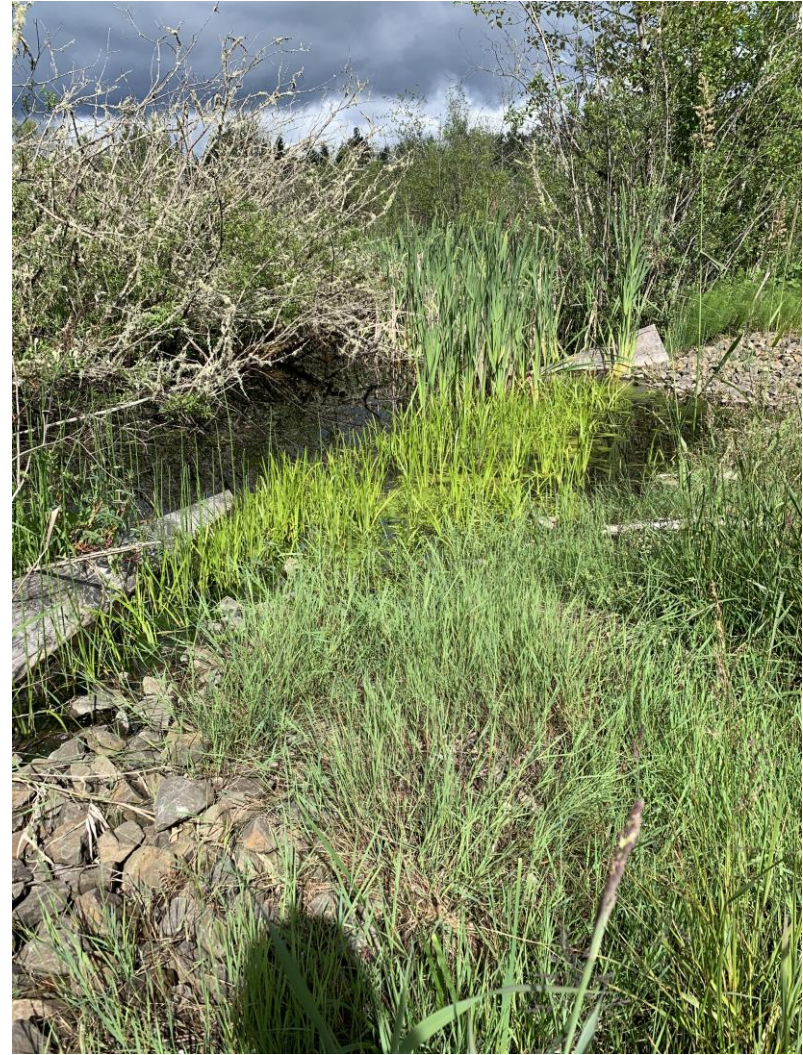
**Photo 2: [IMG_0837]**

Description: Opposite side of Pit 1/Mud Lake dike. Ecology did not observe discharges entering Mud Lake from Pit 1 at the time of the inspection.

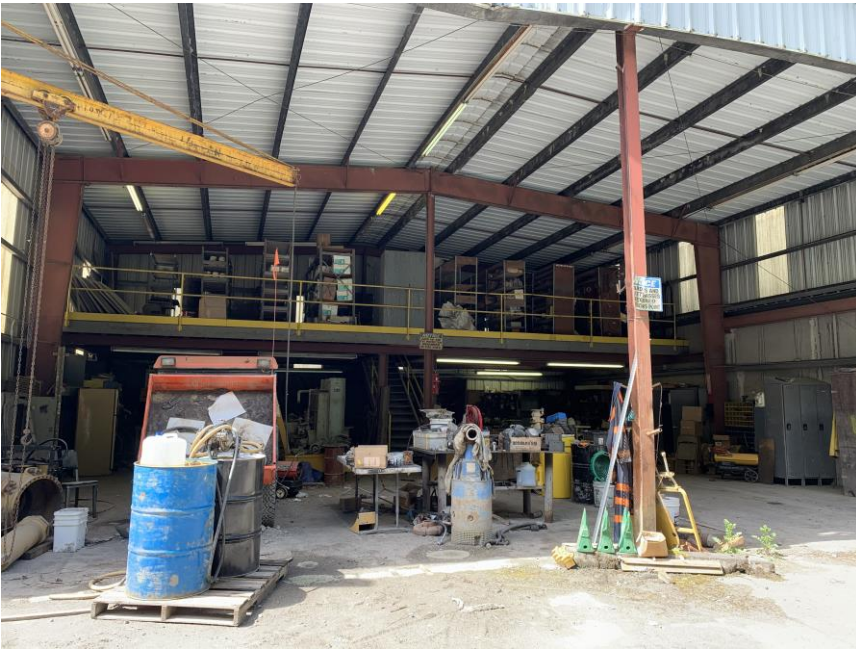
**Photo 3: [IMG_0853]**

Inspection of the facility's maintenance shed and workshop showed two barrels of unlabeled fluids on a pallet stored outside with no within secondary containment. The entrance to the workshop is graded to slope inward to provide containment for all fluids stored within the shop (photos 3-4).

Description: Maintenance, storage, and repair shed with containment lip. Two 55-gallon barrels were staged outside of containment area and lacked secondary containment. Tops of barrels had accumulated stormwater.

The permittee must store all chemical fluids within secondary containment to comply with section S12.B.3. of the permit. Ecology recommends placing the drums observed during the inspection within the graded entrance, or provide cover and secondary containment for all chemical fluids stored out in the open (photos 3-4). All containers should also contain a label describing their contents. Provide Ecology with documentation of compliance with permit section S12.B.3 within 30 days.

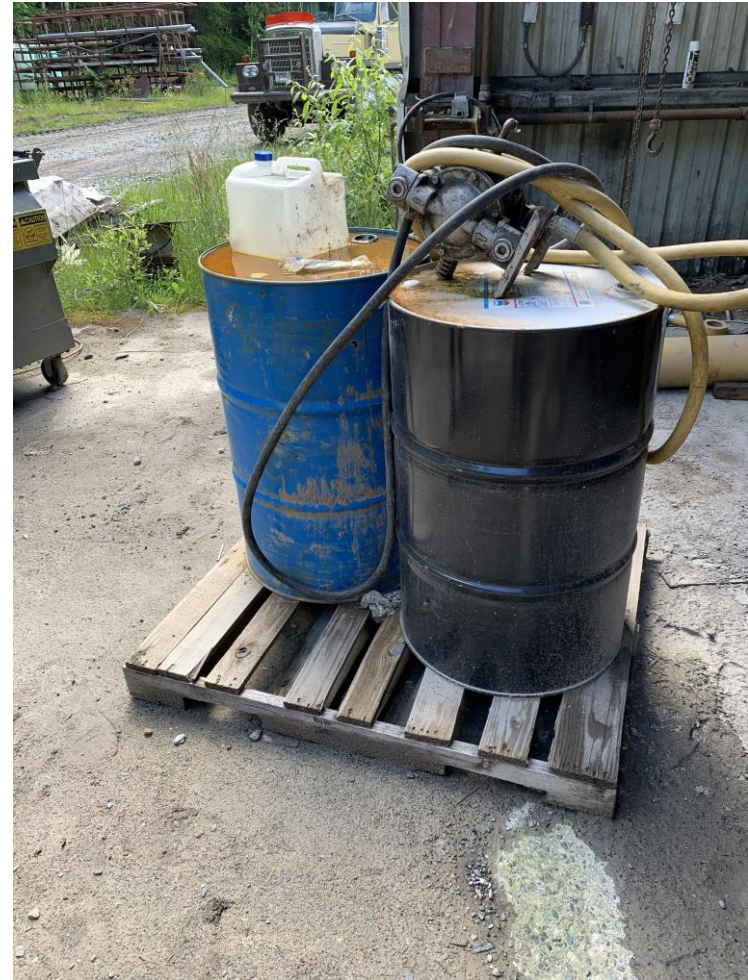
**Photo 4: [IMG_0851]**

Description: Close up of rain water accumulated on 55-gallon drums near maintenance shed. Ecology did not notice any labels identifying the content of the drums.

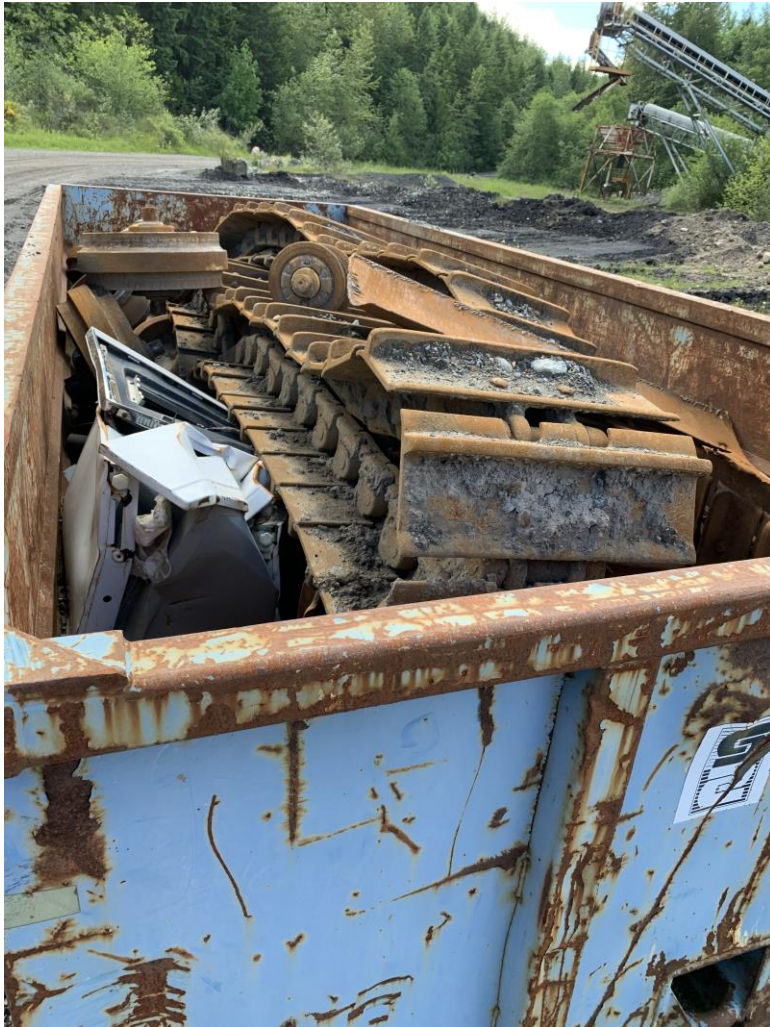
**Photo 5: [IMG_0855]**

Situated next to a covered maintenance area, Ecology observed a roll-off dumpster full of scrap metal waste. The bin appeared full and did not have a cover to prevent rainwater from accumulating within the dumpster (photo 5). Ecology is unaware of any waste removal schedule implemented at the site.

Description: Uncovered roll-off dumpster for gathering metallic waste.

Provide a waste disposal schedule for the scrap metal dumpster to Ecology within 30 days (photo 5). Solid waste must be handled and disposed of in a manner that prevents its entry into waters of state, as required by permit section S5.A.

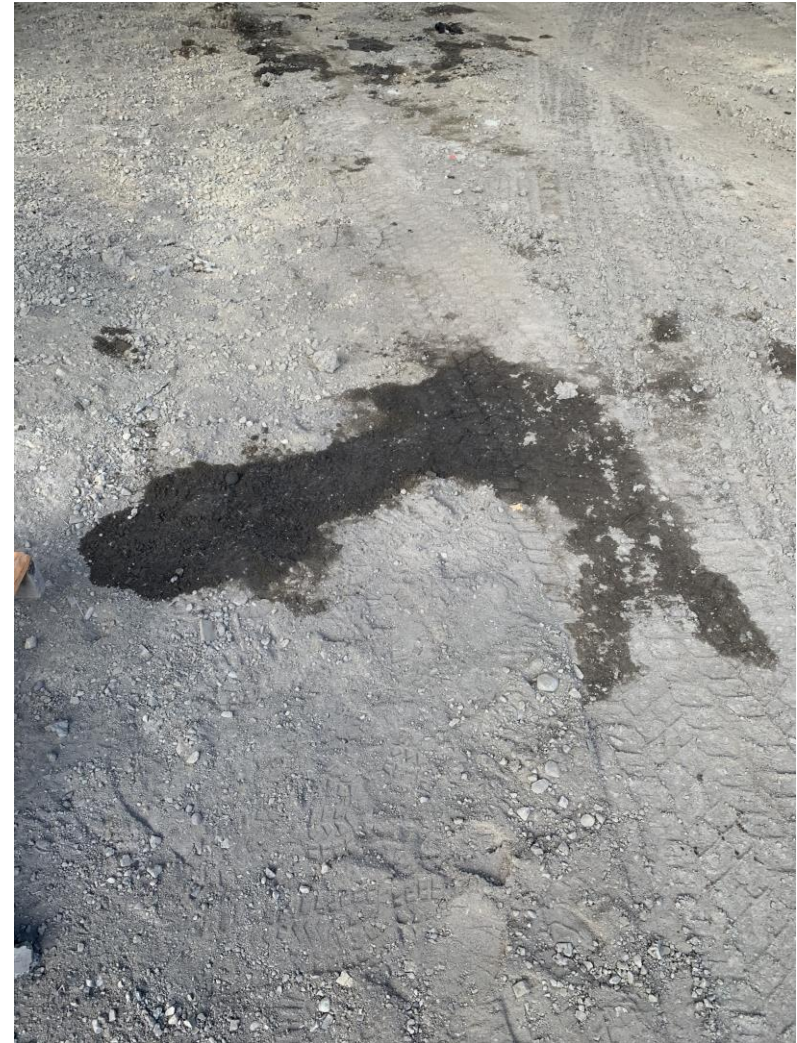
**Photo 6: [IMG_0856]**

In a covered maintenance area across from the site office, Ecology observed multiple areas of stained soils. It appeared that the facility consistently conducts vehicle maintenance over bare ground. Ecology could not locate any spill kits nearby the maintenance area (Photos 6-8).

Description: Stained soils located under large outdoor maintenance area. Ecology observed several instances of stained soils within this maintenance area.

Permittee must immediately clean and dispose of all oil/petroleum contaminated soil and implement BMPs that prevent spills to pervious surfaces when conducting vehicle and equipment maintenance. Provide documentation of compliance with section S11 of the permit within 30 days (photos 6-8).

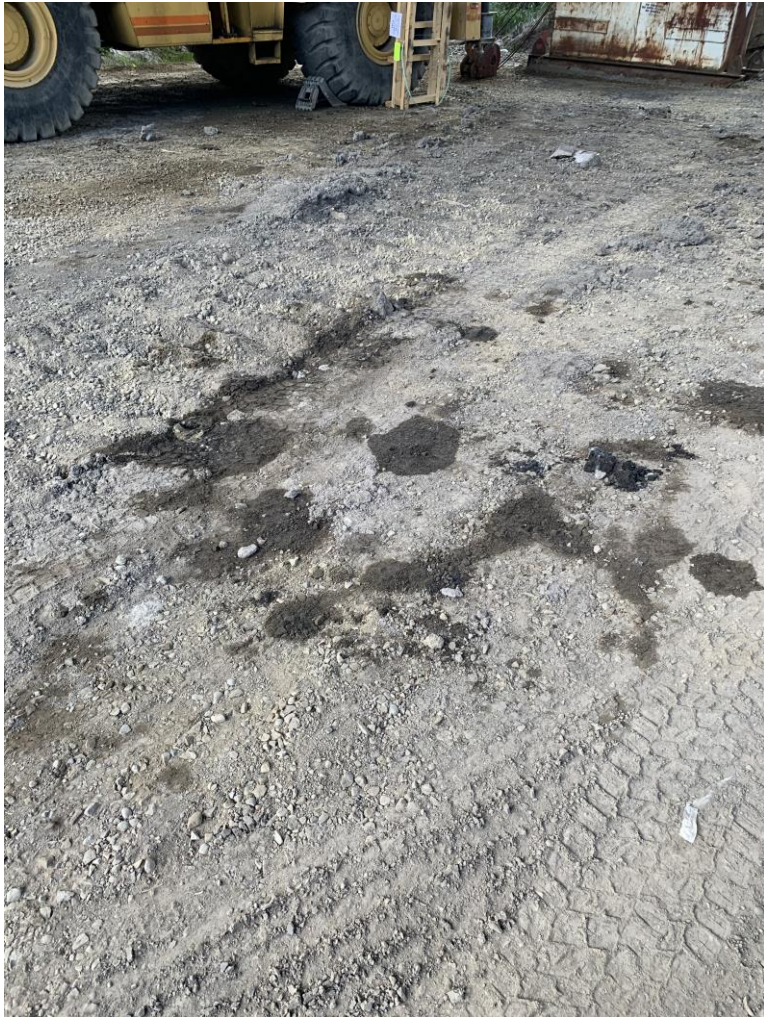
**Photo 7: [IMG_0857]**

Description: Alternate view of soil stains underneath covered maintenance area.

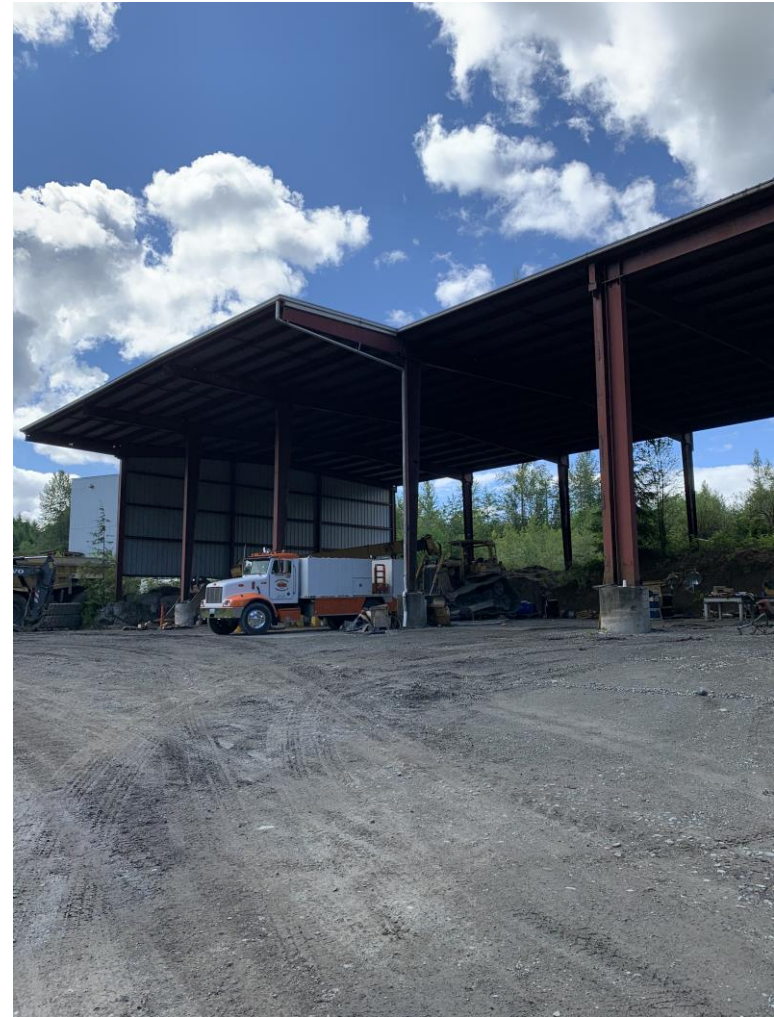
**Photo 8: [IMG_0862]**

Description: Covered maintenance area across from the site office trailers where stained soils, along with several containers of chemical fluids without secondary containment, were observed throughout the area.
