<h2 style="text-align: center;">STORMWATER COMPLIANCE INSPECTION REPORT</h2> <p style="text-align: center;">State of Washington Department of Ecology 3190 – 160th Avenue SE, Bellevue, WA 98008-5452</p>					WADOE Stormwater Phone: (425) 649-7000 FAX: (425) 649-7098										
Section A: General Data															
Inspection Date 3/22/2019	NPDES Permit # WAR001155	County King	Receiving Waters Duwamish River	Inspector(s) Ben Billick	Facility Type Industrial										
Discharges to: Surface Water <input checked="" type="checkbox"/> Ground Water <input type="checkbox"/>				UNANNOUNCED Inspection											
Section B: Facility Data															
Name and Location of Site Inspected			Lat & Long		Entry Time	Permit Effective Date									
Union Pacific Railroad Argo Yard 402 South Dawson Street Seattle, WA 98108			Latitude: 47.55565 Longitude: -122.32901		9:30 AM	01/01/2015									
					Exit Time	Permit Expiration Date									
					10:00 AM	12/31/2019									
On-Site Representative(s): Name(s)/Title(s)/Contact number(s) or E-mail					Additional Participants:										
Damon J Larkin, Manager Intermodal Terminal Operations Phone: (206) 764-1443, Email: djlarkin@up.com					-Chris Wilkerso

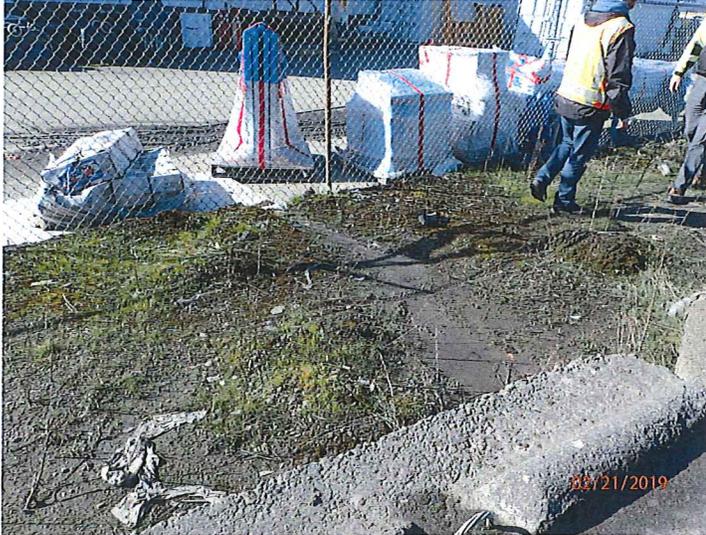
Yes	No	Samples Taken?	<input type="checkbox"/>	<input checked="" type="checkbox"/>	Photos Taken?	<input checked="" type="checkbox"/>	<input type="checkbox"/>
	Yes	No													
Samples Taken?	<input type="checkbox"/>	<input checked="" type="checkbox"/>													
Photos Taken?	<input checked="" type="checkbox"/>	<input type="checkbox"/>													
Section C: Summary of Findings/Comments															
<u>BACKGROUND</u>															
<p>Union Pacific Railroad (UPRR) Argo Yard is covered under Ecology's Industrial Stormwater General Permit (ISGP #WAR001155). Ecology's stormwater unit has conducted an inspection at this industrial site in the past. Ecology's most recent inspection at this facility was on February 21, 2019. Following the February 2019 inspection, Ecology issued a Warning Letter and Inspection Report to UPRR on March 14, 2019 citing the following violations:</p> <ul style="list-style-type: none"> • <u>Violation of ISGP condition S3.A.4.a.ii for failure to correct SWPPP deficiencies within 30 days of receiving written notice from Ecology.</u> On April 18, 2018, Ecology issued a Warning Letter and Inspection Report requiring UPRR to update their SWPPP to reflect the fact that the ISGP applies to all portions of the site, not just the maintenance and fueling areas. These updates were not completed as of February 21, 2019. • <u>Violation of ISGP condition S4.B.2.c for failure to sample each distinct point of discharge off-site except as otherwise exempt from monitoring as a "substantially identical discharge point" per S3.B.5.b.</u> <p>The full March 14, 2019 Warning Letter and Inspection Report were sent to the Permittee via email and post, and copies are available on Ecology's Permitting and Reporting Information System (PARIS) website. The purpose of this inspection was to follow-up on the violations cited in the March 14, 2019 Warning Letter and Inspection Report; determine the facility's compliance with the ISGP; and provide technical assistance as appropriate.</p> <p>This inspection was conducted jointly with Seattle Public Utilities (SPU) Environmental Compliance Inspector Chris Wilkerson.</p>															
<u>INSPECTION/OBSERVATIONS</u>															
<p>Upon arrival, Ecology Inspector Ben Billick and SPU Inspector Chris Wilkerson met with Bryan Robinson, UPRR Manager of Environmental Field Operations. We discussed UPRR's follow-up to the compliance issues noted during the inspection on February 21, 2019 and conducted an inspection of targeted areas on-site. As this was a follow-up inspection, we did not review the facility's compliance paperwork and we did not conduct a full inspection of the entire site.</p> <p>Site Inspection and Discussion:</p> <ul style="list-style-type: none"> • B. Robinson stated that UPRR is currently working to update their SWPPP to address the deficiencies noted in the Ecology Warning Letter and Inspection Report dated March 14, 2019. UPRR expects to have the SWPPP updates completed within the 30-day timeframe given in the March 14 Inspection Report. B. Robinson confirmed that the updated SWPPP will address all drainage basins on-site and that the updated sampling plan will cover all discharge points. B. Robinson also stated that UPRR is also currently investigating the individual drainage basins on-site to ensure that they are accurately defined and mapped. • We inspected a portion of the site northwest of the 4th Avenue overpass where we observed evidence of turbid

001 DESCRIPTION: PHOTO TAKEN DURING INITIAL 2/21/19 INSPECTION SHOWING EVIDENCE OF TURBID RUNOFF FROM THE PERIMETER OF THE FACILITY.

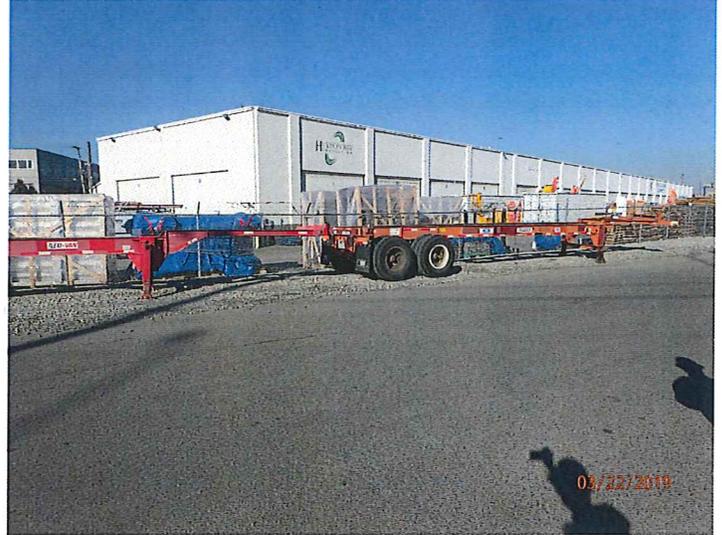
discharge from the facility perimeter on February 21, 2019. Since the February inspection, UPRR has added gravel along the site perimeter at this location in order to cover exposed soil and increase the grade to prevent runoff. Personnel have begun parking equipment on the new gravel, causing compaction in the area. B. Robinson stated that UPRR plans to add more gravel, and will install k-rails to prevent future vehicle and equipment parking. B. Robinson also informed us that the site receives run-on from the 4th Avenue overpass in this area, which contributes to the issue of runoff from the perimeter of the facility. UPRR is currently looking at options to control the run-on, and is considering installing a curb to help contain the run-on in a gravel area where it can infiltrate.

002 DESCRIPTION: GRAVEL ADDED ALONG PORTION OF FACILITY PERIMETER SHOWN IN PHOTO 001 IN AN EFFORT TO RAISE THE GRADE AND PREVENT RUNOFF.

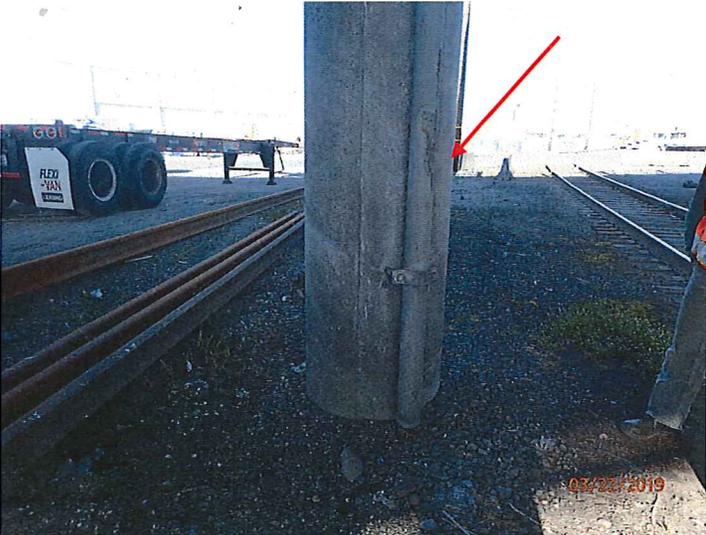
003 DESCRIPTION: DOWNSPOUTS FROM 4TH AVE OVERPASS DRAIN ONTO THE SITE, CONTRIBUTING TO RUNOFF FROM THE FACILITY PERIMETER.

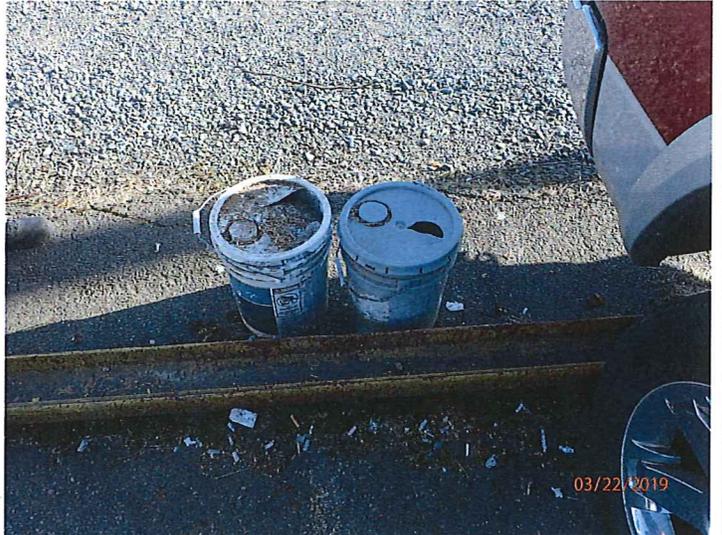
- Two five-gallon buckets that appeared to contain paint were observed on the ground near the main office. The lids of both buckets were broken. B. Robinson stated that they were likely household waste brought on-site by an employee. B. Robinson immediately collected the buckets and put them in his vehicle.
- No new/additional violations or compliance issues were observed.

004 DESCRIPTION: TWO FIVE-GALLON PAINT BUCKETS WITH BROKEN LIDS AND NO SECONDARY CONTAINMENT. BUCKETS WERE IMMEDIATELY MOVED OFF THE GROUND.

- Continue work to update the SWPPP, site map, and discharge monitoring plan and procedures in accordance with the ISGP compliance requirements described in Ecology's Warning Letter and Inspection Report dated March 14, 2019. Submit the updated SWPPP to Ecology by the deadline established in the Inspection Report.
- Ensure that all chemical liquids, fluids, and petroleum products are stored in secondary containment in accordance with permit condition S3.B.4.b.i.4.a.
