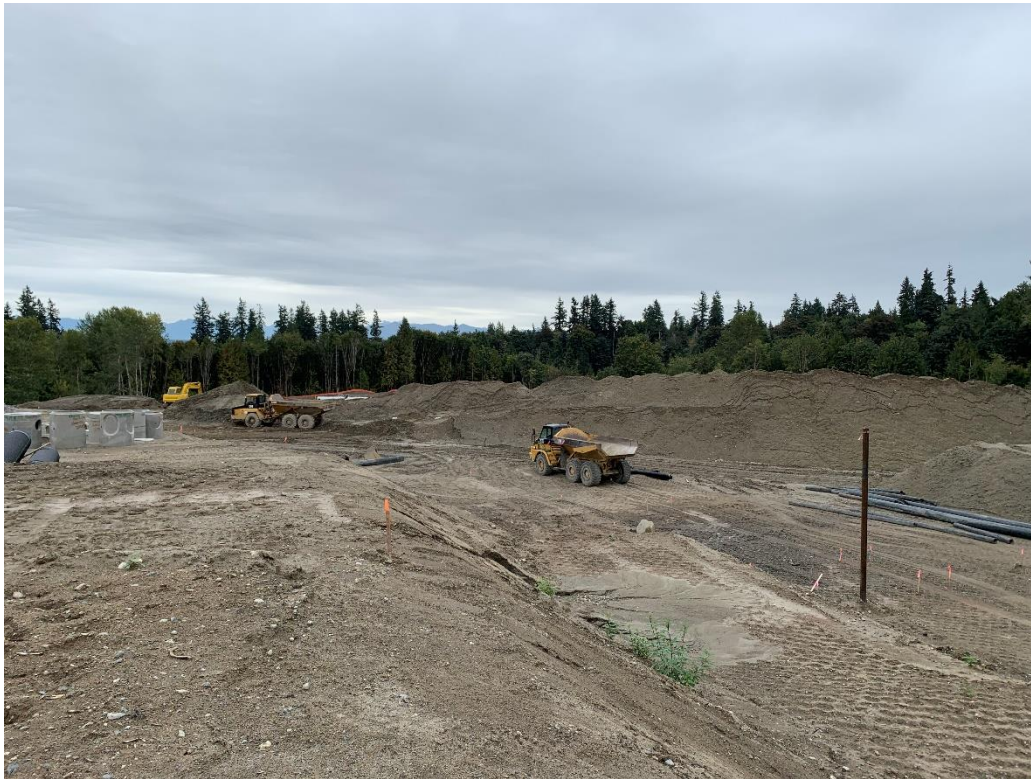
Photo 1: Standing near office/entrance looking southeast. Lined pond east of concrete pipe pieces in photo.

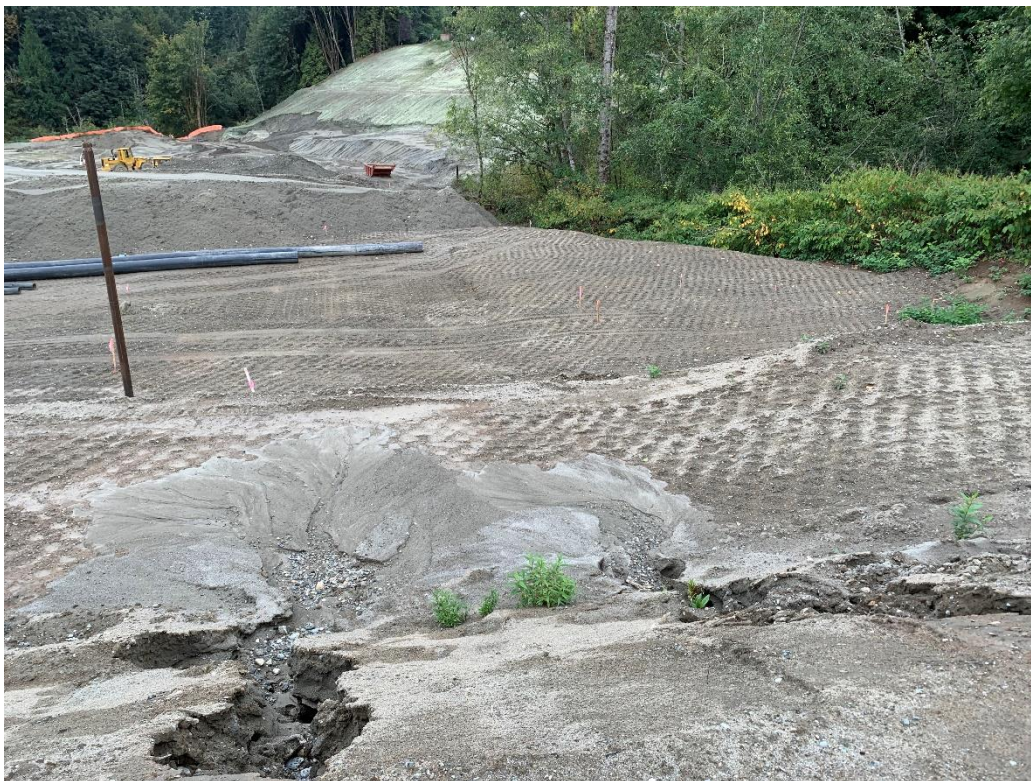
Photo 2: Standing near office looking south. Erosion along contours of regraded, exposed area. Vegetation line is delineating disturbance boundary/wetland

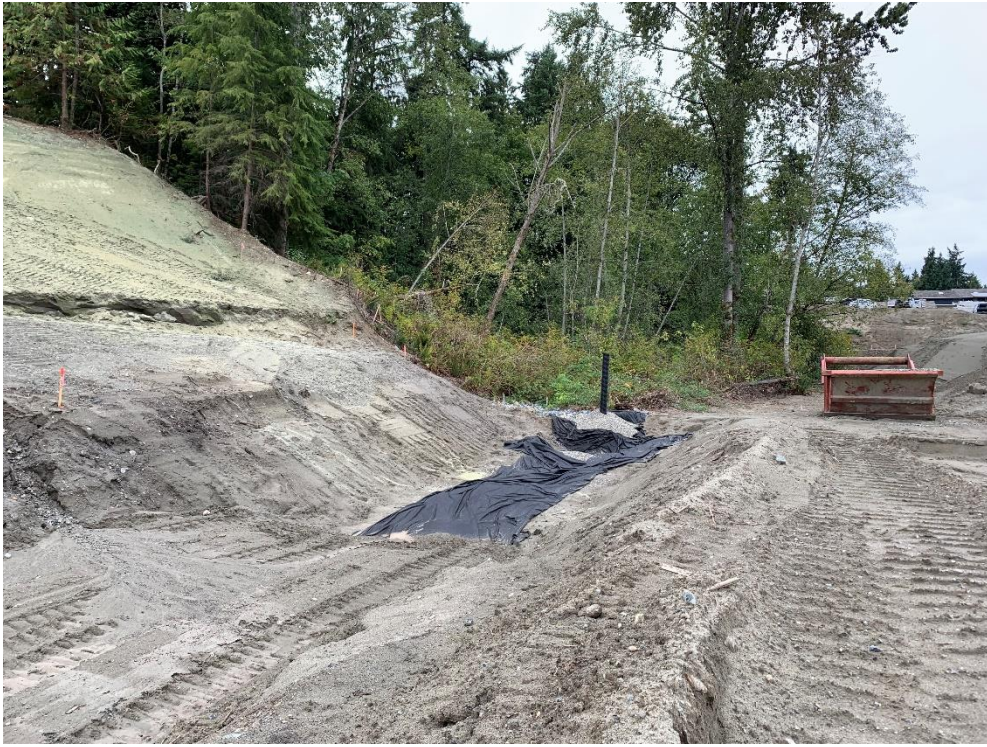
Photo 3: Photo taken looking north at realigned creek discharging from wetland and heading south to Ravine. Pictured is installed French drain (perforated pipe, geotextile, riser pipe) carrying realigned creek flows.

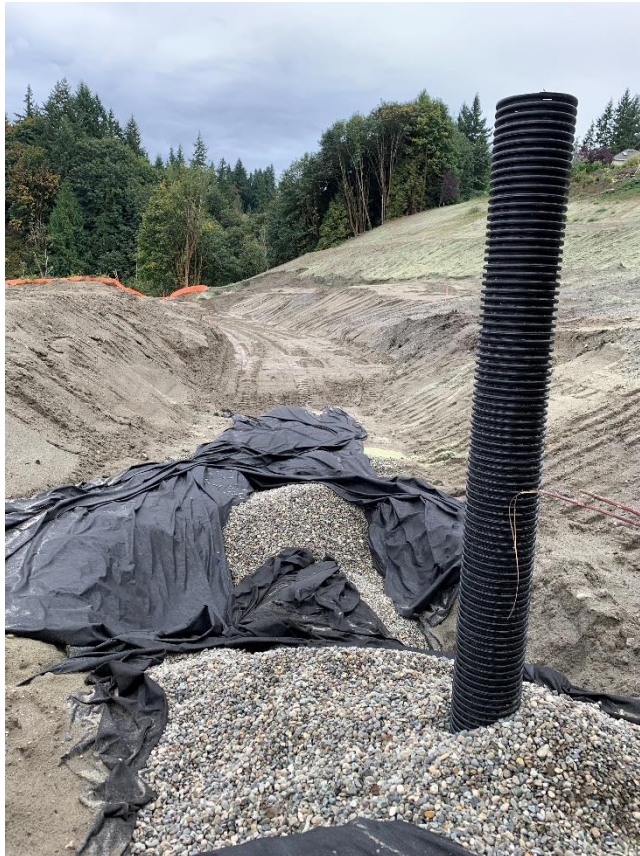
Photo 4: Realigned creek/installed French drain. Looking south towards ravine.

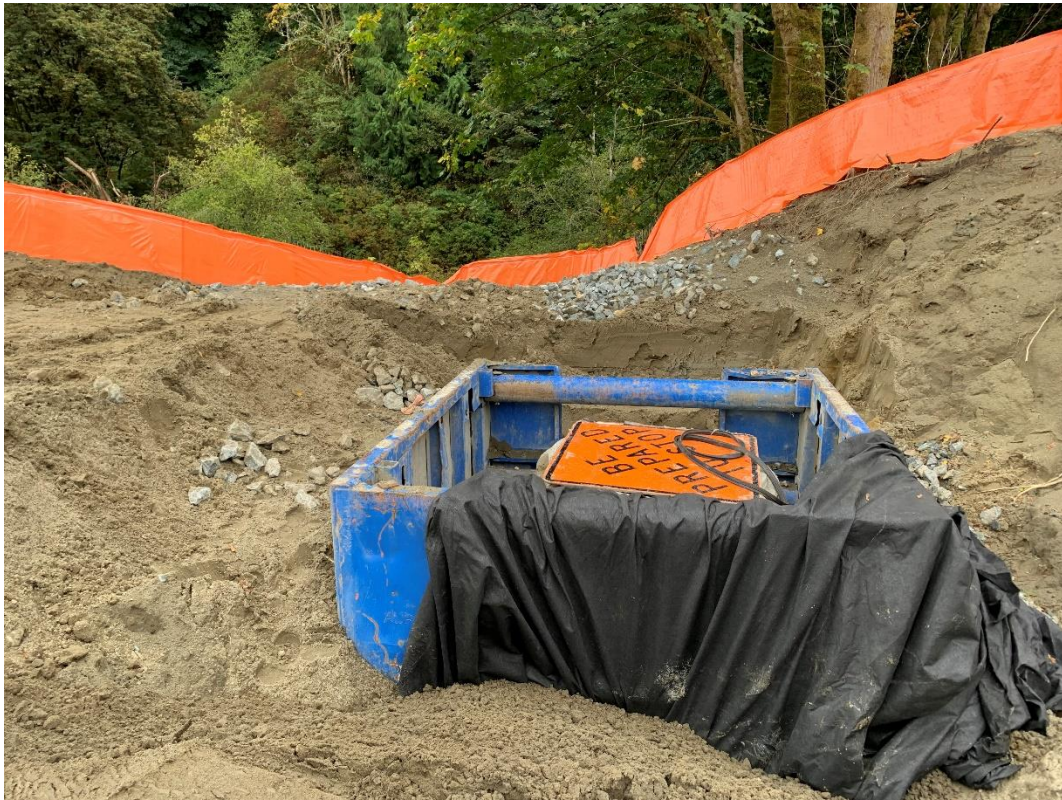
Photo 5: Installed catch basin where creek/French drain terminates and discharges to ravine.

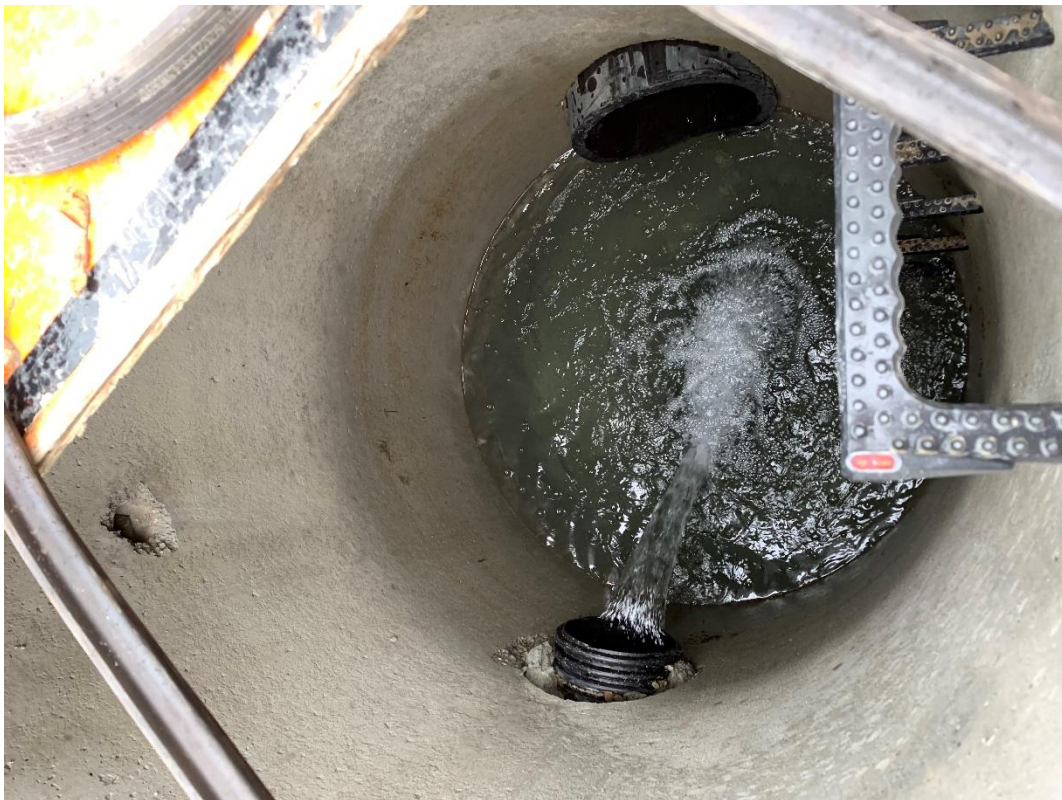
Photo 6: Stormwater flows exiting French drain to discharge to ravine.

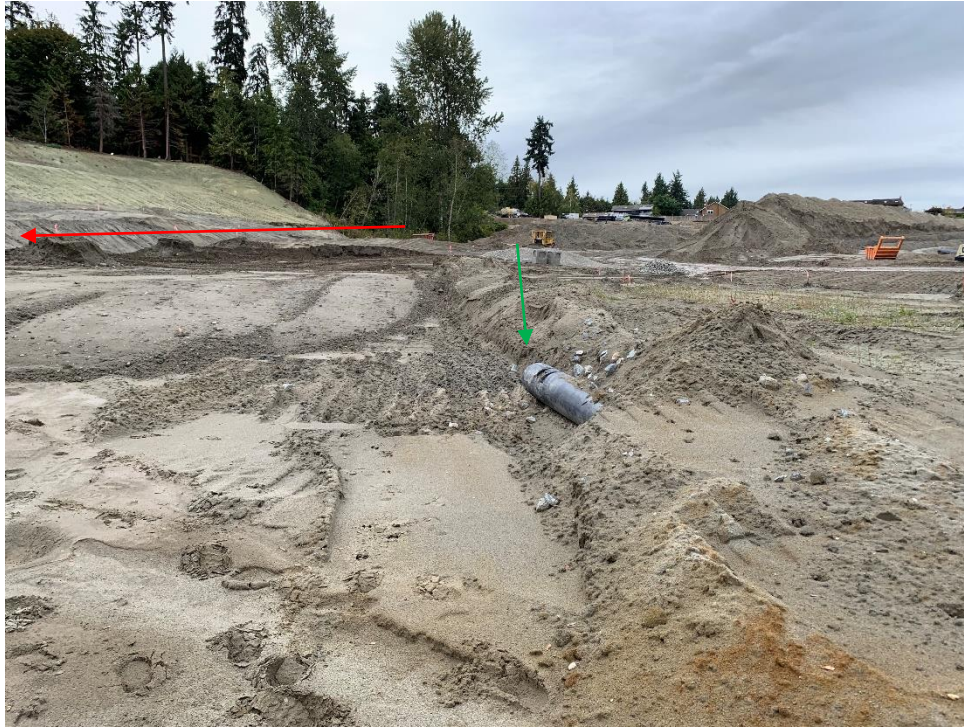
Photo 7: Looking north – diversion pipe shown in photo. Pipe was disconnected and was not flowing at time of inspection. Red arrow shows direction and area of French drain flow. Green arrow shows disconnected end of diversion pipe.

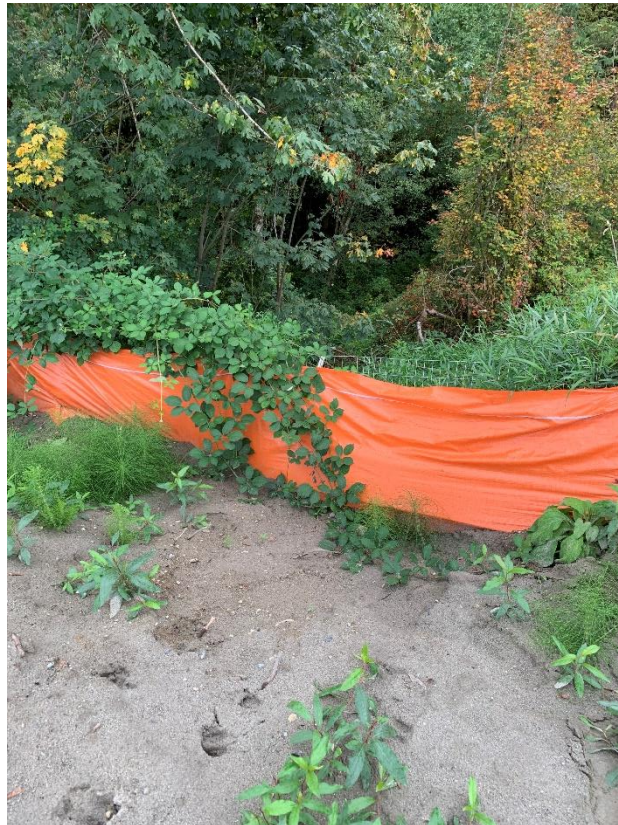
Photo 8: Disturbed material undercutting silt fence boarding ravine, south boundary of site disturbance near creek realignment. Photo looking south into Ravine.

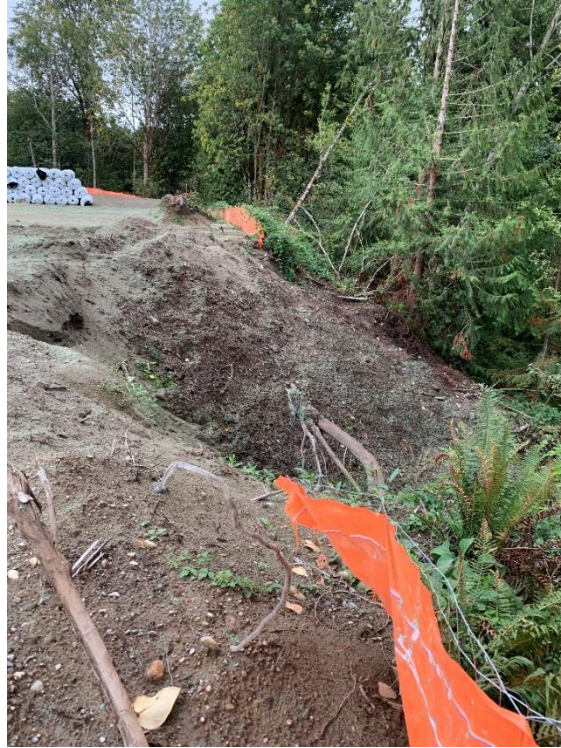
Photo 9: Silt fence removed along south boundary of disturbance near creek's previous alignment (east of - flowing south to ravine. Photo take looking east down southern boundary. No perimeter BMP to control sediment at top of slope.

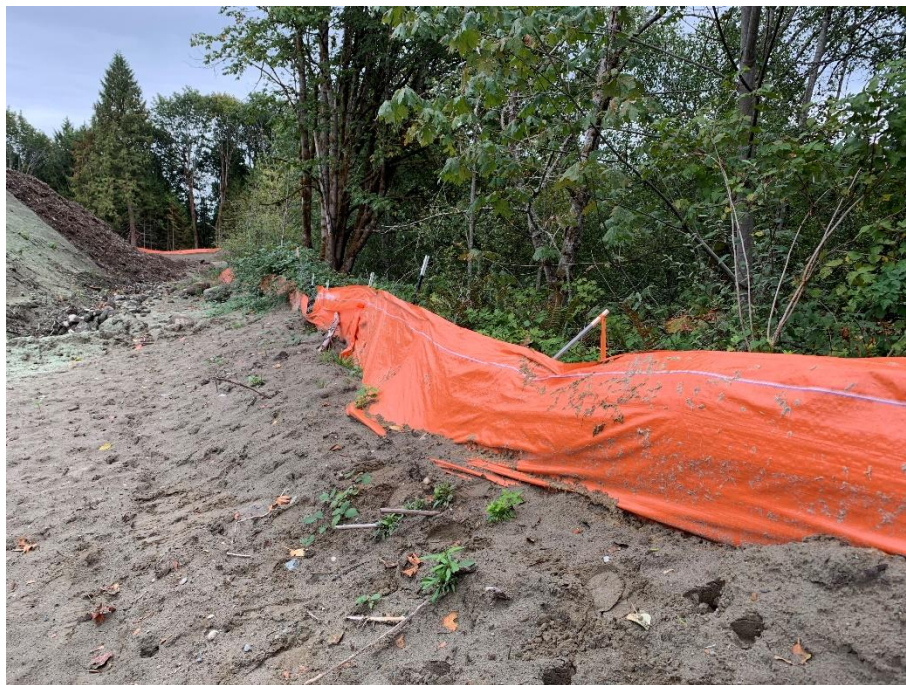
Photo 10: East of site portions of silt fence were damaged – not properly installed or falling over. Some areas had holes at the base where undercutting had occurred from sediment and stormwater discharges.

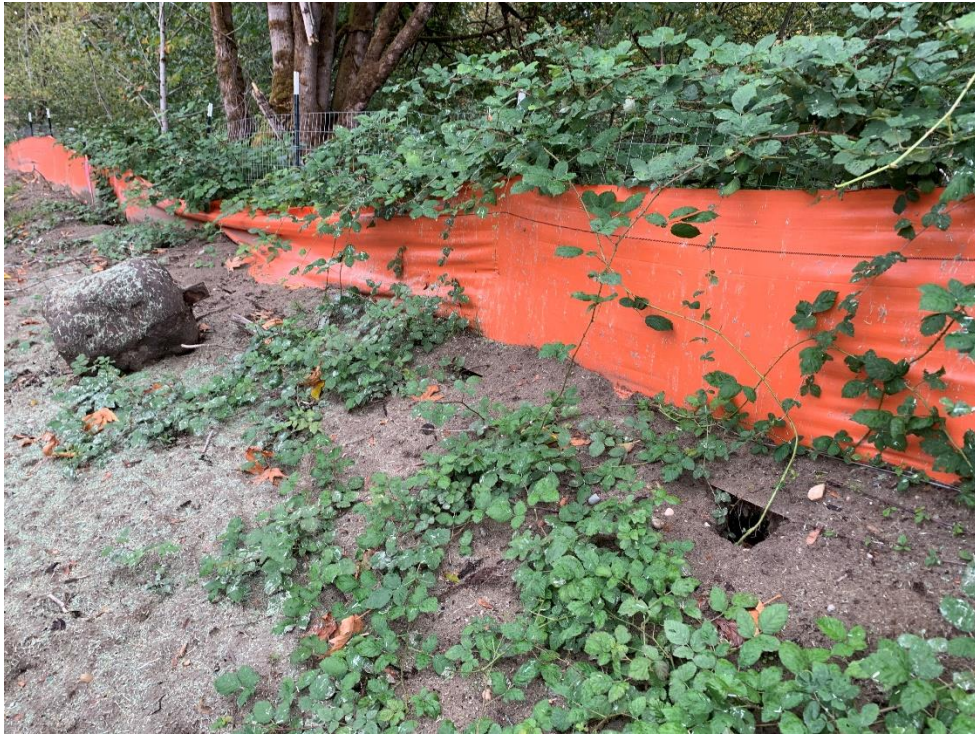
Photo 11: Portions of improperly installed silt fence at the east boundary of site near the stockpiles – undercutting of the silt fence from sediment and stormwater discharges.

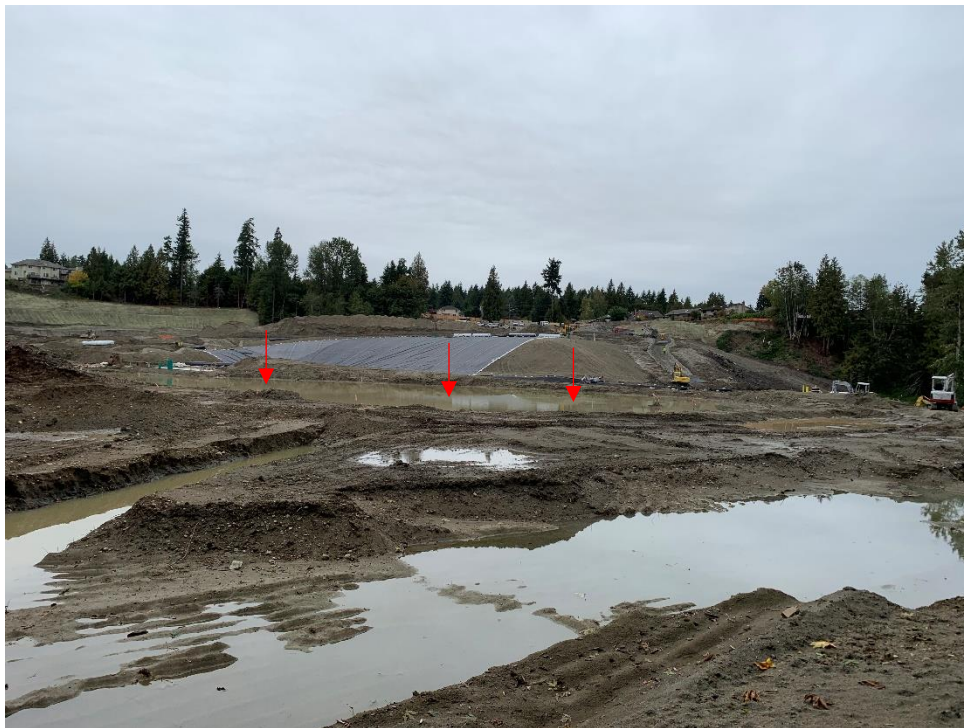
Photo 12: Looking north at temporary sediment pond holding water (red arrow). North slope of newly constructed lined pond just beyond temporary sediment pond. Additional excavated areas with standing water in foreground of photo.

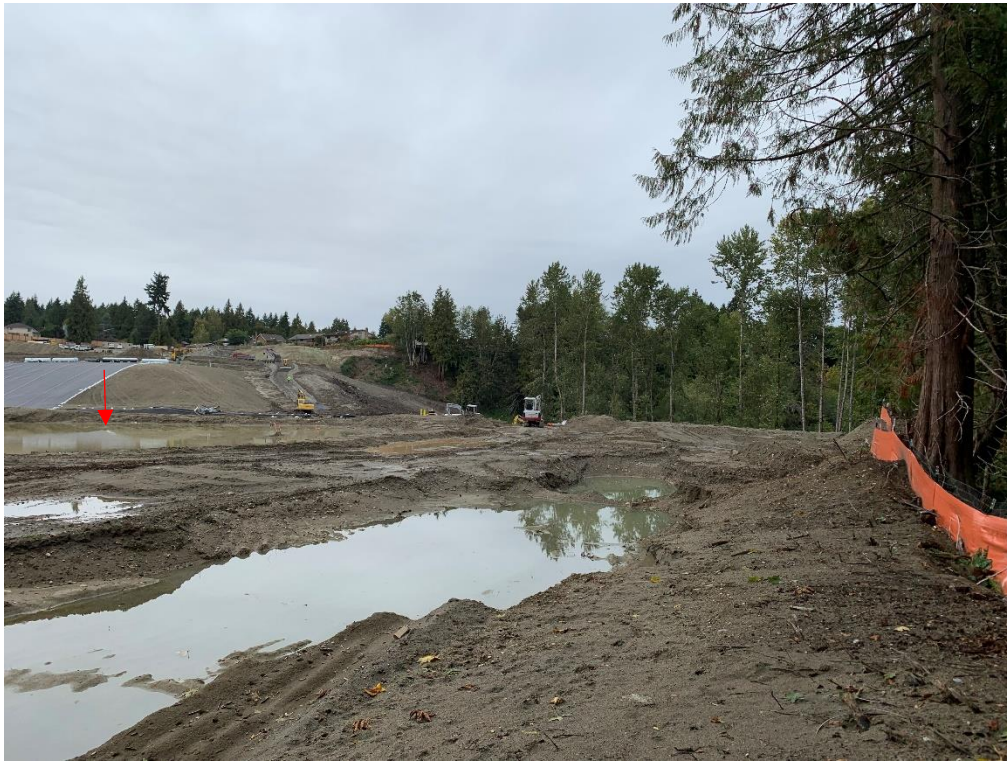
Photo 13: Additional excavations to hold stormwater and groundwater seepage along east project boundary. Temporary sediment pond holding water (red arrow) observed at time of inspection.

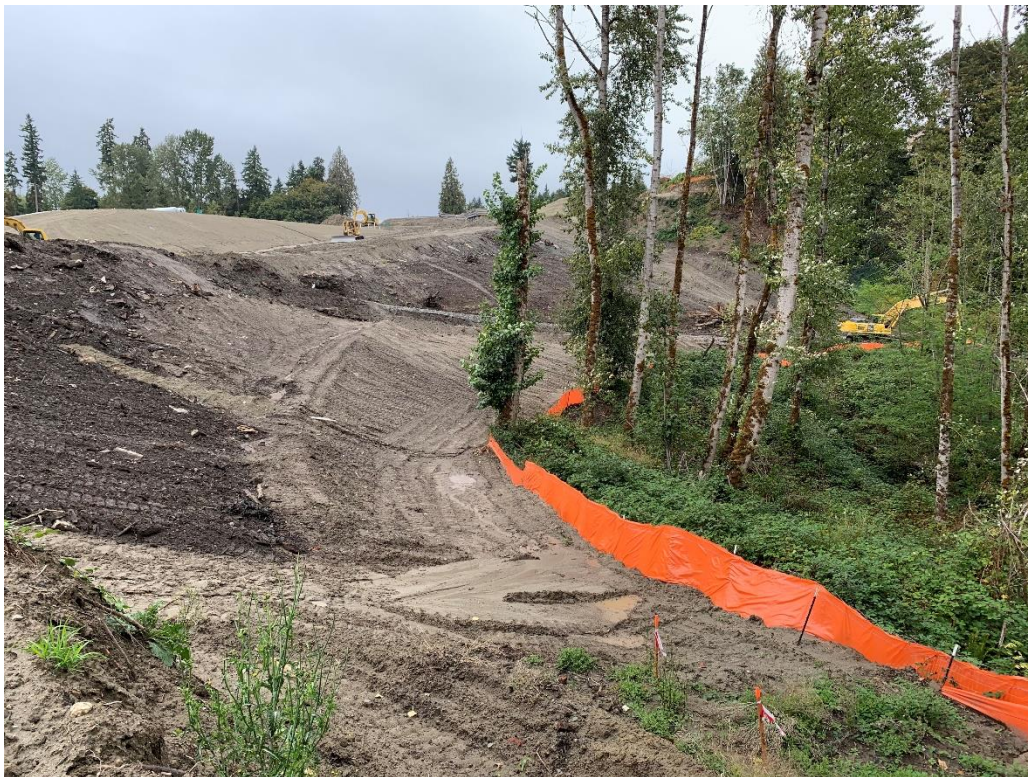
Photo 14: East project boundary, photo taken looking north towards northeast corner of project. Dark material in photo is exposed landfill material, per conversations with Clay Grace at time of inspection.

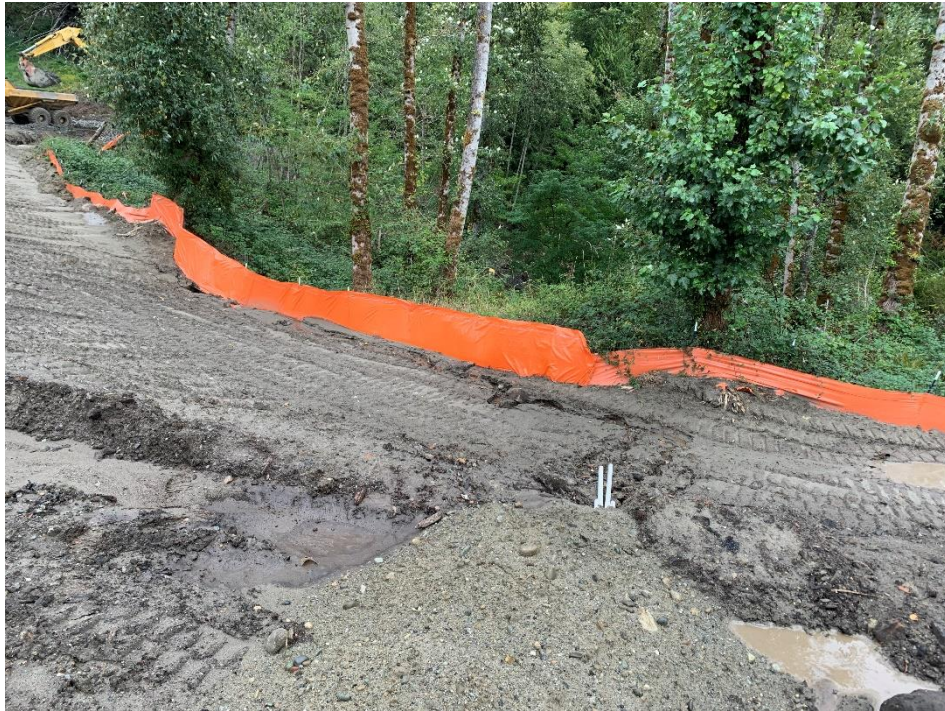
Photo 15: Looking east at project boundary. One-inch PVC pipes from leak detection system of lined pond discharging, undercutting silt fence, and discharging down ravine. Rill erosion may be exposing landfill material and contaminating the stormwater discharging from the PVC pipes. This was corrected at the time of inspection – additional PVC pipe was added which extended over the silt fence and discharged into the vegetation, bypassing contact with landfill material.

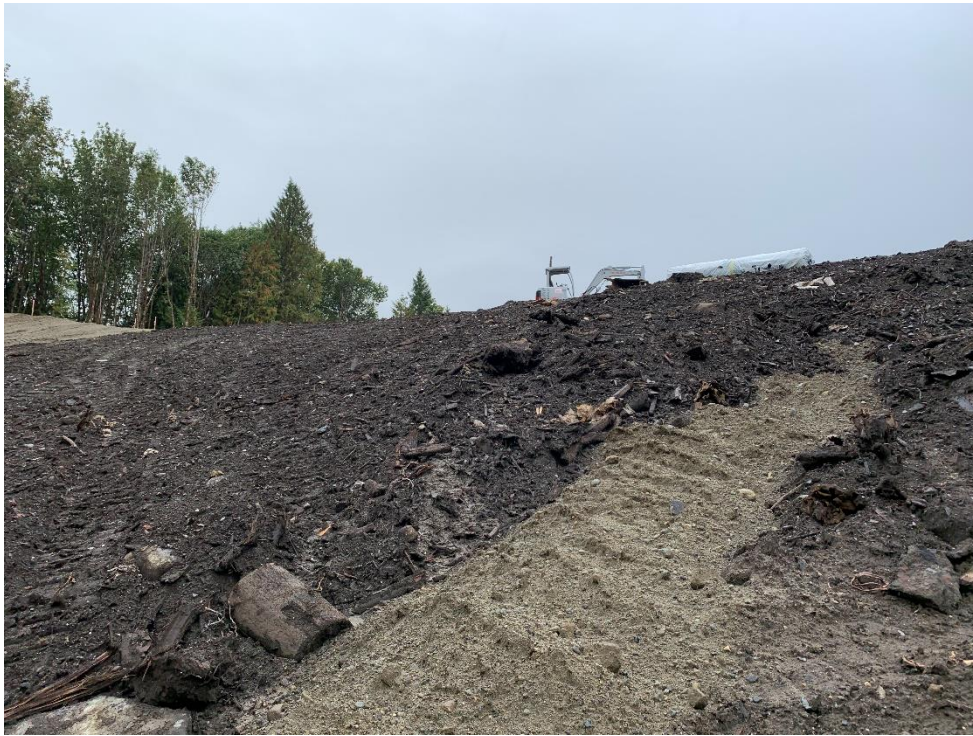
Photo 16: Exposed landfill material on northeast project boundary. Photo looking southwest.

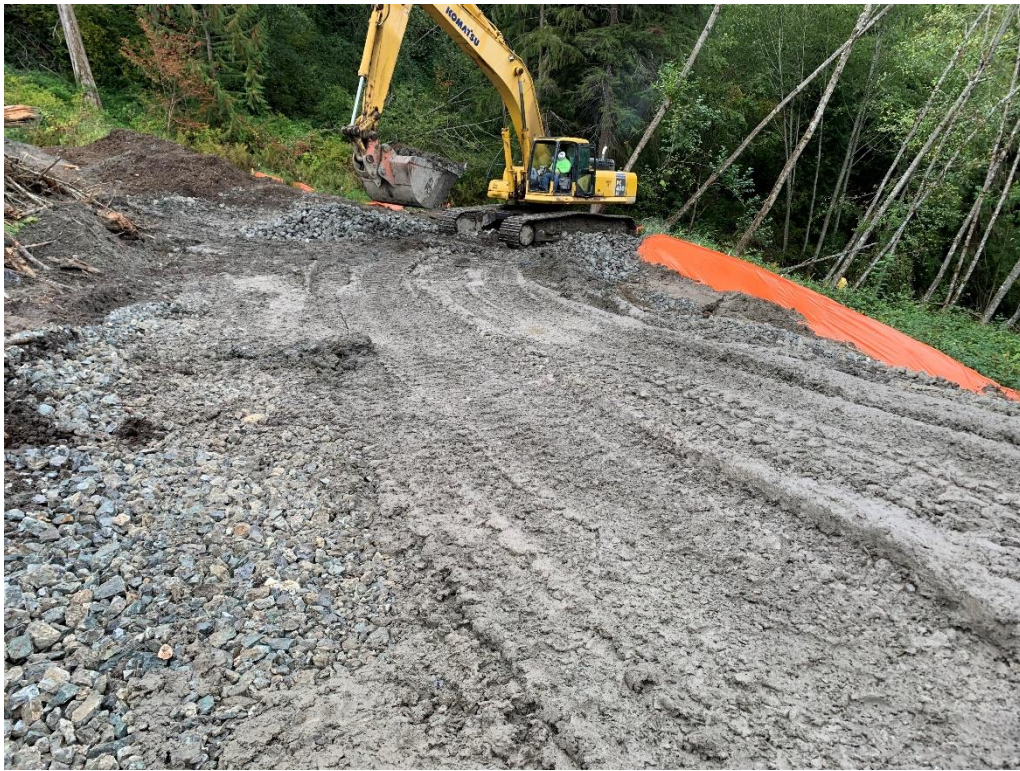
Photo 17: Photo taken at northeast corner of site at beginning of mudslide. Photo looking east down ravine towards landslide.

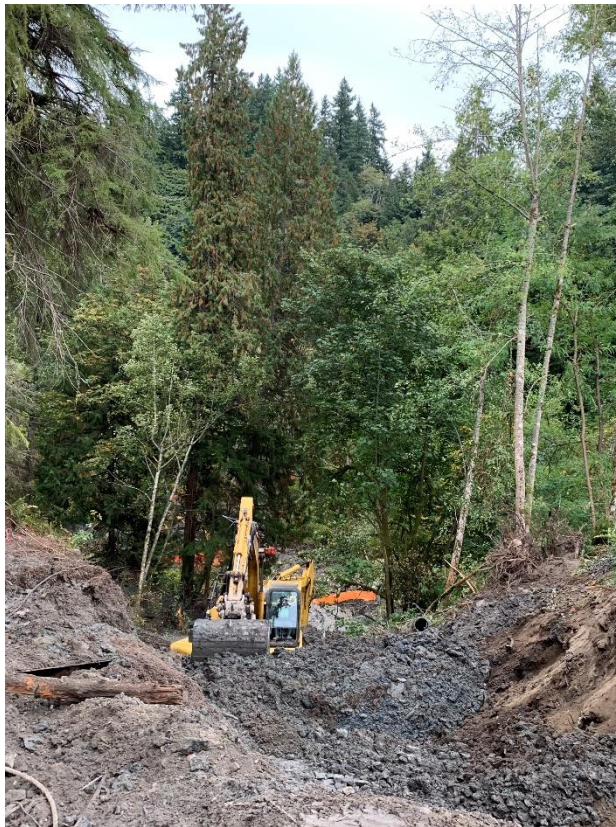
Photo 18: Looking east down ravine at active mudslide area. Silt fence in background are sections installed over mudflow.

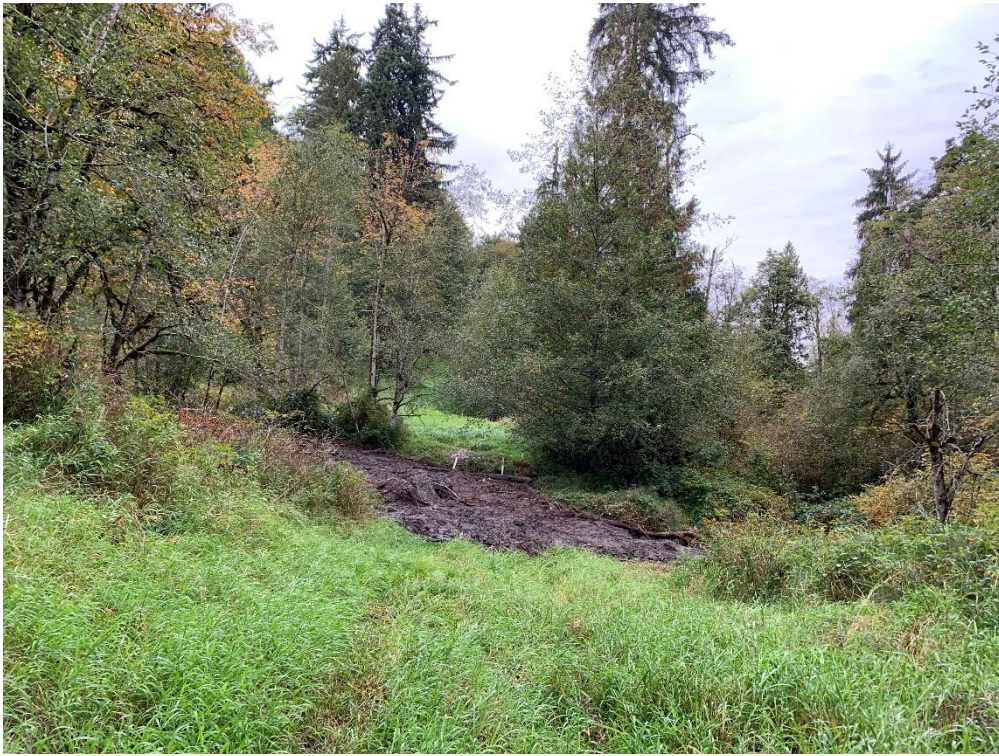
Photo 19: Looking north, approaching the slide material from the Olympic Pipeline Easement.

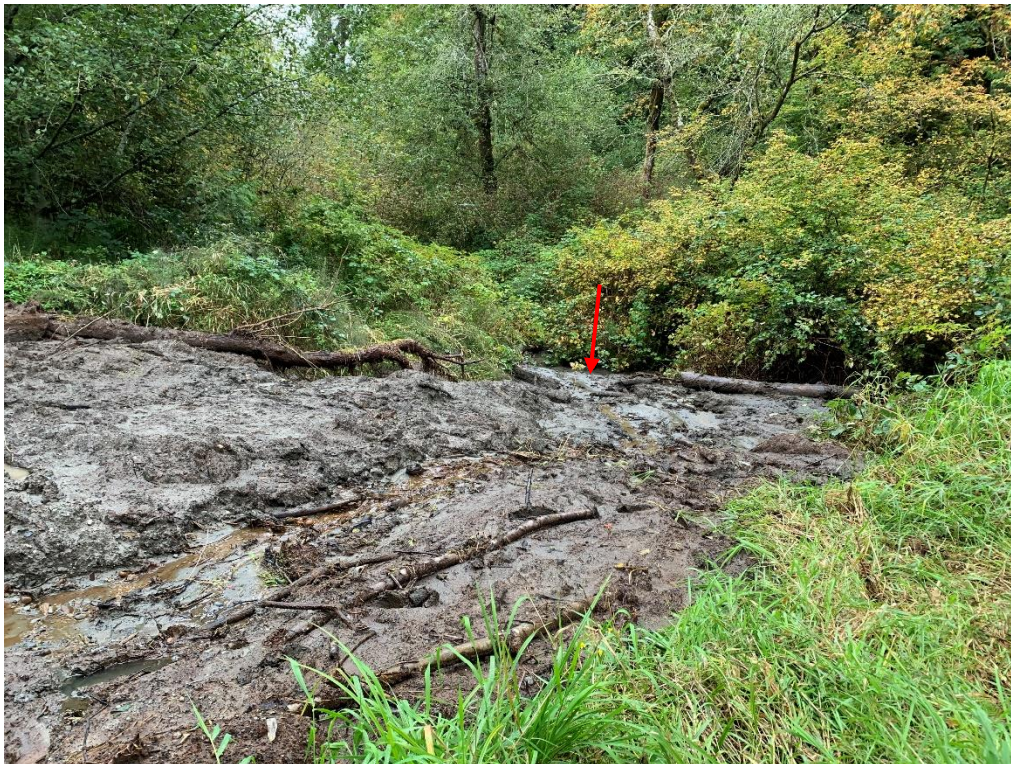
Photo 20: End of mudflow where material meets the creek flows (red arrow). Looking northeast. Note surface water flowing through mudslide material.

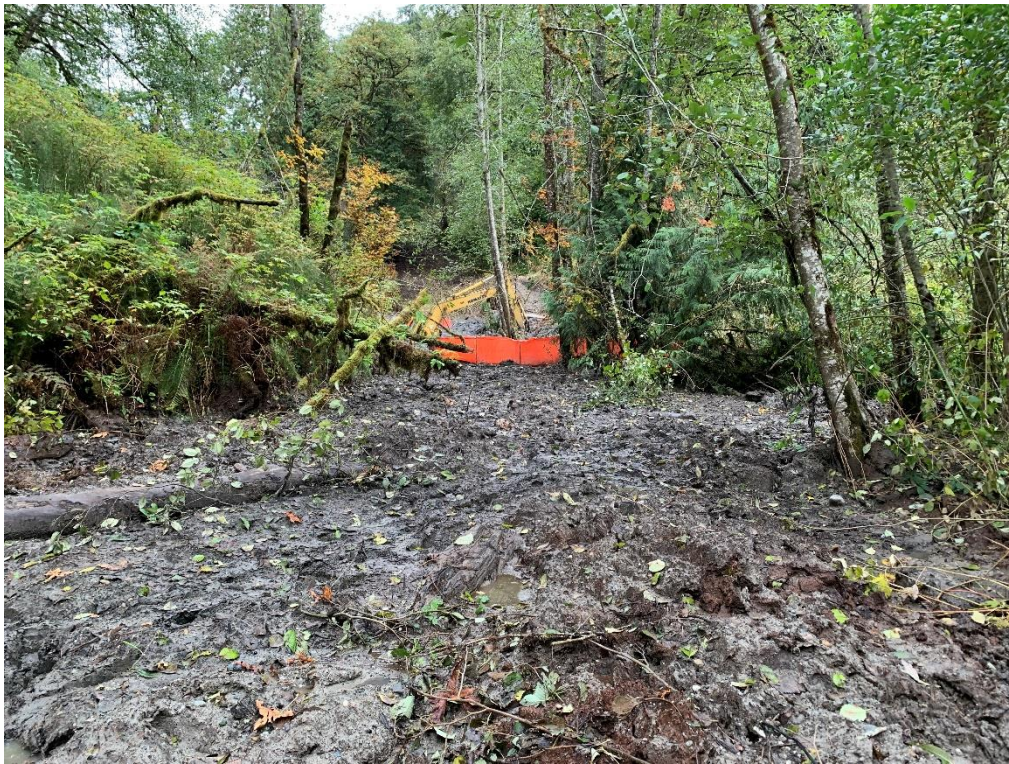
Photo 21: Looking west up towards origin of mudslide. Machinery beyond silt fence is partially buried in slide material.

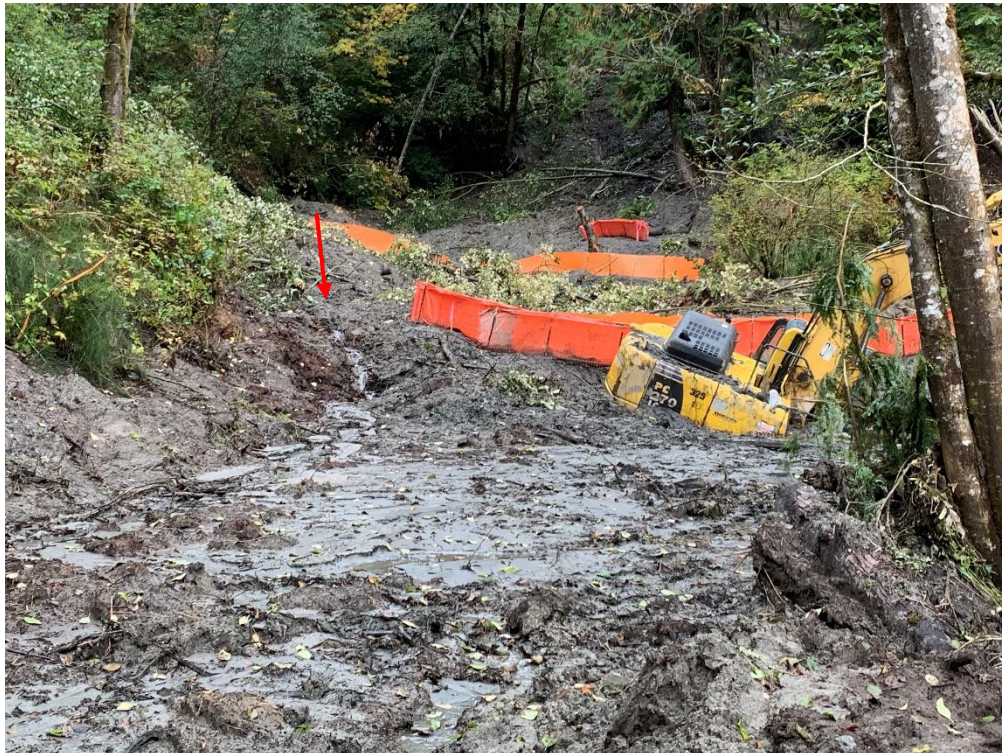
Photo 22: Photo taken looking west towards mudslide. Stormwater/groundwater seepage flows (red arrow) with some pooling water. Water is flowing east towards wetland and creek.

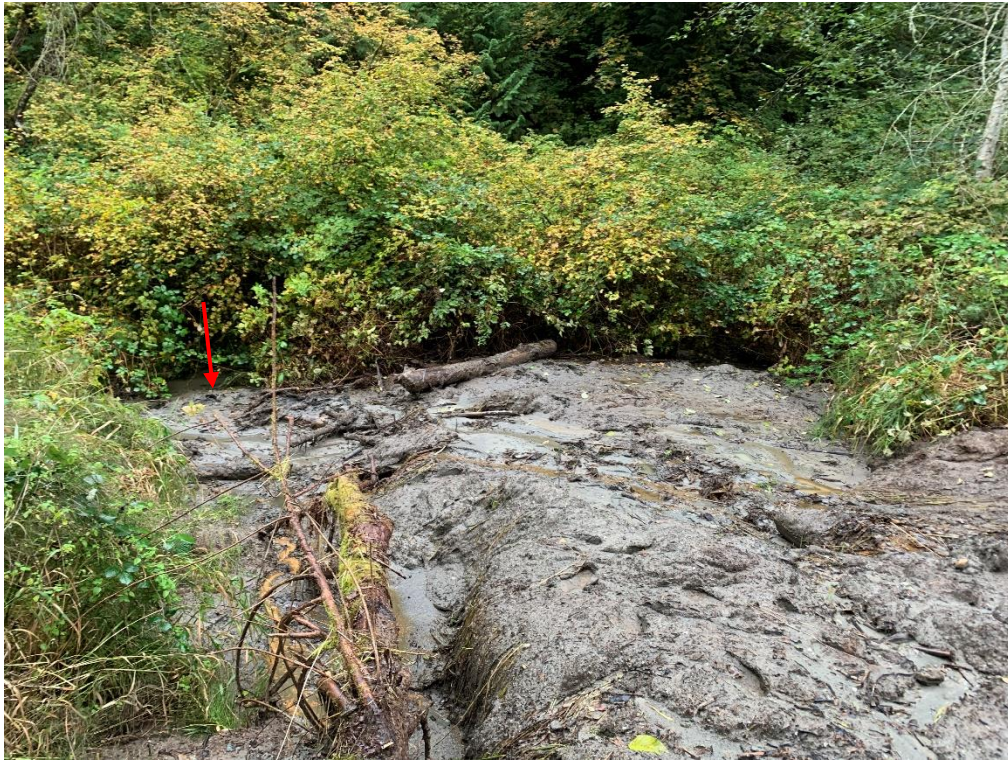
Photo 23: Approximate location of sample point 2 at time of inspection (red arrow) – mouth of mudslide where materials meet creek flow. Sample was 17.5 NTU.

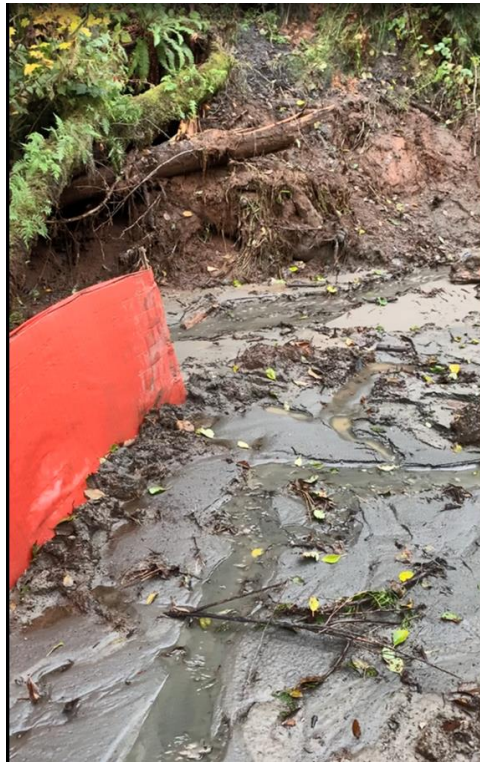
Photo 24: Approximate location of sample point 3. Looking south towards south edge of slide material, at 3rd row of silt fence (nearest creek). Sample was 285 NTU

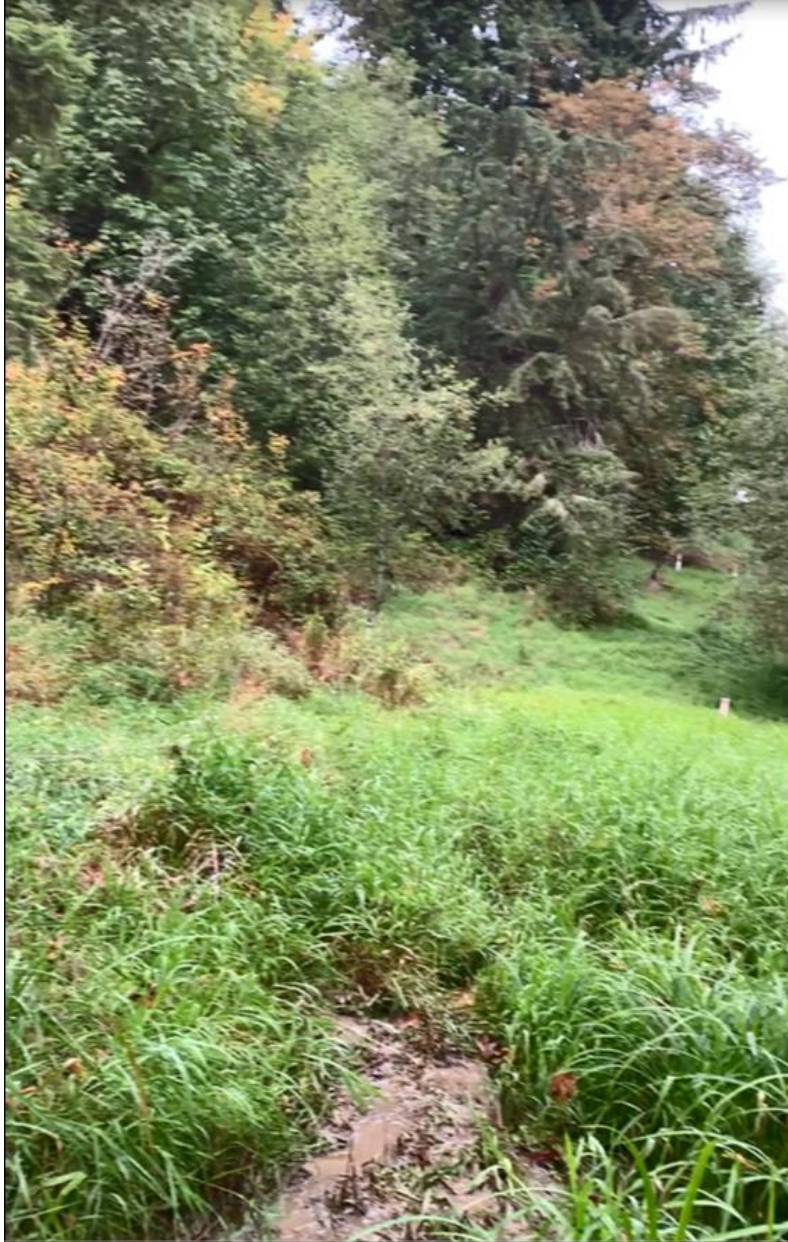
Photo 25: Approximate location of sample point 1 at time of inspection. Looking Northeast towards pipeline alignment and creek buffer. Note turbid flows at bottom of photo discharging northeast through wetland. Sample was 471 NTU.
