DEPARTMENT OF ECOLOGY State of Washington	<h2 style="text-align: center;">CONSTRUCTION STORMWATER GENERAL PERMIT</h2> <h3 style="text-align: center;">INSPECTION REPORT</h3> <p style="text-align: center;">State of Washington Department of Ecology</p>		
Section A: General Data			
Ecology Inspector(s): Elizabeth Fint	On-Site Representative Name: Jay Pullen Title: CESCL Phone: 425-351-0306 Email:	Inspection Date and Entry/Exit Time: October 18, 2021, 10:45/12:30 Receiving waters: Creek and wetland tributary to Snohomish River	Inspection Type: Unannounced Permit webpage: https://fortress.wa.gov/ecy/paris/FacilitySummary.aspx?FacilityId=60941
Section B: Background			
<p>The Bakerview Everett project is covered under the State of Washington's Construction Stormwater General Permit (CSGP). The CSGP is a National Pollutant Discharge Elimination System (NPDES) and a State Waste Discharge permit for discharge of construction-related stormwater.</p> <p>The project is also covered under Administrative Order 18193, which requires additional sampling of stormwater for contaminants that remain on site from past land use activities (landfill). The purpose of this inspection is to conduct a follow-u

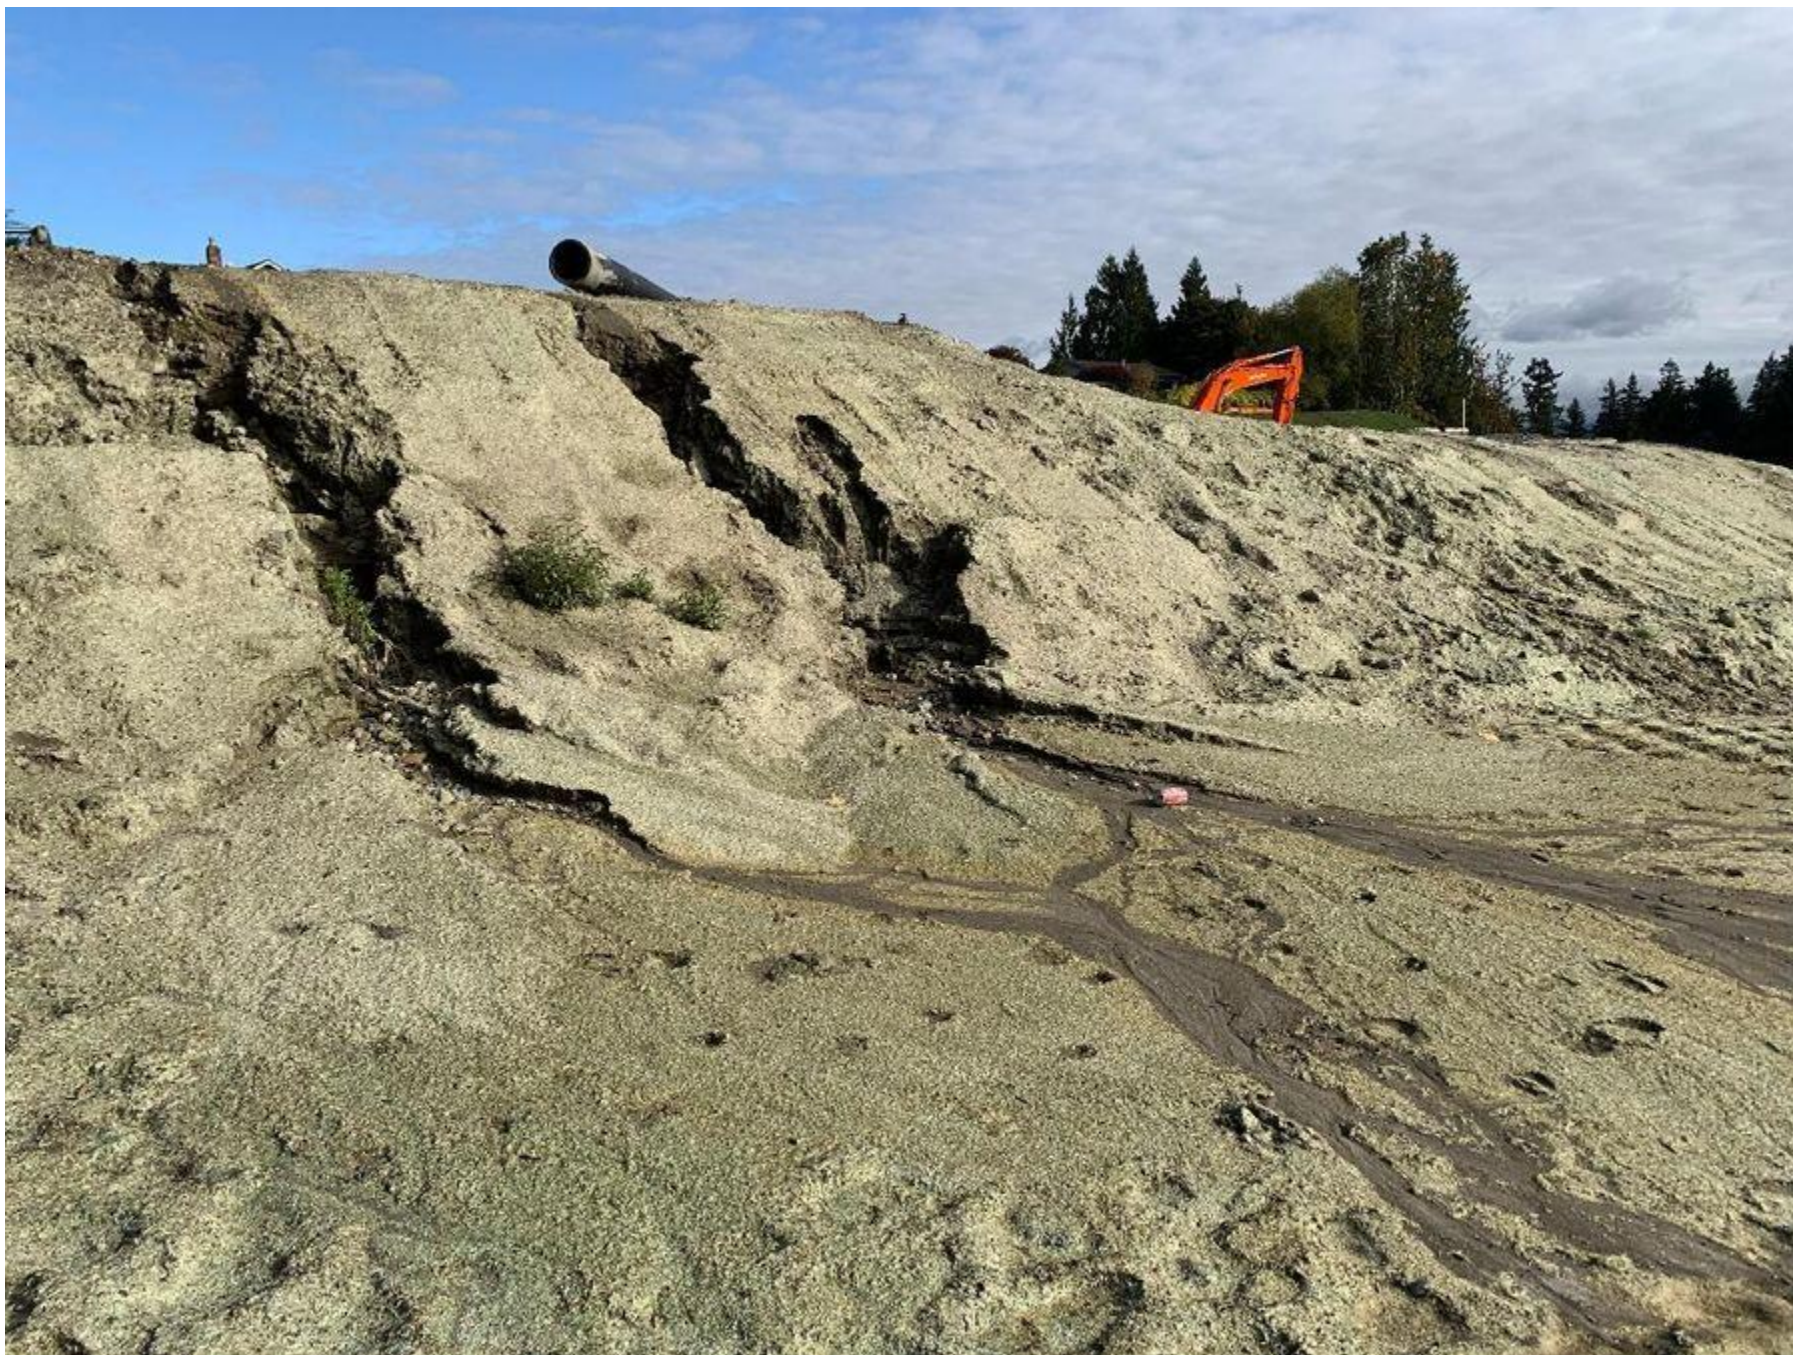
Photo 1

Photo Description: Rill erosion in slopes near entrance of site. Observed at previous inspection

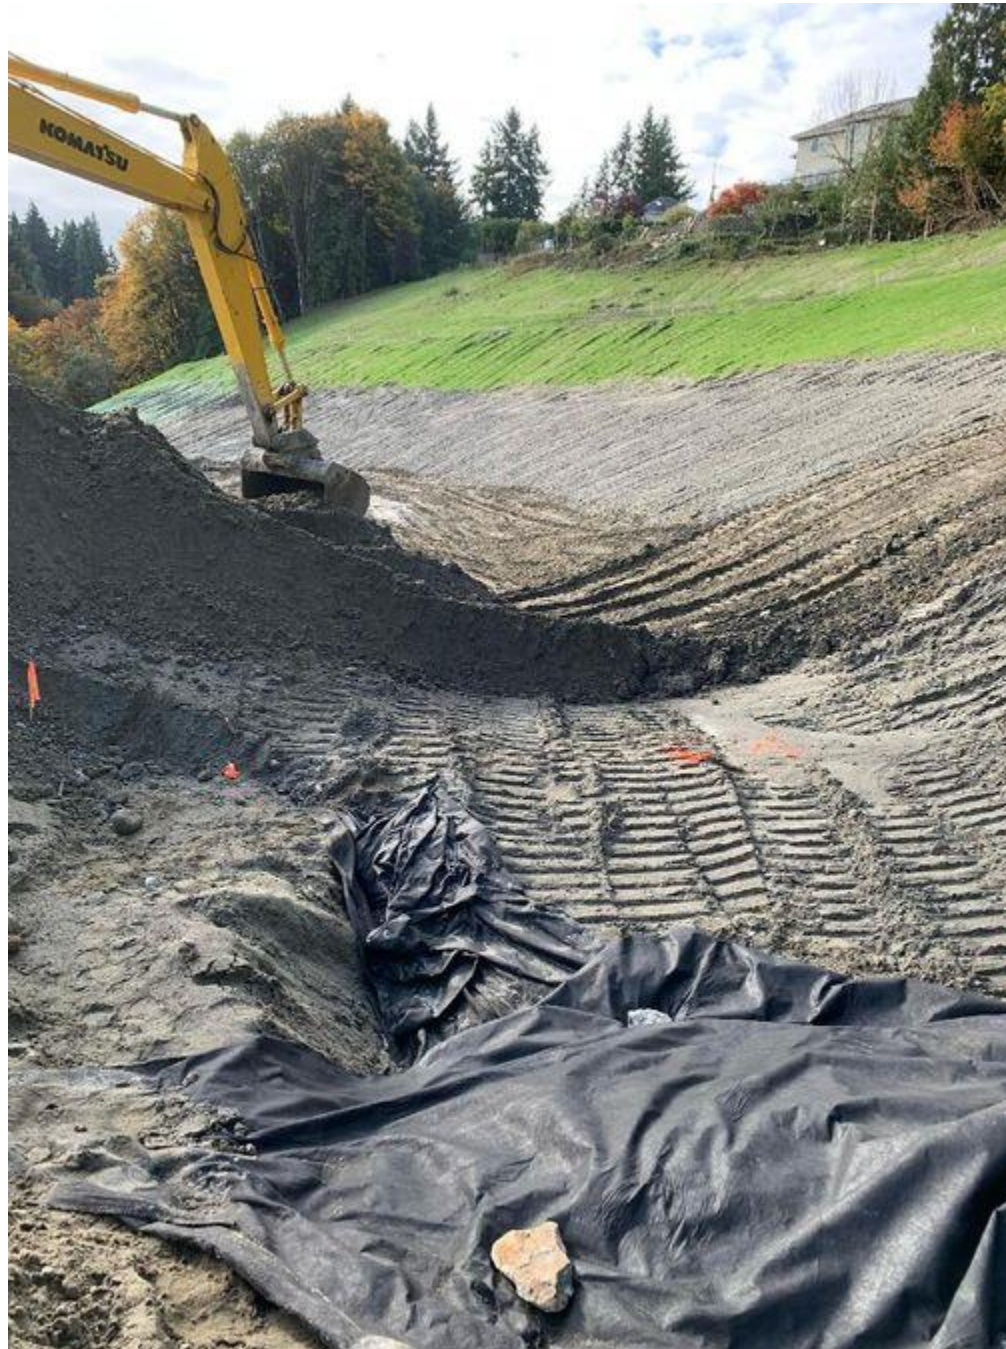
Photo 2

Photo Description: Grading stream channel at toe of west barrow slope. Deadline for stream channel completion is end of October

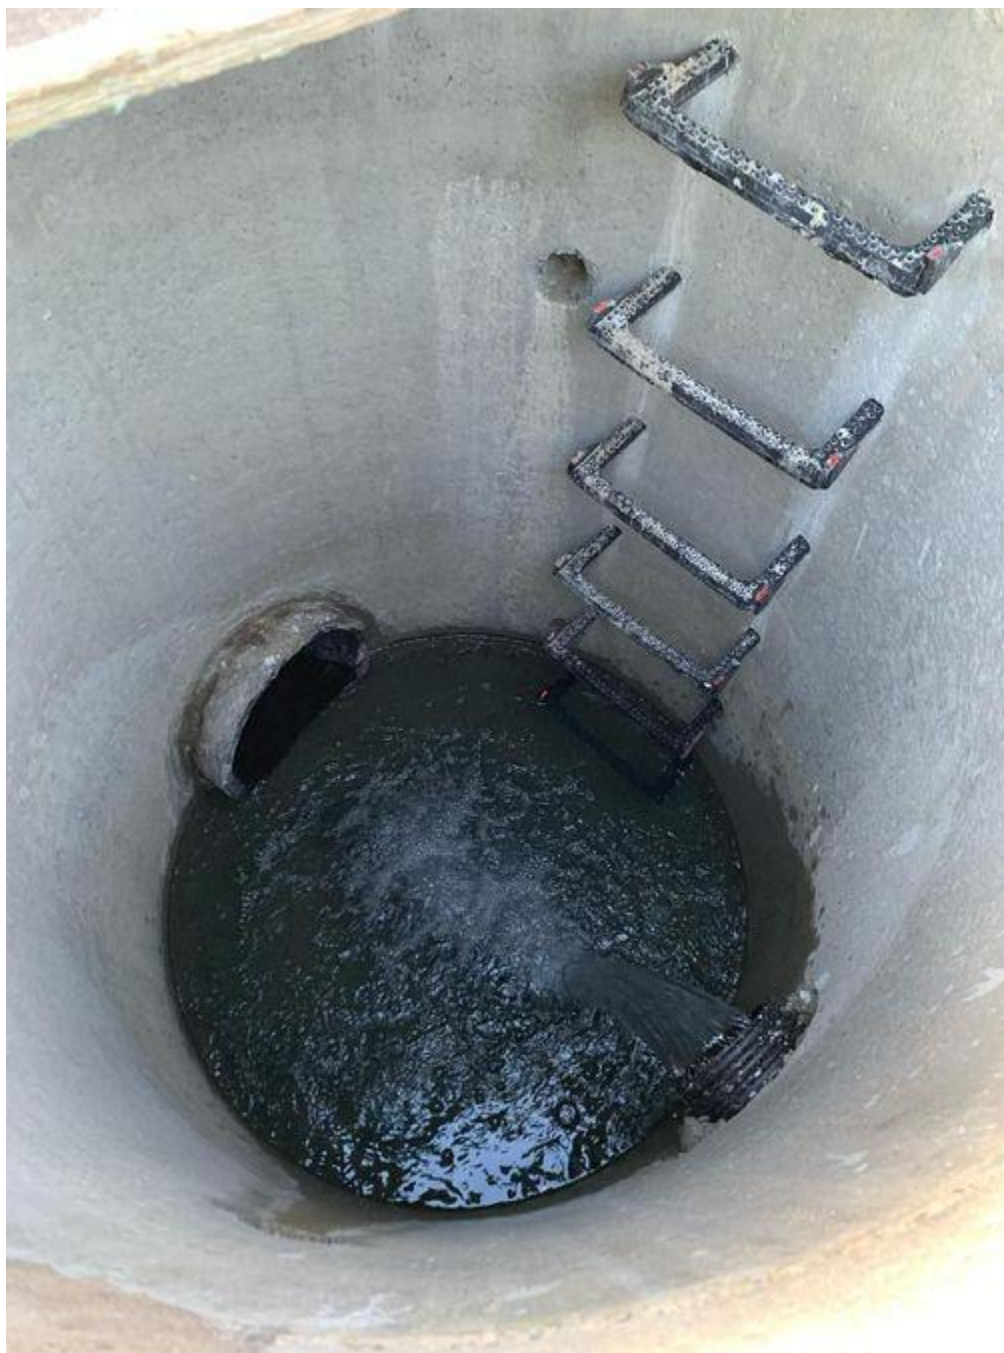
Photo 3

Photo Description: Water appears clear discharging from french drain at time of inspection

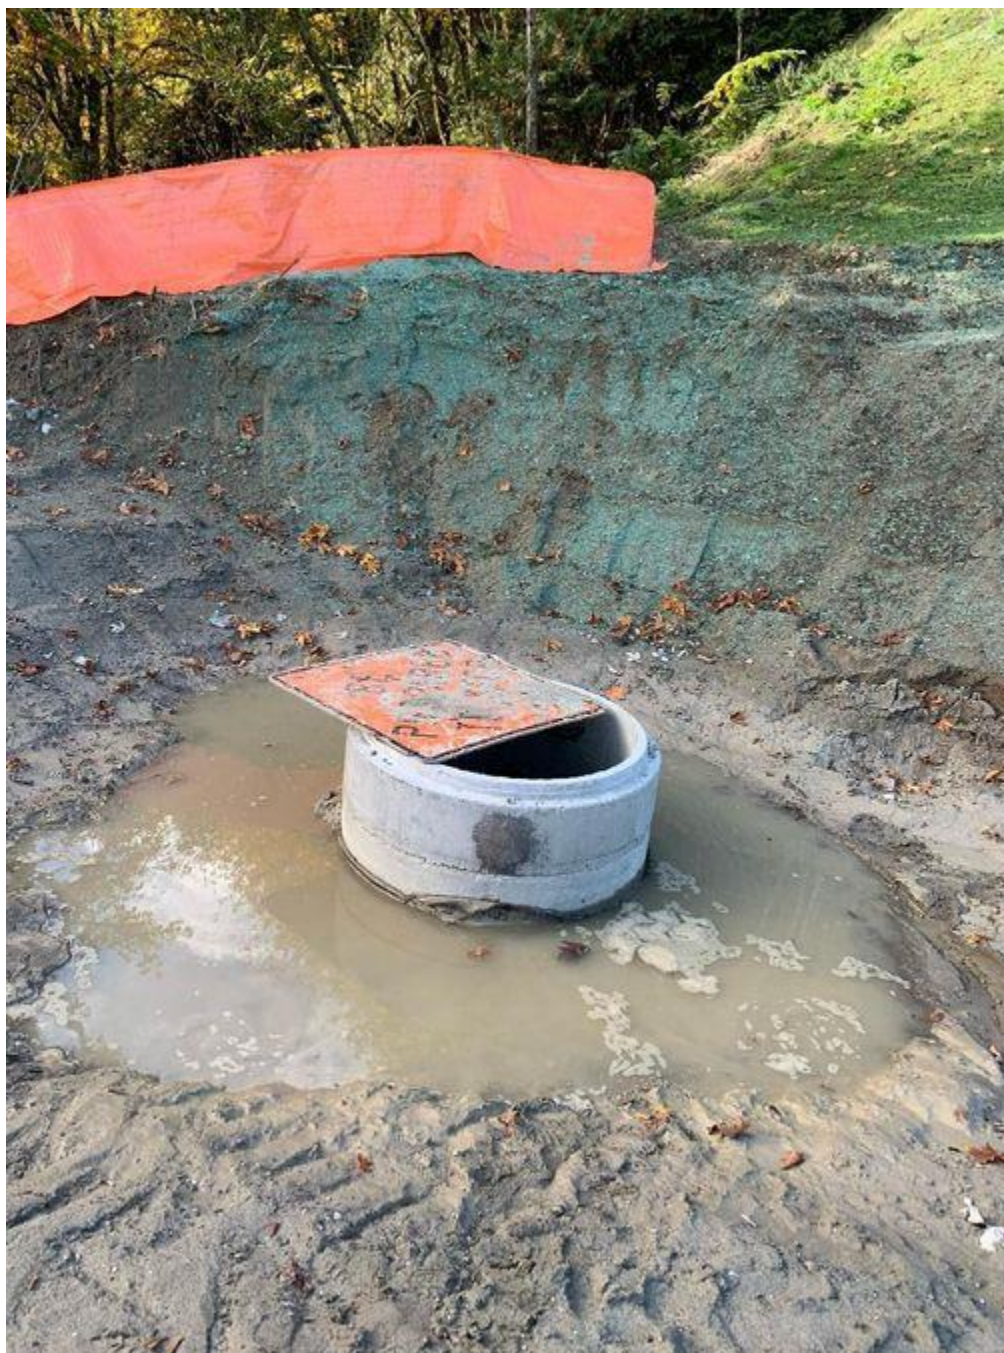
Photo 4

Photo Description: The site will pump any standing stormwater near French drain catch basin to baker tank

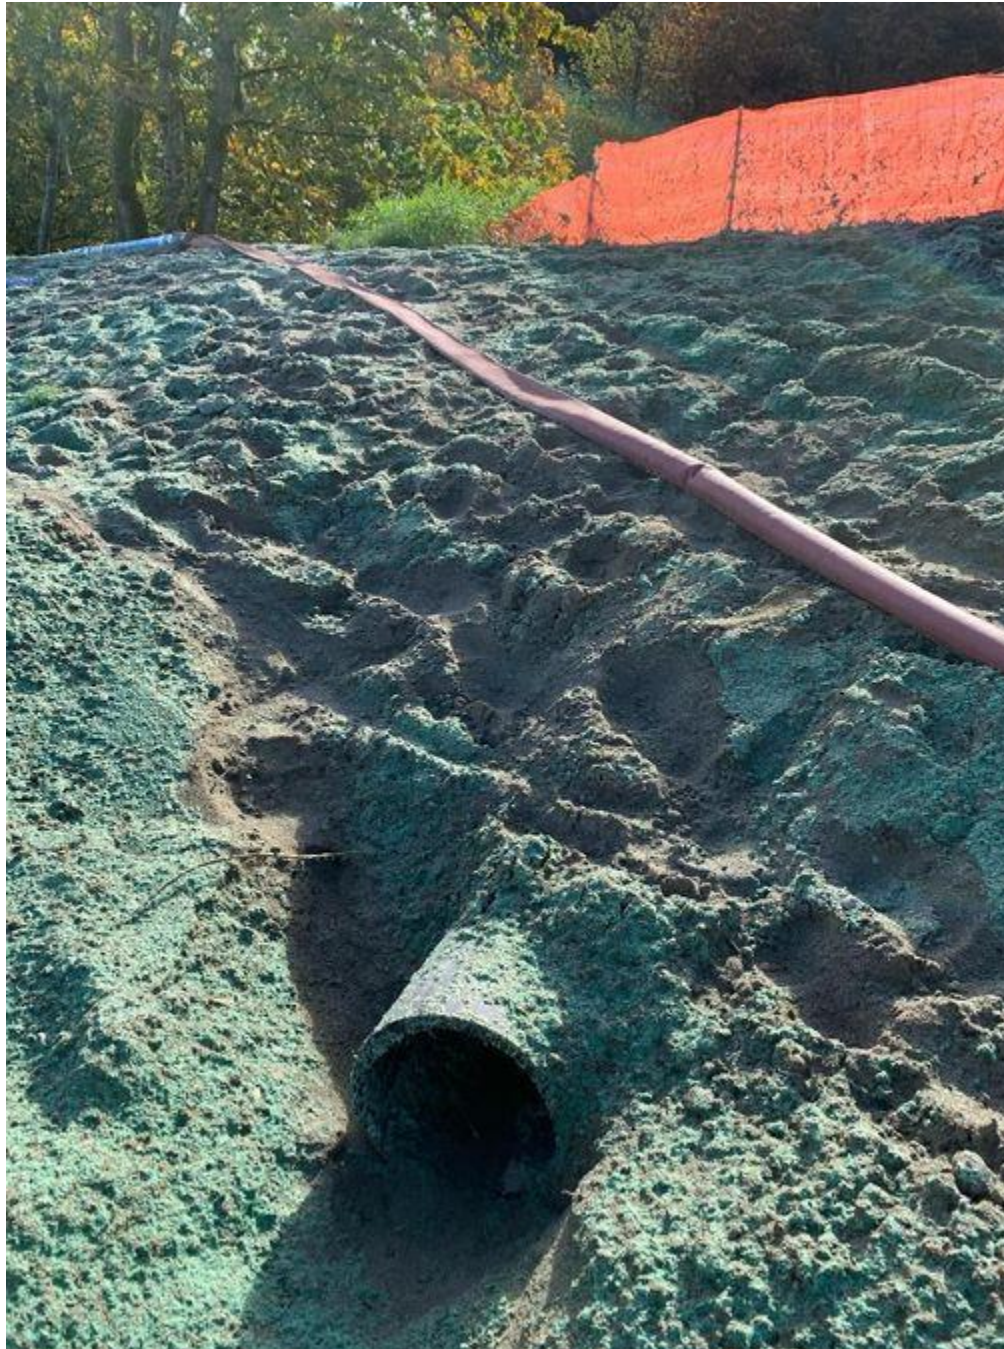
Photo 5

Photo Description: Disconnected diversion pipe - can carry any stormwater accumulating in this area off site. Remove pipe or sample off site discharges per permit conditions

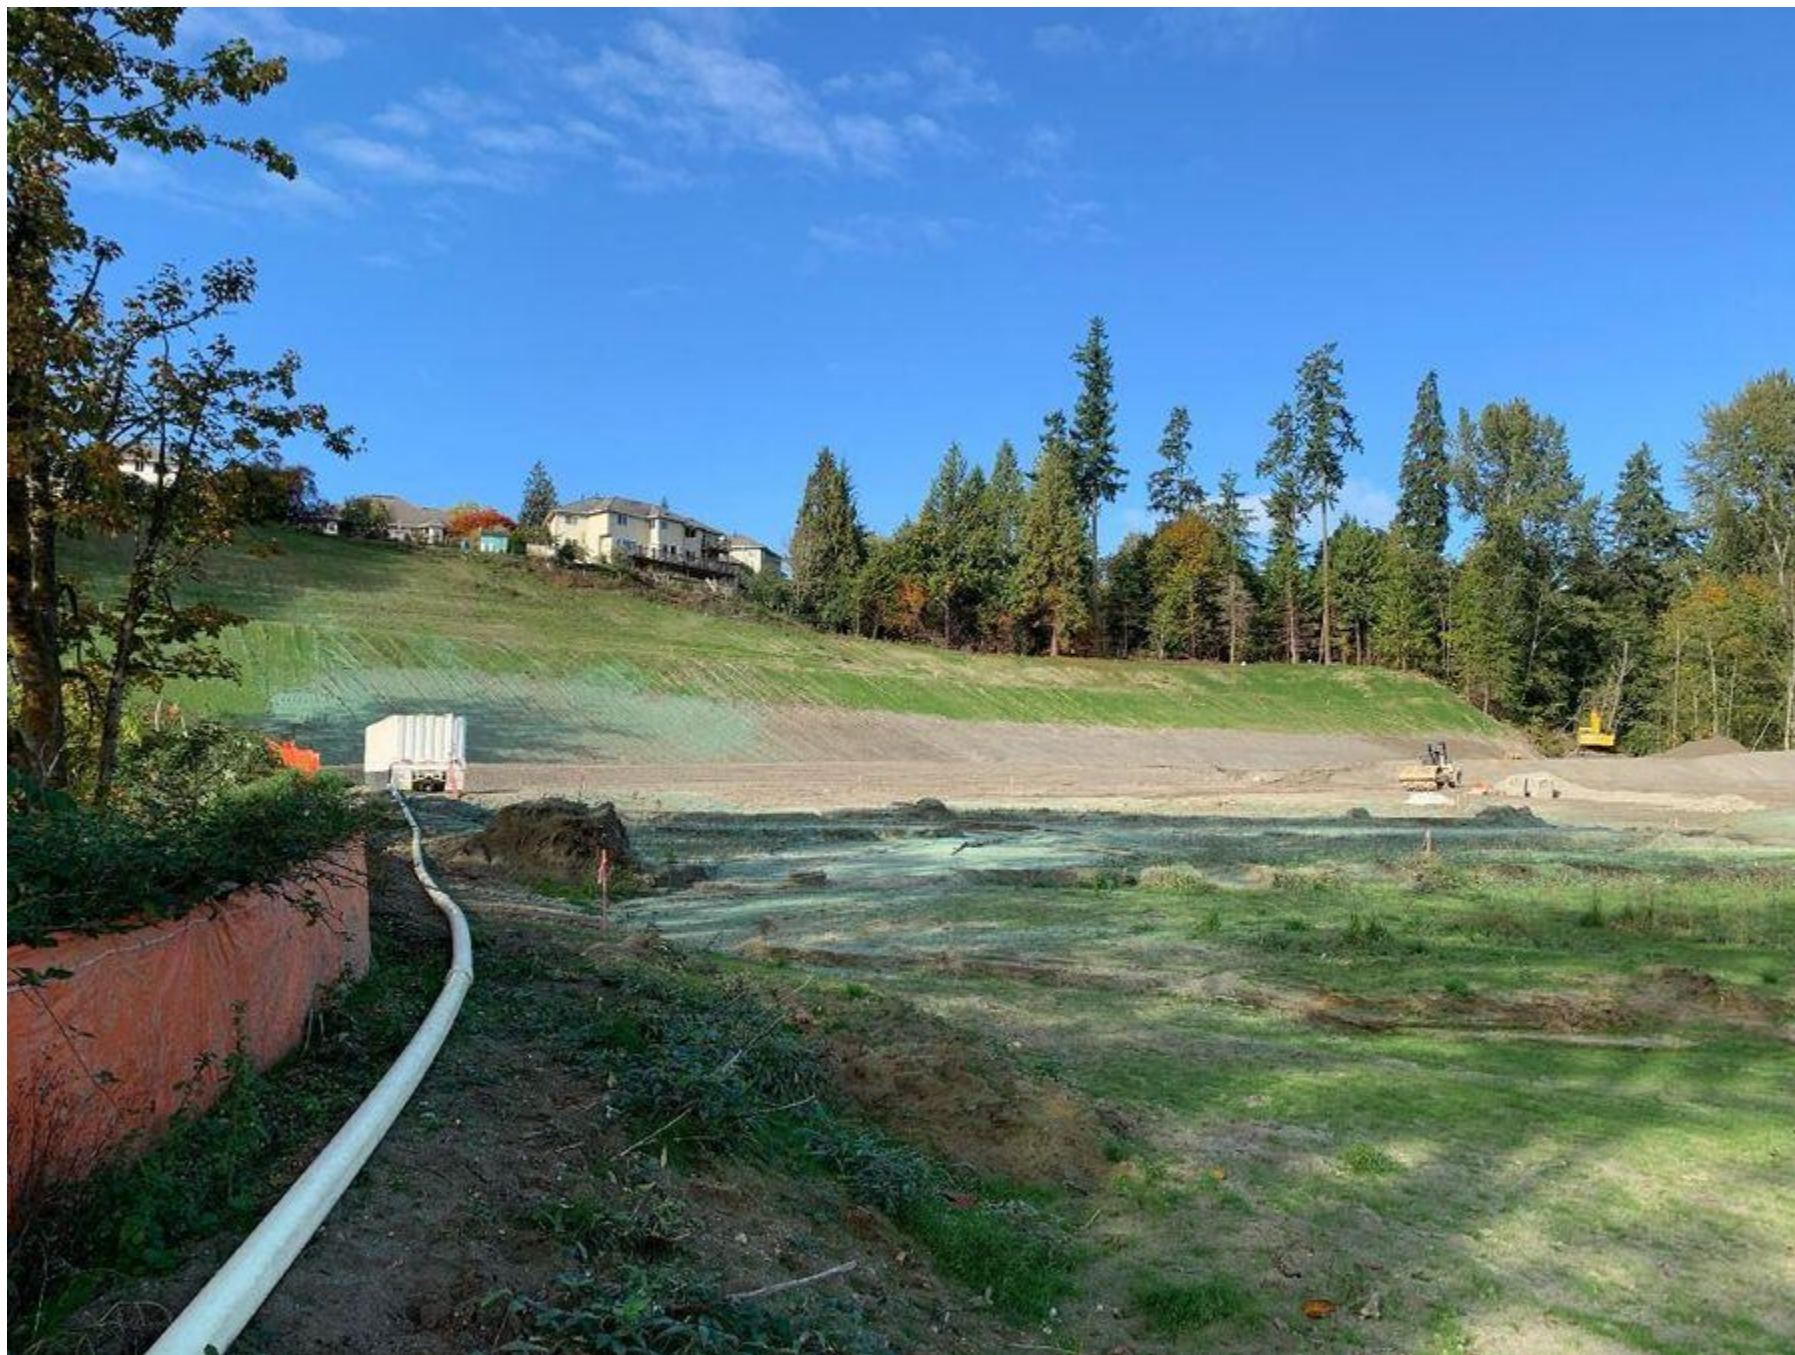
Photo 6

Photo Description: Looking west at baker tank near French drain catch basin

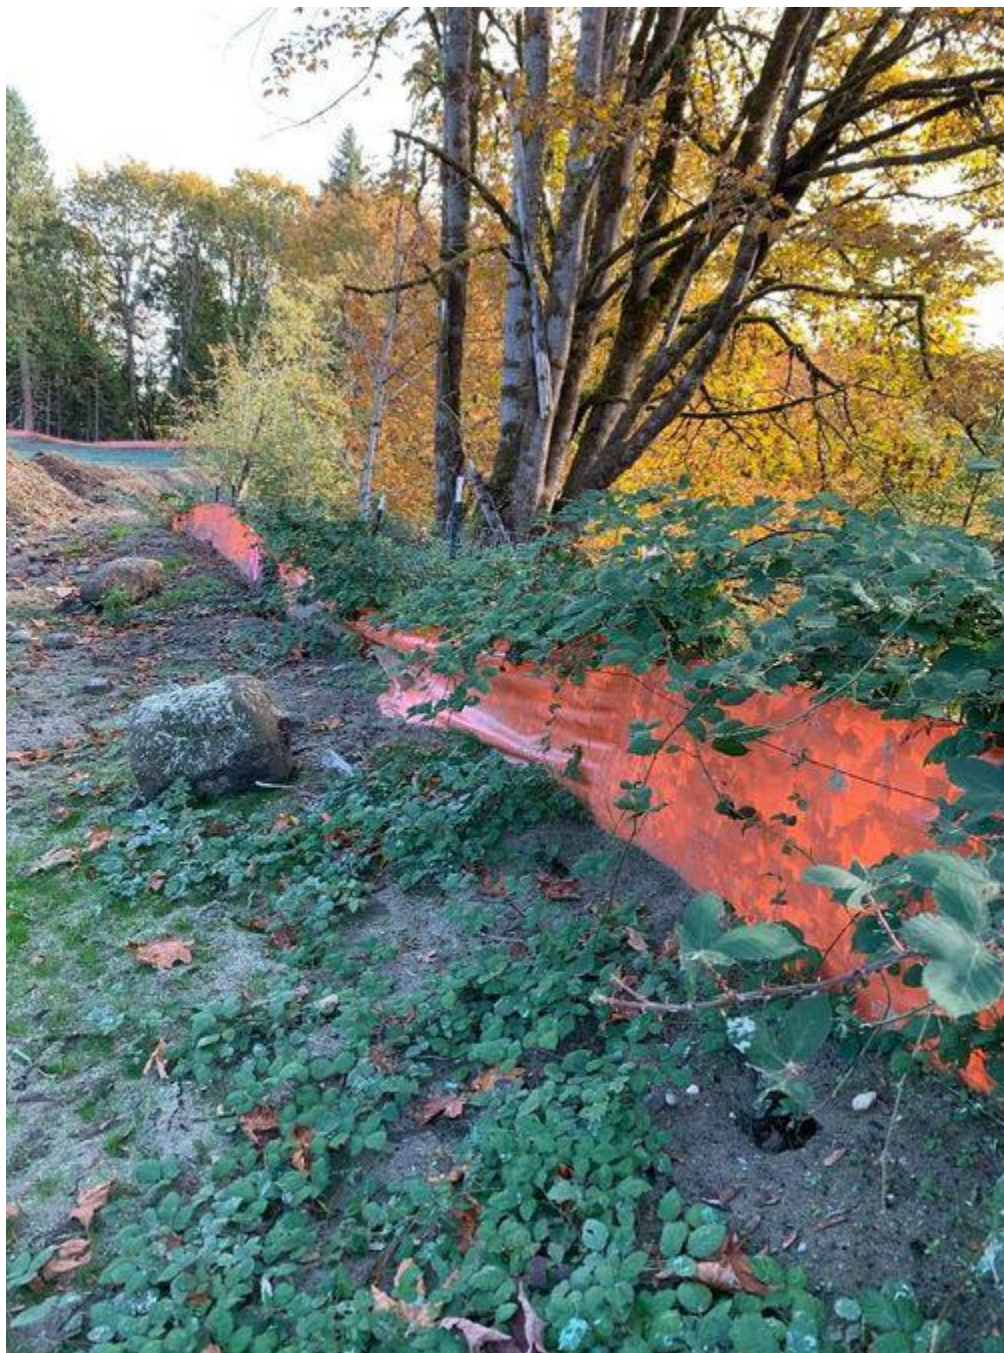
Photo 7

<p>Silt fence east of site has not been repaired per the September 29 2021 inspection report.</p> <p>Some areas of site do not have adequate coverage of straw mulch – the soil can be seen through the mulch in areas where the mulch is not thick enough.</p> <p>Straw wattle BMPs must be staked per standards and specifications in the SWMMWW</p> <p>Failure to meet S9.D.11.a: Permittee must maintain and repair all temporary and permanent erosion and sediment control BMPs as needed to assure continued performance of their intended function in accordance with BMP specifications. Maintain and repair all temporary and permanent BMPs, as set forth in permit condition S9.D.11.a.</p>		
<p><u>S9.D.12 Manage the Project</u></p> <p>Inspect, maintain and repair all BMPs as needed to assure continued performance of their intended function. Conduct site inspections and monitoring in accordance with Special Condition S4. Manage the Project to include inspecting, maintaining and repairing BMPs as needed and maintaining the SWPPP, as set forth in permit conditions S9.D.12.a and S9.D.12.c.</p>		<p>C150, C160, C162</p>

Photo Description: Damaged silt fence south east of site - observed same damaged silt fence last inspection. Note the holes at base of silt fence

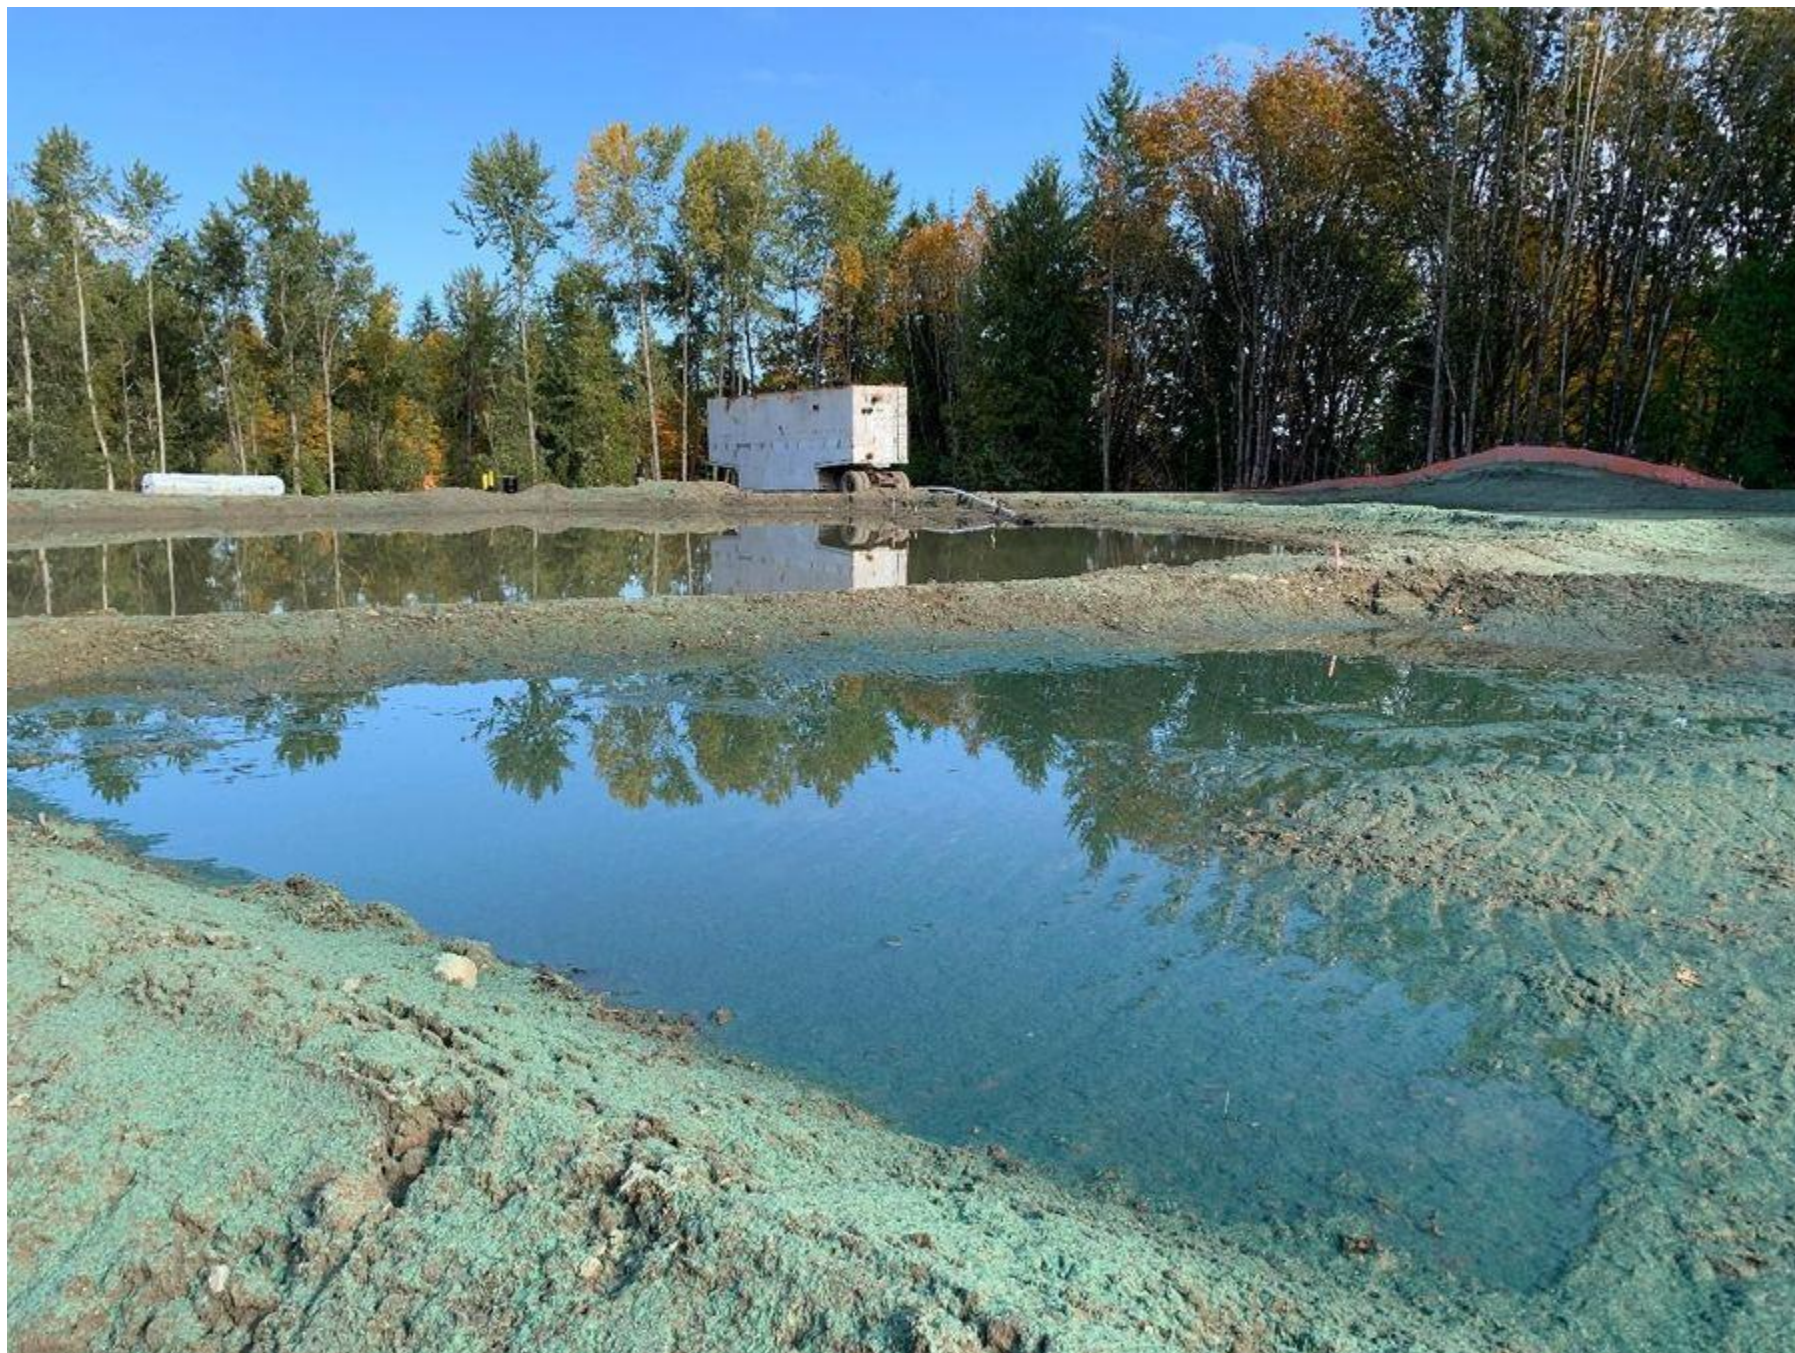
Photo 8

Photo Description: Temporary sedimentation pond east of site. Second baker tank shown near cul-de-sac area

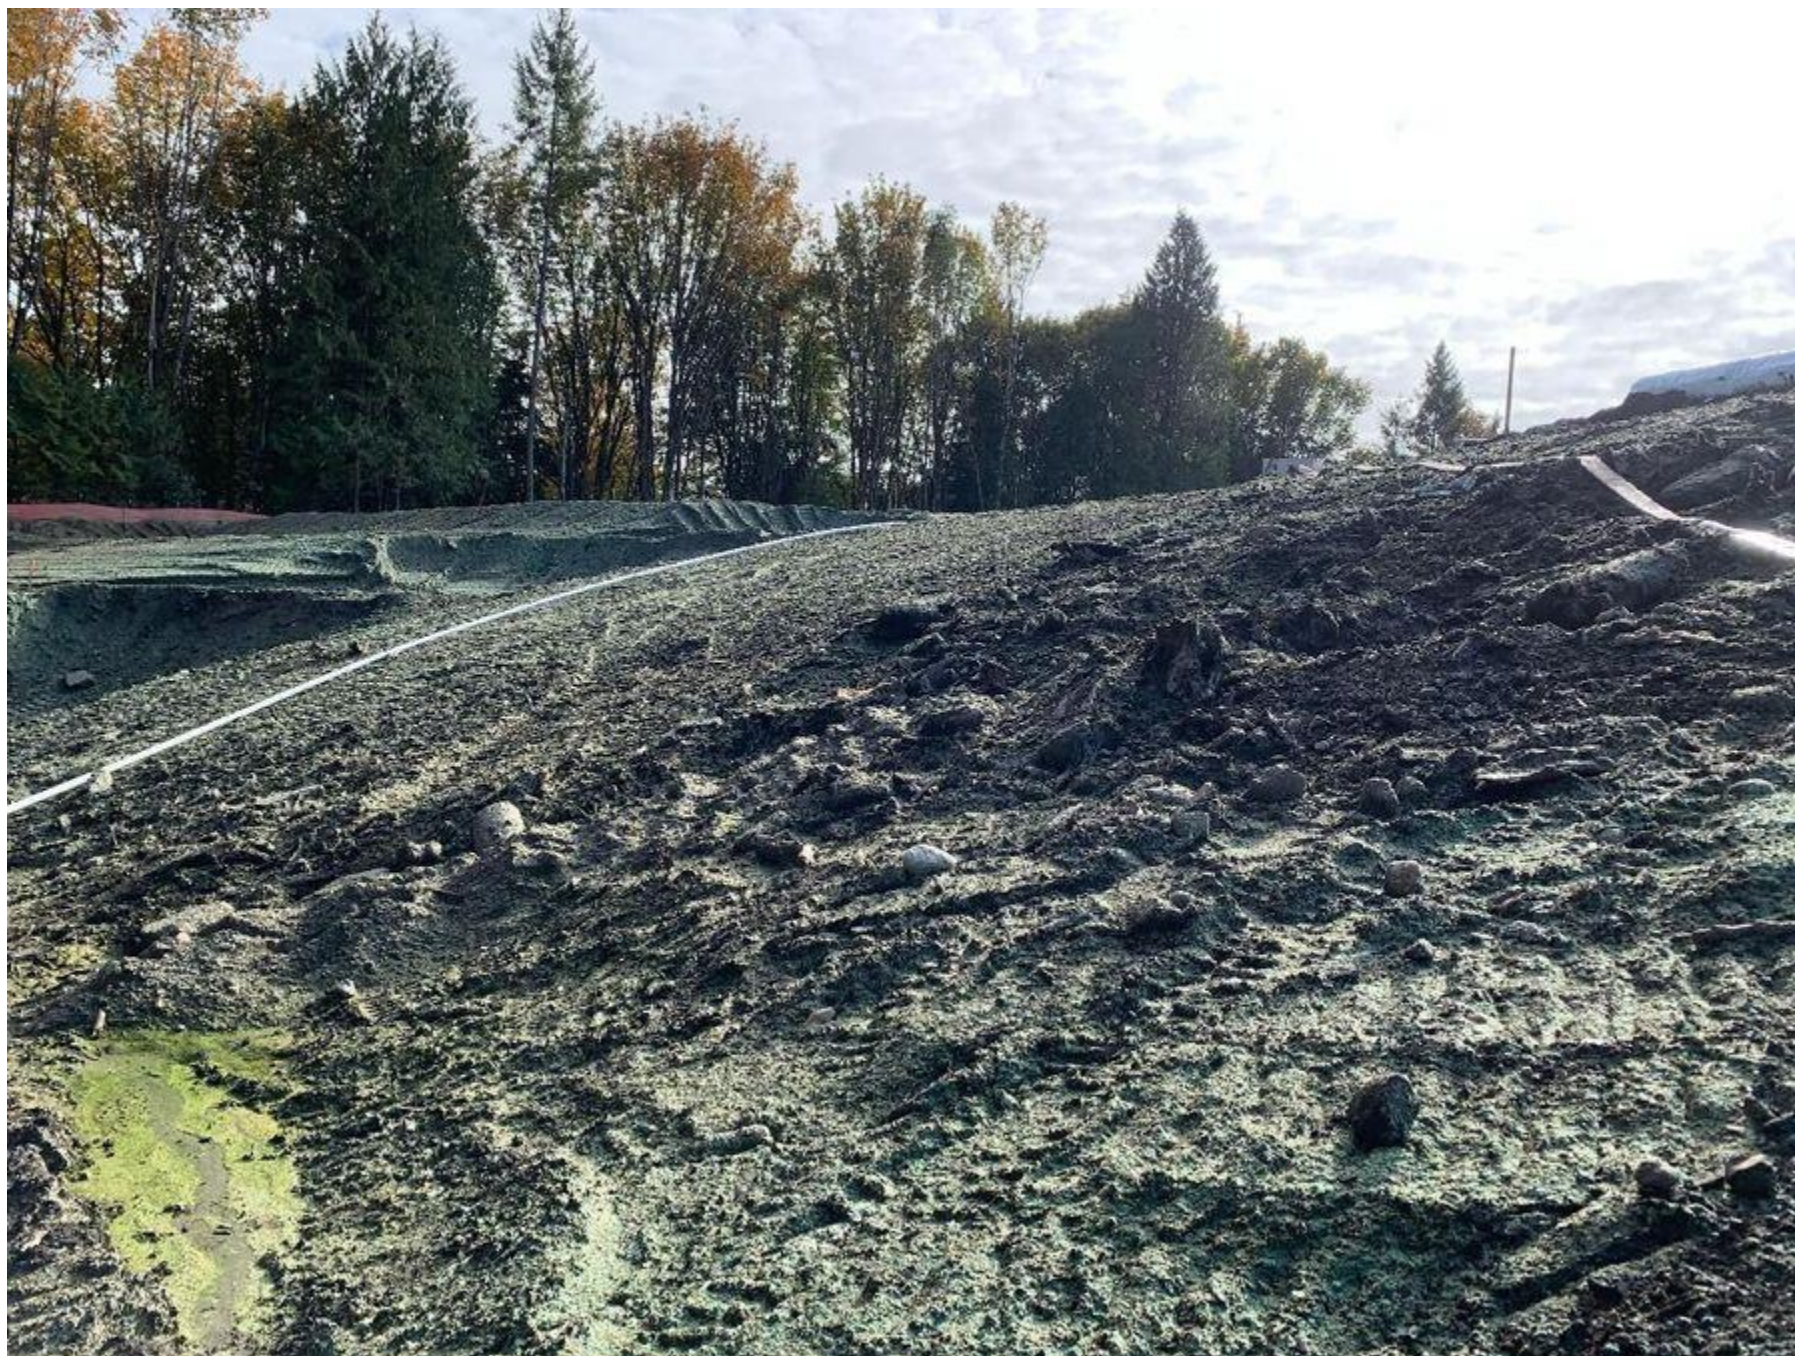
Photo 9

- Stormwater continues to run-off 3:1 northeast slope with exposed landfill material. Site has constructed berming to direct water to a lined temporary pond, but berms have failed to direct run off to pond. Surface run-off from landfill material is causing rill erosion down slope and discharging at toe of silt fence.

Photo Description: 3:1 east slope with exposed landfill material. Rill erosion and sediment deposition at toe of silt fence indicating surface run-off and discharges off site.

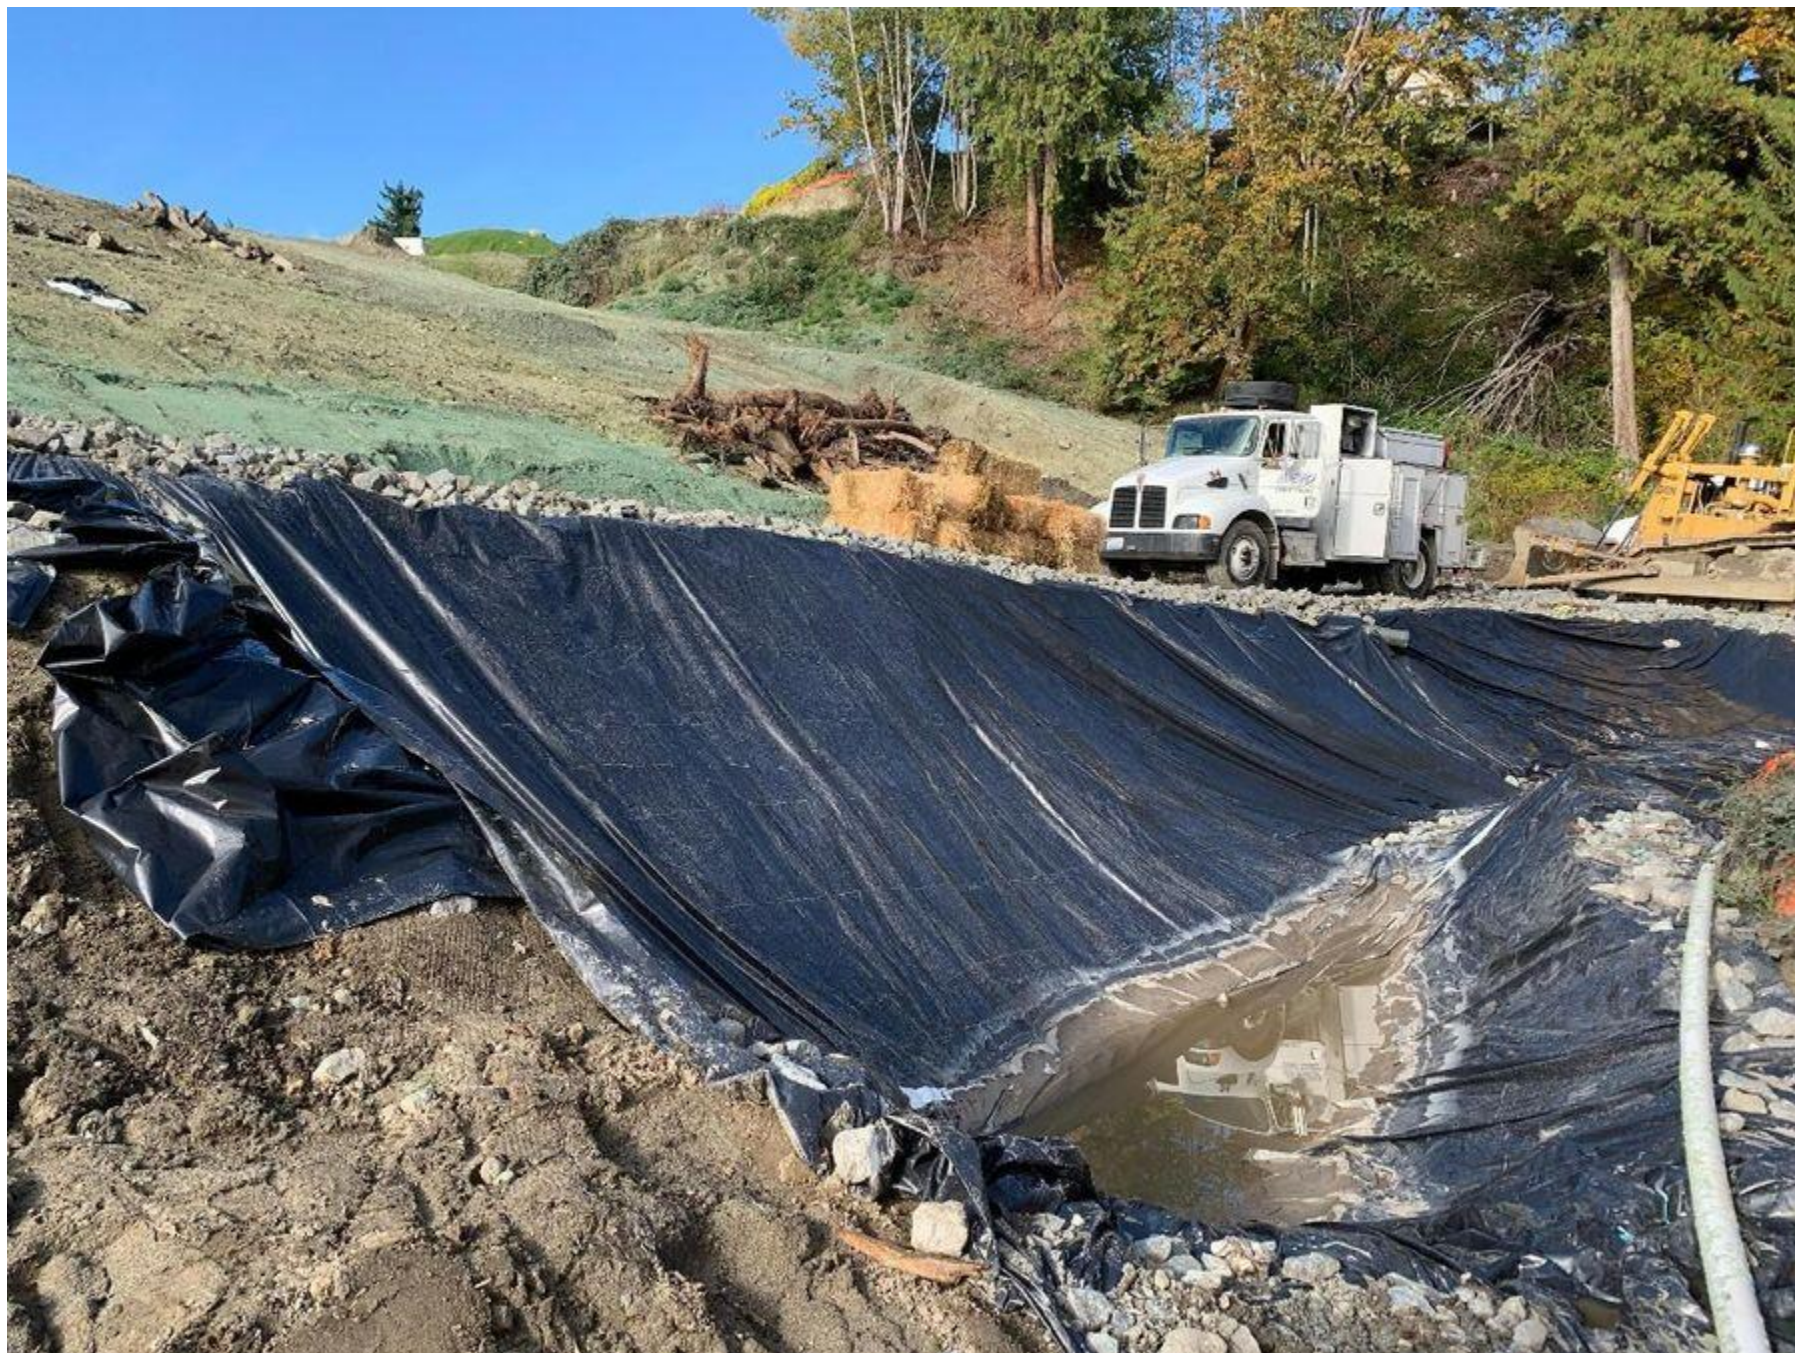
Photo 10

Photo Description: Temporary lined pond to collect potentially contaminated run-off from exposed landfill material

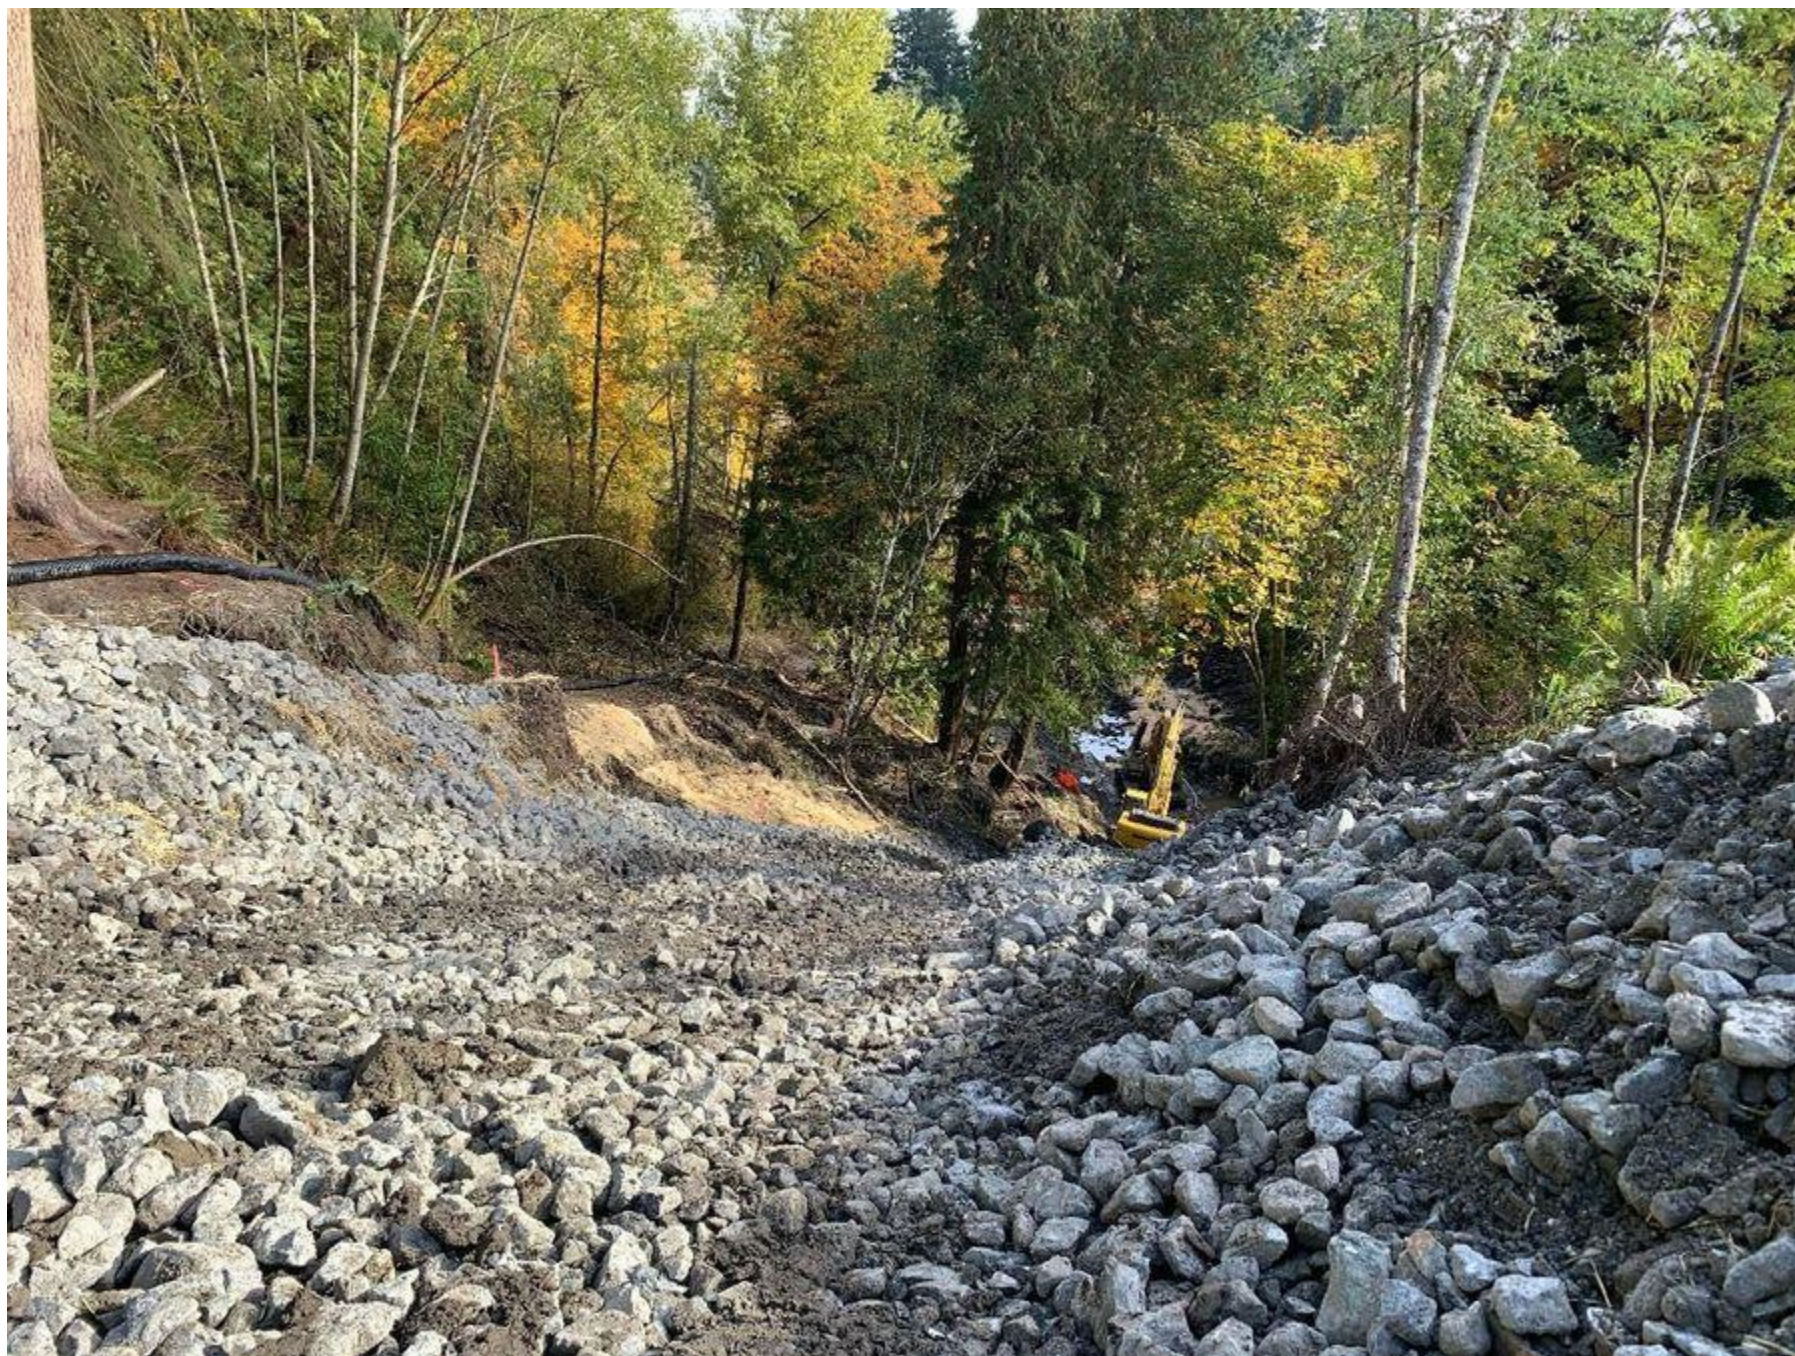
Photo 12

Photo Description: Looking north east down failed slope
