DEPARTMENT OF ECOLOGY State of Washington	<h2 style="text-align: center;">CONSTRUCTION STORMWATER GENERAL PERMIT</h2> <h3 style="text-align: center;">INSPECTION REPORT</h3> <p style="text-align: center;">State of Washington Department of Ecology</p>		
Section A: General Data			
Ecology Inspector(s): Elizabeth Fint	On-Site Representative Name: Jay Pullen Title: CESCL Phone: 425-351-0306 Email:	Inspection Date and Entry/Exit Time: October 18, 2021, 10:45/12:30 Receiving waters: Creek and wetland tributary to Snohomish River	Inspection Type: Unannounced Permit webpage: https://fortress.wa.gov/ecy/paris/FacilitySummary.aspx?FacilityId=60941
Section B: Background			
<p>The Bakerview Everett project is covered under the State of Washington's Construction Stormwater General Permit (CSGP). The CSGP is a National Pollutant Discharge Elimination System (NPDES) and a State Waste Discharge permit for discharge of construction-related stormwater.</p> <p>The project is also covered under Administrative Order 18193, which requires additional sampling of stormwater for contaminants that remain on site from past land use activities (landfill). The purpose of this inspection is to conduct a follow-u

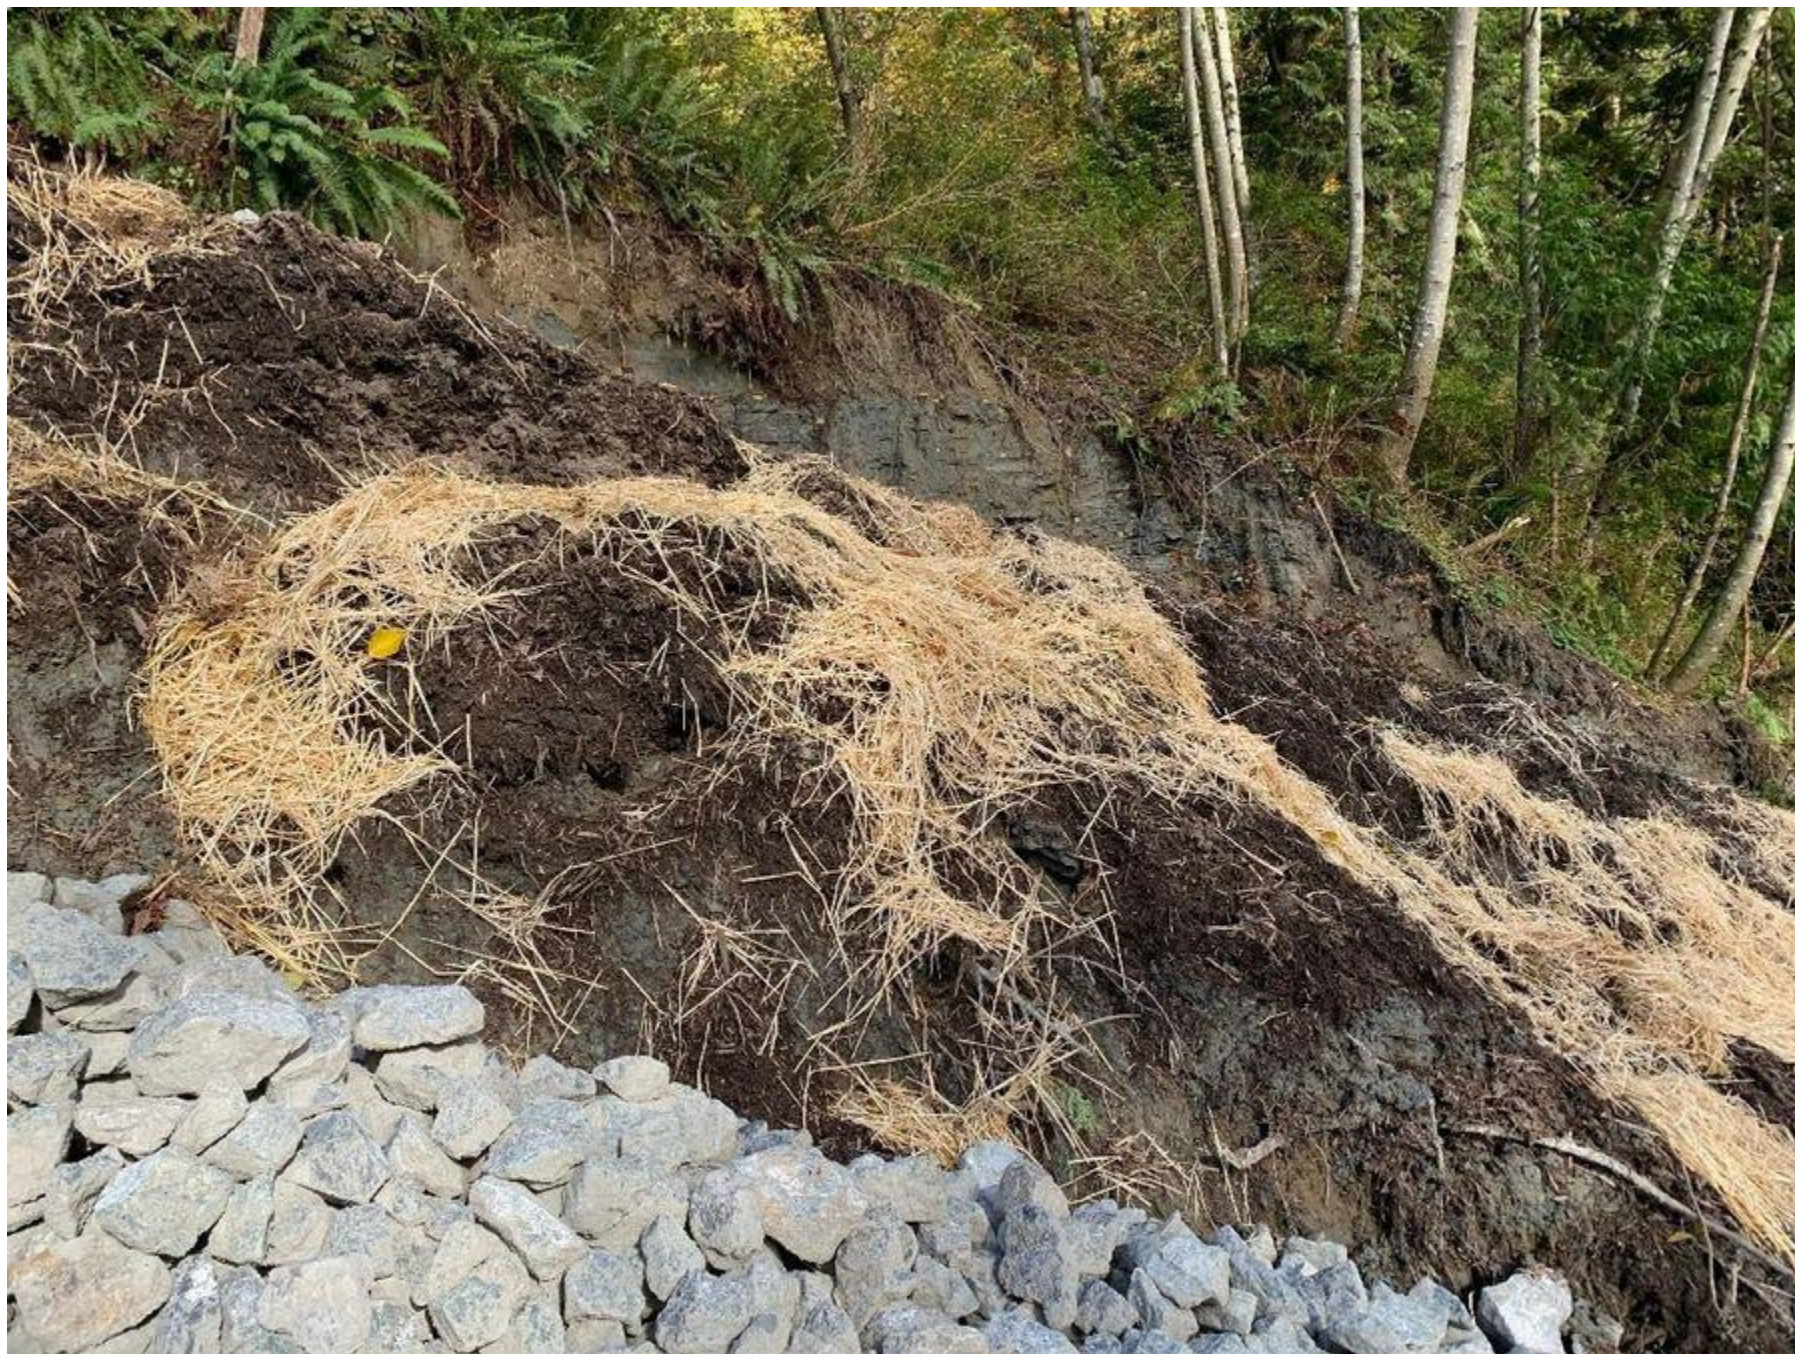
Photo 13

Photo Description: Straw mulch is not thick enough - follow Stormwater Management Manual for Western Washington for standards and specs for BMP implementation

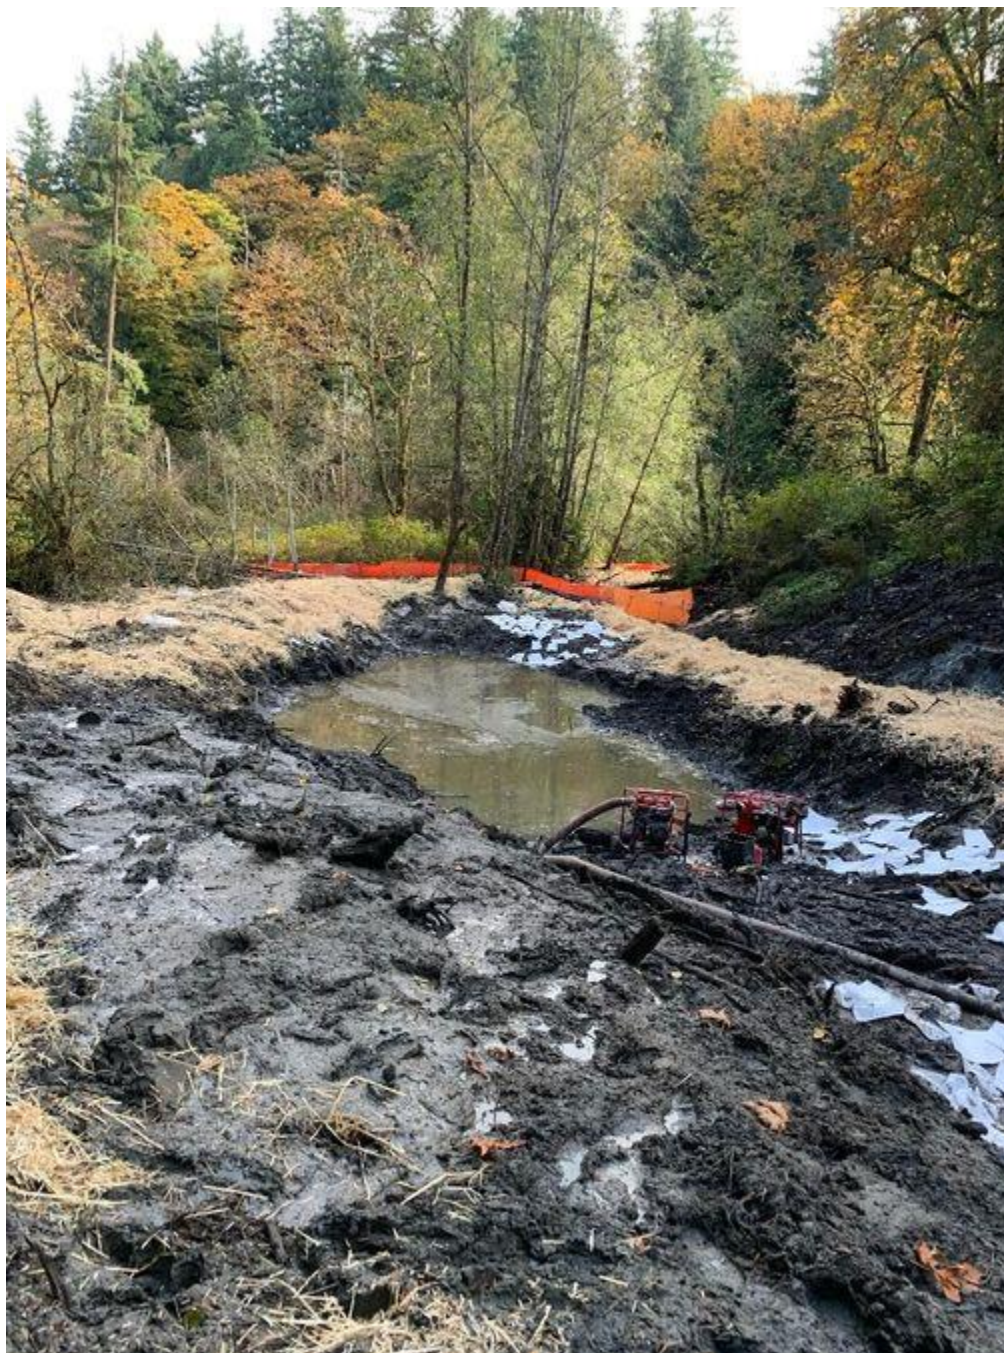
Photo 14

Photo Description: Looking east towards creek

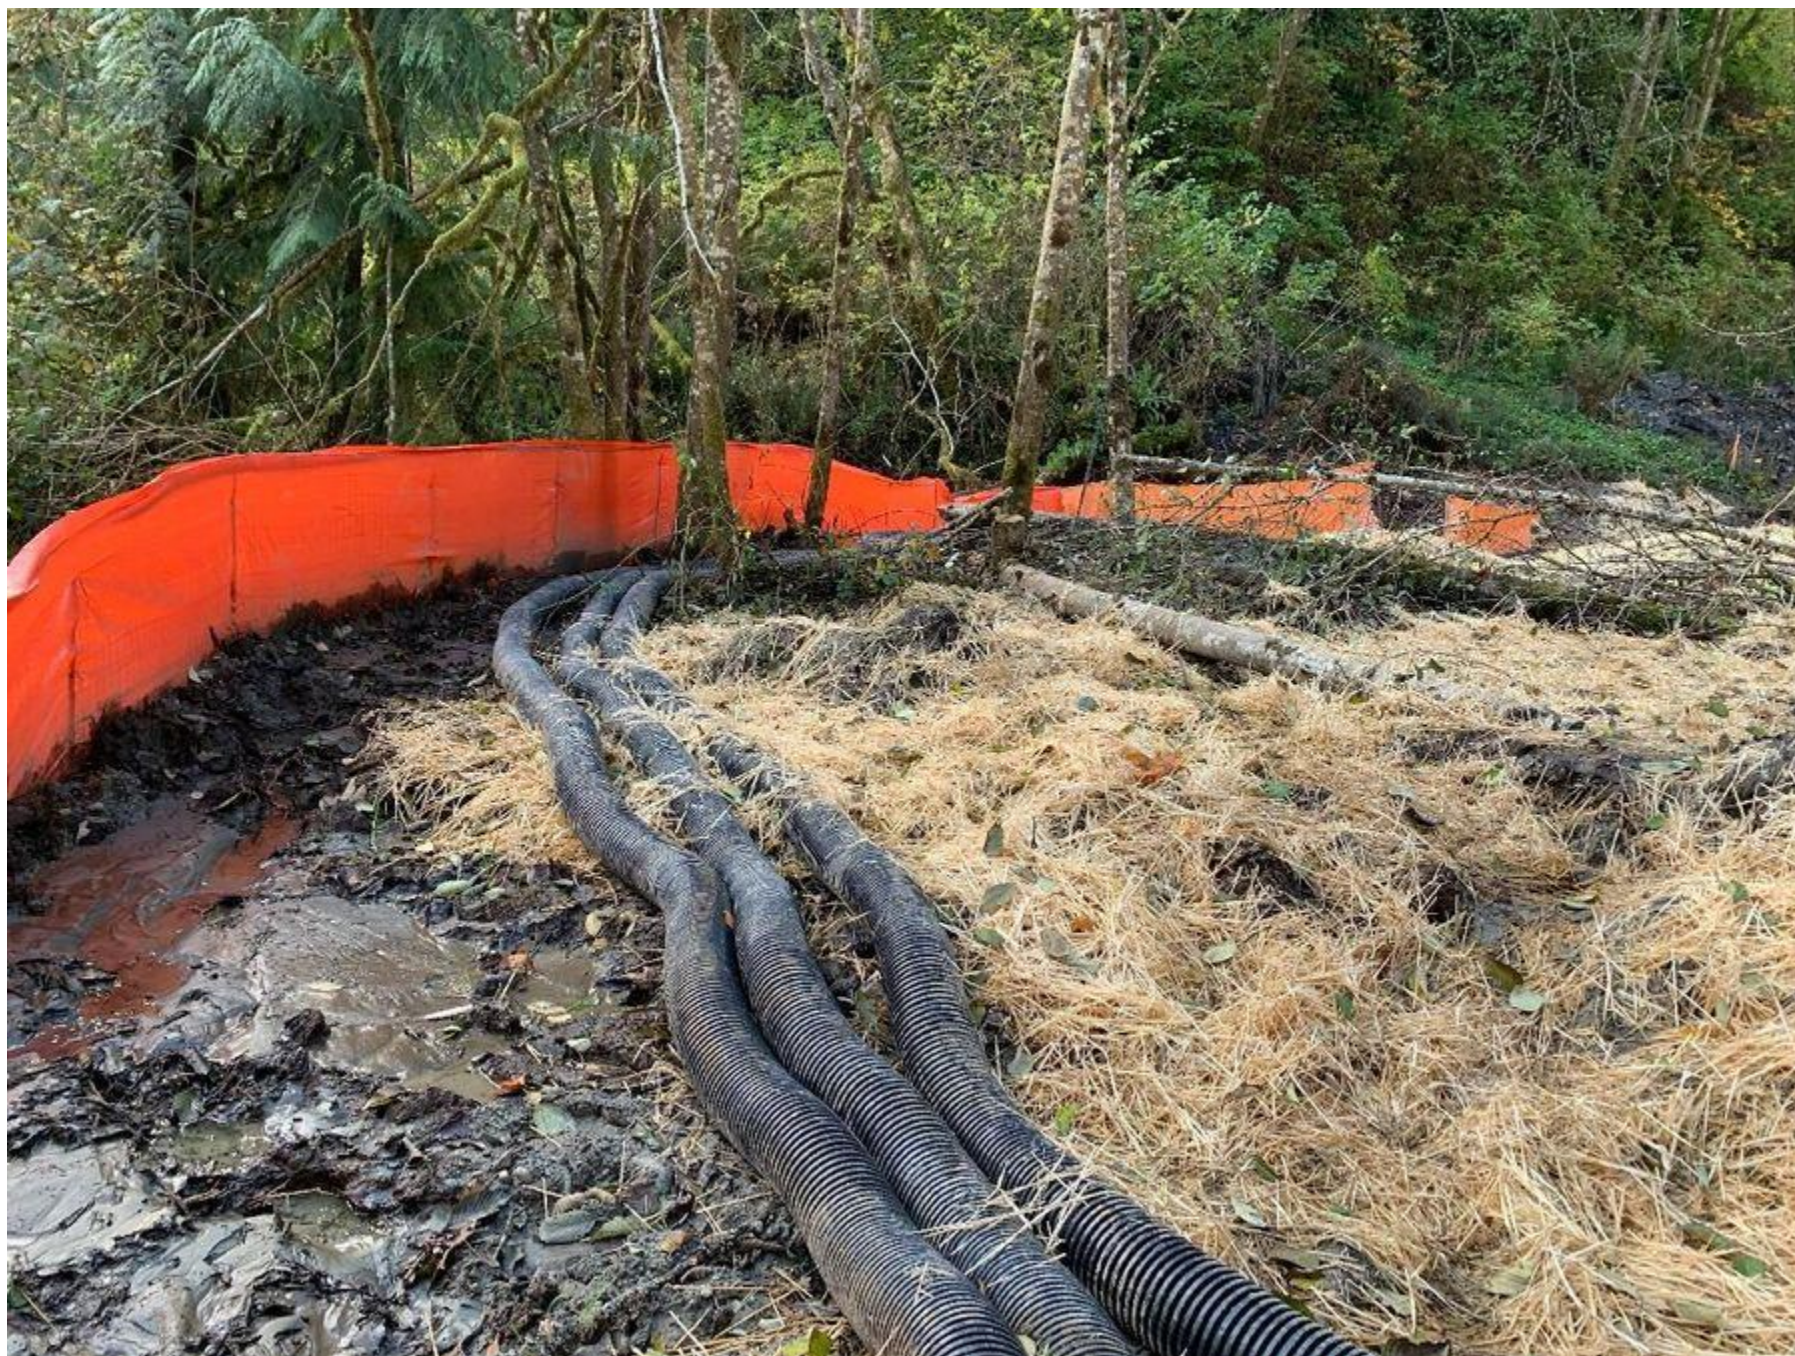
Photo 15

Photo Description: Flexible HDPE piping carrying seepage flows from toe of slope and discharge beyond disturbance to wetland further east and north of slide area

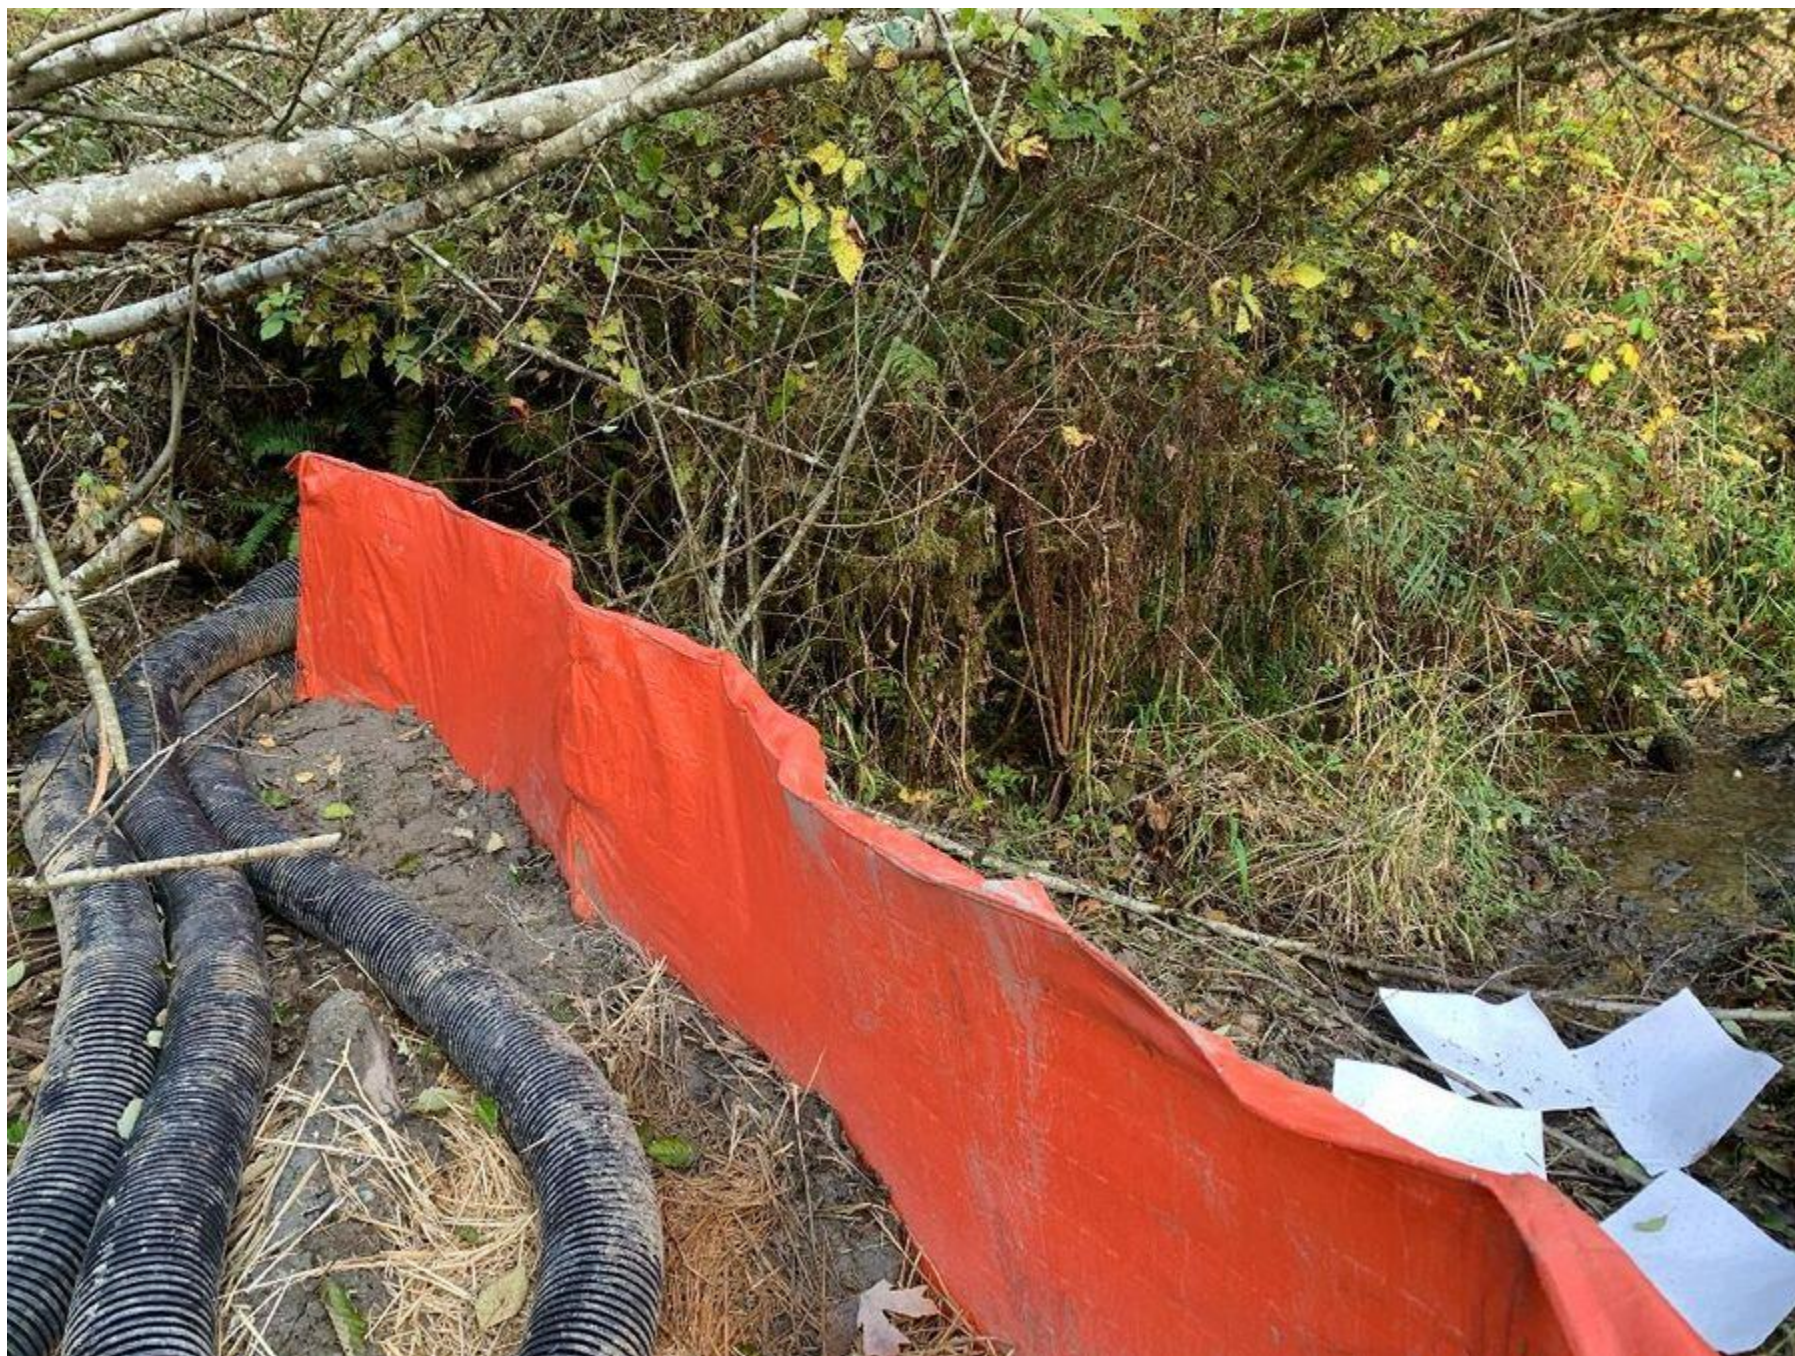
Photo 16

Photo Description: Pipes bypassing seepage flows through mudslide area and discharging to wetland. Discharges were flowing clear at time of inspection. Sample point for DMR

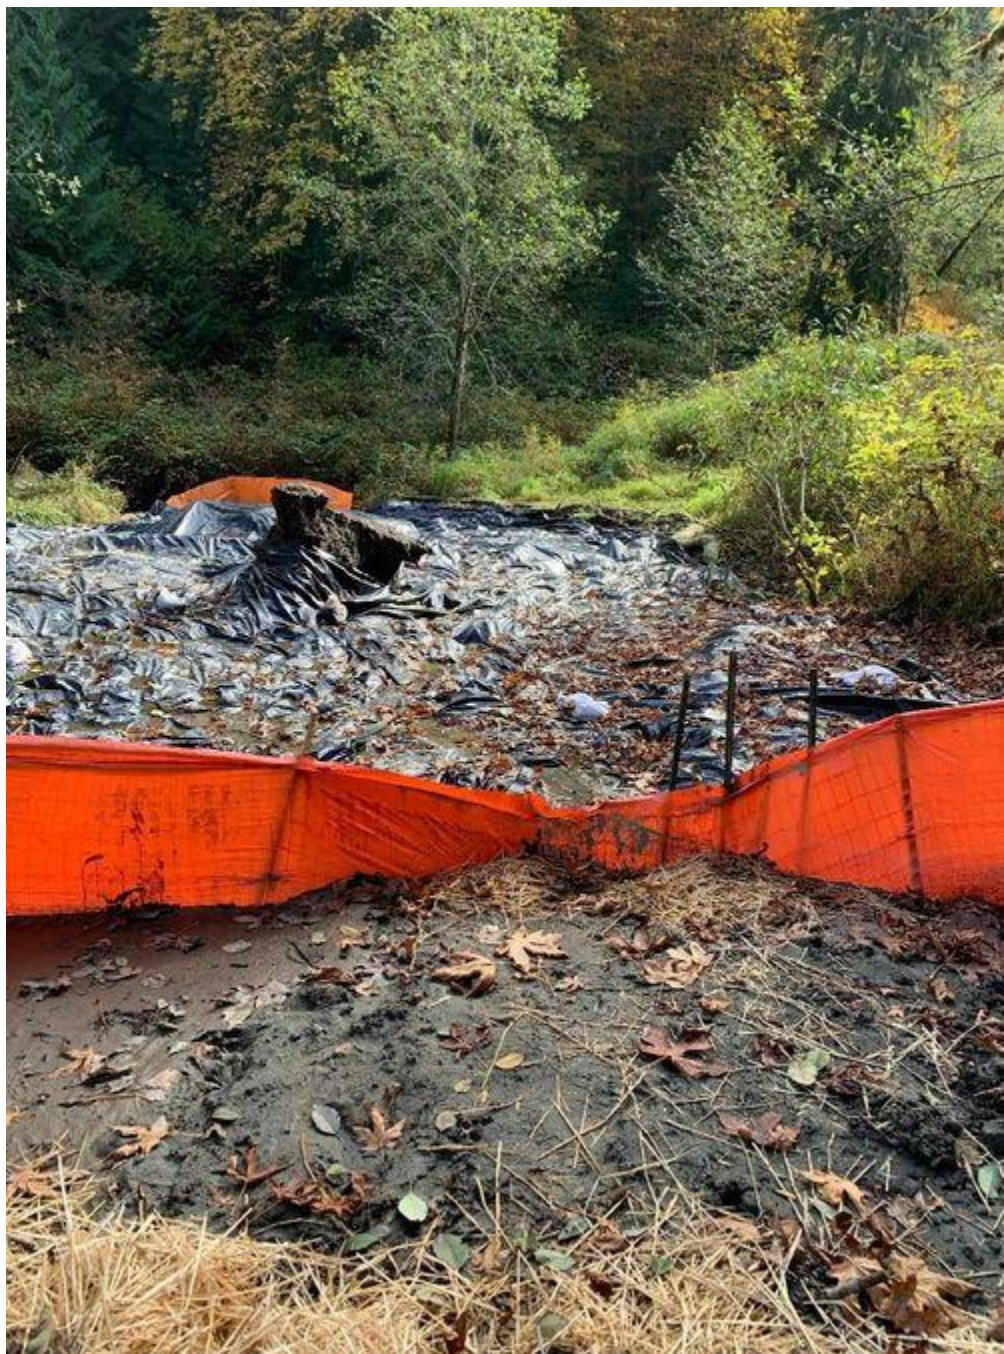
Photo 17

- The silt fence between the mudslide area and creek was overwhelmed during a rain event on October 15 2021 and was not repaired at the time of inspection (photo 17). Sediment accumulation in front of the silt fence and stormwater flows have damaged the BMP. It will not perform as intended, especially during storm events.

Photo Description: Silt fence check dam that failed Friday October 15th. Large amount of sediment buildup at silt fence. BMP has not been maintained or repaired

- The site must ensure BMPs within the mudslide area are adequately monitored, maintained, and repaired, to ensure continued function, especially during storm events.

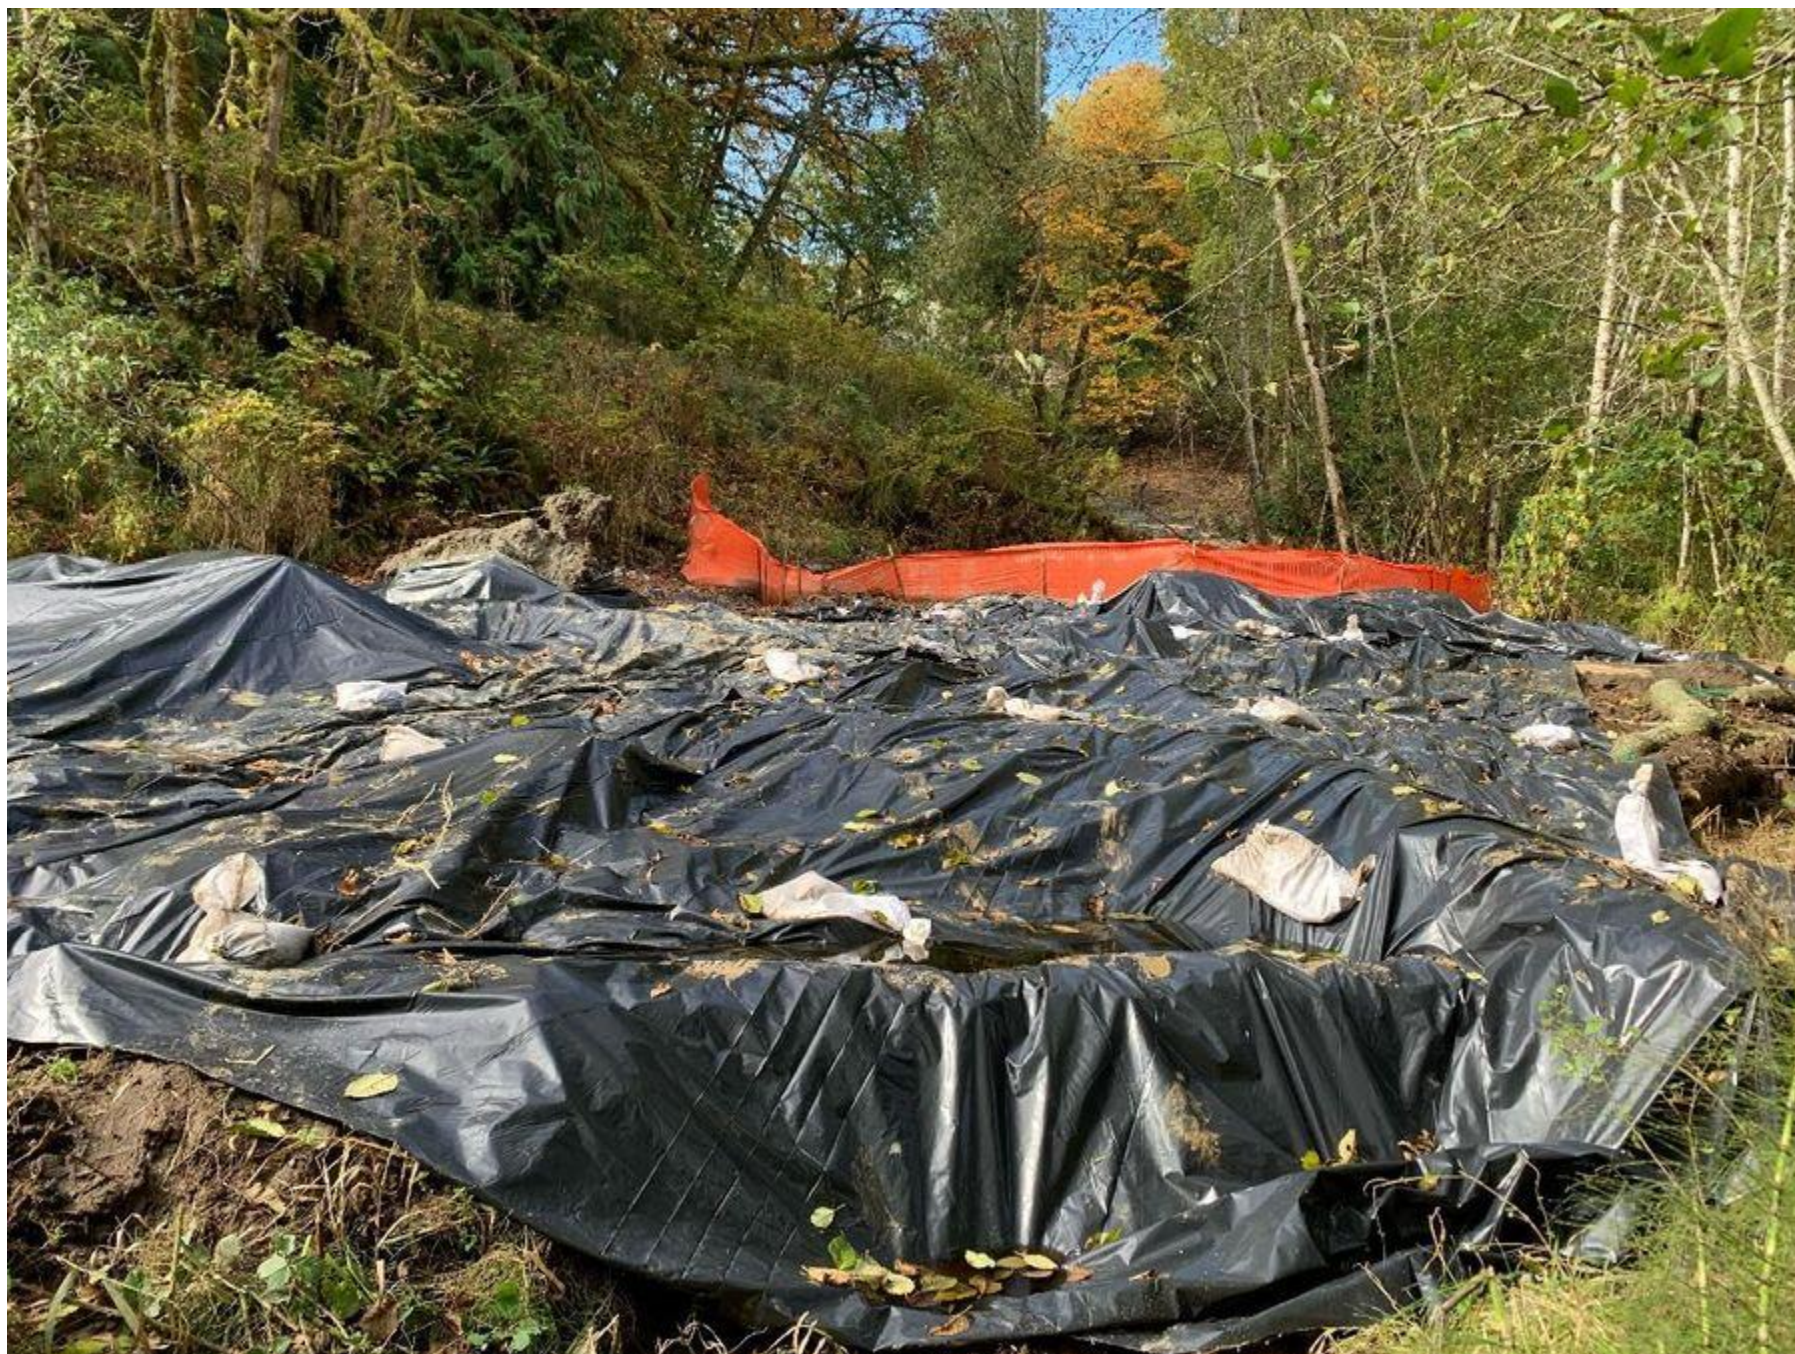
Photo 18

Photo Description: Plastic sheeting covering mudslide material near pipeline easement

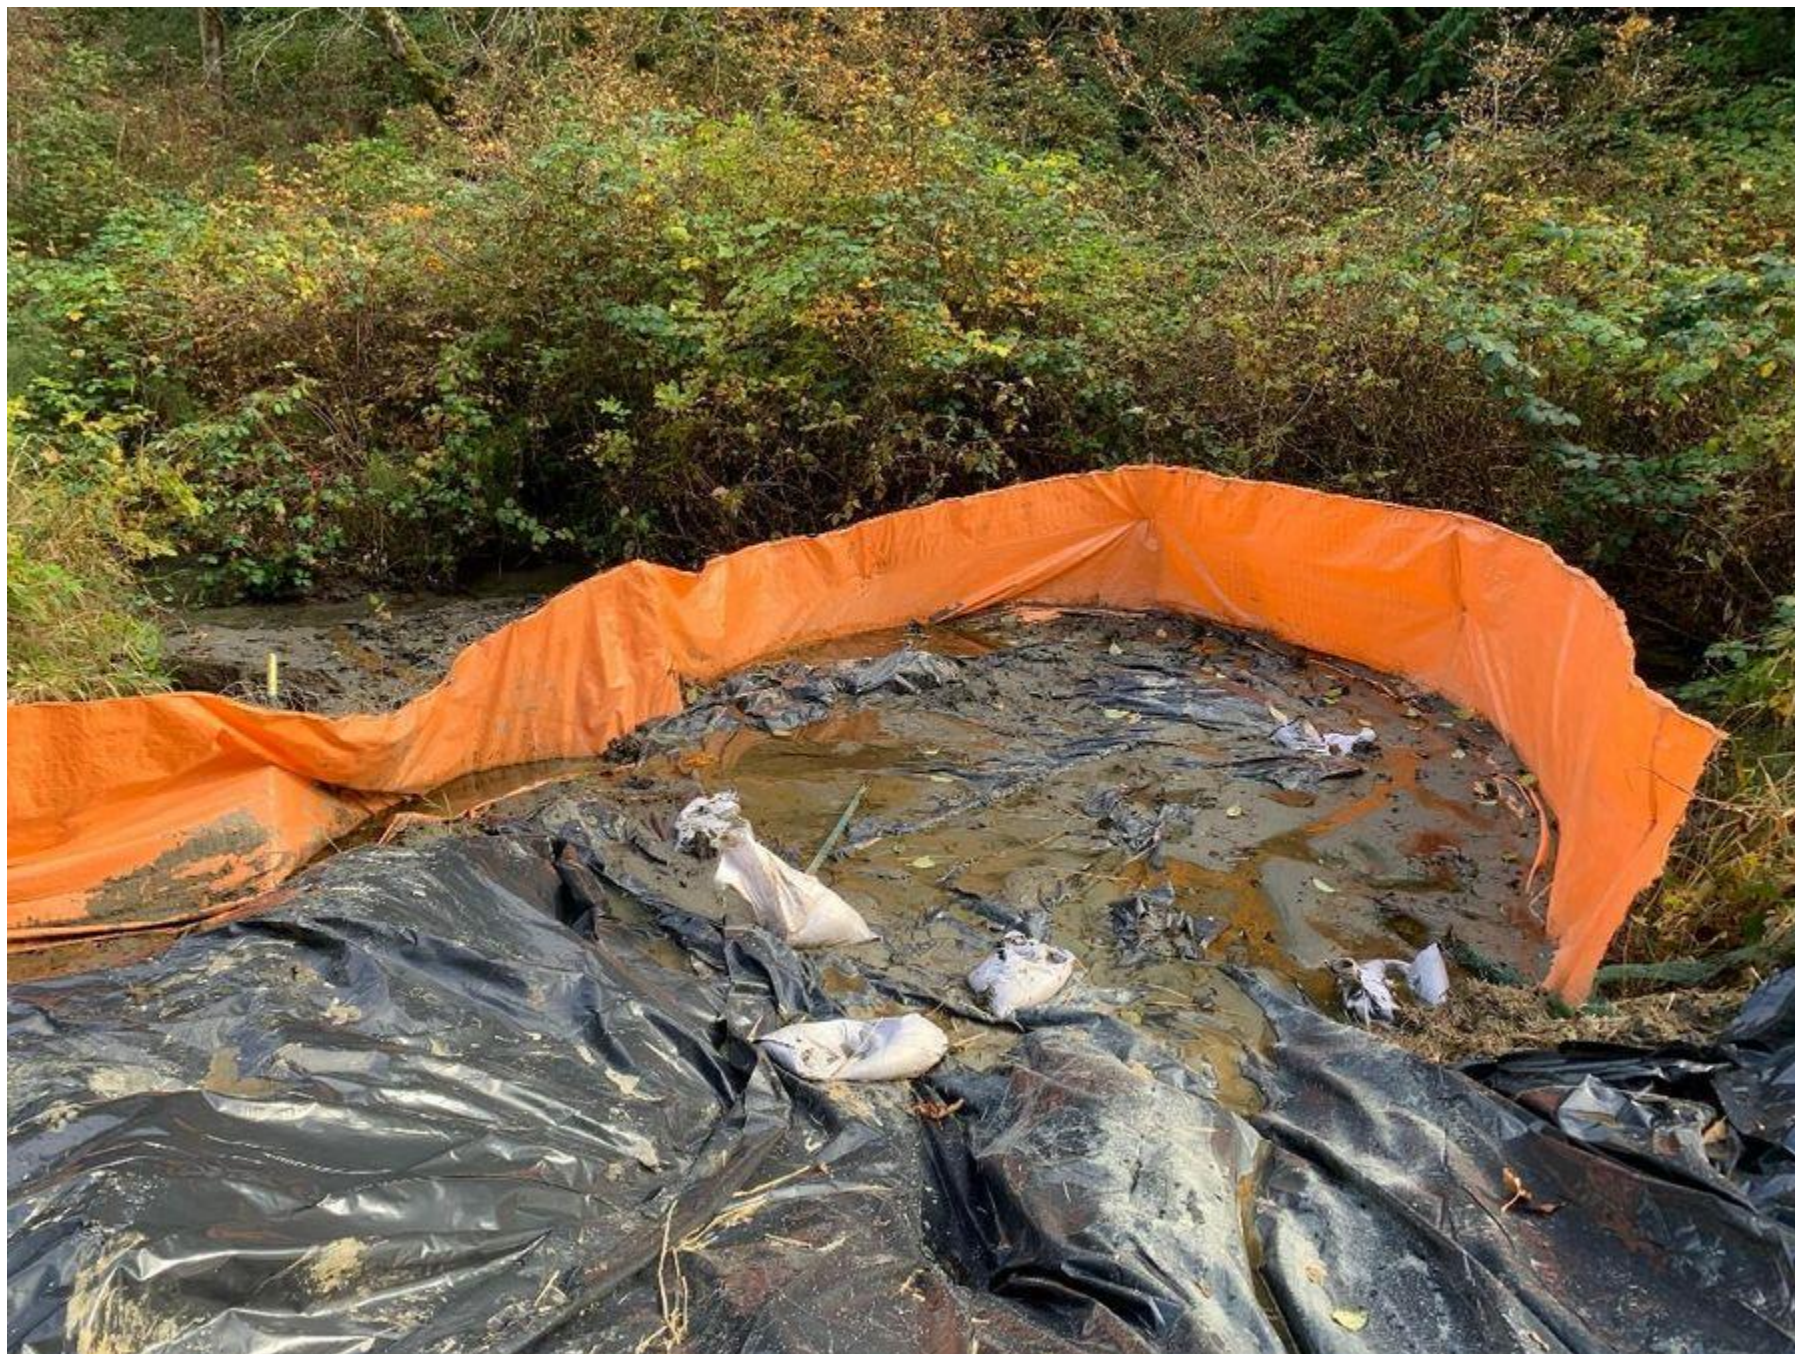
Photo 19

- The silt fence near the creek channel is not installed correctly and is allowing sediment and materials to pass under the silt fence and into the creek bed (photo 19).

Photo Description: Silt fence check dam where disturbed material meets creek channel. Silt fence is not installed properly, allowing undercutting and free flow of materials under silt fence and in to creek

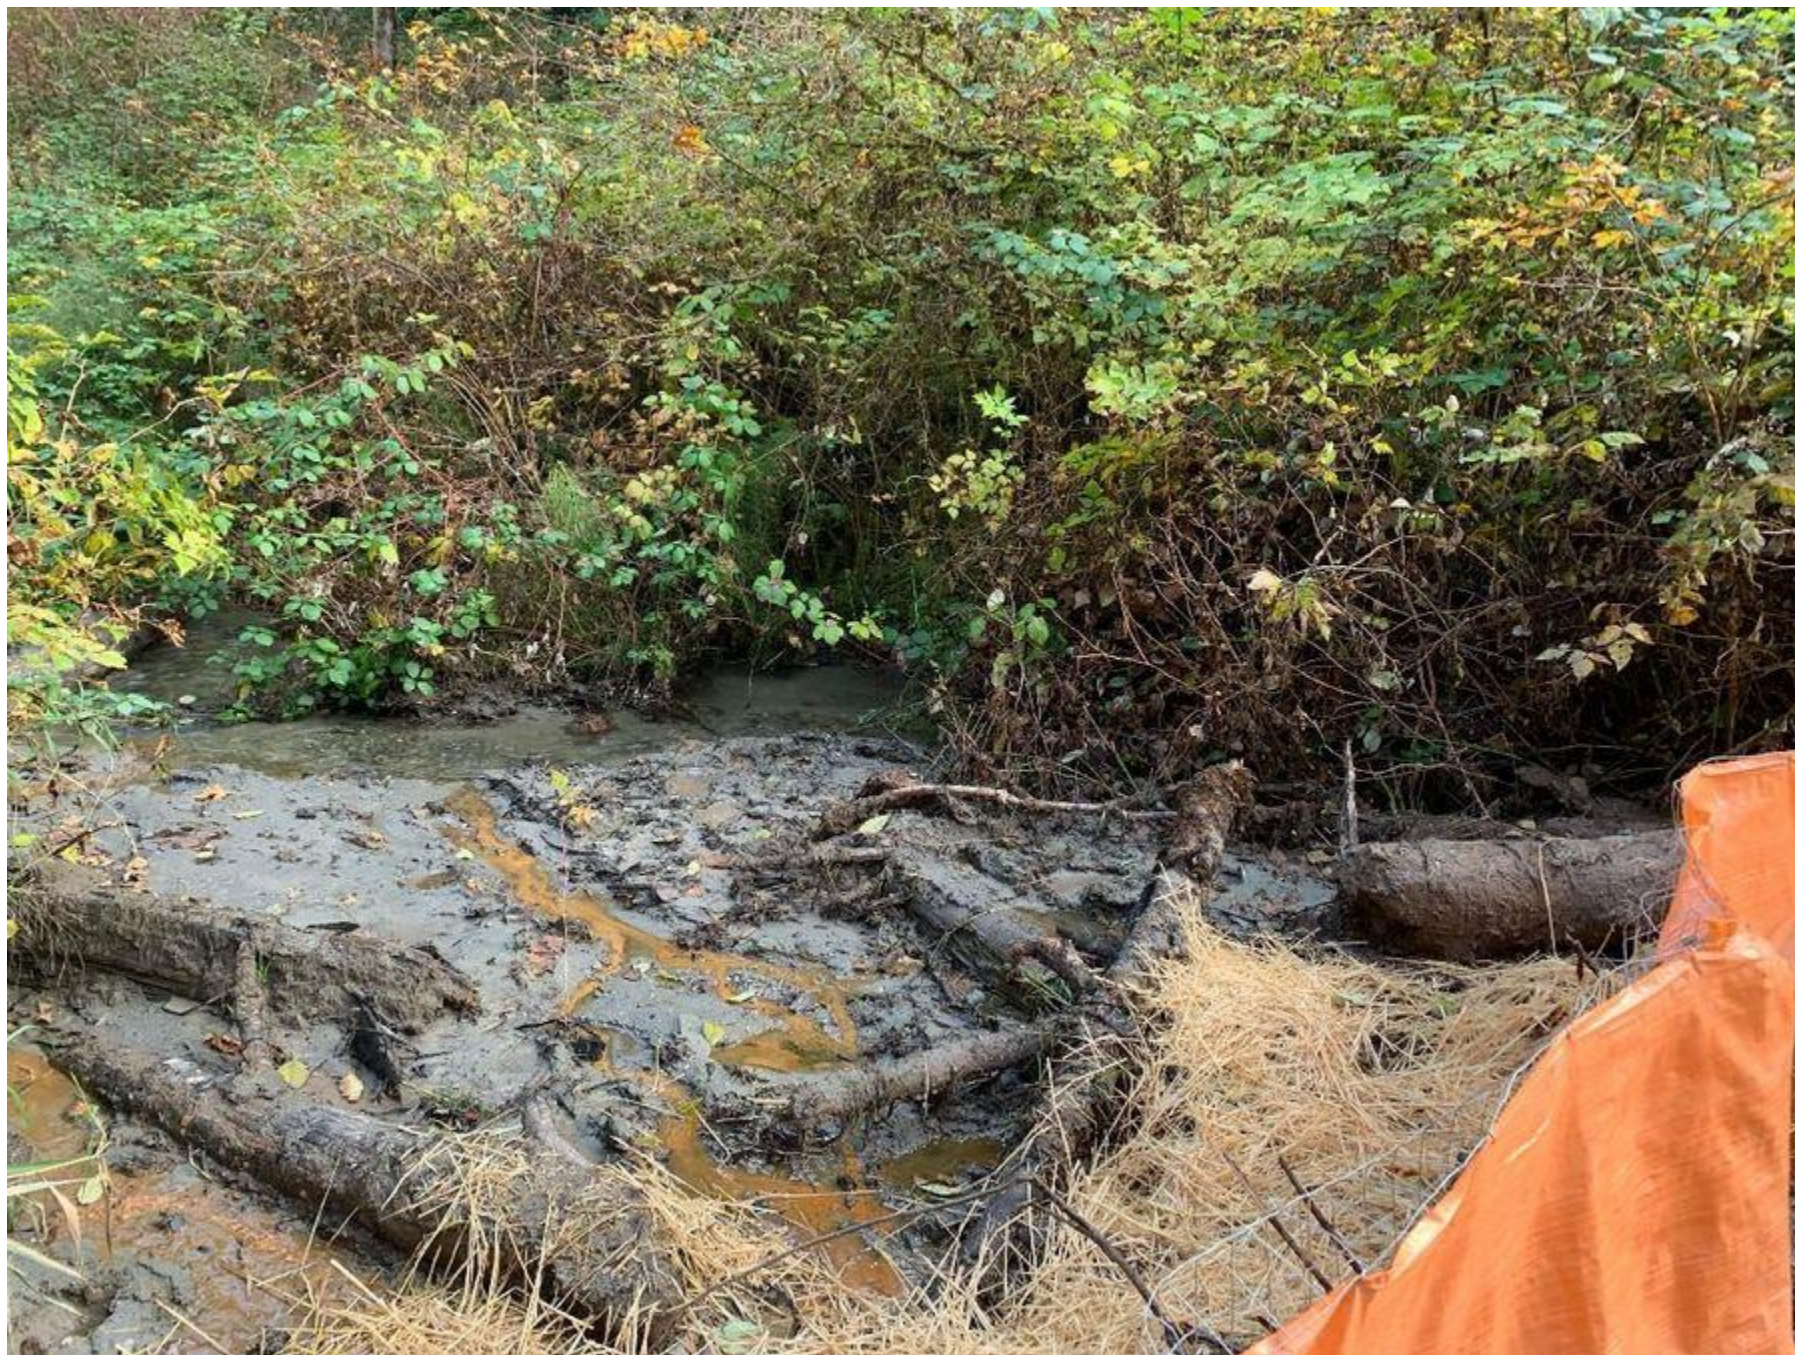
Photo 20

Photo Description: Area just beyond last silt fence. Sediment deposition continues beyond silt fence

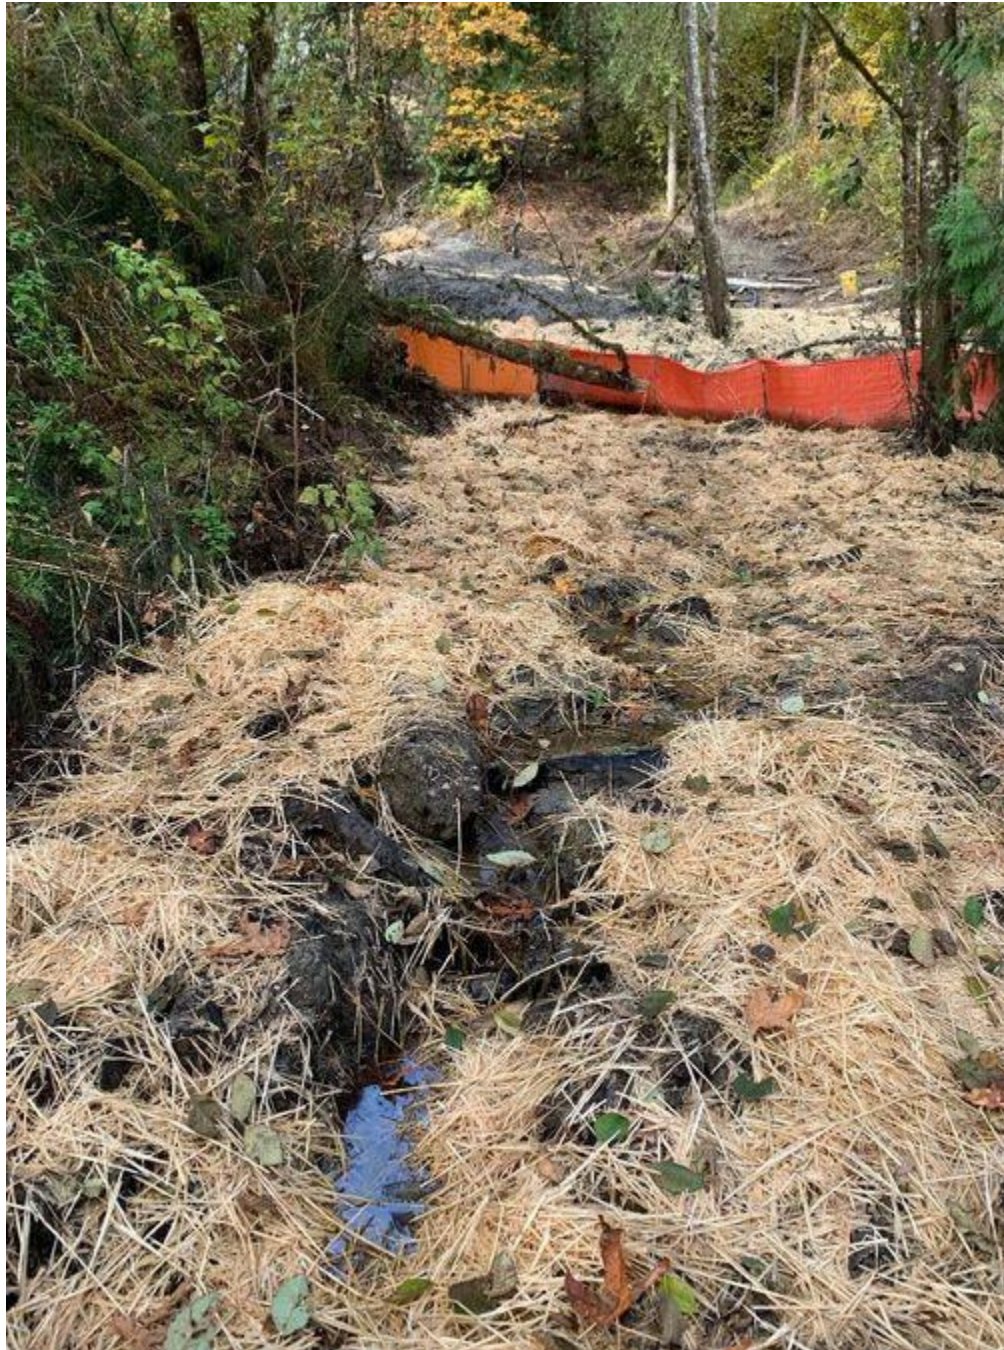
Photo 21

Photo Description: Looking west towards toe of slope, seepage continues through portions of mudslide area

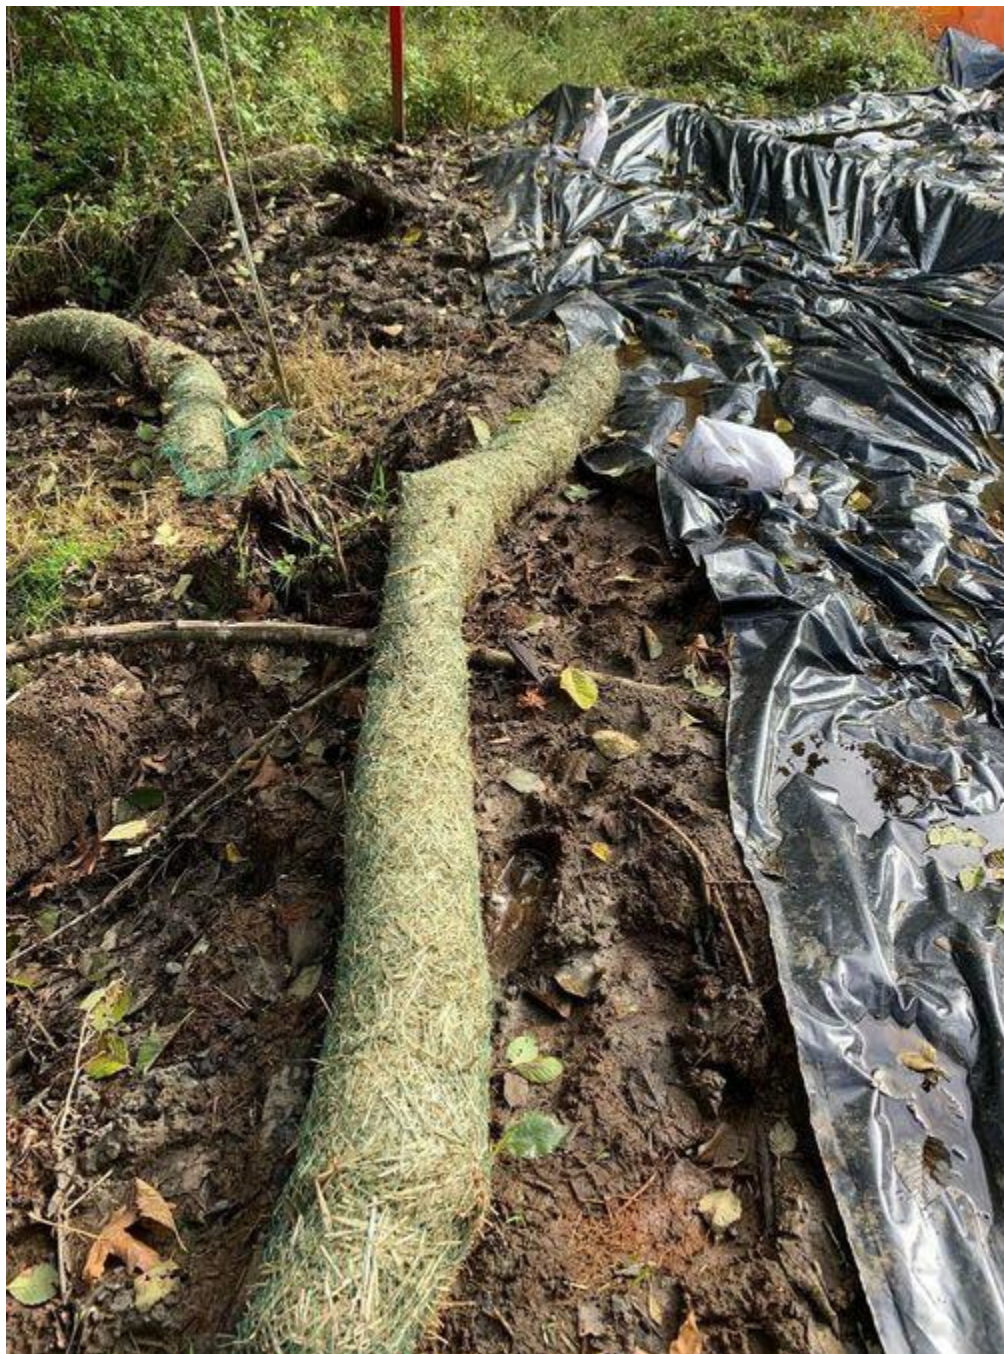
Photo 22

Photo Description: Straw wattle must be staked into the ground to perform as intended. Wattle not staked at time of inspection.

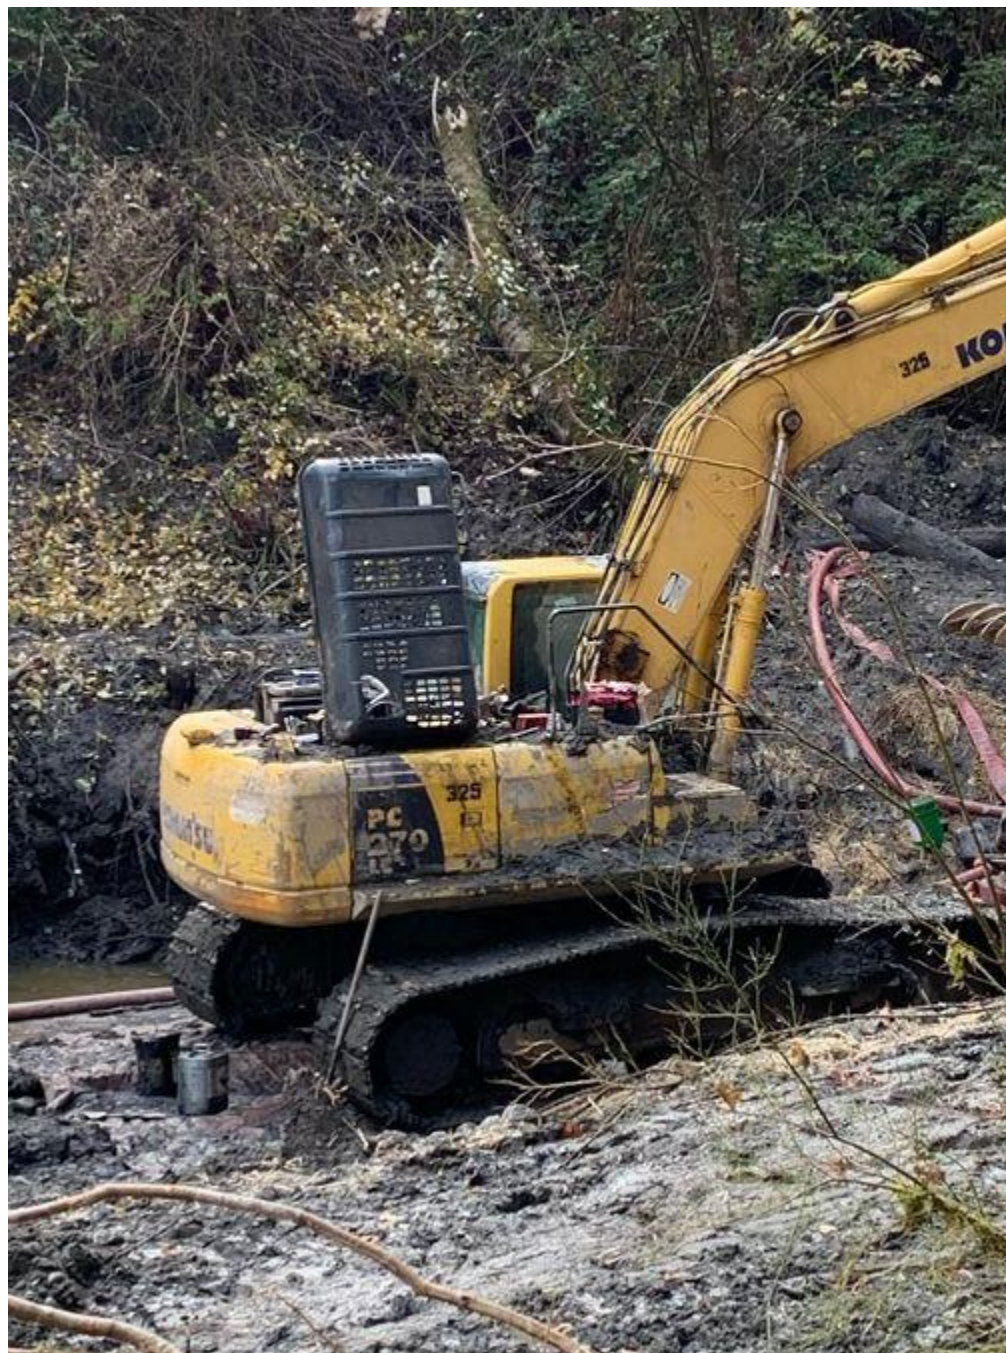
Photo 23

Photo Description: Recovered equipment from mudslide was actively being serviced at time of inspection. Tarp was placed under equipment, but no berming or secondary containment for containers was observed
