DEPARTMENT OF ECOLOGY State of Washington	<h2 style="text-align: center;">CONSTRUCTION STORMWATER GENERAL PERMIT</h2> <h3 style="text-align: center;">INSPECTION REPORT</h3> <p style="text-align: center;">State of Washington Department of Ecology</p>		
Section A: General Data			
Ecology Inspector(s): Elizabeth Fint	On-Site Representative Name: Jay Pullen Title: CESCL Phone: 425-351-0306 Email:	Inspection Date and Entry/Exit Time: October 18, 2021, 10:45/12:30 Receiving waters: Creek and wetland tributary to Snohomish River	Inspection Type: Unannounced Permit webpage: https://fortress.wa.gov/ecy/paris/FacilitySummary.aspx?FacilityId=60941
Section B: Background			
<p>The Bakerview Everett project is covered under the State of Washington's Construction Stormwater General Permit (CSGP). The CSGP is a National Pollutant Discharge Elimination System (NPDES) and a State Waste Discharge permit for discharge of construction-related stormwater.</p> <p>The project is also covered under Administrative Order 18193, which requires additional sampling of stormwater for contaminants that remain on site from past land use activities (landfill). The purpose of this inspection is to conduct a follow-u

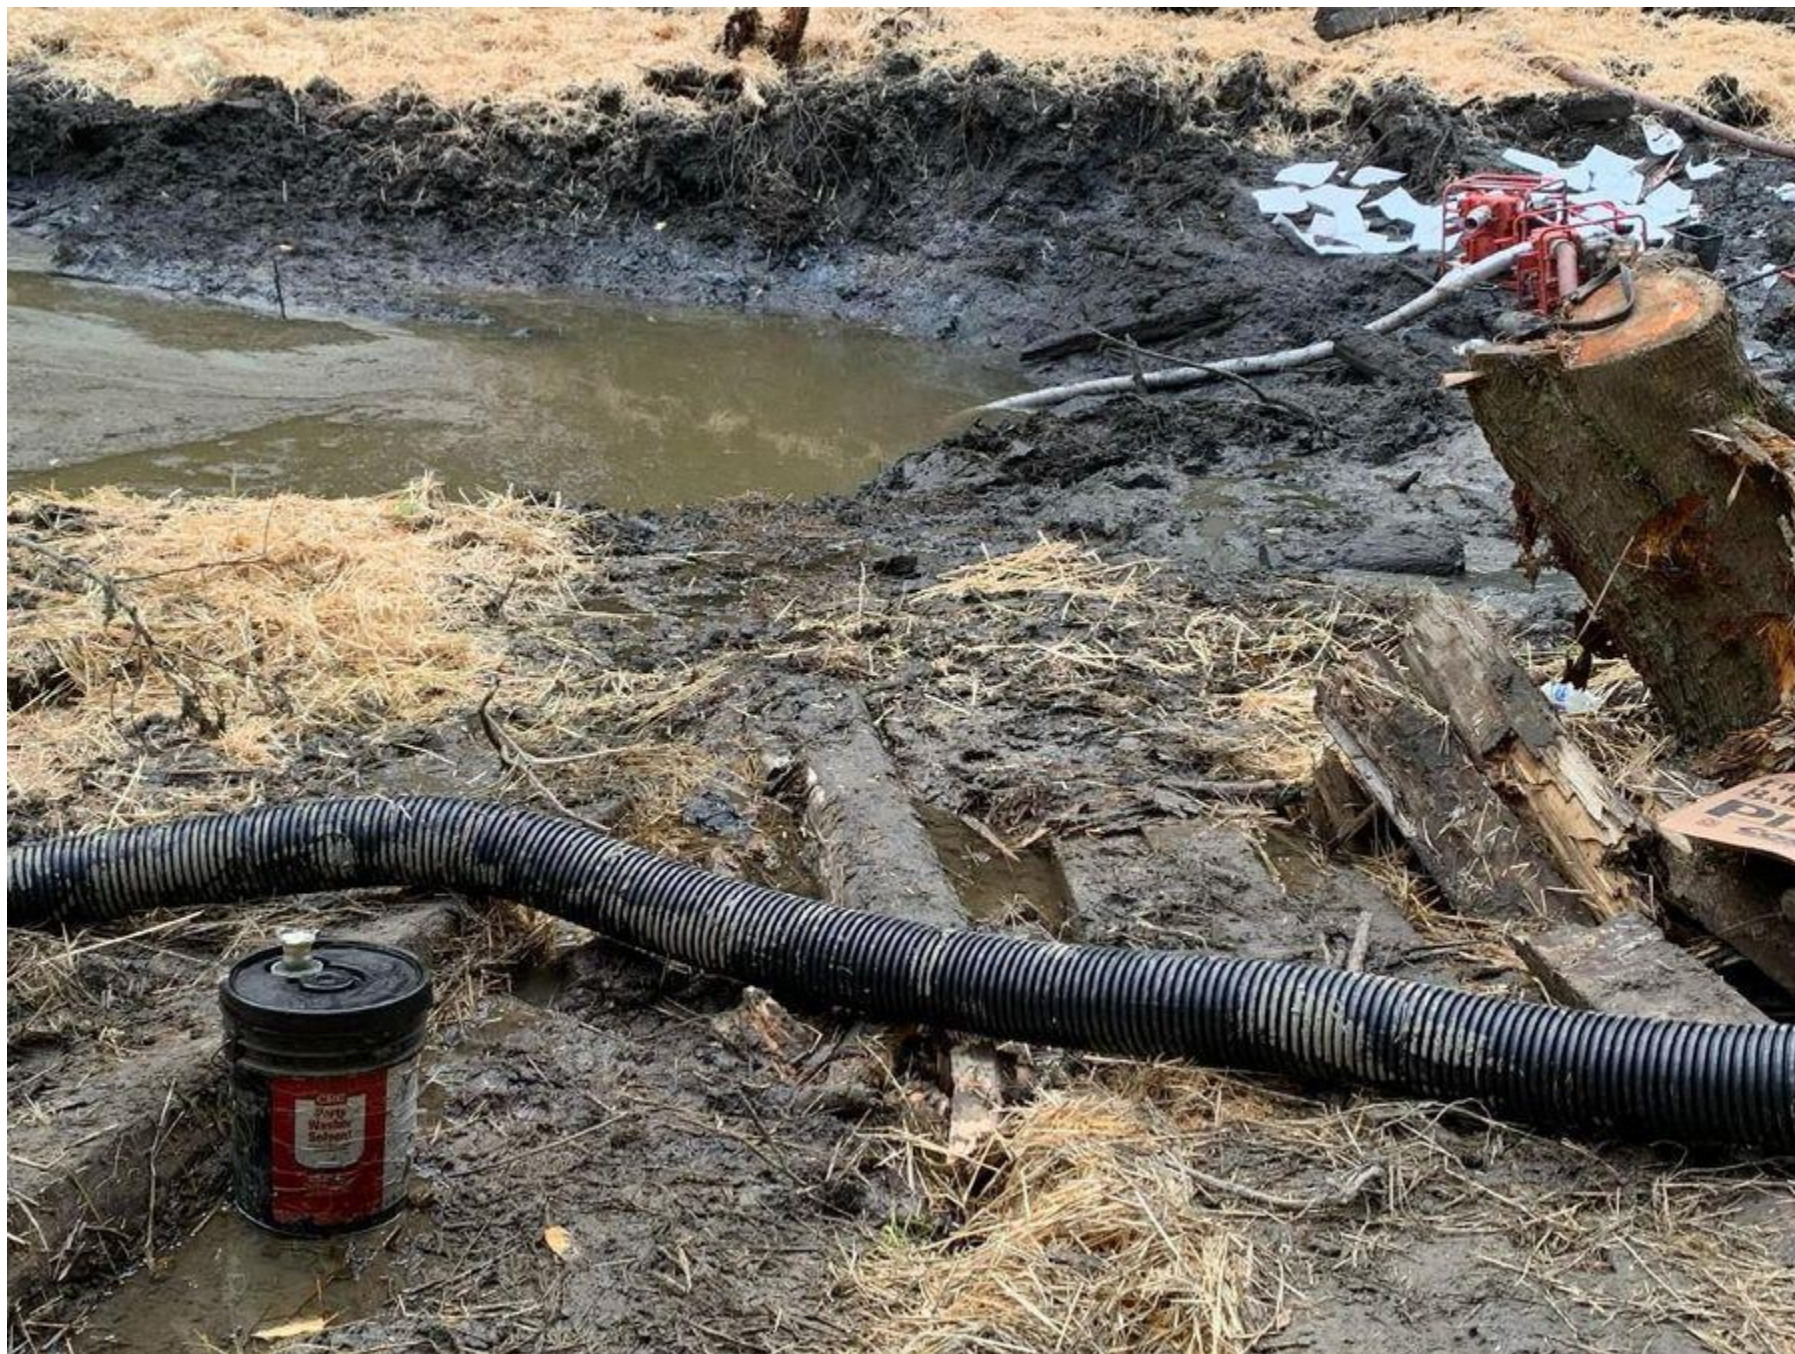
Photo 24

Photo Description: Chemical containers with no secondary containment at time of inspection. Site is pumping water from excavated hole up the slope to temporary sediment basin at cul-de-sac area.

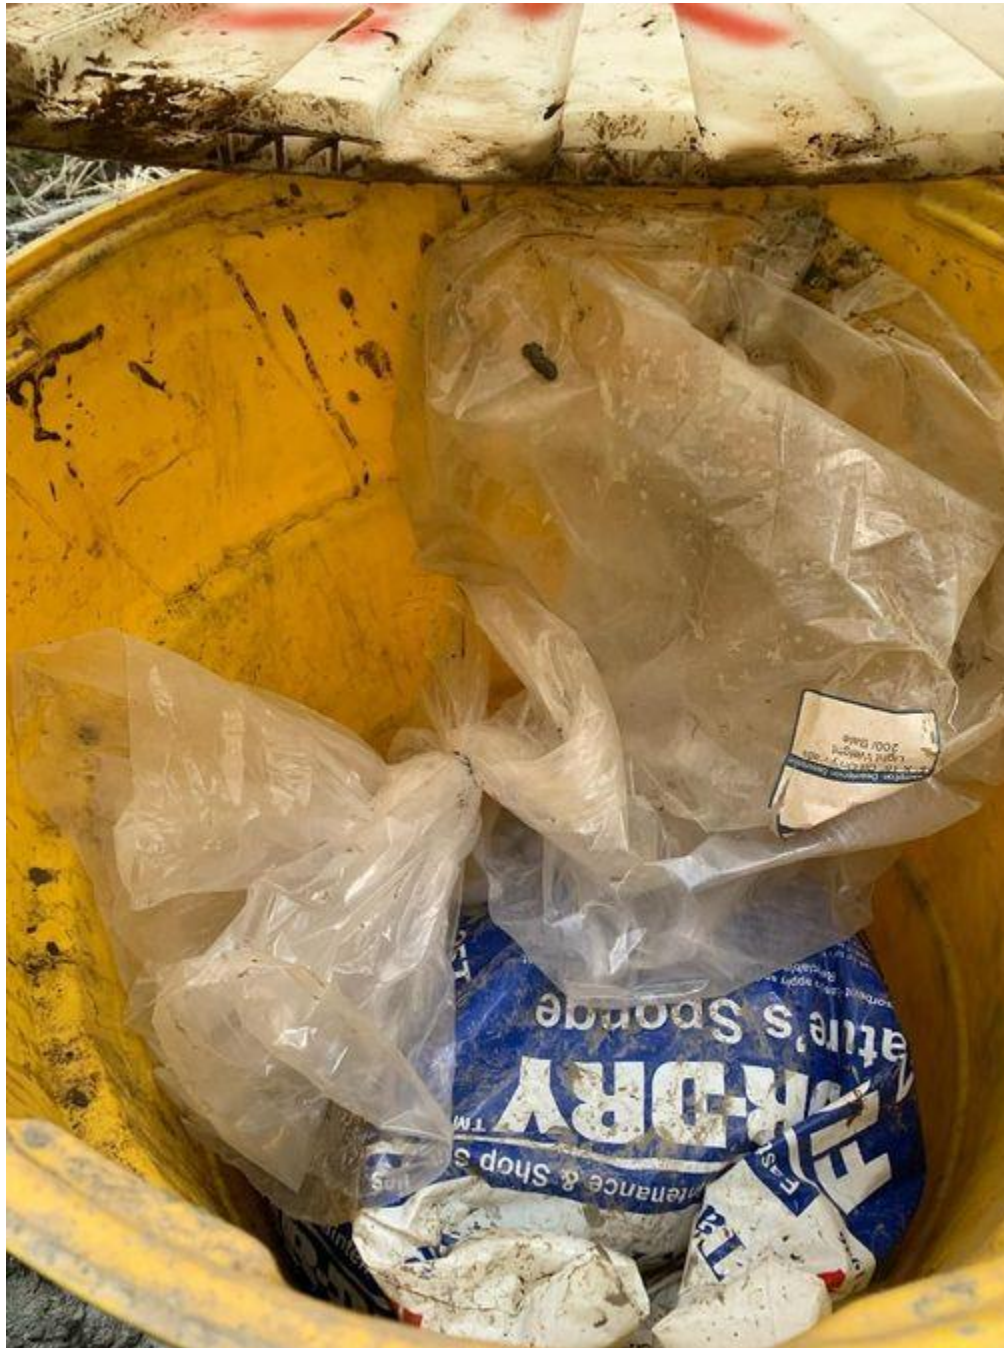
Photo 25

Photo Description: Spill kits only had floor dry product. Spill kits should be inventoried and items replaced as necessary

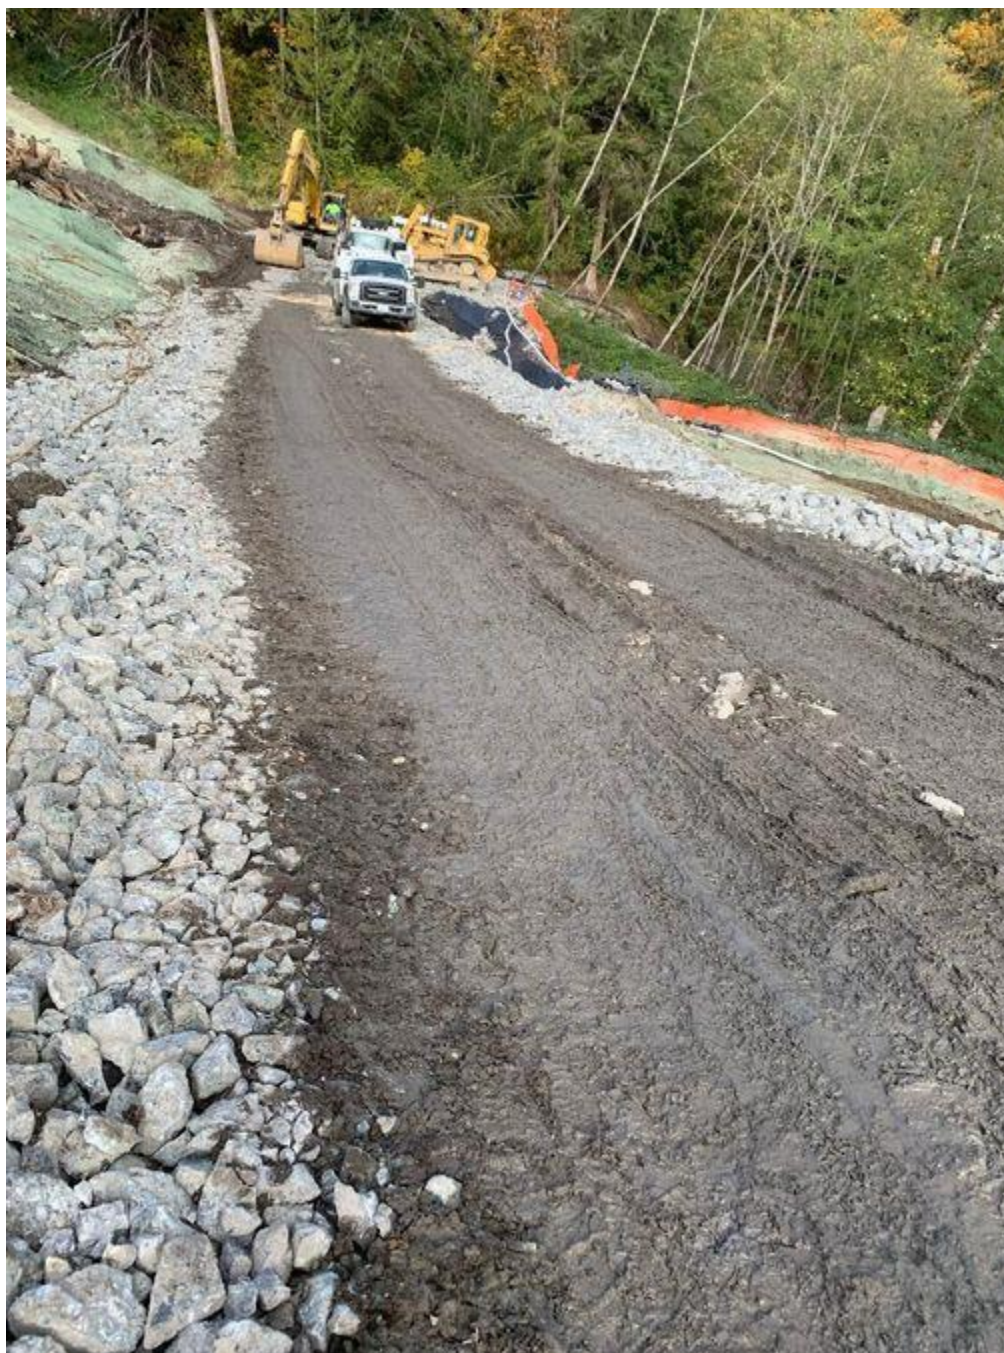
Photo 26

Photo Description: Access roads must be maintained and refreshed - observed access roads with sediment deposition at time of inspection.

- The site should ensure access roads on site are maintained and do not generate turbid discharges – refresh the aggregate access roads and remove sediment build up on the roads (photo 26).

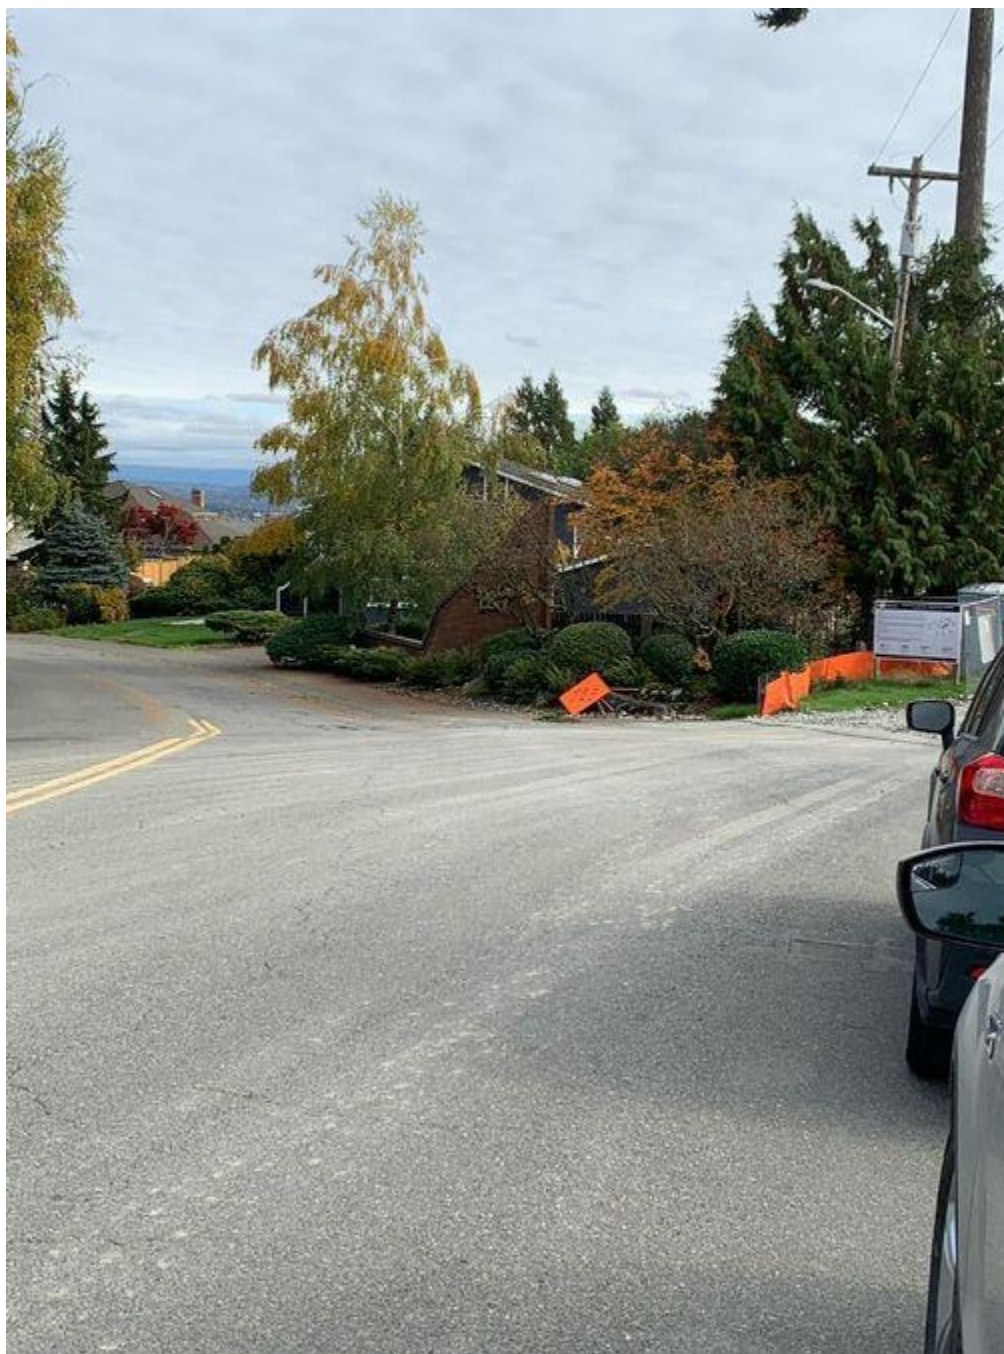
Photo 27

Photo Description: Observed several vehicles drive through track out in road at time of inspection. No sweeper present at time of inspection.
