DEPARTMENT OF ECOLOGY State of Washington	<h2 style="text-align: center;">CONSTRUCTION STORMWATER GENERAL PERMIT</h2> <h3 style="text-align: center;">INSPECTION REPORT</h3> <p style="text-align: center;">State of Washington Department of Ecology</p>		
Section A: General Data			
Ecology Inspector(s): Shannon Adams Jefferson Davis	On-Site Representative Name: Grant Gehring Title: EIT – SynTier Engineering Phone: 509.339.6187 Email: grant@syntierengr.com	Inspection Date: November 1, 2021 Entry/Exit Time: 10:50/11:53	Inspection Type: Announced
		Receiving waters: Palouse Watershed	Permit webpage: Facility Summary
Section B: Background			
<p>The University Village project is covered under the State of Washington’s Construction Stormwater General Permit (CSWGP). The CSWGP is a National Pollutant Discharge Elimination System (NPDES) and a State Waste Discharge permit for discharge of construction-related stormwater. The purpose of this inspection was to conduct a compliance inspection and to provide technical assistance as appropriate.</p> <p>Grant Gehring - SynTier Engineering, was present during inspection and all observations and recommendations were discussed.</p> <p>Weather at time o

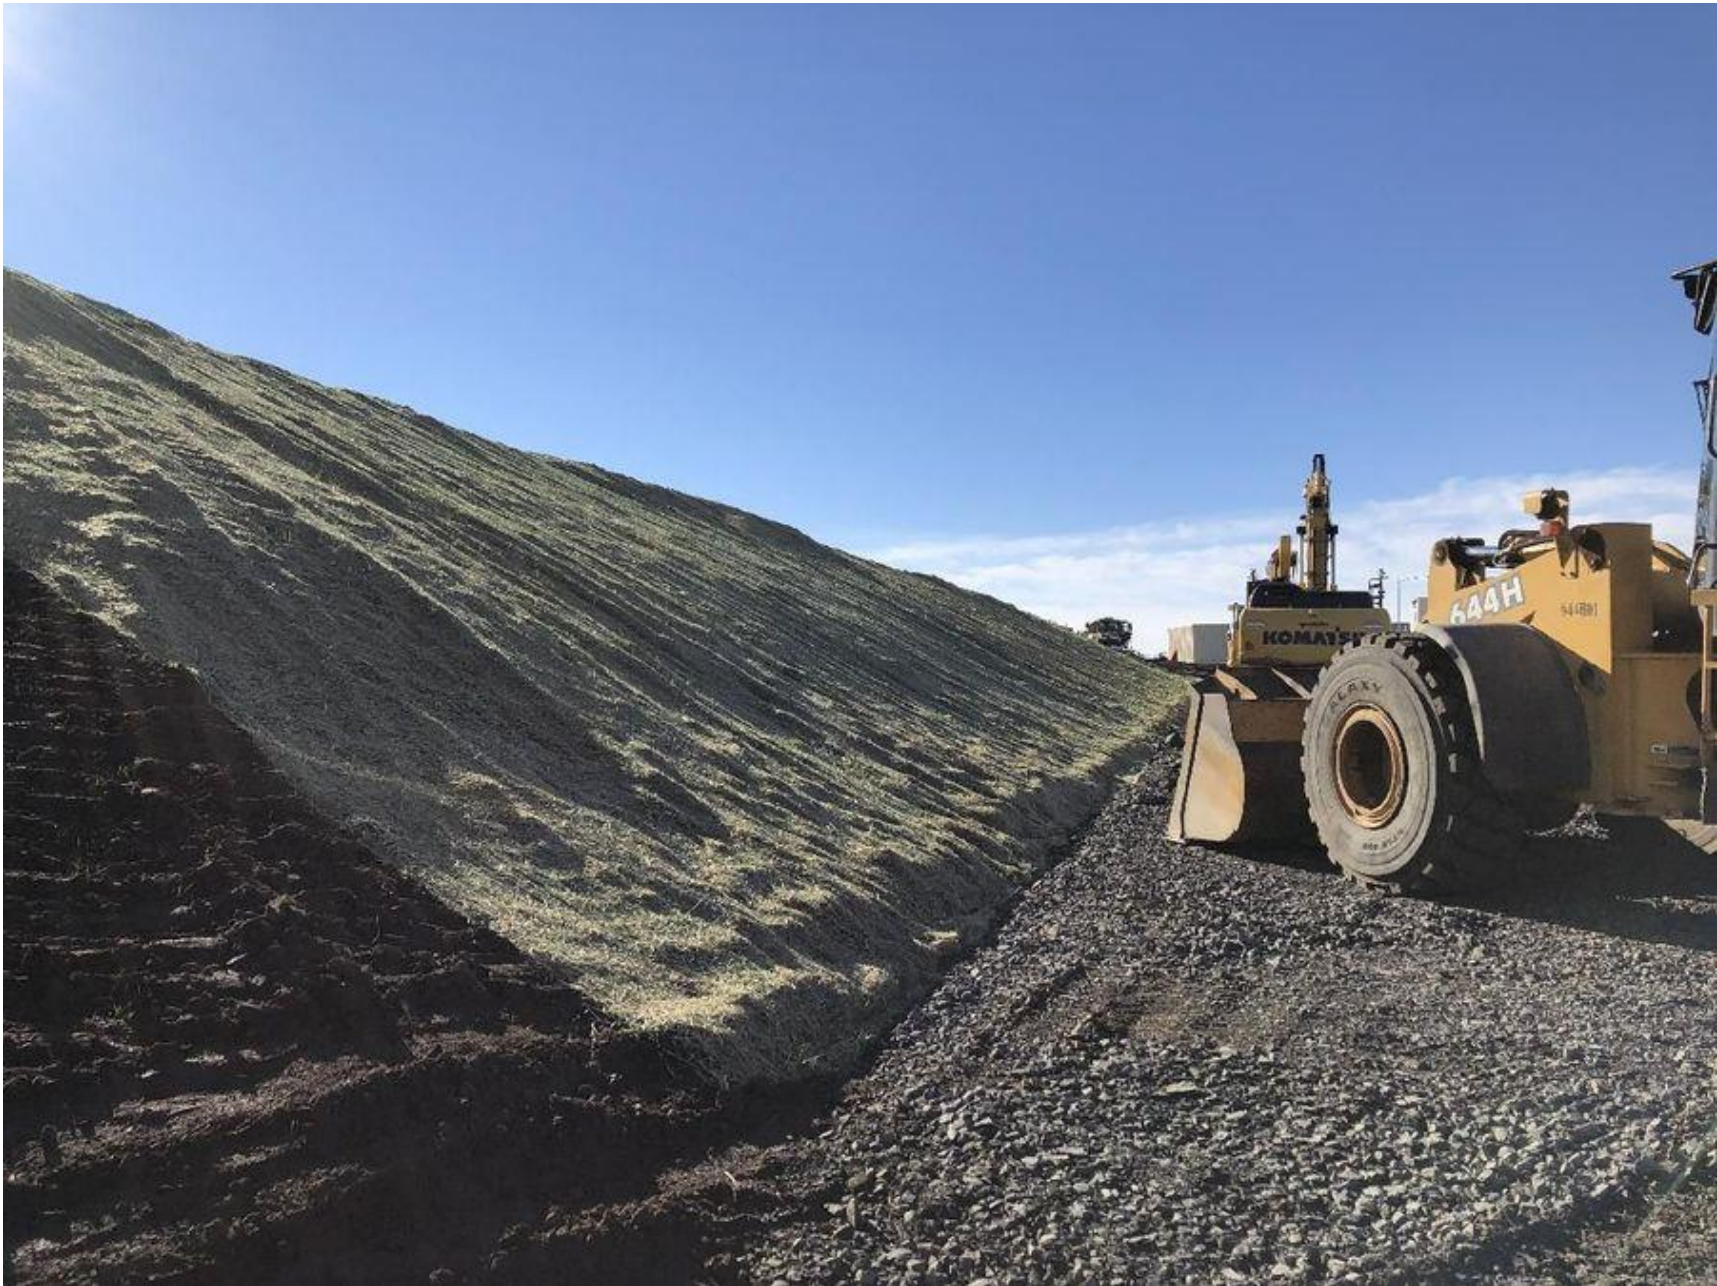
Photo 1

Photo Description: Erosion control blanket installed on slope.

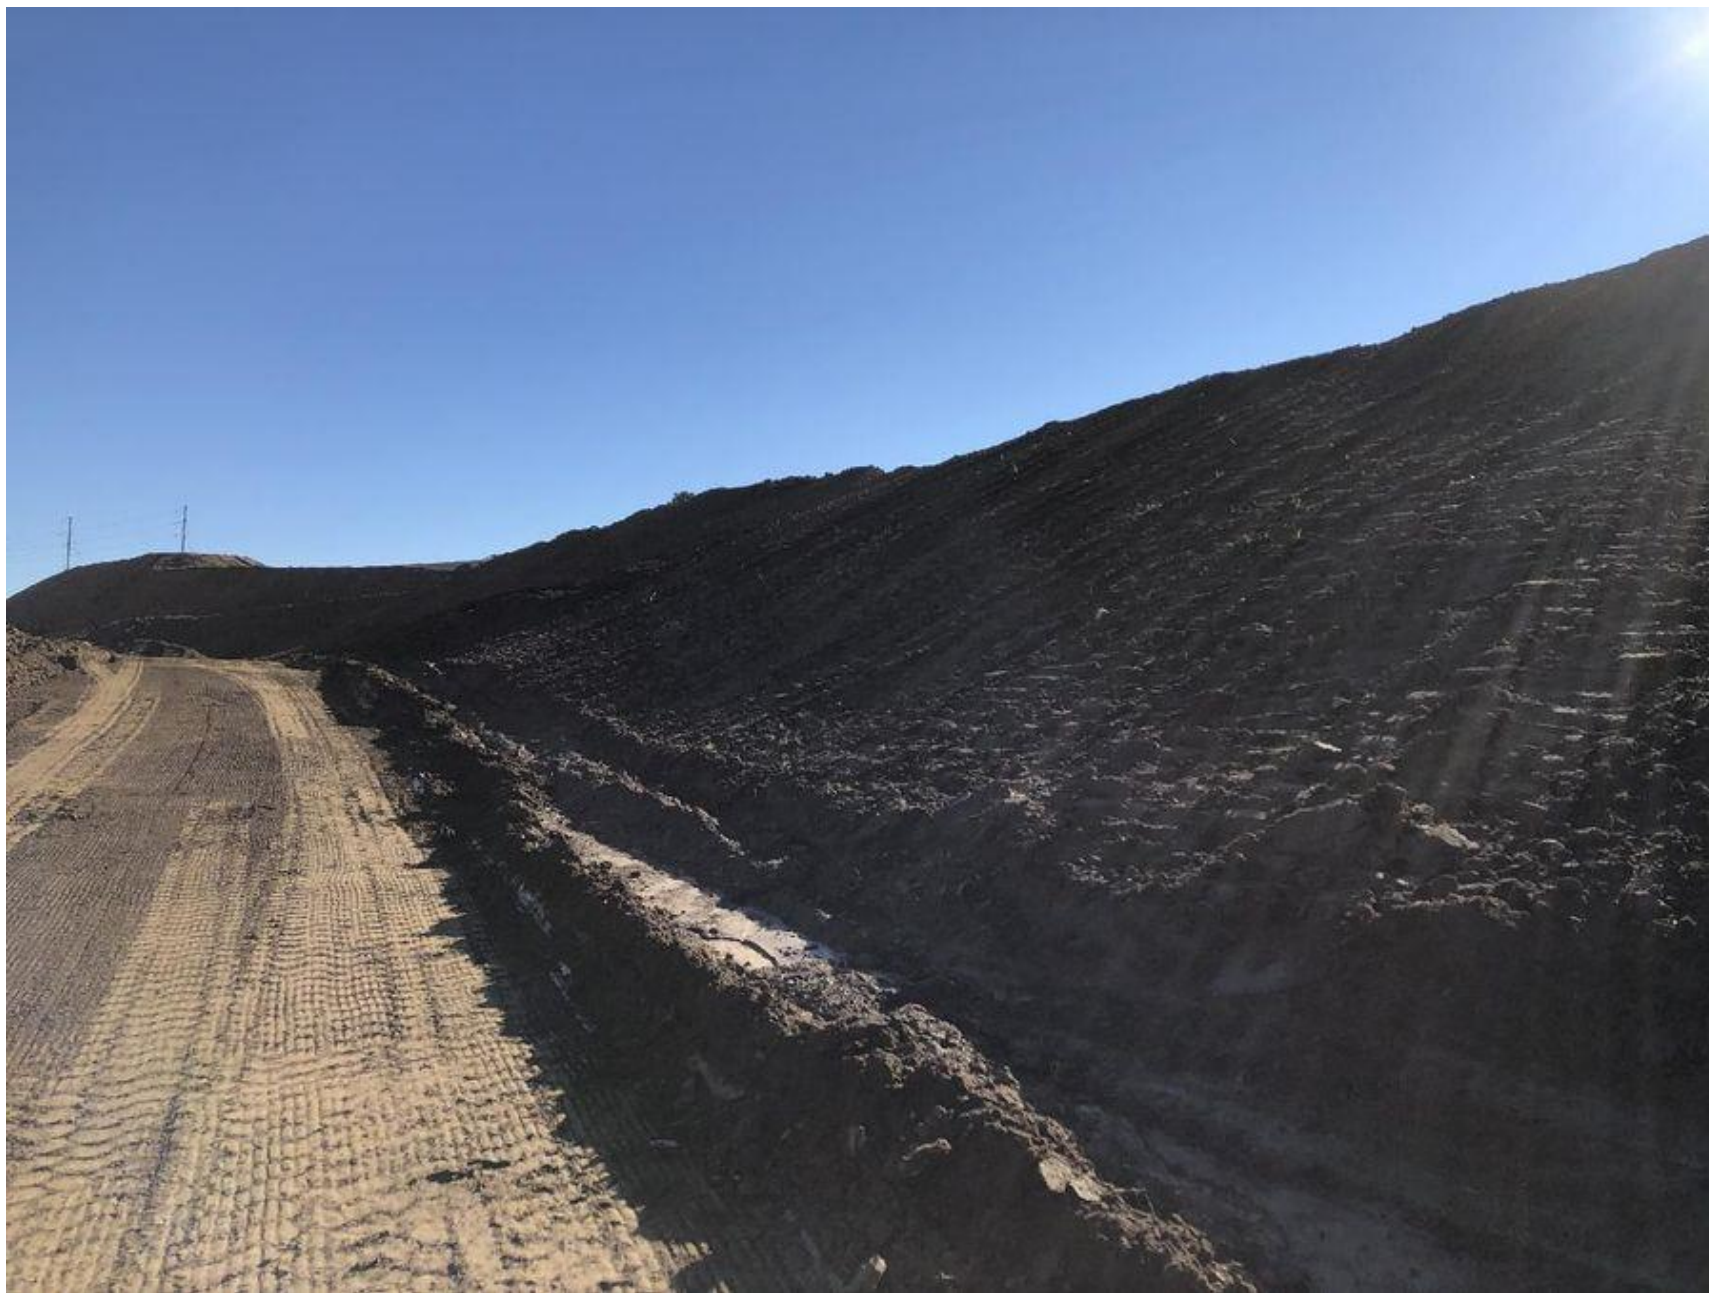
Photo 2

Photo Description: Exposed soil.

<p><u>S9.D.5 Stabilize Soils</u></p> <p>Failure to meet S9.D.5.a: The Permittee must stabilize exposed and unworked soils by application of effective BMPs that prevent erosion. Applicable BMPs include, but are not limited to: temporary and permanent seeding, sodding, mulching, plastic covering, erosion control fabrics and matting, soil application of polyacrylamide (PAM), the early application of gravel base on areas to be paved, and dust control., Failure to meet S9.D.5.d: The Permittee must not allow soils to remain exposed and unworked for more than the time periods set forth below to prevent erosion east of the Cascade Mountains Crest: During the dry season (July 1 - September 30): 10 days or; During the wet season (October 1 - June 30): 5 days., Failure to meet S9.D.5.e: The Permittee must stabilize soils at the end of the shift before a holiday or weekend if needed based on the weather forecast., Failure to meet S9.D.5.f: The Permittee must stabilize soil stockpiles from erosion, protected with sediment trapping measures, and where possible, be located away from storm drain inlets, waterways, and drainage channels. Stabilize exposed and unworked soils, including stockpiles, by application of effective BMPs to prevent erosion, as set forth in permit condition S9.D.5.a and timeline in S9.D.5.d.</p>	<p>Permittee must not allow soils to remain exposed and unworked for more than the time periods set forth below to prevent erosion: During the wet season (October 1 – June 30): 5 days from the date of this inspection.</p>	<p>C120E, C121E, C122E, C123E, C124E, C125E, C126E, C130E, C131E, C140E</p>

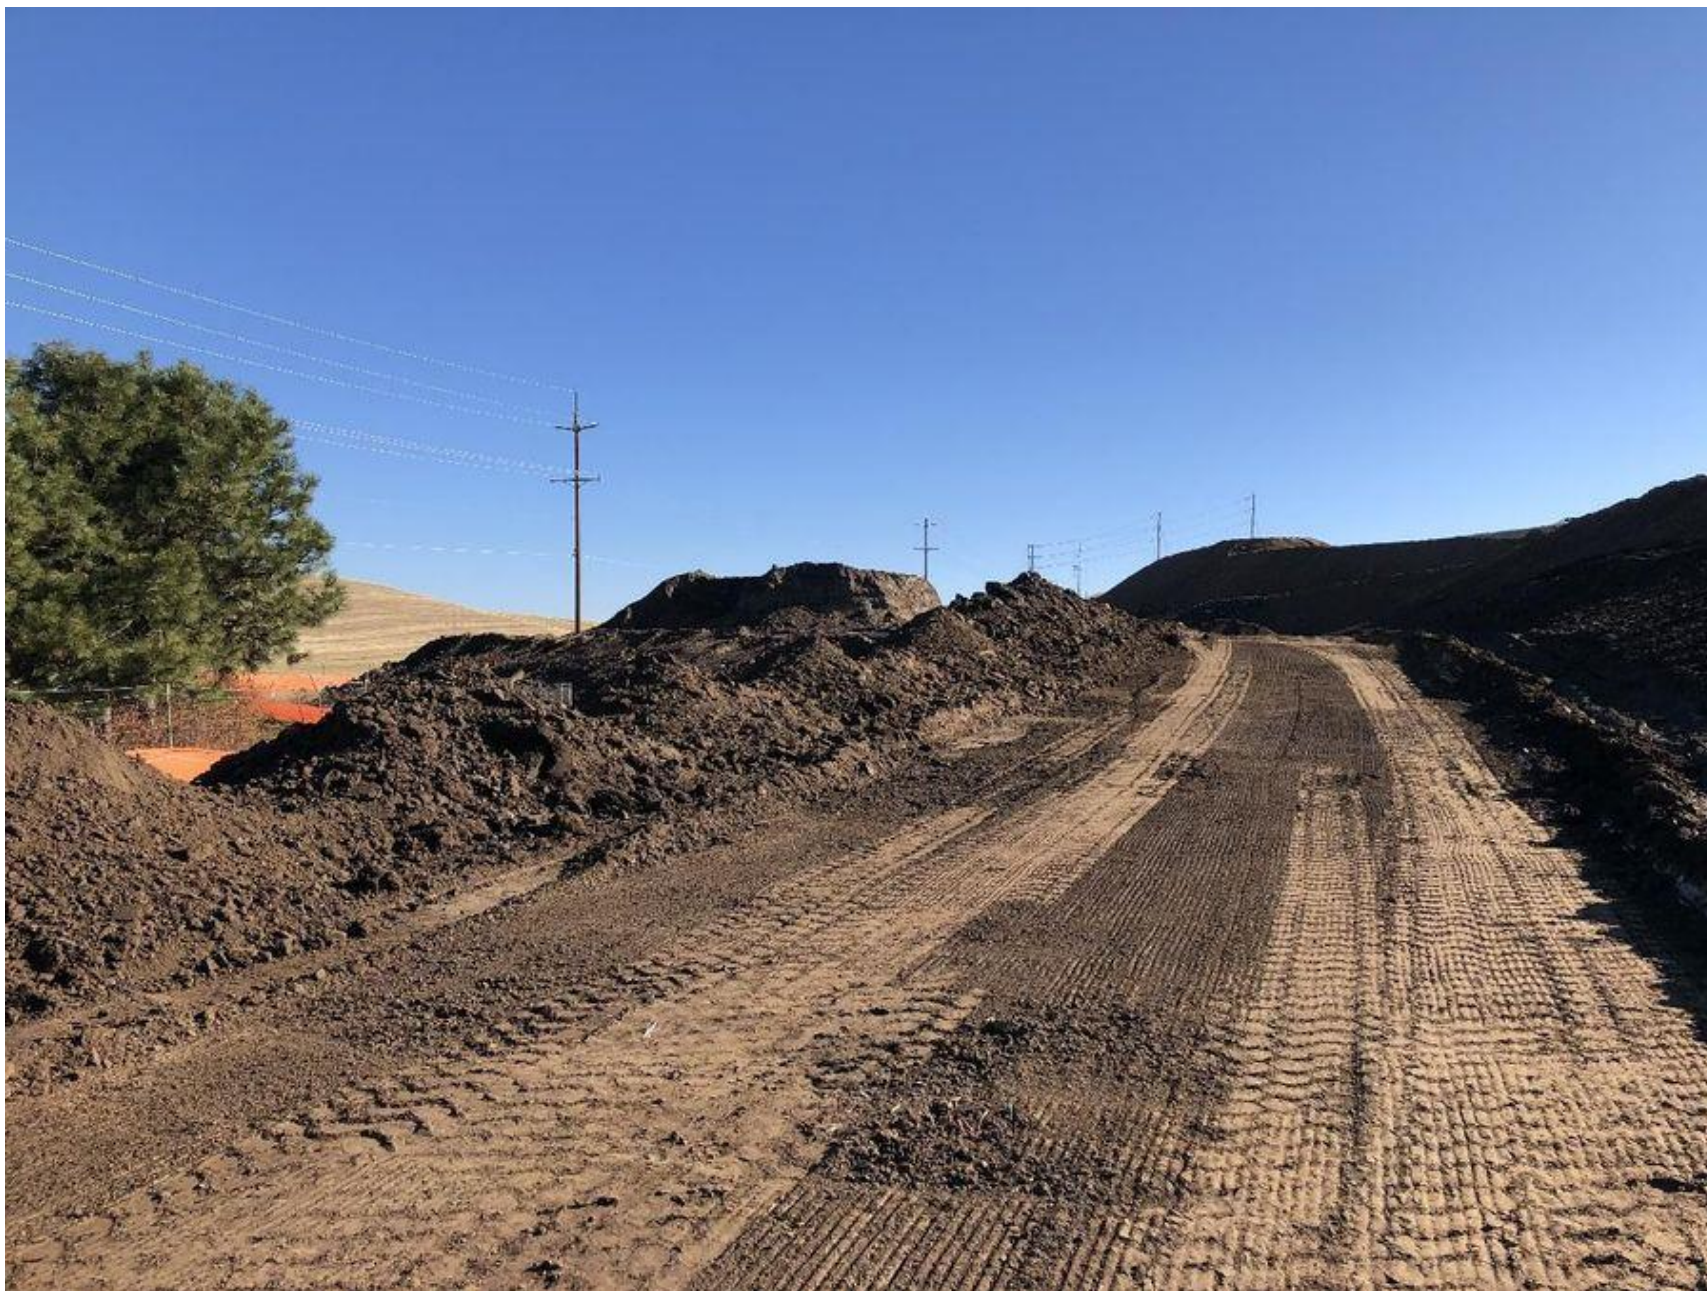
Photo 3

Photo Description: Exposed soil.

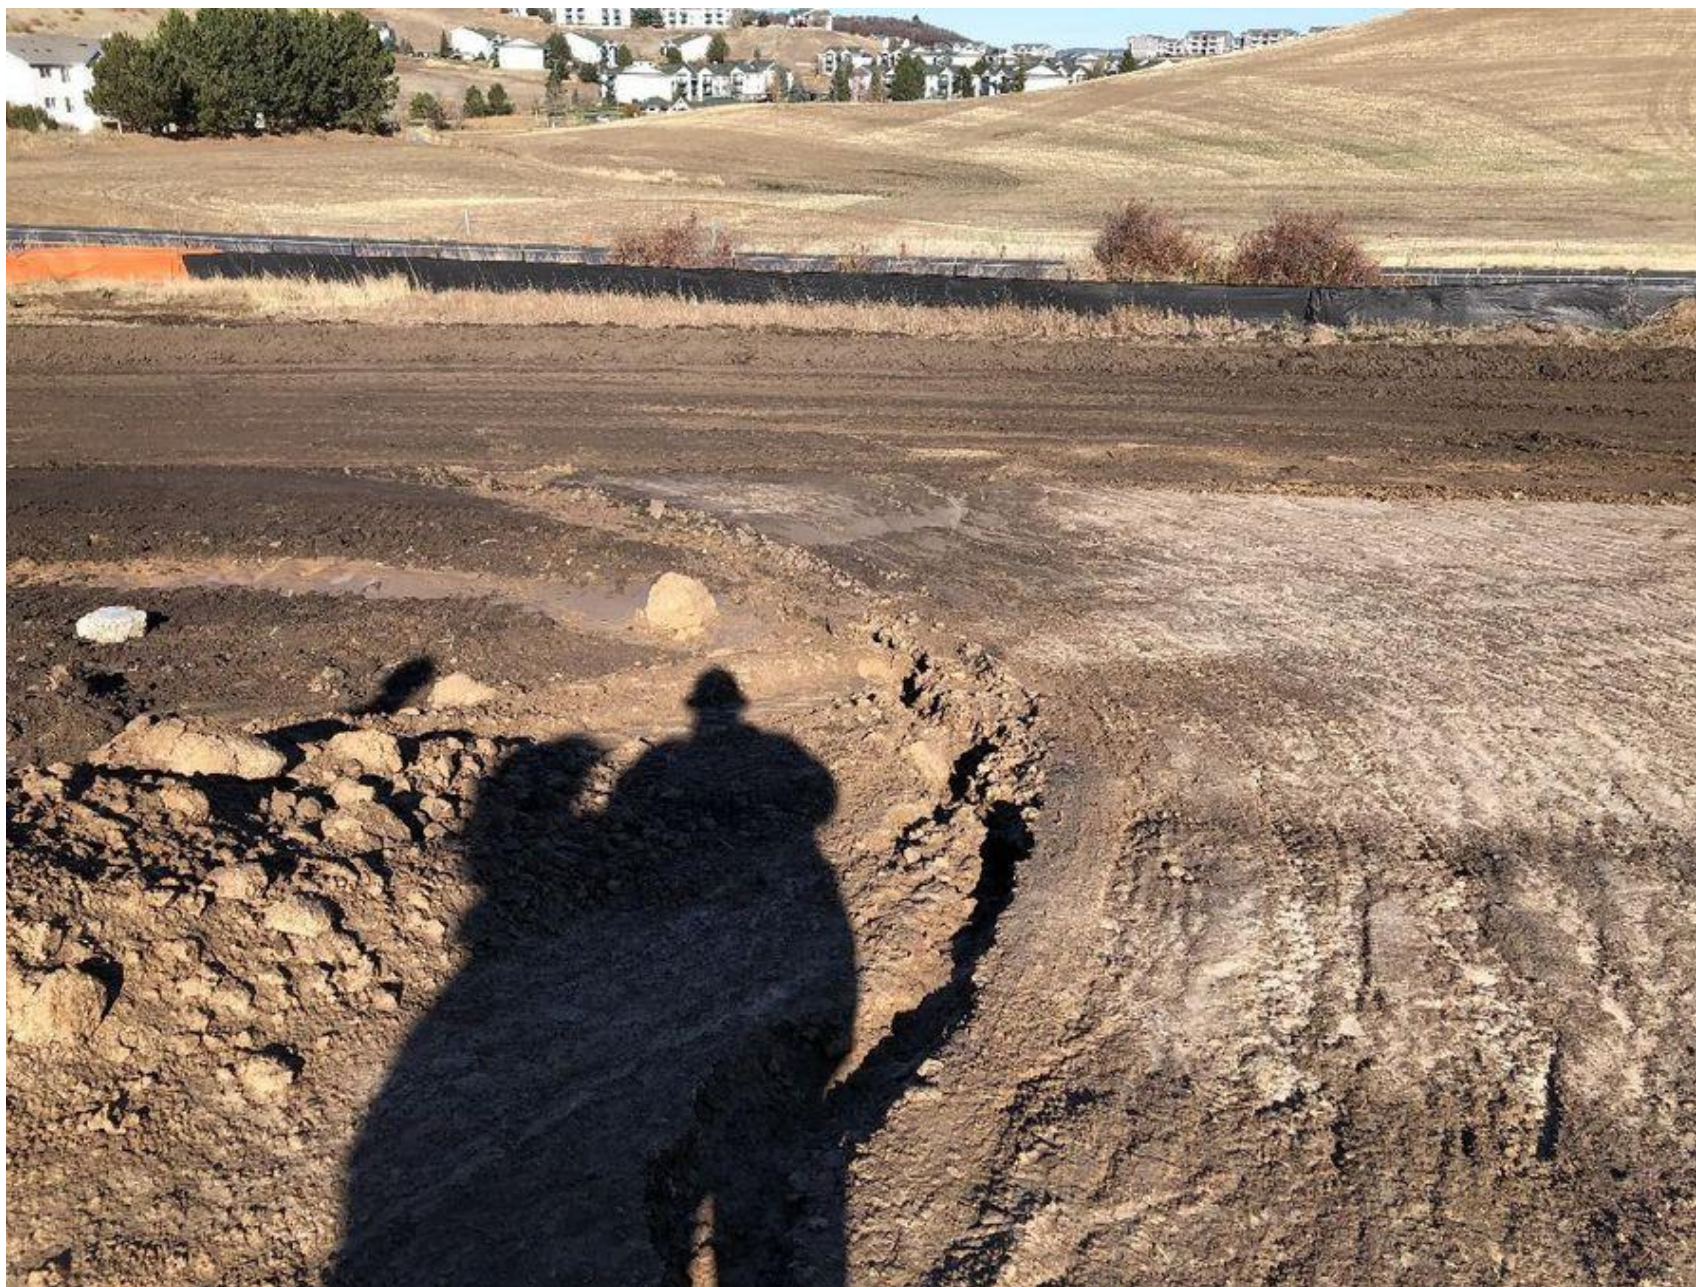
Photo 4

Photo Description: Exposed soil.

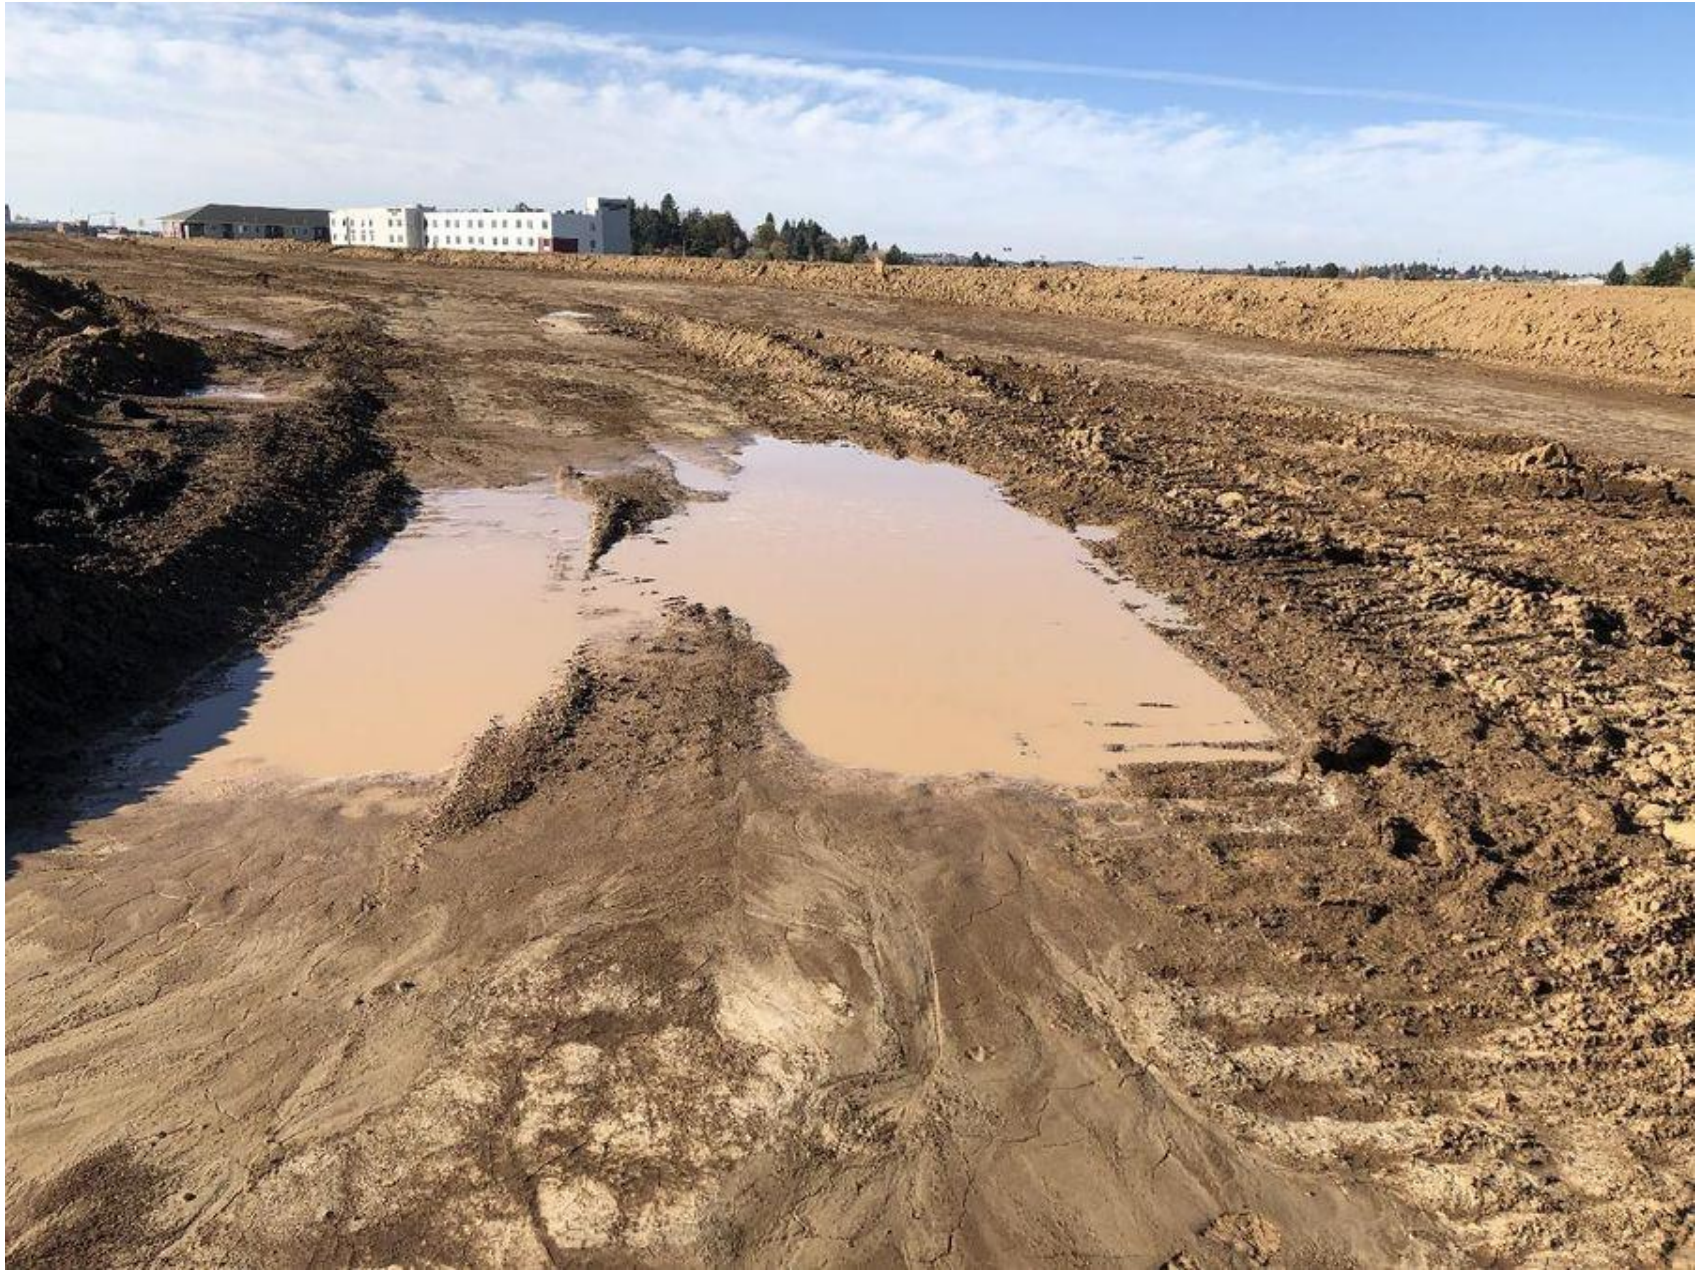
Photo 5

Photo Description: Exposed soil and turbid stormwater ponded on site.

<p><u>S9.D.4 Install Sediment Controls</u></p> <p>Failure to meet S9.D.4.b: Minimize sediment discharges from the site. The design, installation and maintenance of erosion and sediment controls must address factors such as the amount, frequency, intensity and duration of precipitation, the nature of resulting stormwater runoff, and soil characteristics, including the range of soil particle sizes expected to be present on the site., Failure to meet S9.D.4.c: Direct stormwater runoff from disturbed areas through a sediment pond or other appropriate sediment removal BMP, before the runoff leaves a construction site or before discharge to an infiltration facility. Runoff from fully stabilized areas may be discharged without a sediment removal BMP, but must meet the flow control performance standard of Special Condition S9.D.3.a. Install sediment controls to minimize the discharge of pollutants, as set forth in permit condition S9.D.4.b.</p>	<p>Immediately begin. Address the problems no later than 10 days from the date of this inspection.</p>	<p>C231E, C232E, C233E, C234E, C235E, C240E, C241E, C250E, C251E</p>

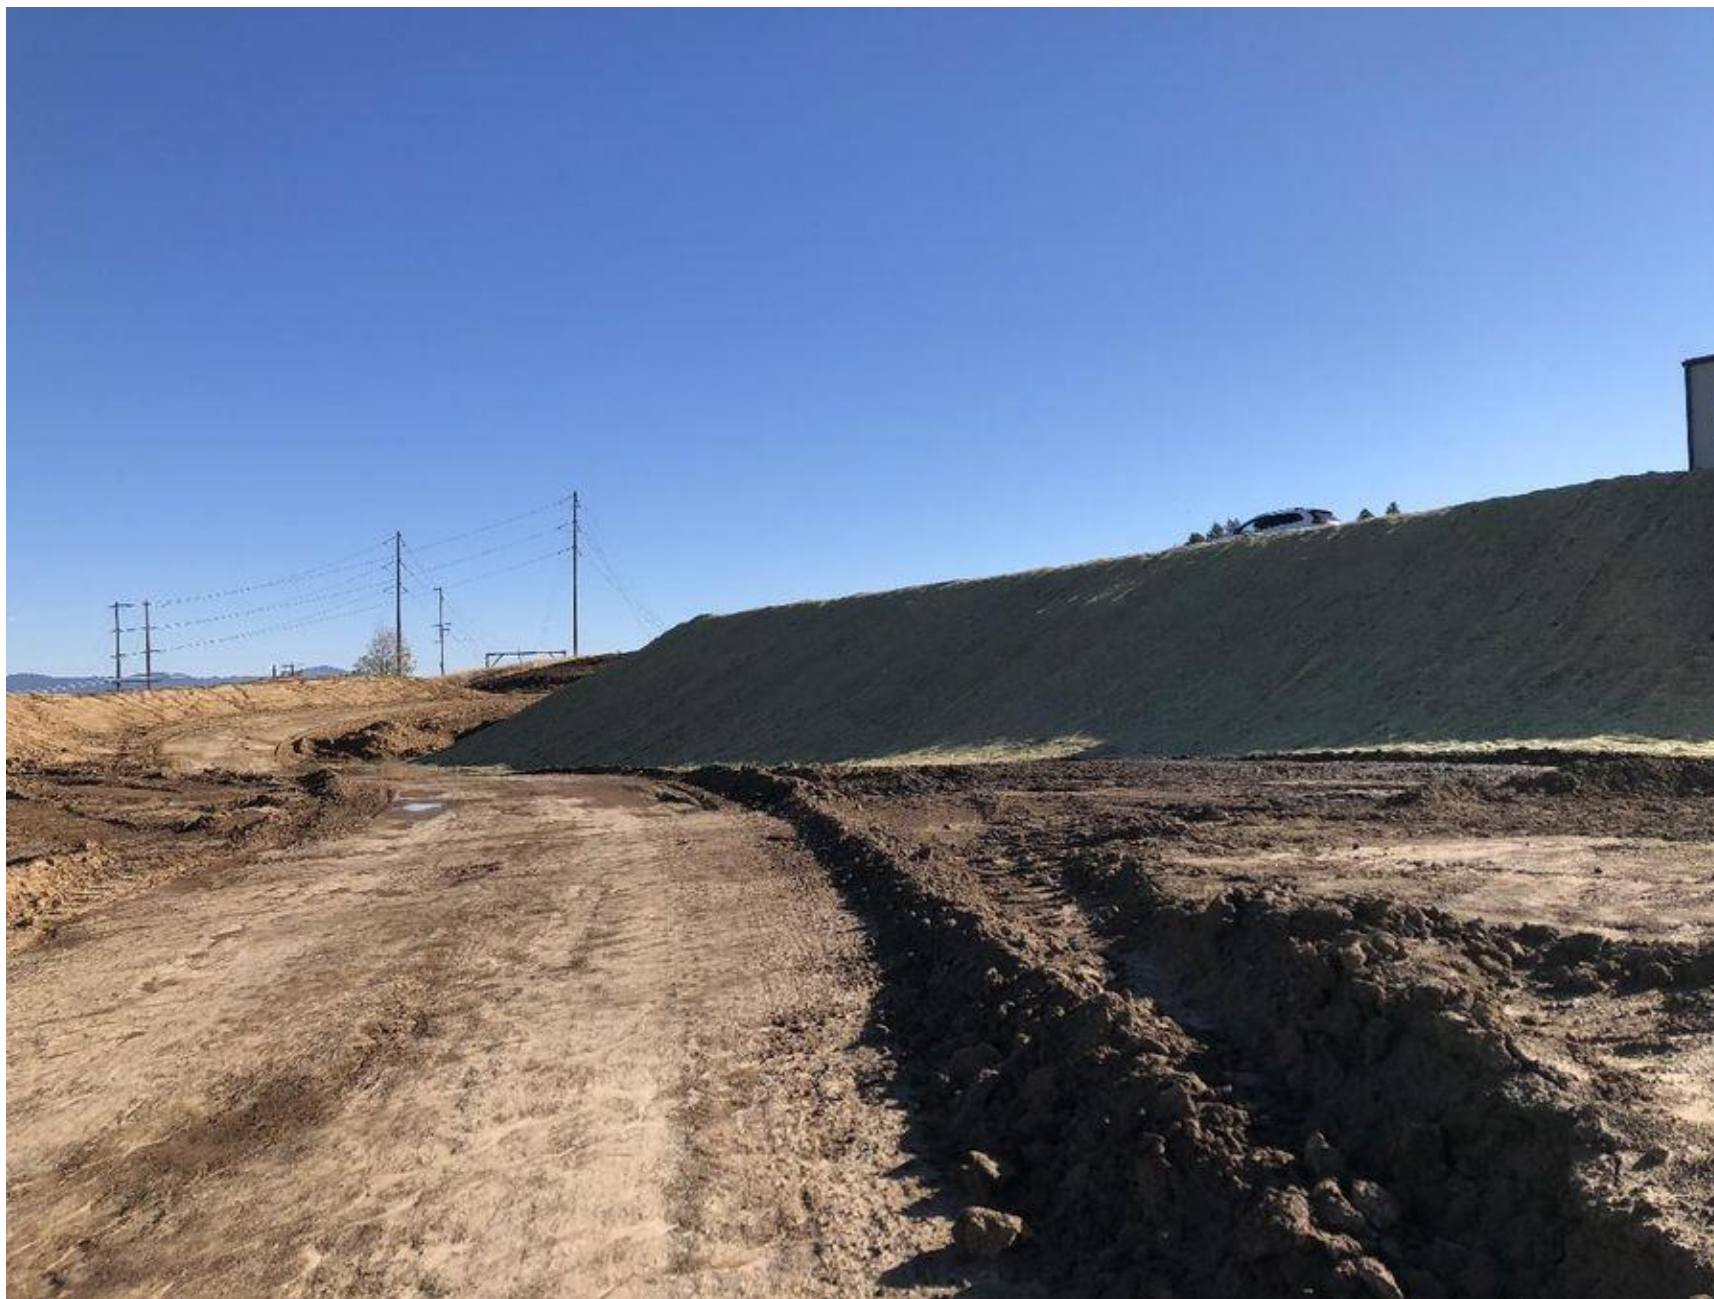
Photo 6

Photo Description: Exposed soil and erosion control blanket.

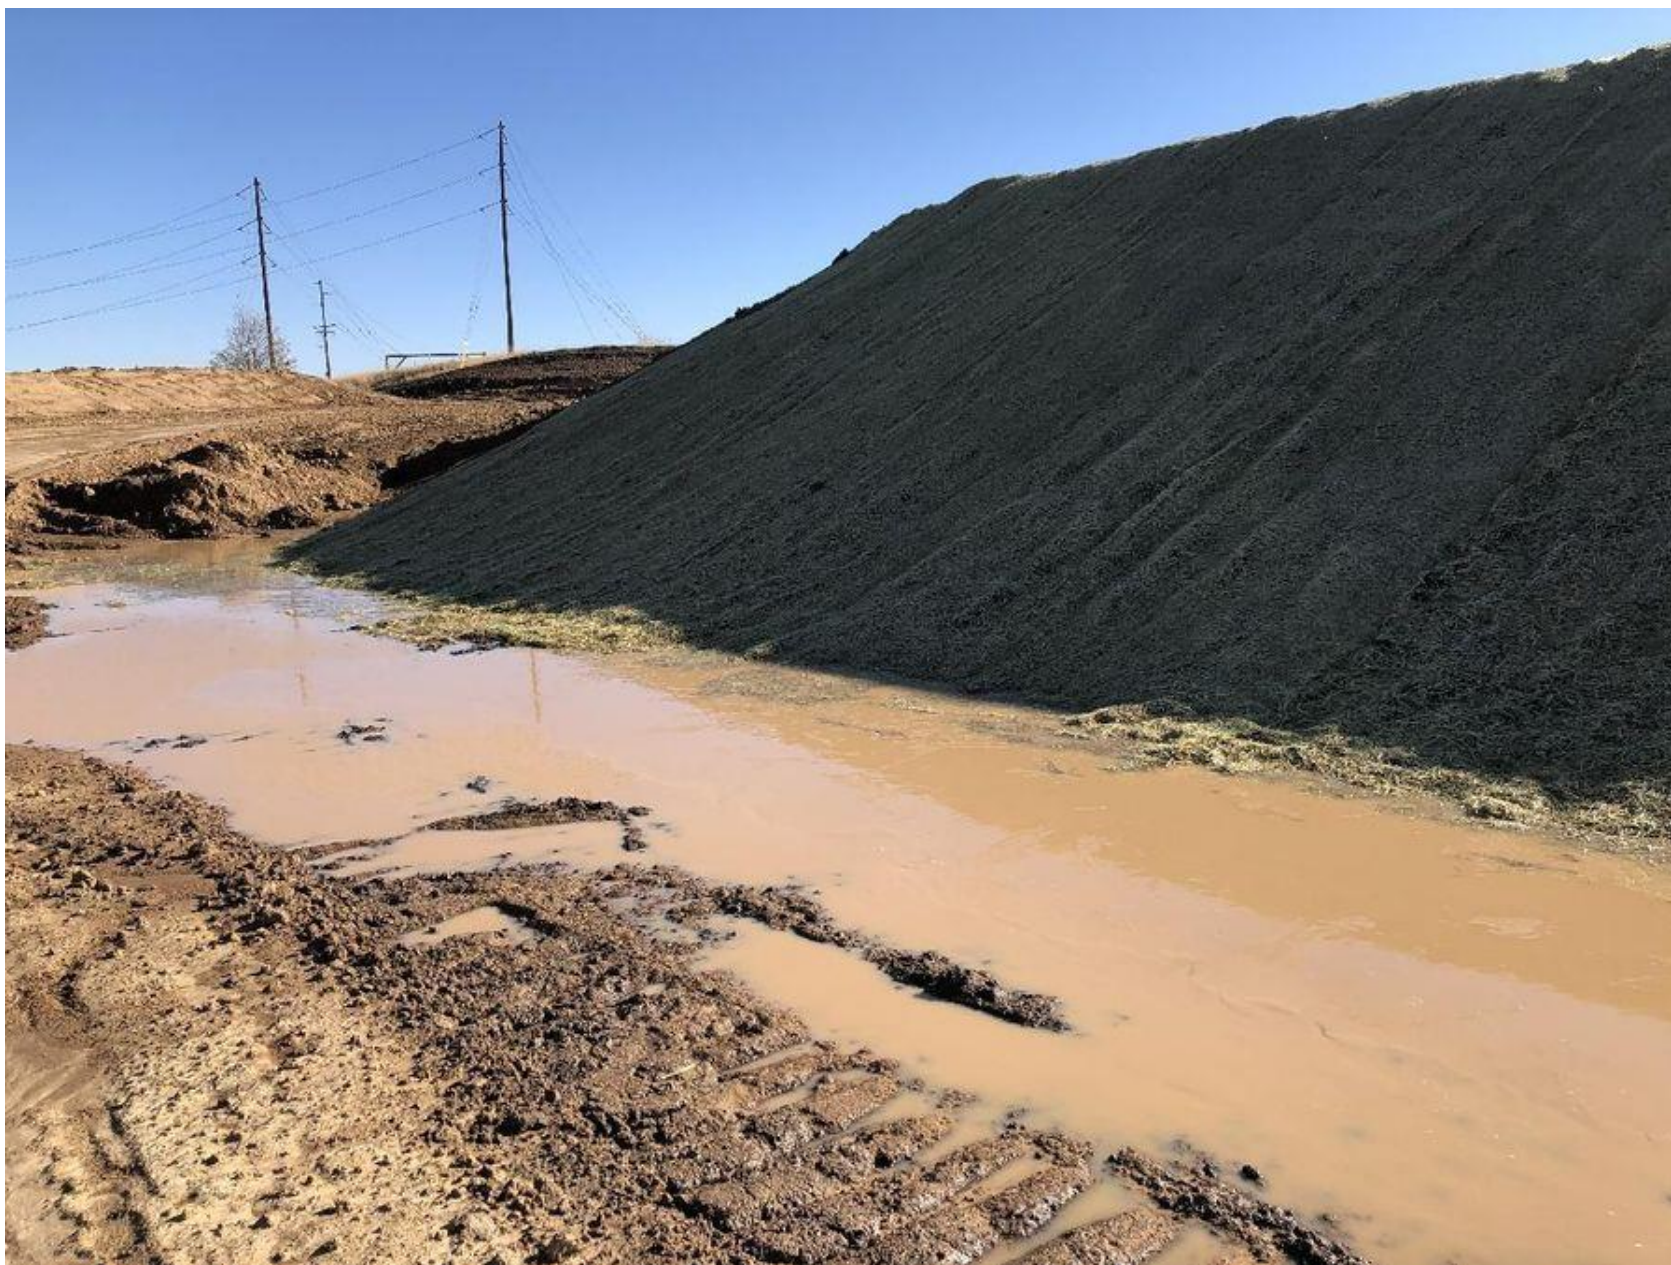
Photo 7

Photo Description: Turbid stormwater ponded on site.

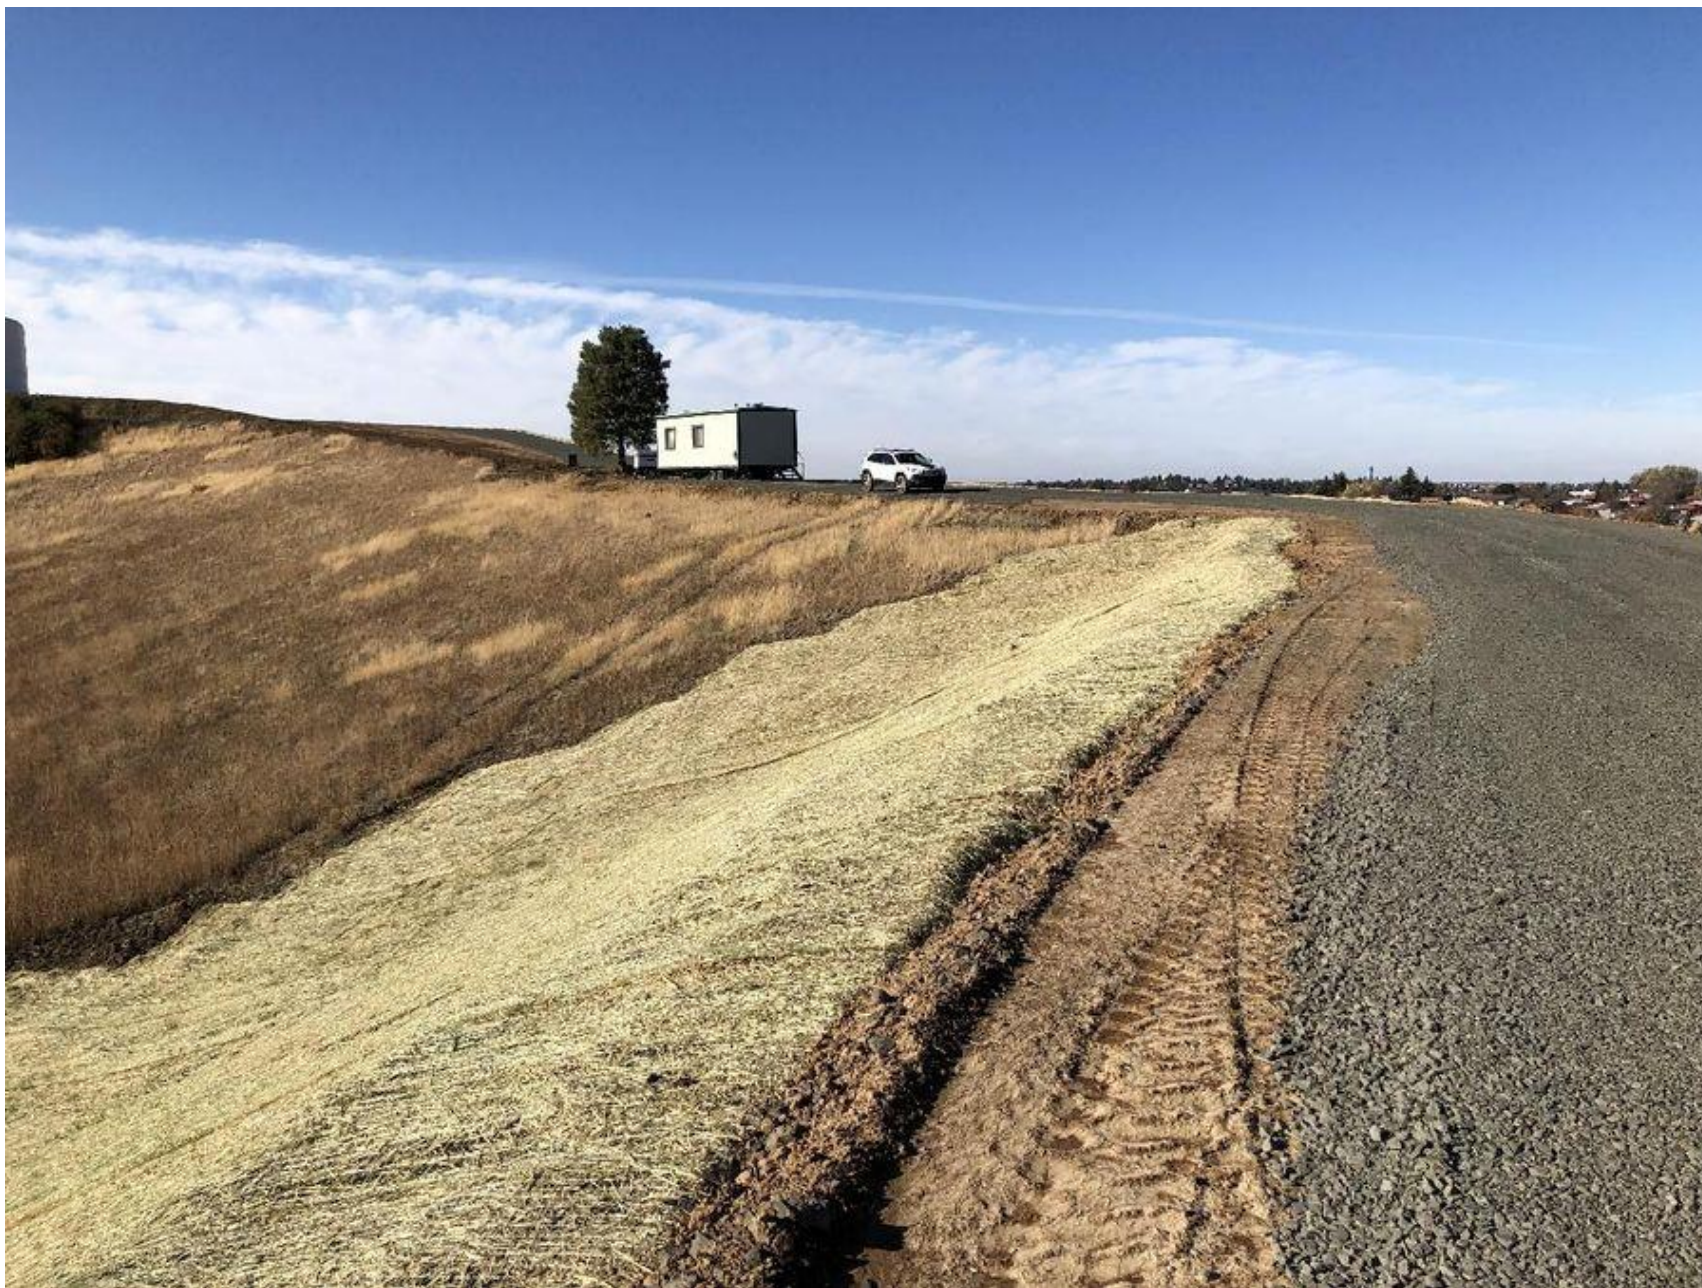
Photo 8

Photo Description: Erosion control blanket above golf course.

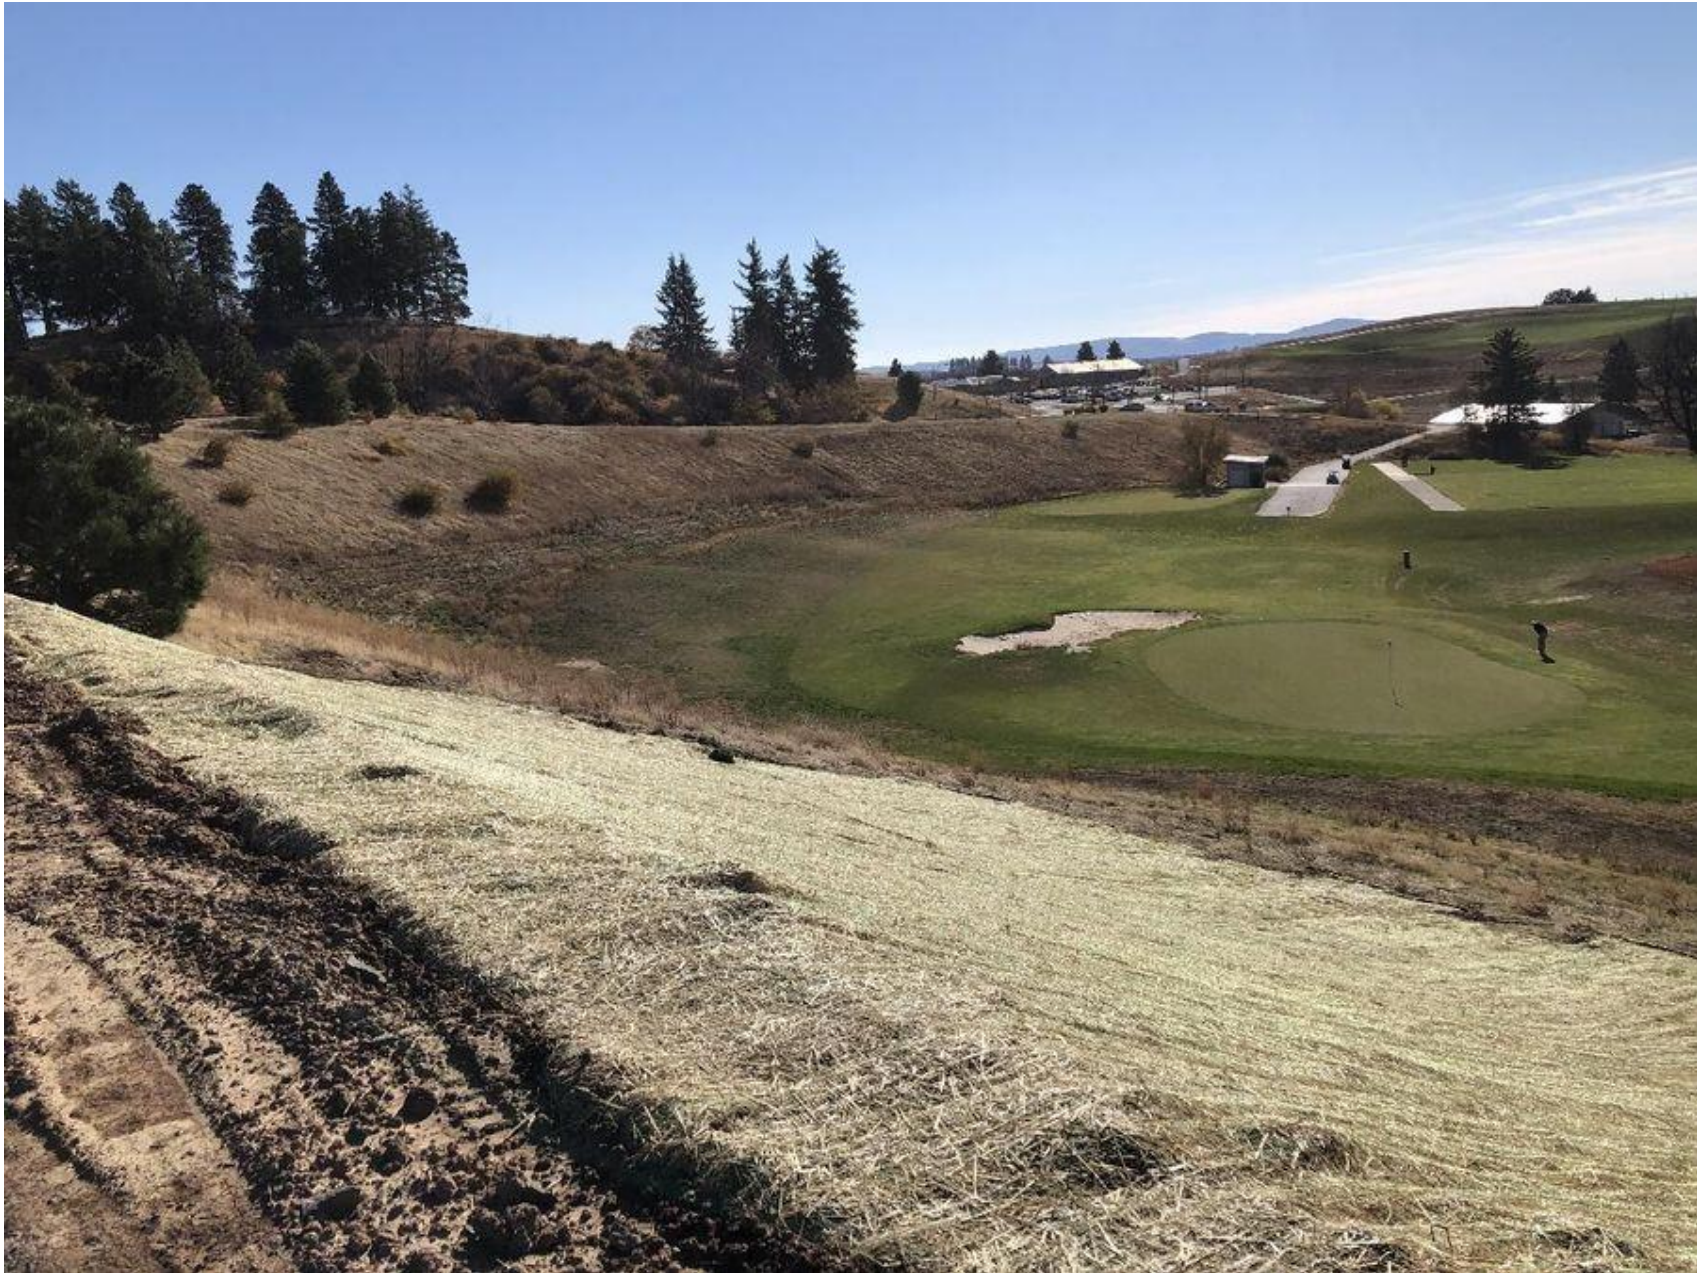
Photo 9

Photo Description: Erosion control blanket above golf course.
