DEPARTMENT OF ECOLOGY State of Washington	<h2 style="text-align: center;">CONSTRUCTION STORMWATER GENERAL PERMIT</h2> <h3 style="text-align: center;">INSPECTION REPORT</h3> <p style="text-align: center;">State of Washington Department of Ecology</p>		
Section A: General Data			
Ecology Inspector(s): Shannon Adams Jefferson Davis	On-Site Representative Name: Grant Gehring Title: EIT – SynTier Engineering Phone: 509.339.6187 Email: grant@syntierengr.com	Inspection Date: November 1, 2021 Entry/Exit Time: 10:50/11:53	Inspection Type: Announced
		Receiving waters: Palouse Watershed	Permit webpage: Facility Summary
Section B: Background			
<p>The University Village project is covered under the State of Washington’s Construction Stormwater General Permit (CSWGP). The CSWGP is a National Pollutant Discharge Elimination System (NPDES) and a State Waste Discharge permit for discharge of construction-related stormwater. The purpose of this inspection was to conduct a compliance inspection and to provide technical assistance as appropriate.</p> <p>Grant Gehring - SynTier Engineering, was present during inspection and all observations and recommendations were discussed.</p> <p>Weather at time o

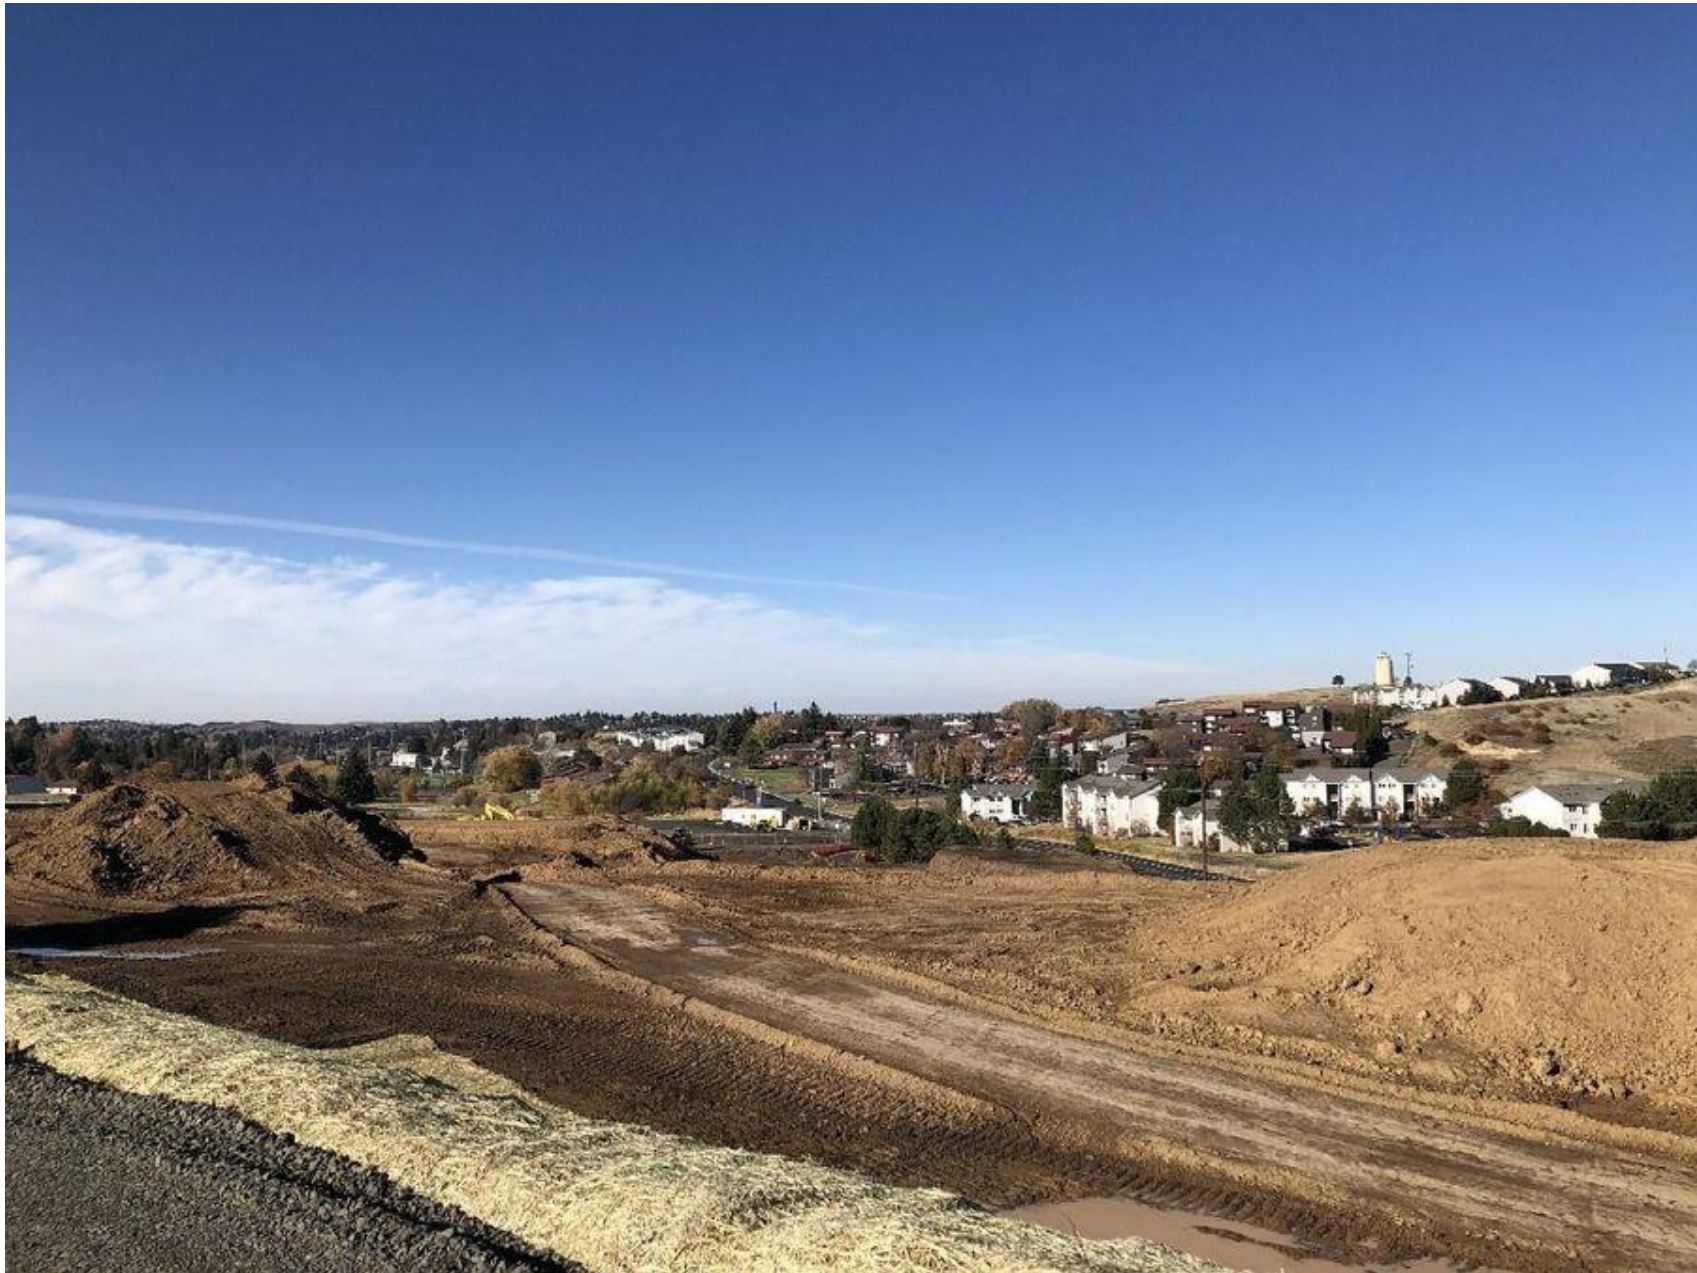
Photo 10

Photo Description: Exposed soil and ponded turbid stormwater.

<p><u>S9.D.4 Install Sediment Controls</u></p> <p>Failure to meet S9.D.4.b: Minimize sediment discharges from the site. The design, installation and maintenance of erosion and sediment controls must address factors such as the amount, frequency, intensity and duration of precipitation, the nature of resulting stormwater runoff, and soil characteristics, including the range of soil particle sizes expected to be present on the site., Failure to meet S9.D.4.c: Direct stormwater runoff from disturbed areas through a sediment pond or other appropriate sediment removal BMP, before the runoff leaves a construction site or before discharge to an infiltration facility. Runoff from fully stabilized areas may be discharged without a sediment removal BMP, but must meet the flow control performance standard of Special Condition S9.D.3.a. Install sediment controls to minimize the discharge of pollutants, as set forth in permit condition S9.D.4.b.</p>	<p>Immediately begin. Address the problems no later than 10 days from the date of this inspection.</p>	<p>C231E, C232E, C233E, C234E, C235E, C240E, C241E, C250E, C251E</p>

<p><u>S9.D.5 Stabilize Soils</u></p> <p>Failure to meet S9.D.5.a: The Permittee must stabilize exposed and unworked soils by application of effective BMPs that prevent erosion. Applicable BMPs include, but are not limited to: temporary and permanent seeding, sodding, mulching, plastic covering, erosion control fabrics and matting, soil application of polyacrylamide (PAM), the early application of gravel base on areas to be paved, and dust control., Failure to meet S9.D.5.d: The Permittee must not allow soils to remain exposed and unworked for more than the time periods set forth below to prevent erosion east of the Cascade Mountains Crest: During the dry season (July 1 - September 30): 10 days or; During the wet season (October 1 - June 30): 5 days., Failure to meet S9.D.5.e: The Permittee must stabilize soils at the end of the shift before a holiday or weekend if needed based on the weather forecast., Failure to meet S9.D.5.f: The Permittee must stabilize soil stockpiles from erosion, protected with sediment trapping measures, and where possible, be located away from storm drain inlets, waterways, and drainage channels. Stabilize exposed and unworked soils, including stockpiles, by application of effective BMPs to prevent erosion, as set forth in permit condition S9.D.5.a and timeline in S9.D.5.d.</p>	<p>Permittee must not allow soils to remain exposed and unworked for more than the time periods set forth below to prevent erosion: During the wet season (October 1 – June 30): 5 days from the date of this inspection.</p>	<p>C120E, C121E, C122E, C123E, C124E, C125E, C126E, C130E, C131E, C140E</p>

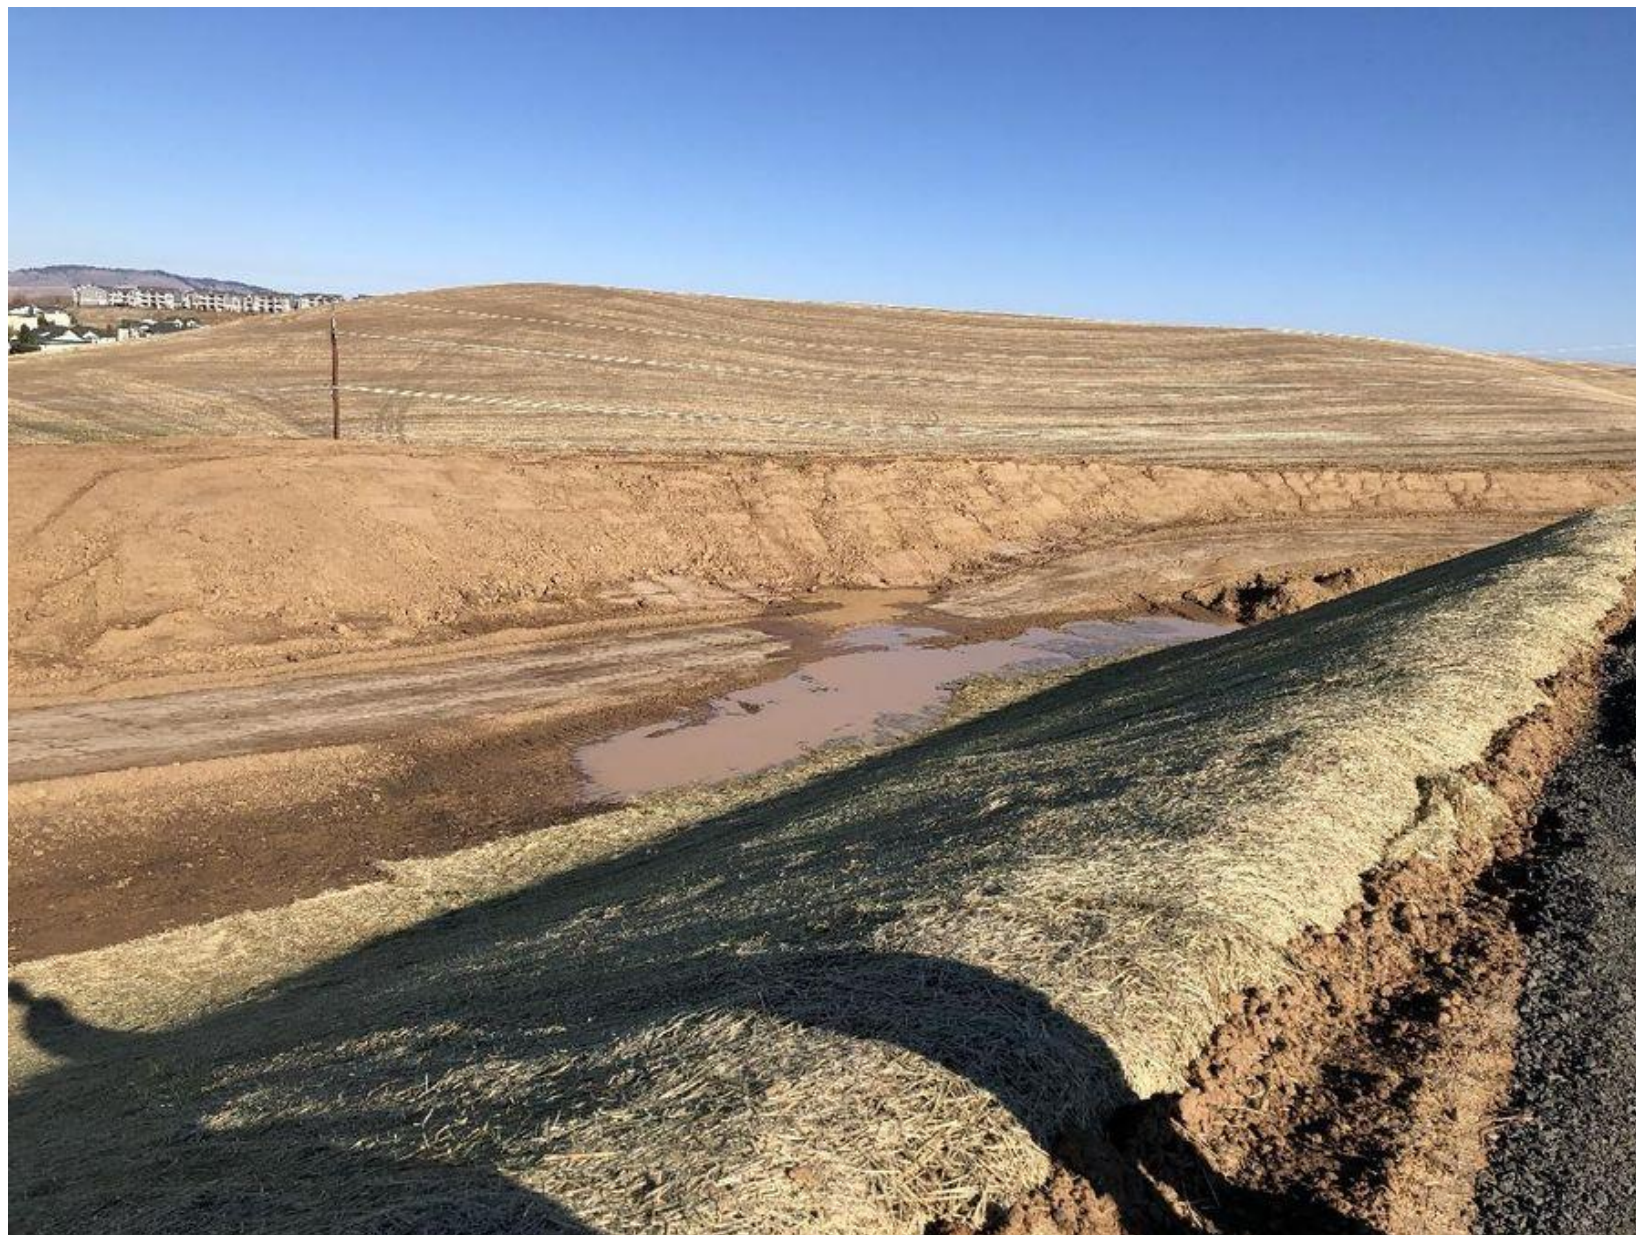
Photo 11

Photo Description: Exposed soil and ponded turbid stormwater.

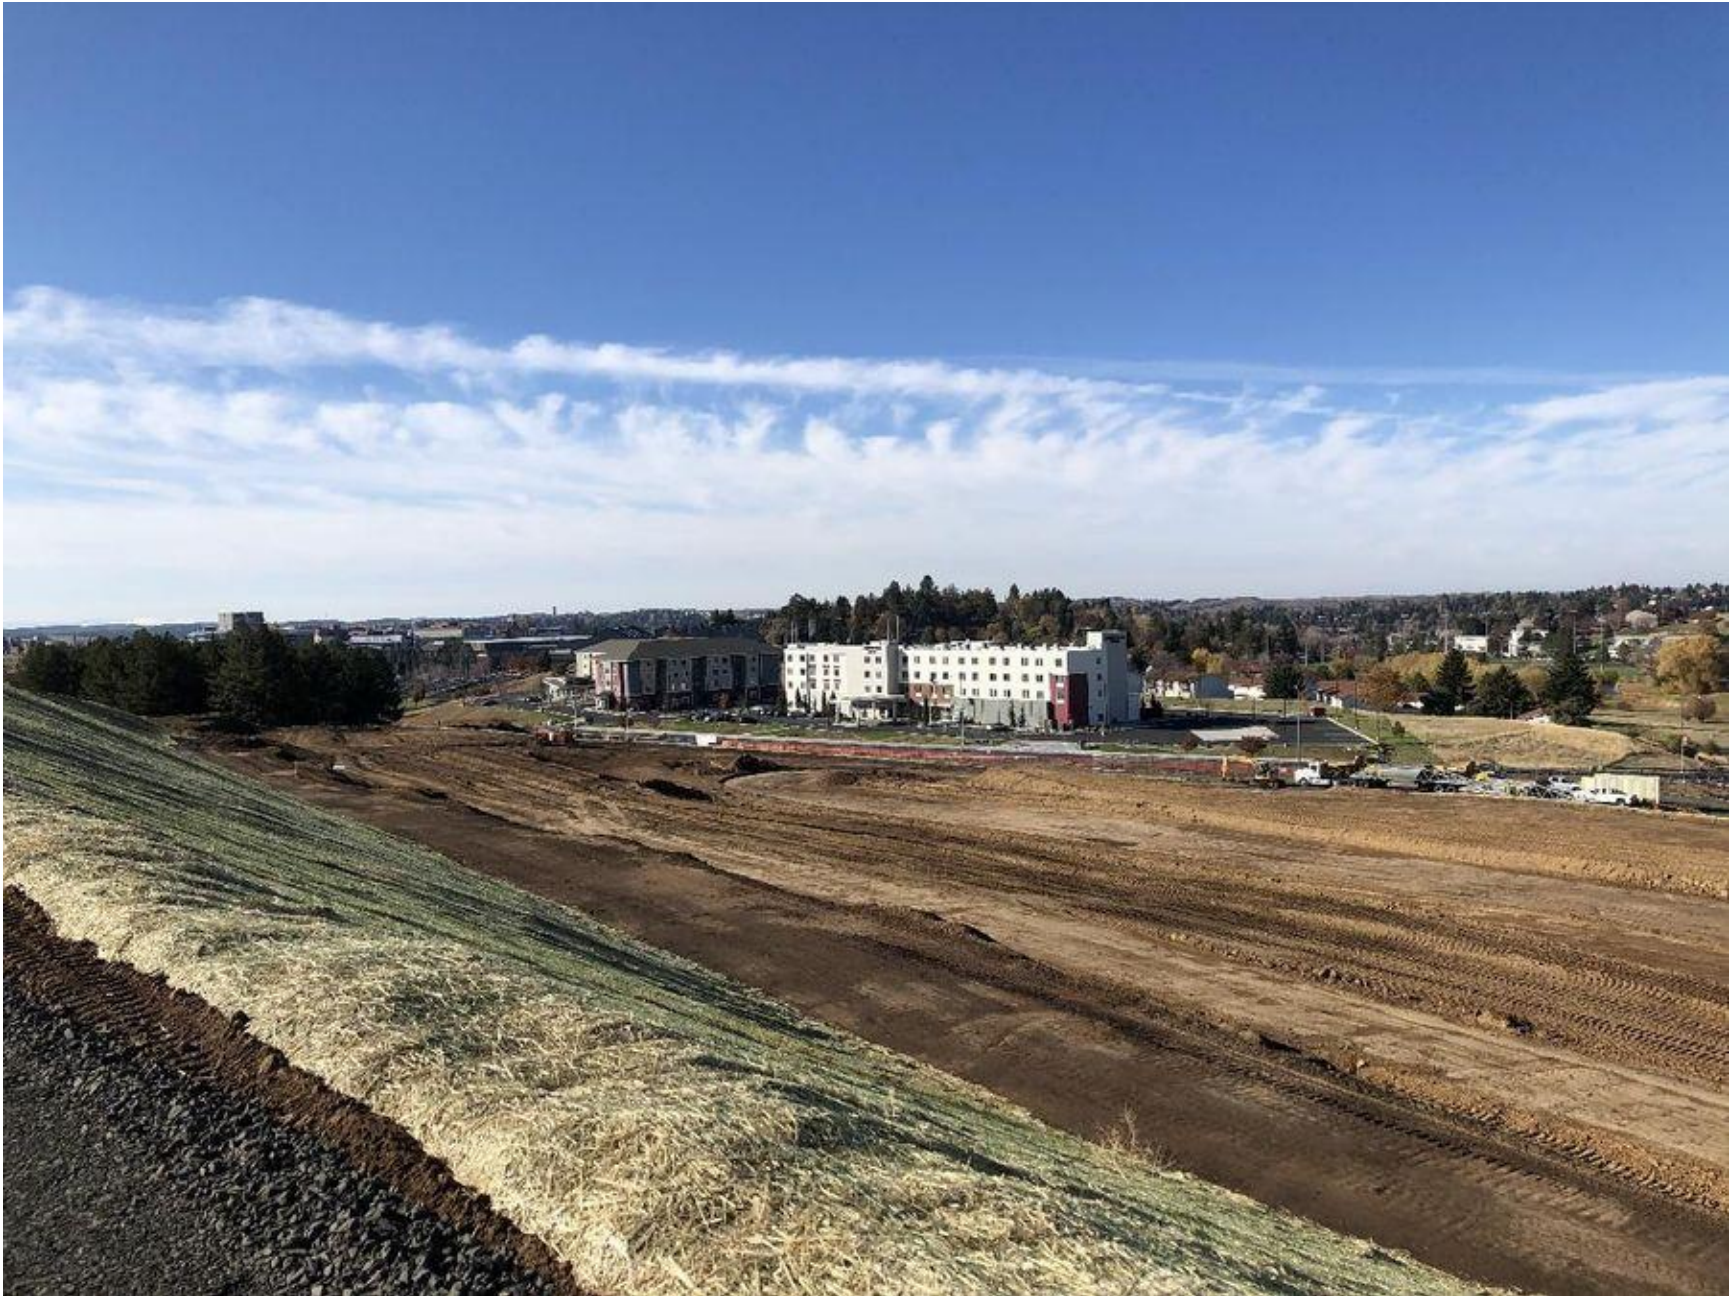
Photo 12

Photo Description: Erosion control blanket with grass establishing. Exposed soil.

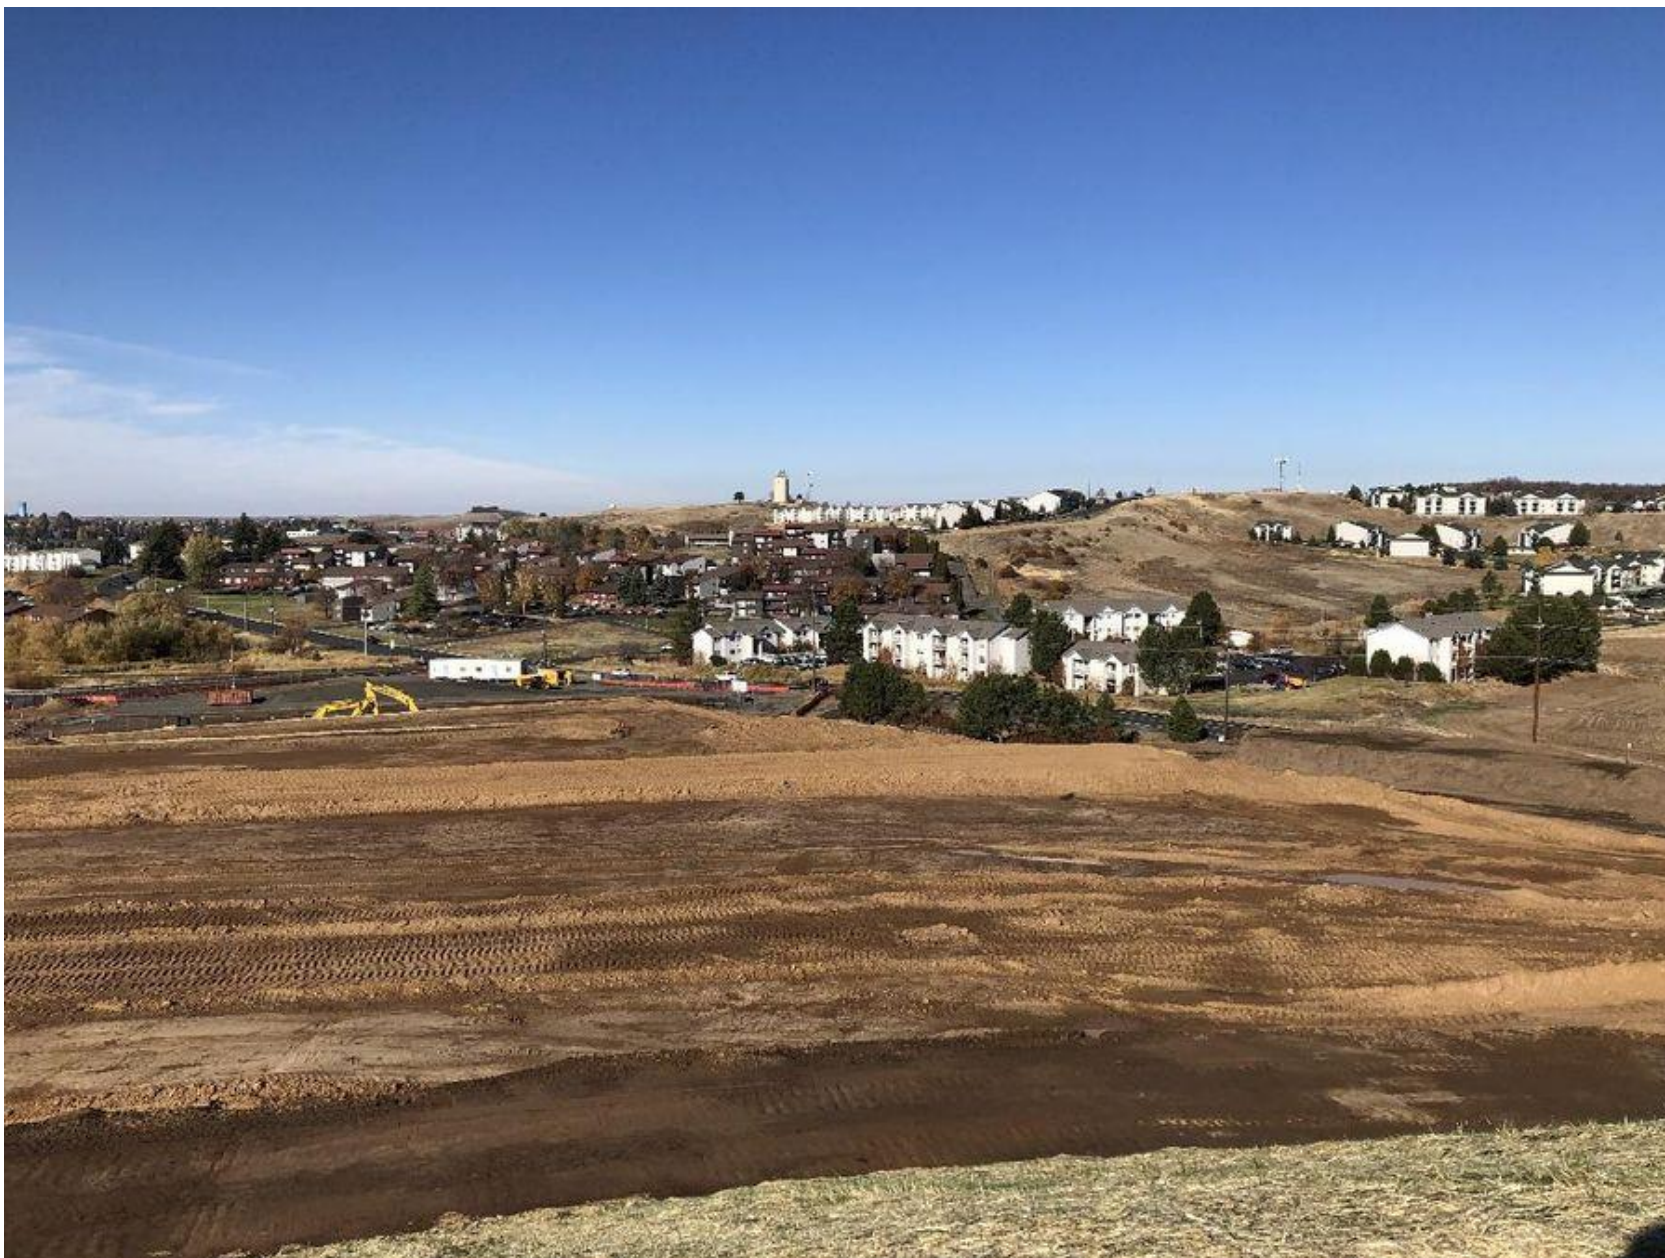
Photo 13

Photo Description: Exposed soil.

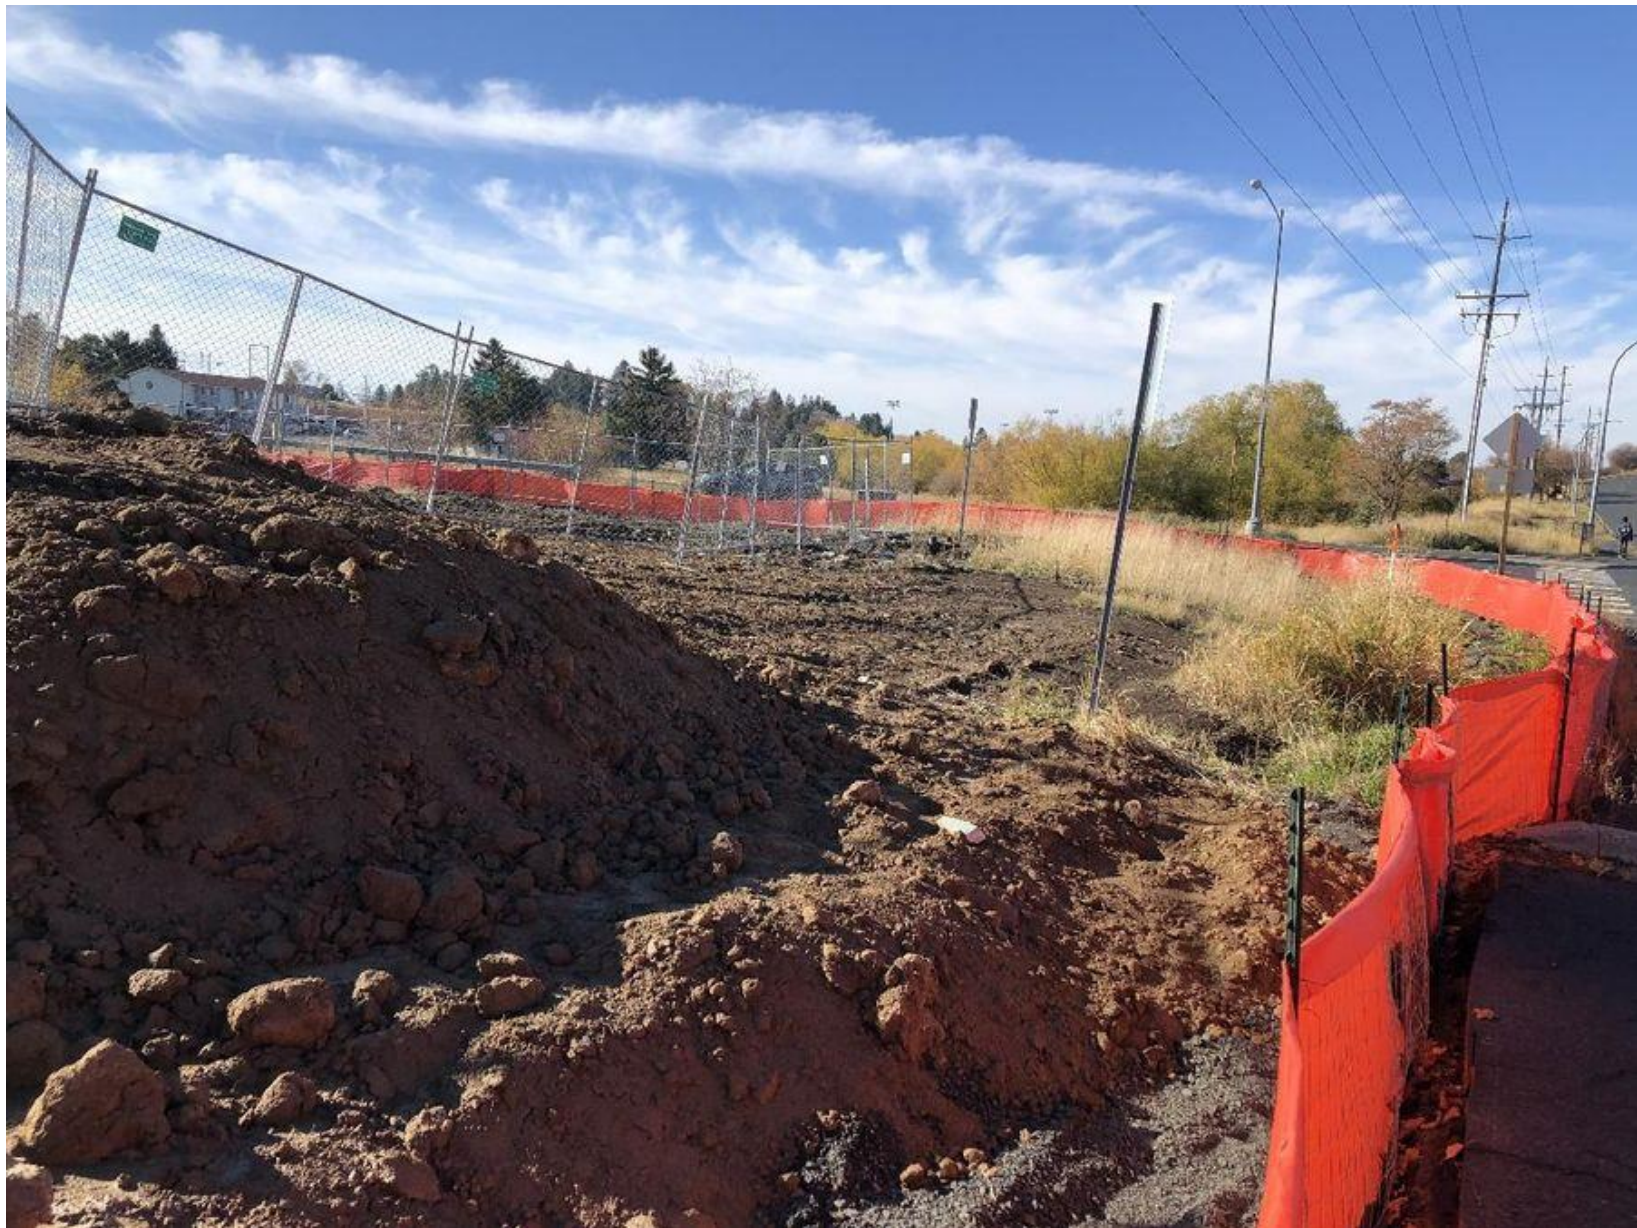
Photo 14

Photo Description: Exposed soil.

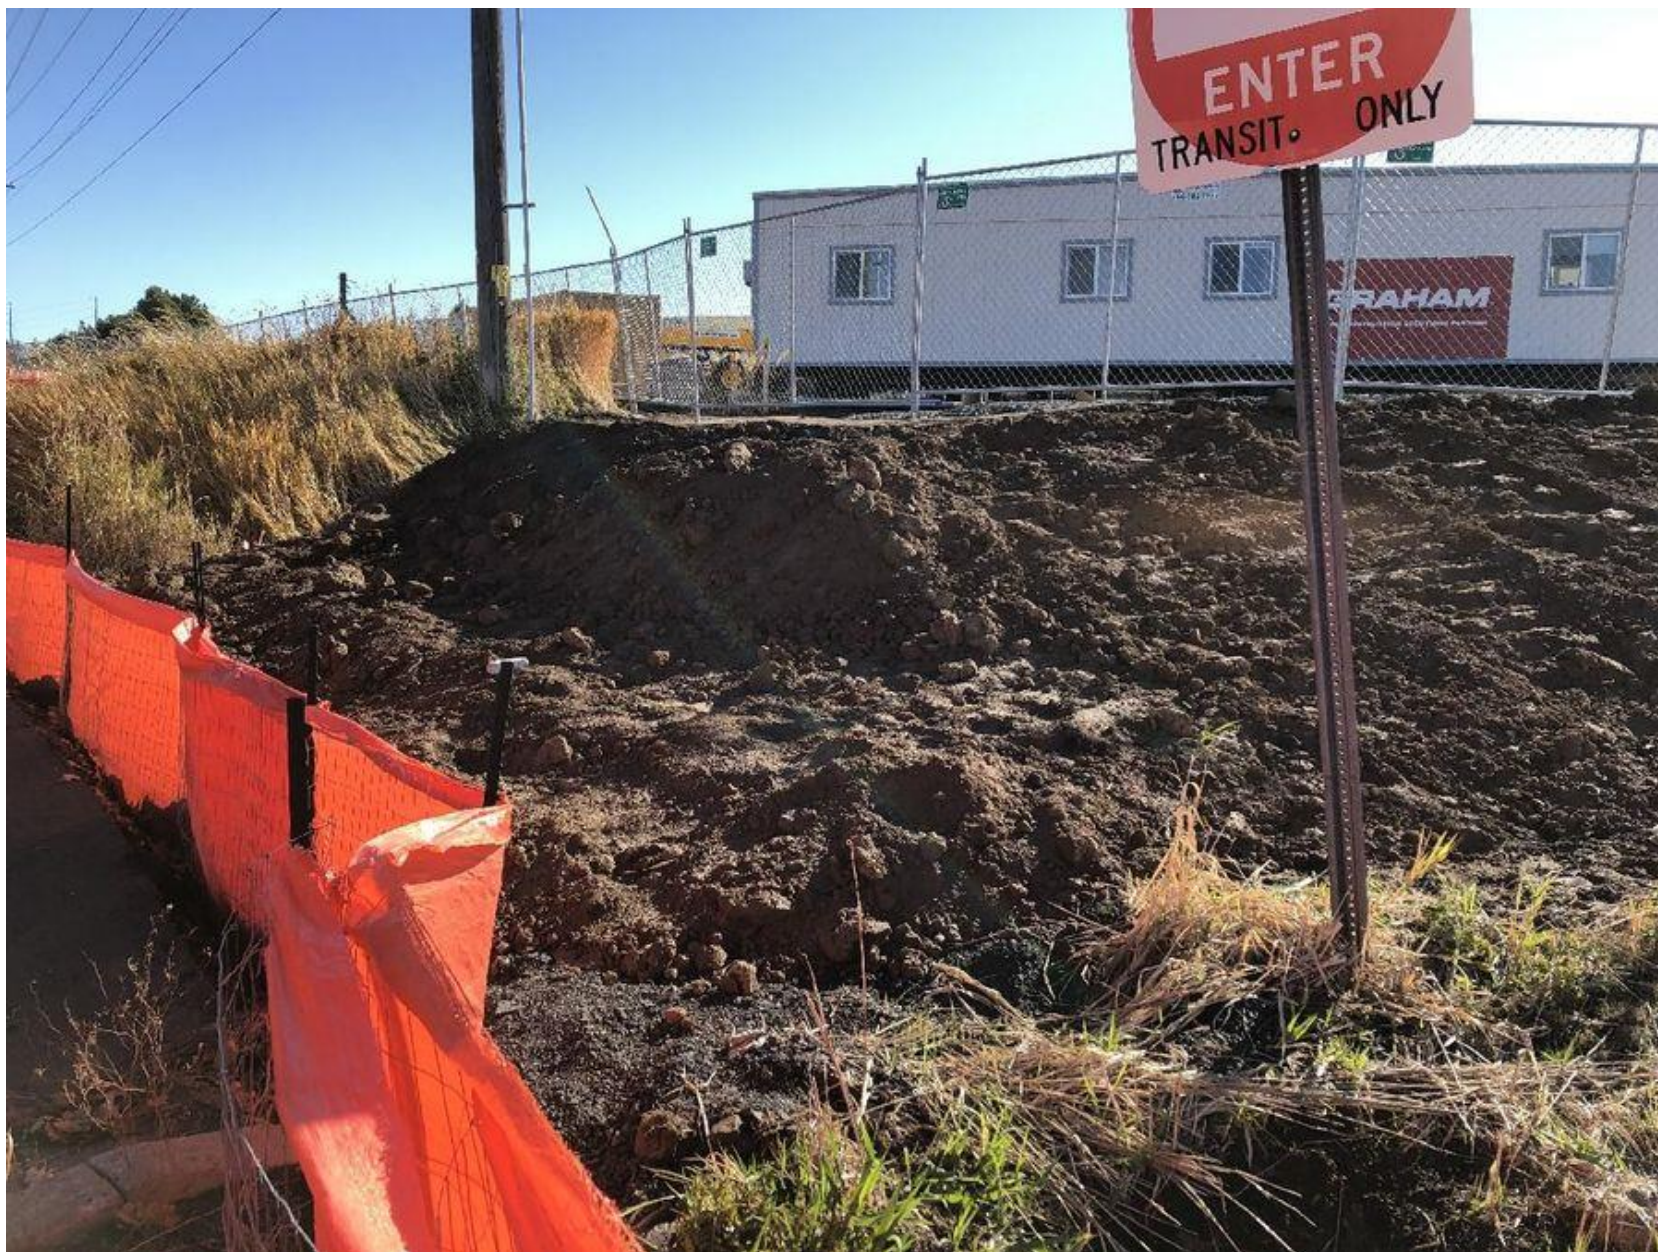
Photo 15

Photo Description: Exposed soil near drainage area and soil in ditch conveyance.

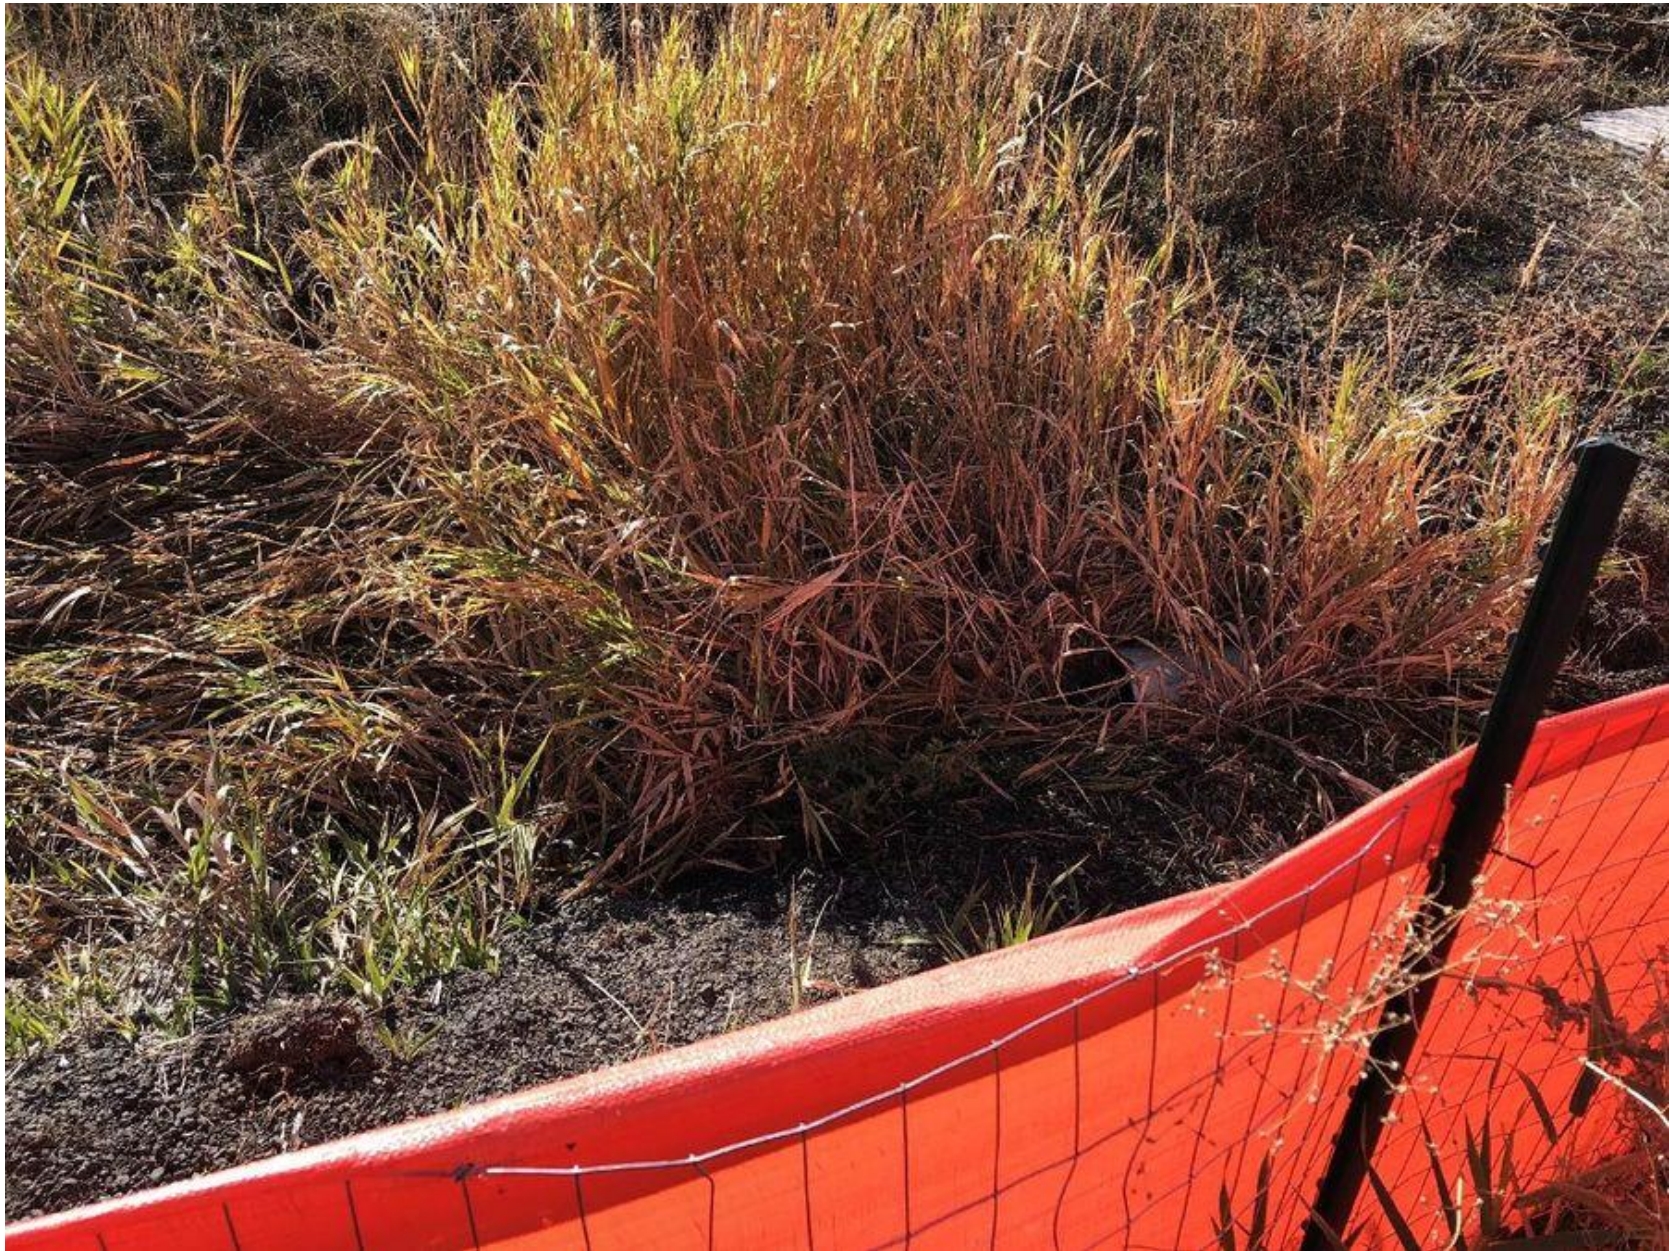
Photo 16

Photo Description: Drainage area.

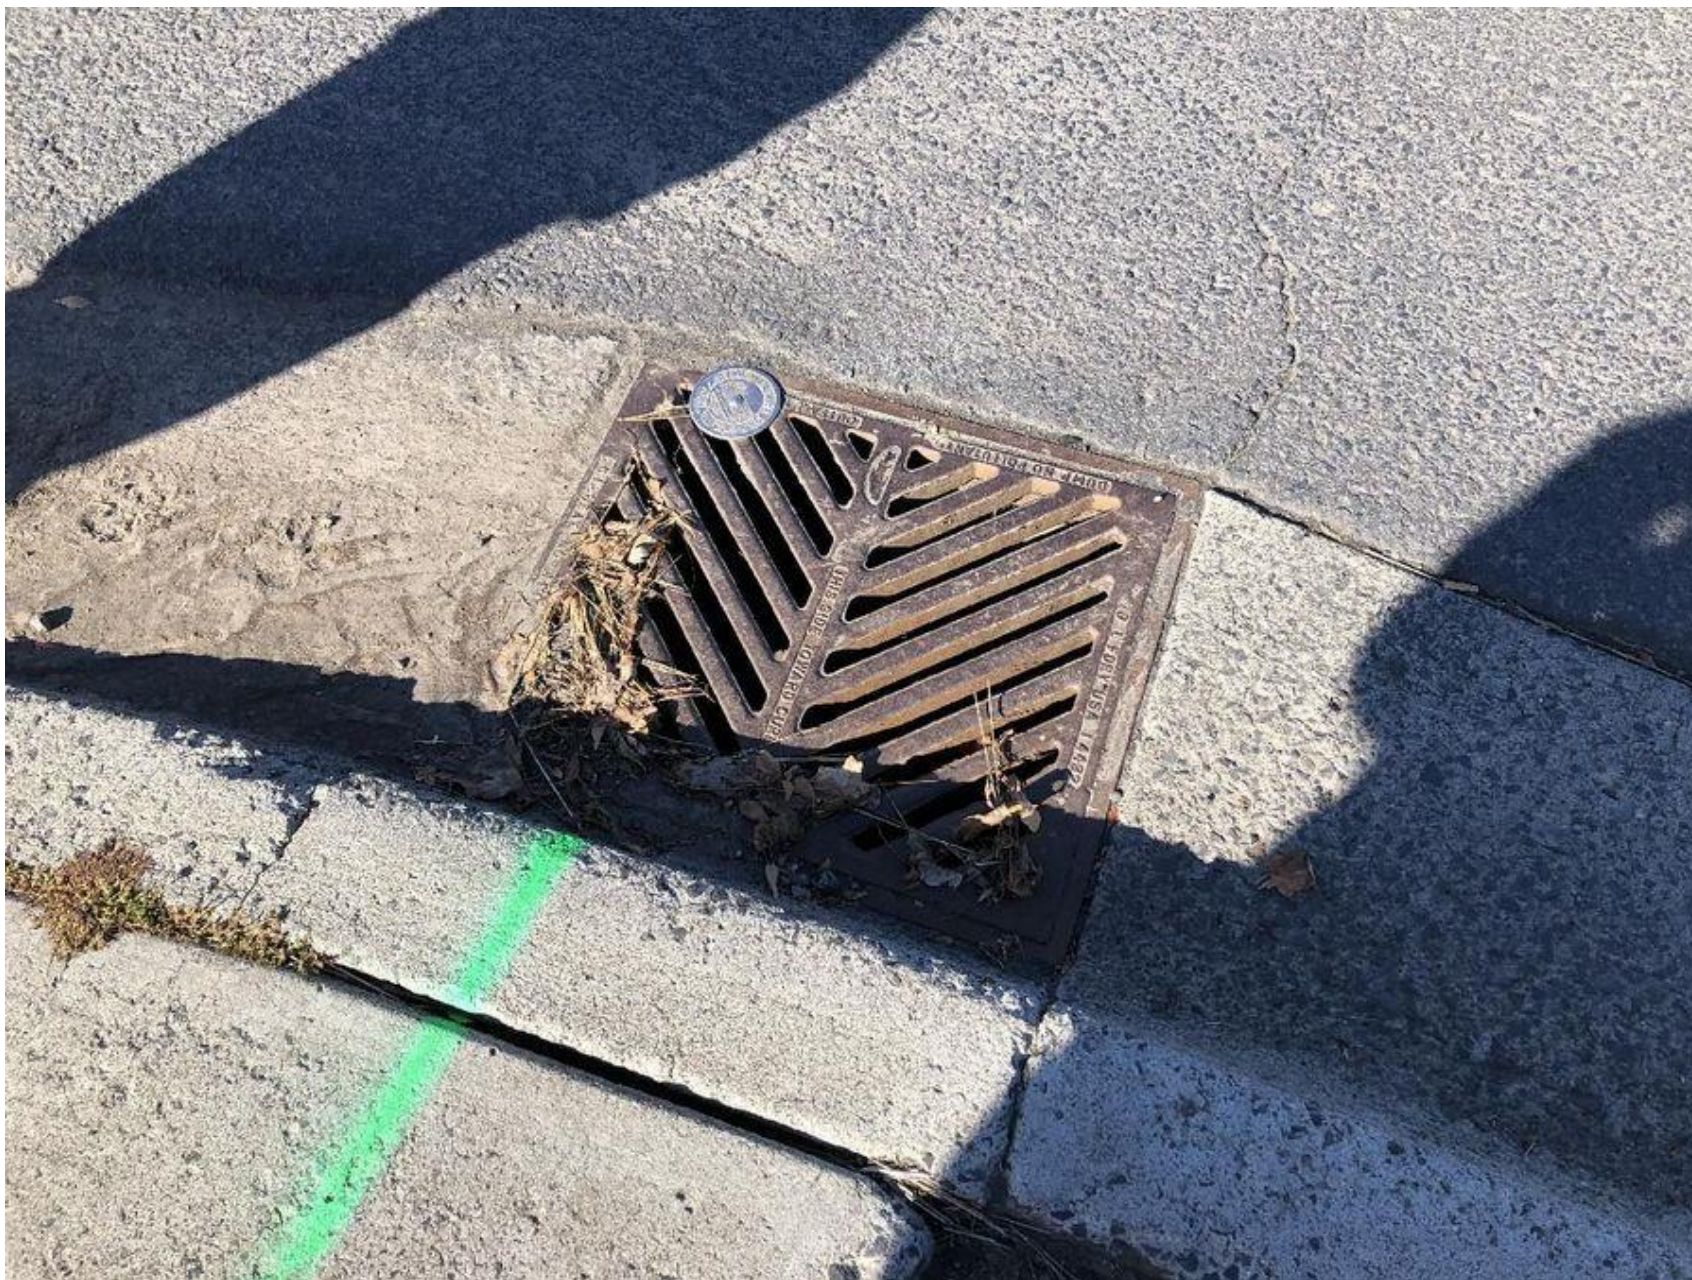
Photo 17

When we completed our site visit, we walked to the corner of Northeast North Fairway Road and Northeast Terreview Drive. We saw a catch basin located at the corner that did not have inlet protection installed. We discussed installing inlet protection.

Photo Description: No inlet protection.

<p><u>S9.D.7 Protect Drain Inlets</u></p> <p>Failure to meet S9.D.7.a: Protect all storm drain inlets made operable during construction so that stormwater runoff does not enter the conveyance system without first being filtered or treated to remove sediment. Protect and maintain drain inlets, as set forth in permit condition S9.D.7.a.</p>	<p>Immediately begin. Address the problems no later than 10 days from the date of this inspection.</p>	<p>C220E</p>

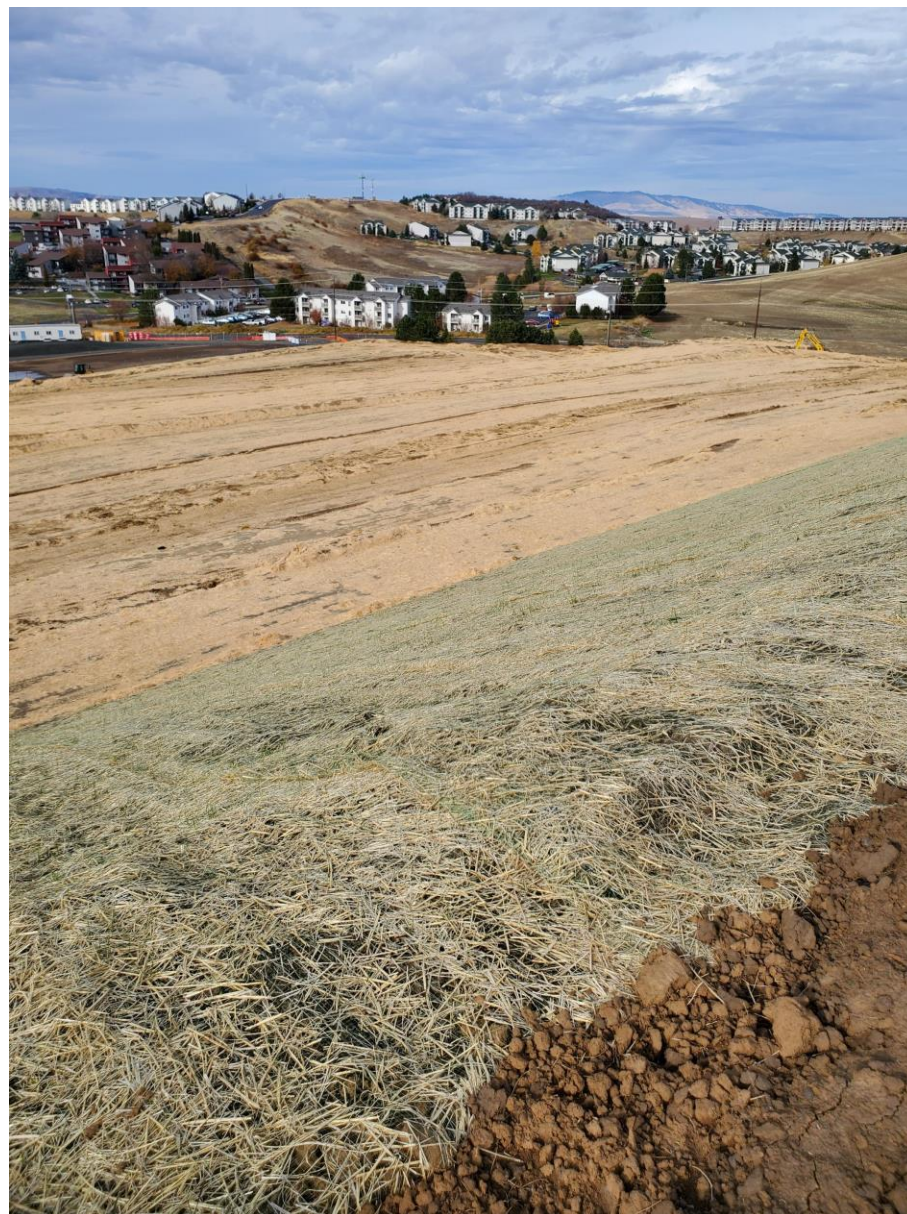
Photo 18

Photos Provided by Linda Applington – Debco. Photo Description: Site on November 4, 2021. Straw applied to exposed soil.

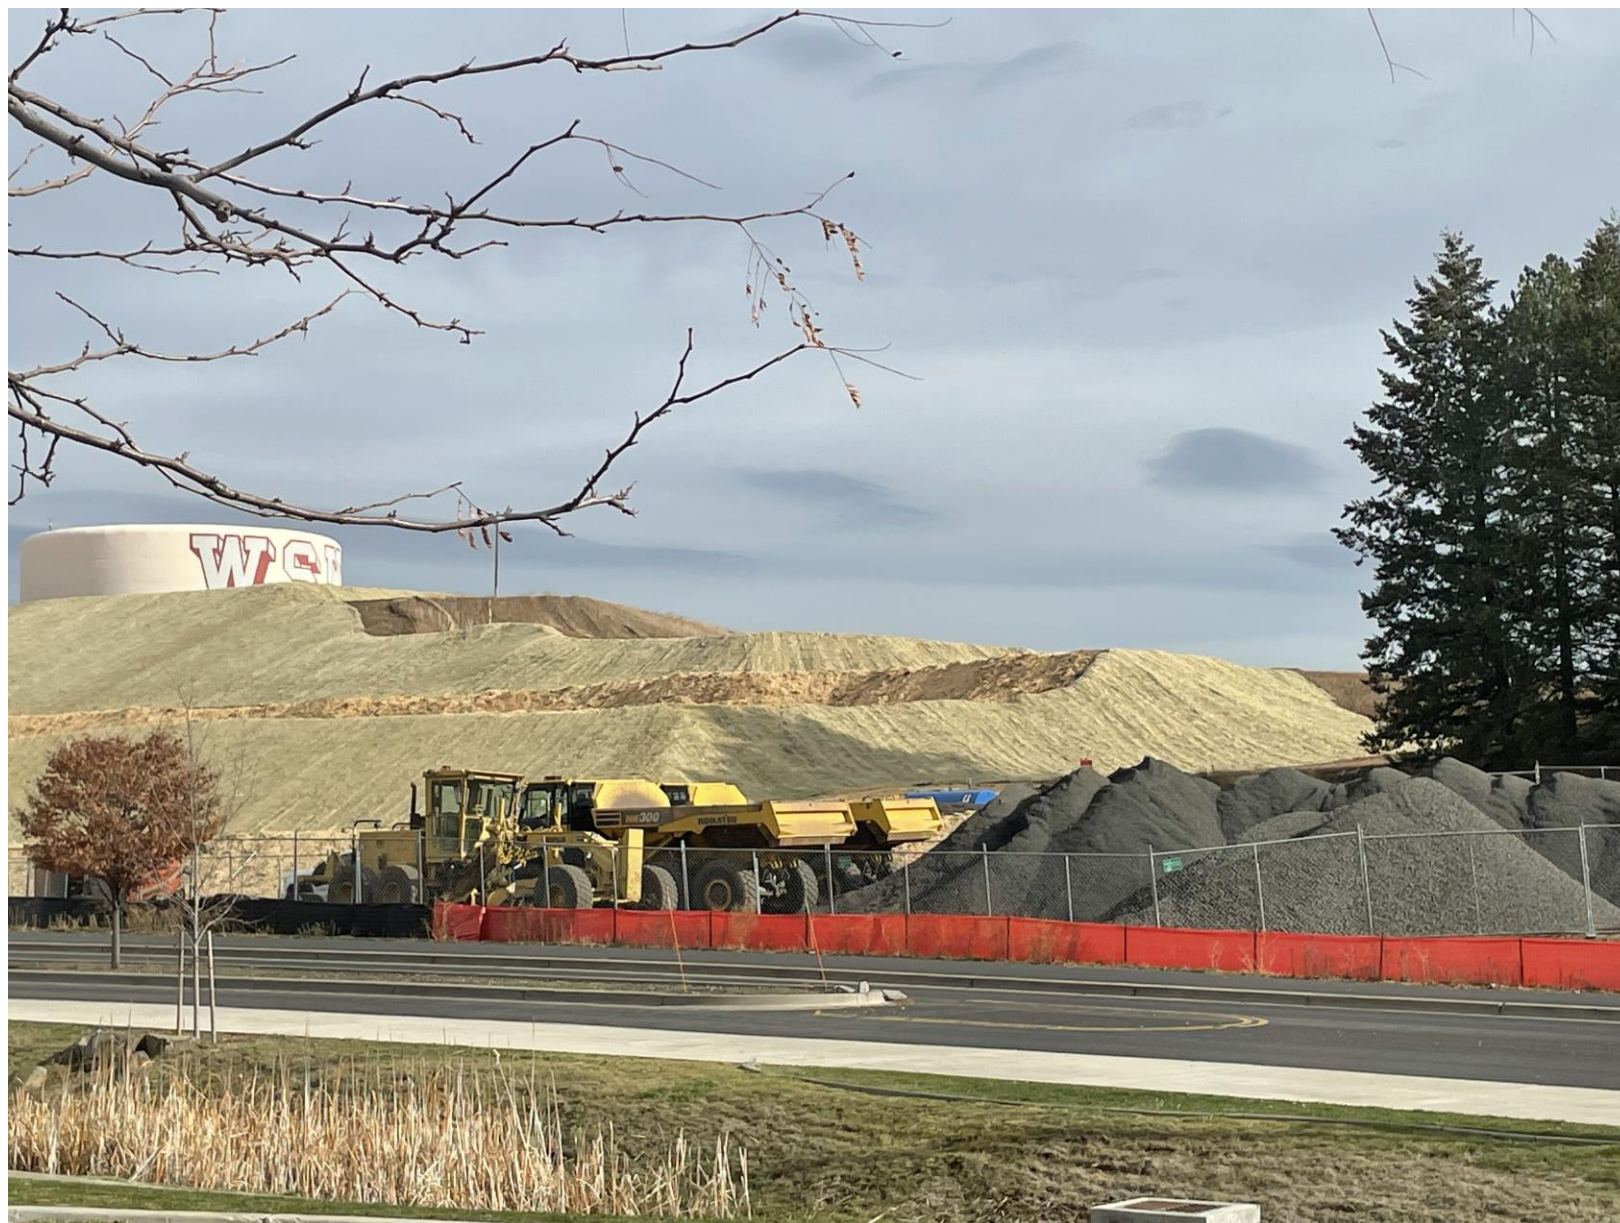
Photo 19

Photos Provided by Lonnie Simpson – Debco. Photo Description: Site on November 4, 2021. Straw applied to exposed soil and erosion control blanket.
