DEPARTMENT OF ECOLOGY State of Washington	<h2 style="text-align: center;">CONSTRUCTION STORMWATER GENERAL PERMIT</h2> <h3 style="text-align: center;">INSPECTION REPORT</h3> <p style="text-align: center;">State of Washington Department of Ecology</p>		
Section A: General Data			
Ecology Inspector(s): Shannon Adams Jefferson Davis	On-Site Representative Name: Grant Gehring Title: EIT – SynTier Engineering Phone: 509.339.6187 Email: grant@syntierengr.com	Inspection Date: November 1, 2021 Entry/Exit Time: 10:50/11:53	Inspection Type: Announced
		Receiving waters: Palouse Watershed	Permit webpage: Facility Summary
Section B: Background			
<p>The University Village project is covered under the State of Washington’s Construction Stormwater General Permit (CSWGP). The CSWGP is a National Pollutant Discharge Elimination System (NPDES) and a State Waste Discharge permit for discharge of construction-related stormwater. The purpose of this inspection was to conduct a compliance inspection and to provide technical assistance as appropriate.</p> <p>Grant Gehring - SynTier Engineering, was present during inspection and all observations and recommendations were discussed.</p> <p>Weather at time o

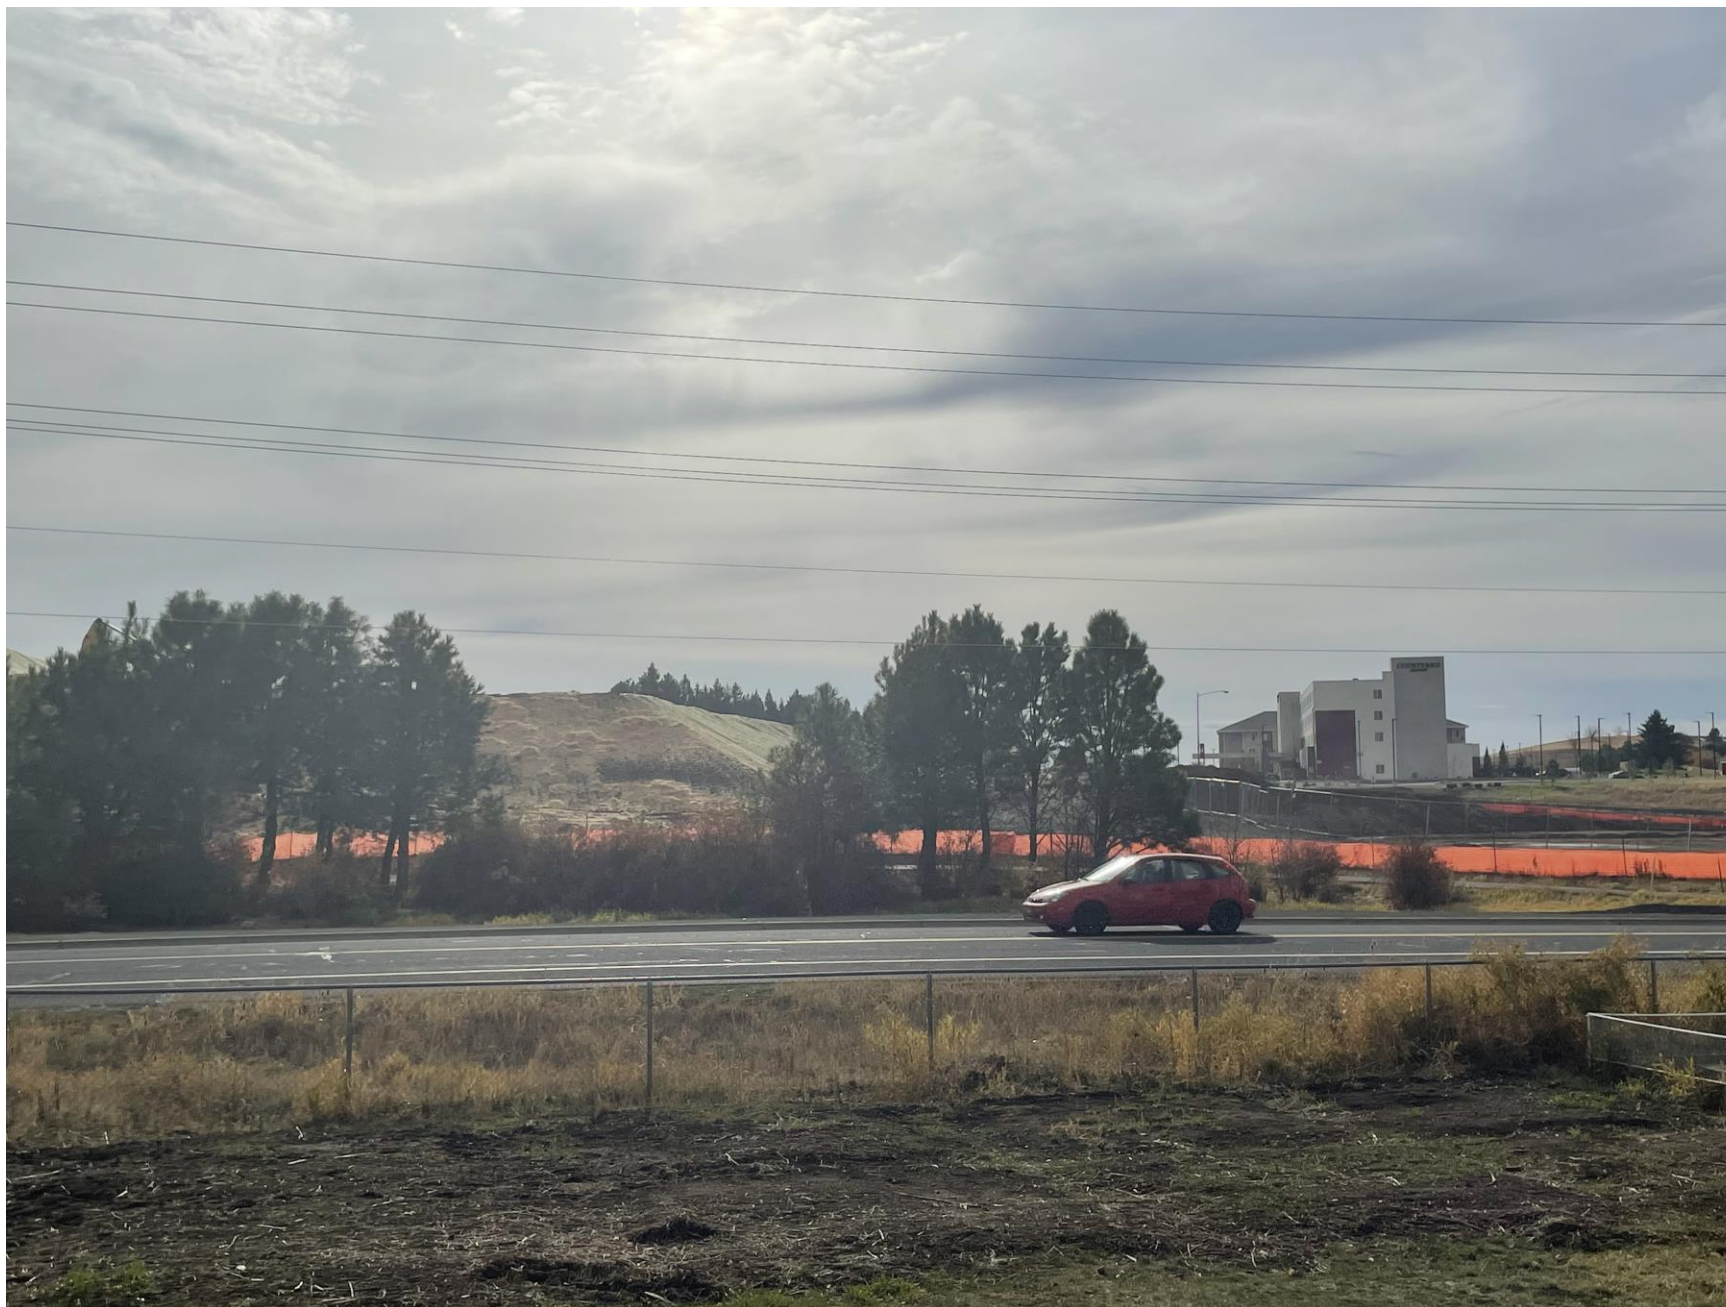
Photo 20

Photos Provided by Lonnie Simpson – Debco. Photo Description: Site on November 4, 2021. Straw applied to exposed soil and erosion control blanket.

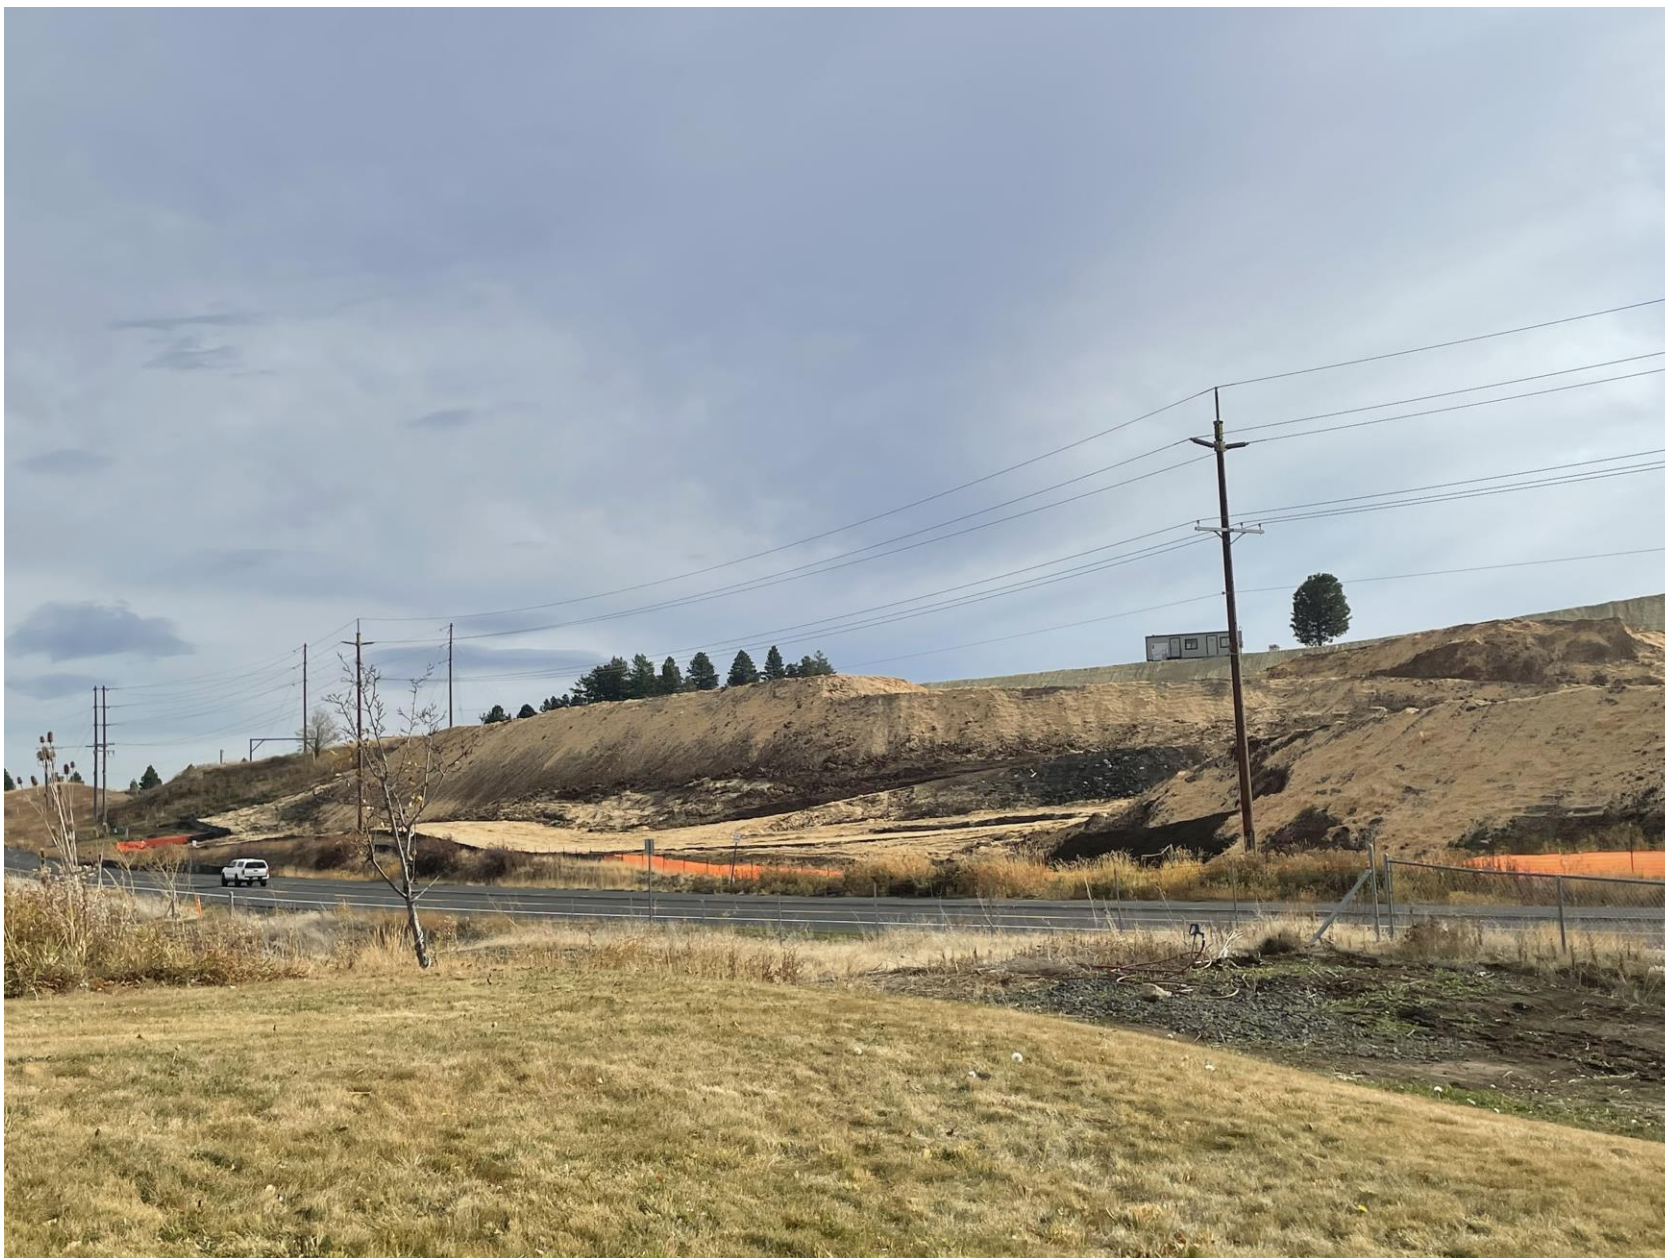
Photo 21

Photos Provided by Lonnie Simpson – Debco. Photo Description: Site on November 4, 2021. Straw applied to exposed soil and erosion control blanket.

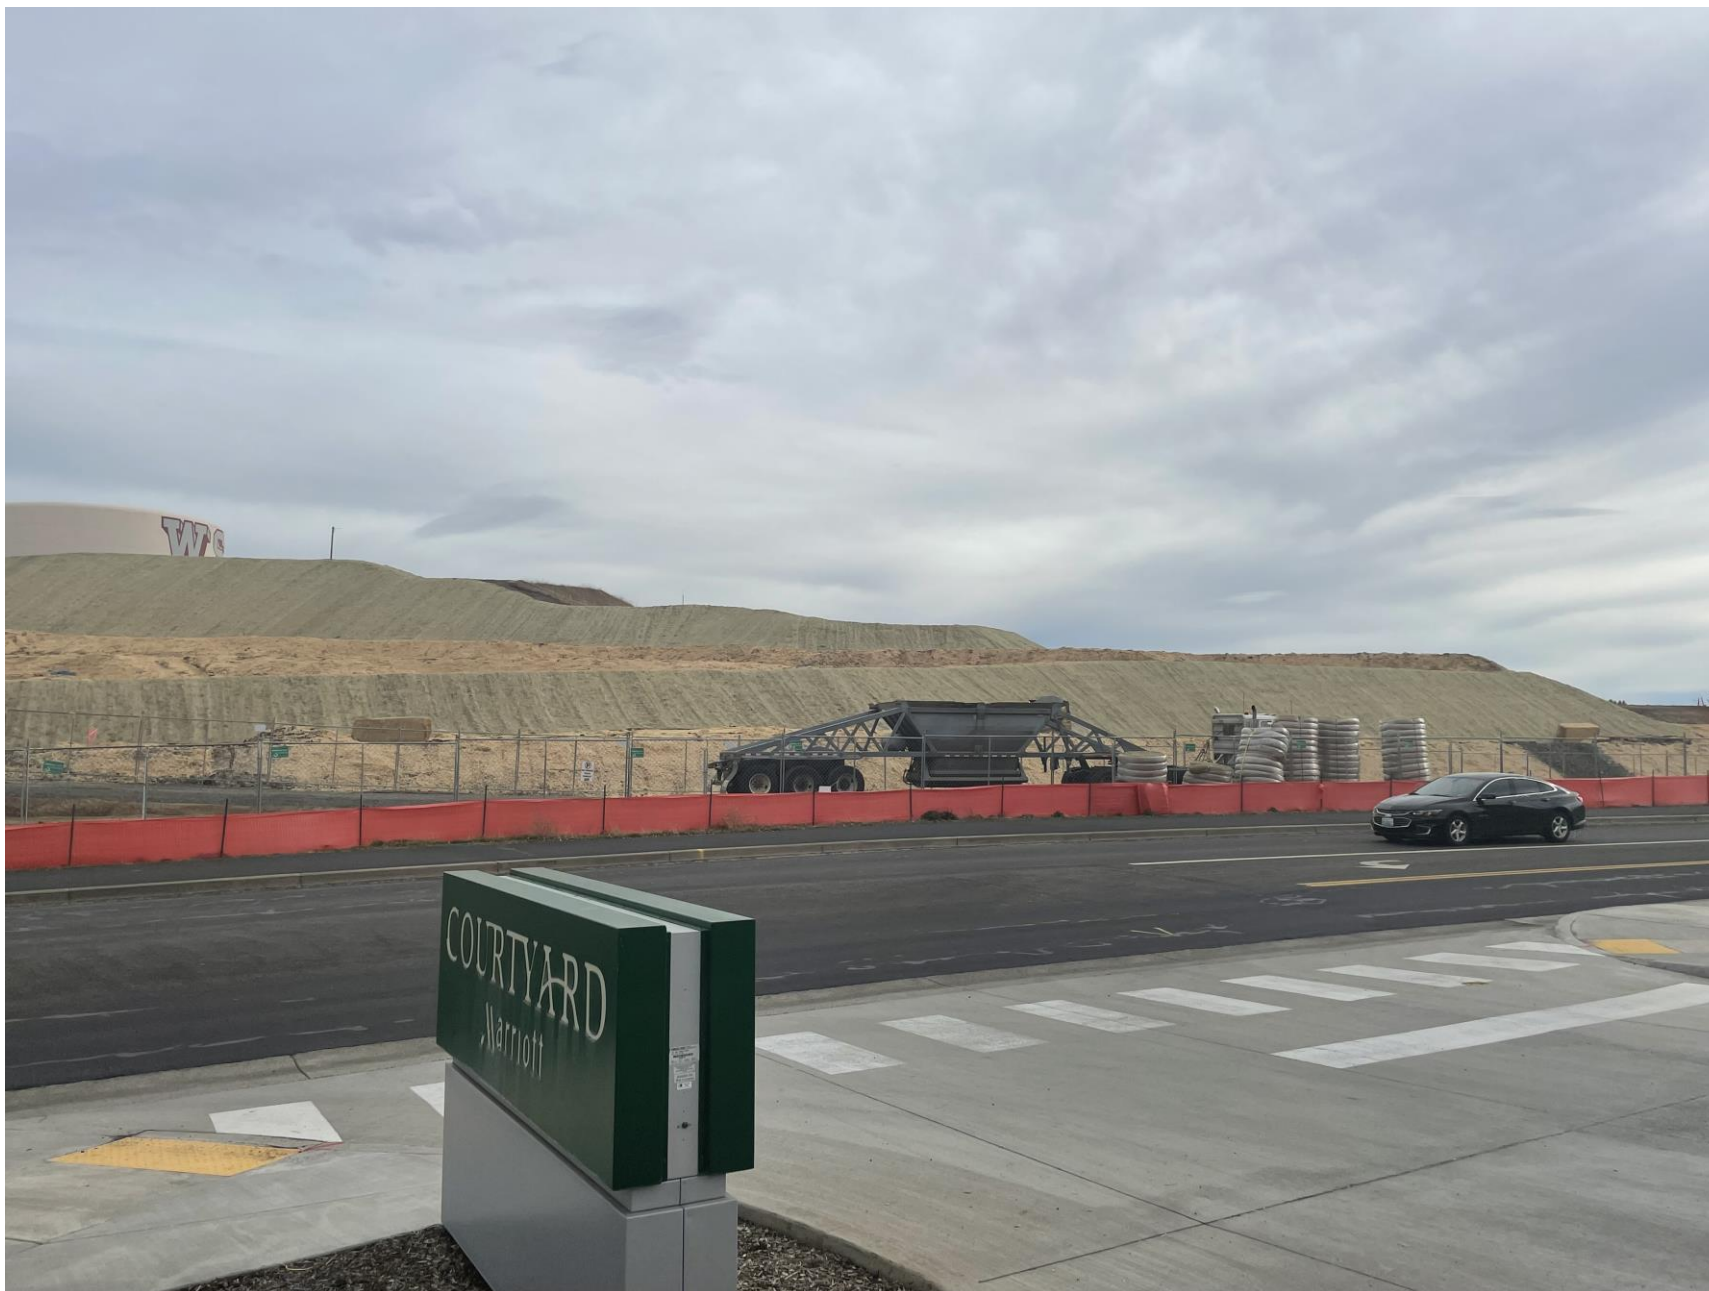
Photo 22

Photos Provided by Lonnie Simpson – Debco. Photo Description: Site on November 4, 2021. Straw applied to exposed soil and erosion control blanket.

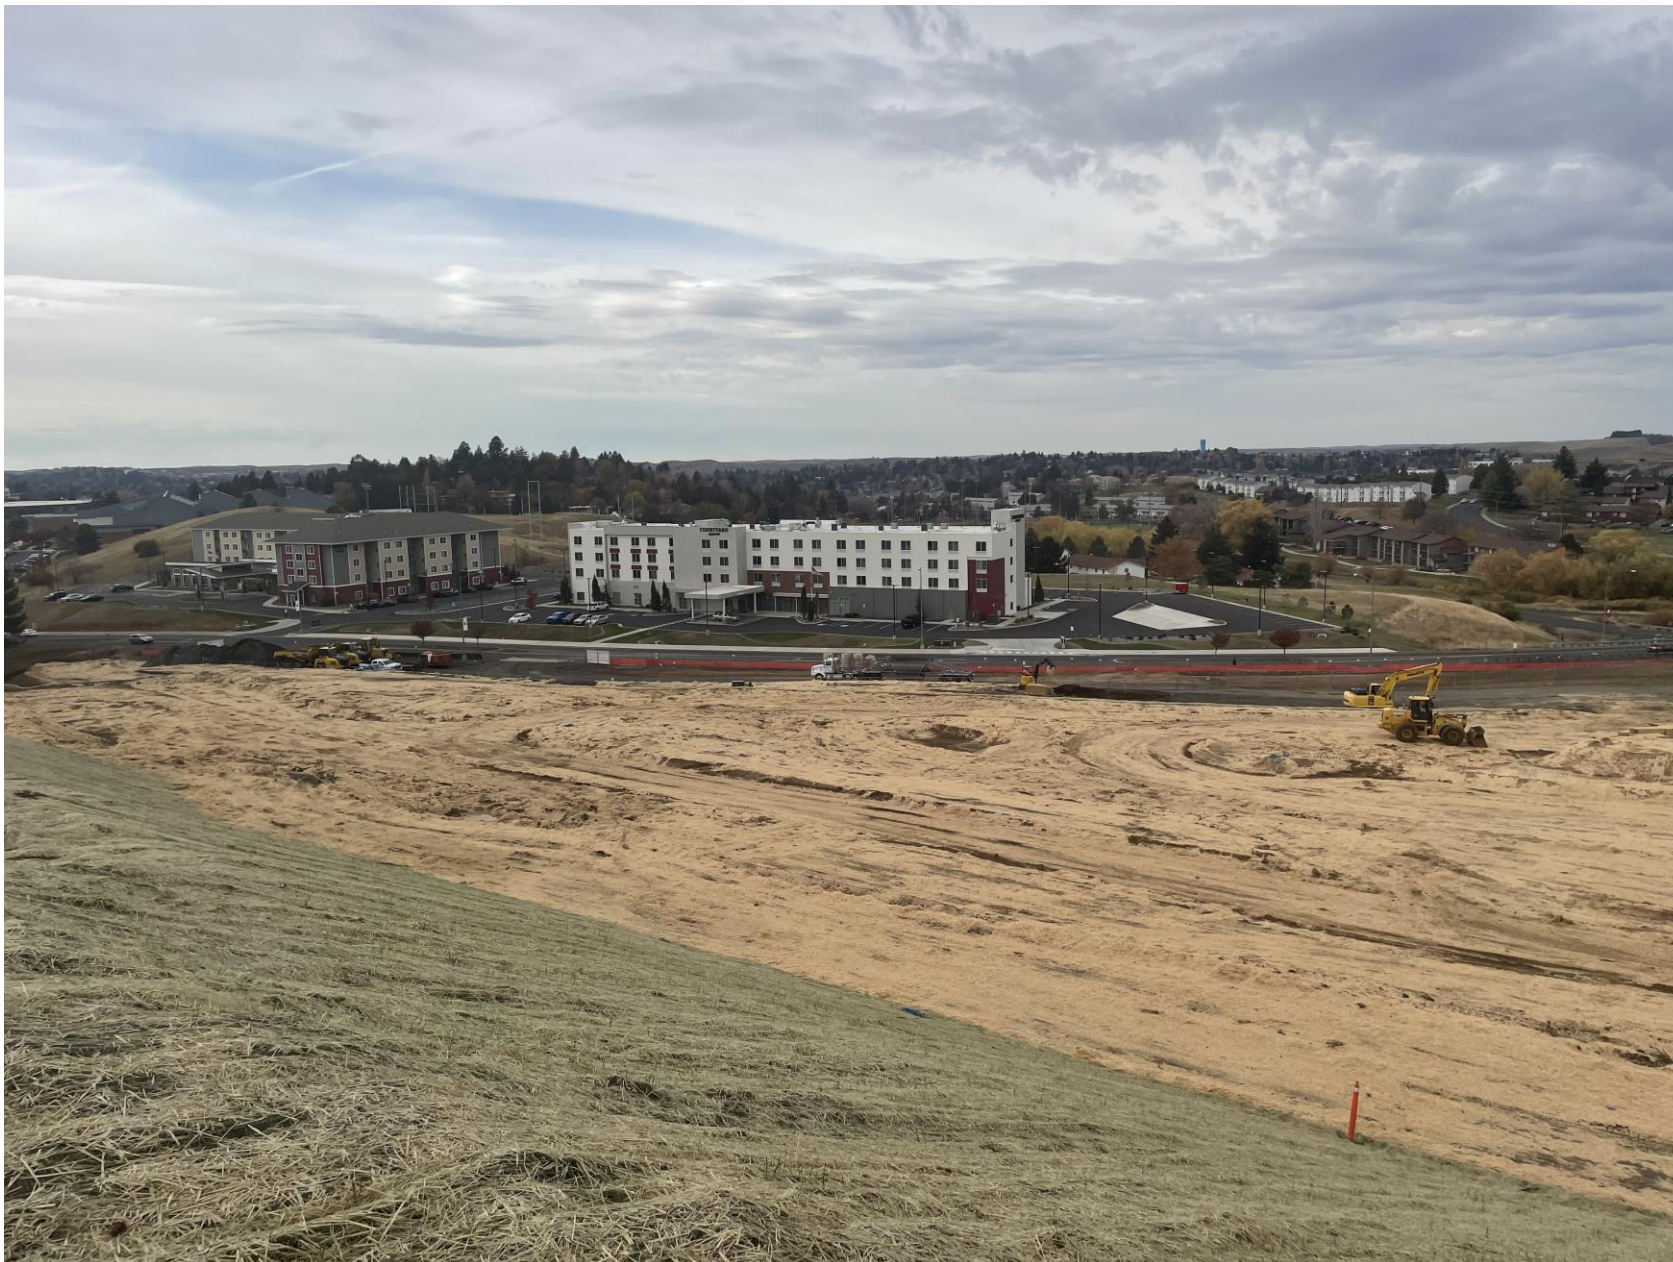
Photo 23

Photos Provided by Lonnie Simpson – Debco. Photo Description: Site on November 4, 2021. Straw applied to exposed soil.

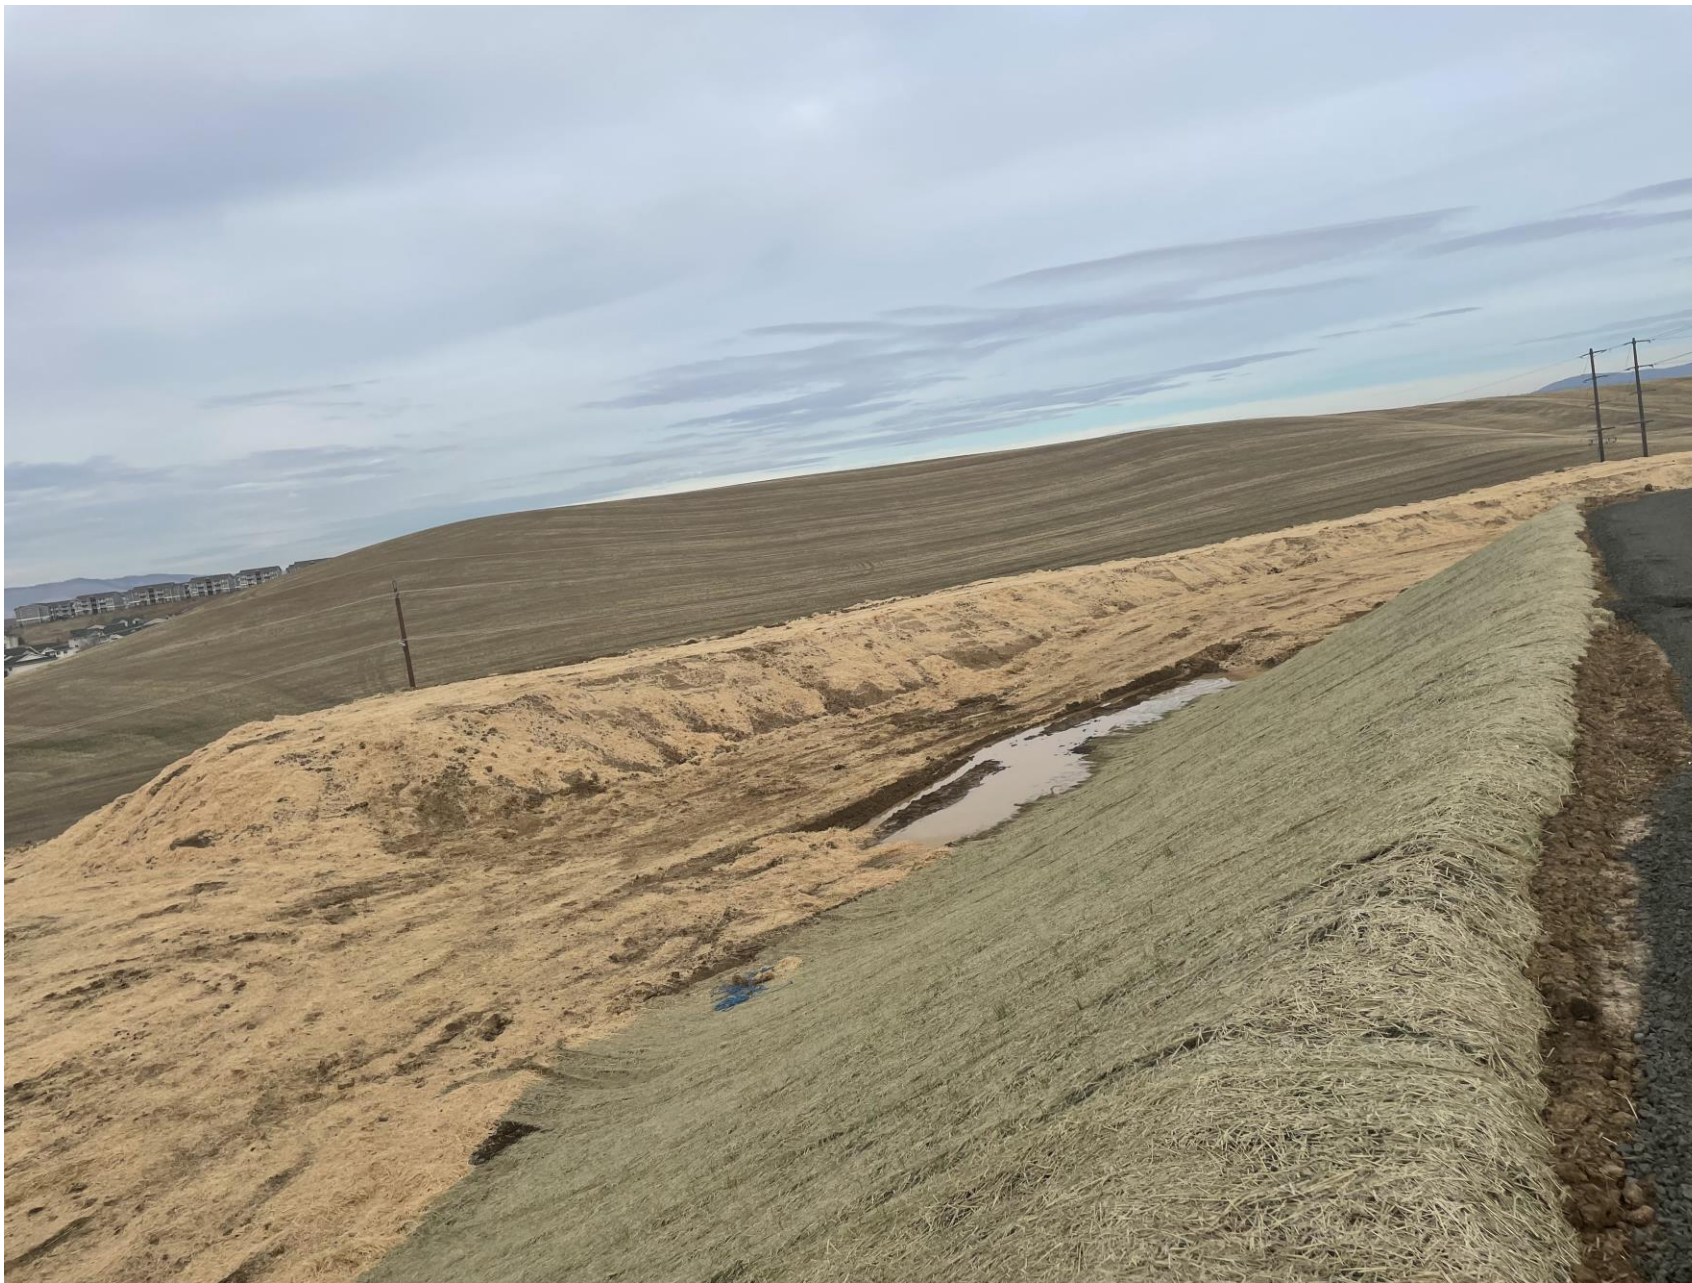
Photo 24

Photos Provided by Lonnie Simpson – Debco. Photo Description: Site on November 4, 2021. Straw applied to exposed soil.
