STORMWATER COMPLIANCE INSPECTION REPORT

State of Washington Department of Ecology

Inspection Date(s): 5/3/2021	Ecology Inspector(s): Stephanie Barney, Maria Zeman	Inspection Type: Announced Inspection
Permittee Name: Martin Penhallegon, P&G East LLC Permittee Mailing Address: 11255 Kirkland Way, Ste 300		NPDES Permit #: WAR306901
City: Kirkland State: WA Zip: 98033		Permit Type: Construction Other:
Discharges to: <i>(Please check all that apply)</i> <input checked="" type="checkbox"/> Surface Water <input checked="" type="checkbox"/> Ground Water		County: Snohomish
Receiving waters: Streams 1, 2, and 3 and wetland west of the landfill		
Weather at time of inspection: Sunny and dry

Water Quality Name and Location of Site Inspected: Bakerview Everett 4308 108 th Street SE Everett WA 98033	GPS Lat: Long:	Entry Time: 11:00 AM Exit Time: 1:00 PM
On-Site Representative Name: Jay Pullen Title: Junior Engineer Phone: 425-827-2014 Email: jayp@paceengrs.com	Additional Participants: Tim O'Conner Clay Grace Megan Engebretson Rob

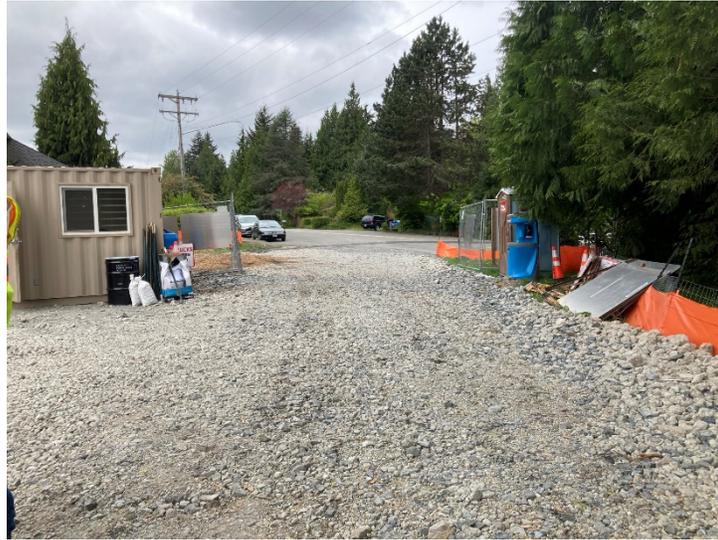
Figure 1 Description: Recycled concrete aggregate used to stabilize on-site road. This material may cause elevated levels of pH in stormwater runoff.

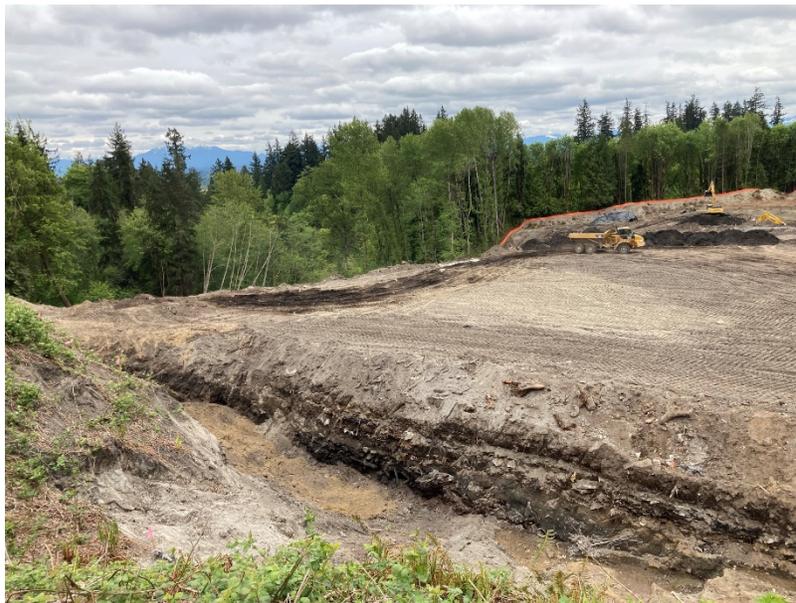
Earthwork started in April. We observed excavators removing landfill materials from areas known as "the wedge".

Figure 2 Description: Excavated areas of the "wedge". Stockpiles of landfill materials (darker in color) remove from the wedge in the background.

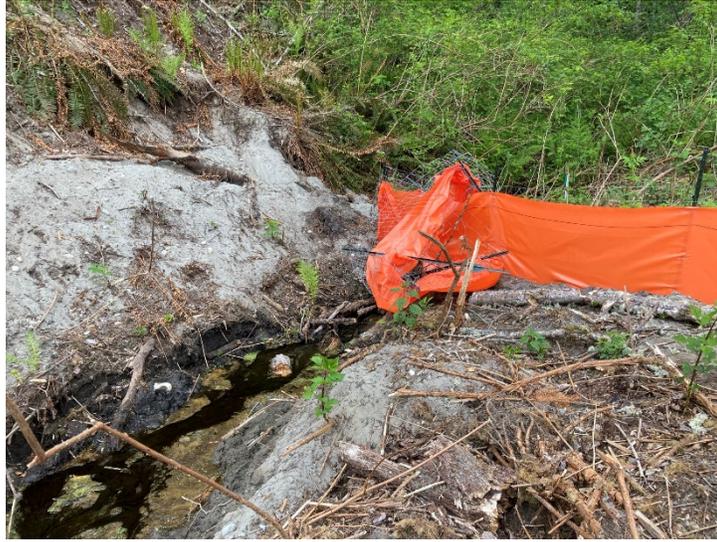
The permittee must project the wetland west of the landfill during construction. Drainage from this wetland creates Stream 1. This stream is southwest of the former landfill, running through an on-site borrow area for structural fill. Stream 1 is tributary to Stream 2. Stream 2 exists entirely outside of the area of disturbance.

Figure 3 Description: Wetland west of the landfill, headwaters of Stream 1.

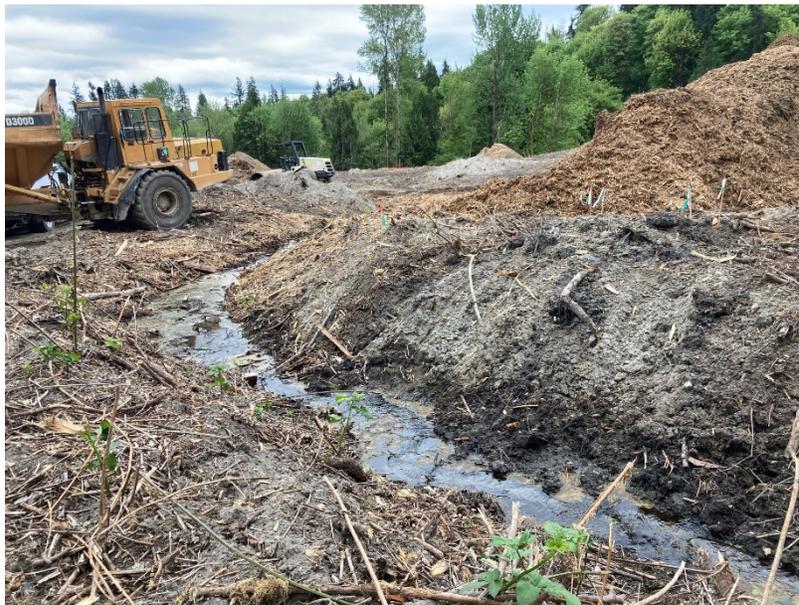
We observed exposed soils on both sides of Stream 1, but clear water in the channel. Jay Pullen, the site's Certified Erosion and Sediment Control Lead (CESCL), samples Stream 1 before leaving the wetland and again at the project limits before Stream 1 runs down a steep ravine toward Stream 2.

Figure 4 Description: Stream 1, exposed soils on both banks.

The permittee must stabilize exposed and unworked soils by application of effective BMPs that prevent erosion.

The permittee must not allow soils to remain exposed and unworked for more than 7 days during the dry season (May 1 – September 30) and 2 days during the wet season (October 1 – April 30).

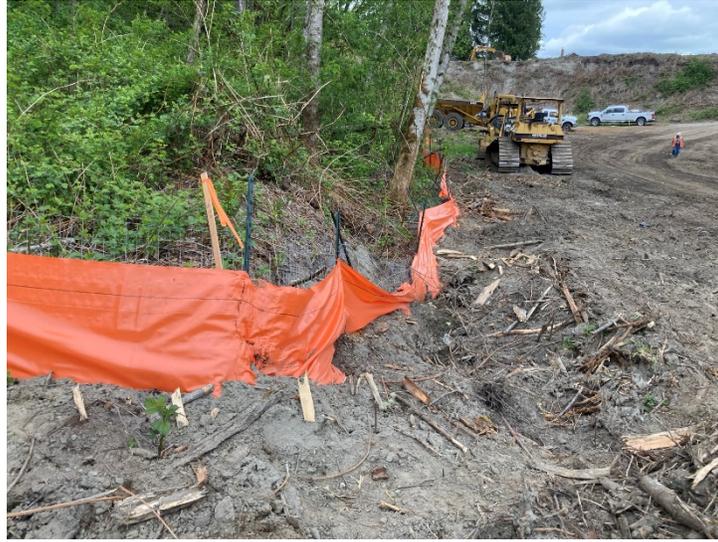
Figure 5 Description: Overall silt fence remained in good condition; however, this section needs repair.

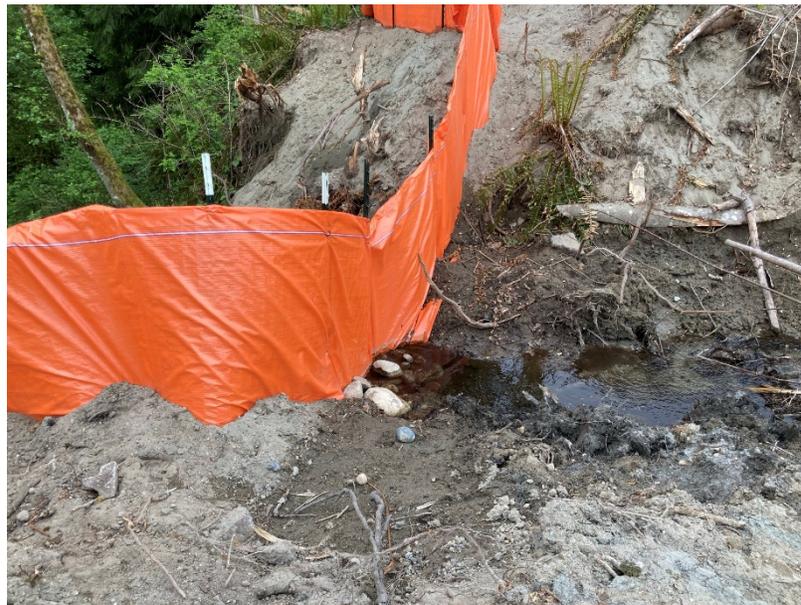
Figure 6 Description: Stream 1 discharge from limits of disturbance down a steep ravine. Stream 1 is tributary to Stream 2. The permittee must sample stormwater discharges occurring here until they achieve permanent stabilization, as required in S4.C.3.a.

Site plans call for realignment of Stream 1. The permittee will route Stream 1 through a temporary diversion pipe during new stream construction. The CESCL may discontinue sampling of the Stream 1 upon completion of the temporary diversion. The CESCL must evaluate all potential stormwater discharges from the construction of the new stream channel. The permittee must sample all stormwater discharges at the location where stormwater enters surface waters.

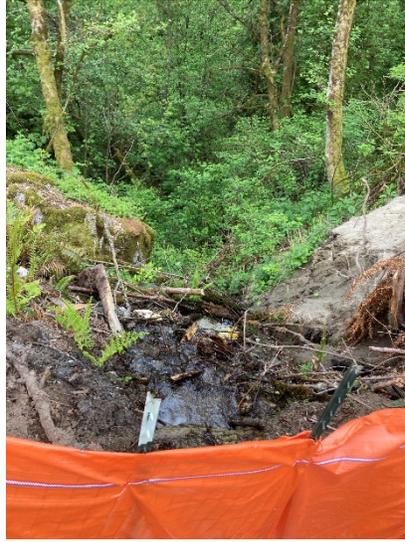
Figure 7 Description: Stream 1 leaving construction site and entering steep ravine.

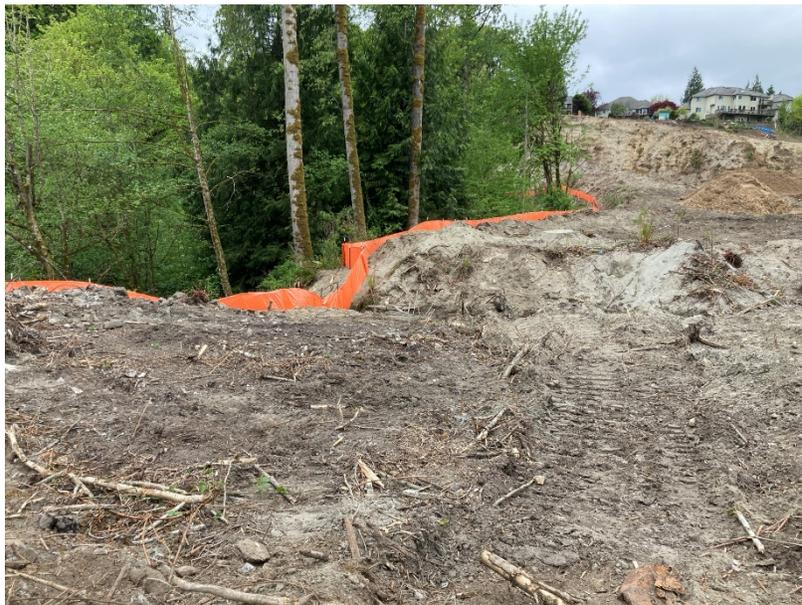
Operators had not recently worked the exposed soils in the on-site borrow area south of the wetland west of the landfill, in the immediate area of Stream 1. They made no attempts to stabilize the soils after the initial clearing. Unstabilized soils exposed to rainfall may cause turbidity in receiving waters.

Figure 8 Description: Exposed and unworked soils without stabilization BMPs for more than 7 days as required in S9.D.5.d.

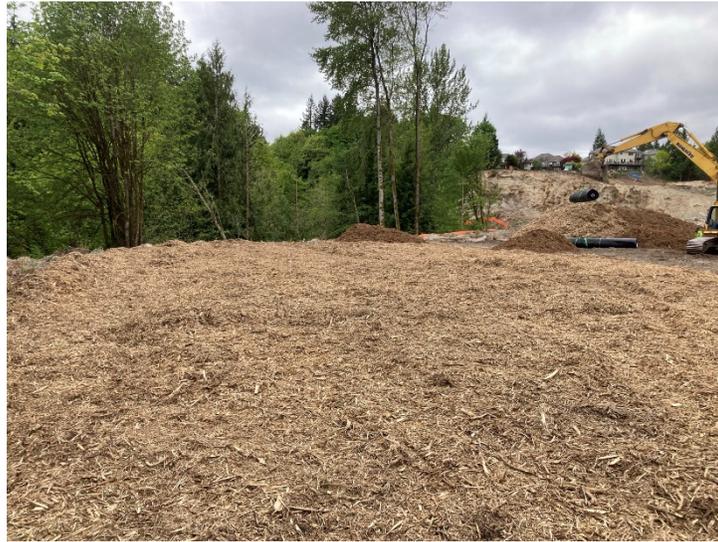
Figure 9 Description: Wood mulch stabilizing exposed soils.

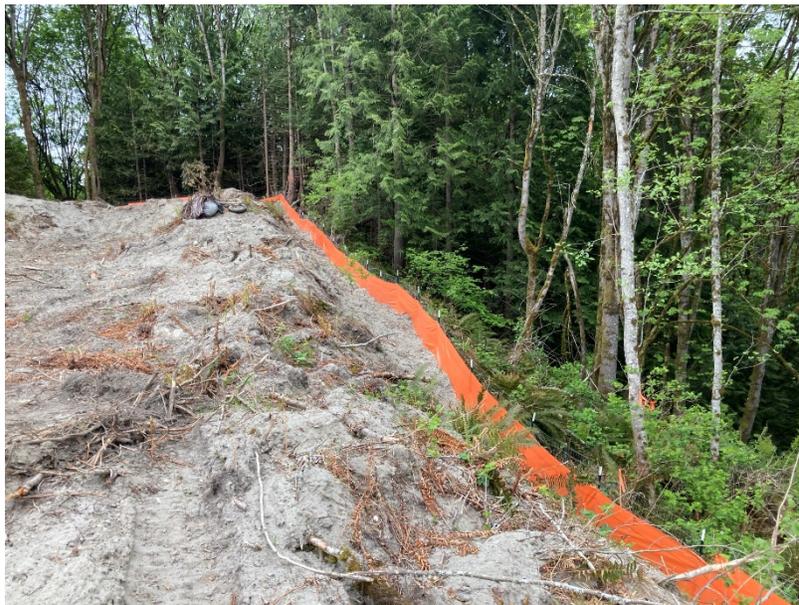
Figure 10 Description: The CESCL must evaluate sediment accumulation along silt fence. Maintain the silt fence as required in BMP C233. Remove sediment deposits when the deposit reaches approximately one-third the height of the silt fence, or install a second silt fence. Stabilize exposed and unworked soils as required in Condition S9.D.5.d.

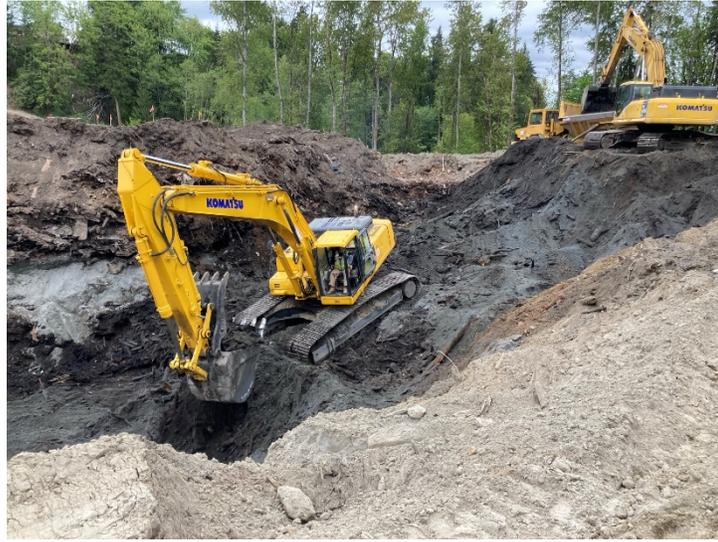
Figure 11 Description: On-going removal of landfill materials from the “wedge”.

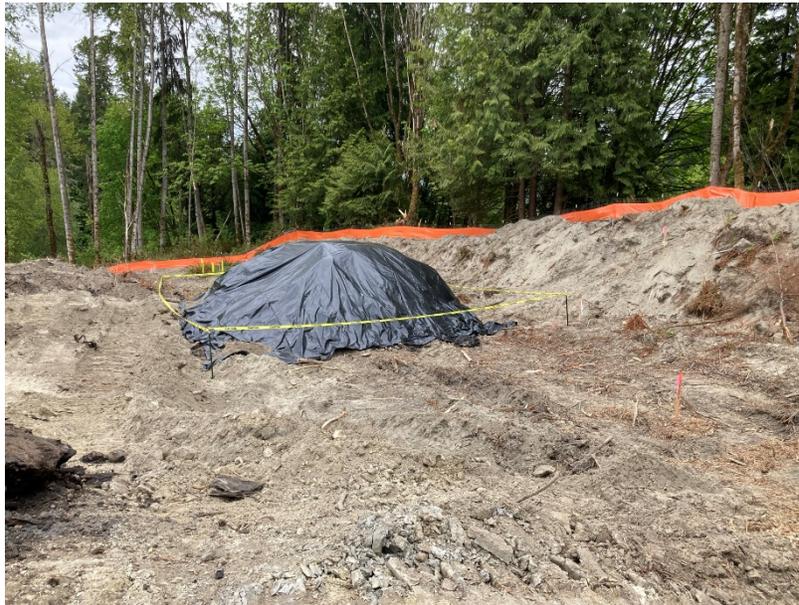
We observed a stockpile of soil covered with plastic sheeting. Initial screening indicated asbestos contamination. The permittee must remove soils that do not meet the Interim Action Soil Clean Up Levels.

Figure 12 Description: Stockpile covered with plastic. Initial screened suggested asbestos contamination.

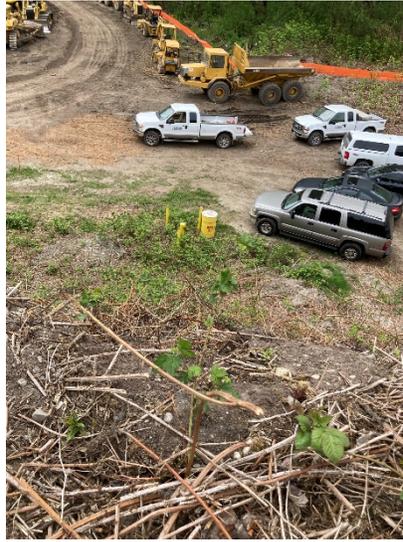
The site maintains a spill kit at the staging area near monitoring well 1. Operators have easy access to the spill response materials.

Figure 13 Description: Spill kit located next to Monitoring Well 1.

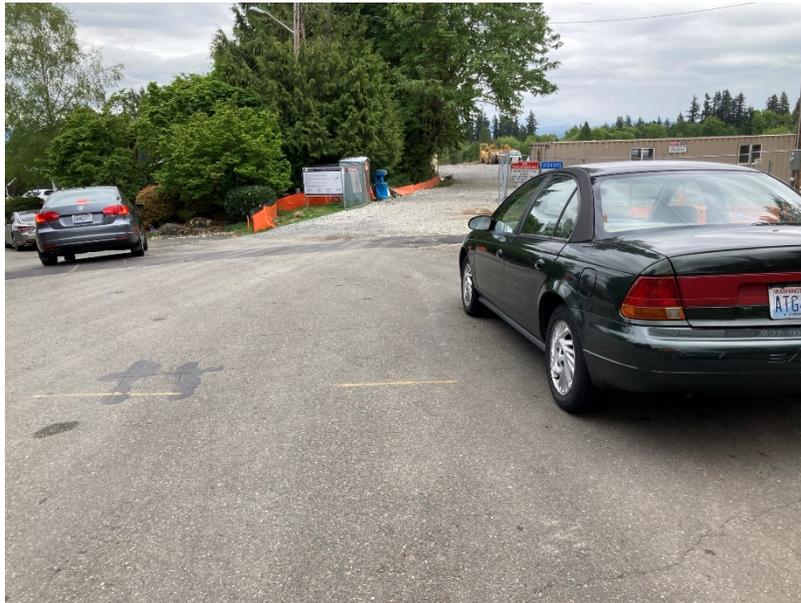
The permittee will inspect 108th Street for sediment track out. When necessary, the permittee will sweep the street remove track out from ingress and egress of the site.

Figure 14 Description: Slight track out on to 108th Street. Maintain the construction entrance as required in BMP C105. Clean 108th Street thoroughly at the end of each day or more frequently as necessary, as required in Condition S9.D.2.d.
